BOSTON GUILDHALL

ARCHAEOLOGICAL INVESTIGATION OF THE NORTH ELEVATION

Dr. KATE GILES
UNIVERSITY OF YORK

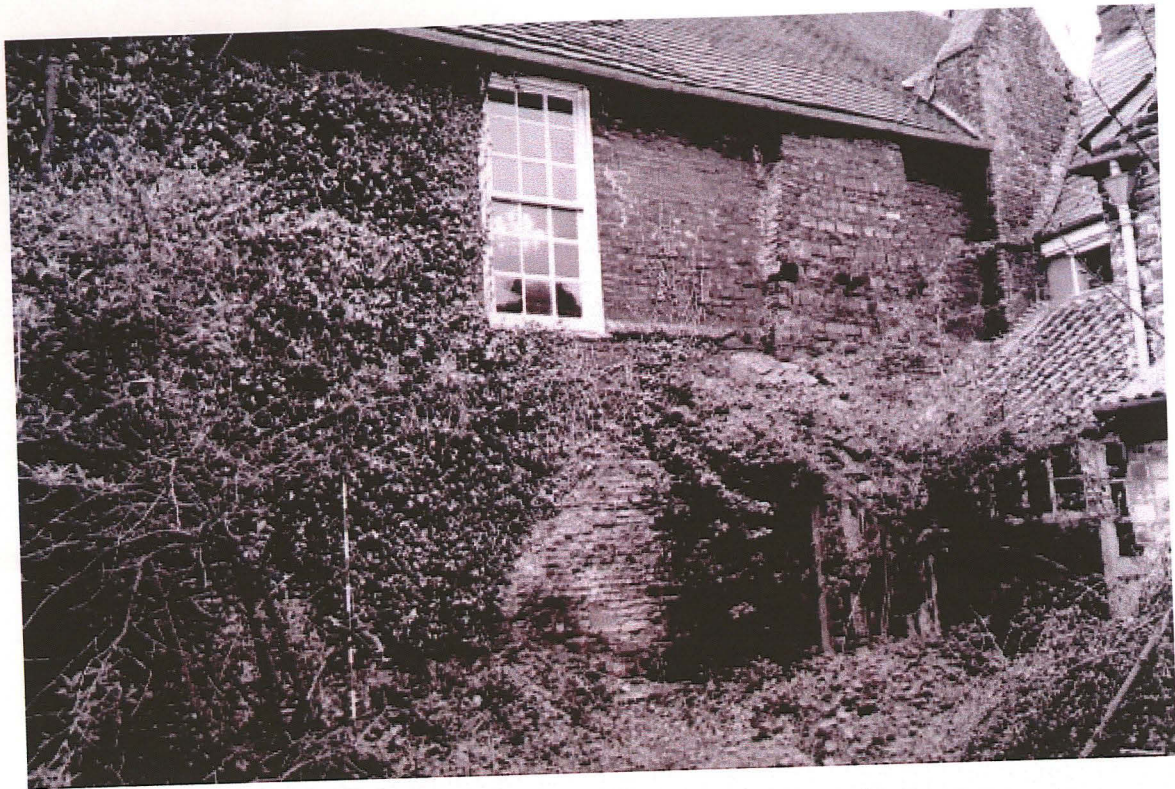
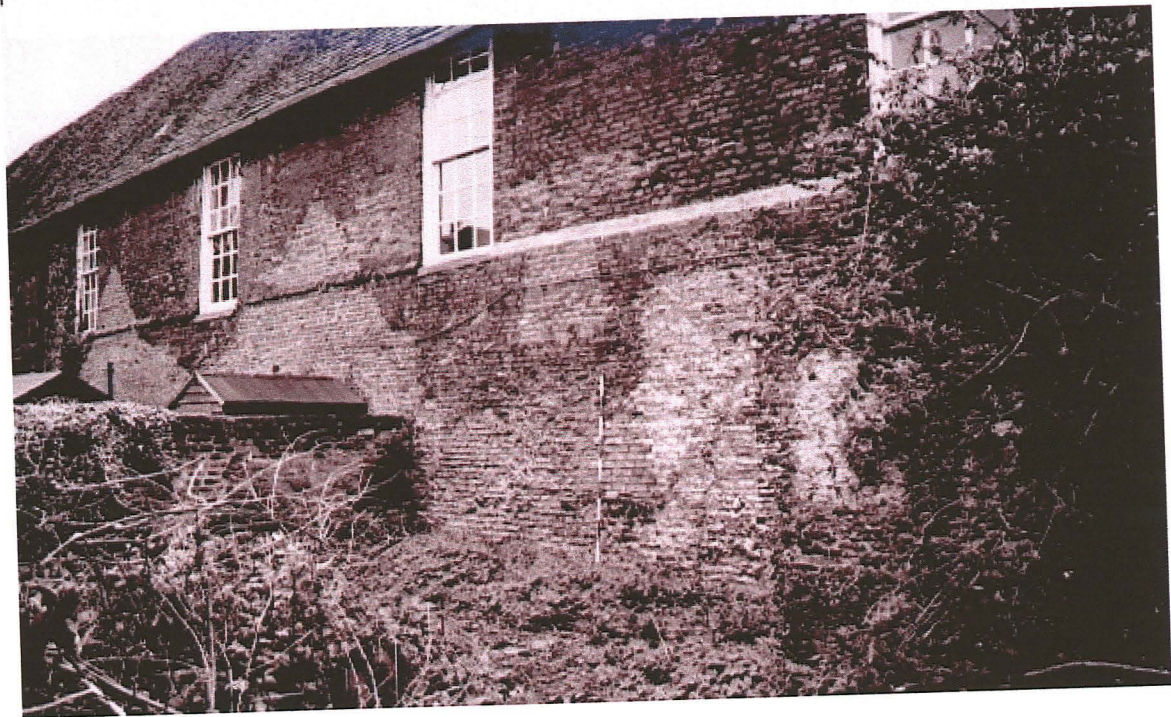
3.3.14 At first floor level the north elevation is also comprised of mainly fifteenth-century brickwork, although there have been several phases of repair and re-pointing (fig.7). The elevation has also been pierced by the insertion of a series of nine-over-nine eighteenth-century sash windows in bays 3, 4, 5, 6 and 7. The wall contains clear archaeological evidence for the cuts and fills associated with their insertion. It is likely that all archaeological evidence for the original fenestration of this elevation was destroyed in this process. However it supports documentary evidence which suggests that the positions of the eighteenth-century windows reflect that of their medieval predecessors.

Fig. 7 The Boston Guildhall, North Elevation, looking west (above) and looking east (below).

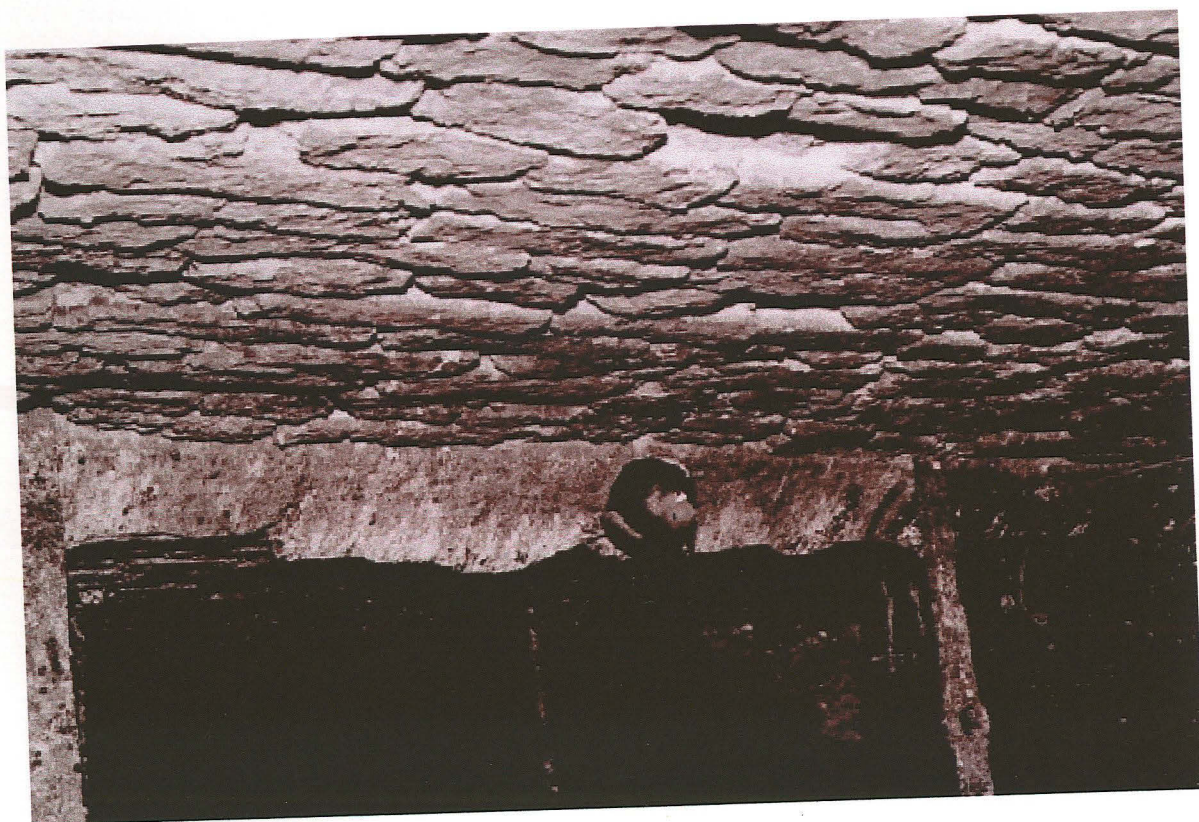
At present the north elevation appears to contrast with the west and south elevations since it does not appear to combine brickwork with masonry dressings. For example, the string course is comprised of cut and rubbed bricks rather than limestone. However, closer examination of surviving areas of the north elevation between the Guildhall and nos. 24-28 South Street reveals evidence for a limestone string course with the same moulding profile as that of its counterparts on the west and south elevations (fig. 10).

Fig. 10 North Elevation. Detail of string course from nos. 24-28 South Street.

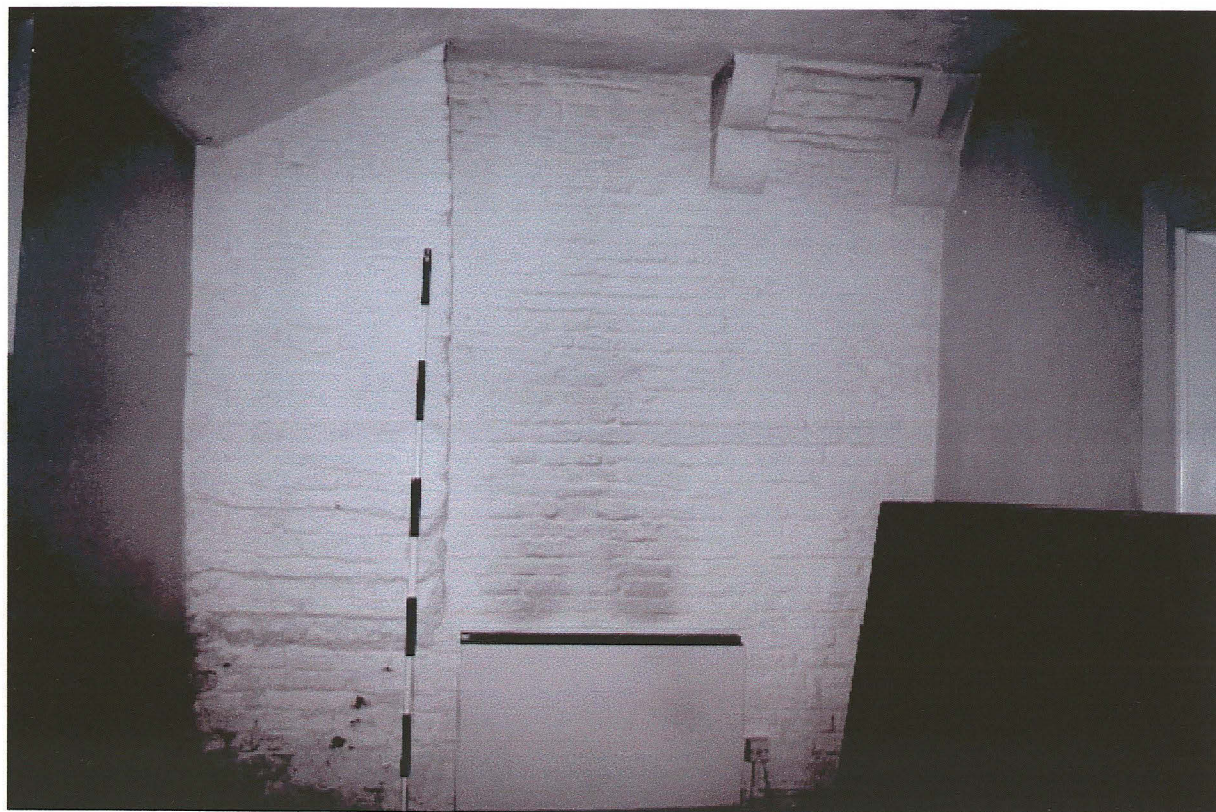
At the west end of the elevation it is impossible to access the lower part of the elevation except for an oblique view through an attic window in nos. 24-28 South Street (fig. 10). Visual analysis of this area suggests that there are no openings or doorways at ground floor level. This interpretation is also supported by the relative proximity of this area to the principal doorway of the Guildhall in the west elevation and the absence of evidence for internal partitioning in this area of the ground floor.

Fig. 11 North Elevation. Interior of no. 28 South Street.

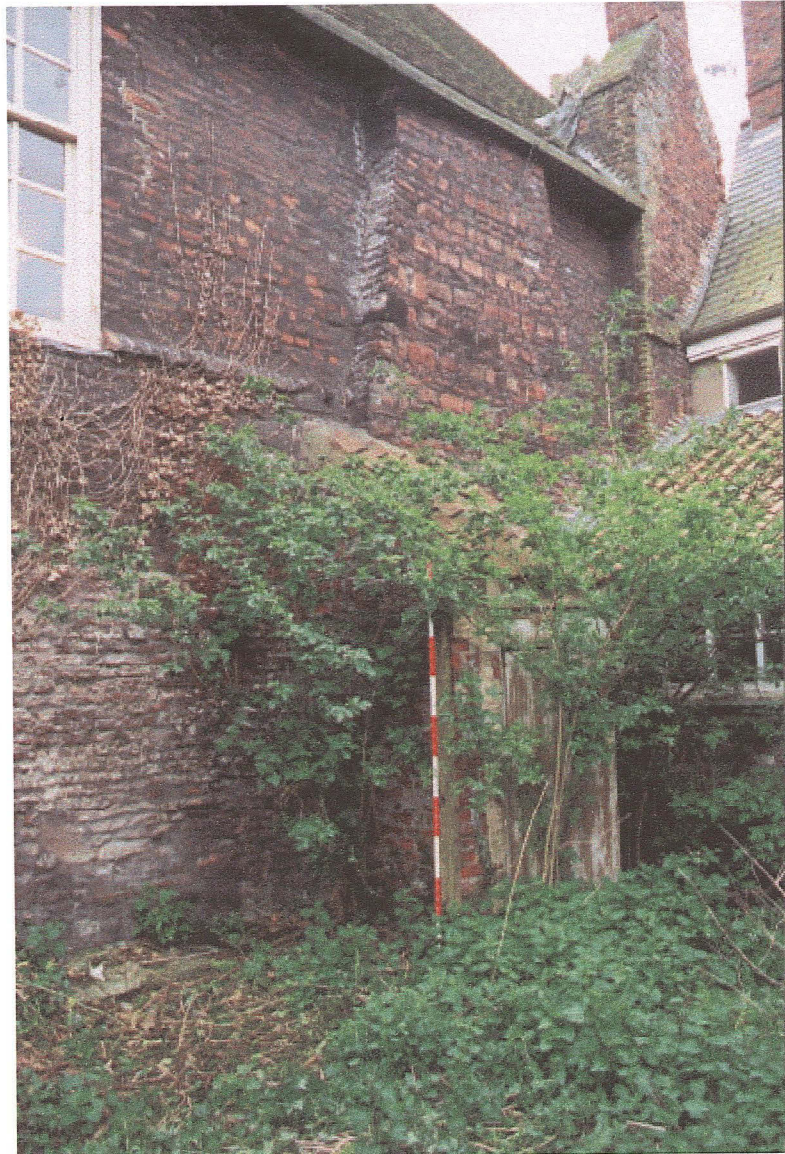
This area of the elevation also contains evidence of a substantial chimney stack abutting the north wall of the Guildhall (figs. 10-11). The stack is supported by two sets of limestone corbels; one of which is visible only within the out-shut to nos. 24-28 South Street. The stack has a straight joint running down its west face. This may indicate that it is an earlier stack, rebuilt during the eighteenth century with tumbled brickwork. Documentary sources suggest a date of 1717 for its construction.

Fig. 12 North Elevation. Detail of chimney stack at first floor level.

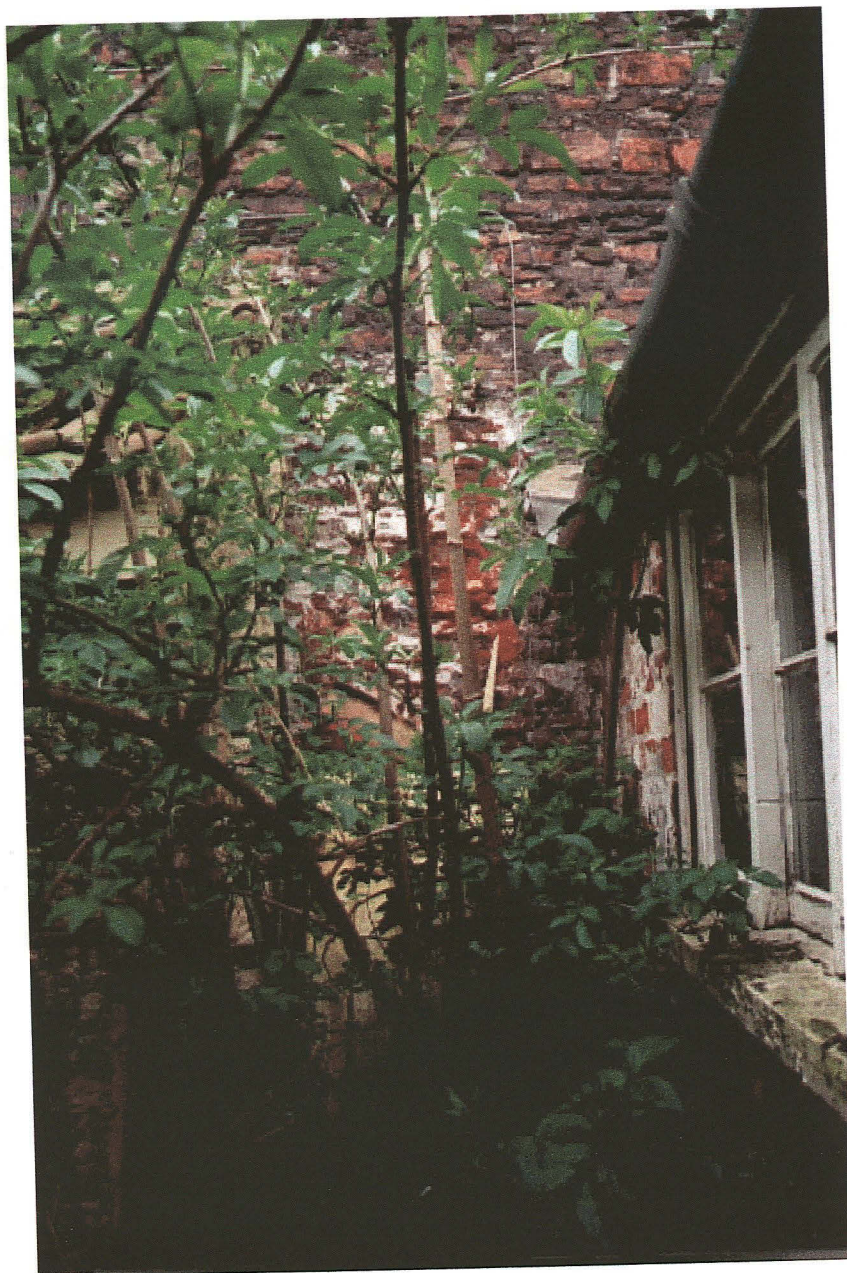
3.3.3 To the east of the out-shut is an area of brickwork obscured currently by a buddleia tree (fig. 15). However behind the vegetation the surface of the wall is covered in plaster and red paint. This area of render continues eastwards and is exposed in the interior of the surviving brick privy and on the surface of the north wall exposed to the east (004; fig. 15-16). It is a relatively recent feature which indicates some common use or maintenance of a series of small privies and out-shuts abutting this area of the north elevation.

Above it is another area of plaster (007; fig. 15-16) which does not appear to have been painted. It may relate to the pitch of the roof of the buildings in this area; a hypothesis which is supported by evidence of the remains of metal brackets still protruding from the surface of the wall at this level.

Fig. 15. North Elevation, West Section.

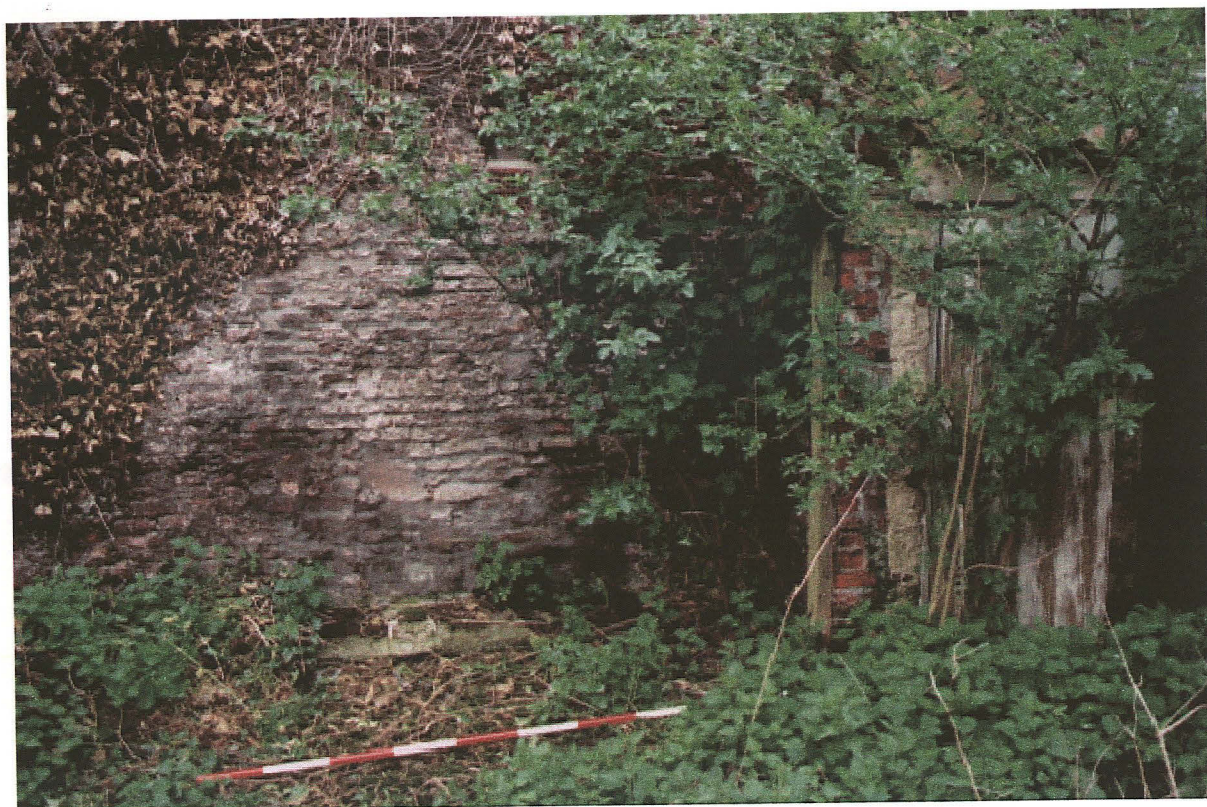
The wall here does not appear to have been plastered or painted in this area. This may be explained by the presence of a toilet and cistern – the base of which survives (fig. 16). Alternatively it may be explained by a difference in ownership or maintenance of this out-shut.

Fig. 16 North Elevation, West Section.

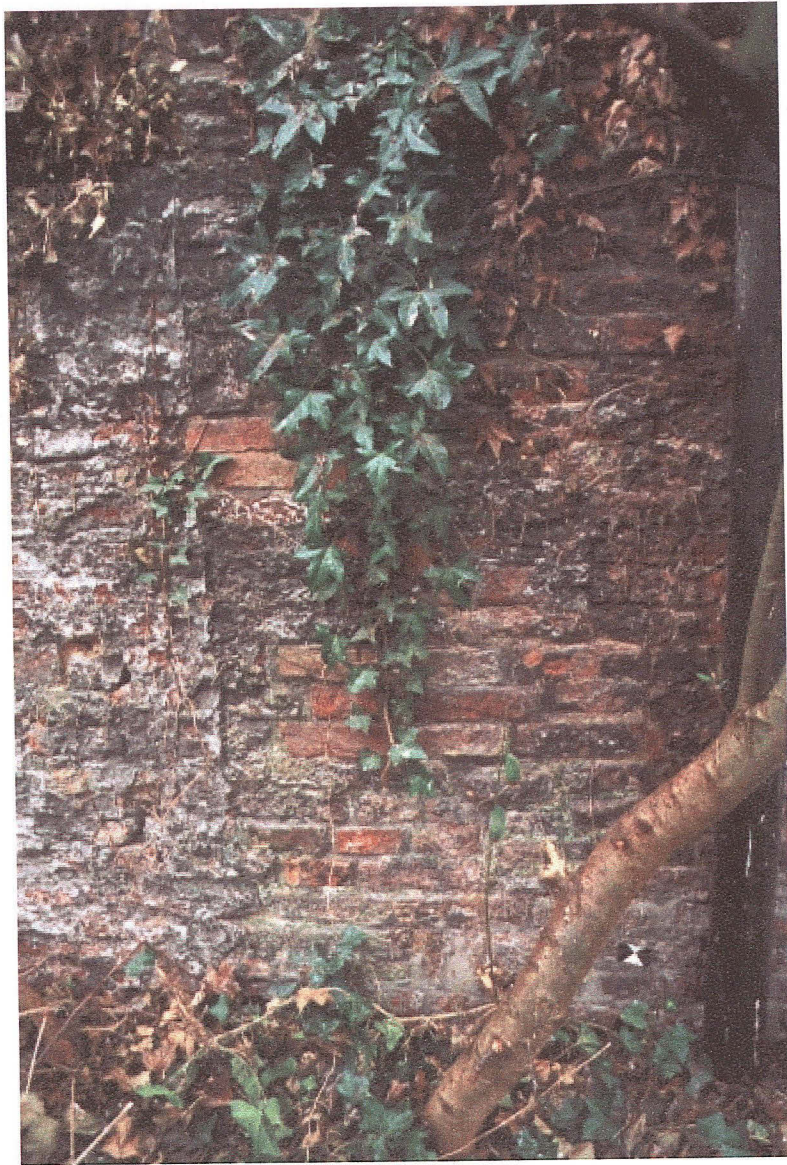
3.3.4 Sadly the area east of these features is largely obscured by vegetation, in the form of a buddleia tree and ivy covering the surface of the wall itself. Internally these bays are also obscured by boards (fig. 17). Although an attempt was made to establish the possible presence of former openings, the only archaeological features visible were an area of plaster (008) and a straight joint (009, 010) to the west of the drainpipe.

Fig. 17 North Elevation. Vegetation and detail of drainpipe.

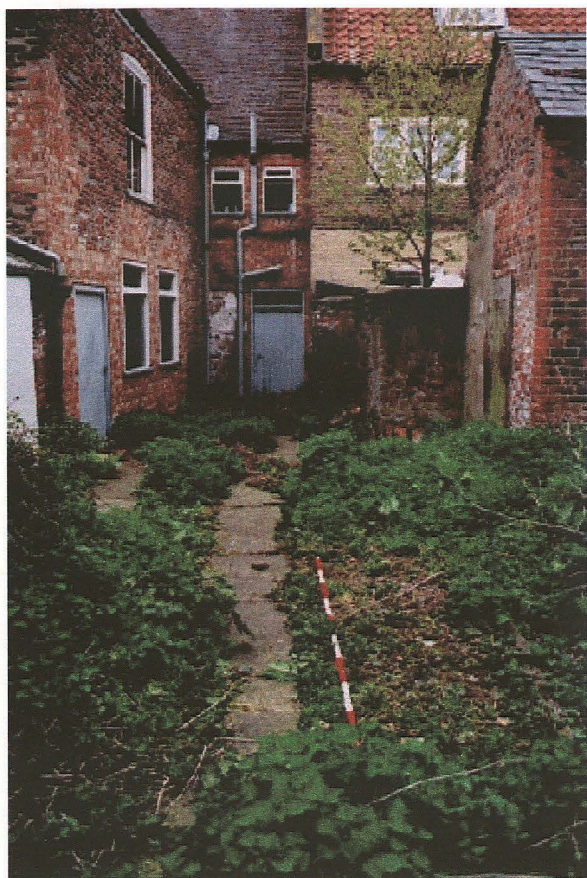
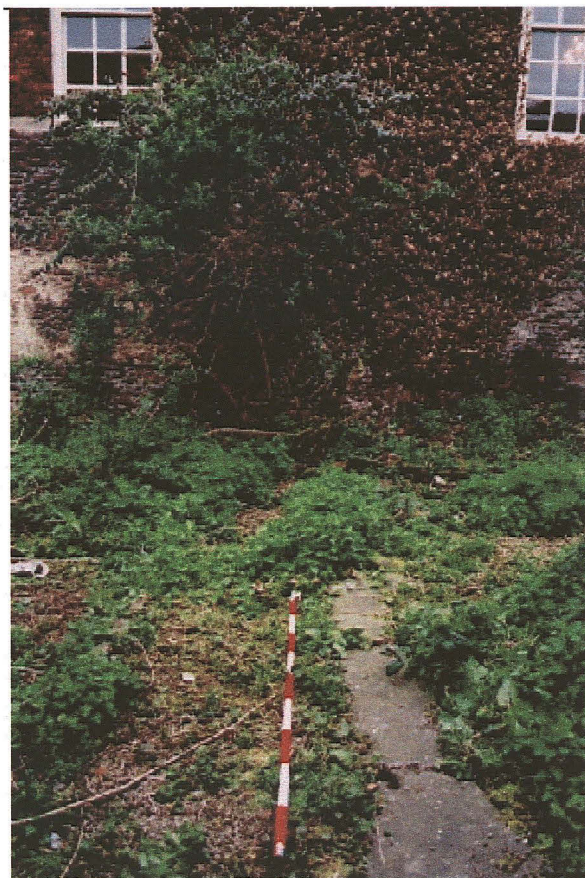
The area of plaster (008) appeared to extend underneath the ivy for some distance. It terminates in a clearly defined line (fig. 18) which corresponds almost exactly with the position of the footings of boundary wall running north of the elevation towards Spain Lane. This appears to represent the boundary line of an historic passage through to the Guildhall from Spain Lane which is visible on Hall's map of 1741 and the OS map of 1887. It has subsequently been in-filled.

Fig. 18 North Elevation, showing property boundary and building line running north-south.

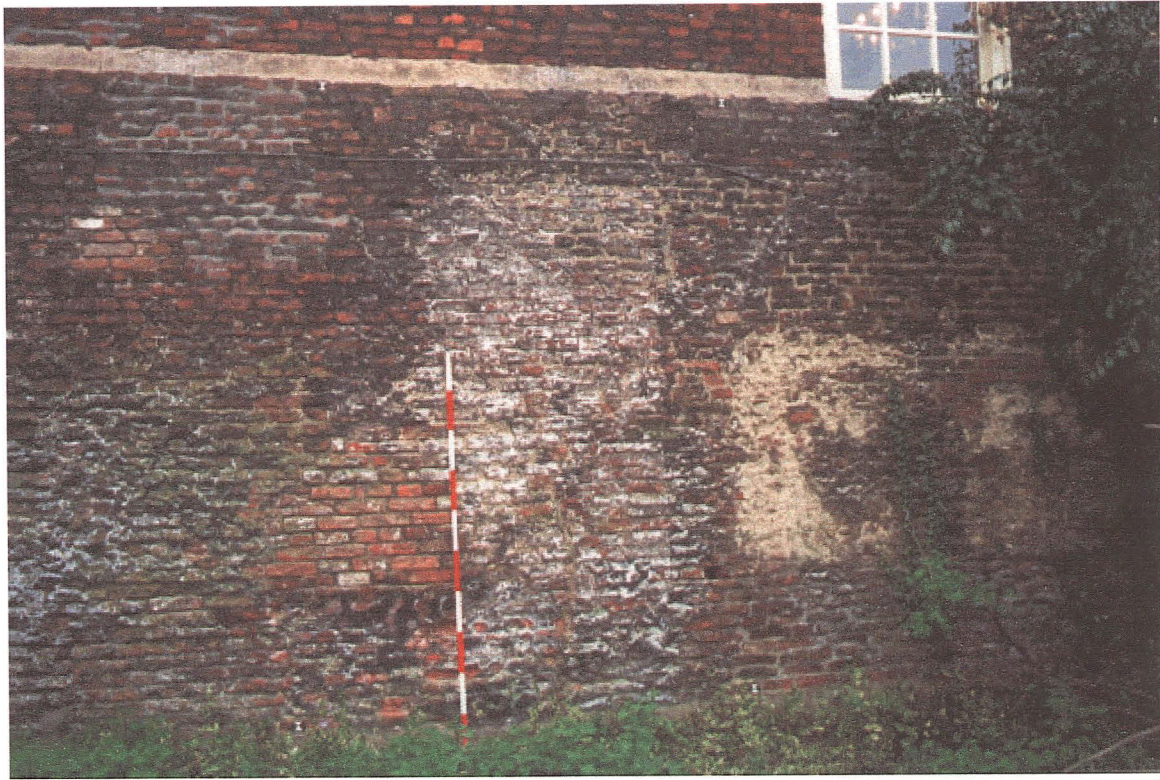
3.3.11 In the upper part of the medieval brickwork (001), to the west of the present eighteenth-century sash window is an area of re-pointed brickwork (024, 025; figs. 20-21). This appears to be a cut and fill which consists of a mix of re-used medieval and later brickwork. A small area of the fill has subsequently been replaced with modern brickwork (035, 036). The interpretation of this feature is problematic. It may be associated with the upper part or roof of a former building.

Fig. 20 North Elevation, East Section.

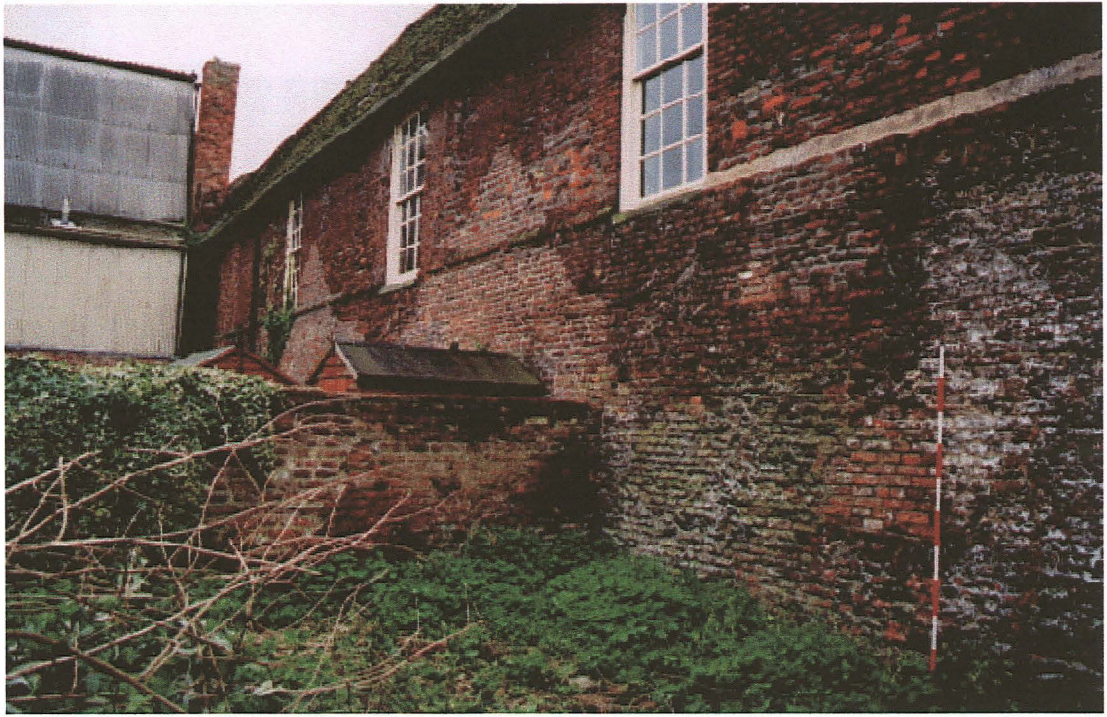
Fig. 21 North Elevation, East Section.

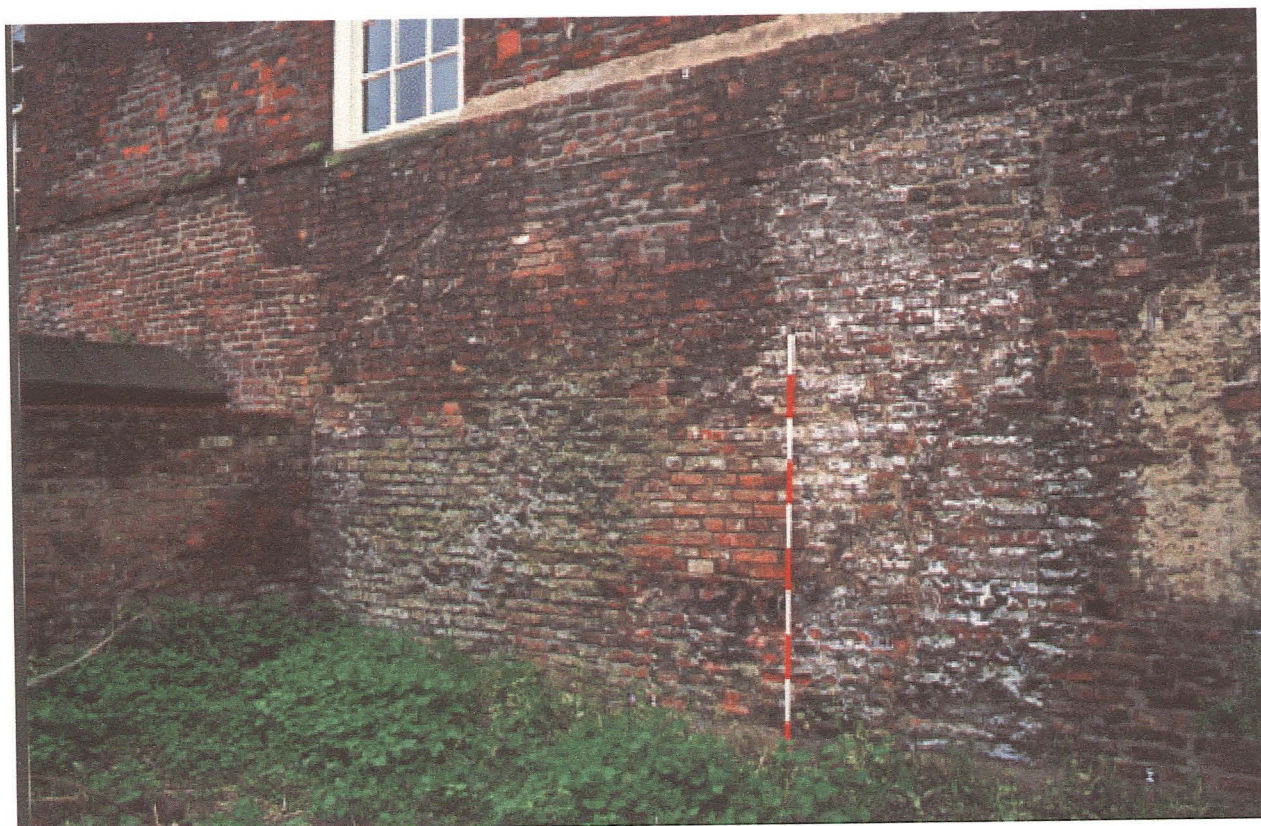
Fig. 22 North Elevation, showing doorway.

4.2.1 The archaeological analysis presented above *has* identified evidence of one former opening in the north wall. However it is *not* recommended that this former doorway be re-opened for the following reasons:

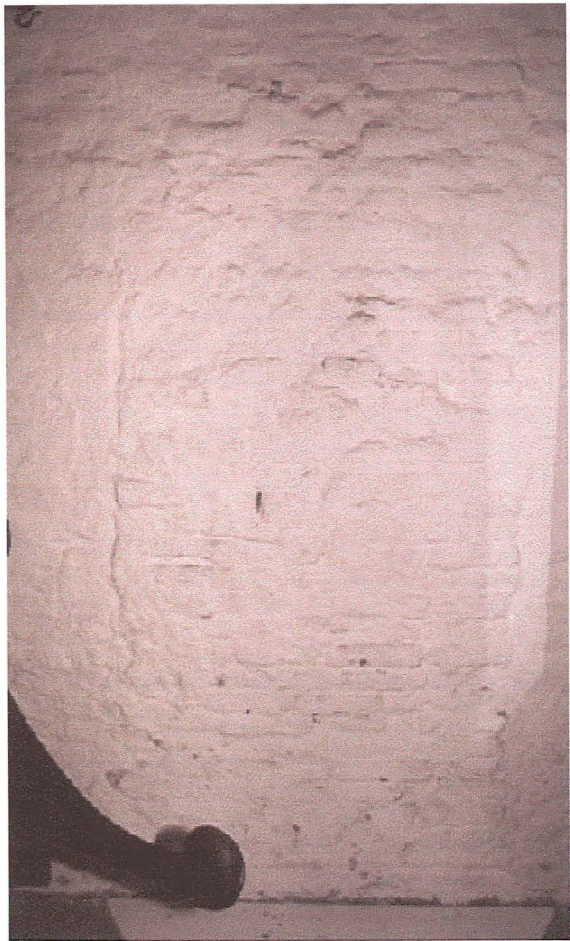
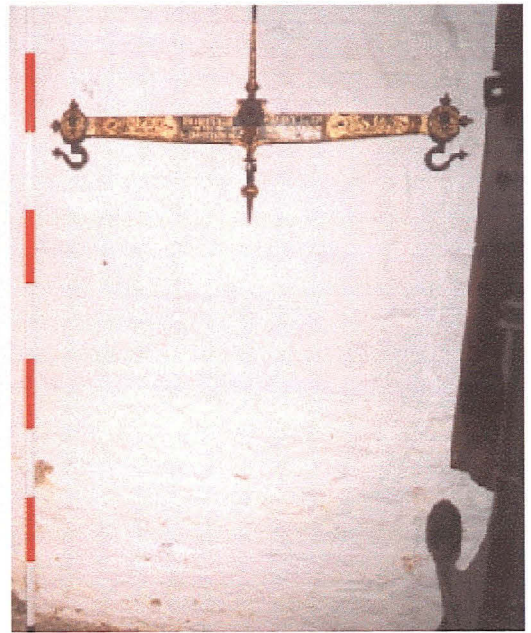
Evidence to support this interpretation can be found on the interior of the building, where straight joints are also visible in an exposed section of the wall (fig. 23). The narrower width of this feature suggests that the doorway was rebated internally. The visual difference in the level of the two openings can be explained by the raising of the external ground surface over time on the north side of the building.

Fig. 23 North Elevation, interior, showing doorway and aumbry.
