**BUILDING RECORDING OF  
THE ROOF OF A SMALL  
TOWER/BUTTRESS  
ATTACHED TO HADLOW  
TOWER, HADLOW, KENT**

**PCA REPORT NO. R11115**

**NOVEMBER 2011**

**Building Recording during the dismantling of the roof of the south small tower/buttress attached to Hadlow Tower, Hadlow, Kent. TN11 0EG**

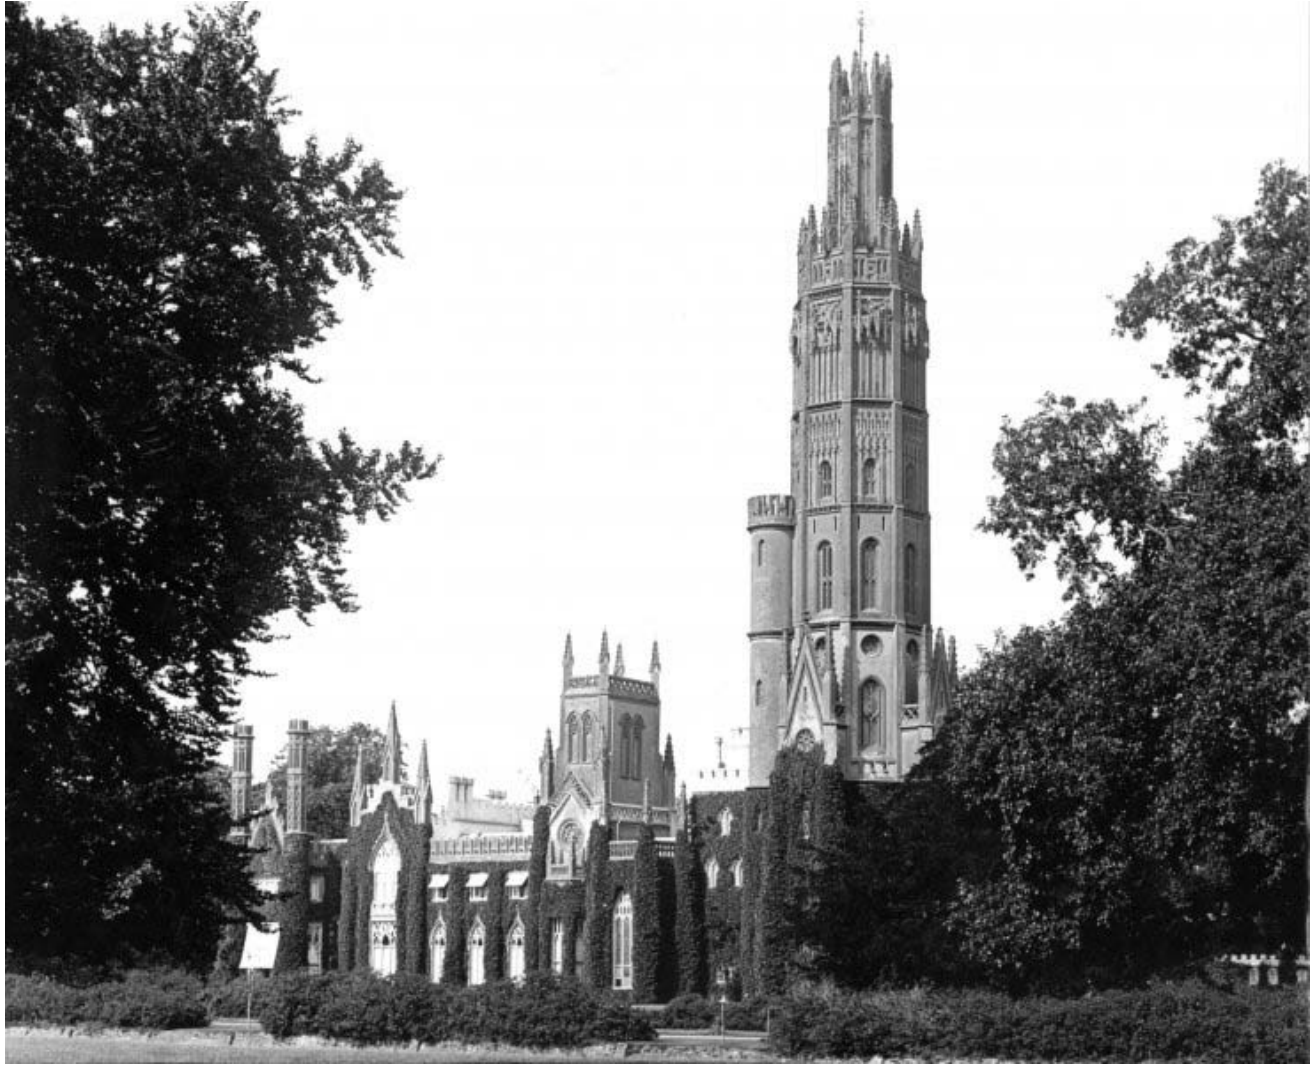
**Plate 1.** Hadlow Castle and Tower in 1901, viewed from the southeast. The roof structure which was recorded lay behind the steep Gothic gable and pinnacles topping the small ivy covered tower/buttress abutting the garden (south) side of the main tower.

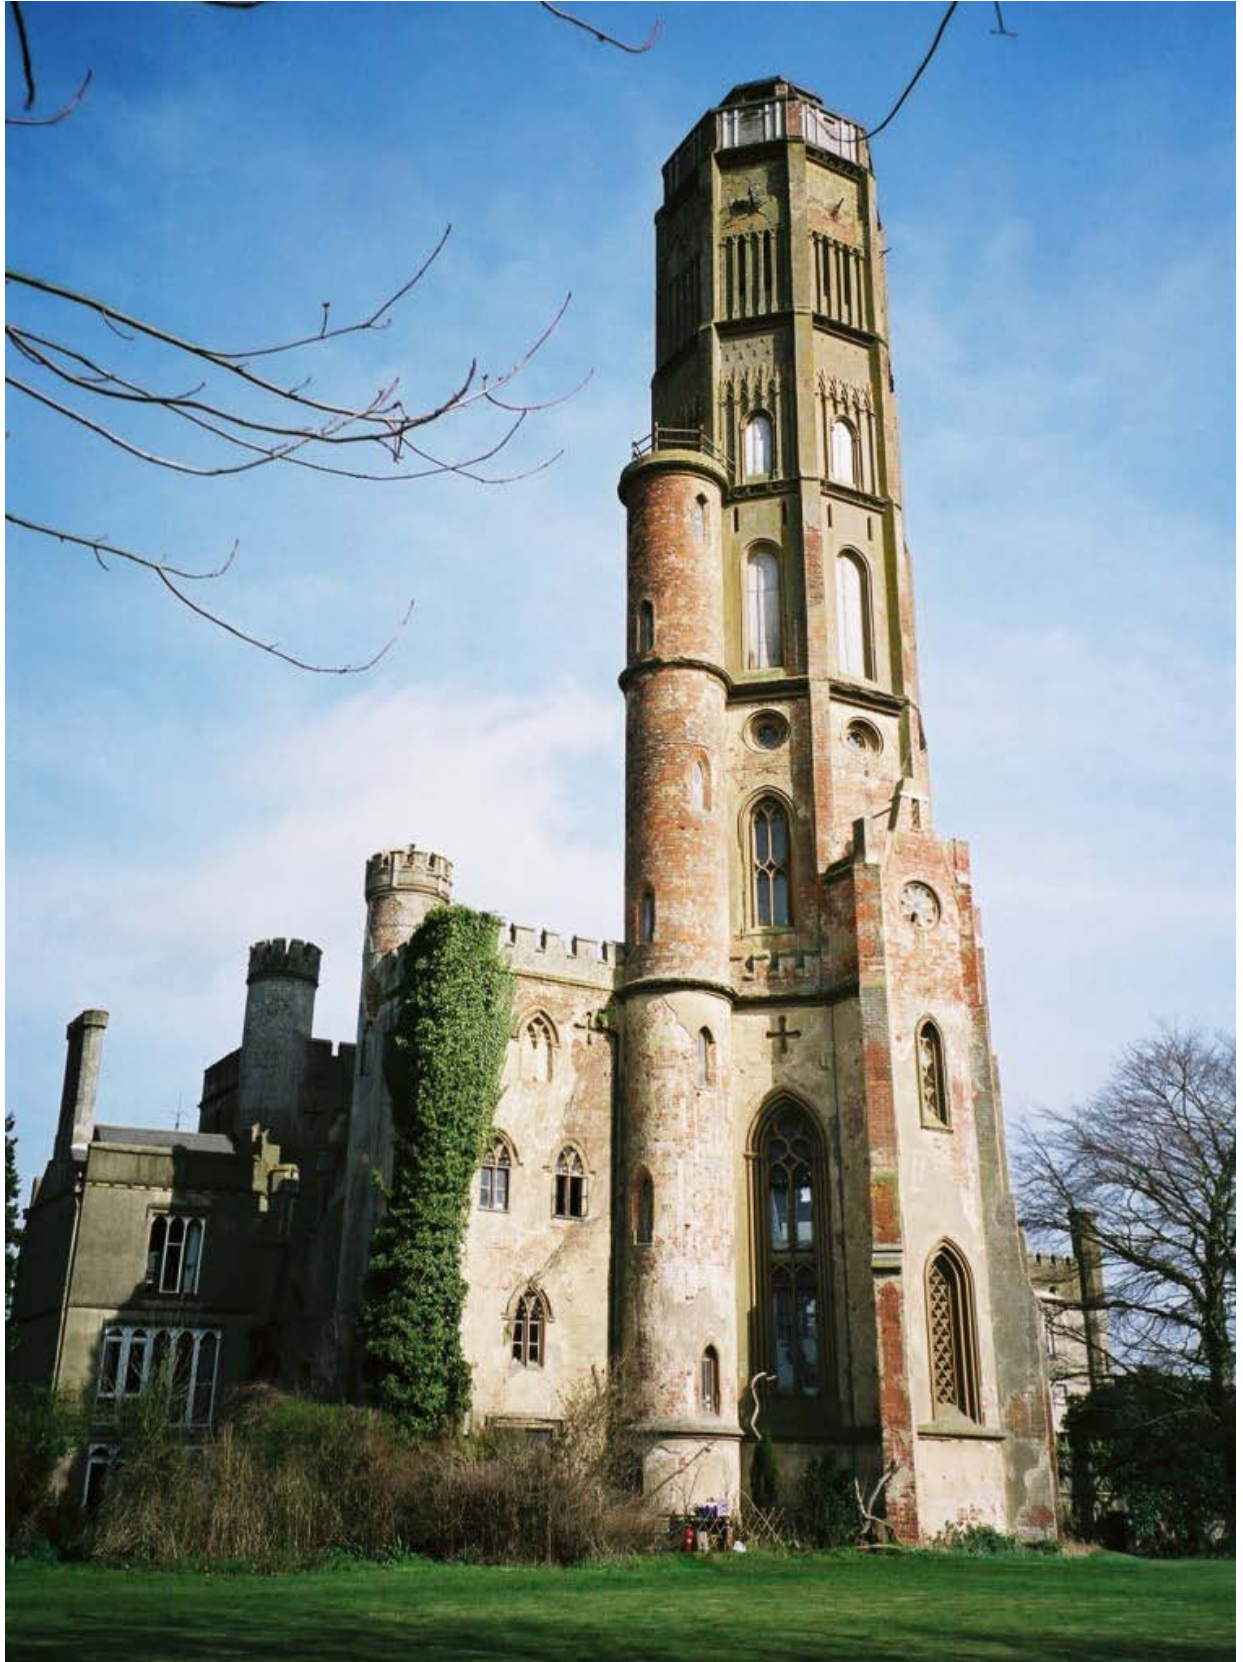
- 3.1 As part of the ongoing program of restoration works a lift shaft is being installed in the small rectangular brick tower/buttress against the south side of the main tower to provide access to all levels up to the fifth floor. The top of this rectangular tower/buttress originally had a steep Gothic style gable flanked by decorative pinnacles (**Plate 1**). However, following urgent repairs by Tonbridge and Malling Borough Council in the mid 1990s to make the building safe, these decorative elements were removed (**Plate 2**).

**Plate 2.** Hadlow Tower looking northeast.

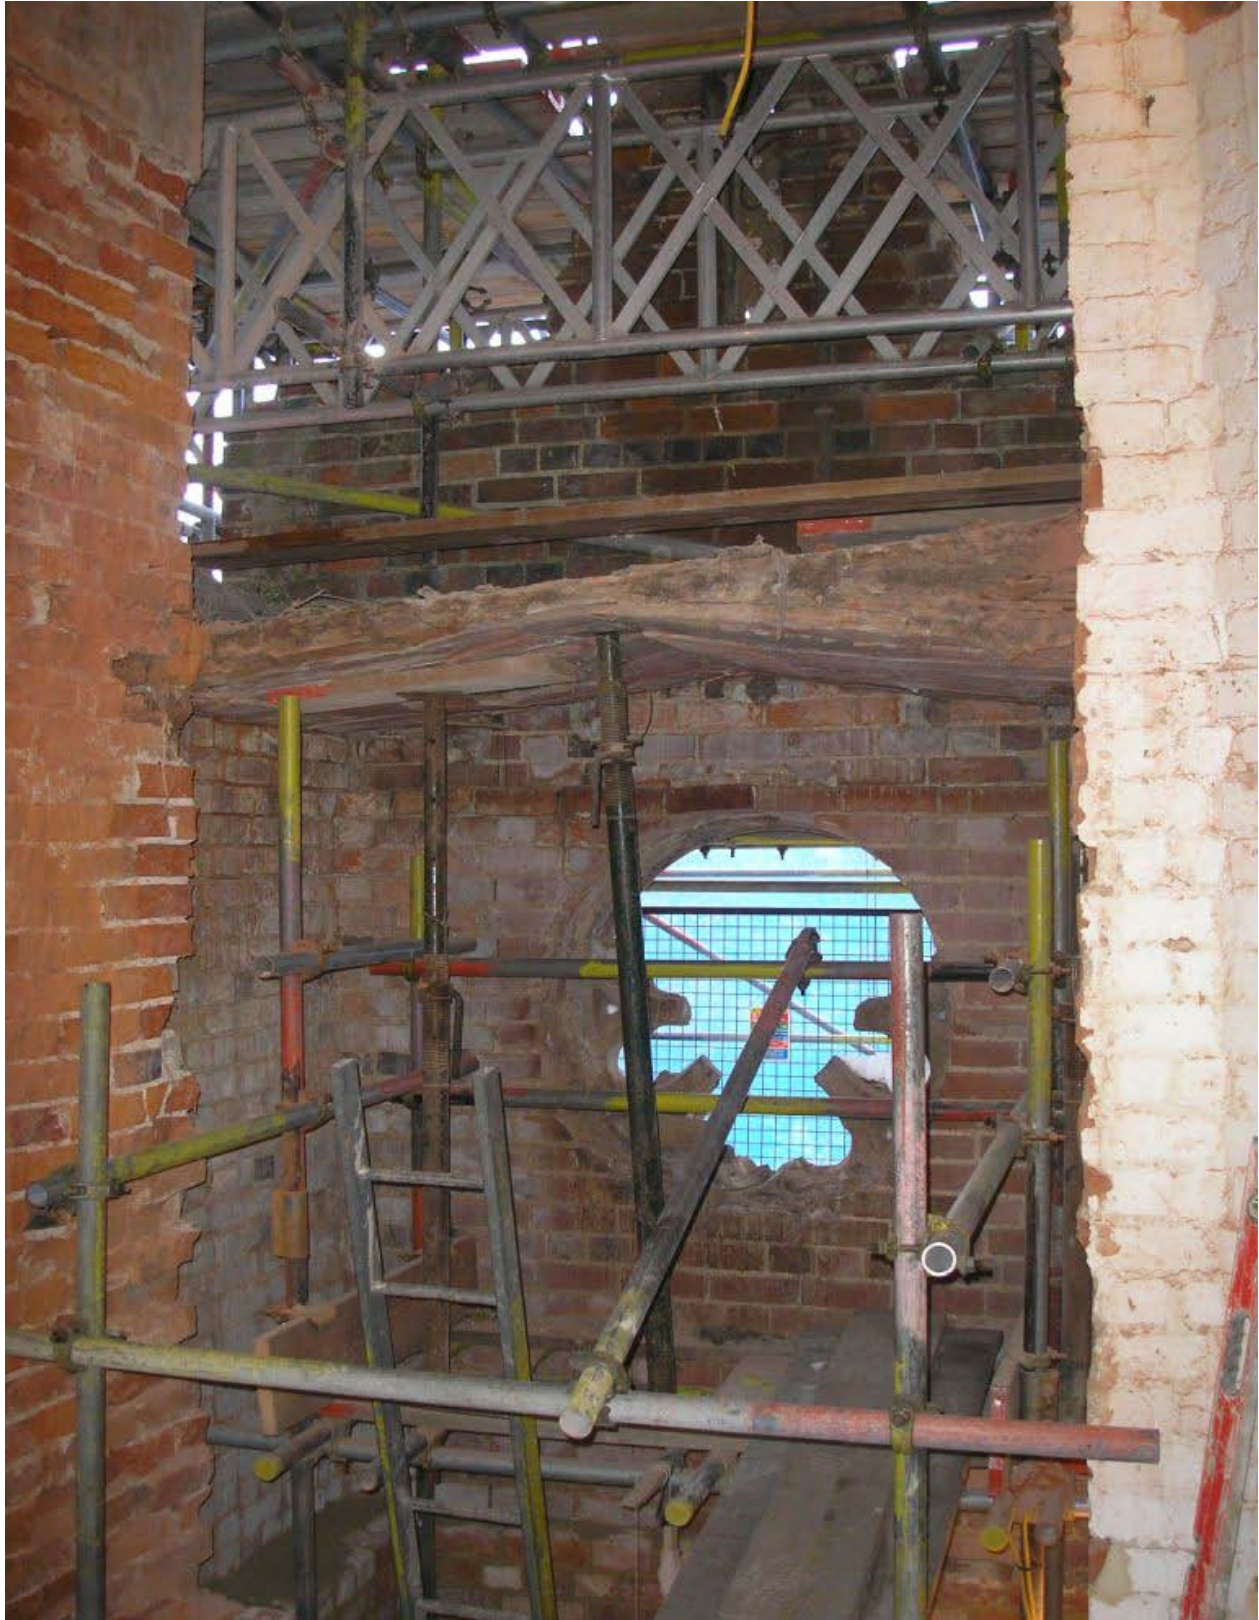
- 5.1 The roof that was recorded was situated on the fifth storey in the small rectangular brick tower/buttress against south side of the main octagonal brick tower. It sloped from west down to the east (**Figure 5; Plate 3**). The fall of this slope was approximately 20cm. The underside of the roof had peg tiles pressed into mortar and had two slopes to east and west with the apex running north south at right angles to the main wall of the tower. The upper surface of the roof had a thin coating of a bitumen type material over a cement mortar screed.

- 5.2 The roof structure was exposed in cross section since a large opening had been made in the south wall of the tower for the new lift. The south wall was 0.73m thick and constructed from red brick with a white lime mortar (**Plate 3**).

**Plate 3.** The recorded roof viewed from inside main tower, looking south.

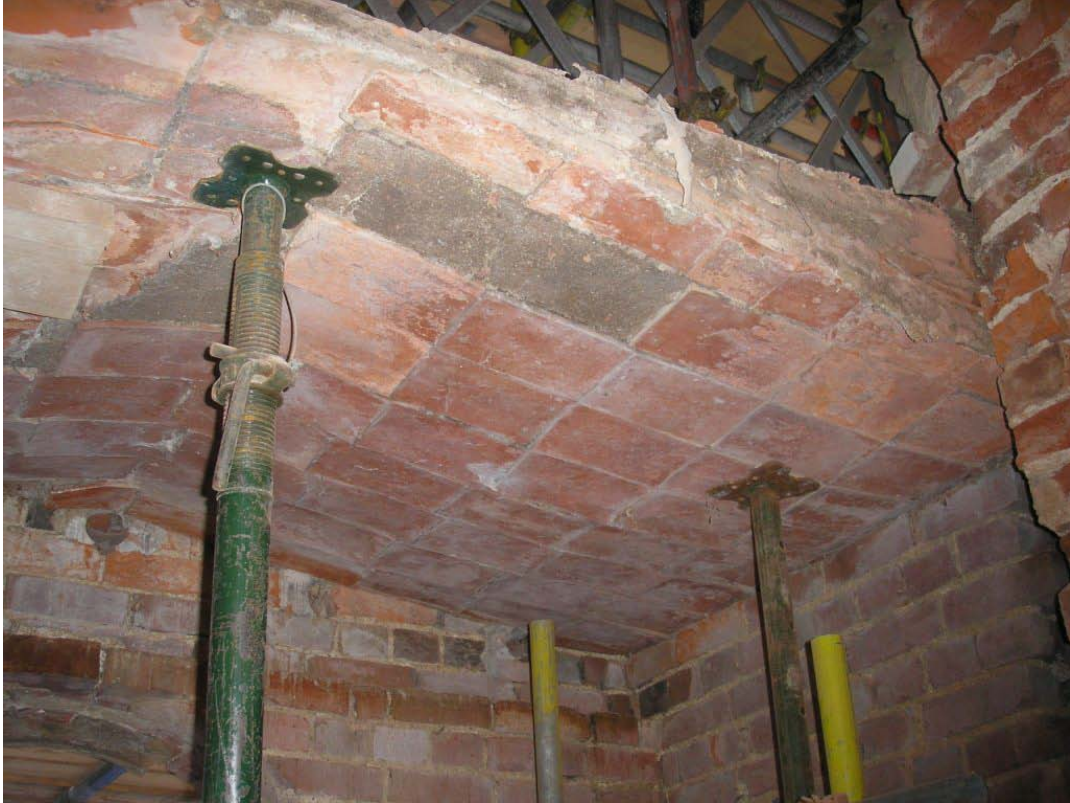
- 5.3 Dismantling of the roof by the building contractors showed that the red peg tiles on the underside of the roof (**Plate 4**) were held in position by a hard, grey cement mortar, possibly of late 19<sup>th</sup> or early 20<sup>th</sup> century date (Kevin Hayward pers. comm.). The peg tiles on average measured 25.5cm x 25cm x 1cm with small square holes and appeared to be of 19<sup>th</sup> century date. On the east side, the upper and lower surfaces of the roof were almost parallel and no more than 0.1m thick and consisted of several layers of peg tiles and cement mortar. There was no additional support for this structure such as timber joists or steel bars (**Plate 5**).

**Plate 4.** Peg tiles on the underside of the roof, looking southwest.

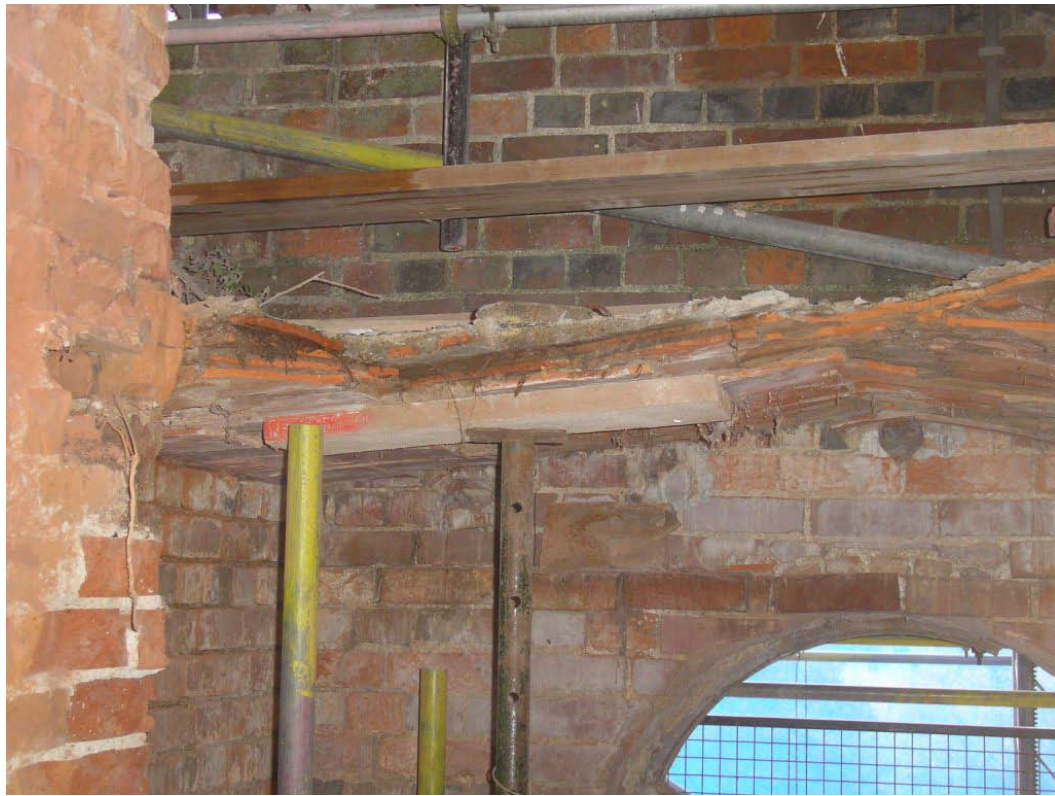
**Plate 5.** East side of roof showing tile construction topped by a concrete screed, looking southeast.

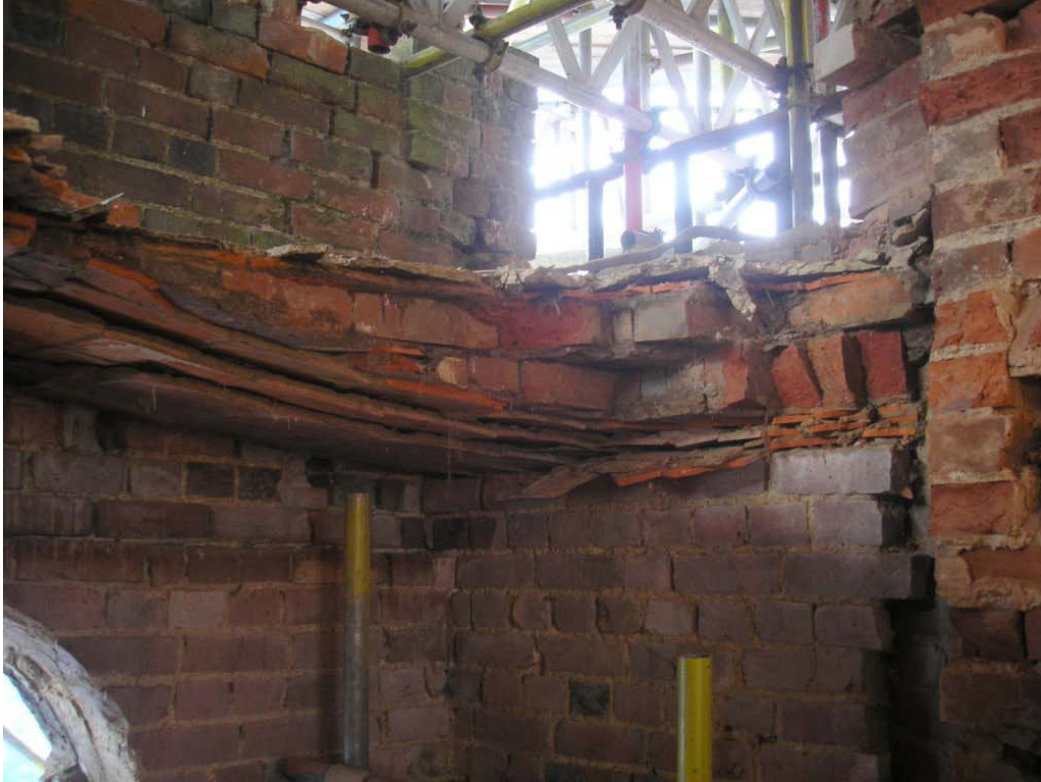
- 5.4 The west side of the roof was thicker as the upper surface sloped up and the underside sloped down to the east (**Plate 6**). The underside had two courses of peg tile held in position by a cement mortar with several more layers of tile added close to the side wall in an attempt to level off the top of this tile layer. Two courses of red bricks had been laid on top of this tile layer and towards the thinner centre of the roof these bricks had been reduced in thickness. The bricks were on average 23cm x 11cm x 7cm and beneath the grey cement mortar showed traces of a white lime mortar, showing that they had been reused. The size, shape and fabric of the bricks were very similar to those used in the walls of the small tower/buttress and they appeared to be 19<sup>th</sup> century in date. They were slightly darker in colour than the red bricks used in the walls of the tower. The rectangular structure abutting the tower had been built against the tower with a clear vertical construction joint between the two showing that the small tower/buttress was a later addition to the main tower. In addition, the brick courses of the two parts of the building did not align.

**Plate 6.** West side of roof showing brick and tile construction, topped by a concrete screed, looking southwest.

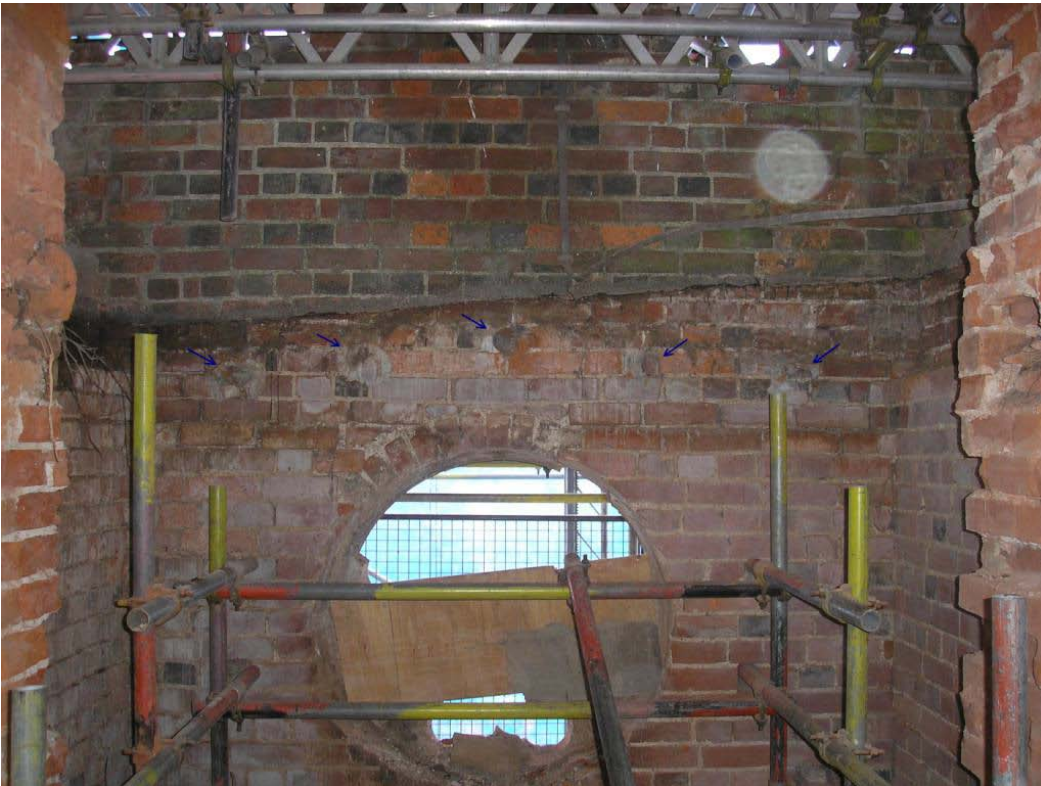
- 5.6 The east and west side walls of the small tower/buttress had a single brick step at the same height which supported the roof and appeared to be part of the original design of the building. However, the parapet walls above had clearly been truncated. Once the removal of the roof had been completed, its outline was left as a scar on the interior elevation of the south wall which it had abutted (**Plate 7**). Just below the underside edge of this were five small, approximately circular grey mortar scars that coincided with some slight damage to the face of the brickwork. These scars were evenly spaced with one at the apex of the underside of the roof and two on each side. It appears that the scars mark the position of temporary timber beams that supported boards that in turn supported the roof (tiles, bricks and cement mortar) during construction. Once the cement had hardened the supporting timbers and boards were removed.

**Plate 7.** Roof removed leaving sloping scar on brick gable and small circular scars just below underside of roof indicated by arrows, looking south.
