Bentfield Bury Farm, Stansted Mountfitchet, Essex.
Description and analysis of a timber-framed granary. Surveyed 19 03 2011.

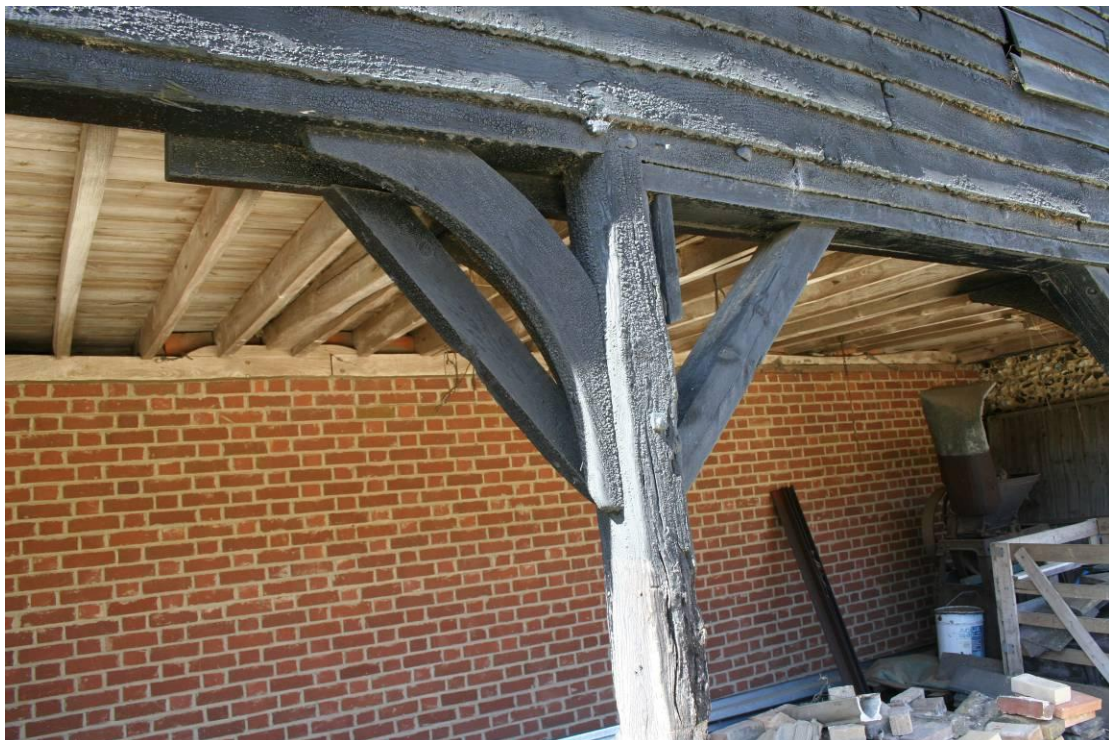
Support post showing original curved brace and later repairs.

The upper floor is supported on five square posts which have been much eroded by cattle and the three central ones have their bases encased in concrete plinths. Each post was originally braced with machined curved braces to the bresummer and tie-beams. Some have been replaced with straight MC20th machined timbers nailed in place.

It is known that the repairs to the posts were done on a running basis in the 1950's and 60's to counteract the damage done by cattle that were byred here. (Farm Manager - pers comm).

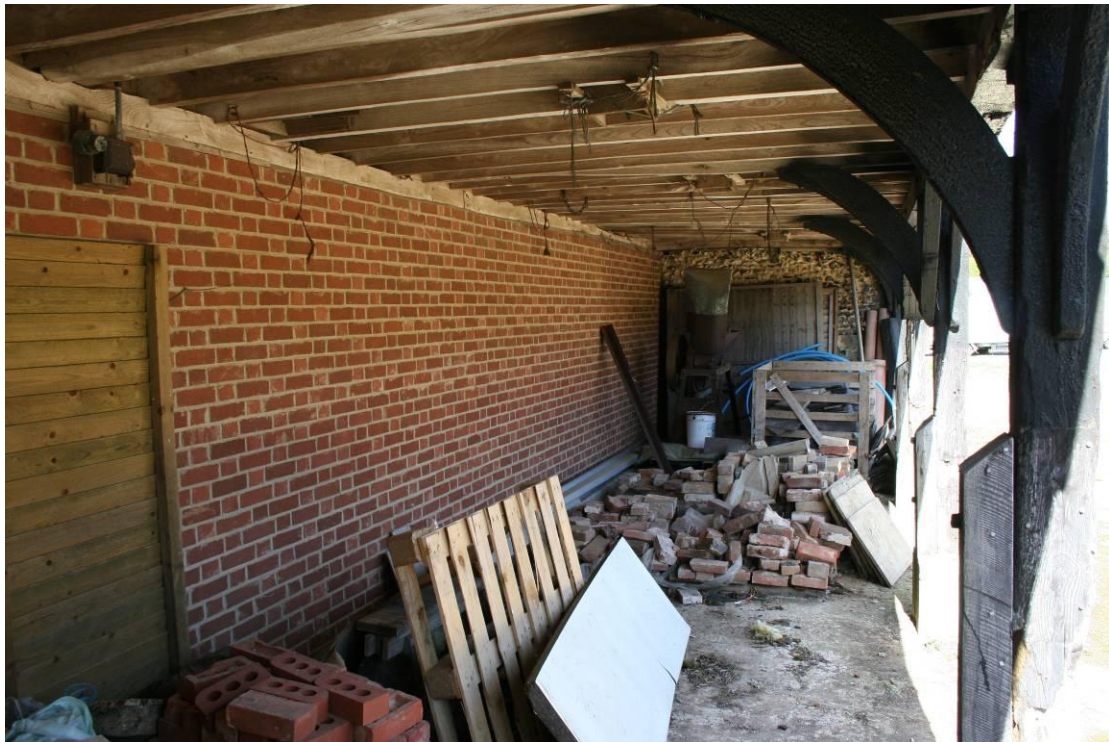
Modern spine wall replaces the original.

The spine wall is a modern replacement of the original which collapsed in the 1970's and was rebuilt using 60x95x210mm, textured reds with large rectangular frogs, bedded in white cement mortar. The terminals of the original wall are still visible in the end elevations. It is evident that the end walls which are executed in red, 65x110x235mm bricks with flint panels were not part of the original design but have been built a little later. That to the north actually sits outside of the plan of the building.

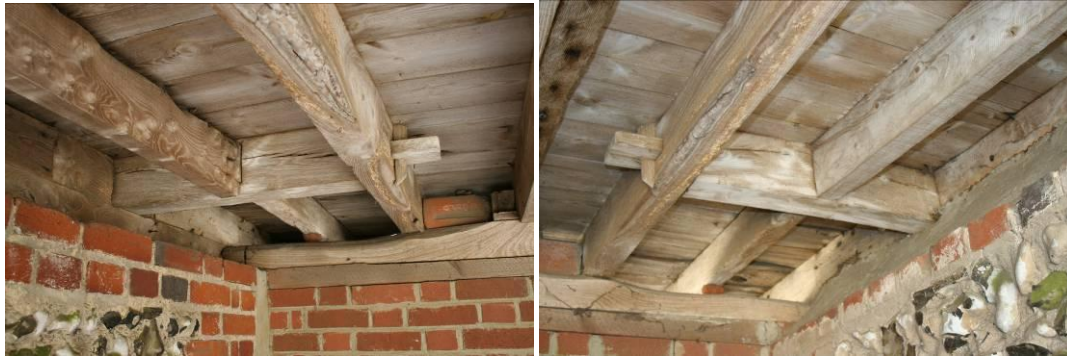
The cantilever supports for the lucam. East (left) and west sides of the building.

Also visible in the floor structure on both sides of the building is the cantilevered support for the lucam situated on the south end of the building. These are tenoned through the second joist along and retained with large wedges. The intermediate joist is tenoned and nailed in position in the flank of the cantilever. The lucam is described in the south elevation.

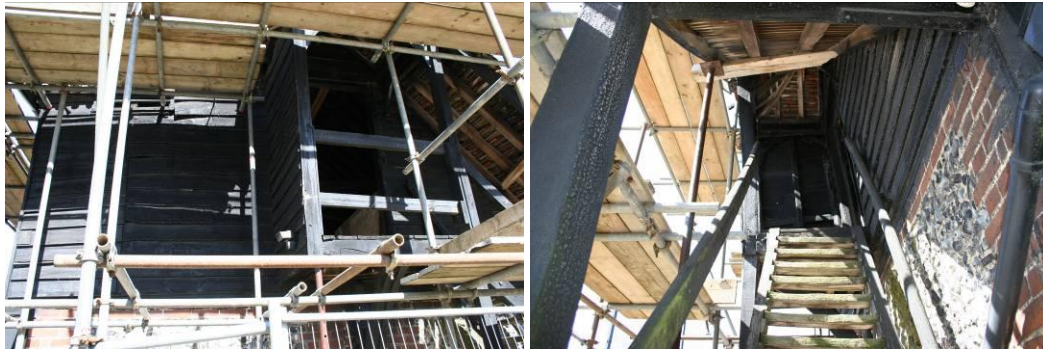
The lucam from the south. Looking up the ladder. Note iron bracket at top right.

The lucam is currently in a parlous state and is supported by scaffold poles. Originally it was self-supporting on the cantilevered beams and a curved bracket to the underside and reached by the staircase ladder which is held on wrought iron hooks and can be removed. This would have made the granary secure from theft and rats but also allow a much wider passing space between the building and the farmhouse wall when the ladder was not required.

The ladder itself is made of machined softwood with 16 steps of a very shallow 4in tread. This was so men could carry hundredweight bags up on their backs without straining their legs on high steps. The ladder is constructed like a staircase and is reinforced with long wrought iron bolts secured with square and hexagonal nuts.

There is a long sloping tiled roof above the ladder which has been added later. The evidence for this is in the way the timbers have been chopped back at the top to receive the three nailed on rafters. The roof structure is supported on a frame that is secured with iron straps to the frame and vertical posts from the ground. Over time the weight has caused the lucam to sag and another C20th post has been added to hold it up.

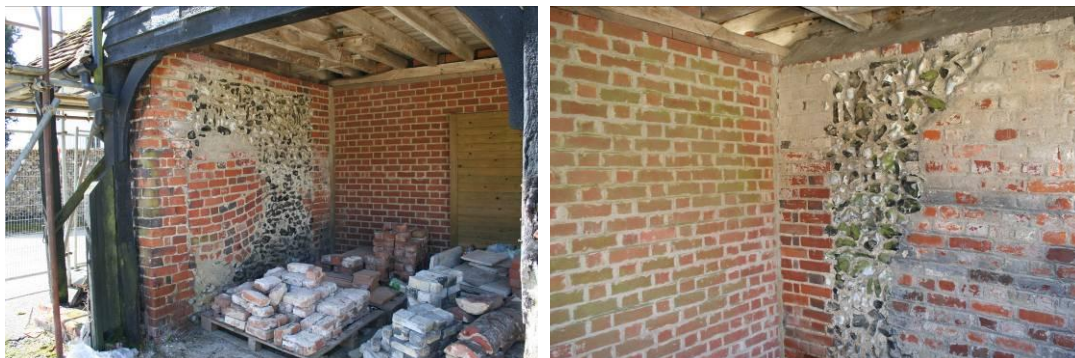
The internal surfaces of the end lower walls. Both have been rebuilt in the C19th.

The lower part of the walls are infilled with flint panels walls with red brick pillars. The bricks are 65x110x235mm orange/reds with some overfired to purples. They have smooth faces, rounded arrises and horizontal pressure lines. The brickwork is properly closed and set in a hard gritty lime mortar. The two panels are butted against the remains of the original spine wall and show they were added later. Both sides have been repaired with bricks - that on the east side with a very similar mortar indicating an early failure and the other side with a more cementitious mortar of the C20th.

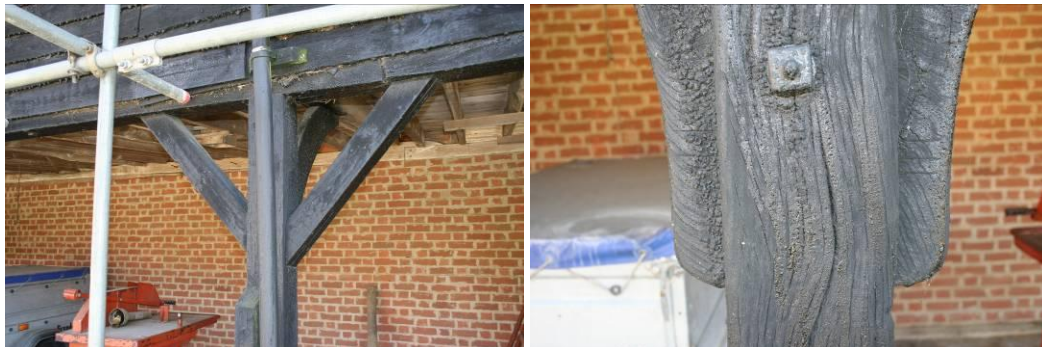
Central post has replaced braces. The others are numbered through.

The original braces are numbered through with carpenter's marks made by a wide chisel point and would have made a sequence of Roman numerals from I to VIII. The northernmost brace is missing and two have been replaced on the central post.

This side of the building was used as a cow byre in the C20th and the concrete apron is formed into gullies to drain the yard down to the south. The posts were repaired ad-hoc and reinforced with other posts bolted on and set into concrete plinths.

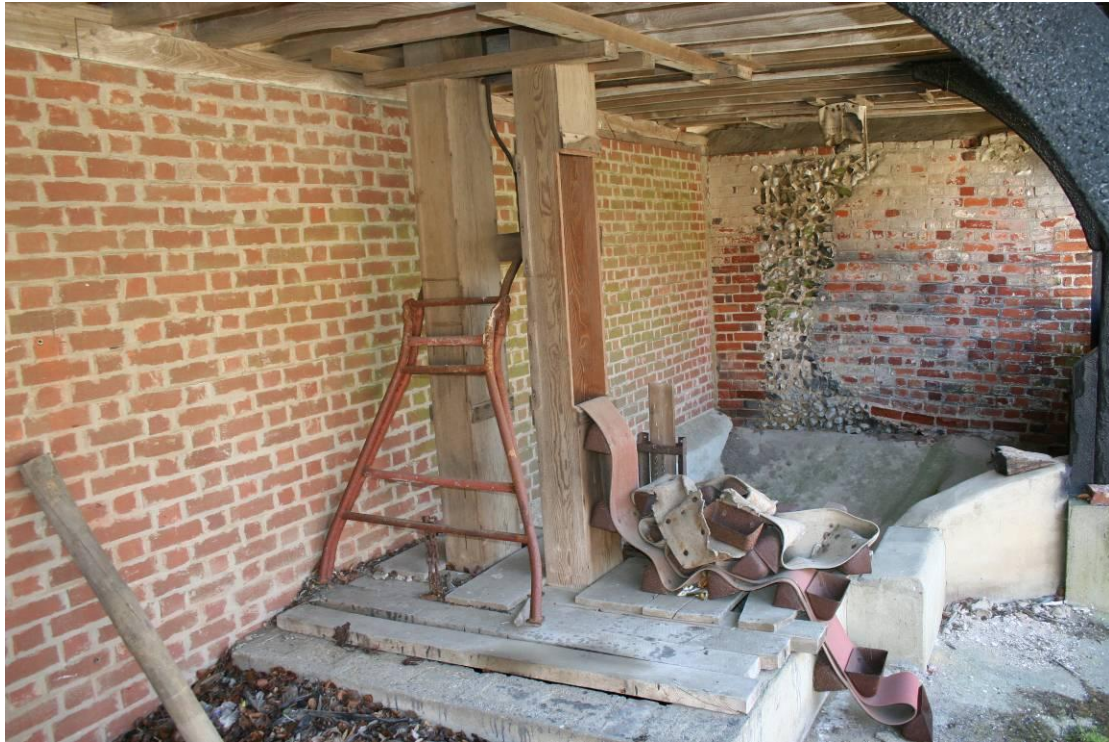
The grain elevator and hopper. The bucket belt has rotted away and fallen out.

It is known that the grain elevator was installed in 1953. The hole for the concrete hopper was dug out by hand by Cecil and Bill Trott, farmworkers. The machine itself has a faded notice on its upper chute noting 'H. Wiseman & Son, Pinkney, Wimbish, Saffron Walden' who most likely supplied it. The grain was poured into the hopper and elevated in buckets attached to a canvas belt driven by an electric motor at the top of the assembly. The entrance to the hopper was protected by a series of boards which drop into slotted posts either side of the bay.

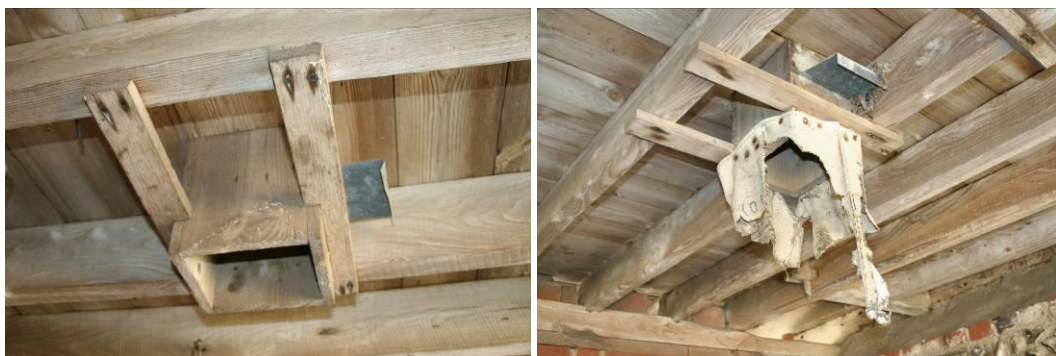
Chutes to empty the grain bins.

Each bay has a timber-fabricated chute with a galvanised tin sheet draw shutter. Originally each had a canvas tube made from old grain sacks nailed in place but only one is left in tatters.

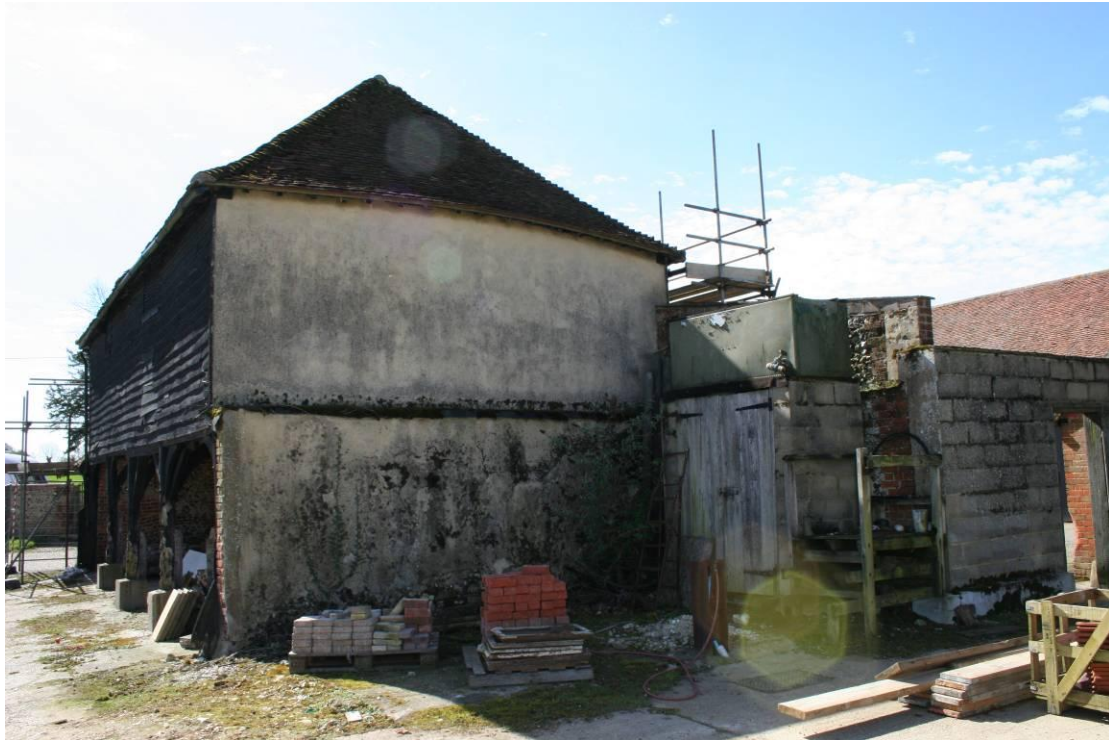
Northern elevation has been lath and plastered.

The northern elevation has been lath and plastered up to the eaves. The lower wall is a brick and flint panel wall which sits outside of the plan of the building. The upper timber-framed section can be seen from inside to be cement render on EML (Expanded Metal Lath) and the original boards have been removed in the C20th. The brick wall formed part of the pigs loose box.

The tank and blockwork cubicle shown in the photograph were built in the 1980's to house the chemicals for the sprayers and the doors were later added for the security of the poisonous materials.

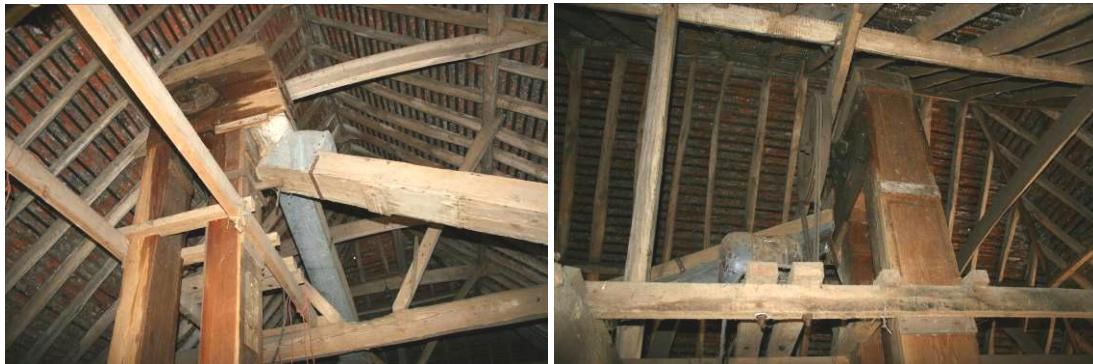
The head of the elevator with its two grain slides. The electric motor drives the belt elevator.

Rising near the centre is the timber carcase of the grain elevator which has two open slides which can be moved around to direct the flow of grain into the bins. There are a number of improvised timber struts and supports to hold the slides into position. At the top is a frame supporting the electric drive motor which nowadays would be considered a fire hazard.

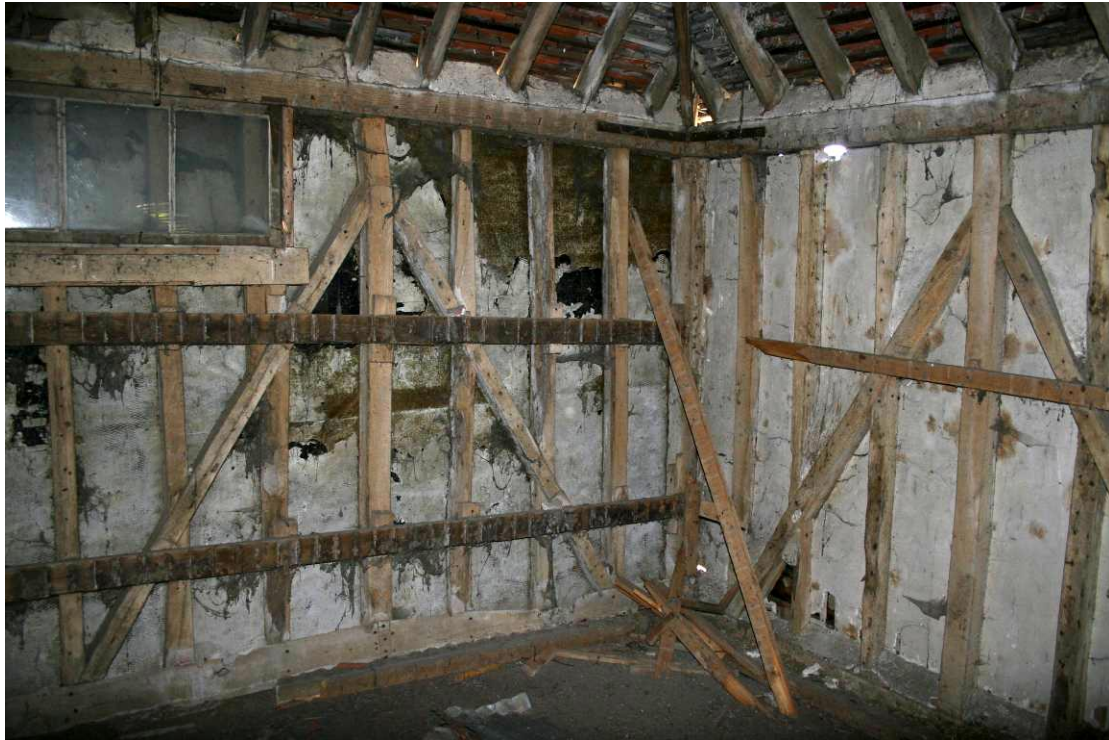
The NE corner of the granary showing the scantling frame and plasterwork.

The timber frame is composed of nailed interrupted studwork. The principal posts, plates and some but not all of the diagonal braces are of straight machined softwood. The remaining studs are a combination of sawn softwood and quarter poles. Although they are all tenoned in place only the principal posts appear pegged in.

The walls are clad in weather-board on the exterior and then lath and plastered in hard white lime plaster between the studs to provide insulation and air tightness. The north wall has been reclad with render on EML. There are some C20th horizontal battens attached to fix up sheets of galvanised tin which have been used to rat proof the walls and some are still in the process of being removed.

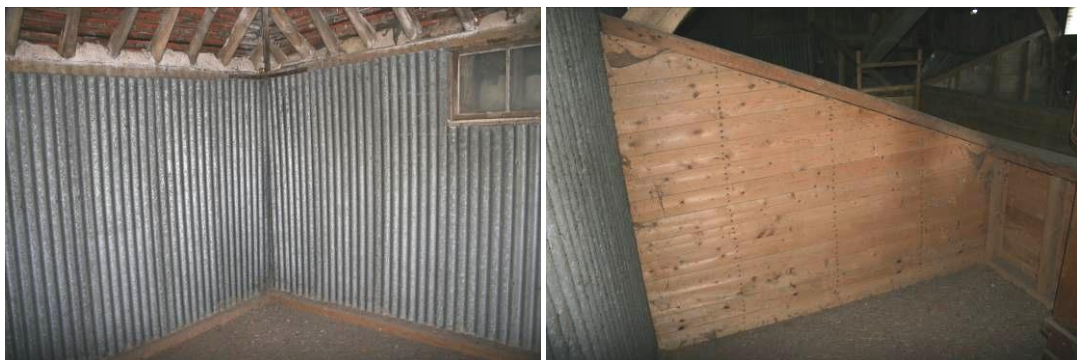
The NW corner and western central bay are clad with corrugated iron sheets.

The louvred windows each have top hung two light C20th casements that open inwards. It is understood the work of cladding the walls, creating new bins and hanging the windows was all done at the same time as installing the elevator in 1953.

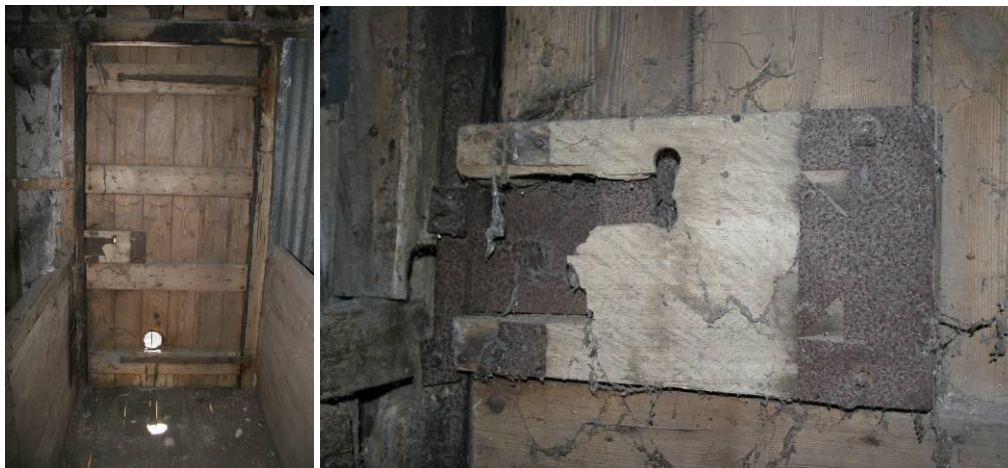
Door into the granary and its Woodstock lock decorated with mild steel plate.

There is a vertically boarded, edge moulded, tongue and grooved and ledgered softwood door hung on wrought iron pintle straps with spooned terminals. It has a large woodstock lock box decorated with mild steel plates and the mechanism is also mild steel. This dates it to after 1856 when mild steel was developed. The low level cat hole must have been a real boon for the rats.

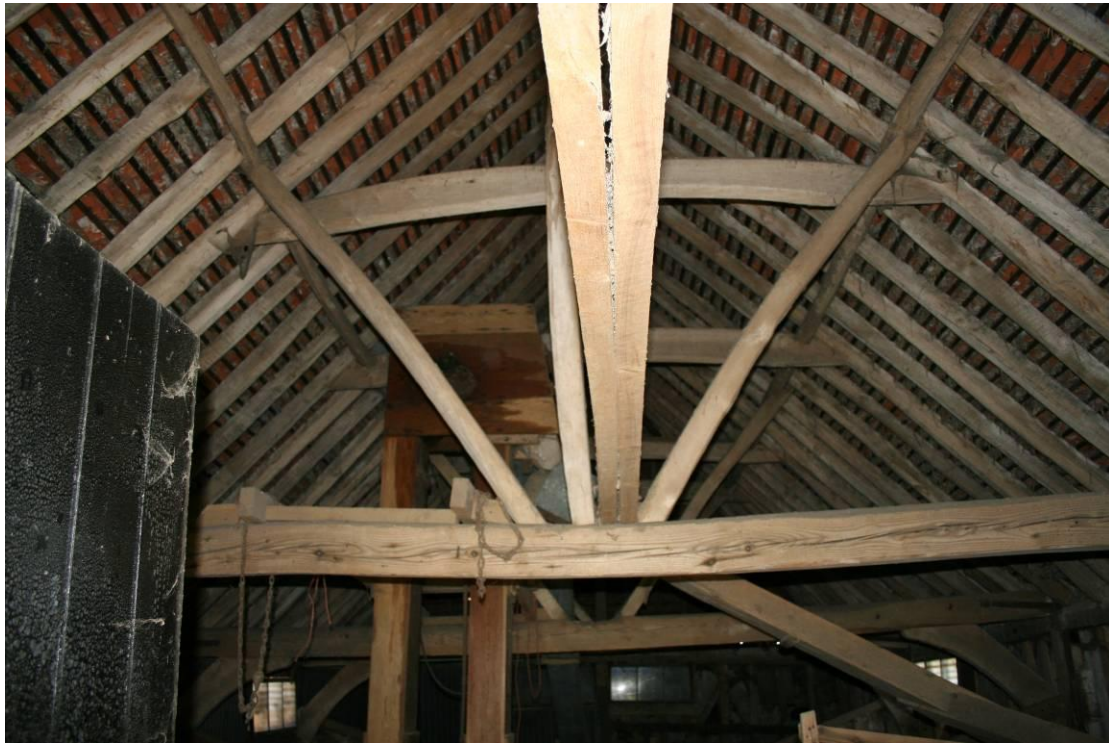
Clapsed side purlin roof with queen struts and later additions. Central strut to the hip and a pair of ties to the south wall.

The roof structure is a simple clapsed side purlin roof with raking queen struts from the tie-beams to the purlins. The queen struts are actually poles stripped of bark and are numbered at their bases. On the southern tie-beam an additional strut has been added to support the hipped end and then a pair of machined tie-beams have been fixed to prevent the south wall pulling out under the weight of the tiled roof over the ladder.

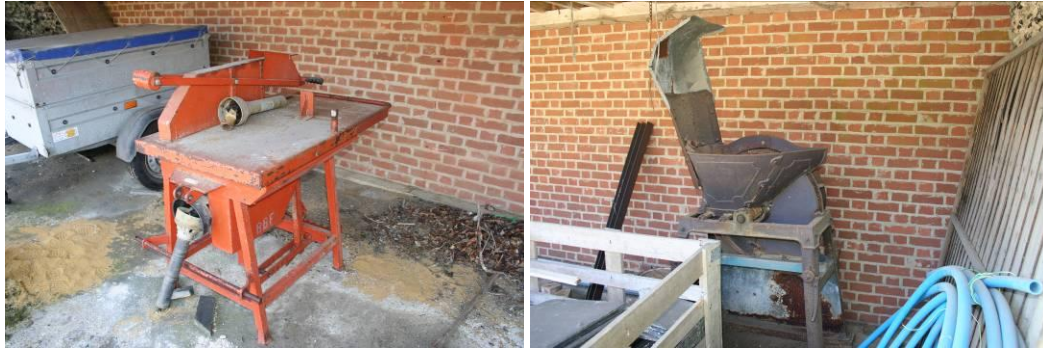
PTO driven saw and hand driven mangel grinder.

In addition to the grain elevator there were two machines in the ground floor of the building. One was a modern table saw driven by the PTO (Power Take-off) shaft from a tractor and the other a much older mangel grinder.

The mangel grinder was marked 'Bentall - Unchokable' and was modified to hand use by the addition of a badly welded handle. Originally it would have been engine driven by a belt drive. It was used by the Farm Manager to chop potatoes as pig and lamb feed. These machines date to the turn of the C20th.
