ART. XI. – *Excavations and Survey at Piel Castle, near Barrow-in-Furness, Cumbria*
By RACHEL NEWMAN, B.A.

THE SURVEY

A major project of excavation and survey was carried out in the autumns of 1983 and 1984, by the Cumbria and Lancashire Archaeological Unit, on behalf of the Historic Buildings and Monuments Commission for England. This was in advance of a proposed full-scale programme of consolidation and repair.

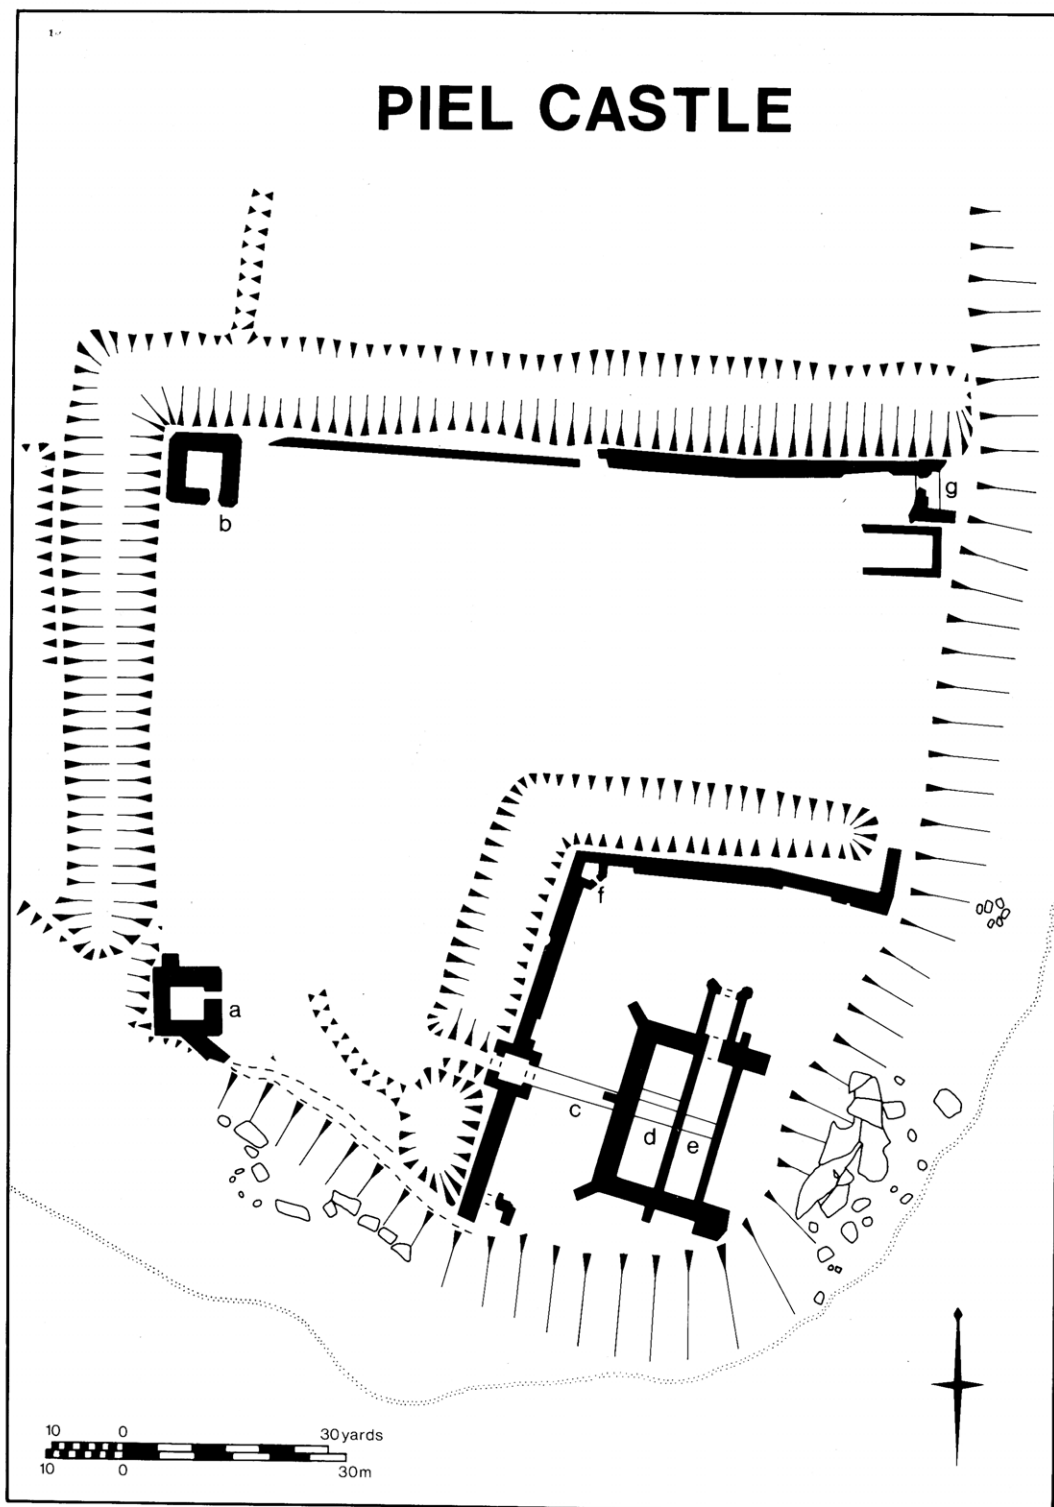
Fig. 2. - The plan of the Castle.

At first glance, it might appear that the castle was once concentric in plan and that a large section of the southern and eastern parts of the site has been eroded. Closer examination suggests that this is, in fact, not correct. The keep lay, with space around it on all sides, within an inner ward, the southern and eastern walls of which have since

been eroded by the sea. The outer ward lay solely to the north and west of the inner ward. The southern outer curtain wall, though now lying in pieces on the beach, appears to have once joined with the inner south-western tower. Similarly, the north-eastern towers of the inner and outer wall circuits respectively seem to have been connected by a wall.

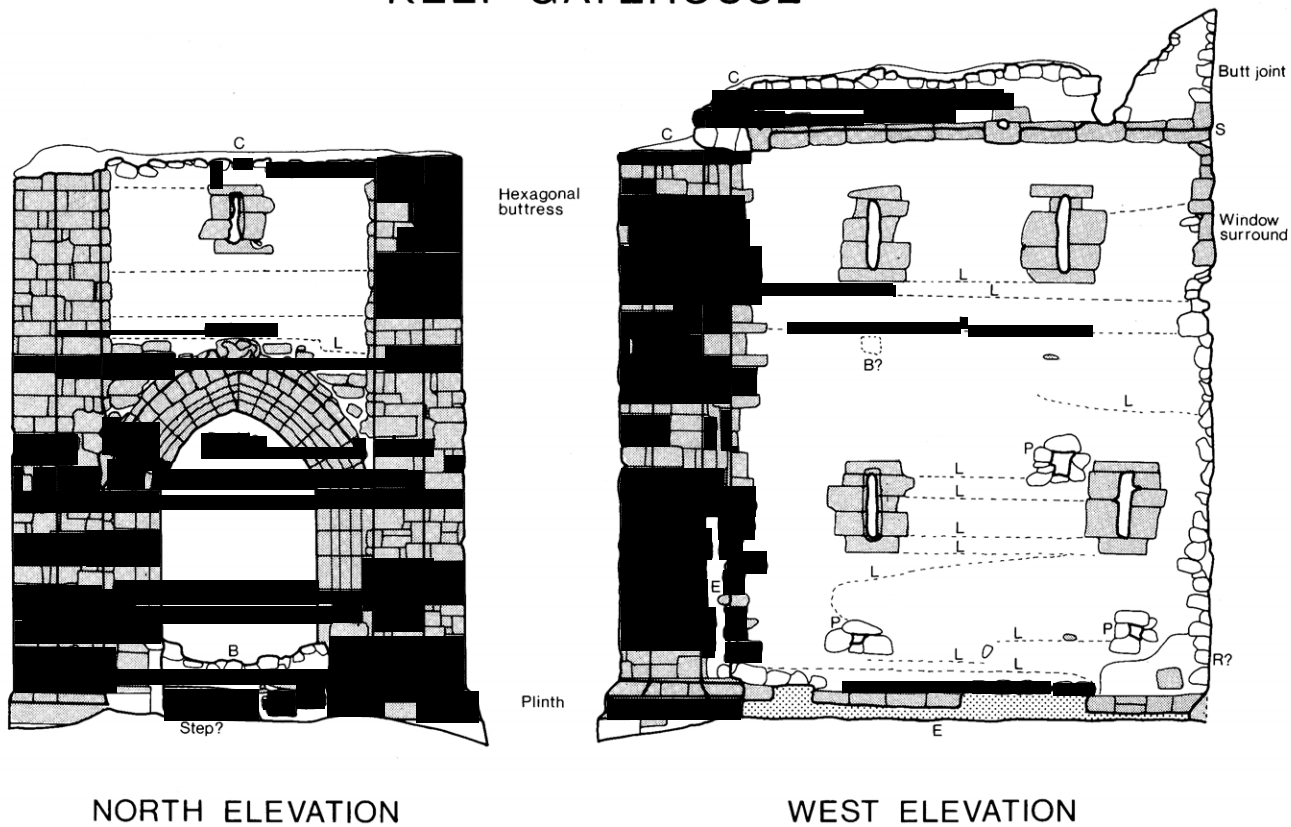
Fig. 3. – Survey elevation of the Keep Gatehouse.

The original entrance through the gatehouse was into the ground floor of the central chamber of the keep. The gatehouse had gate-arches at either end and the lower part of the entrance passage has been blocked beneath each gate-arch, thus raising the entrance to first floor level. The blocking is crude in comparison with the masonry in the rest of the keep, yet it seems likely that it was constructed during the occupancy of the castle. The portcullis slots terminate, by design, at the top of the blocking, in flat pieces of red sandstone. It seems that the head of each arch has simply been raised to the new level and the jambs rebuilt to the required height, since elements of the uprights continue below the level of the blocking and are incorporated in it. In its final form the entrance to the keep was through a two-storey gatehouse into the first floor level of the central compartment of the keep. Both gate-arches in this final phase have portcullis slots and the keystone of the outer arch was decorated with a dancing figure.

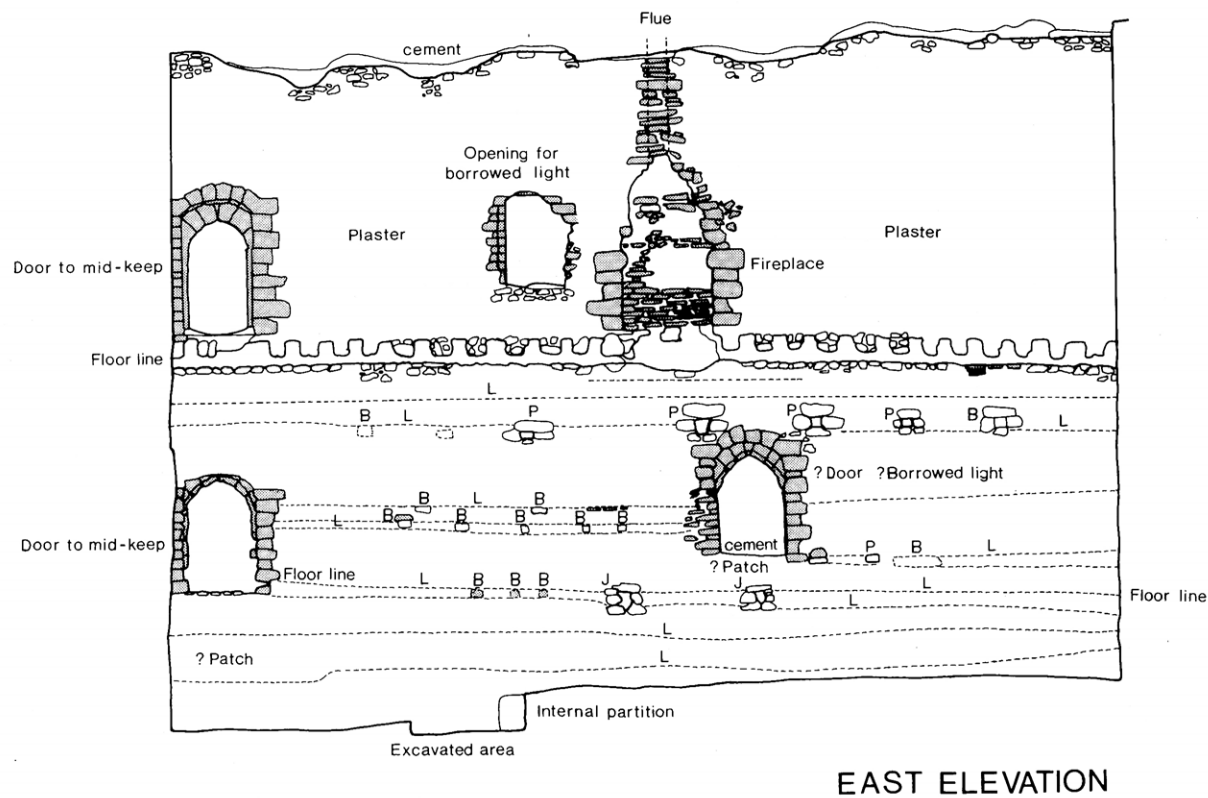
Fig. 4. – Survey elevation of the eastern wall of the west compartment in the Keep.

The windows in the first and second floor walls of the keep are large, and most contain some remains of tracery. There is a reference to the survival of glass from the castle until 1876, when it was loaned to the Barrow Yacht Club (C.R.O., Barrow, BD/BUC Box 3, letters). Despite the fact that the internal architectural details suggest that the living accommodation was on these floors, most of the first floor windows in the central and west compartments were blocked, probably within the medieval period. The blocking consists of a mixture of local stones and chips of red sandstone, laid in rough courses. The southern window of the western compartment contains the head of a small single light within the blocking. The northern window in the first floor of the eastern compartment is blocked and the wall subsequently sheared down the plane of this

window when the eastern side of the compartment collapsed. This makes it certain that the blocking took place before the restoration work of the Duke of Buccleuch, since the wall had collapsed before he began his work on the sea defences in 1854.

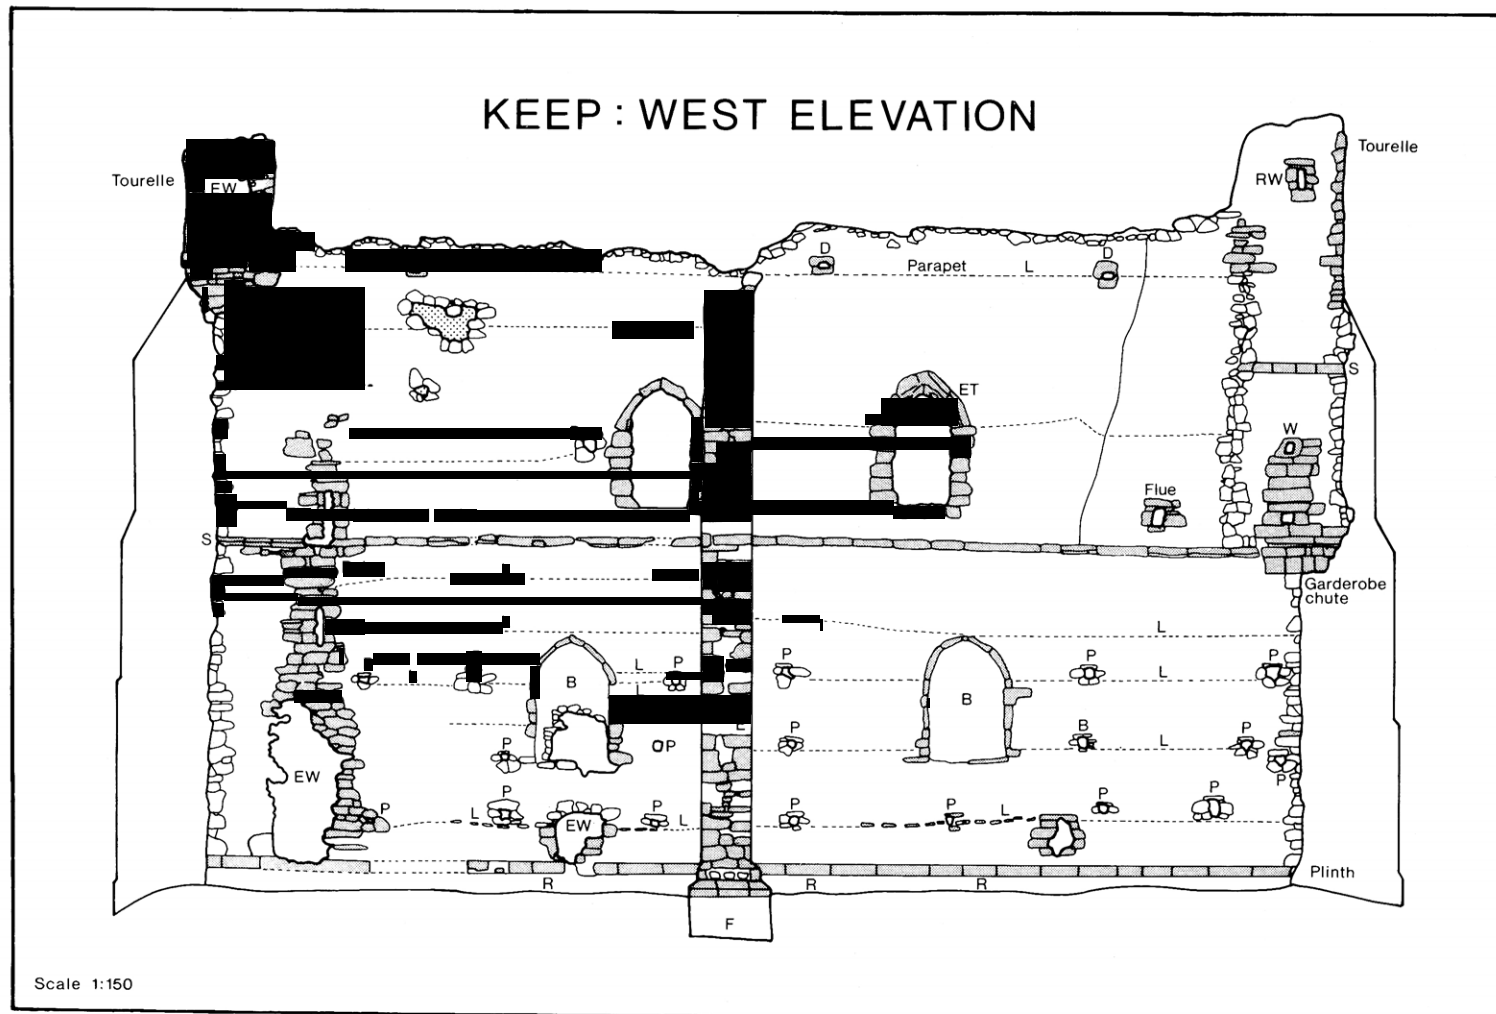
Fig. 5. - Survey elevation of the western external wall of the Keep.

the western wall clearly had stepped foundations a little way below its red sandstone plinth. These foundations had been built within a narrow construction trench, visible only on the inner side of the wall. The base of the plinth seemed to denote the medieval ground level. A small deposit of sand and mortar, which appeared to be the detritus left by masons when finishing the pointing of the wall, was found to lie around the exterior foundations of the keep.

The original plan of the keep had evidently been changed during its construction, as a buttress had been added to the centre of the western elevation. This seems in fact, to have occurred during the construction of the building, as, although the buttress cut through the upcast and there were traces of a slight break in the foundations between it and the wall, the buttress had become an integral part of the design above the medieval ground surface. This addition does not seem to have altered the plan of the upper storeys, since the insertion of the buttress has constricted, rather than displaced, the northern window on the second floor. The buttress had an outwardly sloping rubble foundation, bonded by sand mortar, and presumably once covered by more banking, but this had slumped down the slope, leaving only a thin cover of modern topsoil.
