ART. XI – *Further structural analysis at Piel Castle, 1987-94*

By R. NEWMAN

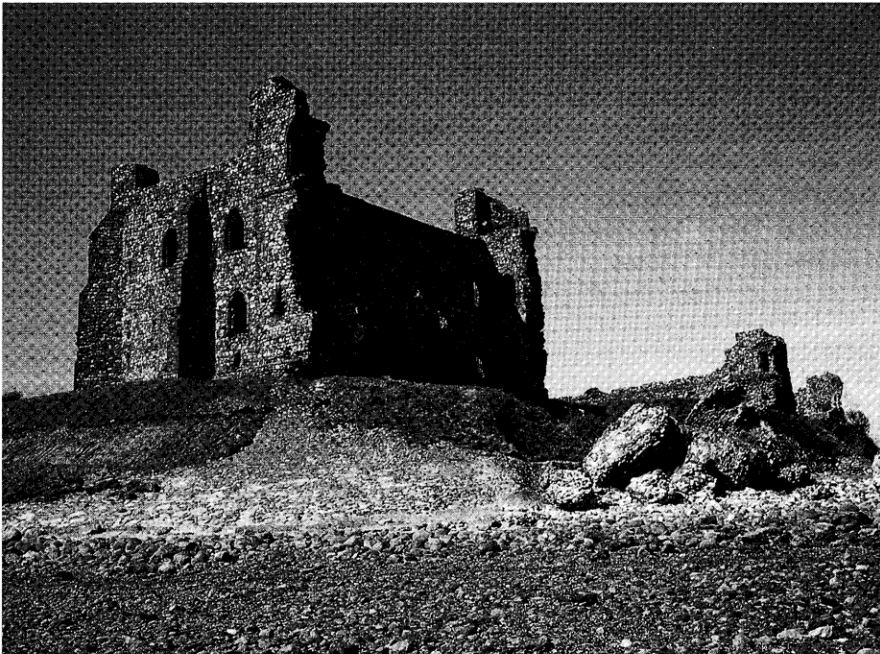
PLATE. 1. Fallen masonry from the eastern wall of the keep lying on the beach, during the repairs of the coastal protection around the south-east sides of the island.

The information recovered from the disposition of the fragments supported the evidence of the Hearne painting of 1781. Coastal erosion had undermined the foundations of the north-eastern corner of the keep, causing it to collapse, bringing down part of the east wall as it did so. As suggested for the curtain wall, the evidence indicates that the wall slipped and turned as it fell, so that the upper parts lay furthest from the cliff, and have been subject to most erosion. Whilst elements of both the ground and first floor of the north-eastern part of the keep have been recognised, little of the second floor could be identified. The comparative lack of survival of the collapsed sections of the south-eastern tower block of the keep amongst the fallen masonry confirms the detail of the Hearne painting, that this element was the first part of the eastern side of the keep to fall, and its remains have therefore had longer to be broken up by the tide. This is only to be expected as this element stood at the south-eastern point of the island, exposed to the full erosive power of the tidal surge sweeping in to the harbour. In general, fragments seem to have broken at points of weakness, particularly through windows.

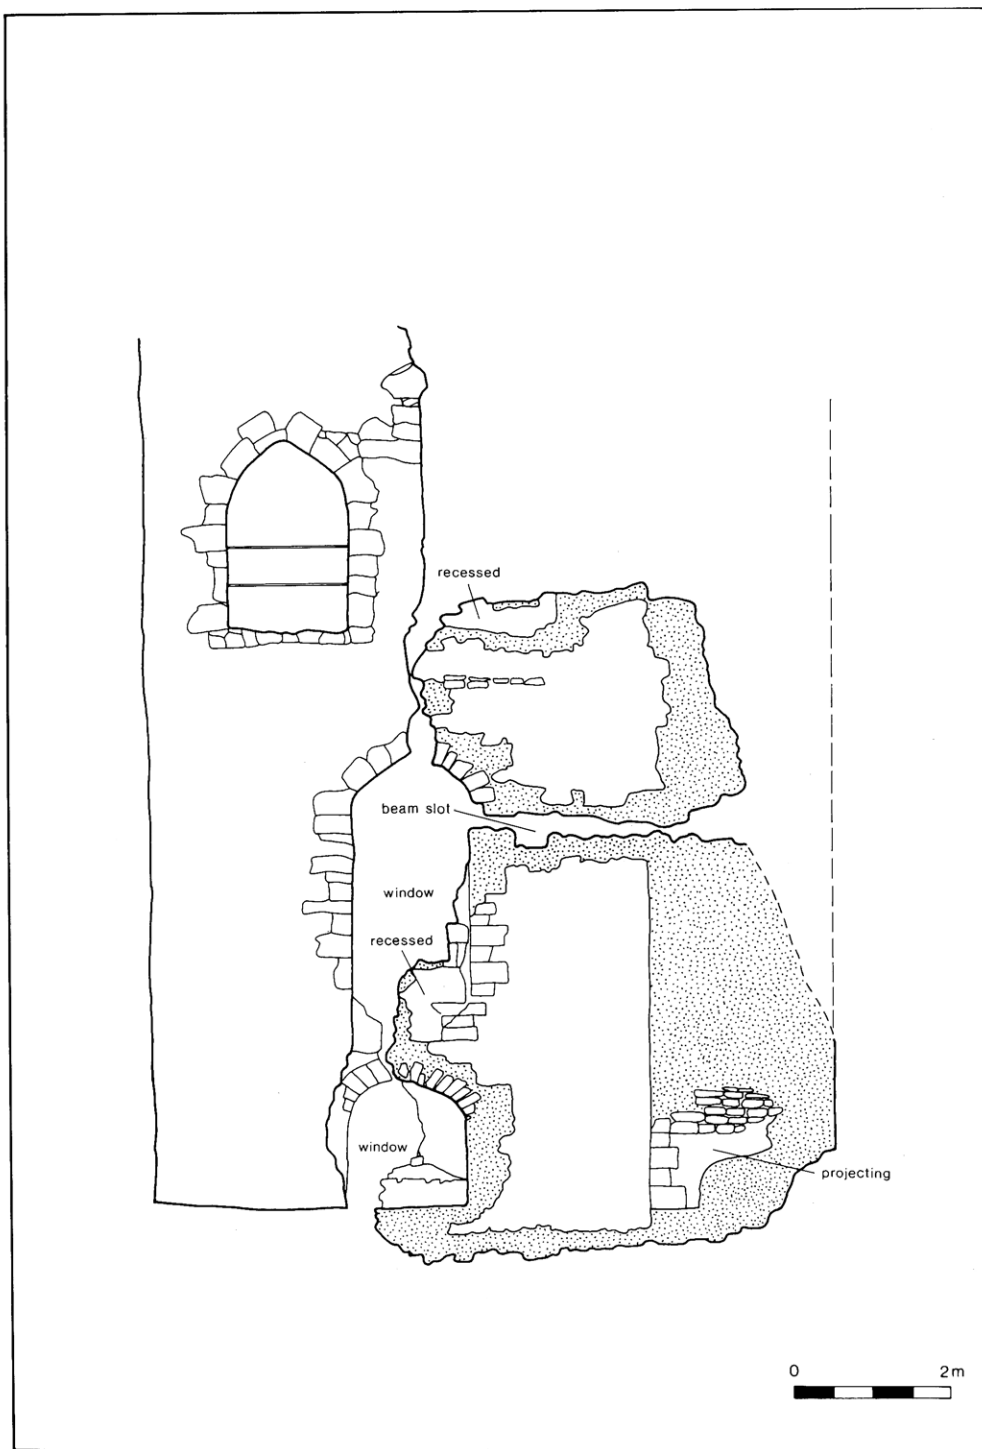
The orientation of some of the fragments and the architectural detail visible on them allowed partial reconstruction, in particular of the north-eastern corner of the keep (Fig. 3). Here the standing structure confirms that the wall sheared at the main point of weakness, where windows on all three floors lie one above the other. This fact made reconstruction simpler, as the two halves of the fractured windows could be matched relatively easily. The entire corner fragment remains intact, with sufficient information relating to the northern end of the eastern wall to allow other sections, lying next to it on the beach, to be matched to it.

FIG. 3. Partial reconstruction of the north wall of the keep (internal).

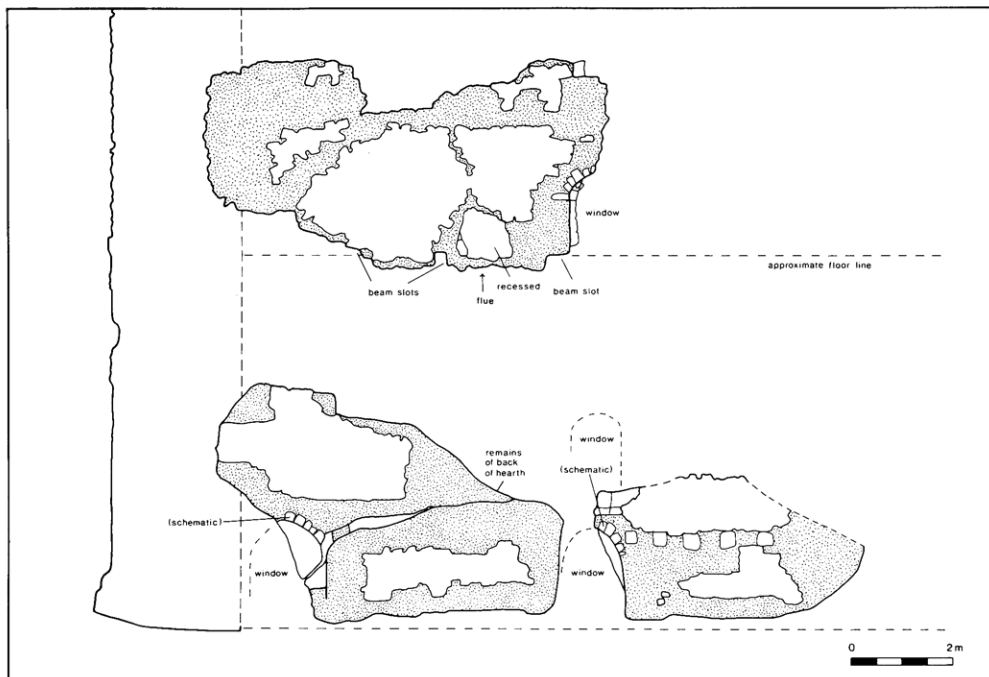
The reconstructed section (Fig. 4) clearly showed that accommodation on the

FIG. 4. Partial reconstruction of the east wall of the keep (internal).

first floor here was relatively similar to that in the western keep compartment, with a fireplace with intramural flue set into an external wall, suggesting some potentially domestic use. Little evidence remains of the first floor windows, but the standing fabric demonstrates that at least the northern light was blocked prior to the collapse of the east wall; again the blocking of first-floor windows was a feature of the western keep compartment. This clearly indicates a change in use, perhaps a move from the castle being a place of retreat for the Abbot of Furness, to a more prosaic activity, the structure perhaps acting as a warehouse and/or customs post. The narrow lights of the ground floor again demonstrate the need for some defence, and the fact that this floor did not supply accommodation.
