**NORFOLK ARCHAEOLOGICAL UNIT**

Report 831

**A Building Record of Ostend House, Ostend Gap  
Walcott, Happisburgh, Norfolk**

January 2004

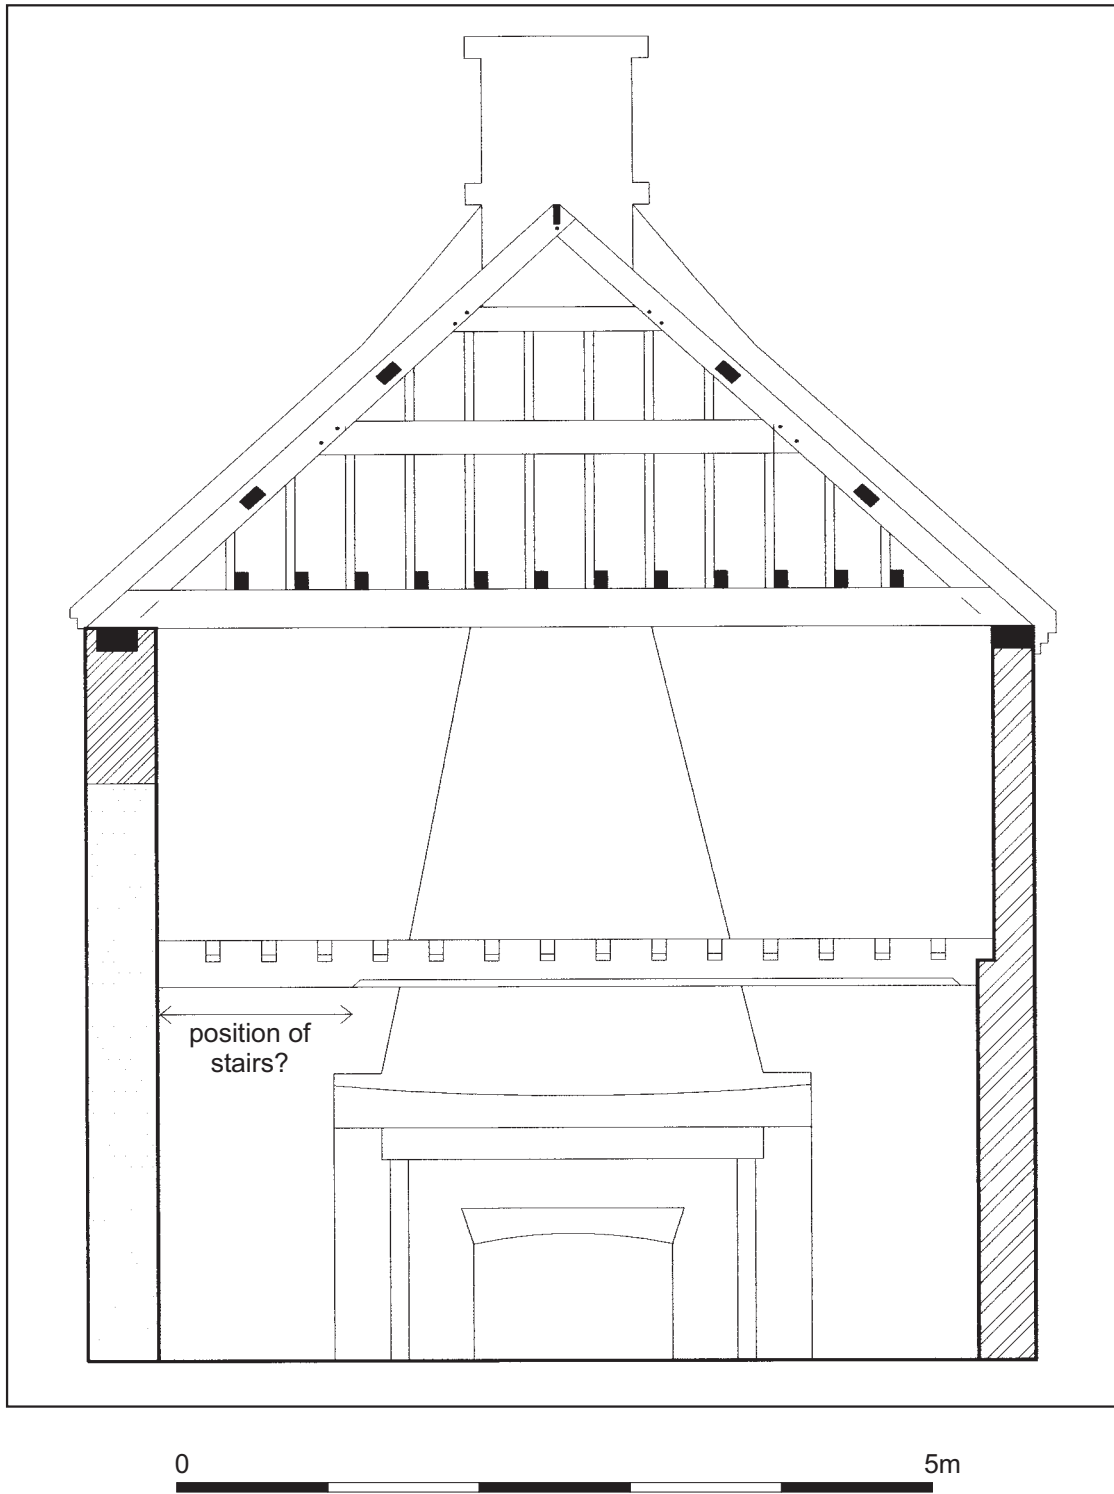
Fig. 3 East to west composite section, truss IV. Scale 1:50

The roof is in seven bays (Plate 11) and the principal trusses are numbered I to VII from south to north (Fig. 3, truss IV illustrated). There are two purlins in each pitch with chamfered-back ends and two straight collars although the lower collar is absent in the truss adjacent to the each of the stacks. The trusses near the stacks and truss IV have associated tie beams and there is another tie between trusses II

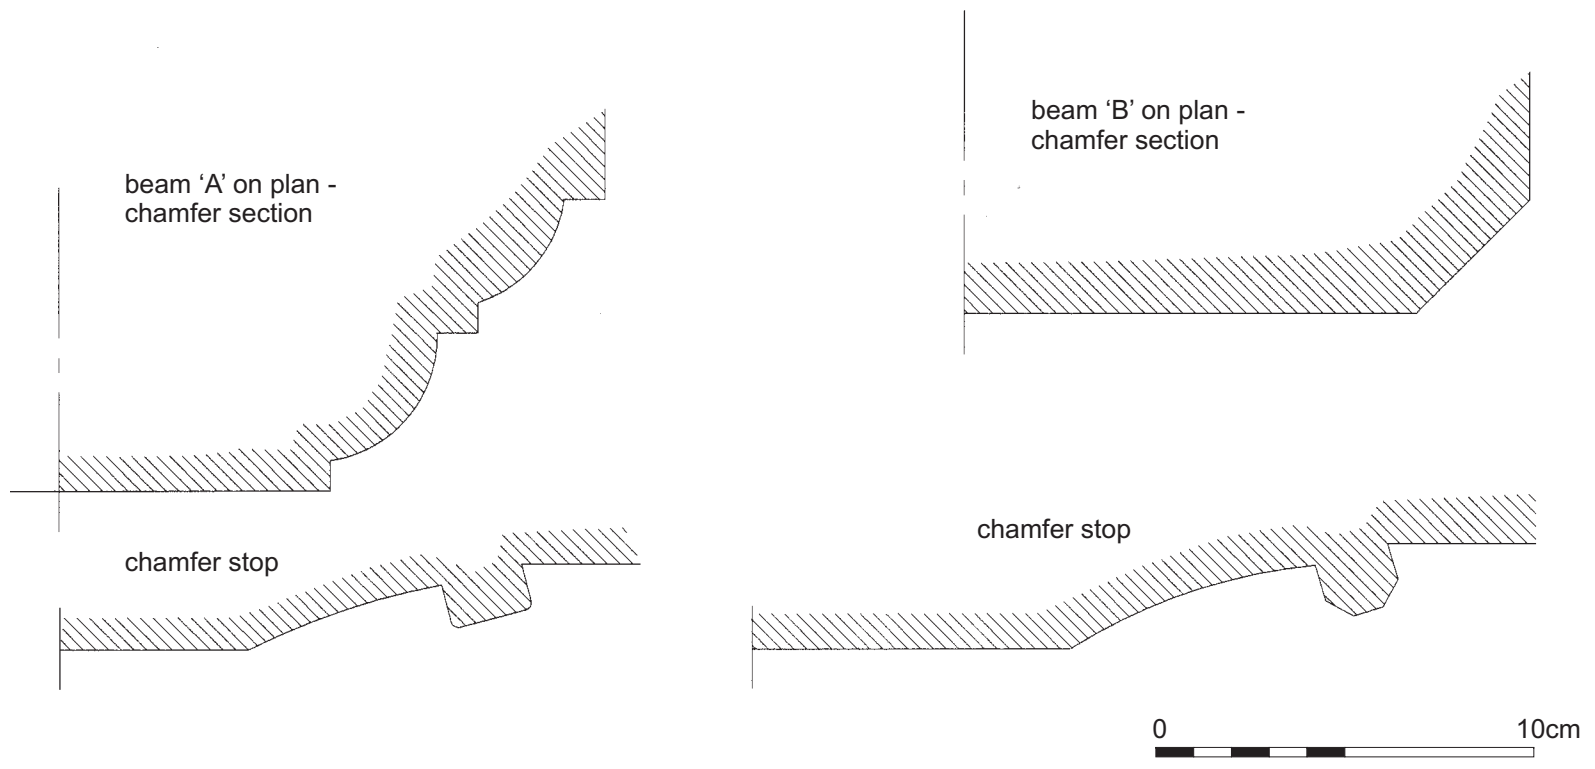
Fig. 4 Ground floor ceiling beams, moulding details. Scale 1:2

As stated earlier no internal partitions survive and three principal ground floor ceiling beams and an encased secondary beam that dates from the 19th or 20th century remain intact. The decoration on the northernmost ceiling beam is particularly fine (Fig. 4, beam 'A' and Plate 4) with a stepped double segment moulding; the bar has a double bobbin profile with scrolled decoration ends and the stop has a bisected foliate motif.

The two other beams have a simple straight chamfer that is terminated with a faceted bar and a simple shallow stop (Fig. 4). The chamfer on the north side of the northernmost of these two beams is 1.3m away from the east wall suggesting that some kind of arrangement for the stairs was against the wall on this side of the beam (Plate 5).

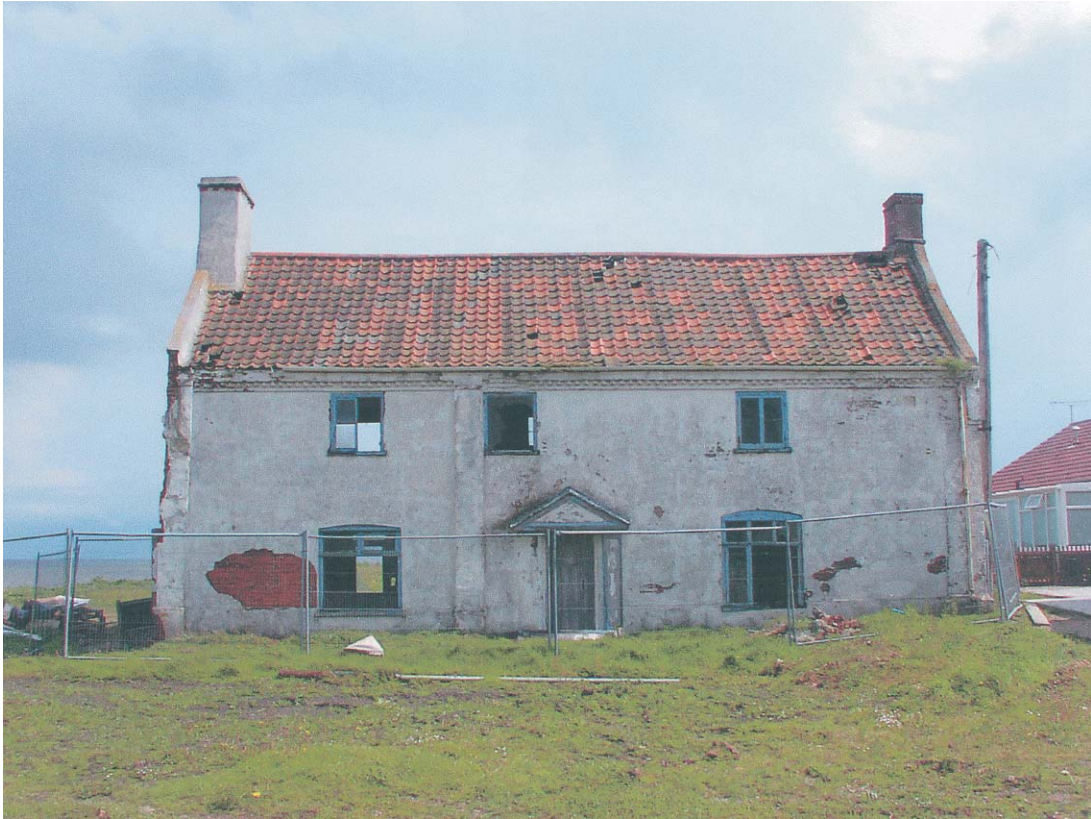
The building is two storeys high (Fig. 3) and the principal, brick-built, west facing façade is three bays wide with a central door that is flanked by simple rectangular pilasters with a pediment, although the pilaster on the left-hand side has been removed (Plate 1). At ground floor level the window on the left-hand side is a two-light mullion and transom and on the right-hand side the window is identical, apart from a slightly more convex arch and it has three lights (Plate 1). At first floor level the windows are all two-light casements and again the window on the right-hand side is slightly different in as much as the frame is slightly heavier. The middle window at first floor level is off-centre to the left and is adjacent to a pilaster that is 0.97m away from the central door opening. There is an identical pilaster against the left-hand corner and a wider pilaster against the right-hand corner that projects out less than the other two and dies into the wall face as it approaches the cornice. The cornice has saw tooth decoration with a flat band above and below.

The outside face of the west wall is rendered (Plate 1) and the removal of the plaster on the inside shows that the wall has been completely rebuilt in bricks laid in an irregular English bond with the occasional course of brick headers laid both vertically and at an angle (Plate 10). From a point 0.66m away from the right of the doorway to the north corner in the west wall, as seen from inside, the wall increases in width by 0.11m. The top of this increase in thickness corresponds in height with the underside of the former ceiling joists, now discerned by the empty mortises in the ceiling beam.

Plate 1 The west elevation

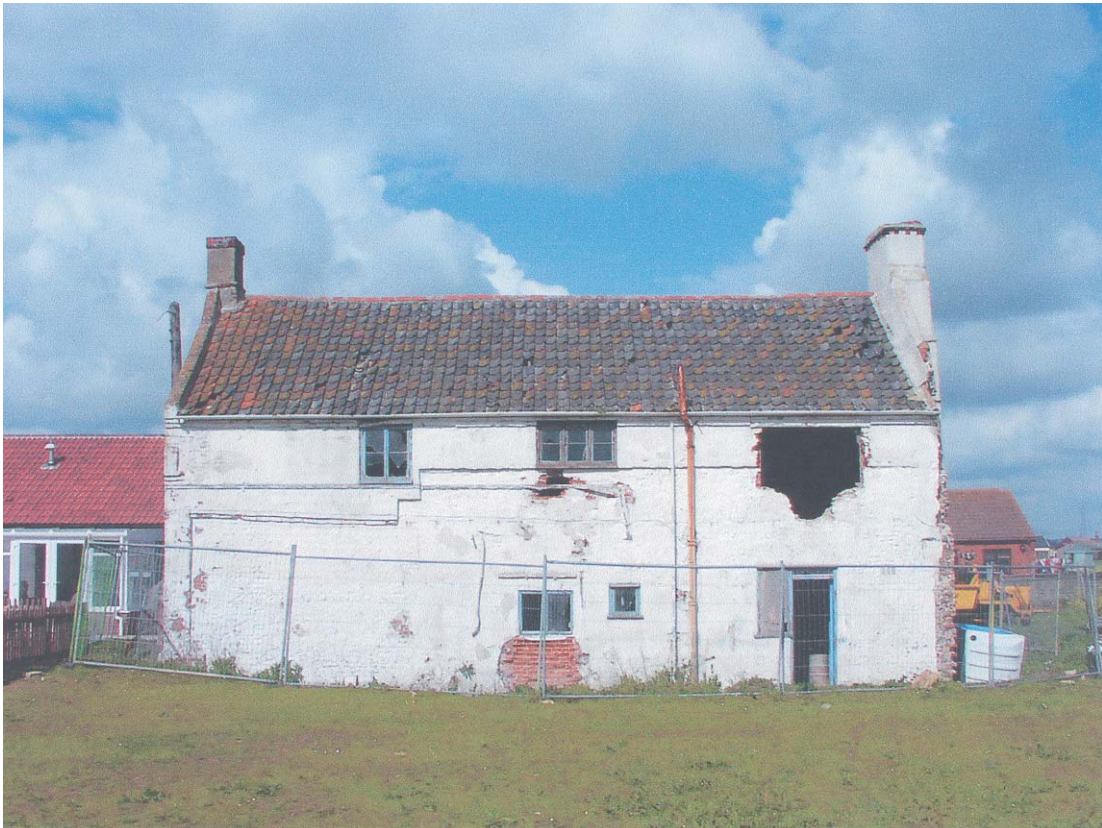
The east facing façade (Plate 2) has an irregular pattern of fenestration with a door opening plus adjoining window on the extreme right-hand side with two small single-light windows to the left. From left to right at first floor level there is one two-light casement window, a three-light frieze window and a large empty former window opening with a badly damaged sill. This façade has been heightened in brickwork by just over a metre for its entire length and from about two-thirds of its length away from the right-hand side this heightening is above bricks laid in an irregular brick-on-edge bond.

Plate 2 The east elevation

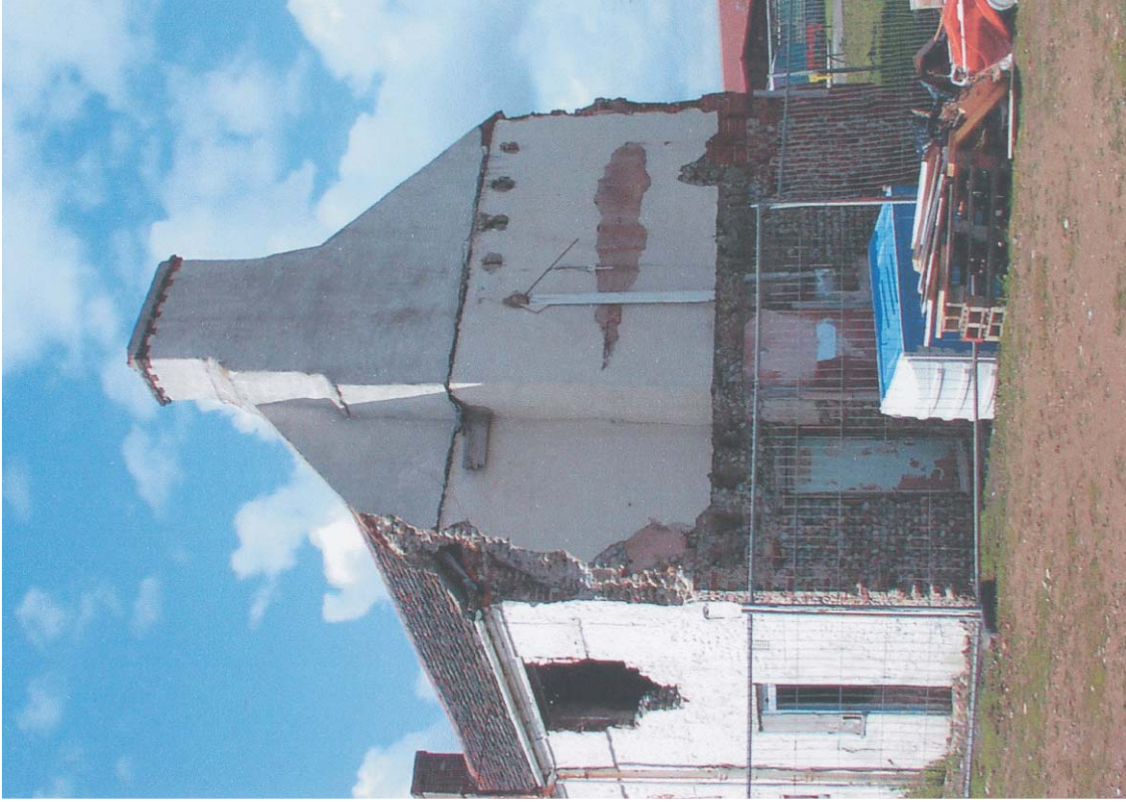
At the time of inspection Ostend House was empty and unused; the ground floor ceiling joists had been removed and likewise large areas of plaster especially from the west wall; some of the wall beneath a window at first floor level on the east side was missing and areas of the north gable were dilapidated (Plate 3). The internal partitions had been removed, although the lack of any scars on the outside walls that would have indicated their position suggest they probably had a lathe and plaster (or similar) construction.

There is an external chimney stack against the north gable (Plate 3) and the wall on the right-hand side of this was rebuilt in brick in line with the external face of the

Plate 3 The north gable

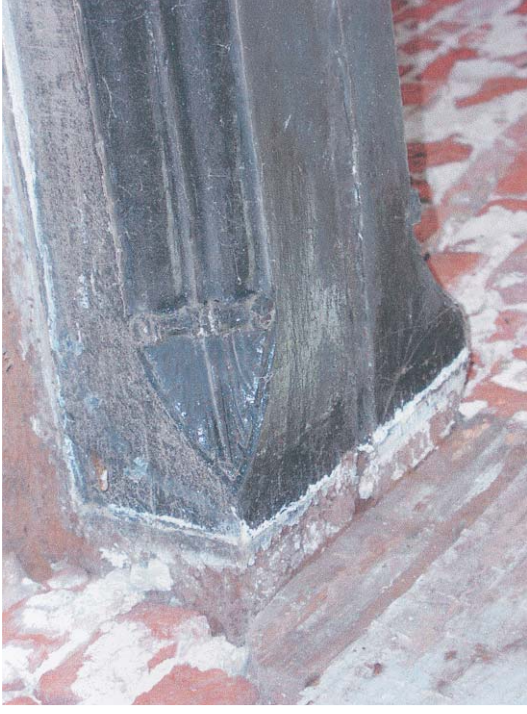
Plate 4 Chamfer and stop on 16th-century beam ('A' on Fig. 4)

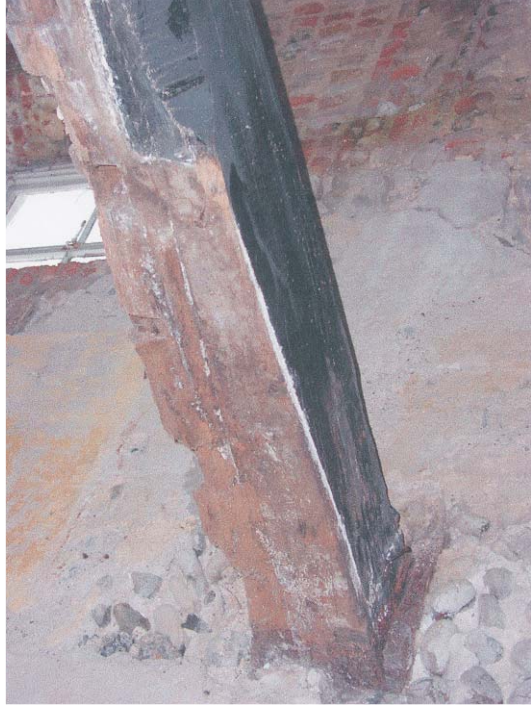
Plate 5 Position of stairs on 17th-century beam as indicated by the position of the chamfer stop

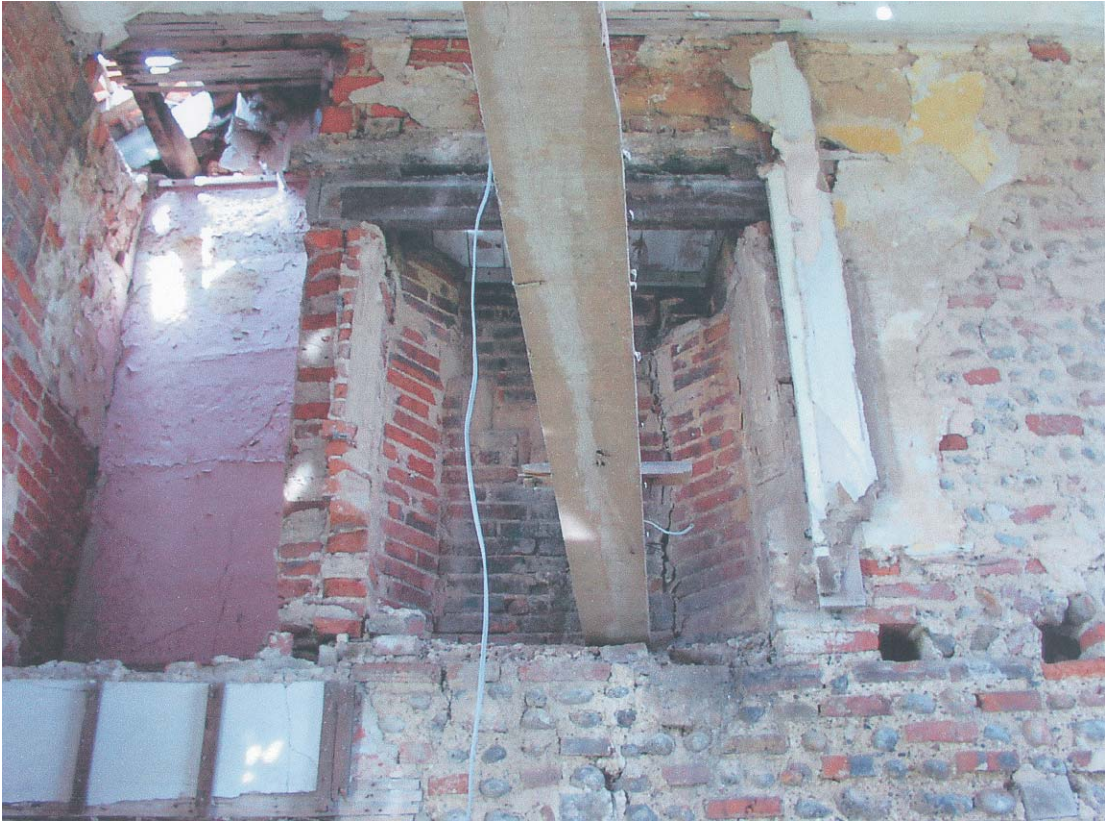
Plate 6 The 16th-century fireplace, north wall, at first floor level

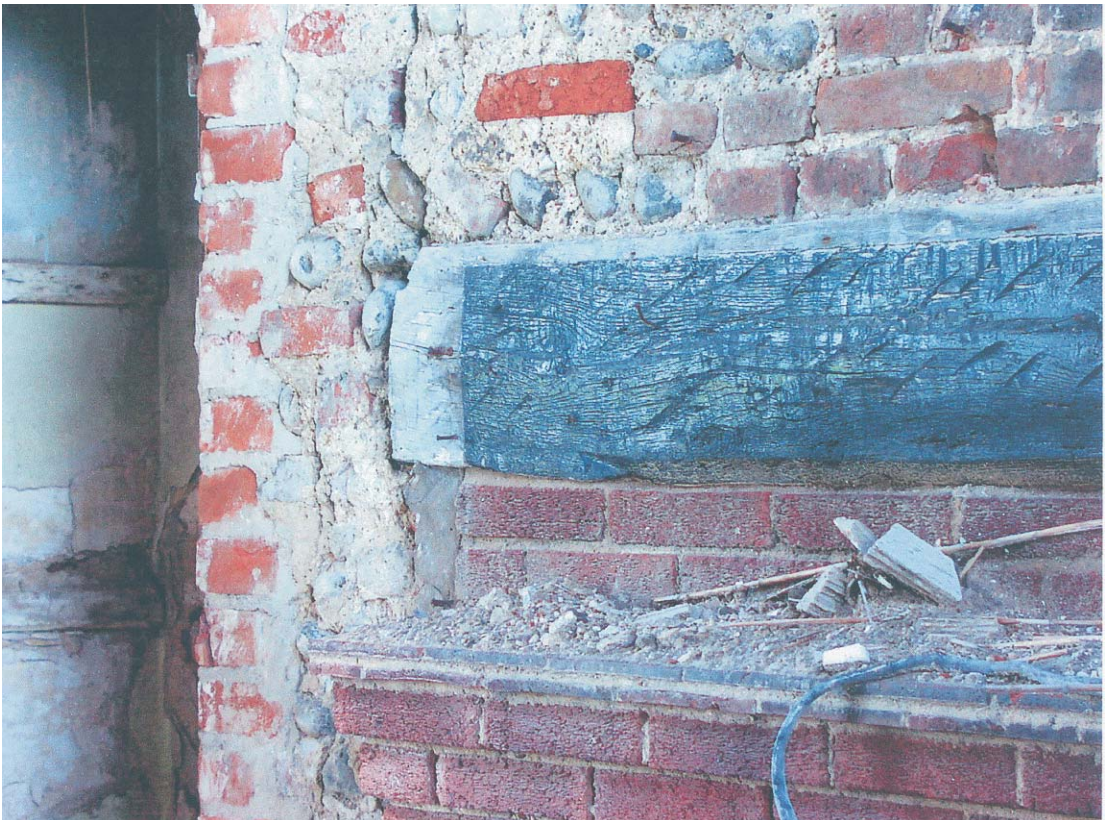
The opening at ground floor level in the north stack has been blocked by the insertion of a 20th century fireplace and the lintel reduced in length by the creation of the door (Plate 10) that gave access to the extension. The lintel has a relatively small straight chamfer that is terminated by a broach stop (Plate 7). At first floor level and to the left of the ground floor fireplace there is a much smaller fireplace with moulded brick cheeks, the design (Plate 6) of which is in the same family as that seen on the beam with the stepped double segment moulding. The top of the opening has been destroyed and is now spanned by a simple timber lintel although the slight beginning of a curve in the brickwork on the right-hand side suggests that initially the opening had a three- or four-centred moulded arch.

Plate 7 Chamfer stop associated with the north stack fireplace at ground floor level

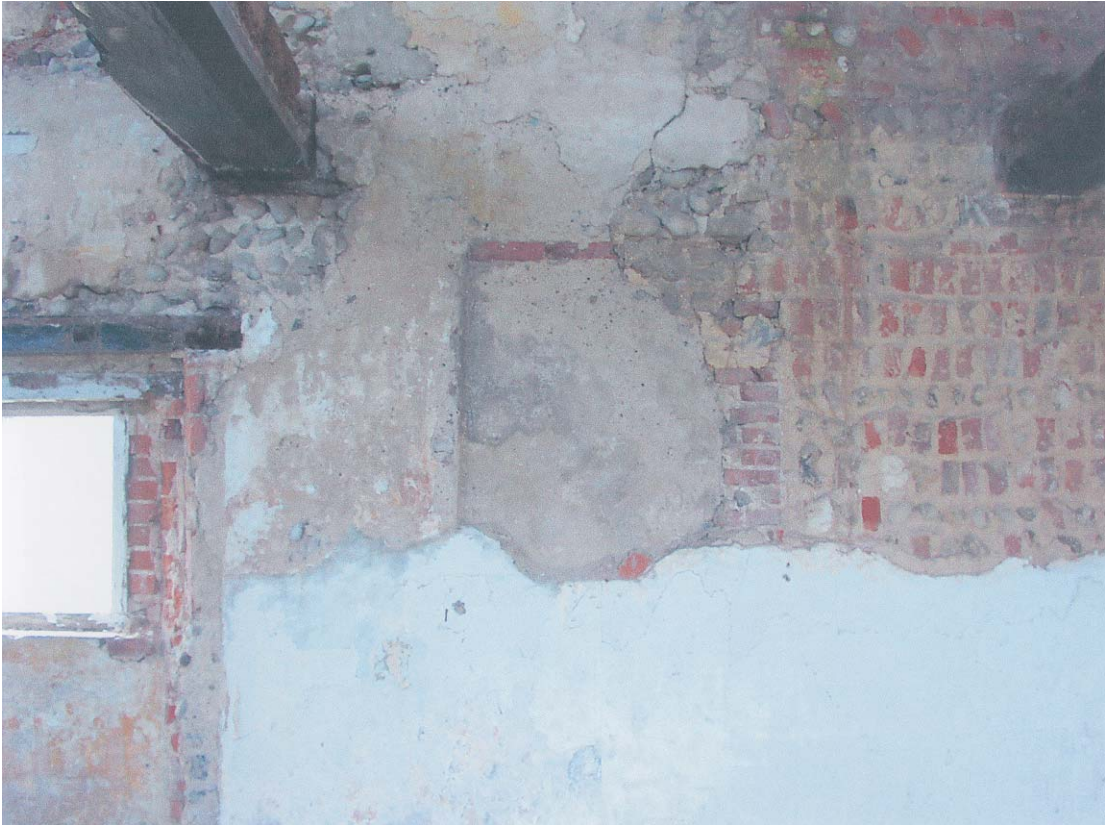
The gable wall associated with the 16th-century fireplace openings is constructed with a mixture of brick and beach pebbles (Plate 8) and this combination of materials continues for some 9.25m along the east wall to a point corresponding with bricks that form the side of a blocked window. Within this stretch of wall there is evidence for three windows at ground floor level and one or possibly two at first floor level, the uncertainty arising because of the eroded state of the wall.

Plate 8 Junction between brick and beach pebble and brick construction

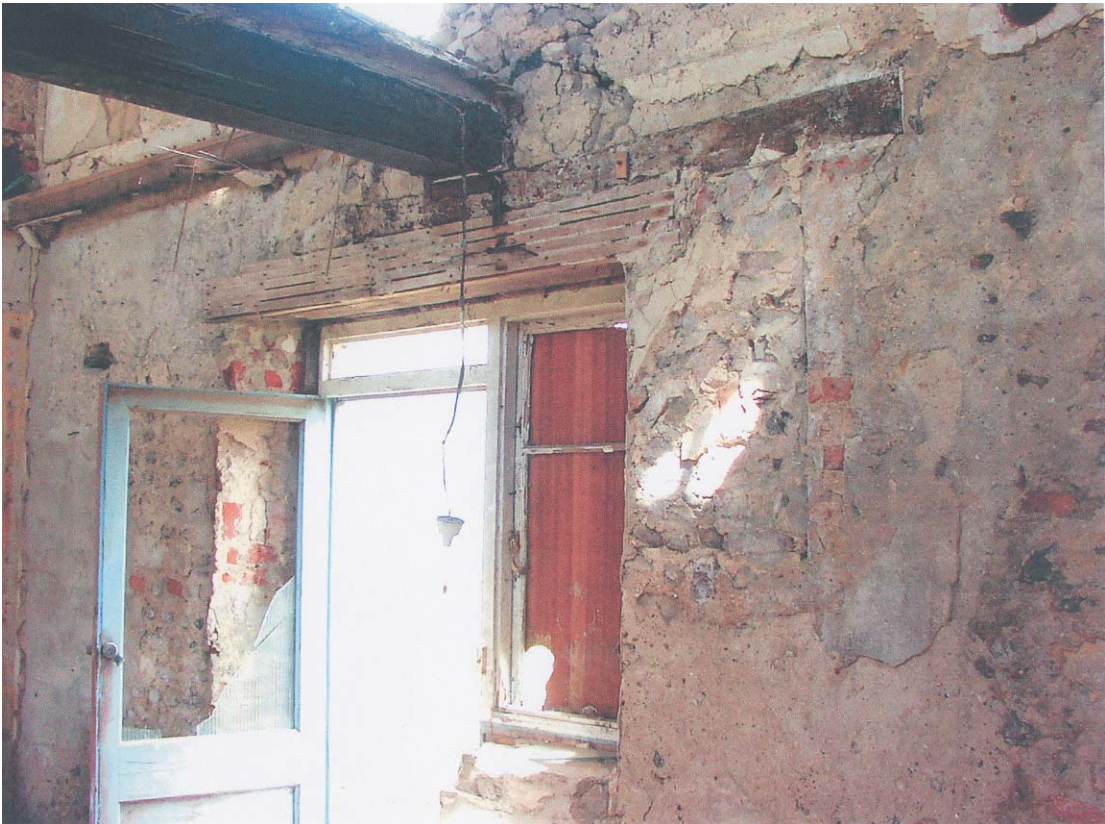
The internal face of the east wall shows that all of the openings have been created by altering existing openings (Plate 9), apart from the small central square window and even this has a vertical joint from the right-hand side of the sill to the floor. The origin of this vertical joint is unclear.

Plate 9 Right-hand side of blocked 16th-century window

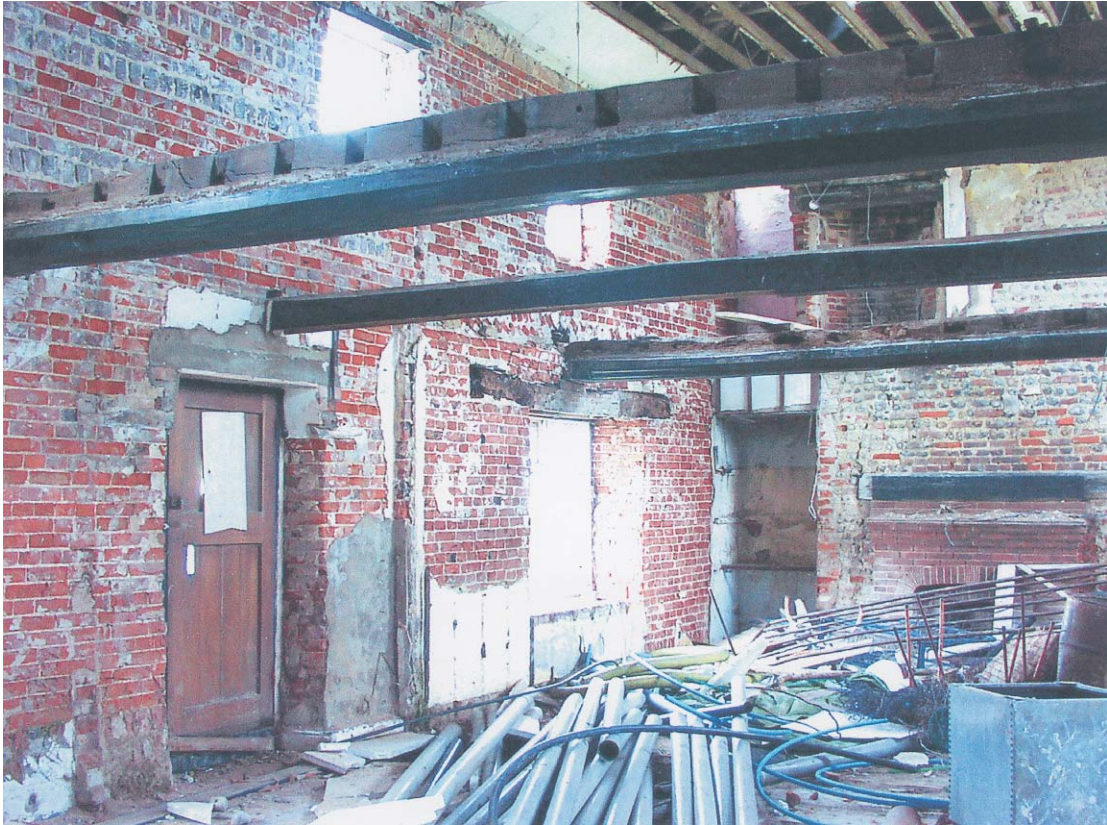
Plate 10 The increase in thickness of the ground floor west wall that starts 0.66m away from the door

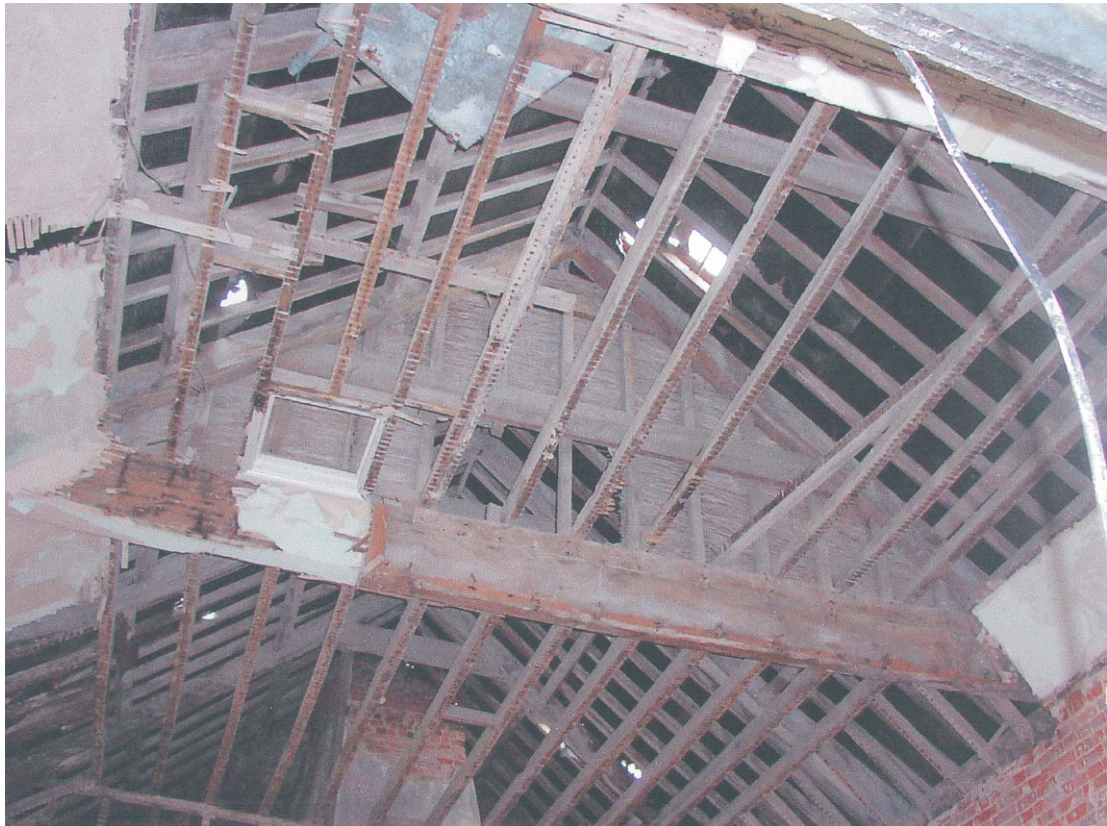
Plate 11 The partition at the attic floor level

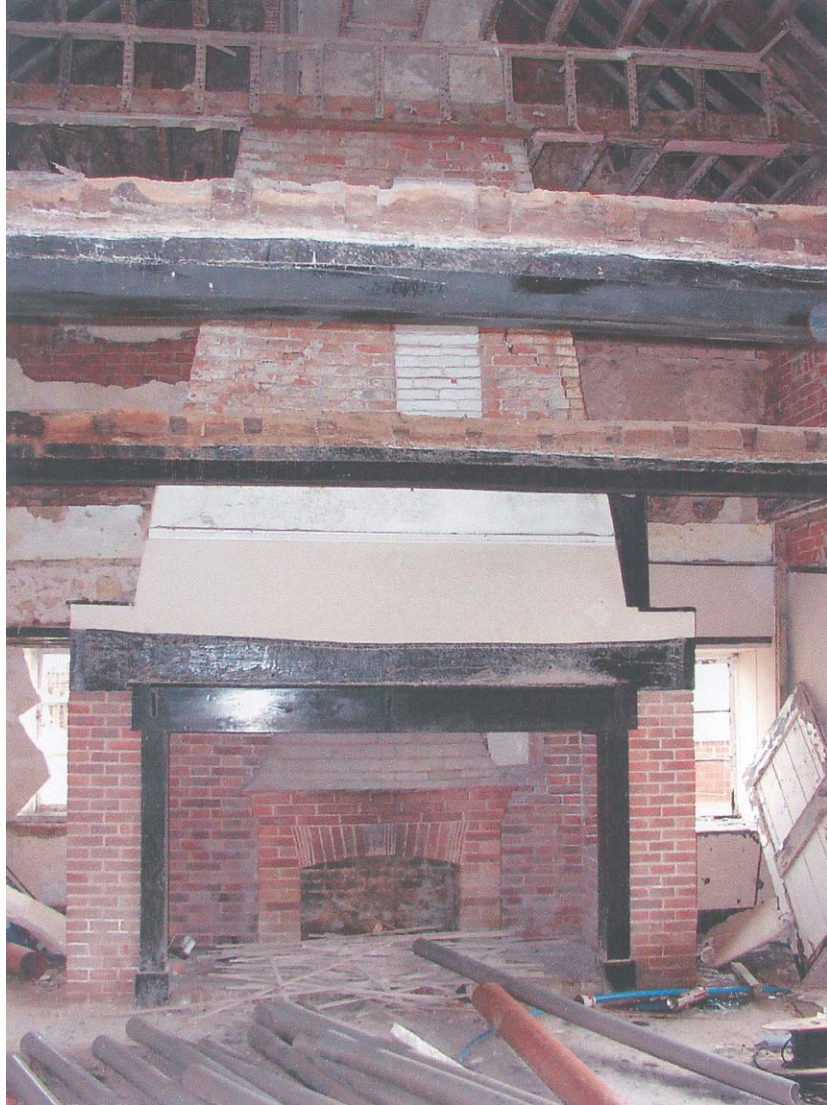
The fireplace against the south gable was rebuilt in brick as a 'fireplace-within-a-fireplace' in the 20th century (Plate 12) and is adorned with various niches although the back of the niche on the right-hand side nearest the fireplace is formed by bricks that are part of the 18th-century stack.

Plate 12 The 20th-century fireplace inside the  
18th-century south stack
