**ARCHAEOLOGICAL BUILDING SURVEY AND  
WATCHING BRIEF AT LOXBEARE BARTON,  
LOXBEARE, DEVON**

**Exeter Archaeology**

**Report No. 07.81**

**October 2007**

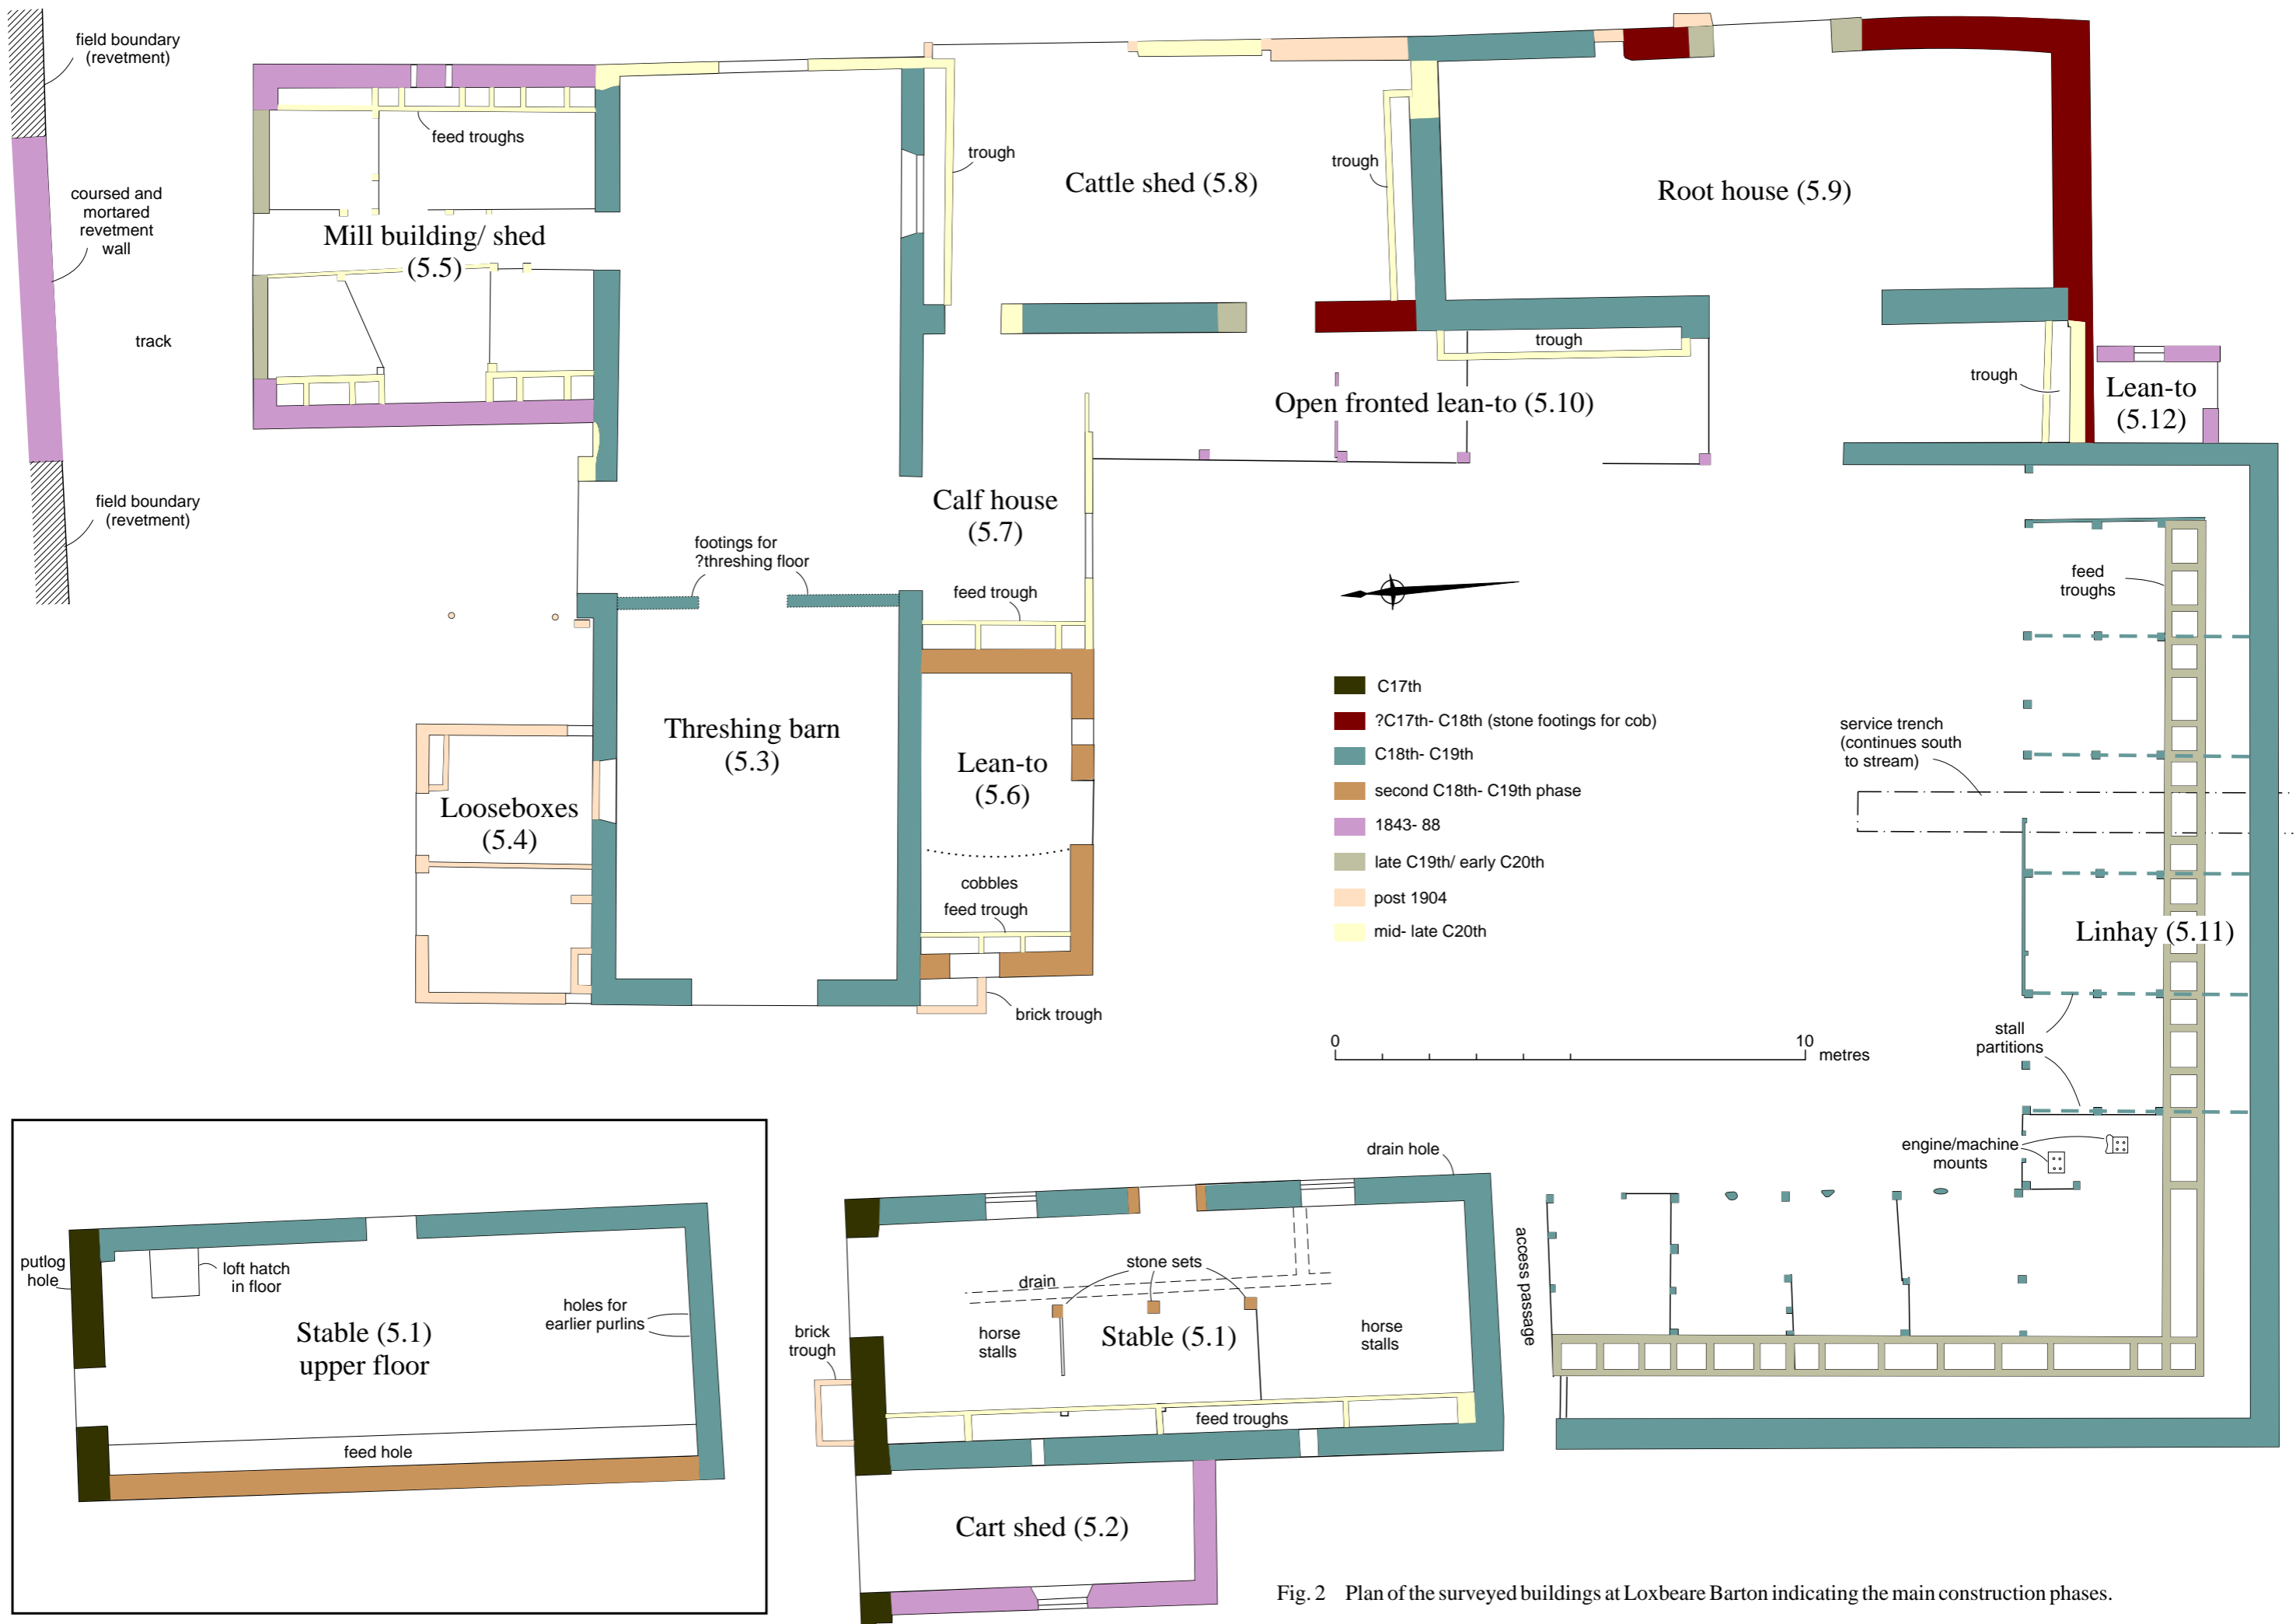
Fig. 2 Plan of the surveyed buildings at Loxbeare Barton indicating the main construction phases.

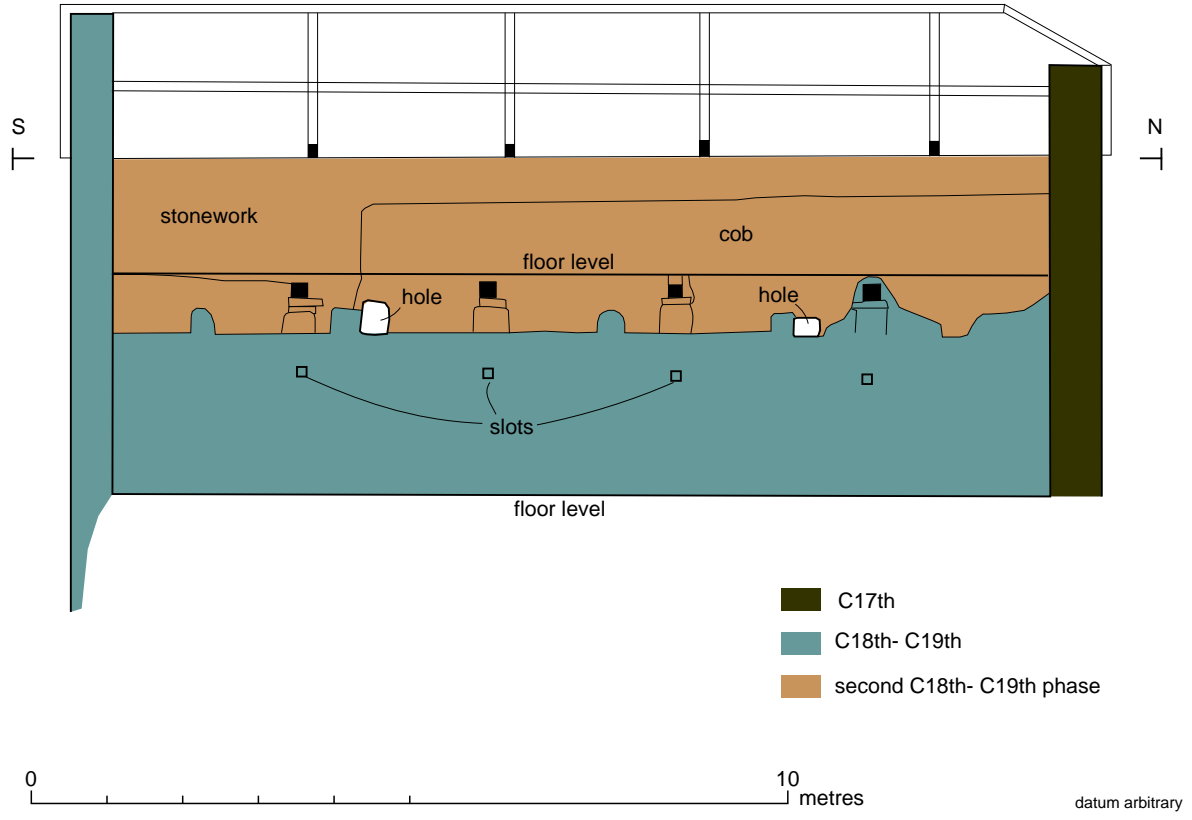
Fig. 5 Interior elevation of the west wall of the stable.

Four loft floor beams sat on timber wall pads, themselves set on 0.35m high stone piers built into the external walls (Fig. 5). These piers were evenly spaced (just over 2.m apart) and alternate with unevenly spaced piers of similar height, presumably from an earlier floor.

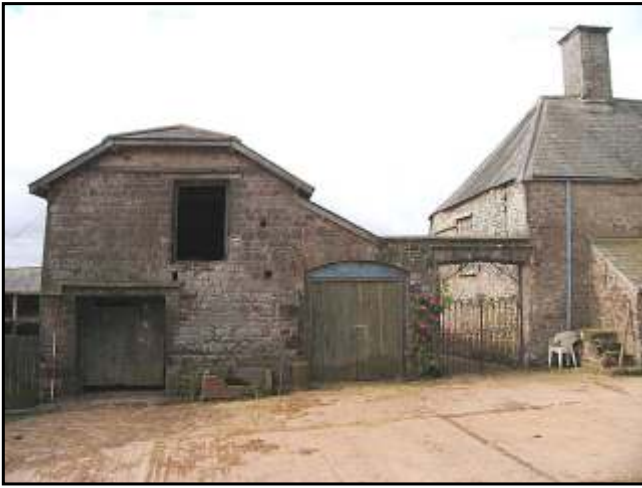
This elevation (plate 1) contained the oldest fabric within the farmyard complex, probably of 17th-century date, although a small amount of 18th/19th-century rubble was added to raise the roofline by *c.* 0.3m. The older masonry was bonded with a pinkish mortar and re-pointed with one of sandy white colour. The wall contained five putlog holes, three at 2.5m above floor level and two at 3.6m. The two easternmost holes were infilled.

The elevation extended beyond the stable to the west to attach to the house and provide a lintel to the garden entrance. This entrance has a low, chamfered cranked arch with a drip mould. Not including the garden entrance, the elevation had three doorways, one to the stable, one above to the loft, and the third, to the east, to the cart shed described below (5.2). The two westerly stable doors were fitted with wooden lintels and doorframes with inward opening doors. The stable doorway was 1.9m wide and located at the eastern end of the elevation. It had a ledged and battened door, hung by two long strap hinges on the inner face. The original planks of the door were covered in carved graffiti. Most were initials, although there were two numbers, *1104* and *1881*, the latter possibly a date. Above the doorway was a drip mould comprised of a number of chamfered short volcanic stones, similar to the one over the garden entrance. The turned down ends were still *in situ*, which implies that the opening was at its original width.

The loft doorway was 1.8m high, and offset to the west of centre of the elevation. Immediately above the lintel was a second drip mould. This extended across the full extent of the original masonry and was chamfered down at the eastern end, where it reached the original slope of the half-hipped roof. This is indicative of an original feature and shows that most of the northern elevation was retained to its full height. Above the drip mould was an area of heavily rendered stonework and the eastern side of the wall contained a section of later stonework, implying an alteration to the roofline.

Plate 1 Northern elevation of the stable with adjoining cart shed, arched entrance to garden and eastern end of house on right.

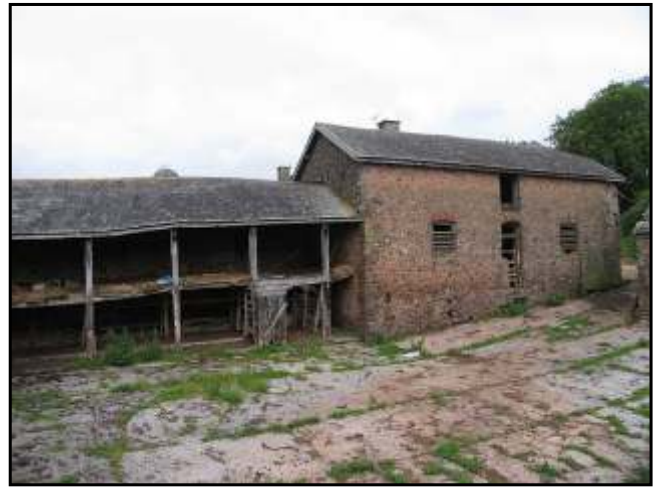
The eastern elevation represented the 18th/19th-century frontage (plate 2). This wall was symmetrically fenestrated with a window positioned to either side of a central door. These were fitted with louvres. A small loading hatch was situated directly over the door. All openings had volcanic stone quoins and were fitted with wooden frames.

The ground floor openings all had identical segmental red brick arches, the doorway formerly being a central window. As a result of the conversion, the volcanic stone quoins to the door varied in colour and size above and below the level of the earlier window. This doorway was *c.* 2.4m high and boarded up during the 20th century. The threshold was over 0.8m above the level of the yard. A shallow recess, *c.* 0.4m beneath, was probably the result of the removal of either stone steps or a ramp.

The colour and texture of the stone of the quoins and facework varied across the elevation, resulting in visible horizontal banding. As the whole wall was bonded with a pinkish mortar, suggesting that repair had not taken place, this banding is thought to be the result of differential wear to bands of stone of differing quality.

Plate 2 Eastern end of the stable and adjoining linhay on the left.

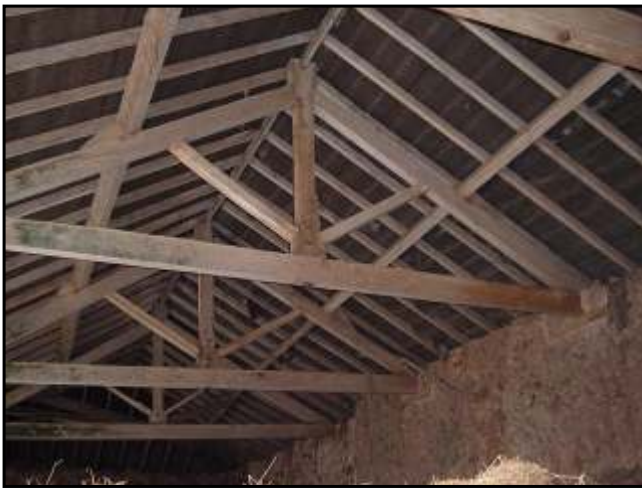
Plate 3 Tie-beam trusses with kingposts in the linhay.

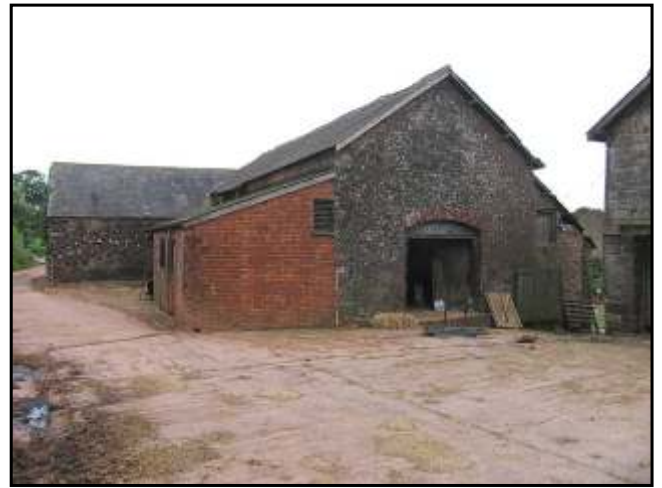
The threshing barn (plate 4) was a large east-west aligned building on the northern side of the yard, with wide opposing doorways at each end. Internally the barn measured 19.1m x 5.9m, with walls *c.* 0.5m wide. These were mainly of volcanic stone and random slate rubble, the latter particularly common on the interior. The western external elevation was finished with snecked dressed stone. Bricks had been used to construct the arch in the western elevation and to block an opening in the northern elevation. The eastern elevation had been completely rebuilt in concrete blocks.

Plate 4 Threshing barn with appendages - late looseboxes on the left, with mill building beyond and another lean-to to the right.

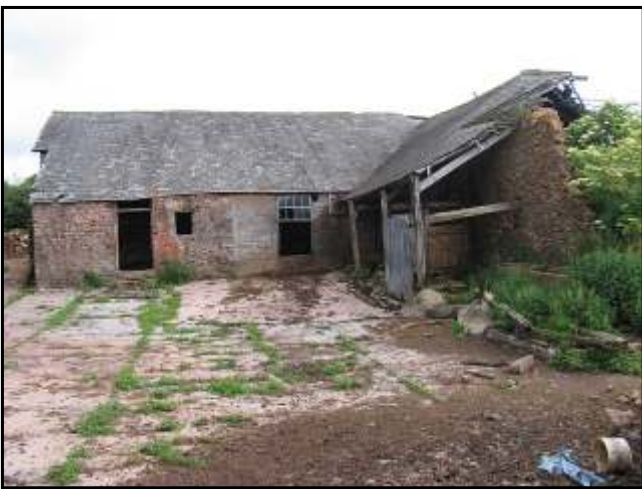
This lofted lean-to was attached to the southern elevation of the threshing barn at the western end (plate 5). The interior of the building measured 3.15m x 5.85m. Constructed in randomly coursed angular slate, volcanic and limestone rubble, the structure was bonded with a pinkish brown mortar. Quoins were only used occasionally on the jambs of the loft loading hatch. Some brick repairs had been carried out on the eastern side of the doorway.

Plate 5 Lean-tos along the front of the threshing barn and the remains of the cattle shed.

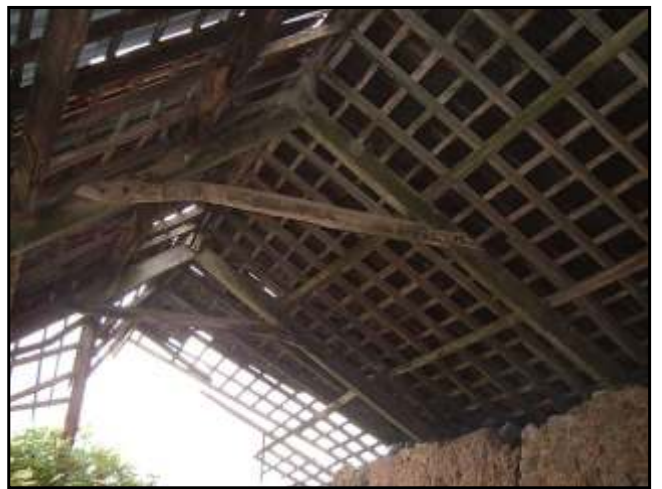
Plate 6 The surviving A-frame roof trusses within the ruined cattle shed.

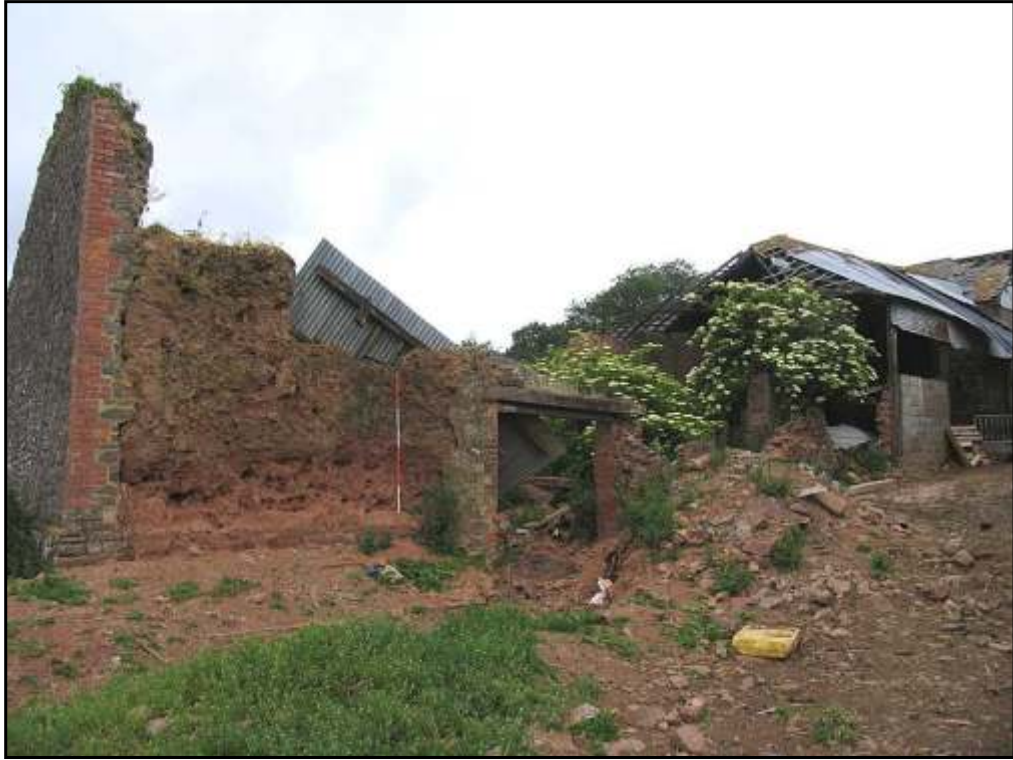
Plate 7 Root house and cattle shed, showing first floor level jamb in the cob walling.

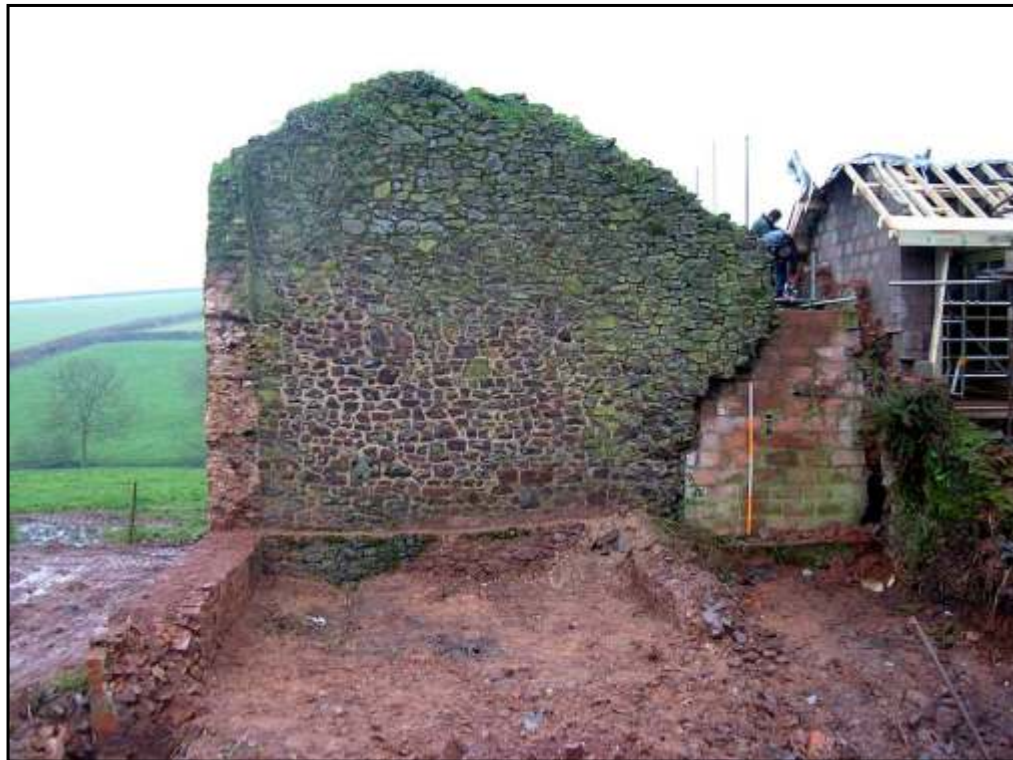
Plate 8 The southern end of the root house after removal of the rubble and demolition of the cob walling.
