**Straits House,
Tennyson Road,
Lower Gornal, Dudley,
West Midlands**

**An Ornamental Audit
and Building Record**

Project No. 1675
August 2007

By Malcolm Hislop

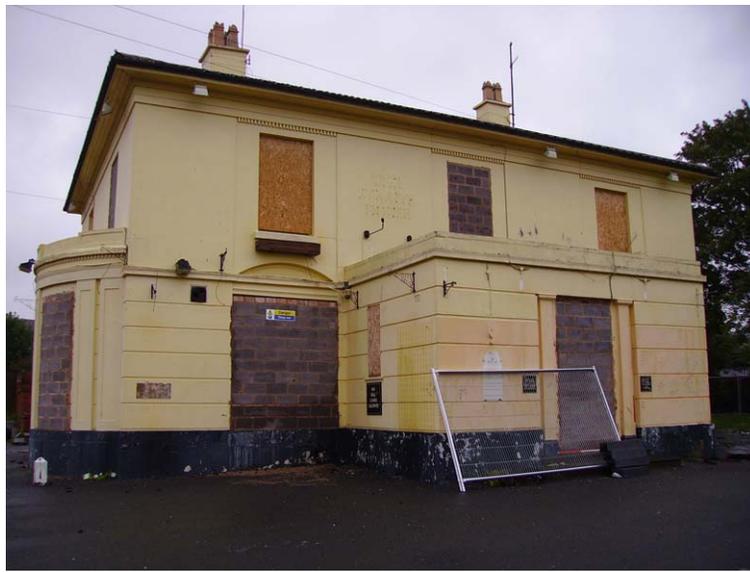
Plate 1

The principal (south) elevation of this brick-built, stuccoed house comprises a symmetrical three-bay front articulated by recessed window bays (Fig. 4A, Plate 1). In the centre is a single-storey porch with a central recessed entrance (blocked) flanked by simple pilasters (Plate 2). The channelled rustication of the ground storey is contained by a first-floor band bearing horizontal reeding which is carried around the blocking course of the porch. Above this band, over each of the two ground-floor windows, is a segmental-arched recess. Over each of the first-floor windows is a dentilated band surmounted by a wide but shallow stepped eaves band. An oversailing hipped roof is covered in 20th-century interlocking tiles.

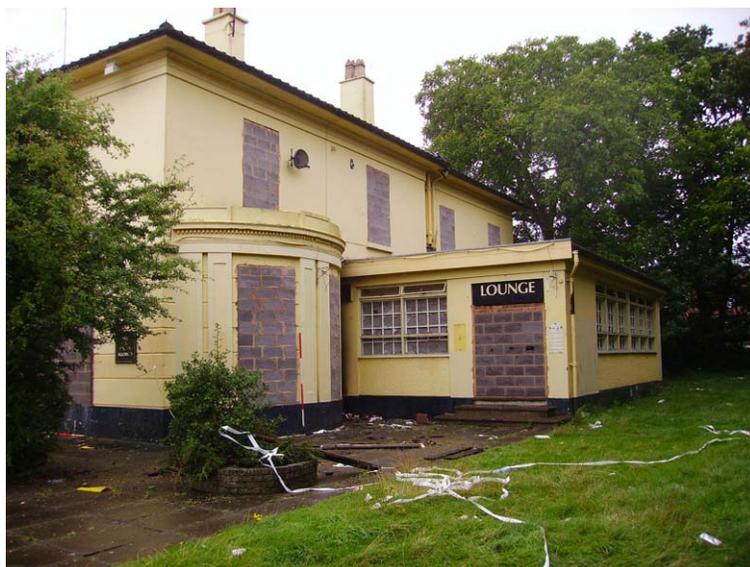
Plate 3

The east side elevation consists of the two-bay main block to the left (south) and two-bay rear wing to the right (north) (Fig. 4B, Plate 3). There is no discernible departure from the rather plain detailing apart from the single-storey bow window to the left (south), which lit one of the principal reception rooms within the main block. The two bays of this feature are articulated by twin, panelled, pilasters, and there is a dentilated frieze to a moulded cornice and panelled blocking course (Plate 4). This elevation is marred by the addition of a later 20th-century single-storey pub extension of no architectural merit.

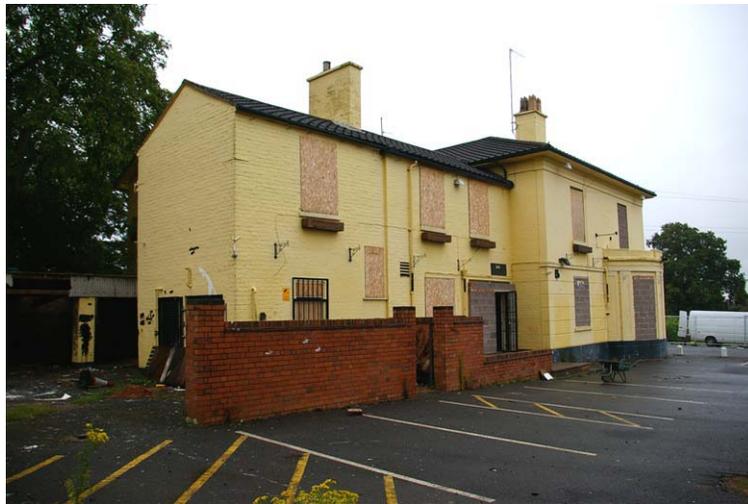
Plate 5

The west side elevation of the main block is similar to its eastern counterpart, the principal feature again being a bow window to the right (south) which lit the other principal front room (Fig. 4C, Plate 5). This side of the main block is more visible than the east side, the continuation of the rustication and other horizontal demarcations being quite clear. The principal difference is in the treatment of the rear wing, which, in common with the rear wall of the main block is of painted brick here rather than being stuccoed like the east front. The wing is in two parts with a two-bay block to the right (south), mirroring the east wing, with a single-bay recessed extension to the left, the dichotomy being emphasised by differences in the character of the brickwork. In the angle between the main block and the wing is an original doorway with a 4-panelled door. It is flanked to the left (north) by a window, obscured at the time of the survey by breeze block screen.

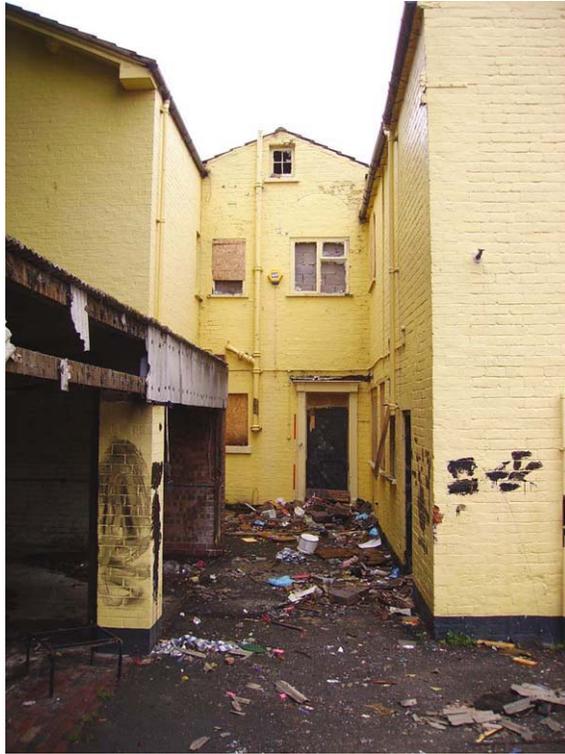
Plate 6

The rear (north) elevation comprises the east wing to the left, the west wing to the right and a deeply recessed central entrance wing of two storeys and attic (Fig. 4D, Plate 6). The central wing has an early 19th-century doorway to the right (west) with overlight, pilastered wooden doorcase and cornice hood. A window to the left (east) is an original opening with a stone sill and segmental-arched head, but the window

frame has been replaced. The two first-floor openings both contain late 20th-century frames, but otherwise appear to be original; the smaller left hand (east) one has a segmental brick arch over, and the larger right hand (west) one a blocked semi-circular arch. A small attic window is also original with stone sill and 19th-century 4-pane frame

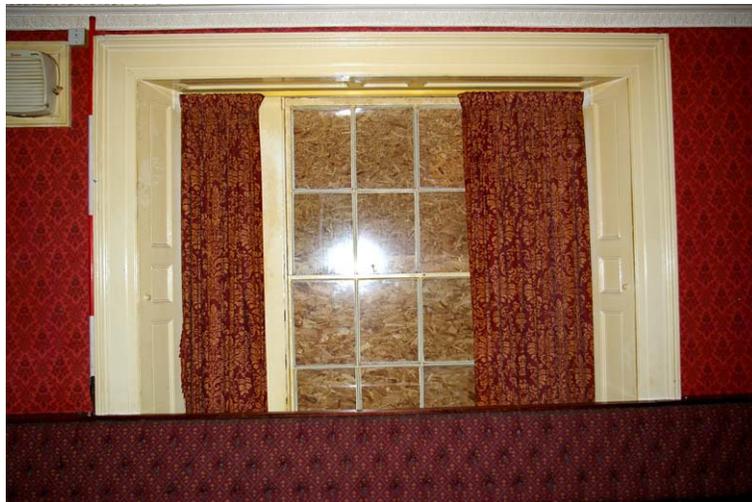
Plate 7

G3 to a great extent mirrors G2. It too retains early 19th-century skirting boards a tripartite window to the south (Plate 7) and bow window (Plate 8) to the east both with boldly projecting moulded window architraves, panelled shutters and small-pane sashes, a moulded plaster cornice (Plate 9), and a chimney breast on the north wall

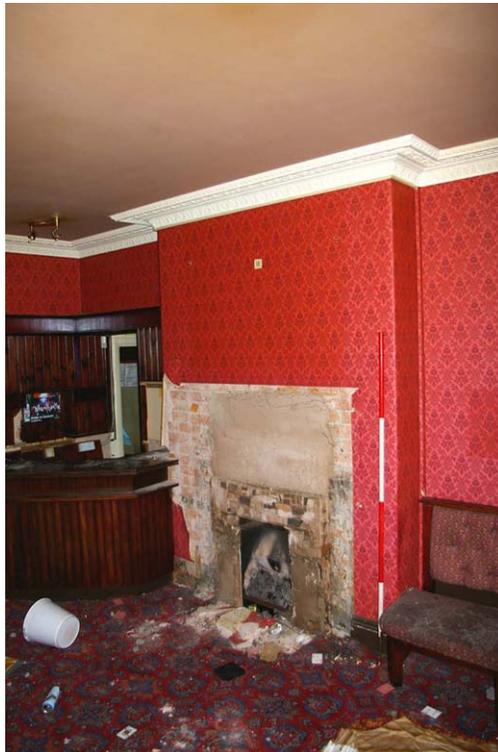
Plate 10

(Plate 10). All other fixtures and fittings are late 20th-century in date and not of special interest.

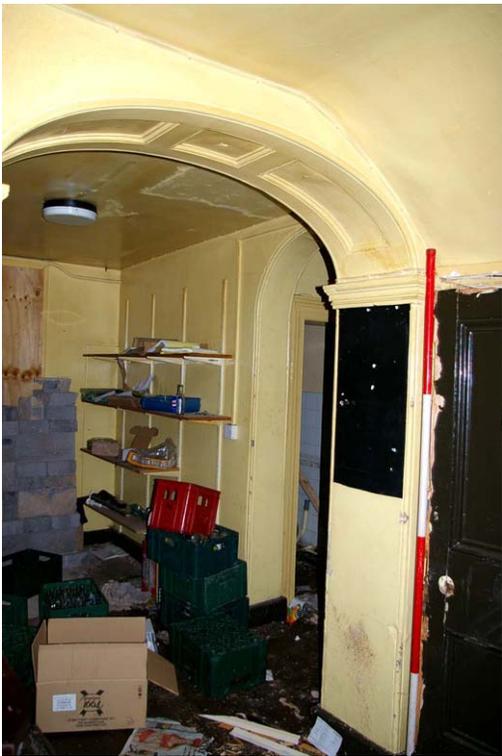
Plate 13

The central area is now partly obscured by the insertion of a bar and fittings and the consequent enclosure of the staircase, and the former west wall has been removed to allow bar access from G4 to the west. Towards the south end of the east wall is an original entrance retaining an early 19th-century architrave, with a late 20th-century door. It is likely that this doorway was mirrored on the west side of the area by one giving access to G4. The early 19th-century staircase survives in the north-east corner of G8. Access was originally from the south, but this has been closed off and the stair is now reached from the north via a short flight of inserted steps which has covered over the still surviving foot of the early-19th century stairs. The staircase itself has a panelled casing, open string with carved tread ends, ramped skirting board ascending in step with the stairs, stick balusters, shaped hand rail and a square sectioned foot newel (Plate 11). A good deal of damage has been inflicted recently by vandal action, as a result of which, a large section of the balustrade has been destroyed. At the north end of the staircase an early 19th-century 4-panel door opens to the head of the cellar steps (Plate 12). The north wall of G8 is pierced by a 3-centred open archway springing from moulded plaster imposts, the soffit of the arch being wood panelled (Plate 13).

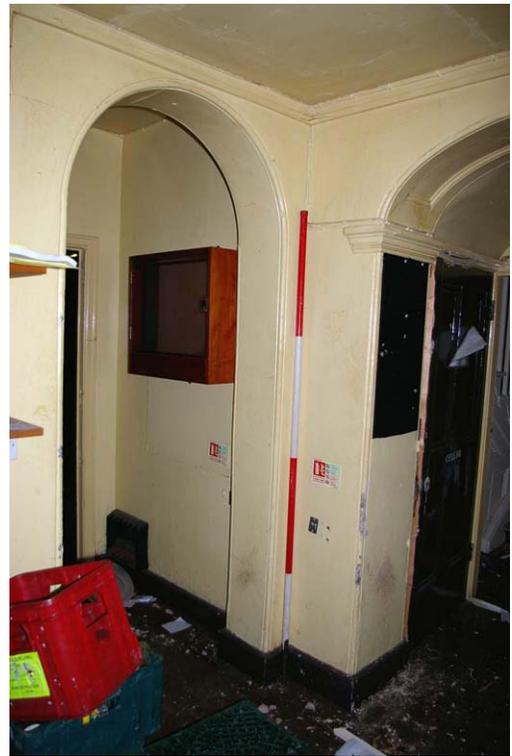
Plate 14

G10 formed the rear entrance hall, with access from the rear (north) and west doorways, it gave access on the west to the kitchen (G9), on the south to G8 and thence to the main house, and on the east, via another, but less ornate archway (Plate 14), to a small lobby (G13).

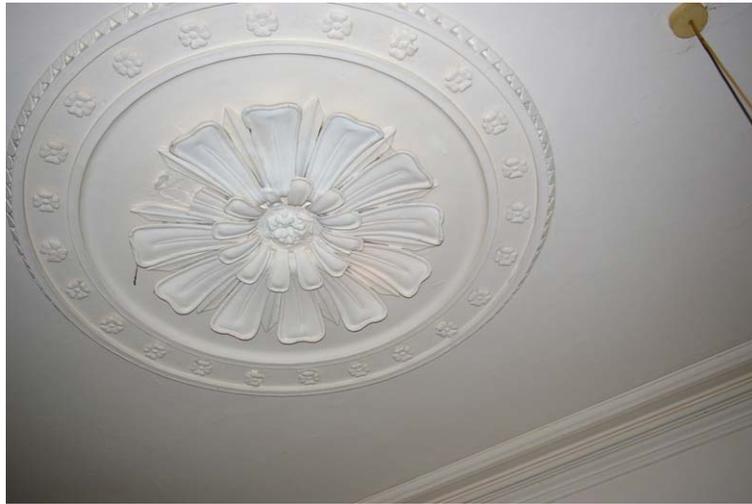
Plate 15

The first-floor landing originally extended from the staircase to the north as far as the front of the house to the south, but the southern portion has been partitioned during the 20th century to form another room. The balustrade to the stairwell has been destroyed by vandal action and the only surviving features of architectural significance are the 19th-century small-pane sash in the south wall, a 19th-century moulded plaster ceiling cornice and an ornate 19th-century plaster ceiling rose over the stairwell (Plate 15).

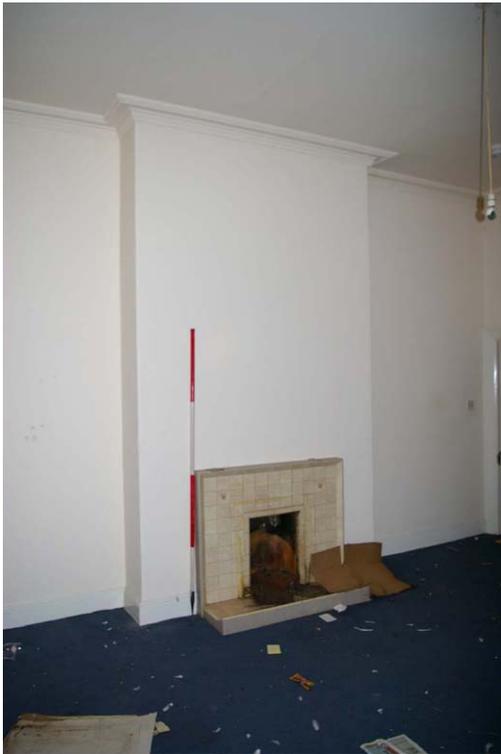
Plate 16

Bedroom F2 is entered from the landing (F1) to the east via an early 19th-century 4-panelled door. Other original features include the beaded skirting boards, chimney breast (north wall), two 12-pane sashes (south and west walls), and the moulded

plaster ceiling cornice (Plate 16). The tiled fireplace dates from the early to mid-20th century.

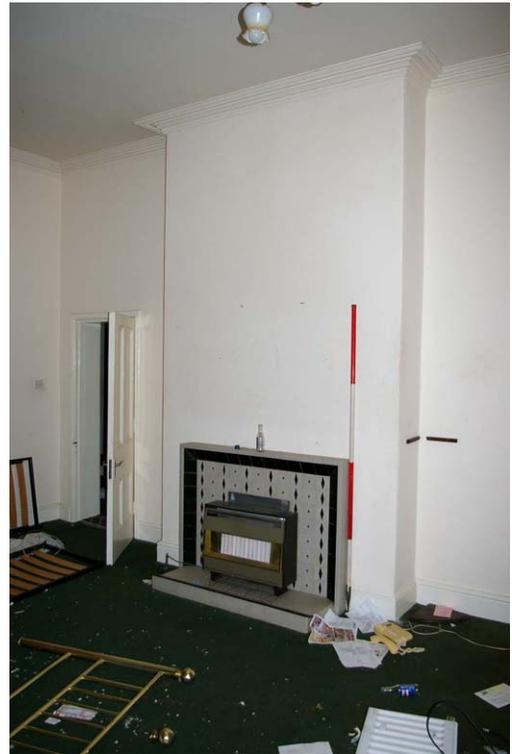
Plate 17

Bedroom F3 has 19th-century skirting boards, a chimneybreast on the north wall with early to mid-20th century tiled fireplace, 12-pane sashes in the south and east walls, and a plaster cornice (Plate 17).

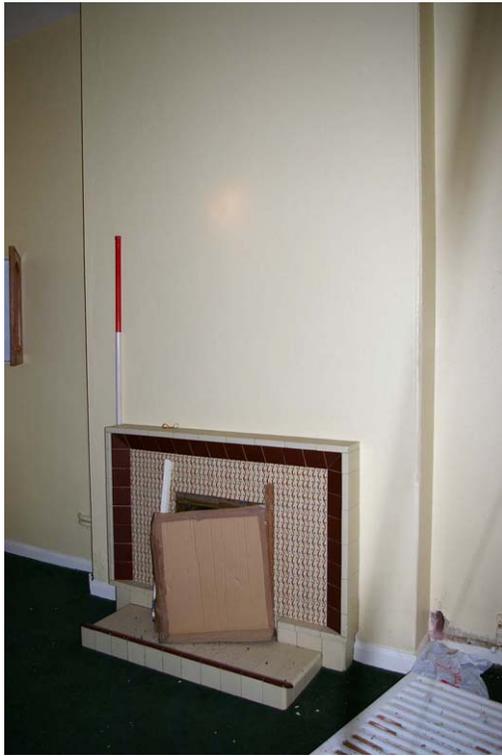
Plate 18

The skirting boards have been replaced in the mid-20th century except in the inserted cupboards to the south where early 19th-century skirting survives. A chimneybreast projects from the north wall with an early to mid-20th-century fireplace, and there is a 12-pane sash window in the east wall. The west wall, which is a stud partition, contains a 19th-century 4-panelled door (Plate 18).
