BARROW CASCADE HOUSE, DERWENTWATER, CUMBRIA

Archaeological Desk-Based Assessment

Client: John Cunningham
Architects

© Greenlane Archaeology Ltd
July 2006

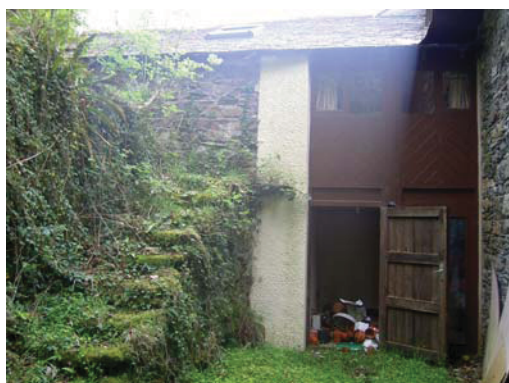
Steps and large doorway on north side

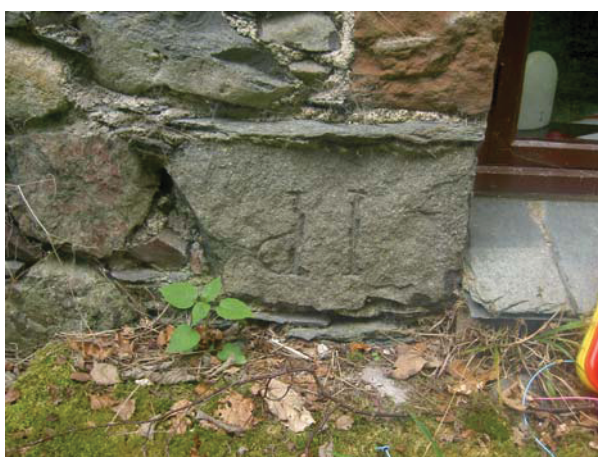
Other features: one of the quoins in the west jamb of aperture to the east has the initials 'IP' (presumably for Joseph Pocklington) carved into it, although it is positioned upside down – late 18th century, poor condition

Initialed stone re-used as quoin

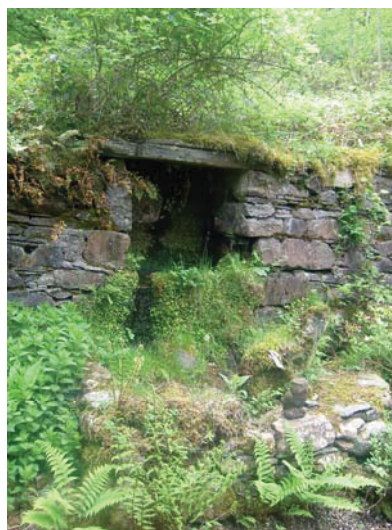
Trough

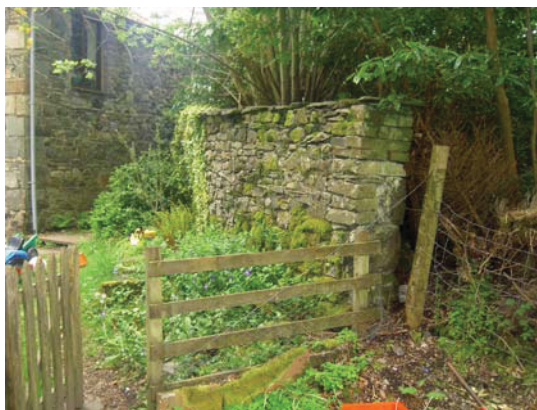
Re-used sandstone in north end

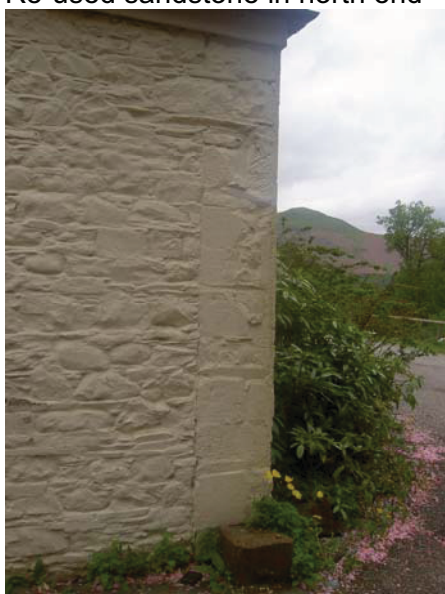
Scar of wall and pillar stub

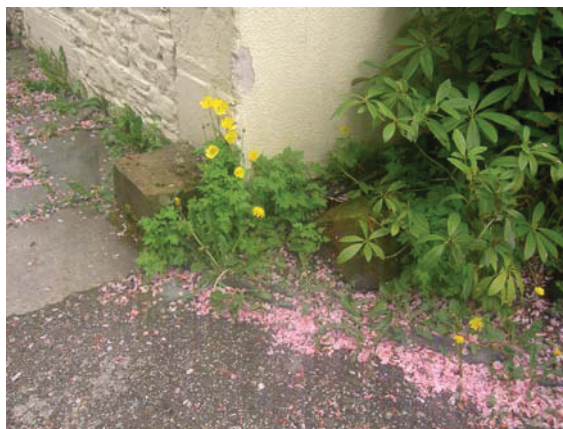
Pillar stub and displaced cap-stone

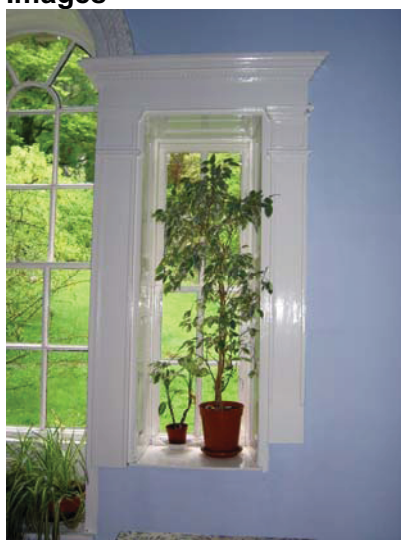
Modified flanking window

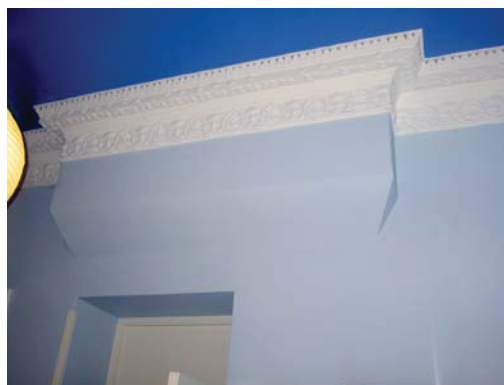
Remains of chimney breast and cornice

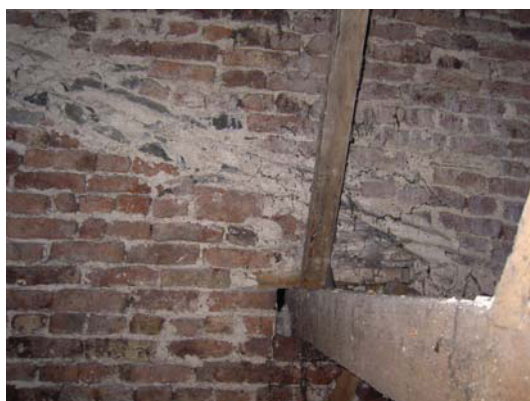
Scar of monopitch roof in roof space

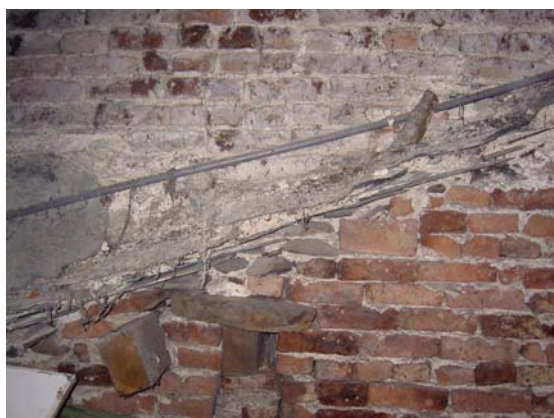
Scar of monopitch roof in roof space

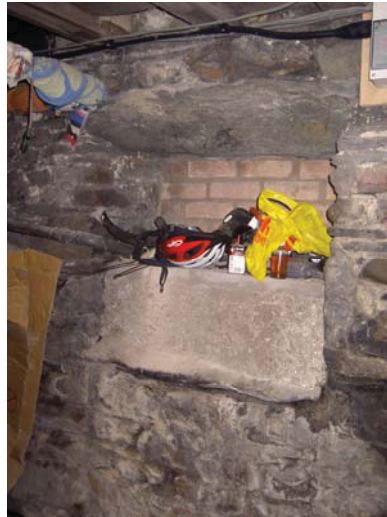
Blocked coal hole to east

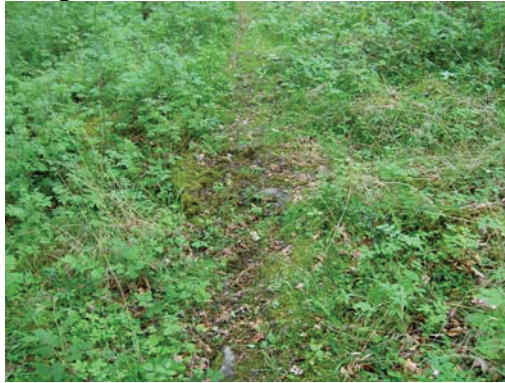
Overgrown clapper bridge
