**BUILDING SURVEY OF  
AN OUTBUILDING AT  
12 BOSTON ROAD  
SLEAFORD  
LINCOLNSHIRE  
(SLBR06)**

Work Undertaken For  
J. Jenkins Radio & Television

February 2007

A.P.S. Report No. **13/07**

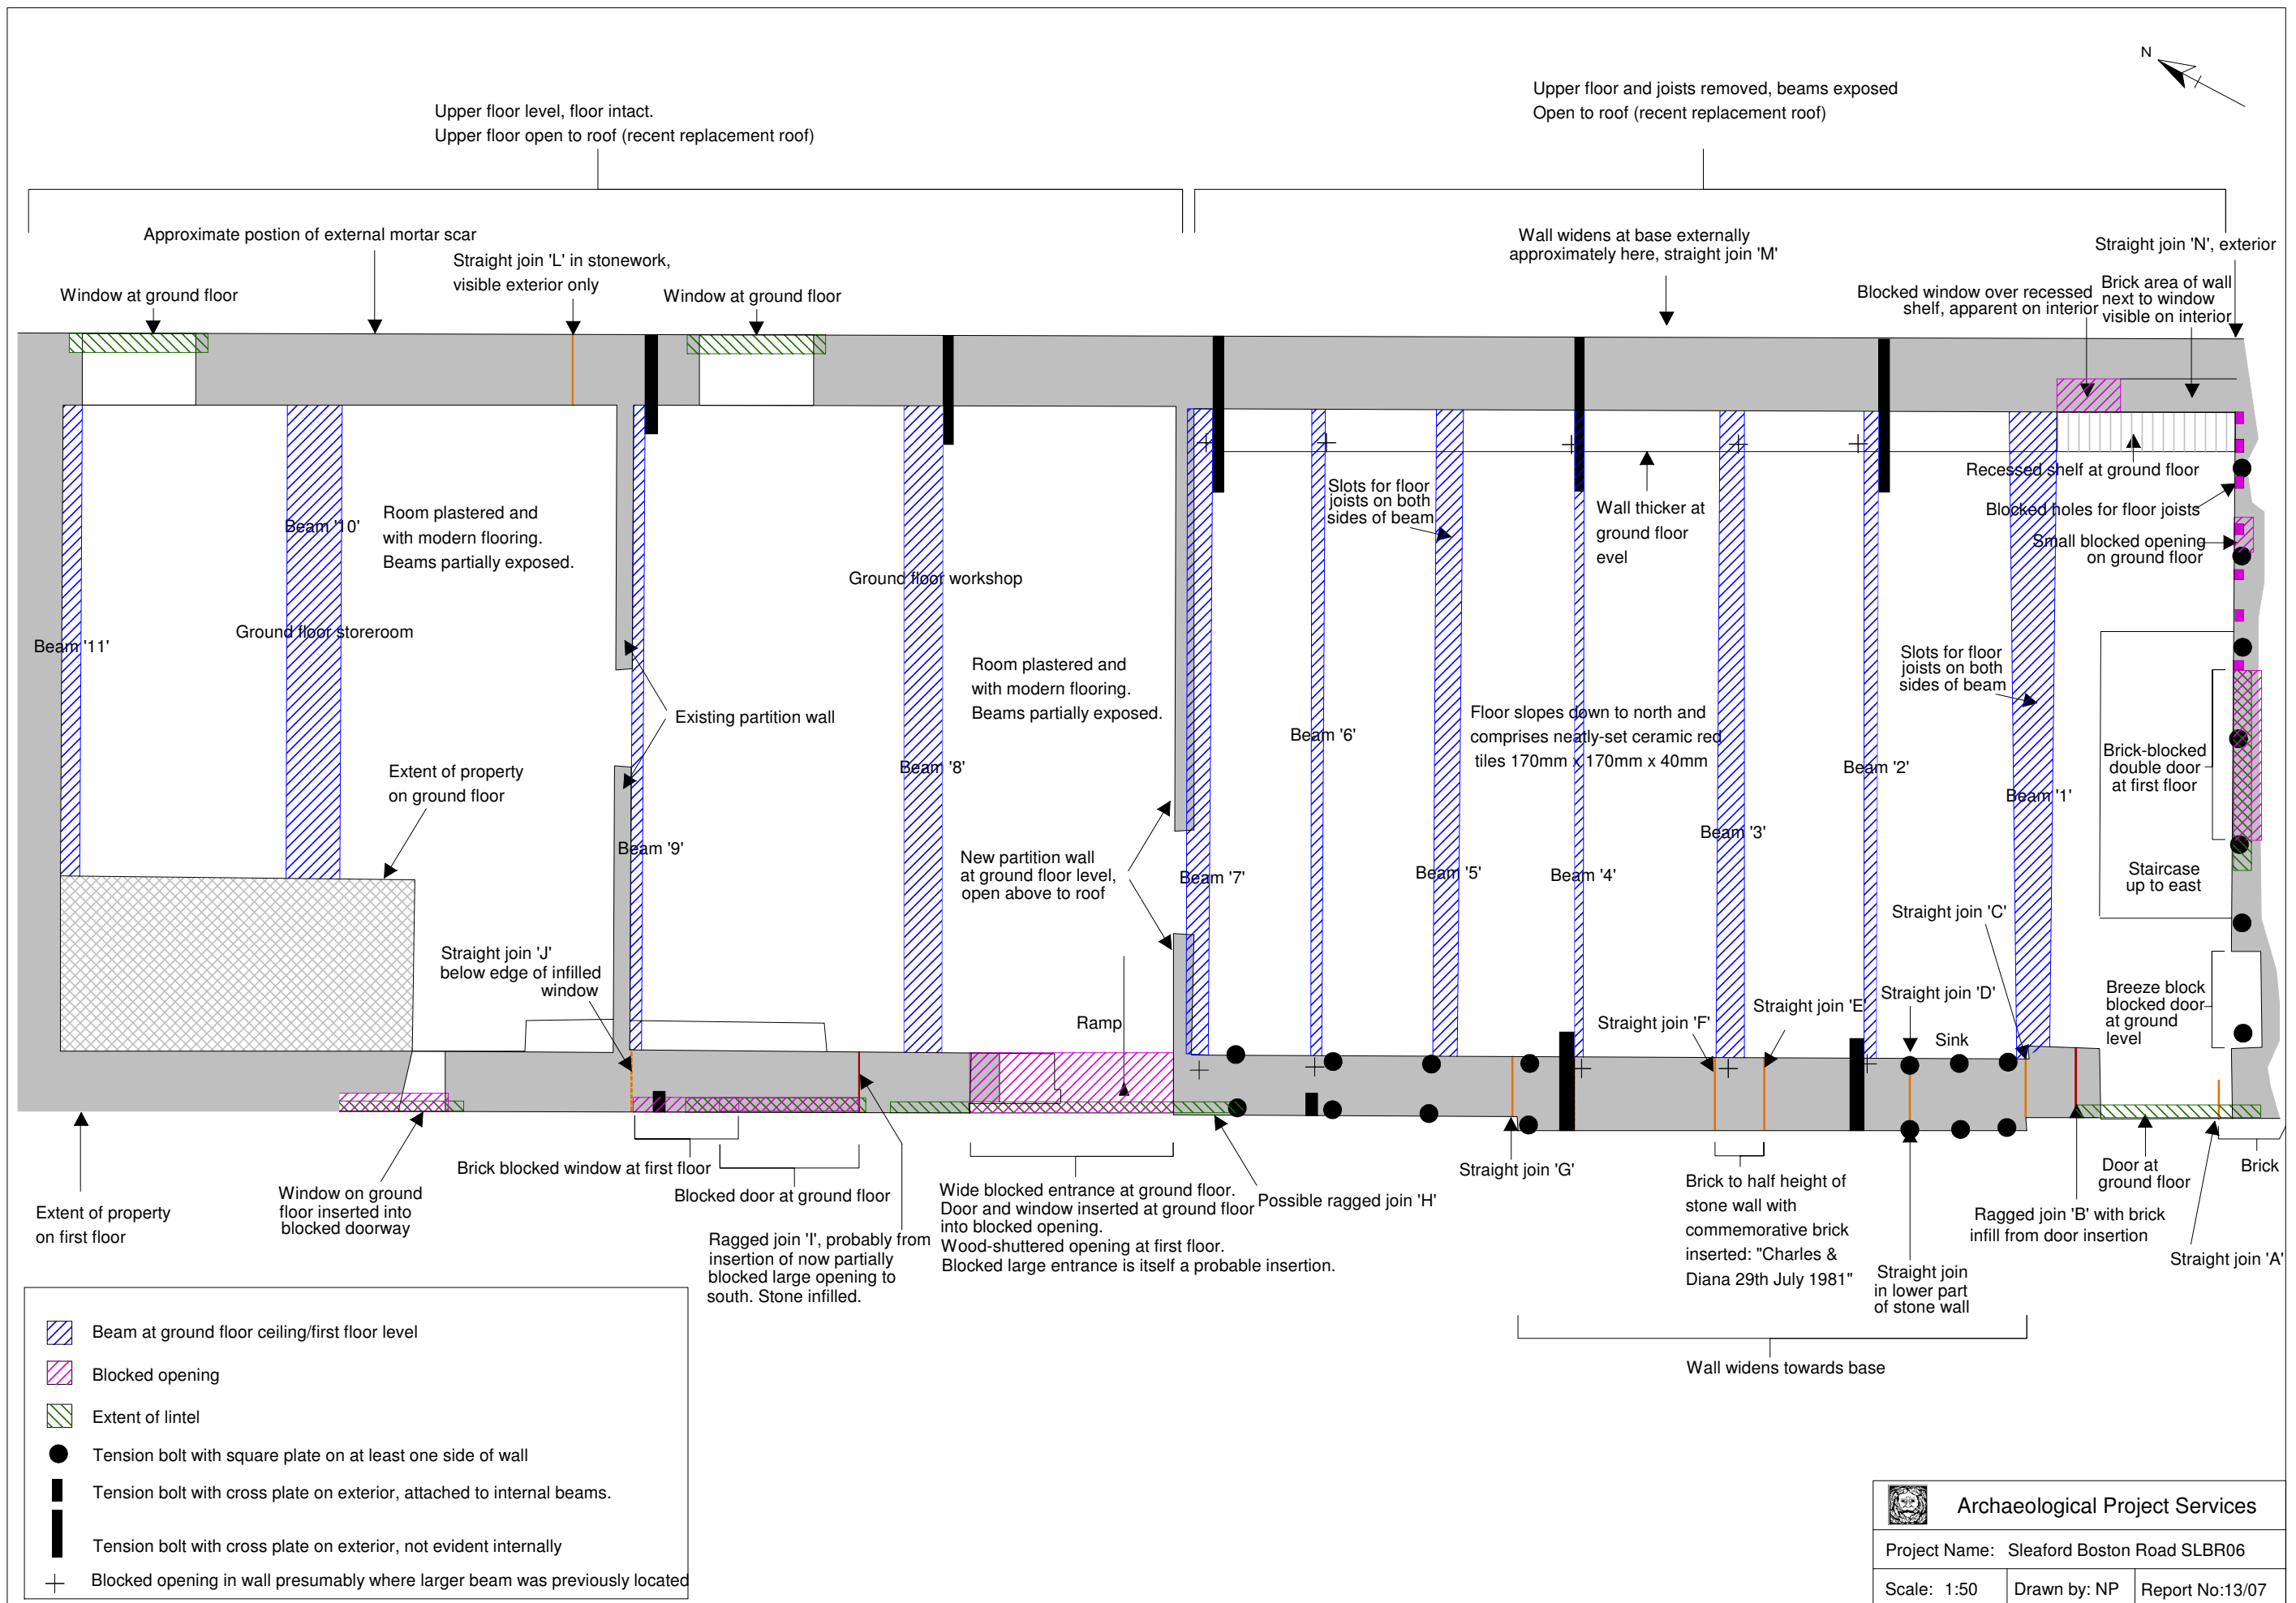
Figure 4 Plan of building

Although the majority of the west elevation was of stone, at the far southern end was a straight join to a portion of brickwork, corresponding to a change in the roofline (Figure 4, Plate 6 'A'). These bricks were apparently a mix of late hand

Just to the north of the doorway, and continuing for c.4m to the north, was a projection in the base of the outer wall (Figure 4, Plate 6). This projecting section of wall gradually narrowed to the top, being absent in the upper portion of the stone wall. Either end of this projecting portion was marked by a straight join ('C' & 'G'). The edge of the projection at 'C' corresponded to a recess in the internal elevation (Figure 4). The other edge of the projection, at 'G' corresponded to a straight join visible on the internal elevation. The reason for this variation in the line of the wall was not clear, although it may be that entrances were blocked or some parts of the wall have been rebuilt. The projecting portion of the wall appeared rather more vertical than other parts of the wall, and this feature may well represent an attempt to strengthen a bowing wall.

Three further straight joins were identified within the projecting portion of wall, each of these only being as high as the projecting section. Approximately 0.95m from the southern end of this part of the wall was a straight join between two areas of stonework 'D'. The reason for this join is unclear, though could perhaps be a blocked entrance. Approximately 1.2m and 1.6m to the north of this were two further straight joins, bounding an area of brickwork (Figure 4, Plate 6 'E' & 'F'). These mainly seem to be late handmade

Further to the north was a blocked doorway to the ground floor, with a wooden lintel and infilled with stone (Figure 4, Plate 6). An electricity meter box was fixed to the wall here.

A window or similar opening to the first floor was blocked with late handmade bricks (Figure 4, Plate 6). These had no

Also noted on the west elevation were tension bolts with both cross plates and square plates. The four cross plates were slightly below the level of the first floor (Figure 4, Plate 6). The southerly three plates were very recent additions, fresh grease being noted on the bolts inside the building. Two were attached internally to replacement floor beams and the third corresponded to the location of one of these beams. The most northerly of the four cross plates was of a different type, and matched the location of a beam in the ground floor workshop, although the bolt was not seen internally. The seven square-

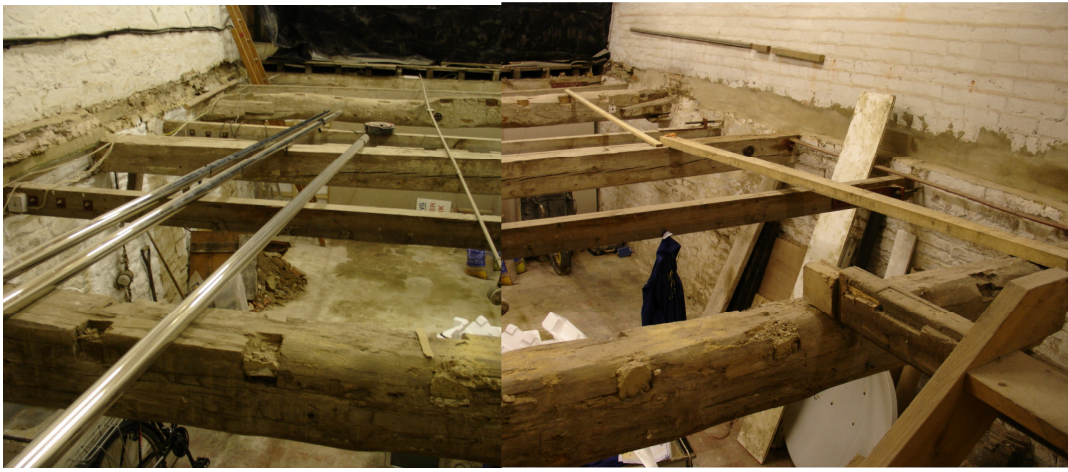
The five remaining beams in this room were each set into larger holes in the walls of the building. This indicates that these may reflect the location of larger original beams which have been removed. Beam '3' is of relatively large dimensions, although is neatly squared in cross section and does not feature the trenched joints noted on beams '1' and '5'. In the western wall, this beam rests above an area of brickwork and two straight joins in the external section (Figure 4, Plate 6 'E' & 'F'), which may have been built as a solid base on the replacement or insertion of this beam.

The remainder of the beams, '2', '4', '6' and '7' are all of lesser width and neatly rectangular in cross section (Figure 4, Plates 8 & 9). These all seem to be rather recent replacements or insertions, and contemporary with one another. Beams '2' and '4' are bolted at each end to recent tension bolt cross plates on the external elevations. Beam '7' was bolted to one such tension bolt at the east end. No tension bolt was observed bolted to beam '6', although it did coincide with the location of a cross plate on the outside, and it is likely to have been attached.

The level of the base of the beams in this room was relatively low, with inadequate space to stand up beneath many of them. The height between the floor and the base of the beams varied from approximately 1.72 to 1.87m.

Plate 8 View of southern storeroom interior showing first floor beams '1-7', composite of photographs, looking north

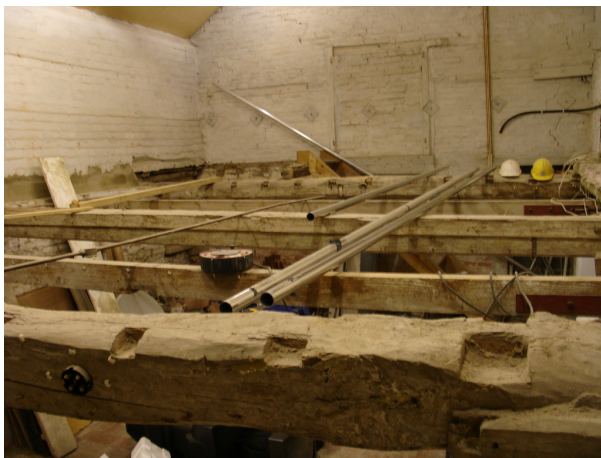
Plate 9 View of southern storeroom interior showing first floor beams '1-5' and south elevation, including blocked entry and tension bolts, looking south

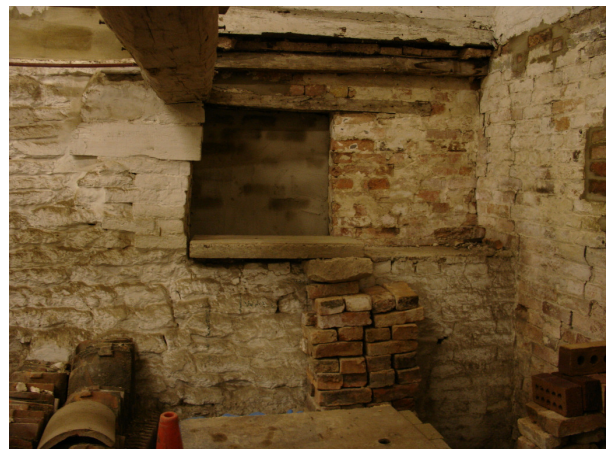
Plate 11 View of southern storeroom interior showing alcove at southwest corner of room, blocked opening and brick and wood insertion under beam '1' in east wall and blocked joist holes and opening in south elevation, looking east

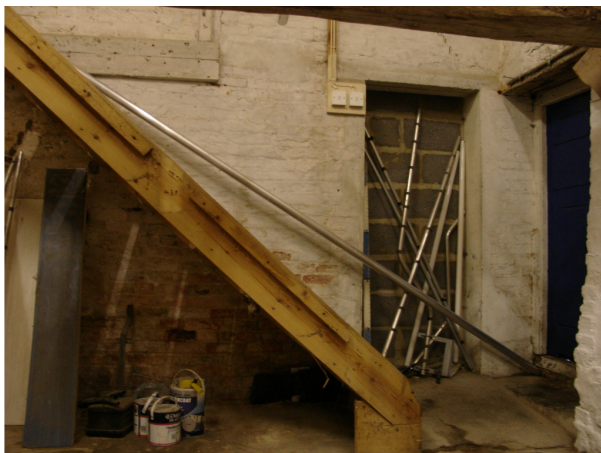
Plate 10 View of southern storeroom interior showing staircase to first floor, access door to room and blocked doorway in south elevation, looking south

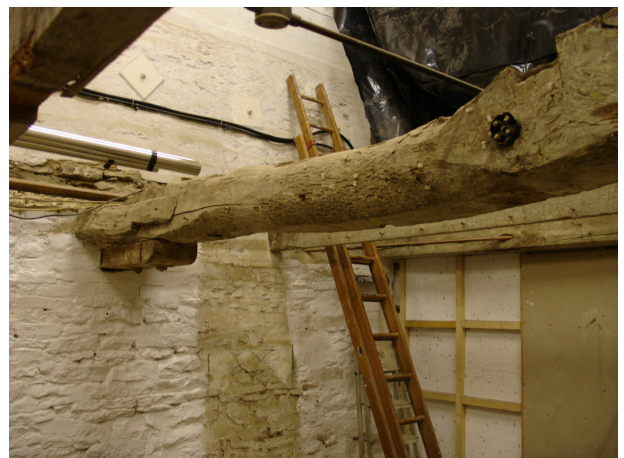
Plate 12 Southern storeroom interior showing detail of possible original beam '5', looking northwest. Partition wall to workshop and storeroom at right, access to first floor store via ladder

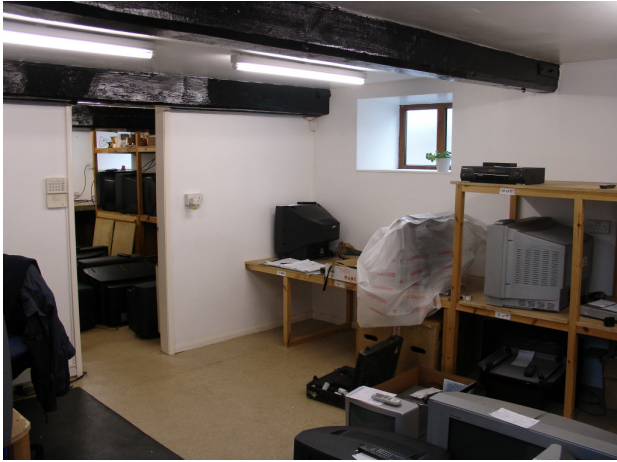
Plate 13 Interior of workshop, showing exposed beams '8' & '9', window in east wall and partition wall and access to ground floor storeroom

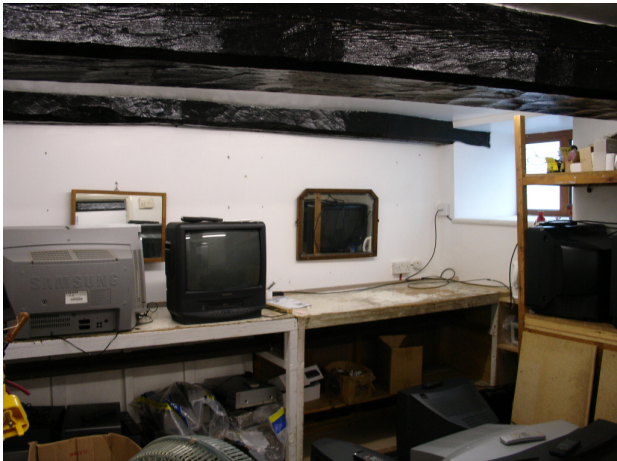
Plate 14 Interior of ground floor storeroom, showing exposed beams '10' & '11' and window in east wall

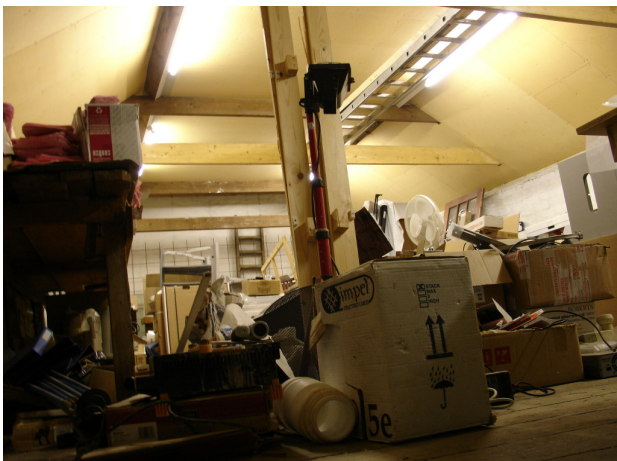
The extent of the property on the upper floor was marked by a change in the colour of the roof tiles, grey on the surveyed building and red on the adjoining property. Both roofs were of modern tiles. It was also evident inside the building that the entire roof was a very modern replacement.

Plate 15 Interior of first floor storeroom showing recent roofing
