## Archaeological Monitoring at Dallas, by Forres, Moray

## Report and Recommendations

Report No. HAS0492

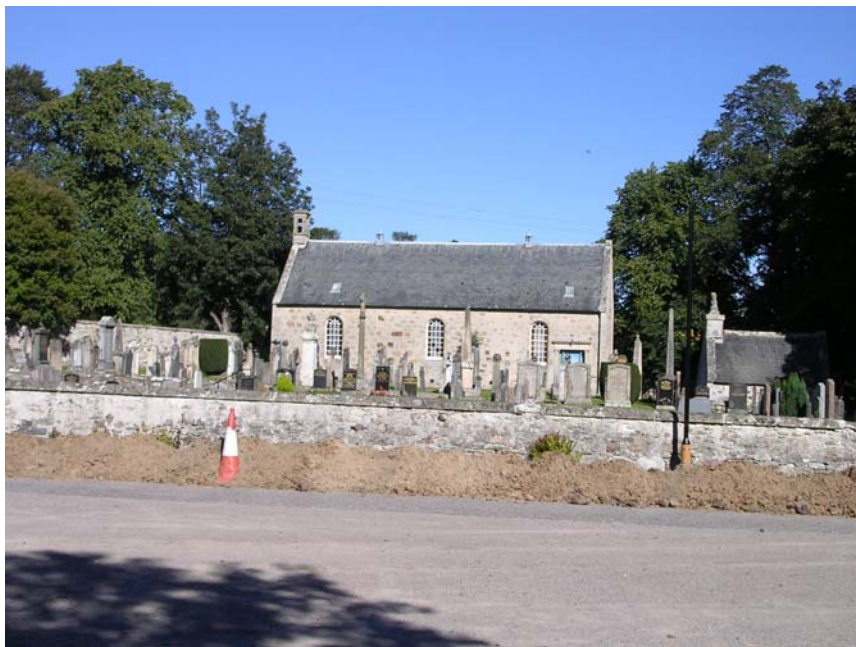
**Figure 3 View north across trench to church and churchyard from [1]**

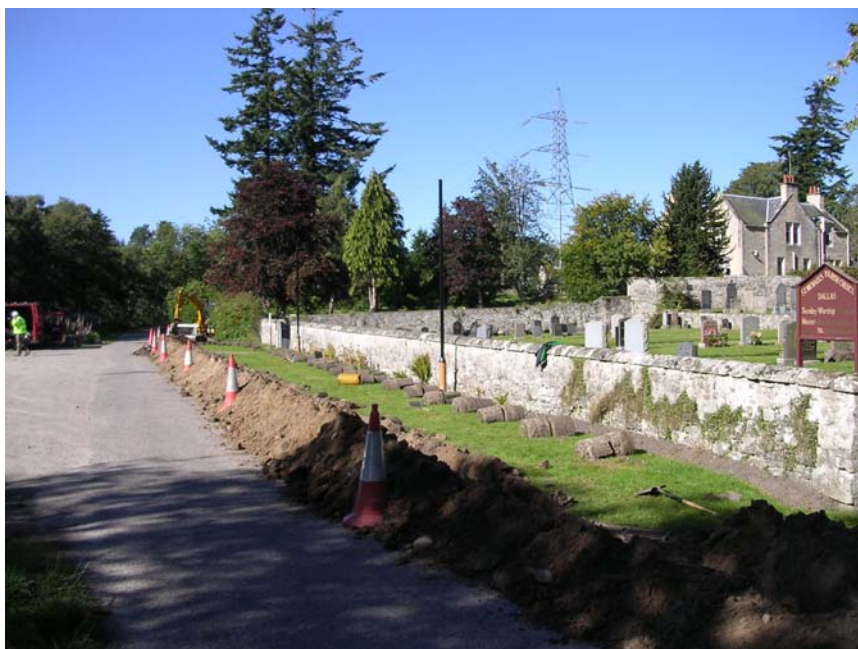
The trench, 910mm deep by 460mm wide, was cleanly cut by a back-acting mechanical excavator. It passed through completely clean and undisturbed sandy silts, apart from one location opposite the entrance to the side access to the church, where there was evidence of disturbance for a manhole and associated drains, and indications of a wide depression, almost certainly natural, containing a fill of rounded river cobbles of about 120mm diameter, below layered silts. Aberdeenshire Archaeology Service was notified of the work by telephone.

Figure 4 View west along trench from [2]

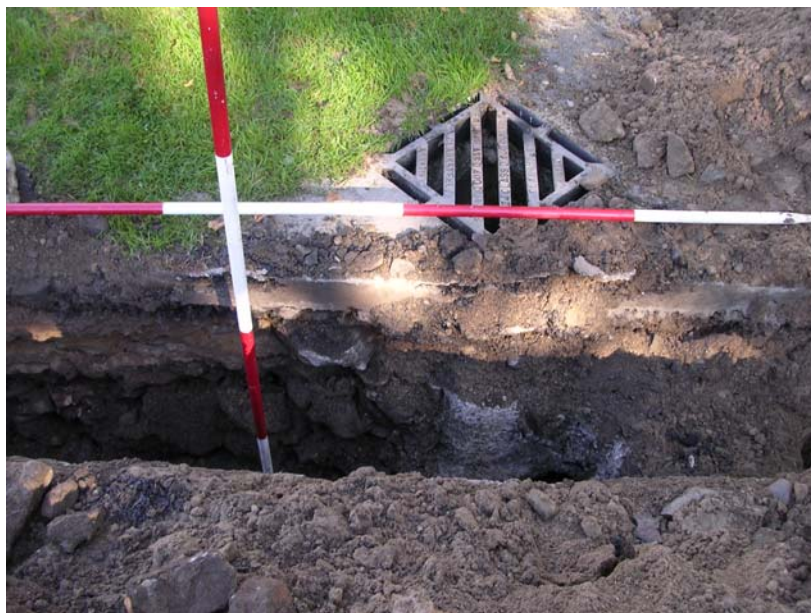
*The contractors' trench revealed clean and undisturbed sandy silts, apart from one location opposite the entrance to the side access to the church, where there was a manhole and associated drains, and indications of a wide, almost certainly natural depression, containing a fill of rounded cobbles below layered silts. This was interpreted as a former pond or similar.*

Figure 5 Disturbance for modern drain and manhole from [2]

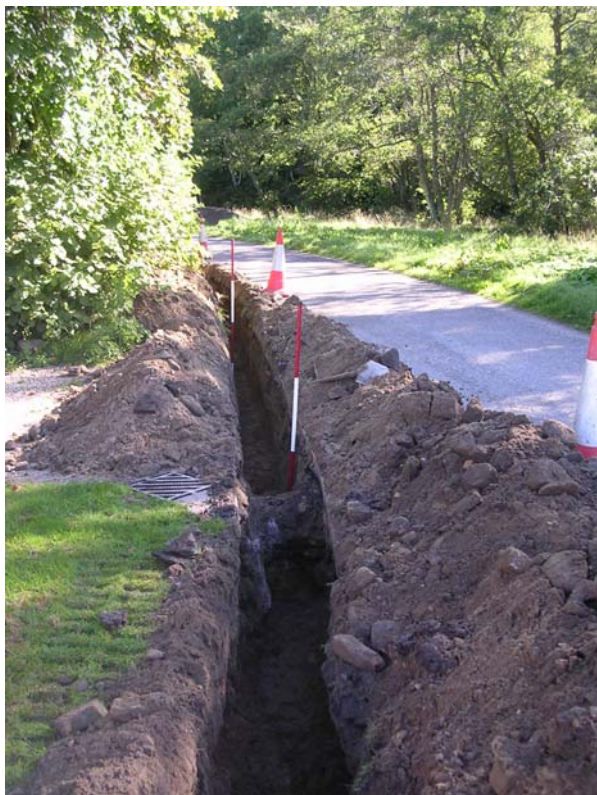
**Figure 6** View east showing drain and manhole at path junction from [3]

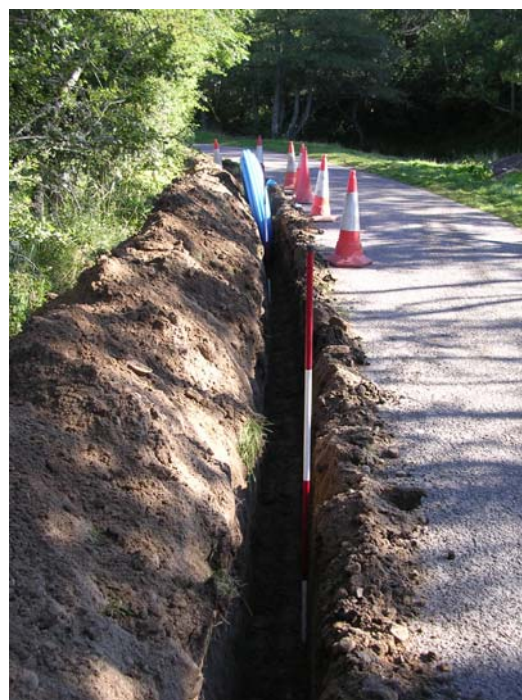
**Figure 7** View east from churchyard corner from [2]

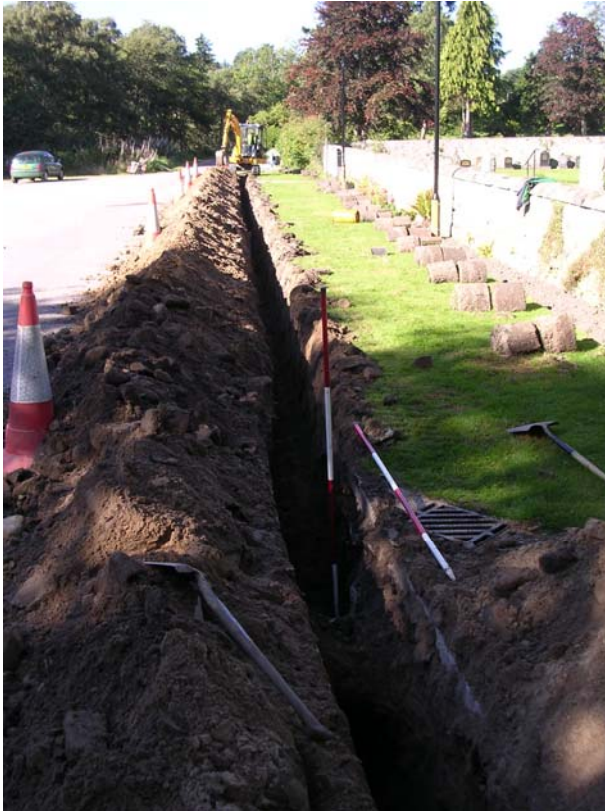
Figure 8 View west from path entrance and disturbed area along trench from [2]
