# **Jones' Farm, Dawson Lane, Chorley, Lancashire.**

## **An Archaeological Building Survey**

**October 2008**

Report ref. 0804

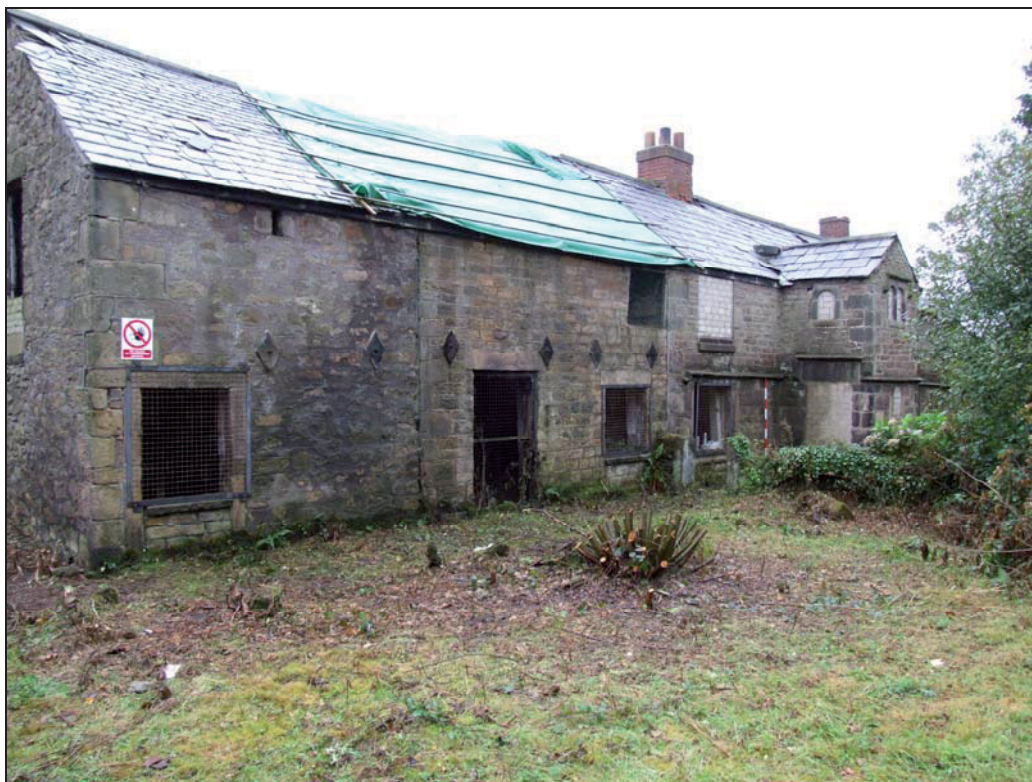
- 6.1** The subject building comprises a rectangular detached two storey stone built structure (plate 1), roughly aligned to the cardinal points with the frontage facing north. The building is located in an isolated position off Dawson Lane. Originally, a three bay building, the layout of the farmstead is elongated; the shippon/stable are constructed on the east side of the farmhouse in two additional phases of construction. These are clearly visible as straight joints with quoins on the west side of each. The exterior fabric is in good condition although the roof has several slates missing, over the first extension, which has been covered with plastic sheeting. The roof is comprised of a double pitched slate roof, although the southern pitch of the main building is of stone tiles. Two brick chimneys are visible rising from the main building, one to the east and one at the west gable. A stone built porch projects from the front of the building with the front door on the east side, creating a baffle entry.

**Plate 1.** North elevation from the northeast

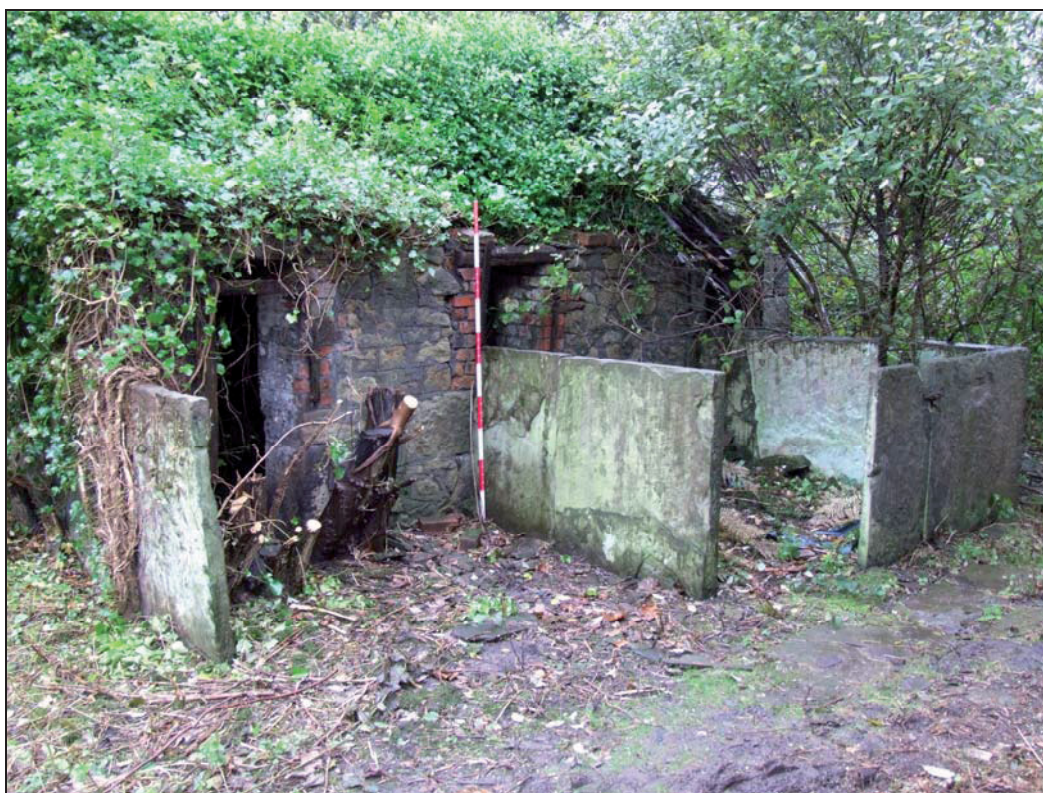
- 6.2** A small (6.46 x 3.00m) piggery is located to the east of the farmhouse (plate 2). It is constructed from sandstone blocks with three entrances in the west face, which all show brick repair work. Two internal brick walls divide the piggery into three stalls. The double pitched slate roof is covered with ivy. In front of the doors on the exterior are two small pens, formed by large vertical sandstone slabs.

**Plate 2.** The piggeries from the northwest

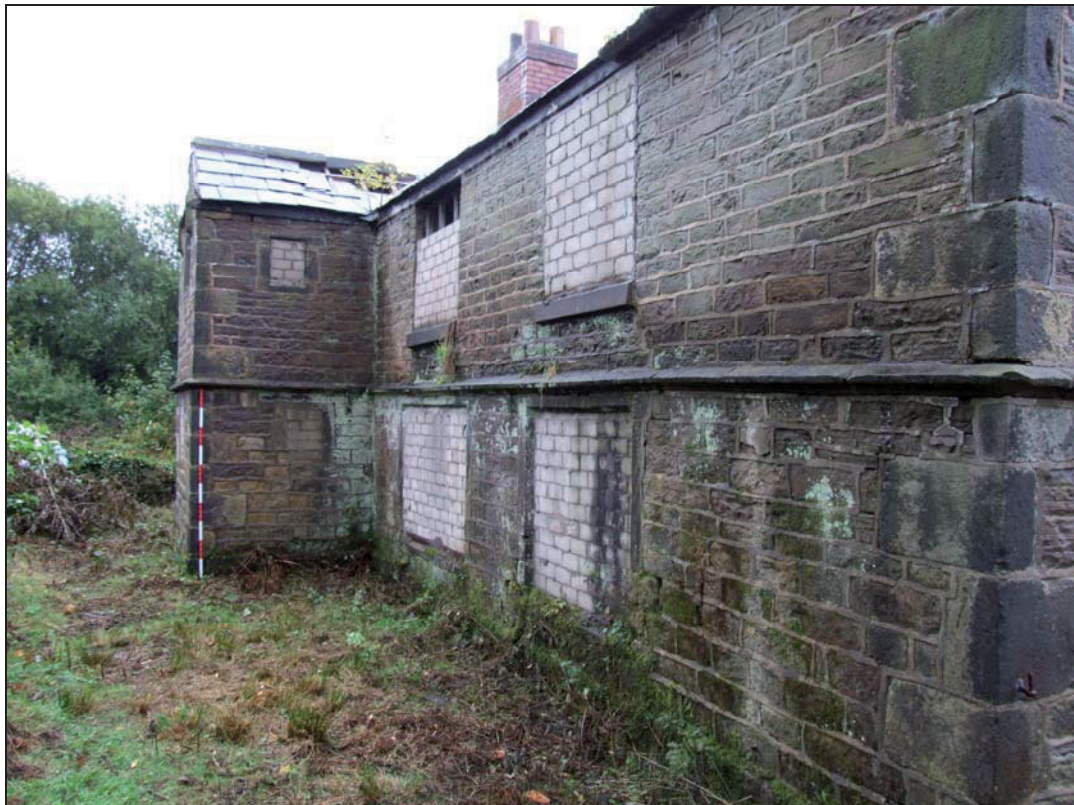
- 6.3 Northern Elevation** (plates 1 & 3). This elevation comprises the front of the building and is constructed in coursed and shaped sandstone block, re-pointed with cement (plate 34). The second extension, furthest to the east, is constructed in uncoursed rough rubble (plate 35). The face is characterised by several windows and a protruding porch. The second extension has a single window at ground floor level, with a sandstone cill and dressed sandstone jambs and lintel. It has no frame remaining and was previously a doorway, blocked to form a window, as evidenced in the straight joints and sandstone jambs reaching ground level and the sandstone blocking beneath it; it has been fitted with a metal grate. A small wind eye is located centrally, close to the roofline. In the first extension, located between the second extension to the east and the main building to the west, two square windows, one at ground floor level, the other above it, are located in the western side. The ground floor window has a sandstone cill and lintel, but no frame and is fitted with a metal grate. The first floor window has no cill or jambs and is located below the roofline, the aperture is fitted with a timber frame. A large personal timber framed door with heavy sandstone lintel is located to the east, fitted with a metal grate. Six diamond shaped faceplates are located across the face of both extensions (plate 4). The main building has eight windows in total, four at each level, all of which are blocked, with the exception of the eastern ground floor window. This square timber framed window has a chamfered sandstone cill, jambs and lintel, although the cill has been cement rendered. A hood mould is located above this with a dog-legged label stop at its eastern end and runs west. Above this window is another square window, located below the eaves has a cement rendered cill. West of these is the projecting face of the porch, built in the same manner as the rest of the building, but with a gabled slate roof running south to meet the northern pitch of the main building. This contains two small, decorative arched windows. The ground floor window has a sandstone surround, the lintel shaped to form an arch. Located at first floor level, is a two light chamfered mullion window with a sandstone surround shaped similar to the window below, but having two round-headed lights. Between these is the extended hood (drip) mould, which continues to run along the elevation (plate 5). To the west, on the face of the main building once again, are four landscape windows. The two at ground floor level have chamfered sandstone cills and lintels, and sandstone half jambs, supporting the lintel. Above this, the prominent hood mould runs the length of the face. The two windows above have cement rendered cills and rise up to the roof level. The eastern most of these is not fully blocked, and three lights can be seen at the top. A low chamfered plinth runs around the face of the building.

**Plate 3.** Western end of the north elevation from the west

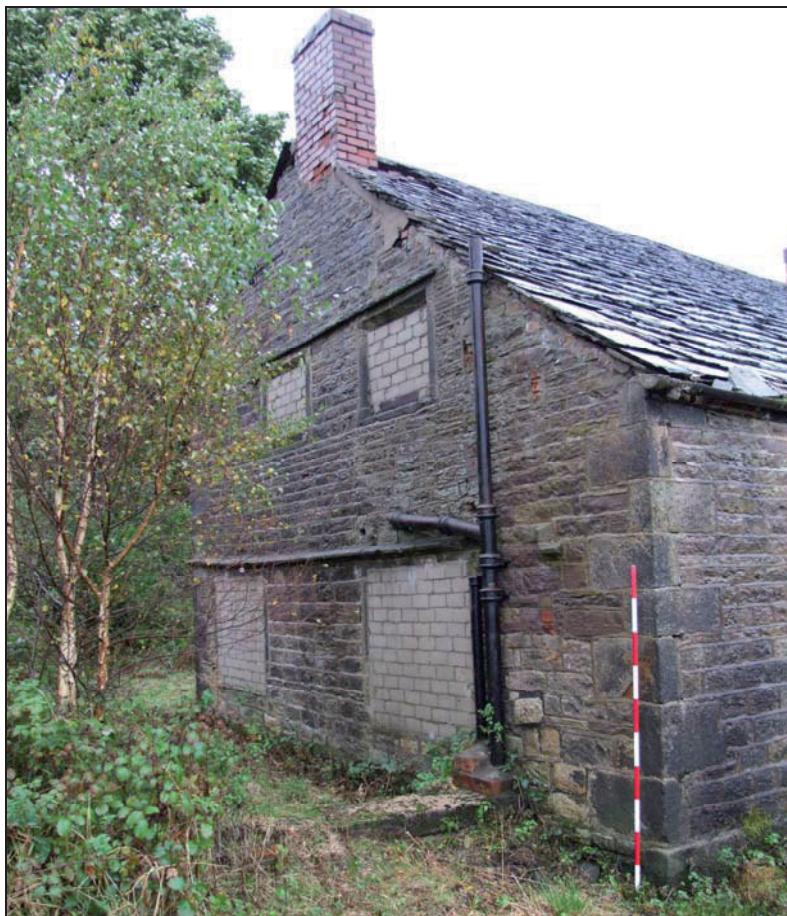
- 6.4 Western Elevation** (plate 6). This forms one of the gable ends of the building and is built in coursed sandstone blocks with lime mortar, although it has been re-pointed with cement. The face is characterised by four windows, all sealed with concrete blocks and all having chamfered

**Plate 6.** West elevation from the south west

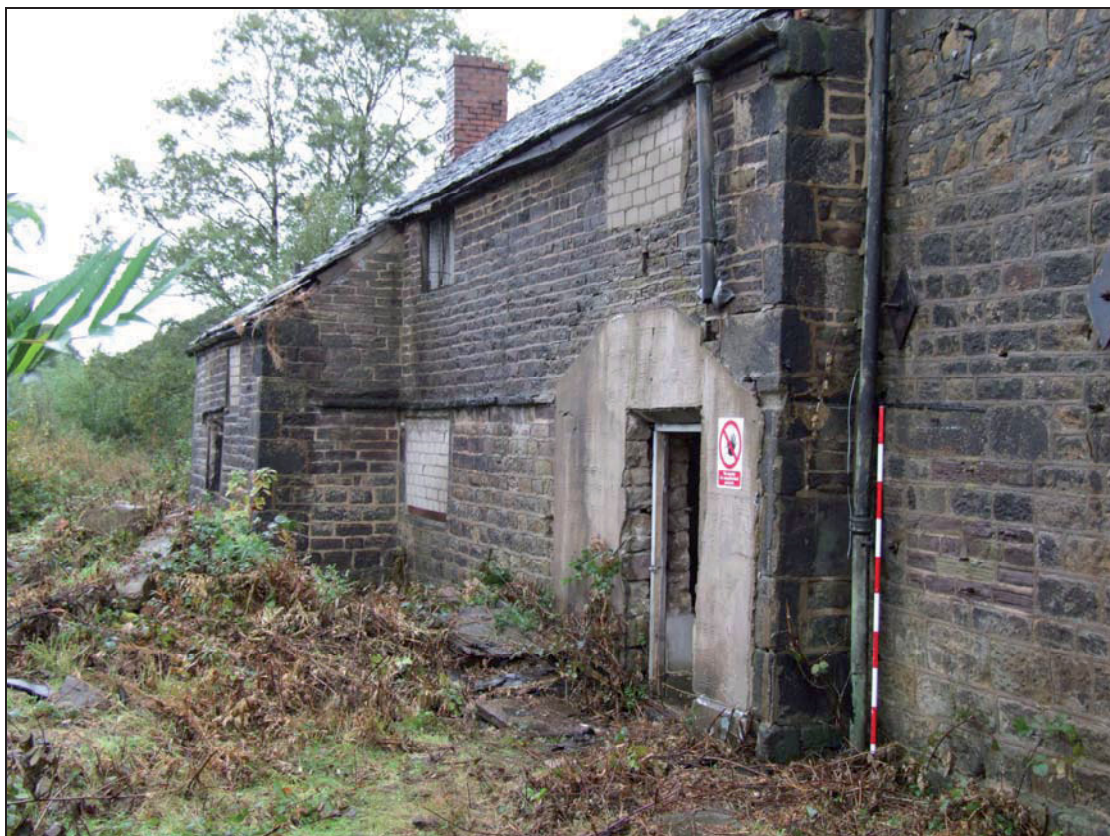
**6.5 Southern Elevation** (plates 7 & 8). This elevation forms the rear of the building and is characterised by several windows, most of which are sealed with modern concrete blocks. At the western end, the building protrudes, with the sandstone tile roof running down beyond the normal roof level. In this section are two square windows, both with chamfered sandstone jambs, one at ground floor level and the other on the below the eaves in the stairwell. The lower window is not blocked and has a timber frame with a cement rendered cill and a chamfered sandstone lintel. Above this is a hood mould with a dog-legged label stop at the west end, the right end butting the stairwell window. This latter window has a chamfered sandstone cill. The corners of this projection are constructed in staggered quoins. To the east of this the face of the main building continues. It has three windows, two of which at first floor level are situated below the eaves. The western most of these two is not blocked and contains a timber frame with three lights. Below this window is another, but with chamfered sandstone jambs, lintel and cill, and a hood mould above. To the west, this the hood mould joins the east face of the projection and to the west terminates by a patch of cement rendering around a personal doorway. This is timber framed and fitted with a batten & braced timber door. The lintel is chamfered sandstone and the top half of the eastern jamb is also chamfered. The area around the doorway retains evidence in the form of a roofline, of an attached single storey gabled porch. The eastern end of the main building is marked by a straight joint and quoins running down the wall. The first extension houses two windows at ground floor level, both blocked in the same style as the wall, making them difficult to recognise, except for the large sandstone lintels above. Quoins and a straight joint once again mark the end of this building and the construction of the second extension. This has a single square window at first floor level, with a heavy sandstone cill and lintel. The whole building is constructed in coursed, shaped sandstone rubble. However, the first floor level of the first extension is constructed in rough un-coursed sandstone, as is the second extension. Six diamond shaped iron-bracing plates are also located across the face of both extensions.

**Plate 7.** Main house from the southeast ( western end of south elevation)

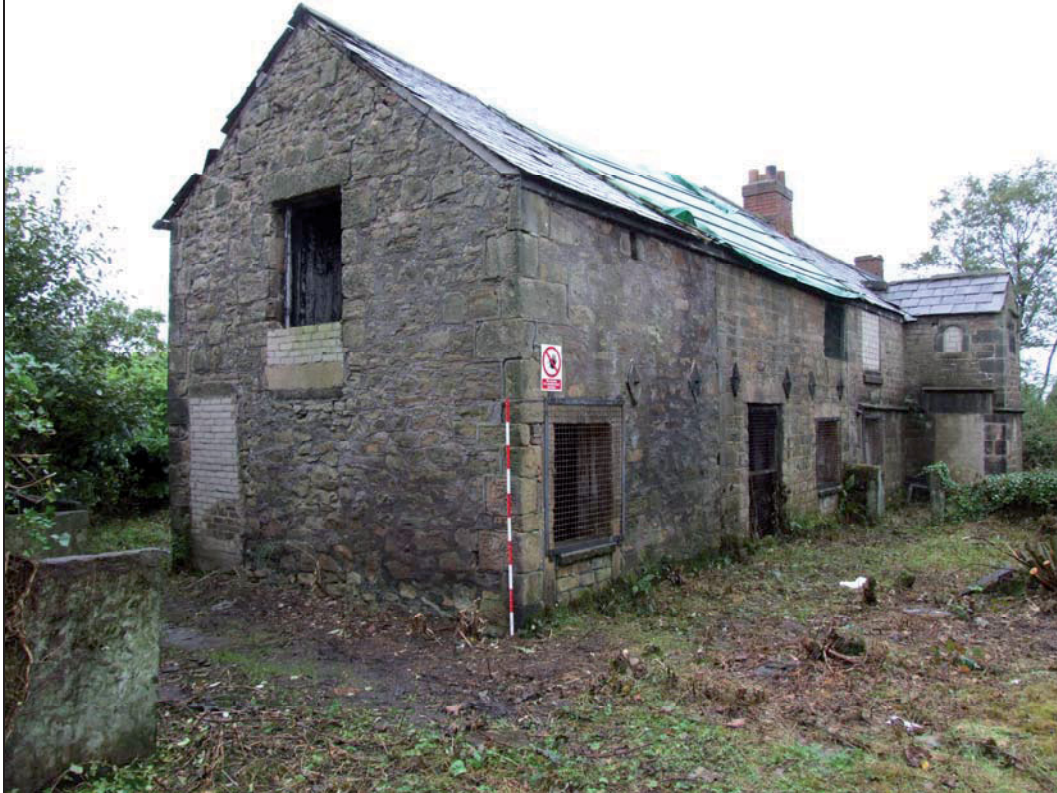
**6.6 Eastern Elevation** (plate 9). This elevation comprises the other gable end of the building and is eastern face of the second extension. Once again, this face is constructed in sandstone rubble, is occasionally brought to course,

**Plate 9.** East and north elevation from the northeast

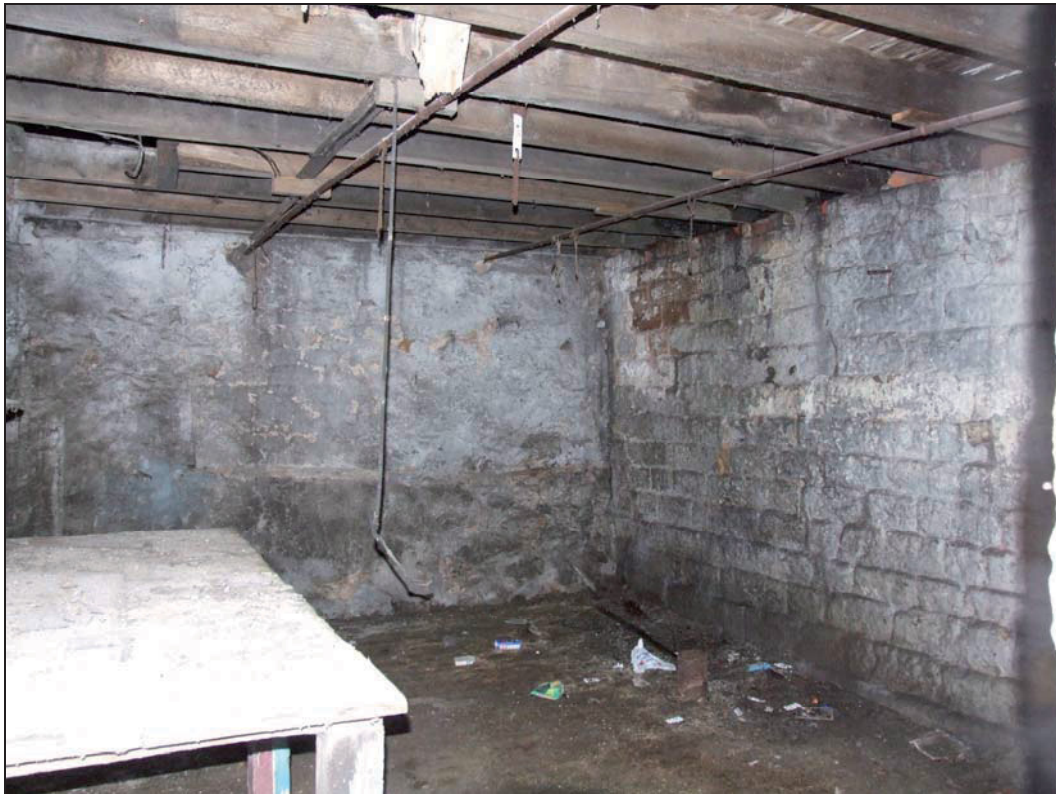
- 6.7 Extensions 1 and 2.** (4.48 x 4.92m & 4.48 x 3.60m) Full access to these rooms was not available and consequently only a limited survey could be undertaken. Access to the first extension is via a doorway in the northern wall. Although having no frame or door the doorway is fitted with an iron grate. The floor of the room is concrete and the walls whitewashed in lime. The walls appear to have been constructed with uncoursed rough rubble, with the exception of the west wall, which is coursed sandstone blocks, having once formed the original east elevation of the main building. A timber partition (stall) is located at the east end of the room, running from the south wall halfway into the room, suggesting use as a stable. The ceiling is timber with two timber beams running north – south across the room. A square window fitted with an iron grate is located in the north wall, west of the door (plate 10). The second extension was originally accessed via a door in the east elevation, although this has been recently blocked. The walls have again been whitewashed and are constructed of uncoursed rough rubble. Likewise, the western wall is once again constructed in coursed sandstone blocks, having once formed the east elevation of the first extension. The ceiling is timber and the floor concrete. A timber workbench is located on the east wall and a window fitted with an iron grate is located in the east of the north wall (plate 11).

**Plate 11.** View of interior of the second extension from the northeast

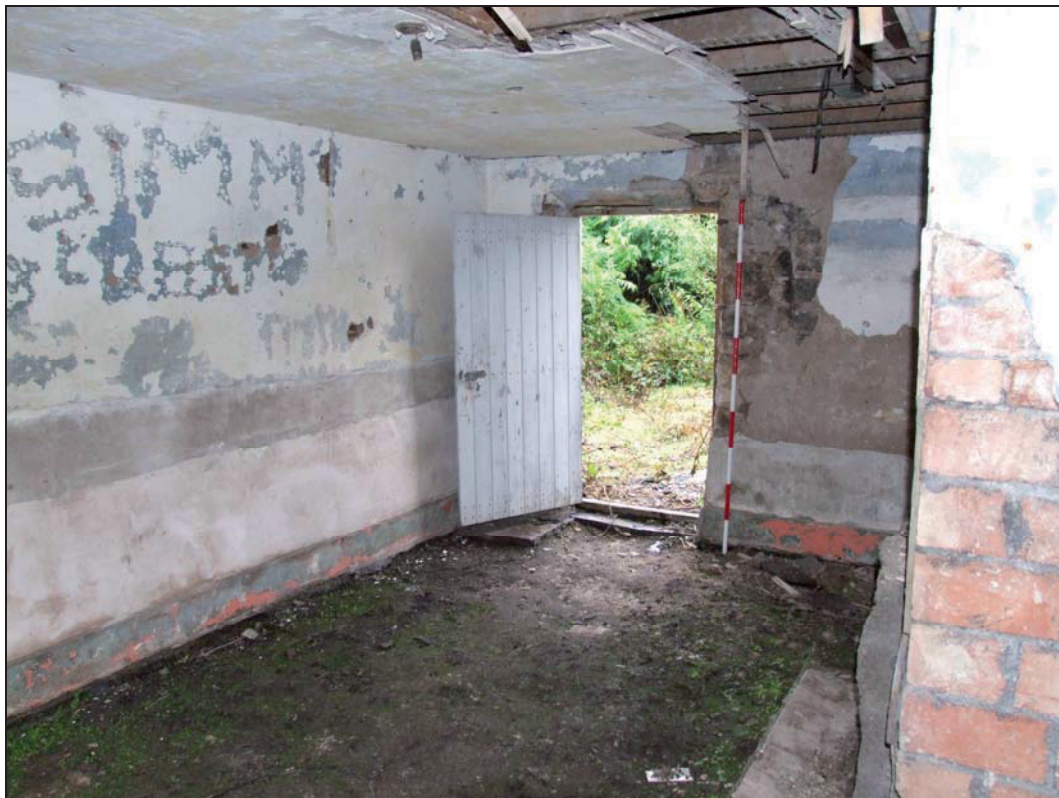
- 6.8 Room 1.** (4.98 x 3.48m) This room is located at the east end of the main building (plate 12). The floor originally had a sandstone flag floor, although most of these have been removed, with only a few small pieces remaining. The walls are covered with a lime rendering, although patches have deteriorated around the external doorway in the south wall, revealing a wall constructed of sandstone rubble. This doorway is located in the eastern side of the south wall and is fitted with a timber frame and door. It has a chamfered sandstone lintel and the eastern jamb is likewise of chamfered sandstone. Opposite this, in the north wall, is a square window with a broken timber frame. The chamfered timber casement surrounding is detaching from the sandstone. A chimneybreast is situated in the west wall, with a ceramic tiled fireplace set within it. An internal doorway is located to the north of this in the west wall, without frame or door and leads through

**Plate 12.** Room1 from the northwest

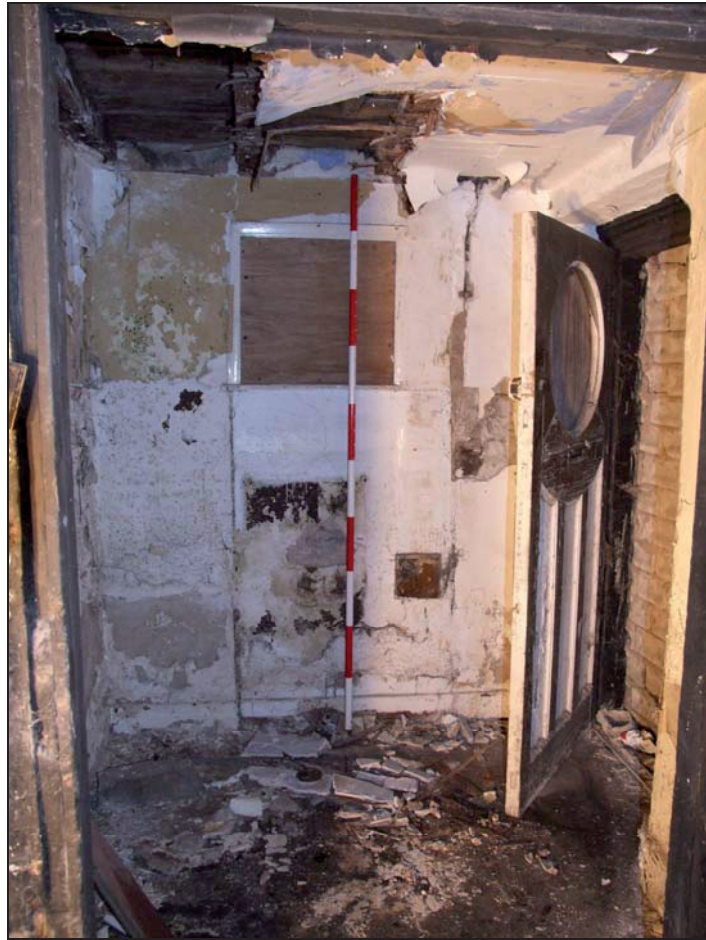
**6.10 Porch** (plate 17). This room is accessed through the personal door to the south and has a concrete floor and a lath and plaster ceiling. The front door to the building is located in the east wall and has been recently sealed with cement blocks. The doorway has a decorative lintel with rounded rendered jambs and is fitted with a timber door with a circular light within it. Both the north and west walls have small square windows, with moulded timber frames and internally sealed with plywood.

**Plate 17.** The interior of the porch from the south

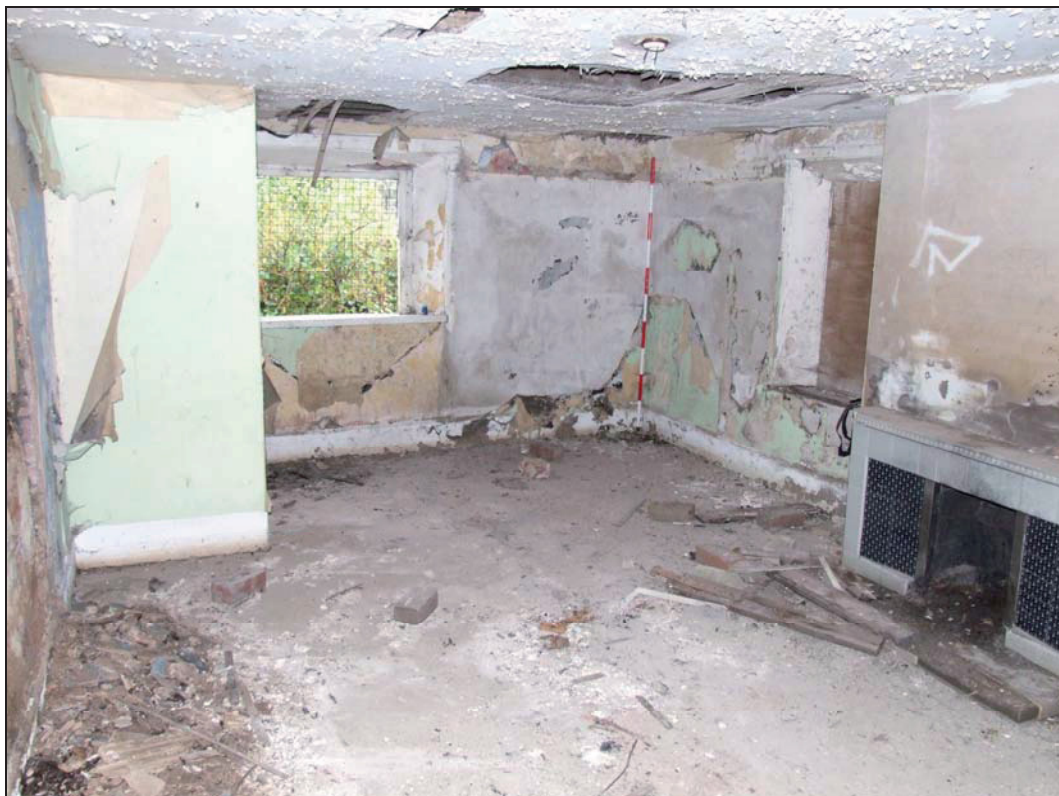
**6.11 Room 3.** (6.63 x 3.99m) This room is accessed via the doorway in the west wall of room 2, with a small step down (plate 18). It has a concrete floor and a lath and plaster ceiling. The north, south and west walls are cement rendered, whereas the east wall is a timber framed wattle and daub wall

**Plate 18.** Room 3 from the northeast

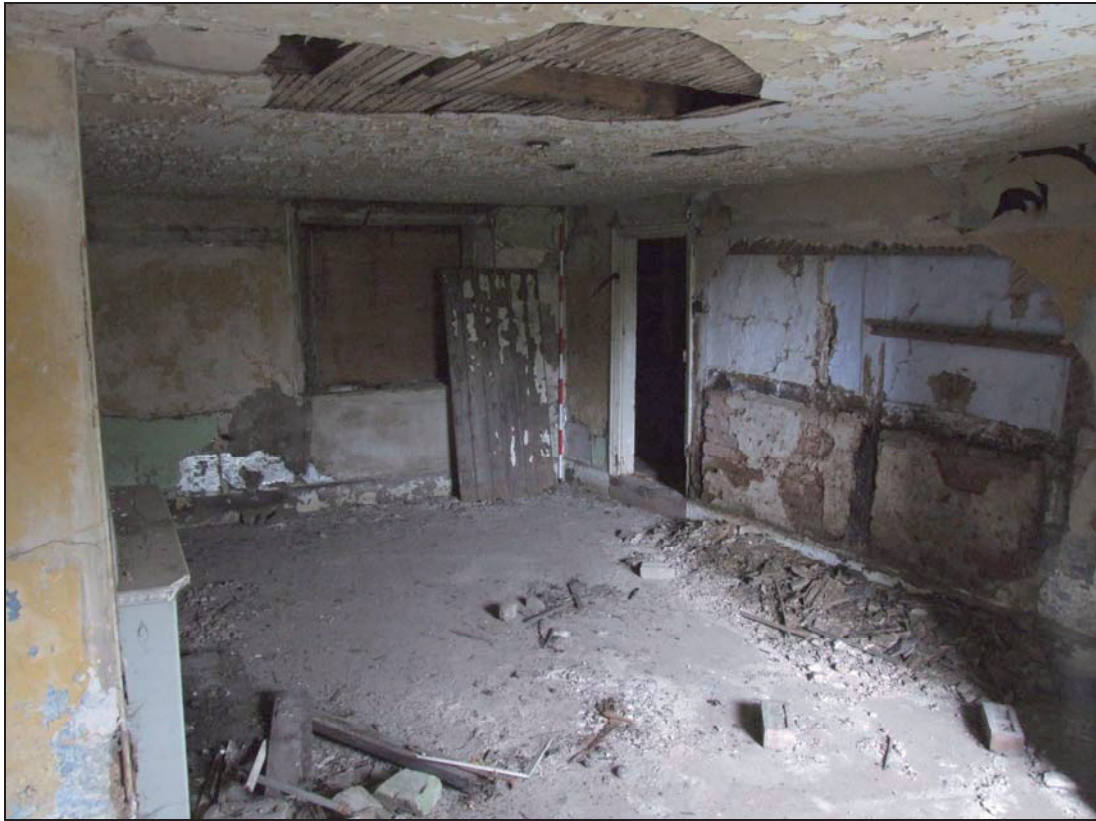
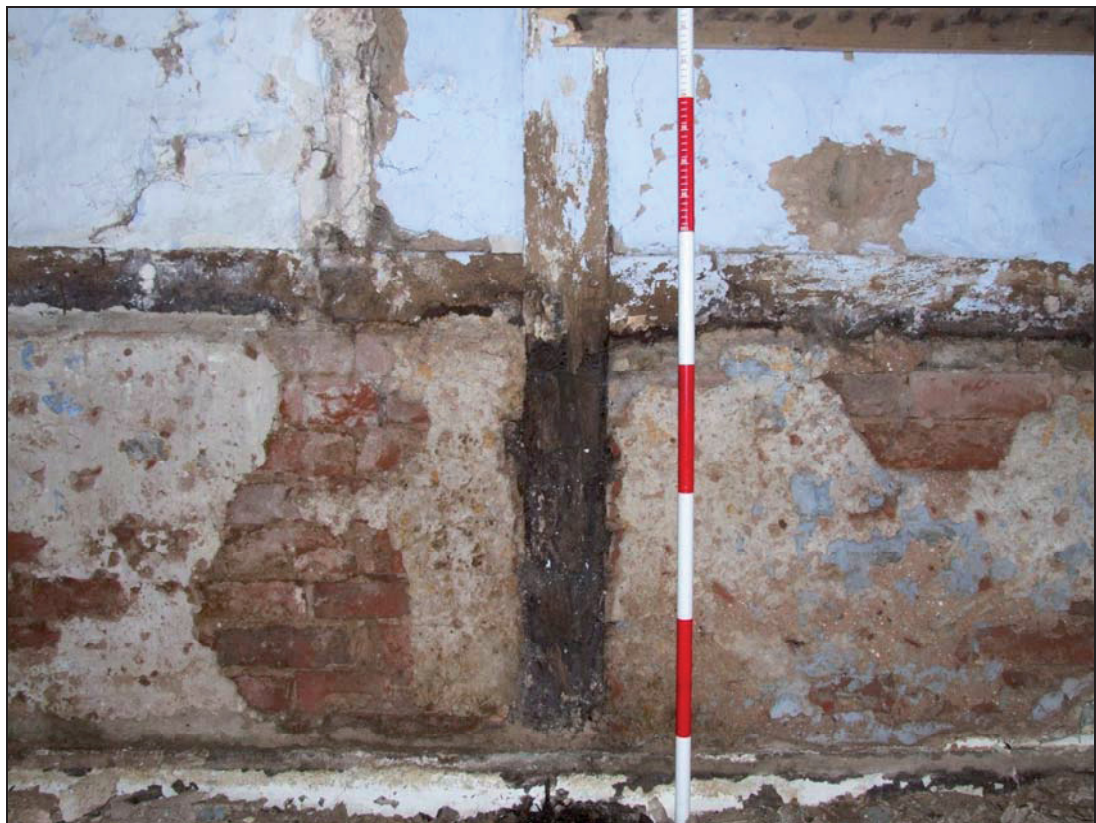
(plate 19 & 20). The lower central panel has been filled with handmade brick noggings and the southern end has been plastered. In the west wall is a cement rendered chimneybreast, with the rendering decayed and showing brickwork beneath. A ceramic tiled fireplace has been set within it. Four timber framed portrait windows are located in this room, one in the north wall, one in the south wall and two in the west wall, flanking the chimneybreast. Both the north and south windows have timber cills with a chamfered surround, rendered in cement (plate 21). The western windows have concrete rendered cills and while the southern of these has a rendered, chamfered surround, the northern has a chamfered timber casement. All of the windows are blocked, with the exception of that in the south wall. A timber partition wall in the southeast corner forms a small cupboard and a concrete skirting runs around the room.

**Plate 19.** Room 3 from the southwest

**Plate 20.** Detail of the timber framed partition – Room 3

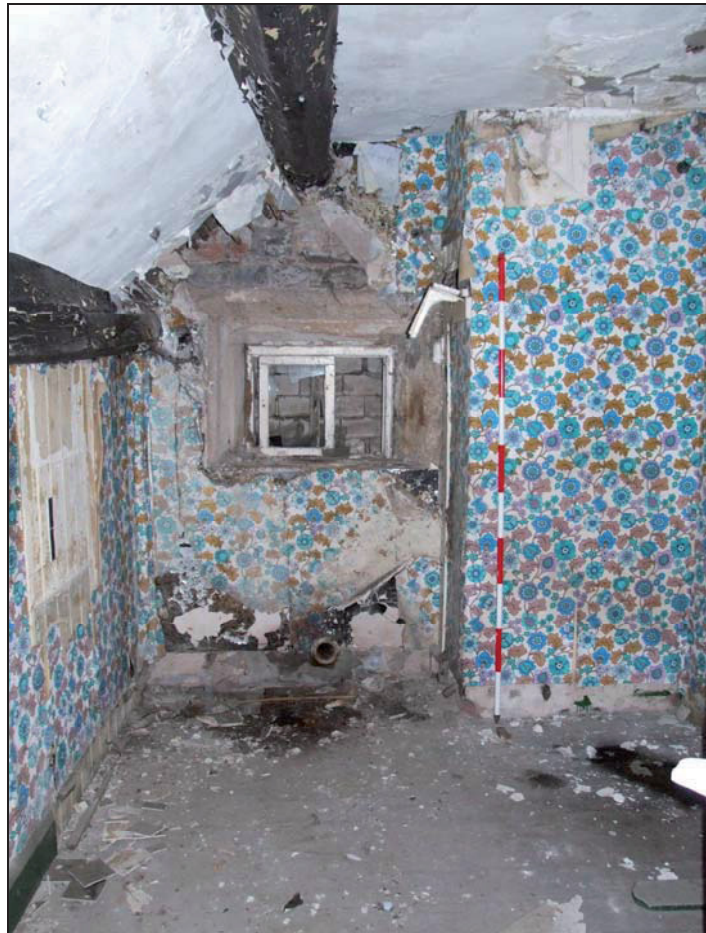
- 6.12 Room 4.** (3.73 x 3.05m) This room is located in the southwest corner of the building (plate 22). The floor is timber and the ceiling lath and plaster. The south and west wall are constructed of sandstone blocks and rendered with plaster. The north and east walls are constructed of timber stud partition. Another timber stud partition wall runs east – west on the south side of the room, with an opening in its eastern end, creating a small cupboard (plate 23). This wall is capped with a hand cut timber purlin. Another hand cut timber purlin run across the centre of the room, with the ceiling to the north of this being flat, whereas on the south it slopes down in line with the roof. A Yorkshire slider window is located in the west wall with a chamfered timber casement. A chimneybreast is located in the northwest corner of the room, hung with floral wallpaper. The room is accessed through a timber framed doorway in the eastern wall, although no door is present. This door leads to a corridor running east west along the south of the building, and to room 5 to the north of room 4 (plate 24).

**Plate 22.** Room 4 from the east

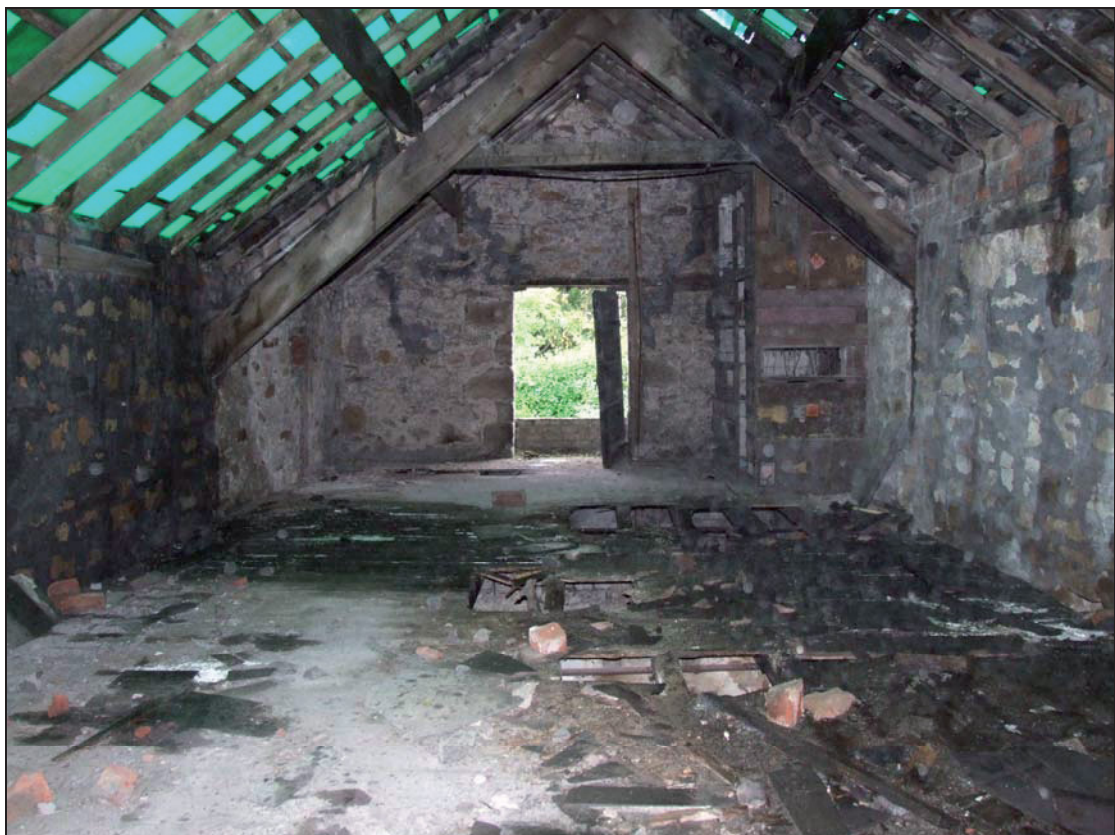
**6.16 Room 8.** (4.48 x 9.02m) As noted, this room is only accessible visually from the mullion window in room 7 (plate 30). There is no dividing wall and thus room comprises the first floors of both extension 1 and 2. The walls are constructed of rough sandstone rubble and have been heavily re-pointed in cement. In addition, both the north and south walls have been rebuilt at the top in brick. The floor is timber and the ceiling open to roof. An 'A' frame roof truss, is located where the two extensions meet, replacing the stone gable of the first extension. In addition to the mullion window in the west wall, is a single window/door in the north wall, at its

western end, although it has no frame and is fitted with a metal grate. A wind eye is located further along the north wall, within the wall of the second extension. A timber framed doorway is located in the east wall, the lower part is blocked and the timber frame is beginning to collapse.

**Plate 30.** Room 8 - the hayloft above the two eastern extensions

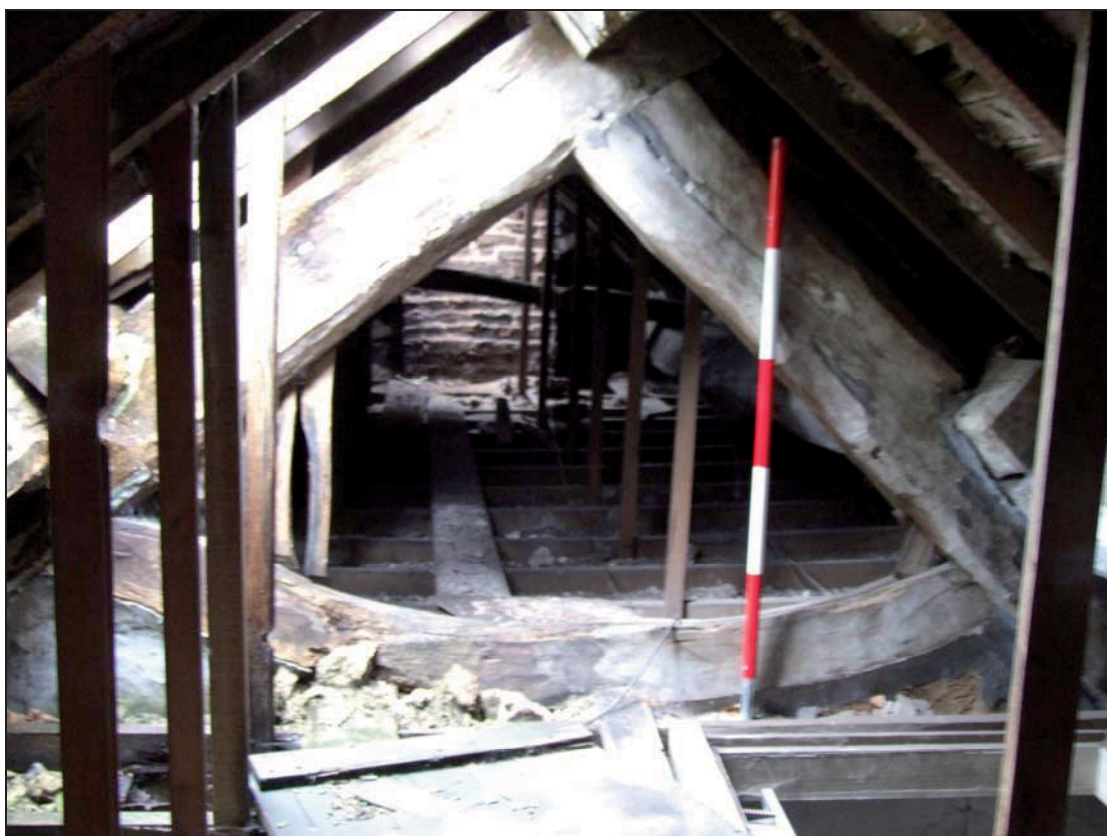
- 6.17 Attic.** The attic was only partially accessible. The main building had a single hand cut 'A' frame truss, with a curved tie beam (plate 31). The trenched purlins are likewise hand cut and rise from two heavy east-west running longitudinal beams (see plates 23 & 26). The purlins are extended with pegged splayed scarf joints, as is the diamond set ridge pole. The principle rafters and tie beam are connected by pegged mortis and tenon joints. The chimney breast at the east of room 6 and the west of room 7 rises up the whole length of the building, as does the wall, and both can be seen to be of hand-made brick construction (plate 32). The slates of the roof were visible in places, where the plaster between the rafters had decayed. The common rafters are constructed of machine cut timbers, suggesting that the originals had been replaced (plate 33). These are attached to the joists by two rows of vertical machine cut timber posts providing additional support for the roof structure (plate 32).

**Plate 31.** The roof truss from the west

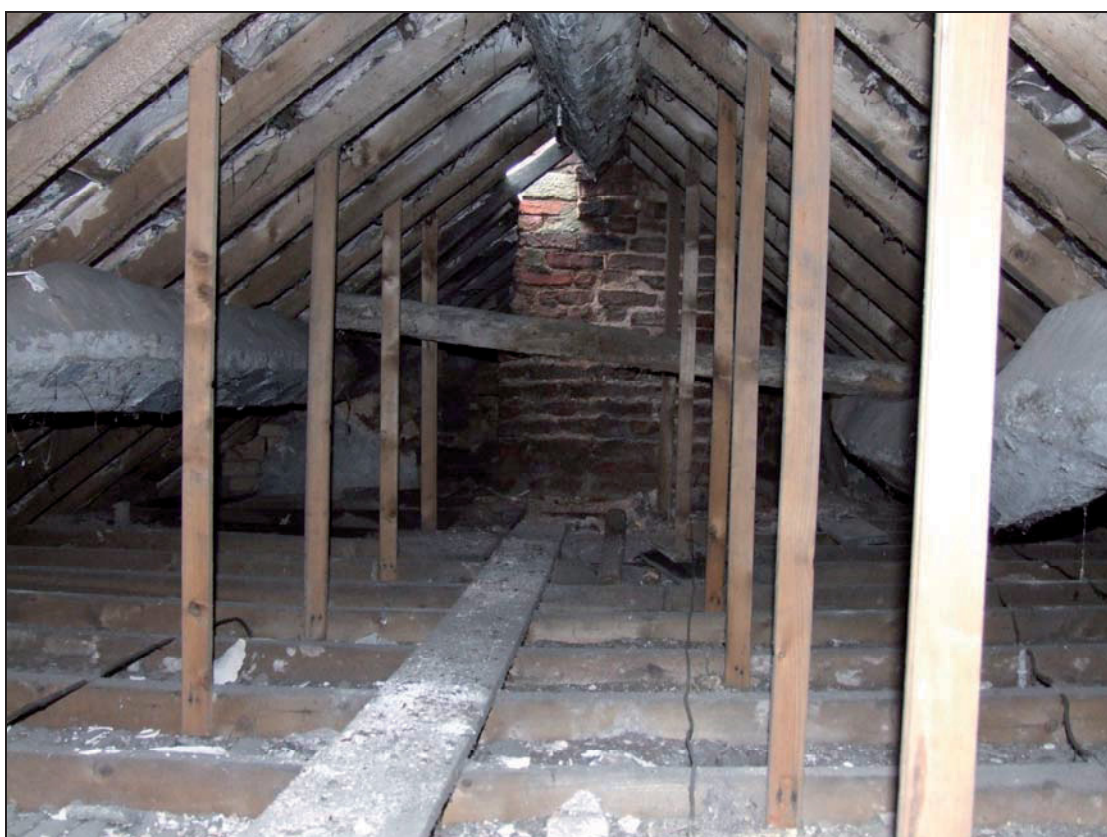
**Plate 32.** The handmade brick chimney and vertical timber supports from the west

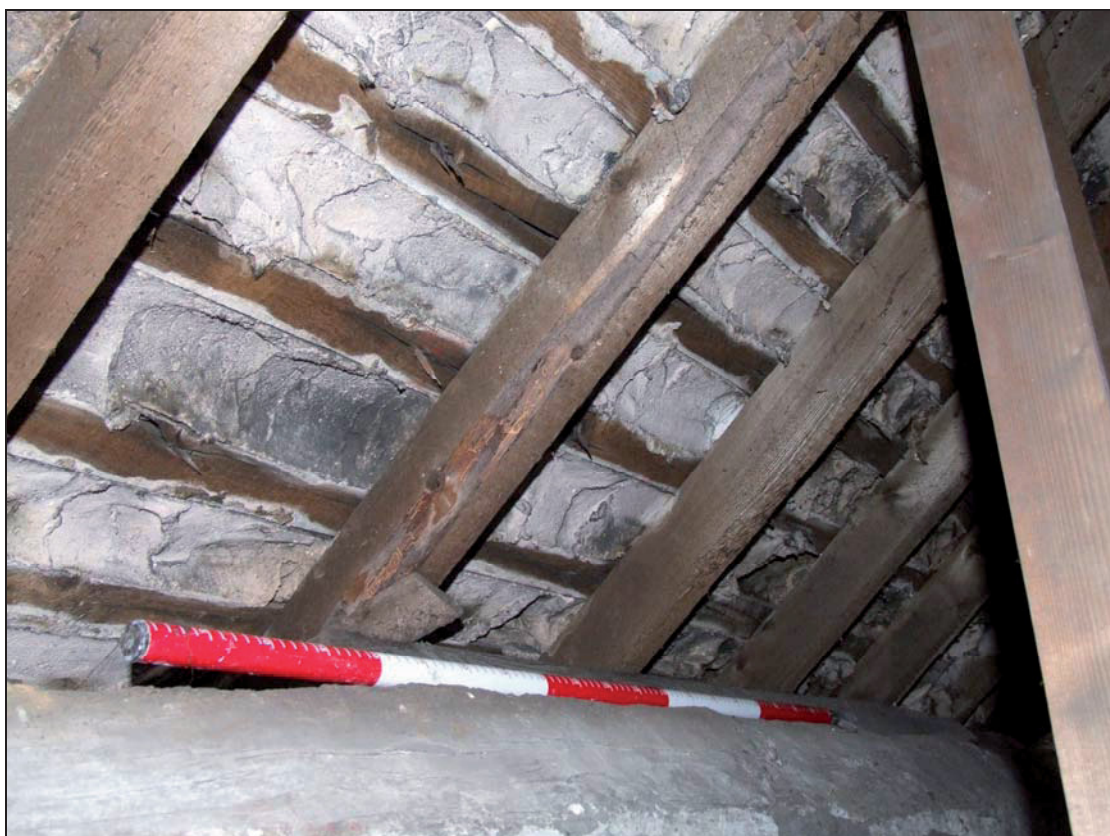
roofing the original part of the building. Although the principal rafters of the single truss are hand cut and original, all the common rafters are of machine cut timber with the added insertion of vertical machine cut timber hangers to provide additional support for roof. The original stone slates appear to have been reused on the southern pitch and replaced with Welsh slate on the northern pitch. The eaves of the western gable had also required significant repair with a sand and cement mix, presumably at the same time. Both chimneys had been repaired, above the roofline, with machine cut brick, whilst the interior construction, below the roofline was of early hand made brick. It is probable that the repairs to the roof may have occurred not long before its purchase date, as although in poor condition the building has, without doubt survived remarkably well, in view of the length of time it has been unoccupied.

**Plate 33.** Machine cut timber rafters
