Standing Building Recording
on Proposed Demolition at
East Mains of Carseburn
Lunanhead
FORFAR
FF13

**STANDING BUILDING RECORDING ON
PROPOSED DEMOLITION AT EAST
MAINS OF CARSEBURN
LUNANHEAD
FORFAR
FF13**

The site code was FF13

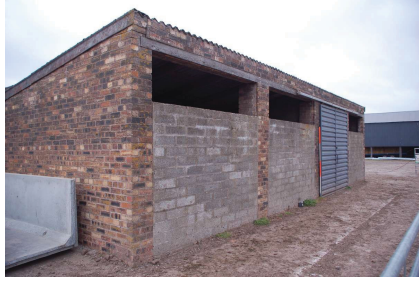
0009

Later alterations to this building seem to have included the partial blocking up of three of the bay entrances with breezeblocks (leaving a gap for light) as well as creating internal breezeblock divisions on either side of the third bay. Sliding doors had been added to the front of the third bay and the small side door in the E wall.

Shot of the S side of the bayed building showing the blocked entrances. View NE

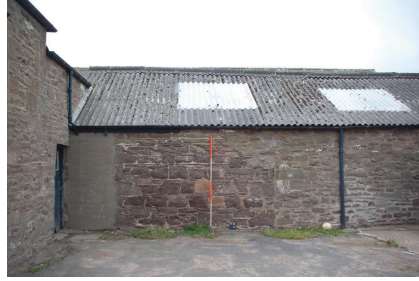
0009

The northern-most end of this wall was constructed from large roughly cut sub-angular blocks of pinkish-purple sandstone with a white lime mortar built to roughly level beds. Ladder pinning using small, flat pieces of sandstone was evident in between the large blocks. At the N end this area of stonework ended in large cornerstones showing that the building had originally ended short of the barn. The gap between the cornerstones and the barn wall was filled with breezeblocks and rendered in concrete. South of the pinkish purple stonework the W wall of the building had been constructed from smaller blocks of grey and purple sandstone, larger grey angular blocks of circular sawn sandstone and large well squared tooled blocks of angular pink sandstone arranged in a more random way. This stonework continued southwards into the milk processing building to the S end of the W wall where there were two fairly wide blocked doorways, both with hardwood lintels. The reveals of these doorways had been constructed from large circular sawn blocks of grey sandstone. One of these doorways was still partly open, though its width had been reduced; the other was completely blocked. The blocking was similar in style to the S part of the E wall incorporating small and large blocks of grey and pink sandstone, some of it circular sawn. Still pinned to the lintels above the blocked doorways were rainwater gutter holders. The internal elevation of this wall had been rendered in concrete.

During the survey only two areas of stonework were found that could possibly be original. These were the N end of the W wall - the portion of the wall built in pink sandstone incorporating ladder pinning, and the pink roughly faced sandstone portion of

Shot of the early stonework at the N end of the W wall of the byre. View E

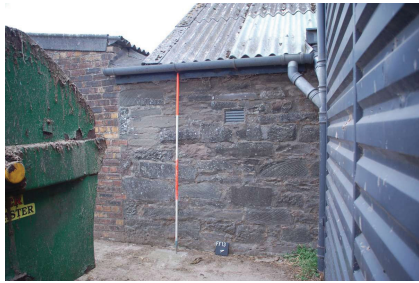
0063

Much of this wall was constructed in a similar manner to the S part of the E wall (using greyer more angular stonework containing circular sawn blocks). This included the S end of the E wall and the area just to the N of the southern doorway in the E wall. North of this the stonework had been constructed from pinker roughly faced and tooled sub-angular blocks of sandstone with a white lime mortar. Two doorways were incorporated into this part of the wall one blocked with breezeblocks and the other with red brick. The S doorway appeared to be a late insertion as it had no stone reveals, but the northern doorway appeared original and had large stone reveals on both sides. The portion of the E wall just north of the northern blocked doorway had been refaced or rebuilt with liberal use of mortar and incorporated circular sawn blocks of stone. The internal elevation of this wall had been rendered in concrete.

the E wall. The rest of the stonework of the building appeared quite different as it incorporated angular grey blocks of circular sawn sandstone. This suggests that much of the byre was partly re-built or heavily repaired in the late 19th or early 20th century when stone shaping had become more mechanised. The end of the byre due to be demolished was built in this manner.

Shot of the S end of the E wall of the byre showing circular sawn stonework. View W

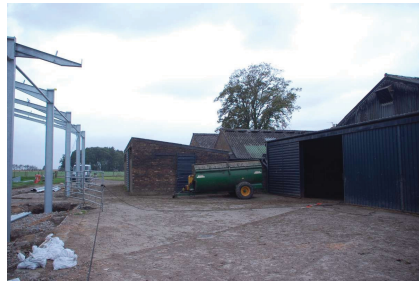
0066

General shot of the E side of the area to be demolished. View NW

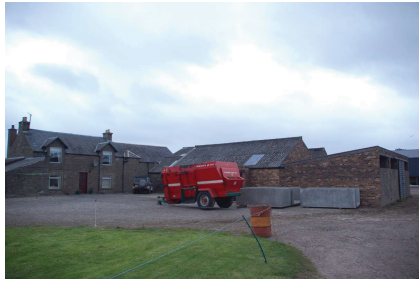
0067

General shot showing the milk processing building and the bayed building. View NE

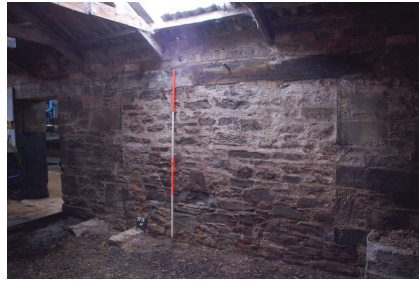
0026

View of the blocked southern doorway in the W wall of the byre. View NE

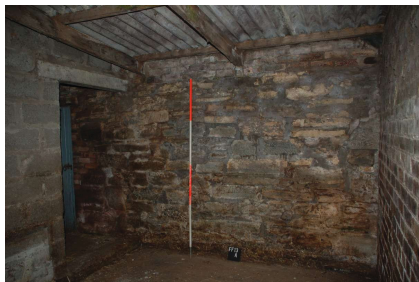
0046

The south wall (the wall to be demolished) was constructed in a similar style to the S ends of the E and W walls of the byre/milk parlour. The stonework largely comprised rectangular angular blocks of creamy-grey circular sawn sandstone built to roughly level beds. A doorway had been inserted through this wall (presumably for access to the bayed building) and either side the doorway had been faced in brick similar to that used for the bayed building and the milk processing building. The upper part of this wall (above the joist height) was finished in a creamy grey brickwork built in stretcher bond with a white mortar. The internal elevation of this wall was rendered in concrete.

View of the S wall of the byre from inside the bayed building. View N

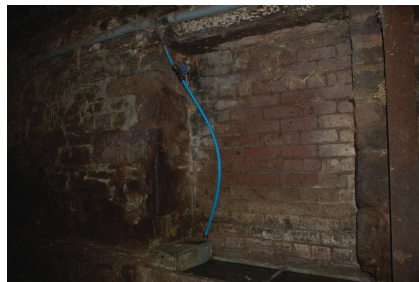
0114

Of the two small blocked narrow entrances in the E wall, only the one blocked with brick appeared to be original, having large roughly cut reveals. This may have been for access to the enclosure on the E side of the byre shown on the 1st edition OS map. The second doorway seems to have been inserted for access to an outbuilding which was built against this side of the byre some time in the first two decades of the 20th century (3rd edition OS map). The doorway in the S wall is a late insertion, almost certainly created for access into the bayed building.

Shot of the northern blocked doorway in the E wall of the byre. View SW

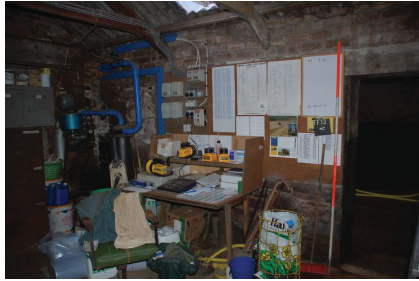
0021

Shot of the office in the milk processing building. The wall behind the boards is part of a blocked doorway. View NE

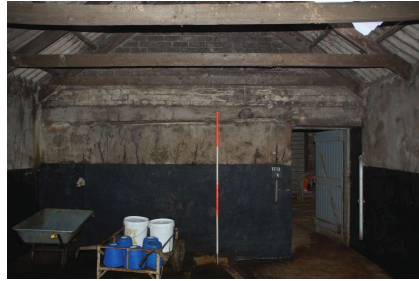
0039

The S end of the byre from the inside. View S

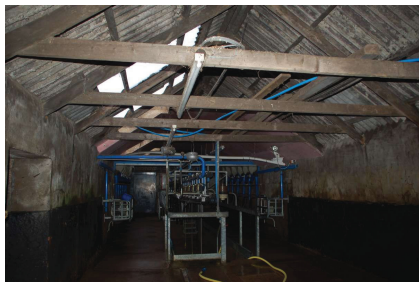
0041

Shot looking into the milk parlour / byre. View N

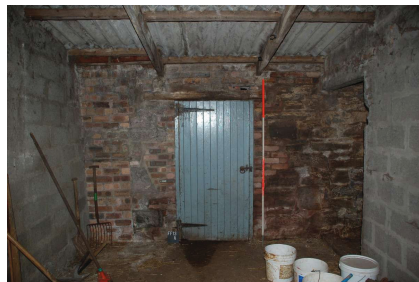
0044

Shot of door in the S wall of the byre. View N

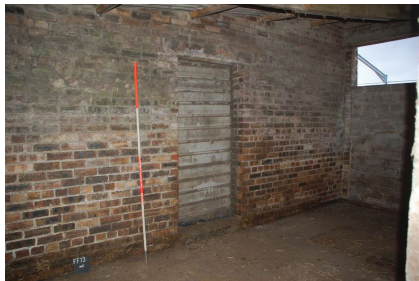
0049

Shot of the E bay in the bayed building from the inside. View SE

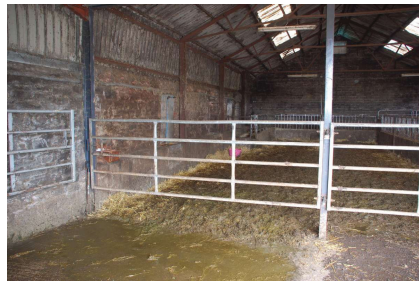
0061

Shot E wall of the byre from inside the cattle shed. View NW

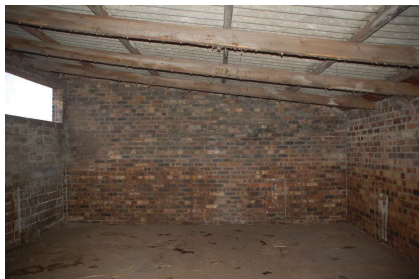
0078

Shot of the W bay in the bayed building from the inside. View W

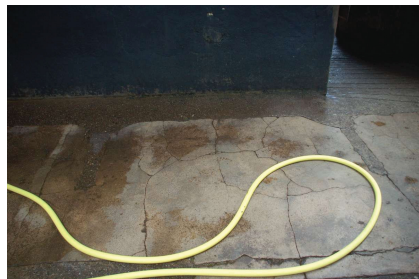
0093

The inside of this building had been converted for use as a milking parlour which meant the walls were rendered in concrete. However slight bumps on the E wall and markings on the floor gave away the former locations of stalls at the S end of this building.

The stalls noted in the survey are evidence that the building was used as a byre before being converted into a milking parlour. As these stalls were aligned along the E wall it seems likely that the main cattle entrances into the byre would have been from doorways in the W wall, leading out into a yard in front of the farmhouse. The two wide doorways (one fully blocked) that were found in the W wall were probably used for this purpose; their width making the passage of cattle very easy. However, as they were blocked up with stonework similar to the rest of the E wall, they may not have been in use for very long. This blocking was perhaps carried out when three outbuildings were built against the W wall of the byre in the first two decades of the 20th century (3rd edition OS map).

Shot showing the former stall positions in the byre / milk parlour. View E
