THE SOUTHBANK BASIN  
AND THE FORTH AND CLYDE CANAL,  
KIRKINTILLOCH  
DATA STRUCTURE REPORT

PROJECT 2364

carried out  
on behalf of  
The Miller Partnership and Strathkelvin Development Company Ltd

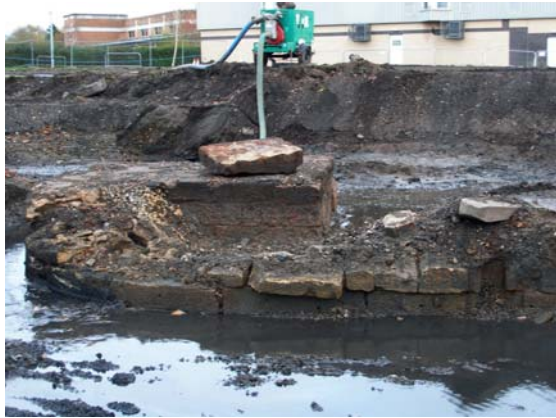
Plate 6:

Seven elements of the basin walls were exposed (Figure 1). The first described is feature (A), which was a squared area (roughly 2 by 2 m) of large sandstone blocks which stood three courses above the surrounding walls (Plate 6). It did not have a rubble core and the blocks of stone were held together by 40 mm (inch and a half) wide strips of iron (Plate 7). This was the tallest surviving masonry of the area between the two basins. Feature A is noted on archive photographs (Plate 8) and on the 1<sup>st</sup> edition Ordnance Survey map as a raised area, with a squared recess to its immediate west and another, possibly later, recess to the south. The photographic and map evidence suggests that this particular piece of masonry may have had different functions over time, such as for mooring ships, for taking the weight of a lifting device, or even as a buffer for a wagon line that ended at the basin. The purposes of the recesses to either side of it along the course of the basin walls are at present unknown.

*Feature A emerging from the fill of the railway basin.  
(PB293790)*

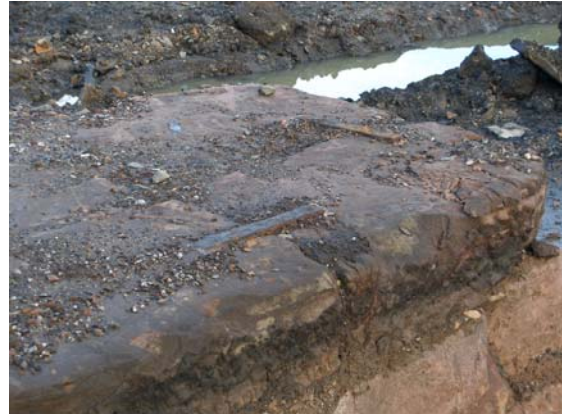
Plate 7:

*Detail of the metal ties to Feature A.  
(PC013834)*

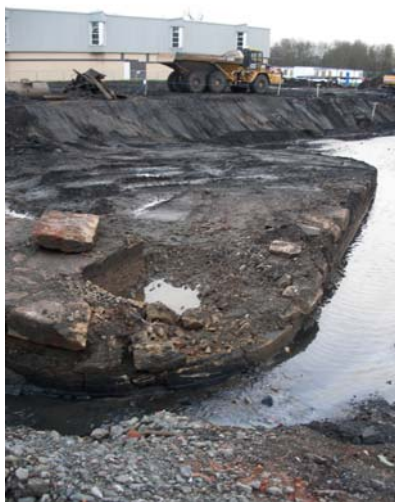
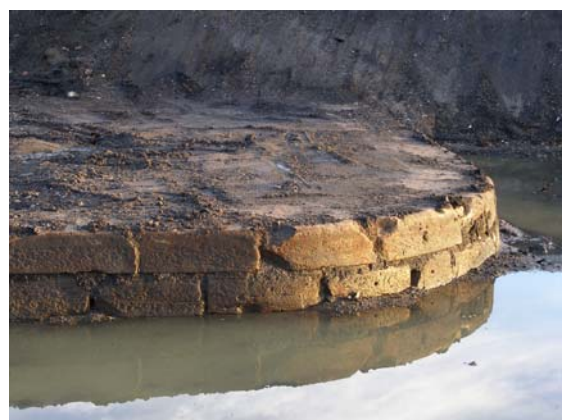
Plate 9a & b:

In the centre of each stone of the second course from the top of the wall (Feature B and C), as it survived, was a drilled hole (Plate 9b). The line of holes ran across the wall from end to end and may have been fixing points for a horizontal rail used to protect both the wall and shipping from damage when vessels manoeuvred, entered or left the basin. When it was revealed beneath the basin fill, some of the stones of

the wall had missing corners or pieces, or were slightly out of alignment, emphasising the need for protection in the past.

*Curved end of the peninsula dividing the two basins (Feature B PB293792 and Feature C.  
(PC013815)*

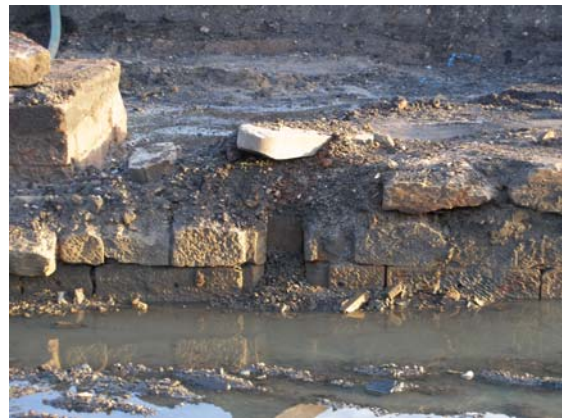
*Plate 11:*

Feature F in walls B/C was a vertical stop log channel for timber stop planks or a barrier across the basin passage (Plate 11). The channel was cut into the stonework and measured *c* 0.15 to 0.2 m deep by *c* 0.2 m wide. Notches in the front faces of the stones to either side of the channel made its access wider and therefore easier to use. It was opposed by a partner recess in Feature G to the north (see below). The stop planks at this point, when required, would have been *c* 7.5 m wide, comprising timbers *c* 0.2 m thick. Its function would have been to control the level of water in the south-western half of the basin.

*Feature F in end of peninsular separating the two basins .  
(PC013811)*

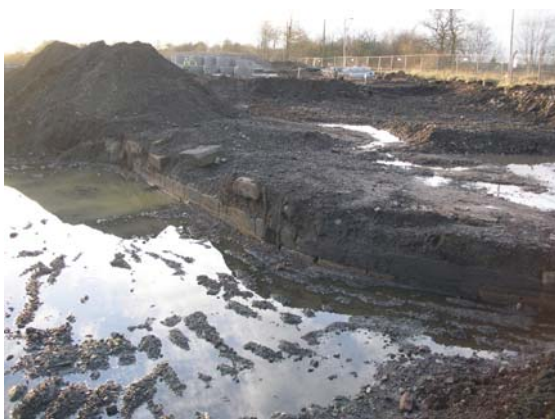
*Plate 12:*

*North wall (Feature H) of the basin.  
(PC013817)*

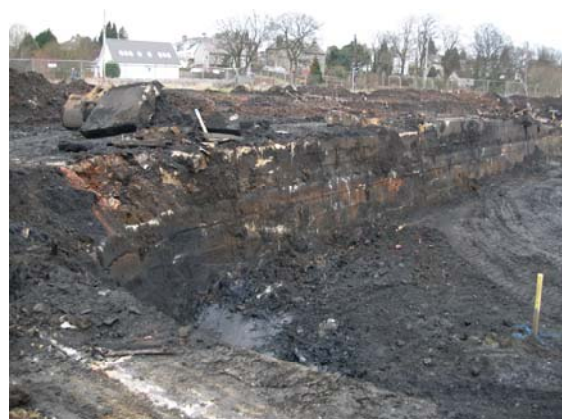
*Plate 13:*

*Heightened end to feature H, north wall of basin.  
(P1254019)*

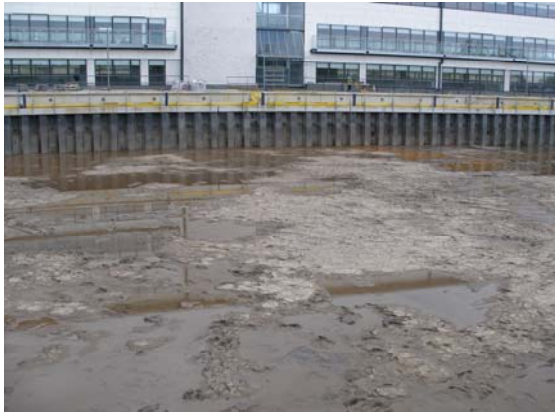
*Plate 14:*

*Floor of the modern basin with a new layer of puddle clay.  
(P5156362)*

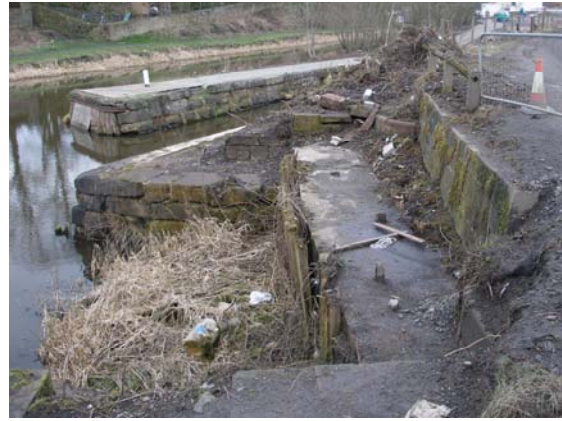
*Plate 15:*

*The blocking of the basin mouth with concrete.  
(P2234186)*

The modern concrete plug was constructed around steel rails and wooden shuttering close to the end of the mouth where it opened into the canal. Its function was to block water from the canal entering the filled-in basin. On its removal, although some damage was recorded to the walls of the mouth, the stonework survived 13 courses high and was the best preserved on the site. The walls of the mouth had similar foundations to those beneath the basin walls. The tops of the walls had been raised during the use of the basin for the construction of a bridge across the basin mouth (Plate 31). The extra courses of stonework were removed and the original height of the walls was reinstated; the walls were also repaired, and reinforced where they joined the concreted and piled walls of the new basin. New capping stones were also added.

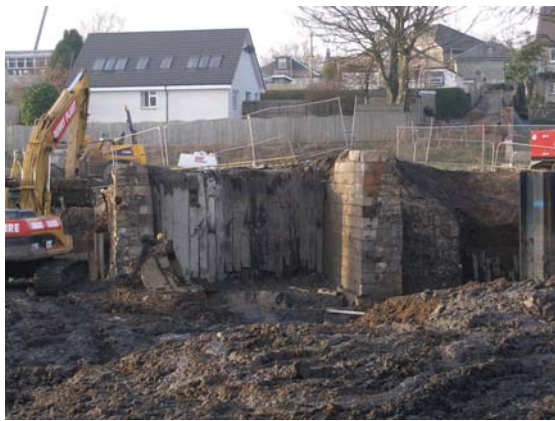
*Plate 16:*

The fill of the basin mouth behind the concrete plug consisted of railway sleepers, slag, fragments of concrete, bricks, oil drums, metal and general building debris. Once this had been removed the base of the walls was found 14 courses deep (Plate 16). At this point the walls survived 4.86 m in height, and rested on a foundation of concrete and natural pebbles. Natural grey puddle clay had been laid down between the walls after their construction to line the mouth and entrance.

*Rear view of the plug within the basin mouth and the depth/ height of the basin walls.  
(P2196005)*

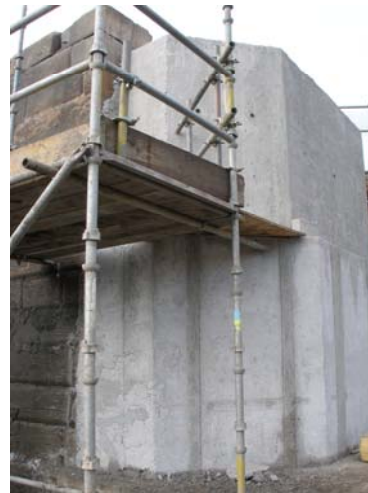
*Plate 17:*

*The joining of old and new walls at the north east side of the basin mouth.  
(P3276208)*

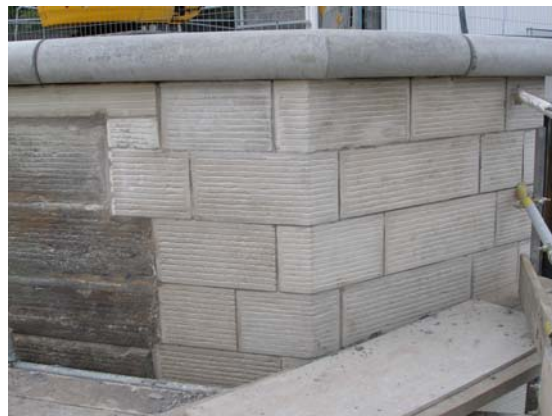
*Plate 18:*

Prior to the construction of the plug, horizontal steel rails were inserted into the walls of the basin mouth in order to stabilise the concrete, and timber shuttering was erected. On the removal of the plug it was noted that the insertion of steel rails had caused some dislodgement of the wall stones, so much so that they needed repositioning, while others had fragmented and required indenting or replacing. Prior to its consolidation the basin mouth was temporarily filled with sand and gravel during the completion of the basin perimeter piling on either side of it. The ends of the original walls of the basin mouth were cut back and replaced in concrete to tie into the piled and concrete perimeter of the new basin (Plate 16 and Plate 17). Their upper portions were finally faced and capped with blond sandstone and tooled to the same design as the rest of the stonework (Plate 18).

*New and old stonework at the basin mouth.  
(P5156367)*

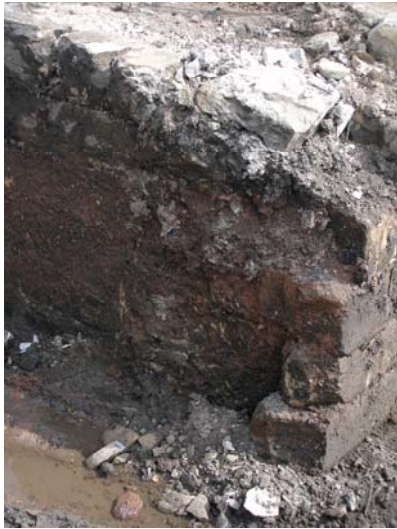
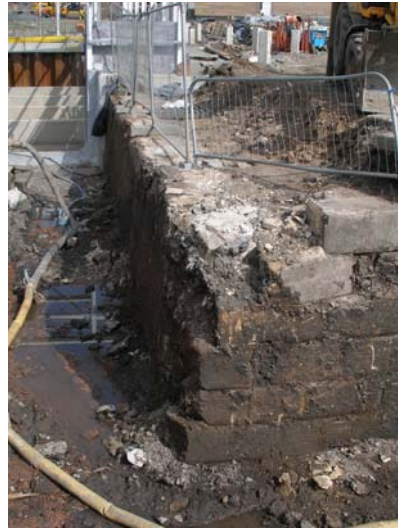
Plate 19a & b::

*Junction of the new slipway reveting wall with the north wall of the basin mout.  
(P4226248, P4226250)*

The most interesting alteration concerned the construction of the slipway (see below) which disrupted the end of the north-eastern end of the basin mouth. The end was removed and part of the wall was dismantled. During the building of the slipway retaining wall against the south side of the canal, it was noted that the walls were not going to join neatly (the new wall abutted the back of the basin mouth wall) and the end of the basin mouth was left protruding some 0.1 to 0.3 m in an unfinished state.

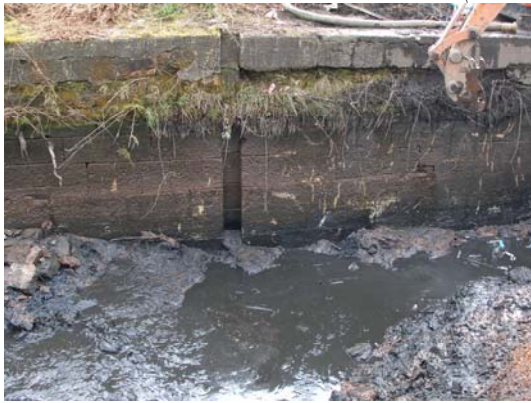
Plate: 20

*The construction and the dressing of the slipway masonry was  
different from that to the basin.  
(P3304273)*

The slipway was constructed into the gap between the canal and the basin, but it was not built to the same standard as the basin and its mouth, although some emulation of the latter's construction was noted. The techniques of building the retaining walls and the stop log channels were the same, but the sandstone blocks were generally of smaller size, and their dressing was different. The use of the slipway may have resulted in many repairs to the walls evident in the use of cement, concrete, bricks and small sandstone blocks, which did not occur in the basin walls.

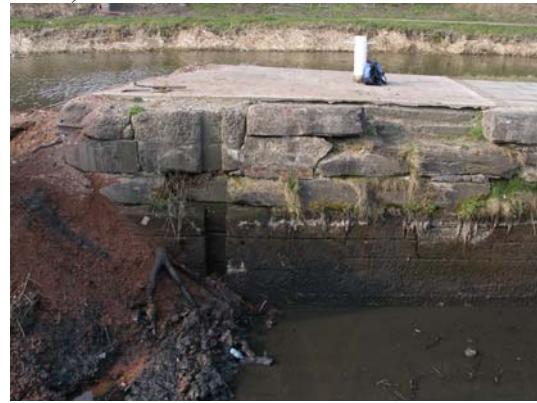
Plate 21:

*The stop log channel in the slipway wall.  
(P3284255)*

The walls of this feature were exposed on both sides. The wall of the slipway finger on the north side comprised a minimum of five courses of good dressed sandstone from its base. Above this were two courses of largely undressed stone with a capping of rough stone, dressed stone or concrete (Plate 20). In places, but mainly towards the north-east end of the wall, the upper courses were interspersed with red brick. The upper two or three courses of the opposite wall, revetting the bank between the slipway and the canal basin, were in a similar condition above the water line. Here, the lowest course comprised large dressed sandstone blocks, but above was an intermittent layer of much smaller rough stone with small sandstone blocks (possibly reused and cut dressed blocks) set on edge and capped with a thick layer of cement. These upper courses appeared to be quite badly eroded. In the walls on either side of the slipway there was a stop groove or channel for stop planks to cut off the water supply (Plate 21).

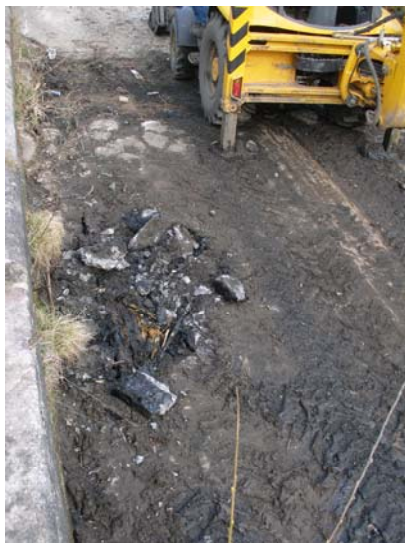
Plate: 22:

*Wooden rails running down the length of the slipway.  
(P3284260)*

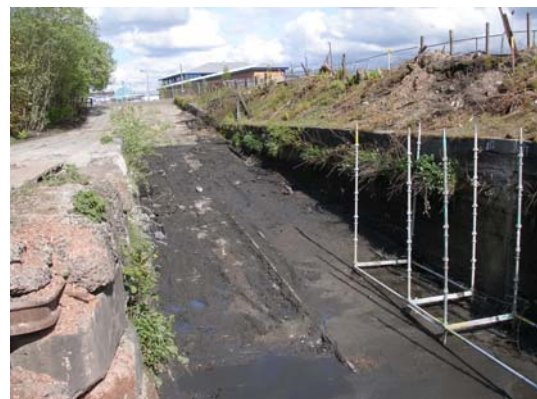
Plate 23:

*Wooden rails running down the length of the slipway.  
(P5094535)*

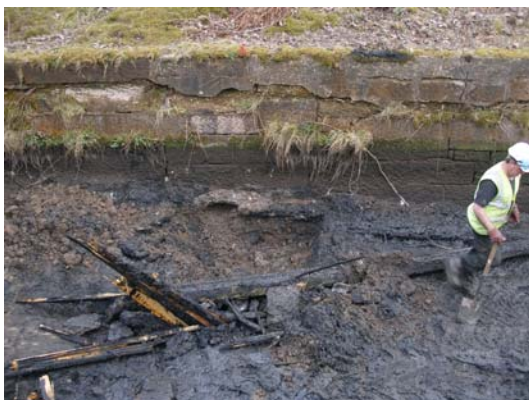
Plate: 24:

*Trial hole 4 with remains of a wooden rail.  
(P3284265)*

Trial hole 4: It was similar to TH2 but the wall survived 3 m high and rested on natural sand and cobbles with a concrete and pebble foundation. The bottom of the slipway from midway to the canal mouth was lined with a layer of pink clay (Plate 24).

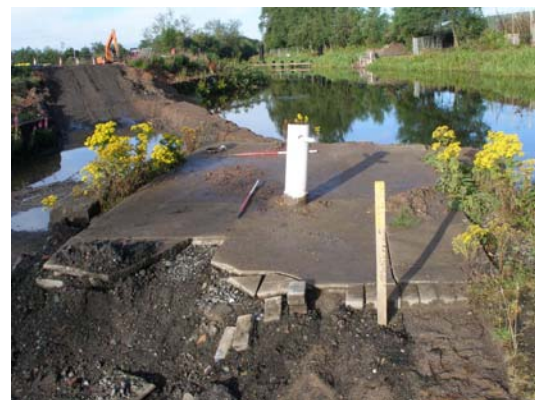
Plate 25:

*The surface and features of the slipway finger.  
(P8155299)*

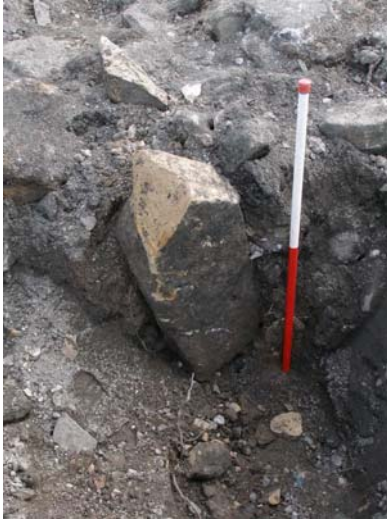
Plate: 26:

The bollard was removed with some difficulty as it was set into an irregular concrete base measuring roughly 1.2 m by 1.2 m that projected c 0.75 m into the slipway fill. The foundation of the bollard had in addition to the concrete base, three metal spikes which projected another 1.8 m into the fill of the slipway.

The slipway finger was built up between the walls at its west end with a mixture of large rubble (waste building stone), earth, sand, clay and gravel. Elsewhere it was infilled with cleaner sand and gravel derived from the subsoil. A large vertical sandstone block 0.75 m high was noted in the side of the pit produced when the metal bollard and its foundations were removed. The block was not secured by concrete or cement, but was loosely packed around with stones and earth. Its tip was broken off but it is not inconceivable that this was an earlier or original mooring bollard that was placed in the middle of the slipway finger. Its width and thickness both measured c 0.3 m (Plate 26).

*Sandstone mooring bollard within the fill of the slipway finger.  
(P8155327)*

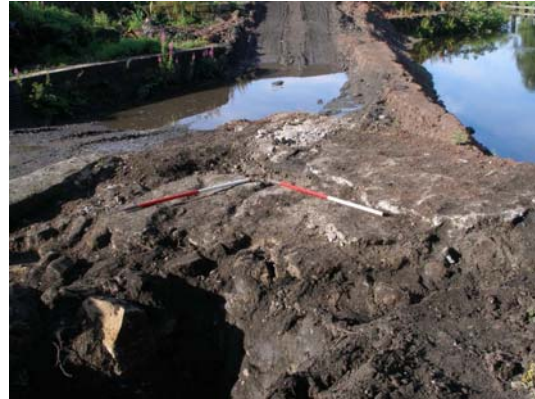
Plate 27:

*Earlier mortar surface of the slipway finger.  
(P8155313)*

The remains of the earliest surface found on top of the slipway infill was a cream-coloured cement mortar with stones, which survived in the centre of the finger and measured  $c$  3 by 1.5 m by  $c$  0.10-0.13 m thick. It was in poor condition and its edges were soft and friable (Plate 27). The relationship of the surface to the sandstone block was not clear. However, if it had functioned as a mooring bollard, its top could have broken off before this surface was laid. A cement patch on top of the cement mortar surface was also noted.

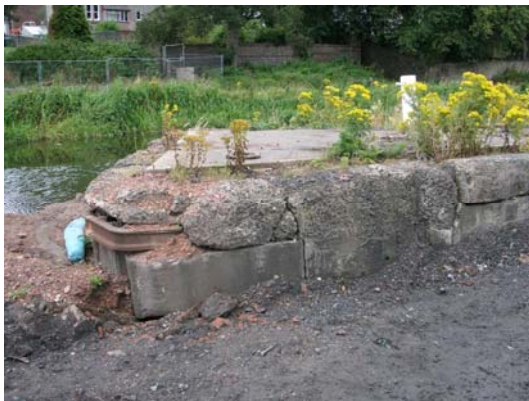
Plate: 28:

*The end of the slipway finger.  
(P8105295)*

The slipway finger was made by building into the canal, and narrowing the waterway slightly, during the building of the slipway. Its construction was noted as comprising industrial debris and stone. The end of the finger was poorly built and it was probably extended or strengthened during its use. It had various surfaces but the concrete capping masked much of its earlier coverings and features.

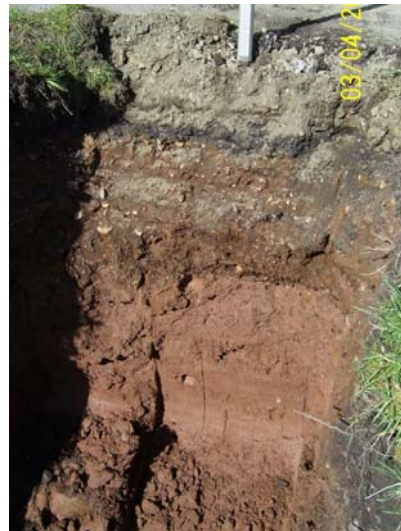
Plate 29:

*The tow path test pit.  
(Chris Henderson Image 100-0925 taken 03.04.07)*

A test pit, c 1 m long by 0.6 m wide and c 1.2 m deep was dug in the tow path on the north bank of the canal to the west of the basin entrance. Its sections revealed a c 0.6 m depth of undisturbed pink boulder clay, on top of which was deposited a c 0.4 m of metalling for the tow path, comprising hard packed small stones, clay, industrial debris, and blaes (Plate 29). This was capped by a thin layer of bitumen and stones, which in turn was covered by c 0.15-0.2 m of grey stone chips and dust forming the modern ground surface.

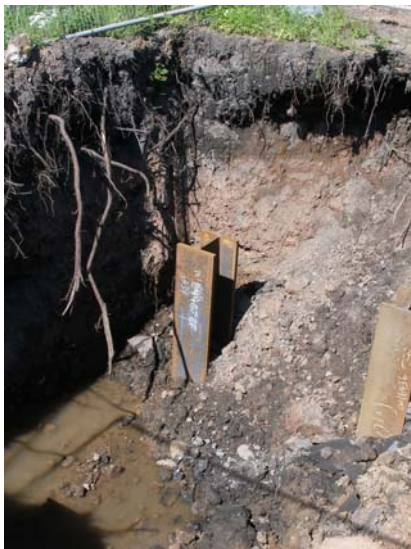
*Plate 30:*

*Steel beams within the hole dug through subsoil for receiving the new bridge superstructure.  
(P6274808)*

Two new holes measuring c 2 m by 2 m by 2 m were dug on either side of the canal, close to its edge, for the reception of vertical steel beams to hold the superstructure of the new bridge designed to cross the canal west of the basin mouth (Plate 30). The sections in these holes revealed natural pink boulder clay with turf and soil capping. No archaeological features were noted.
