Reconstruction of Marton Bridge, Warwickshire:

Archaeological Recording - Stage 1 Preliminary

Surveys and Stage 2 Trial Trenching

Report 9921
April 1999

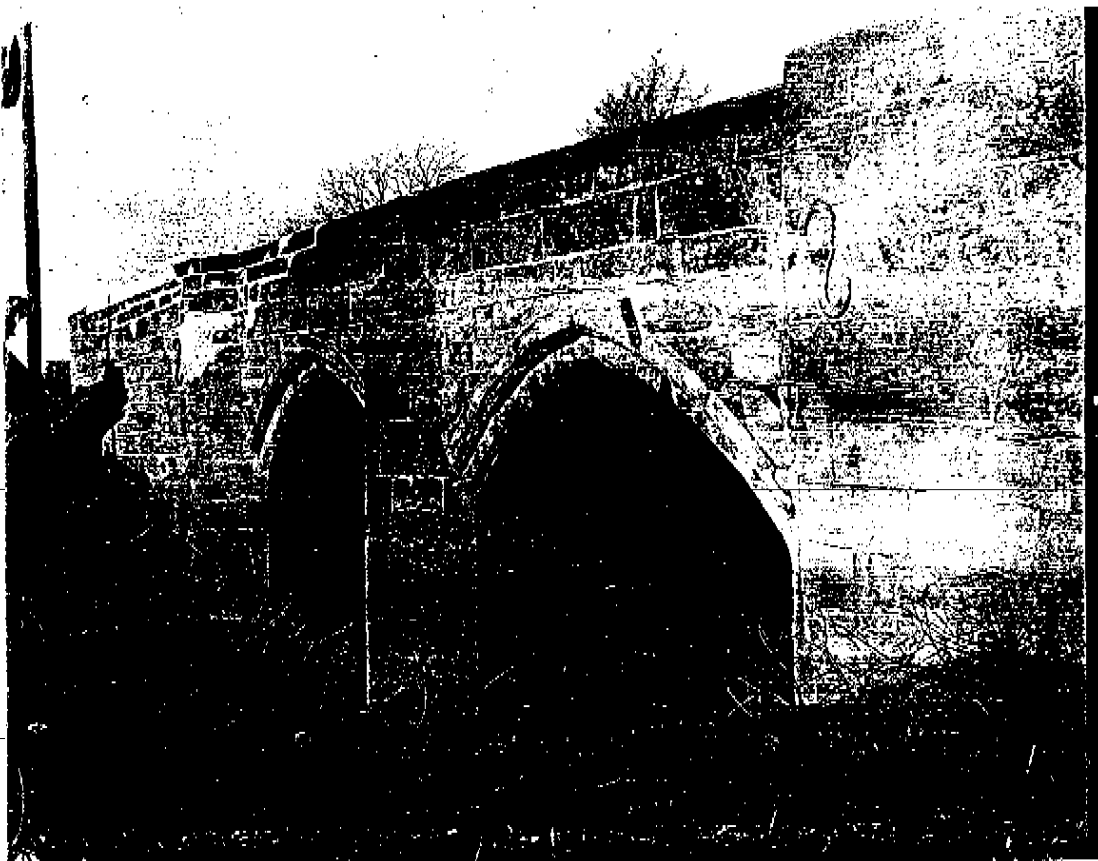
Fig 6: Marton Bridge, 1920s, south side (WRO PH 210/120)

exactly the same scene as the Aylesford Collection painting. A more detailed view of the south side of the main arches (Fig 6) shows a number of iron tie rods which presumably represent 19th century repairs. An area of lighter pointing on the west side suggests a recent repair of damage to the parapet.

4.9 The Phase 4 work is visible on the 1920s photo of the south side of the main arches (Fig 6) which it must therefore predate; it is also overlaid by the structure of the 1926 extension. Such an 'archaeological' approach to repair of a historic structure is in line with the best late 19th century, SPAB inspired, conservation thinking. Furthermore the date '1887' scrawled into the pointing at the top of the Phase 4 work on the west abutment (Elevation E) is entirely consistent with the other evidence. The same corduroy tooling is also visible on the south side of the western flood arch suggesting that it may also have been refaced at this time.

4.10 The 1920s photograph (Fig 6) also shows the ends of the existing iron tie rods inserted into the bridge in order to strengthen it. These iron supports are also likely to be 19th century repairs, possibly of the same date as these others.

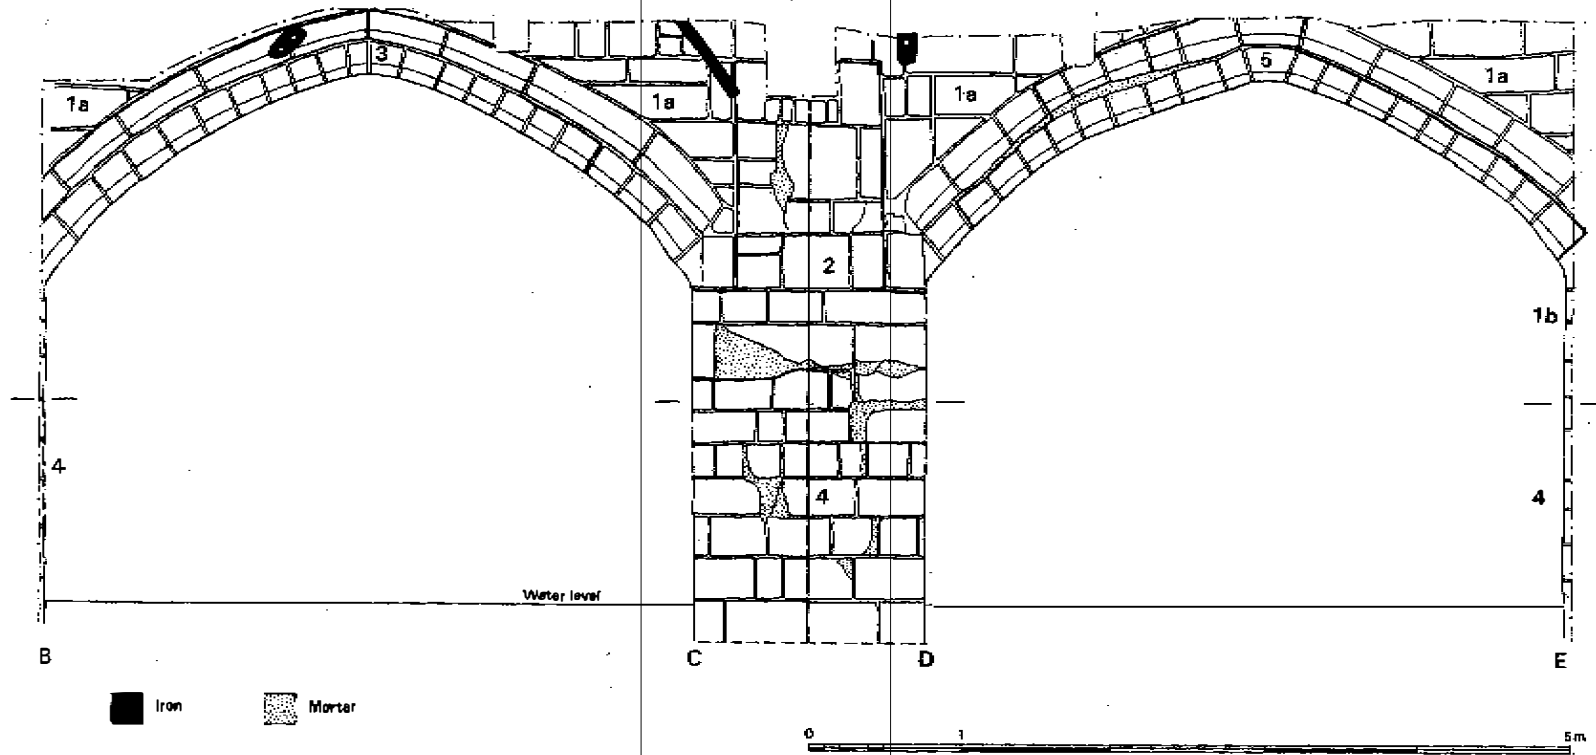
4.3 The following phases of repair and rebuilding could be detected (Figs 12, 13, 16, 19):

Fig 12: Main arches, A, north side

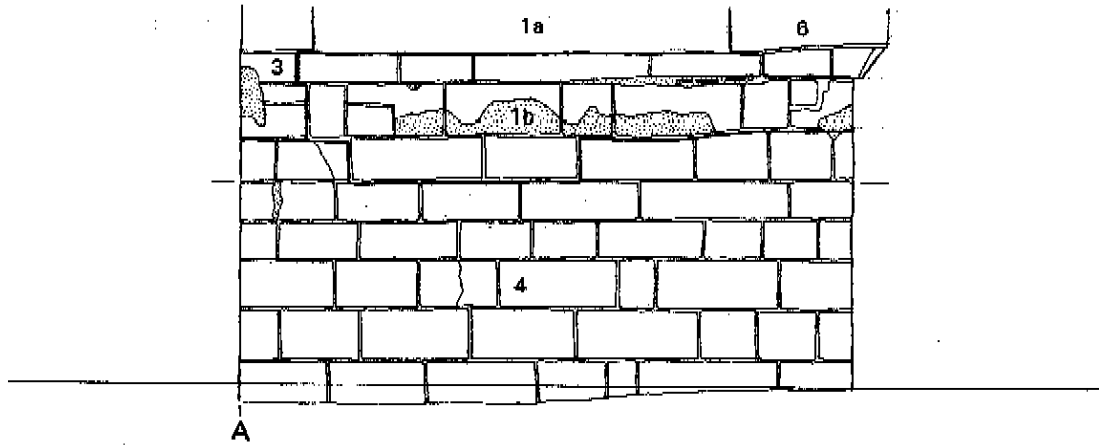
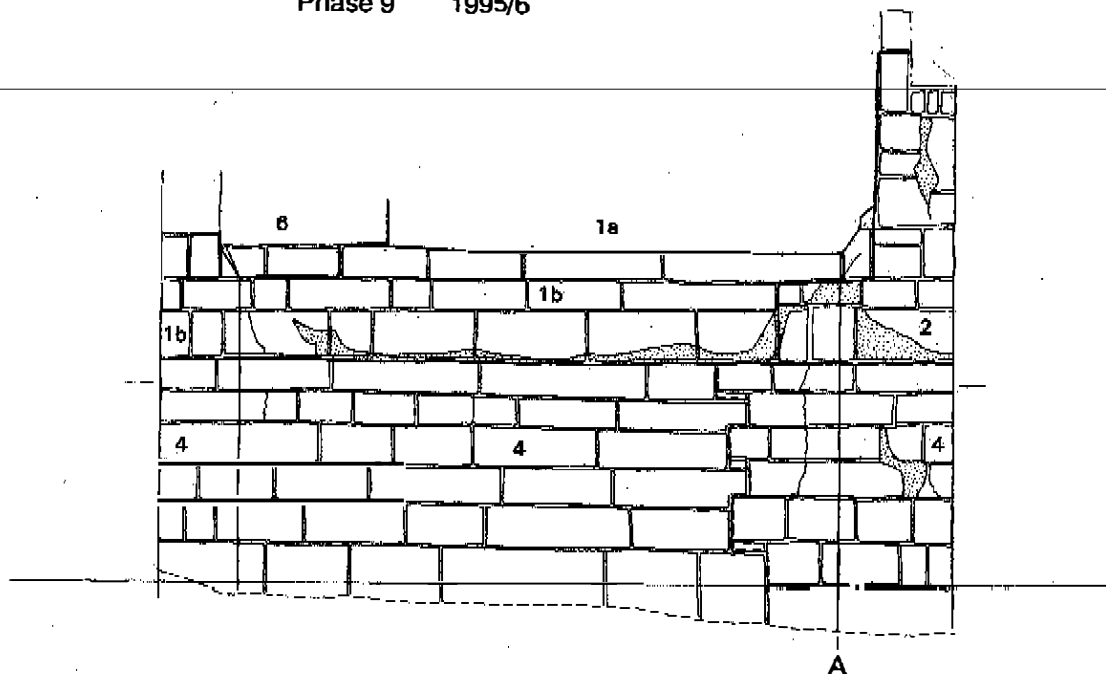
Fig 13: East main arch, B, east side, C, west side

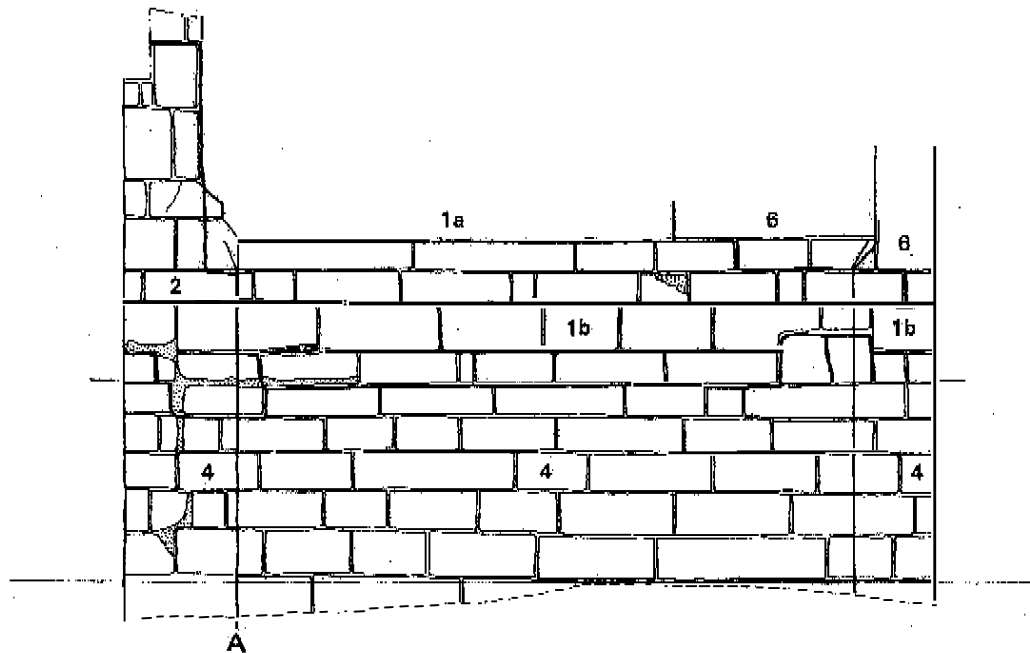
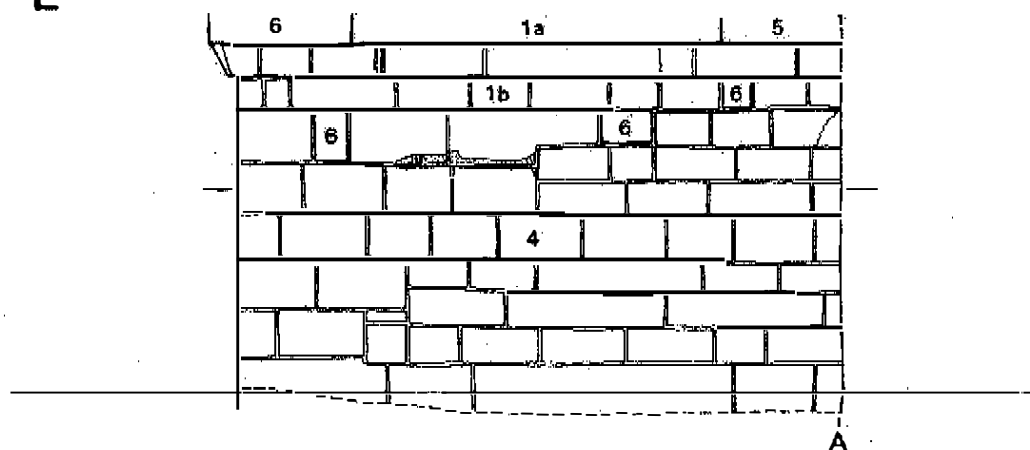
Fig 16: West main arch, D, east side and E, west side

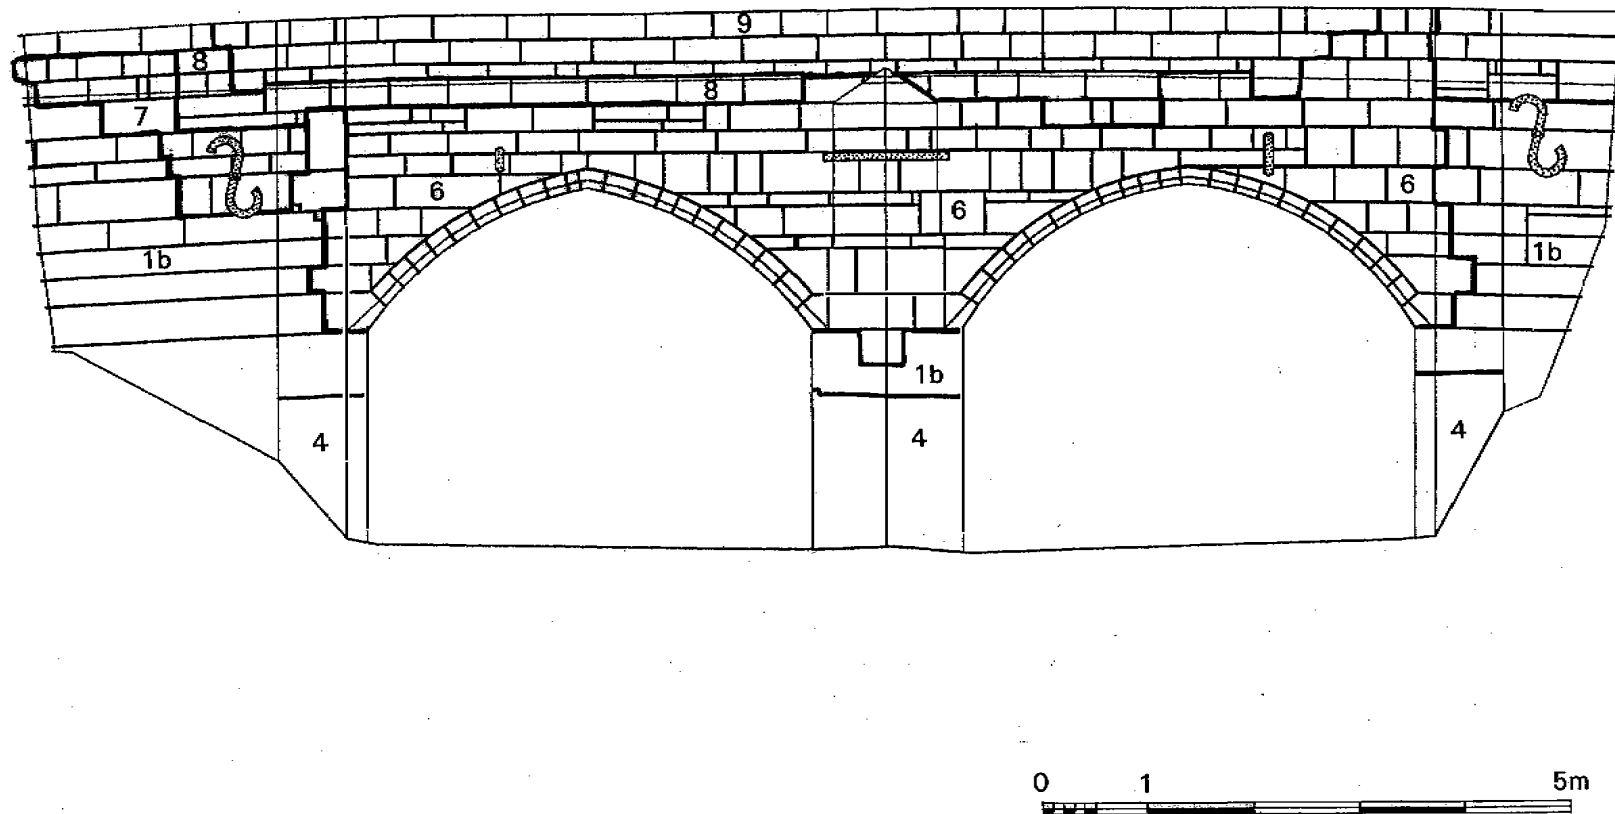
4.12 The disastrous repairs of 1978 involved the complete refacing of the southern face of the bridge above the main arches. The two medieval orders of arches were replaced with one, for no apparent reason. The refacing was carried out using a mixture of the original olive sandstone along with new machine cut blocks of red and beige mottled Hollington sandstone. Some of the reused stones retain their original lichen growth but as they were used at random the resulting effect is strange. The coursing of the new masonry contains a number of random discontinuities and the voussoirs of the new single order arch do not join up properly with the abutments and central pier. At the same time a few of the original (Phase 1b) stones on the western abutment were also replaced (Elevation E).

4.14 Some time between 1978 and 1991 a 7m section of the parapet up to four courses deep over the western arch was demolished, presumably by being hit by a vehicle. It was repaired using new, red sandstone blocks. The full extent of the repair is visible on the photograph taken in 1991 (Fig 9) although most of was subsequently destroyed by another vehicle collision, and only a single course now survives.

4.15 The final phase represents the most recent replacement of the southern parapet after vehicle damage. A 11m length of parapet, mainly three courses deep but up to five courses deep to the east, is shown as down on a photograph taken in 1995 (Fig 10). This damage destroyed most of the previous Phase 8 repair, except for its lowest course. The repair of this damage was carried out in 1995/6, under SMC HSD 9/2/2533 pt 4, using red sandstone blocks.

Fig 19: Main arches, south side
(WCC Bridges Section SWB 363/10a, manually amended 1999)

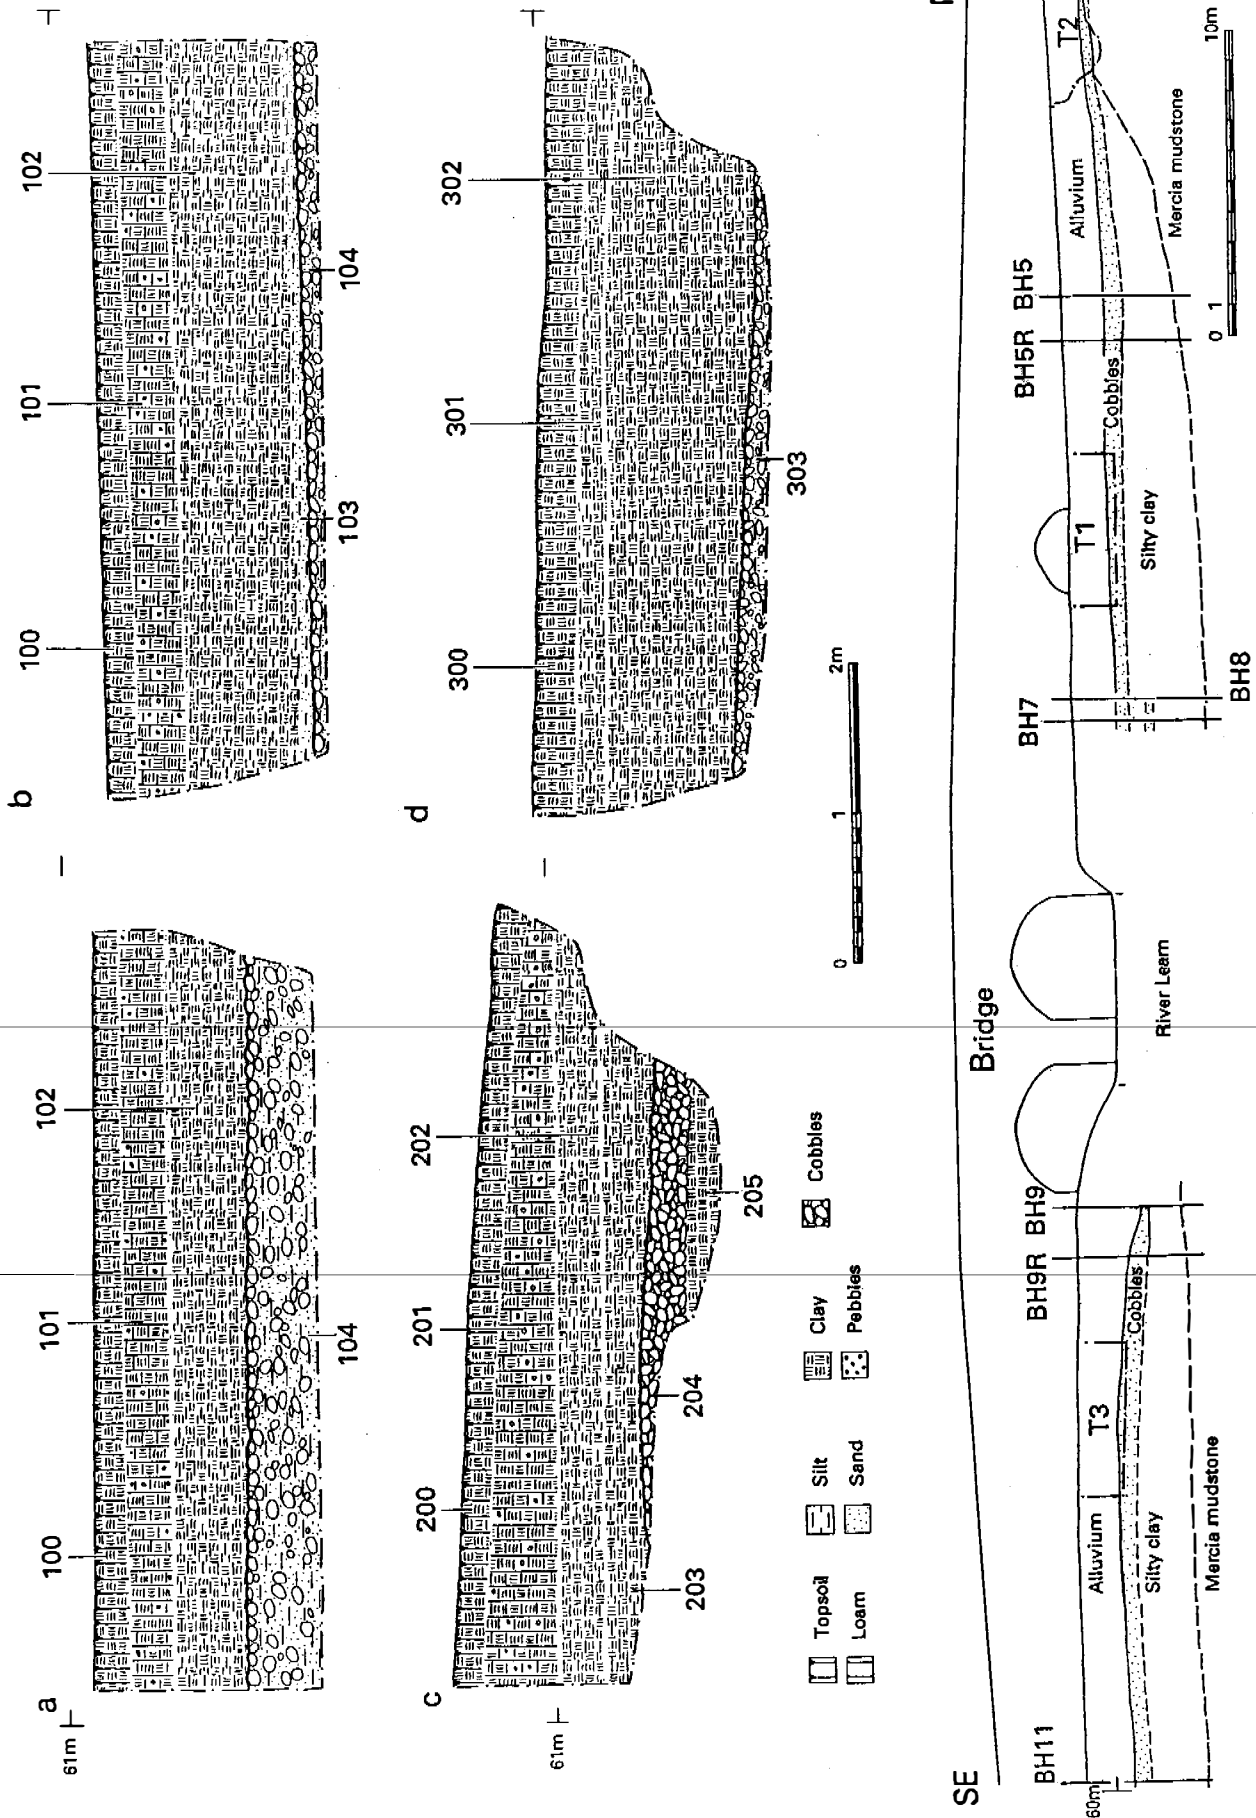
5.4 The trench was excavated to a maximum depth of 1.5m at a level of 59.30m aod (Fig 22, Sections a and b). The lowest layer (104) revealed consisted of rounded and subrounded with occasional nodules (2mm) of reddish brown clay and decayed roots. The surface of the cobbles was moderately compacted and sloped steeply down from north-south, the difference being some 0.50m (59.80-59.30m aod) across the 1.60m width of the trench.

5.10 The lowest layer exposed was of cobbles in a coarse black silty sand matrix (303), at least 0.20m deep (Fig 22, Section d). It was identical to layer 104 in Trench 1 and its moderately compacted surface sloped down westwards towards the river (from 59.75m-59.54m aod along the length of the trench).

Fig 22: Trial Trenches 1-3 , cross-sections

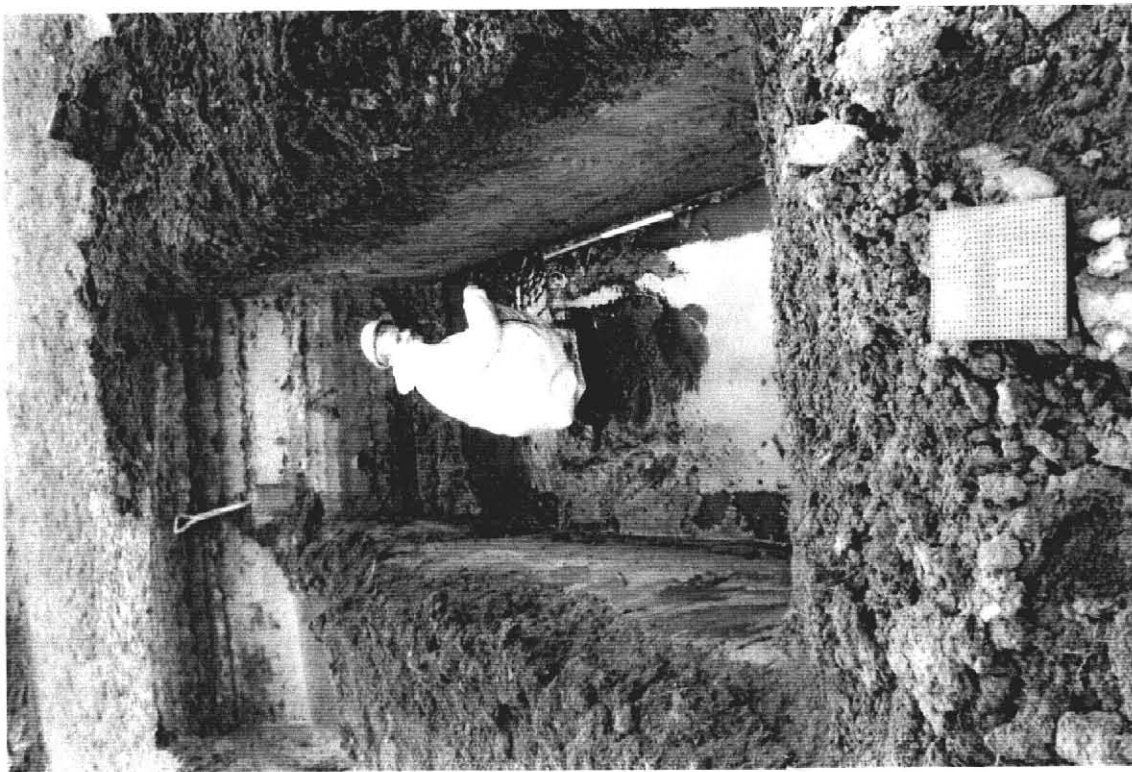
5.3 Trench 1 was the central of the three trenches, placed parallel to the existing bridge, 5m north of the western flood arch (Figs 3, 23). After the topsoil had been removed the trench had to be moved slightly to the south of its planned location to avoid a drain pipe serving the farm to the west of the river.

5.5 Overlying 104 in the south section but petering out across the trench towards the north section was a thin (0.08m) layer of light greyish brown sandy silt (103). There were no finds or inclusions, and the layer had the appearance of a waterlain deposit. Sealing 103 was a thick and homogenous layer of yellowish brown alluvial silty clay (102). This was 0.80m thick in the south section, but only 0.50m thick in the northern section where the cobble layer (104) was thicker. It was again completely sterile. Overlying 102 was a 0.30m thick dark yellowish brown silty clay loam subsoil (101), overlain in turn by the topsoil (100), a humic and very dark greyish brown clay loam layer. Its surface sloped 0.08m west-east over the length of the trench.

Fig 23: Trial Trench 1

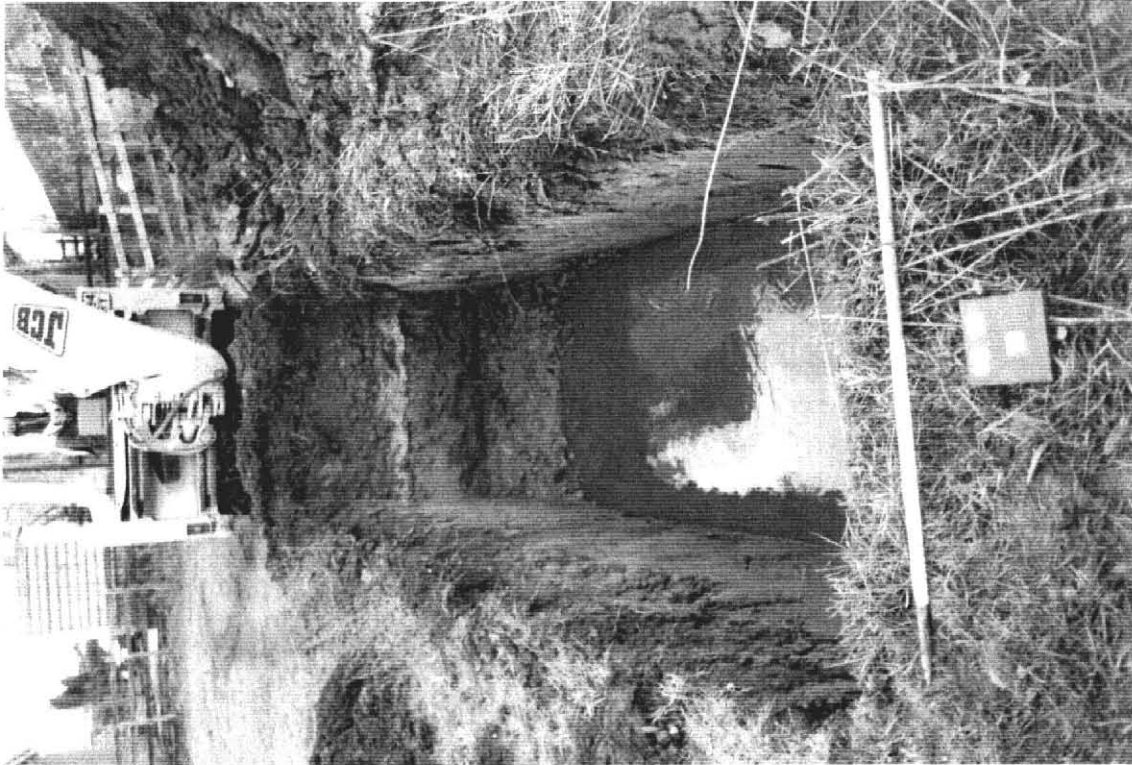
5.9 Trench 3 was located on the east bank of the River Leam, c.5m out from the bridge between the main arches and the eastern flood arch (Figs 3, 22, 24). It was oriented slightly irregularly due to the need to avoid the area of the proposed foundations for the new bridge and the existing embankment.

5.11 The cobble surface was overlaid by an up to 1m thick layer of brown silty clay with very few small pebbles (302), up to 1m thick, the surface of which was almost level but then sloped at the western end of the trench steeply towards the river. It was in turn overlaid by a layer of strong brown silty clay (301), apparently a subsoil, overlaid by the dark greyish brown clay loam topsoil (300).

Fig 24: Trial Trench 3
