**64/65 HIGH STREET, ST.MARTIN'S,
STAMFORD, LINCOLNSHIRE**

An Archaeological Building Appraisal

NETWORK ARCHAEOLOGY LTD

Report No.160

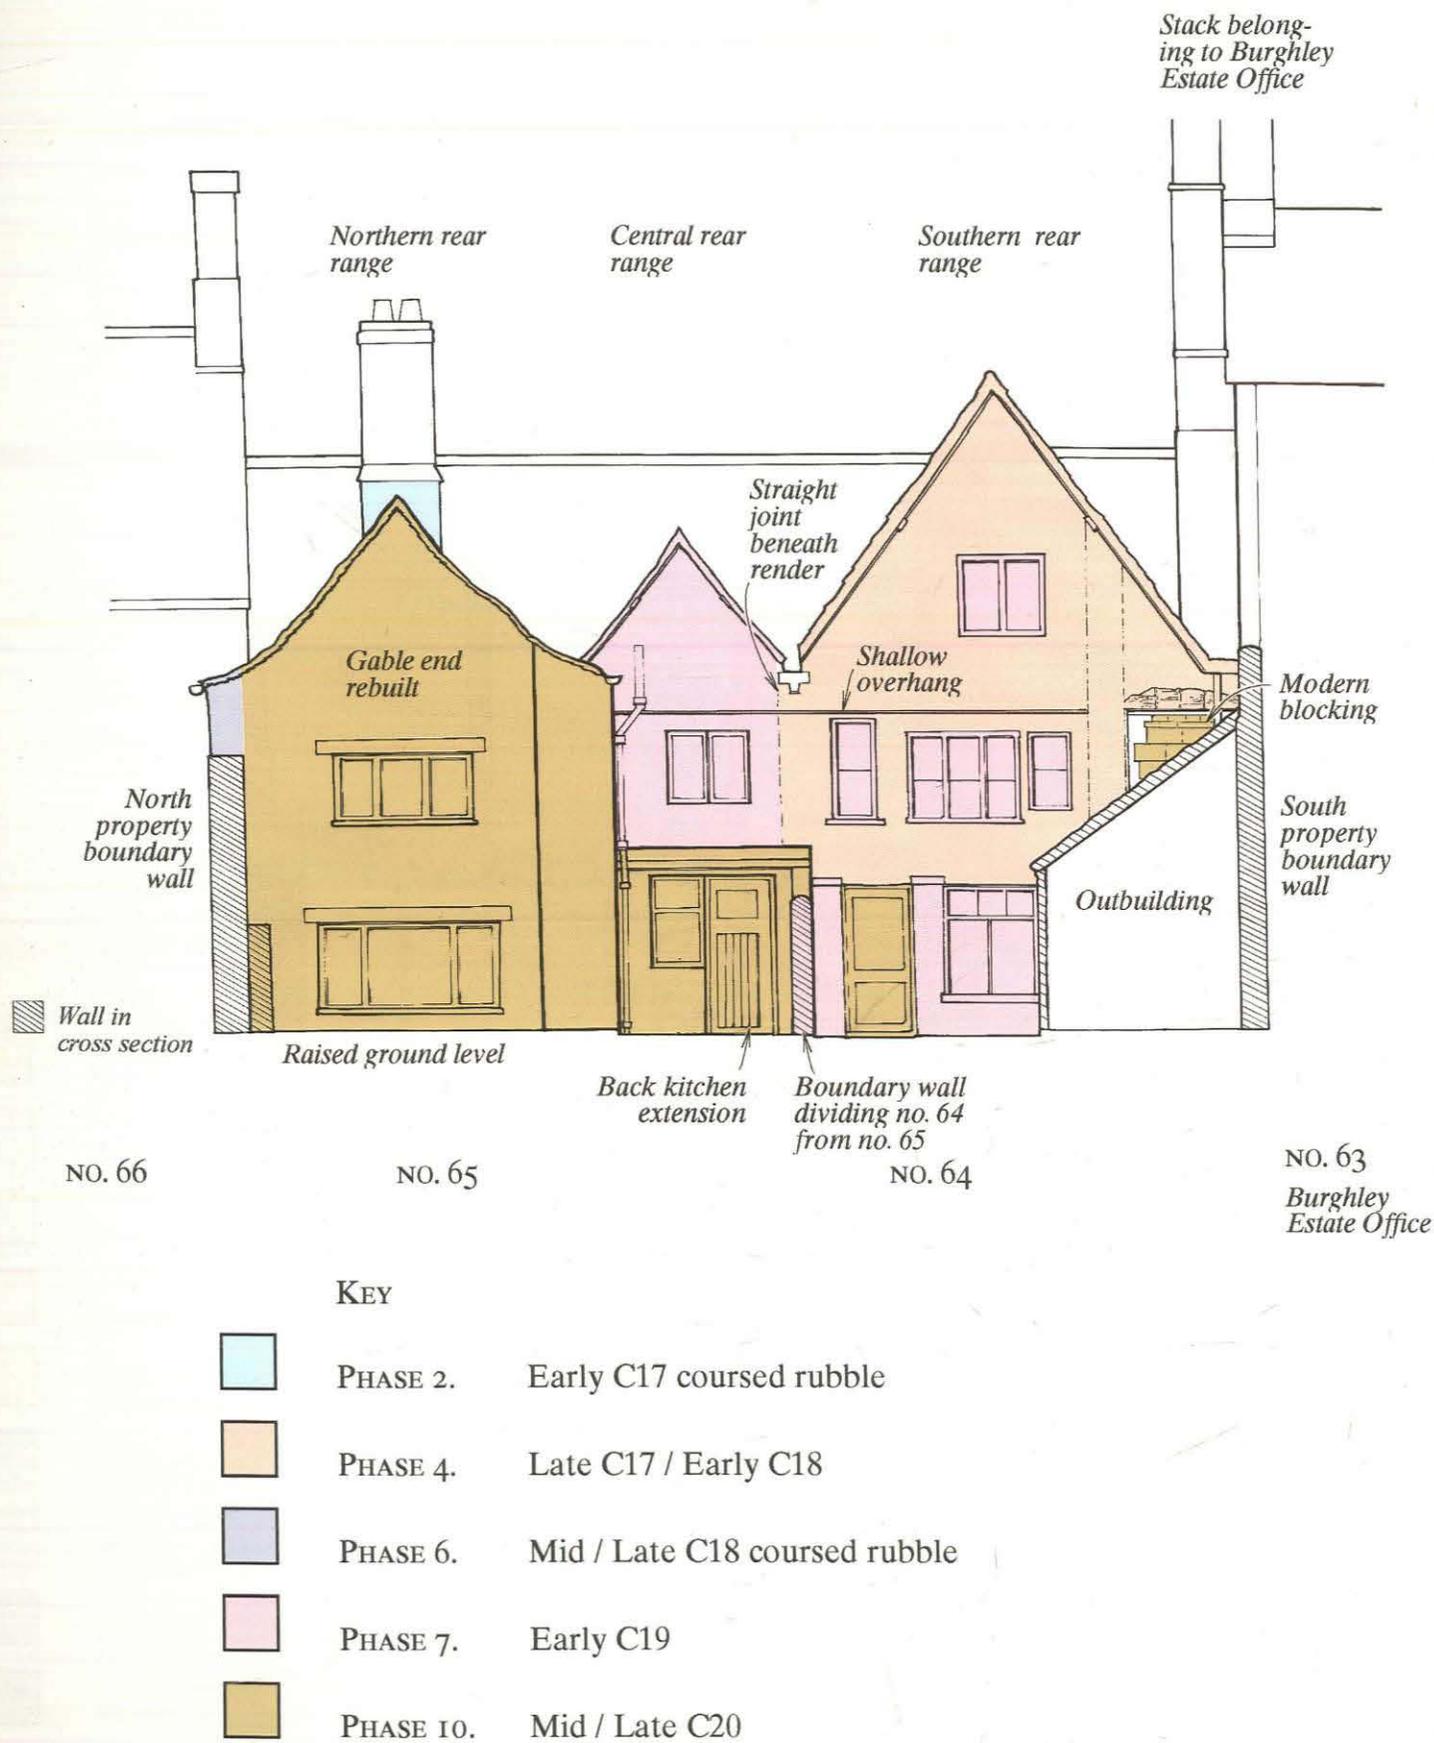
Figure 18: 64/65 High Street St. Martin's; west (rear) elevation showing range of building materials and inserted features

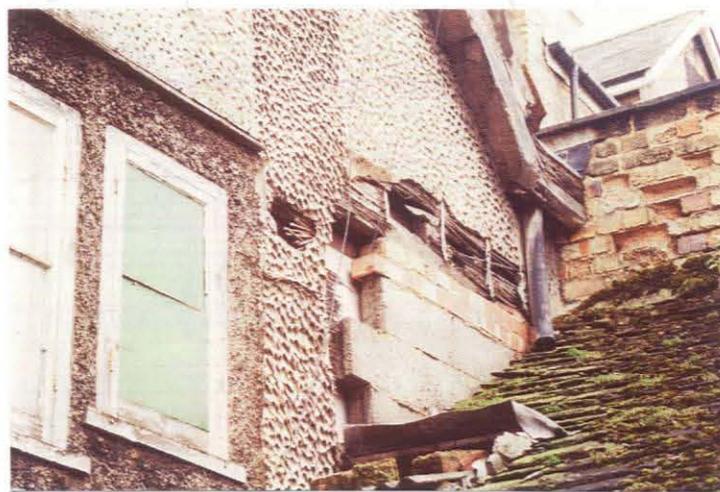
Plate 19: West (rear) gable end of the southernmost range (no.64), looking southeast; showing area of disturbance and repair work in building fabric. Note the exposed timber work and reeded infill panels above the brick and breeze block insertions.

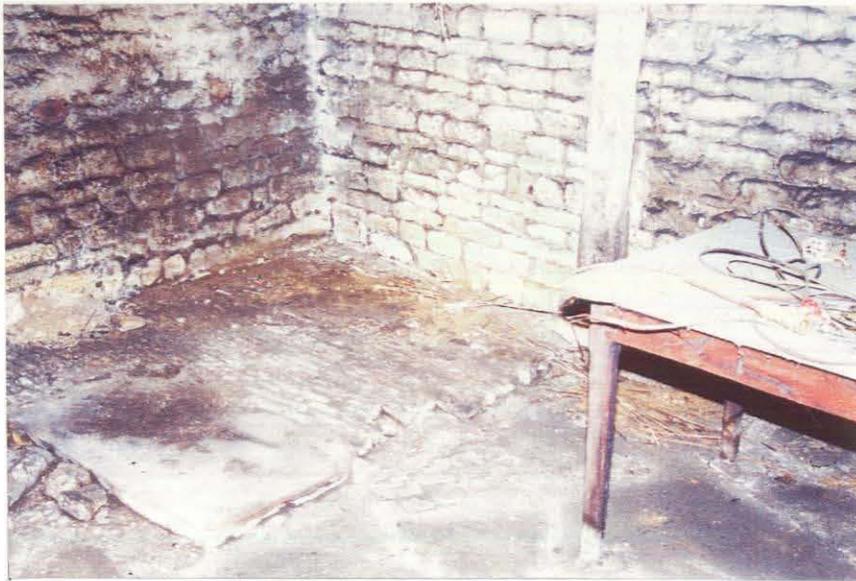
In the northwestern corner of the cellar the remains of a raised, rectangular cobbled floor surface is visible which measures approximately 2.5 x 1.8 metres (plate 67); the rest of the floor comprises roughly laid flagstones and compacted earth. The ceiling is in a poor state of repair; exposed and disintegrating areas of reeding and lath and plaster are visible between the joists.

Plate 67: Cellar basement 65/20, no.65; north-western corner of the cellar, featuring the remains of a raised, rectangular cobbled floor surface.

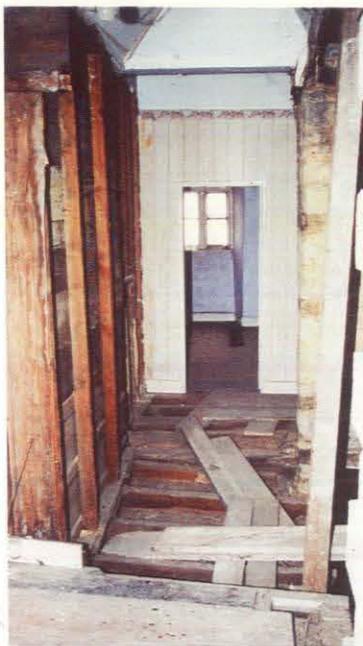
Plate 73: Corridor 65/12, no.65, first floor. View looking east down the corridor from Room 65/11 and into Room 65/13. The west wall of the corridor is missing and the western half of the south wall has also been demolished. There is presently open access between the corridor and Rooms 65/11 & 64/8.

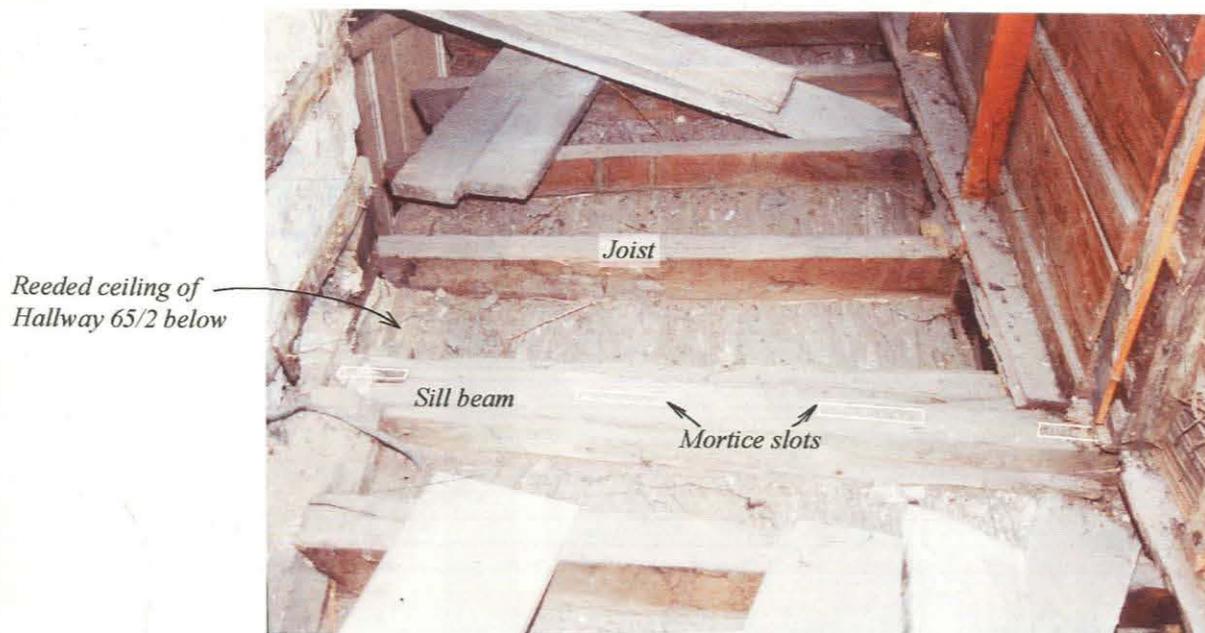
Plate 78: Corridor 65/12, no.65, first floor; most of the corridor floor boarding has been lifted and the joists and reeded ceiling below are exposed. Note the north-south aligned sill beam which contains mortice slots.

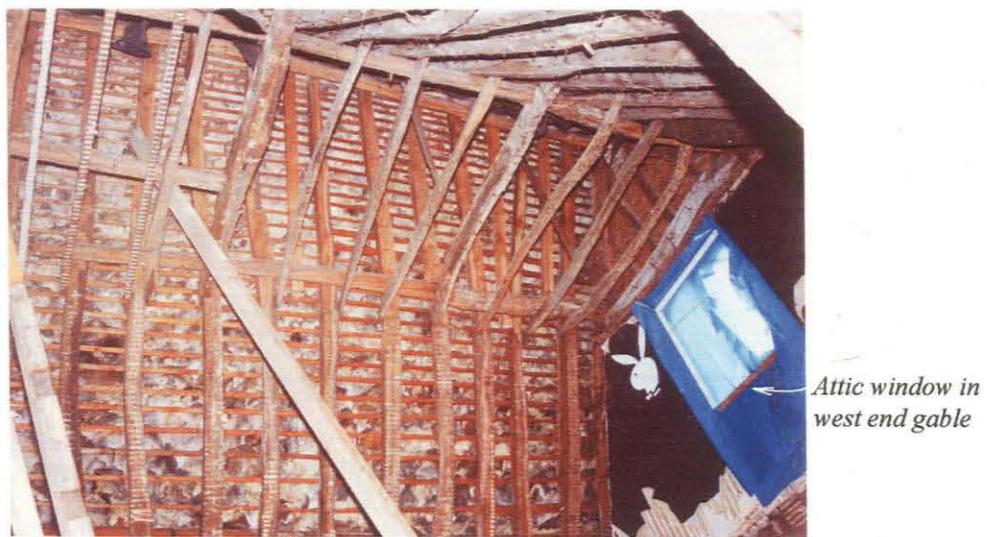
Since there is no ceiling to room **64/8** the west gable wall above the level of the tiebeam is exposed, together with all the roof timbers. Situated above the tiebeam, the southern gable end features a centrally-positioned attic window which is largely obscured by a sheet of blue plastic. From external examination (see **6.22**), the window appears to be a square, two-light casement with side-hung lights. The glass from the southernmost light is missing (plates 96 & 98).

Plate 98: Room 64/8, no.64, first floor, looking southwest up into the roof space.

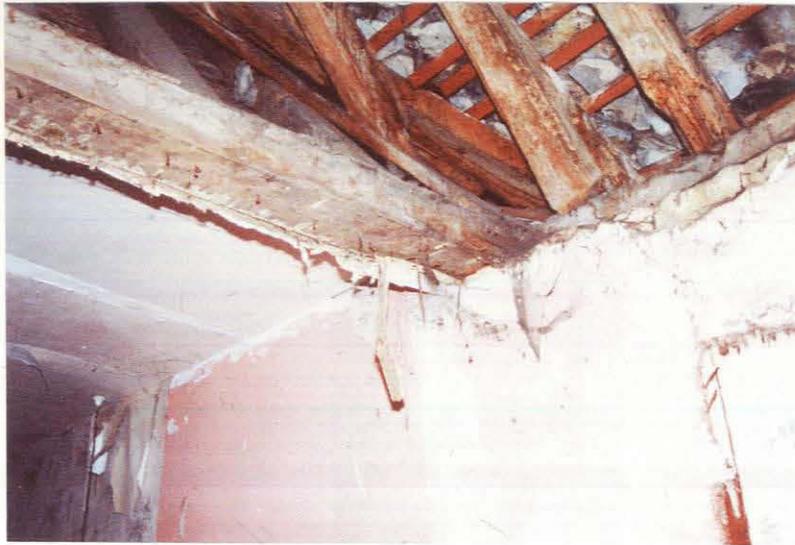
The room is accessed through a doorway at the western end of the plastered north wall, which leads in from corridor **65/12**. The floorboards are wide and aligned east-west; their condition is particularly poor at the eastern end of the room. A plain, high skirting board is applied to the base of most of the walls. The ceiling is plastered and there is a north-south beam running in front of the window bay on the east side of the room. The ceiling behind the beam (within the window bay itself) is missing, and the roof timbers above are fully exposed (plates 100 & 101).

Plate 100: Room 64/9, no.64, first floor, view of the north-south beam running in front of the window bay on the east side of the room. Note that the ceiling behind the beam (within the window bay itself) is missing and the roof timbers are exposed.
