# **Alford Manor House Alford, Lincolnshire.**

**Conservation Plan: Understanding the Place  
Volume Two: October 2006**

**Alford Manor House Conservation Plan: Volume Two**

**ARCHAEOLOGICAL WATCHING BRIEF**  
ALFORD MANOR HOUSE  
LINCOLNSHIRE

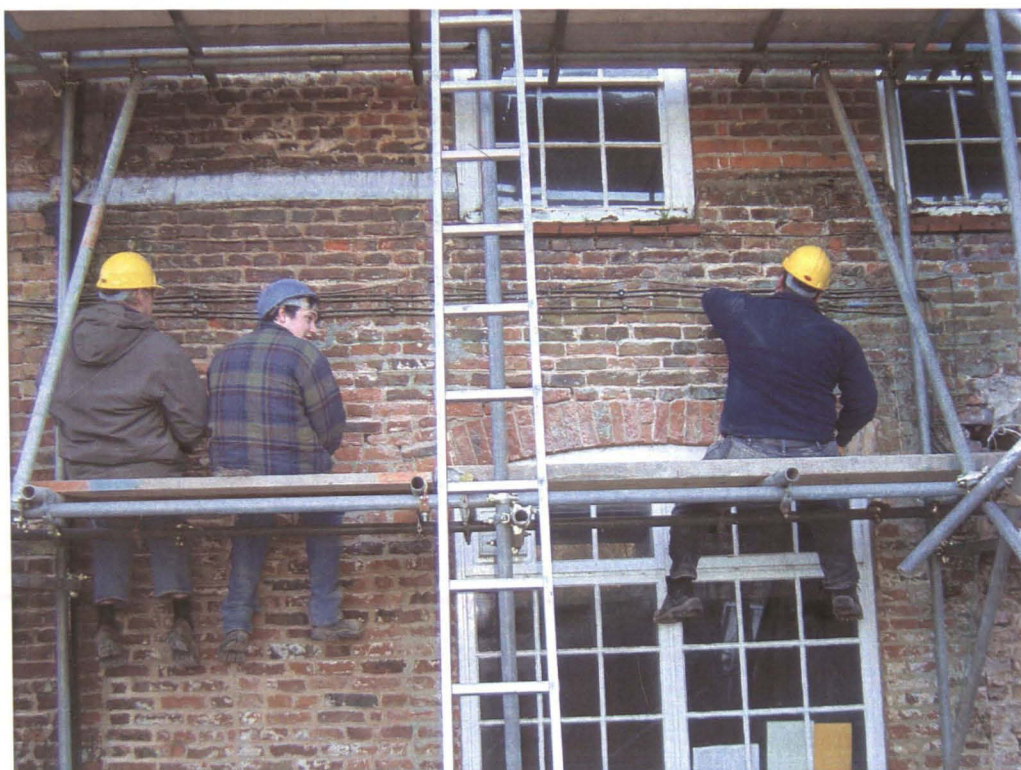
Plate 12: Repointing brickwork using pre-mixed lime putty/coarse sand.

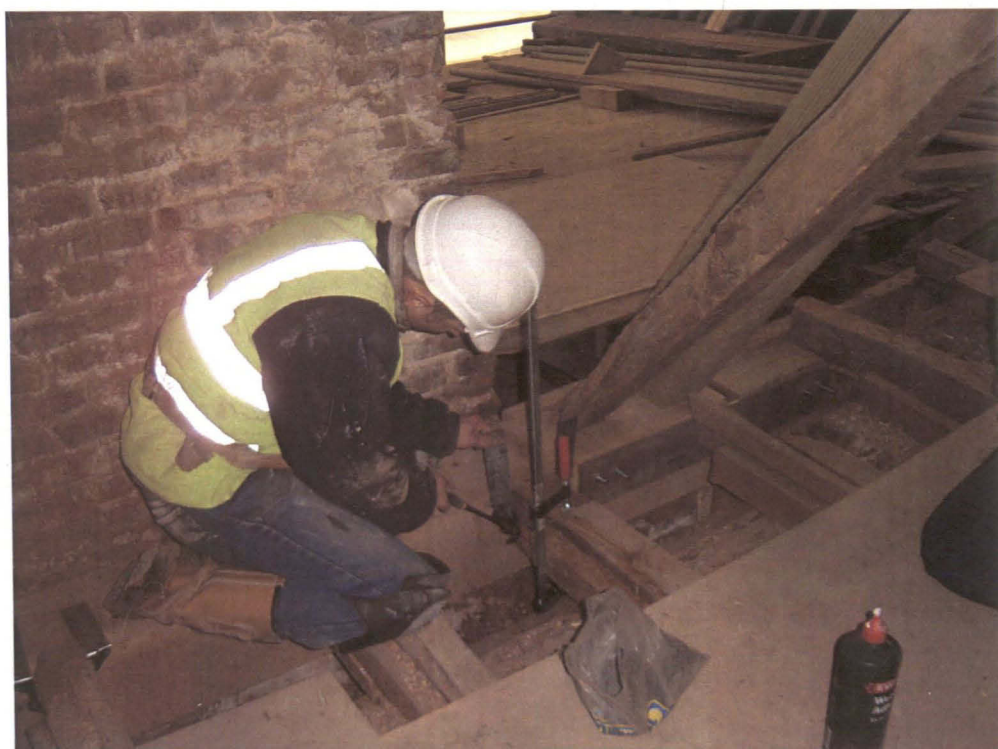
Plate 15: Repairs to oak wall-plate.

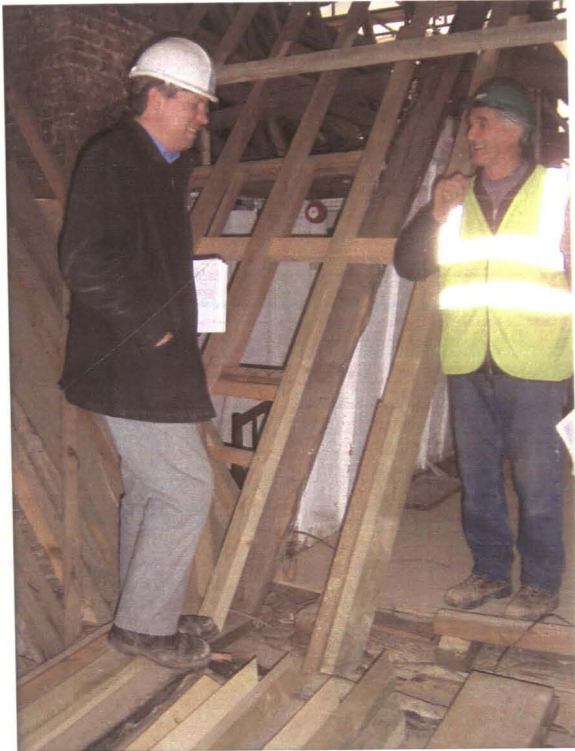
Plate 16: Repairs to the attic & first floor structures were overseen by structural engineer Ed Morton.

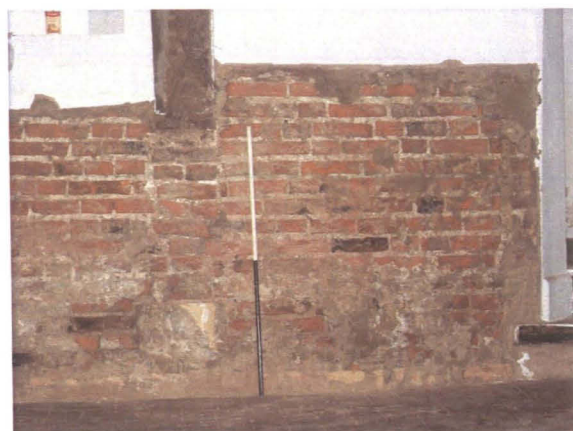
Stripping of the plaster from the lower part of the walls in room G11 (the kitchen) revealed a little more of the history of alteration to the house. The timber post, which had been observed previously in the east wall, could be seen to have been shortened (Plate 2). This was probably as a result of decay at the base of the post, the resultant gap being infilled with brickwork. The stone pad, originally intended to support the post, remained *in situ*. Clearly the original builders were aware that the bases of the timber posts would have been prone to decay and tried to avoid this problem with pad stones, a solution not entirely successful.

**Plate 2** Room G11, shortened timber post with brick infill

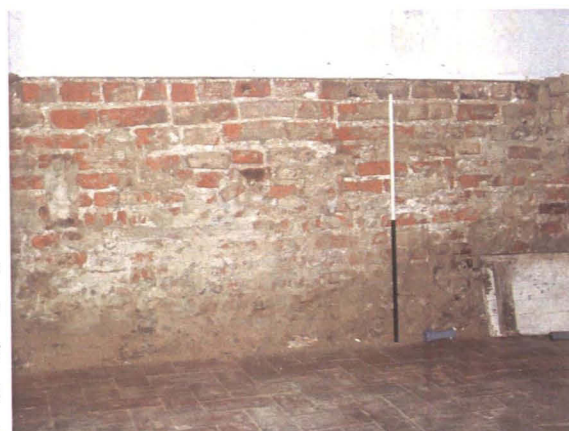
Stripping plaster from the north wall of room G11 provided some evidence of the proportions of the original window (Plate 3). It was clear that the window had been longer originally; a lower sill was visible, evidence consistent with that observed on the exterior. When the window was shortened, the sill and jambs were built up and narrowed using larger bricks with much wider mortar joints. Judging by the bricks and mortar type used this alteration appears to have been undertaken in the late 18th or early 19th century.

**Plate 3** Room G11, scar in the wall showing the original window proportions

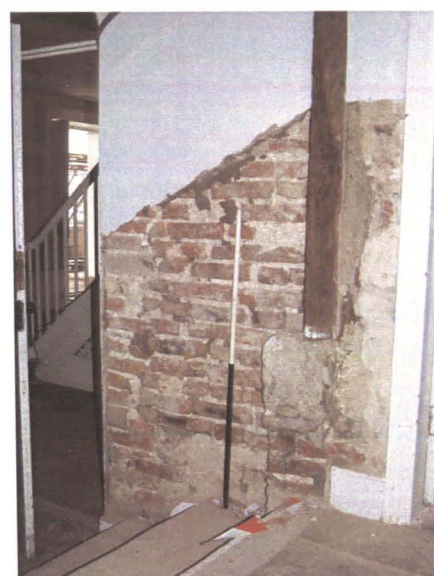
The west wall of the passage, also serving as the west wall of G11 (the kitchen) retained evidence for being a primary feature of the house. On removal of the plaster from the lower part of the wall it could be seen that there had originally been a timber post incorporated into the fabric (Plate 5). The post had been removed and replacement brickwork inserted. However, the pad stone, intended to support the post remained *in situ*. Within the same wall, to the south of the removed post and door opening to the buttery and pantry (rooms G13-14), a further post remained *in situ* along with its pad stone (Plate 6). The pad stone appeared to have been raised on several courses of brick, perhaps as a result of the bottom of the post decaying. This wall also provided evidence that the current access between the entrance hall (G3) and kitchen (G11) had been inserted. The brickwork forming the north jamb of the door could be seen to have been inserted crudely against a cut made into the primary brickwork. Access to the kitchen appears to have been either from the cellar door or *via* the common parlour (room G4).

**Plate 6** Room G11, *in situ* timber post and padstone

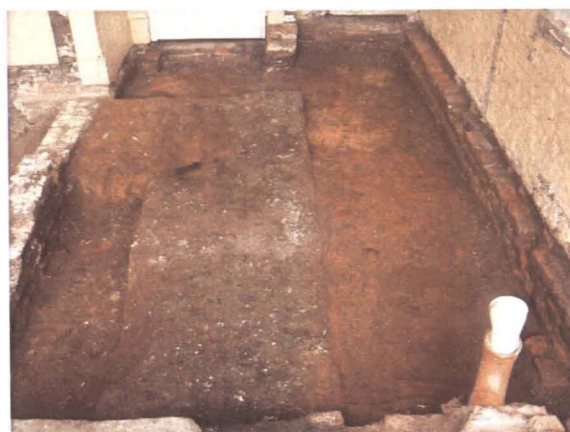
**Plate 11** Rubble levelling and foundations of the house

disturbed made ground, including rubble, probably associated with the levelling of the area prior to the construction of the extension (Plate 11). Two sondages were cut through the rubble, which continued to approximately 0.6m below the present ground level (as seen in the yard to the north of the house). Beneath this layer, subsoil was encountered with a number of features cut into it. Most of these appeared to be construction cuts associated with the foundations of the house, identifiable extending approximately 0.1m from the current walls. In the northwestern corner of the area the line of a truncated pit was identified, apparently Victorian in date, although this feature was not excavated further.

The removal of the ground to this level also revealed the foundations of the house, which consisted of bricks of the same proportions and type as found in the elevations of the manor house. The foundation layers stepped out from the main elevation of the house with rows of stretchers and headers identifiable.

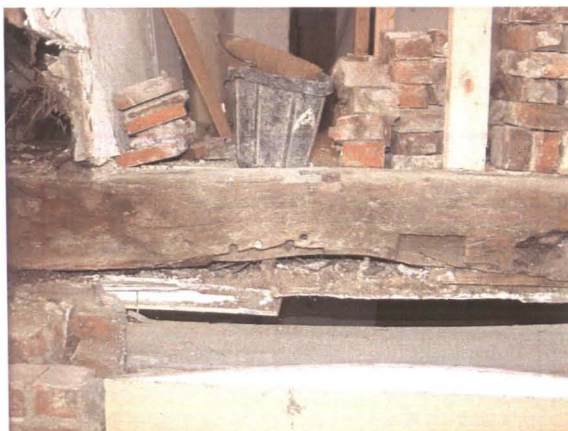
The south gable wall of the eastern wing was taken down for consolidation, and the opportunity was taken to record the uncovered wall plate in greater detail (Figure 5). The earlier phase of work on the manor house noted that the wall plates at the gable ends of each wing were bonded into the gable walls, making a full examination difficult, although partial plans were created (FAS 2003). The current renovation work confirmed the presence of a series of nine mortices towards the outer edge of the upper surface of the wall plate, approximately 0.25m apart. These are clearly associated with the upright timbers of the framing used at this level, which unlike that below, would have been a visible part of the structure of the house. This close studding represented a decorative element in the timber framing of the upper stories.

During investigation, the wall plate was not removed from the wall and it was therefore not possible to examine the base or rear of the timber, however there was some evidence on the front of the plate to suggest that further structural joints would be included on the base, probably associated with timber-framed elements at first-floor level (Figure 6; Plate 13). Two cuts survive in the front surface of the beam, approximately 0.05m deep, tapering very slightly towards their top. These appear to be the front sections of lap joints, which would have held timbers running downwards from the plate. The two chases are approximately 2.5m apart. On the outer side of both of these chases three empty peg holes

**Plate 13** South gable; uncovered wall plate with lap joints

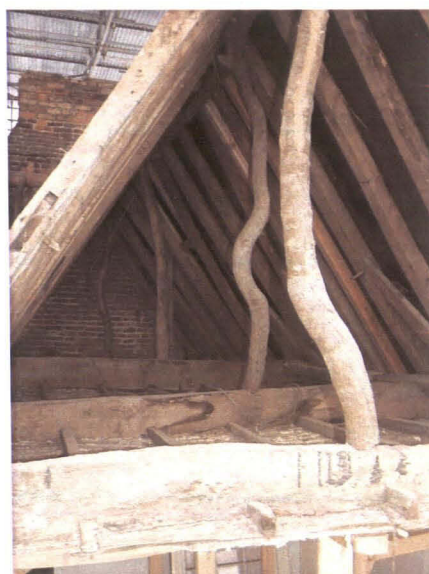
Several phases of repair were visible in the surviving roof structure. Particularly noticeable was the use of unconverted timber, rough hewn wood sometimes with the bark surviving, in a number of locations (Plate 20). It had been used as a ridge piece in the central range. In the southern section of the west cross wing, shorter lengths of unconverted timber had been pegged to the double row of purlins.

**Plate 20** Unconverted timbers used to brace the ridge piece in the eastern wing
