Historic Building Photographic Record for Property at 30 Oxford Street, Market Rasen, Lincolnshire.

This record has been produced in accordance with Planning Condition No 2 of Approval
Notice referenced M06/P/1018 dated 10th January 2007

Photographs were taken during July of 2007, prior to commencement of the works to convert
the existing warehouse and retail unit into 11 No self-contained apartments.

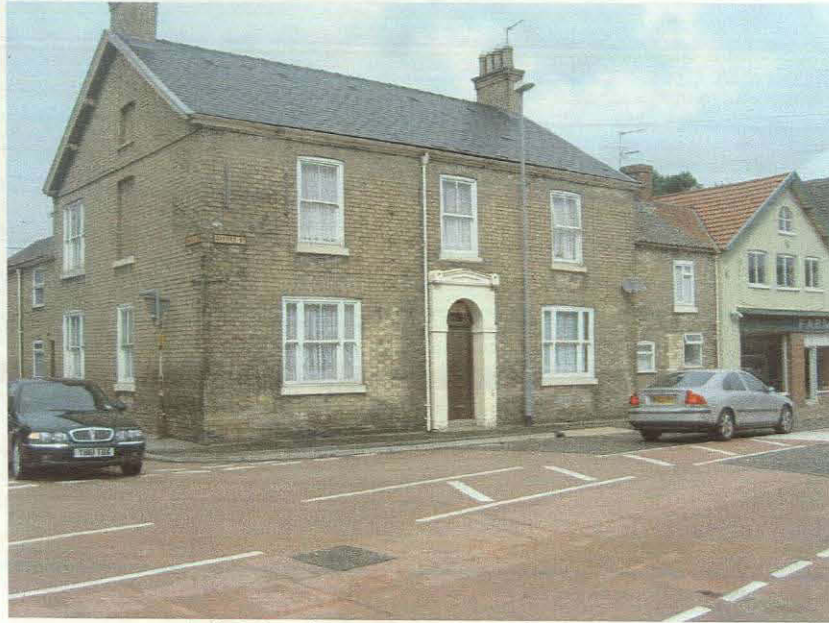
Elevation and Street Scene Photographs

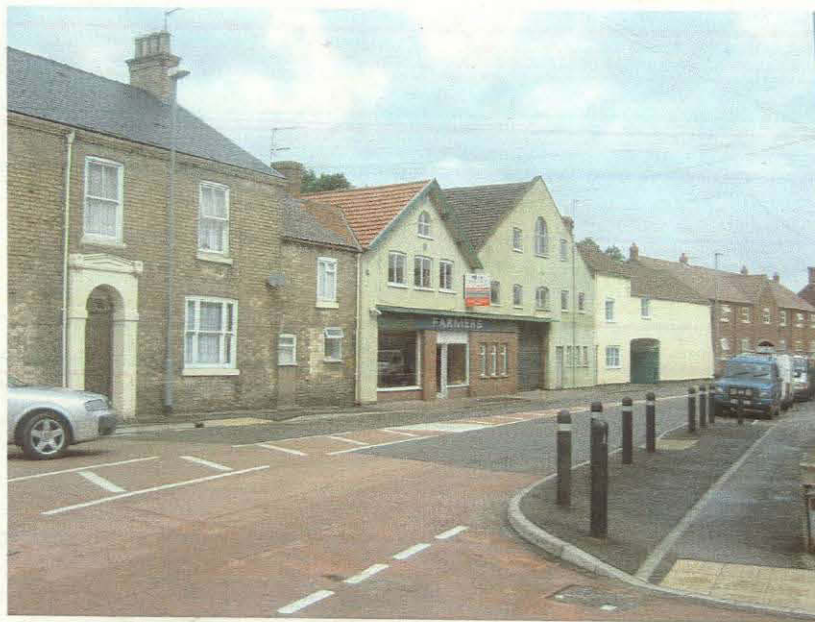
Adjoining Properties on Oxford Street

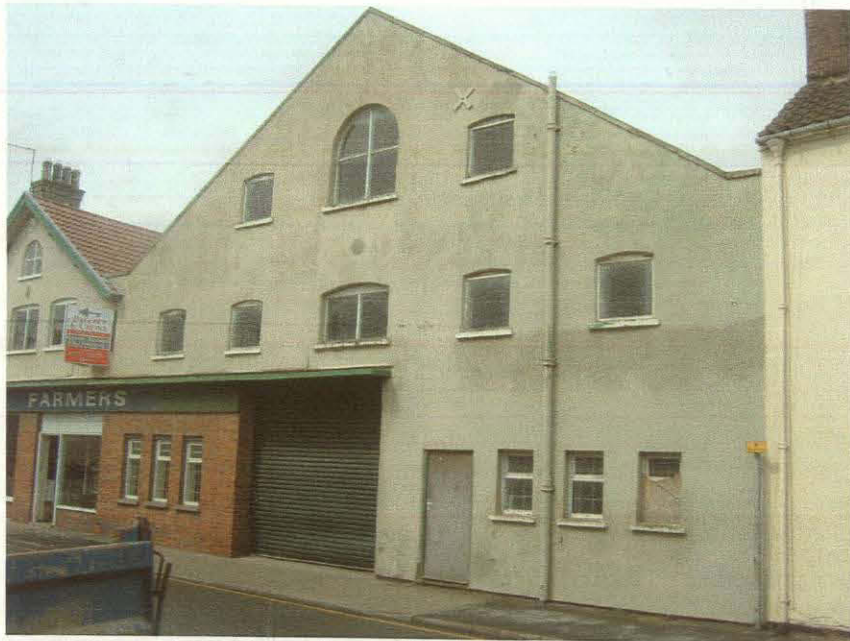
Front Elevation of Two Storey section.
Former 'Farmers' retail unit.

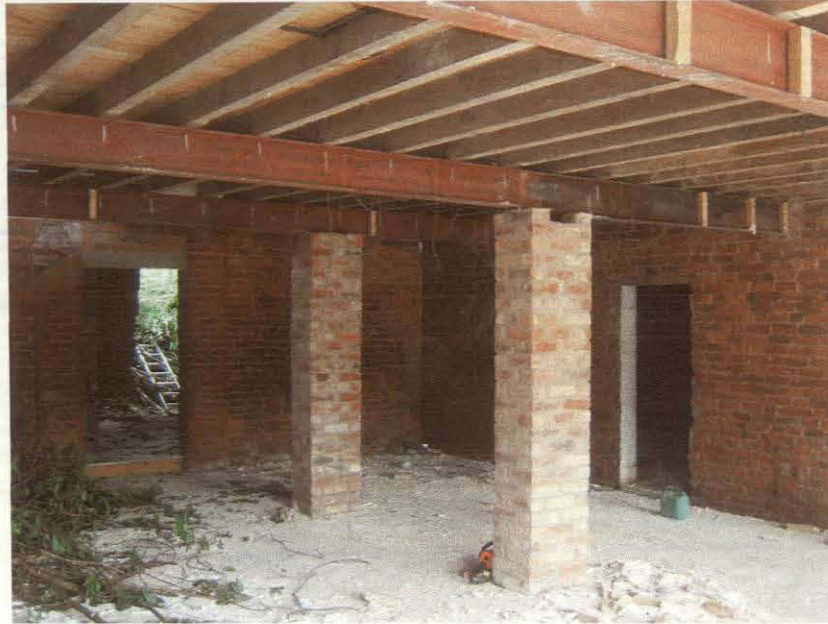
Photograph Number 1
Ground floor of retail unit showing steel support to existing floor joists
Steelwork stamped Caledonian Steelwork Company
Brickwork pillars hide further steel stanchions

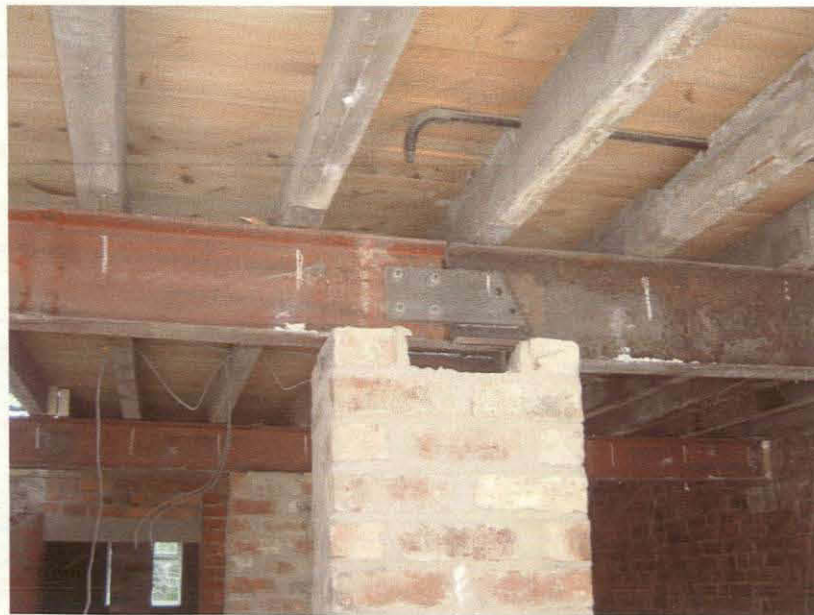
Photograph Number 2
Joint in steel beams at stanchions
Note joints in timber above line of steelwork. The staining on the timber suggests that the original support structure was not on the same line.
Also note slight difference in depth of steel and the inconsistency of jointing, which could suggest that these beams were replacing originally installed timber beams. Note also that the

steel beam in the background does not sit directly onto the padstone, which does suggest that the beams are later replacements.

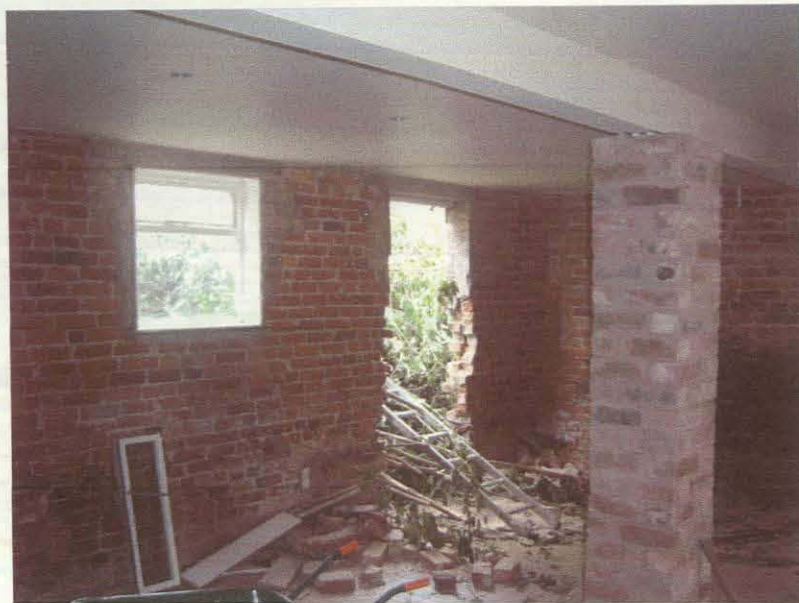
Photograph Number 3
Openings formed in existing structure during previous occupancies
Note use of concrete lintels and that windows do not accord with brick coursing
Steel beams and stanchions with brick cladding.

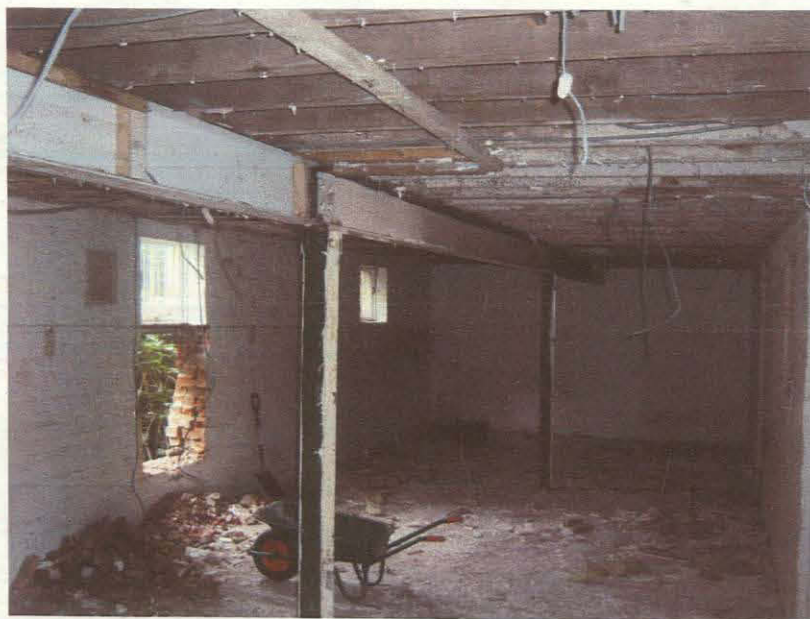
Photograph Number 4
Ground floor of 3 storey warehouse with steelwork and timber floor joists exposed

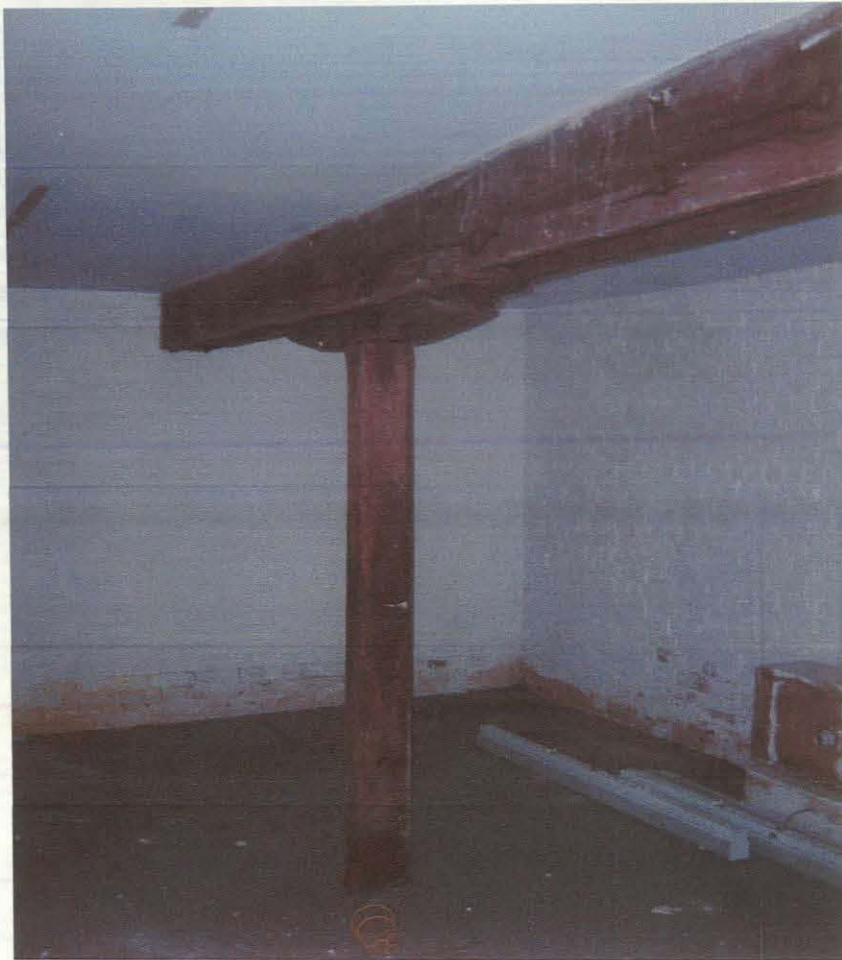
Photograph Number 5
Timber stanchion at ground floor
To be retained within new development.
Stanchion appears to be original structure.

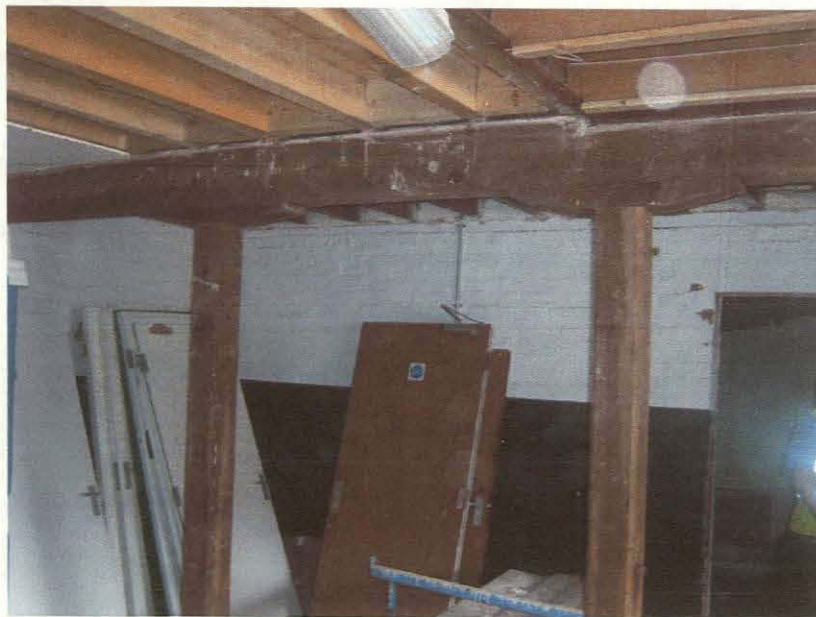
Photograph Number 6
As above.
Note amendments to floor joists and the addition of steelwork to provide opening for roller shutter during former occupancies.

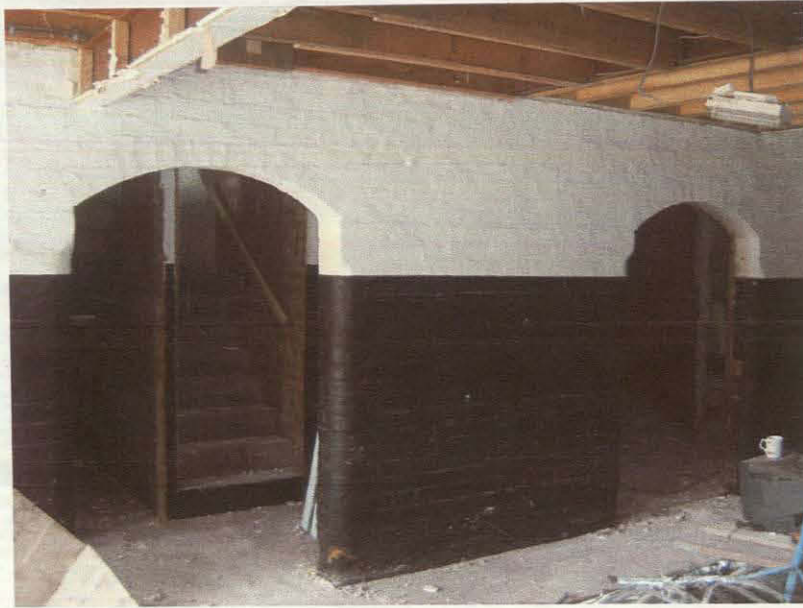
Photograph Number 7

Shows original arched brick openings and bull-nosed bricks
Left Hand opening to be retained in development, Right hand opening to be infilled.

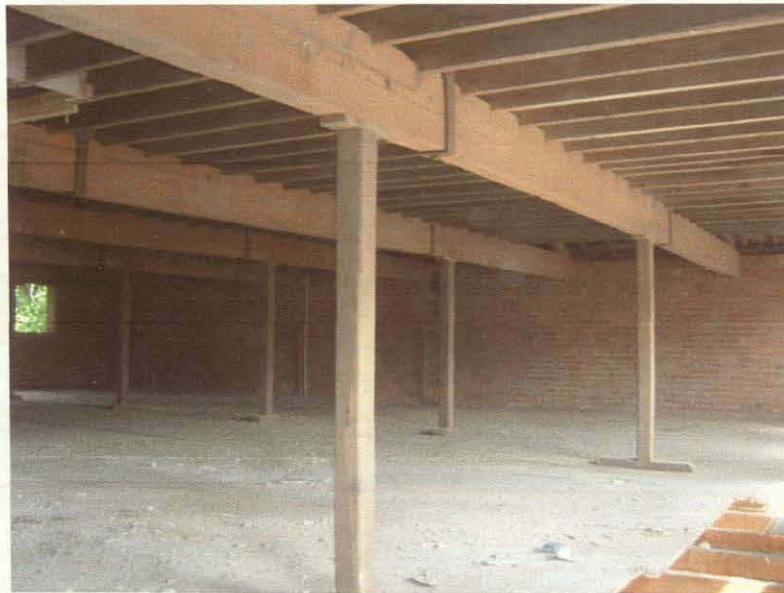
Photograph Number 8

First Floor showing the bottom chord of the timber truss which provides the second floor storage area. The oak support posts and floor spreaders appear to be later additions to the structure. These will be replaced with steel stanchions in the same positions as the structural engineers cannot prove their ability to support the existing and proposed loadings.

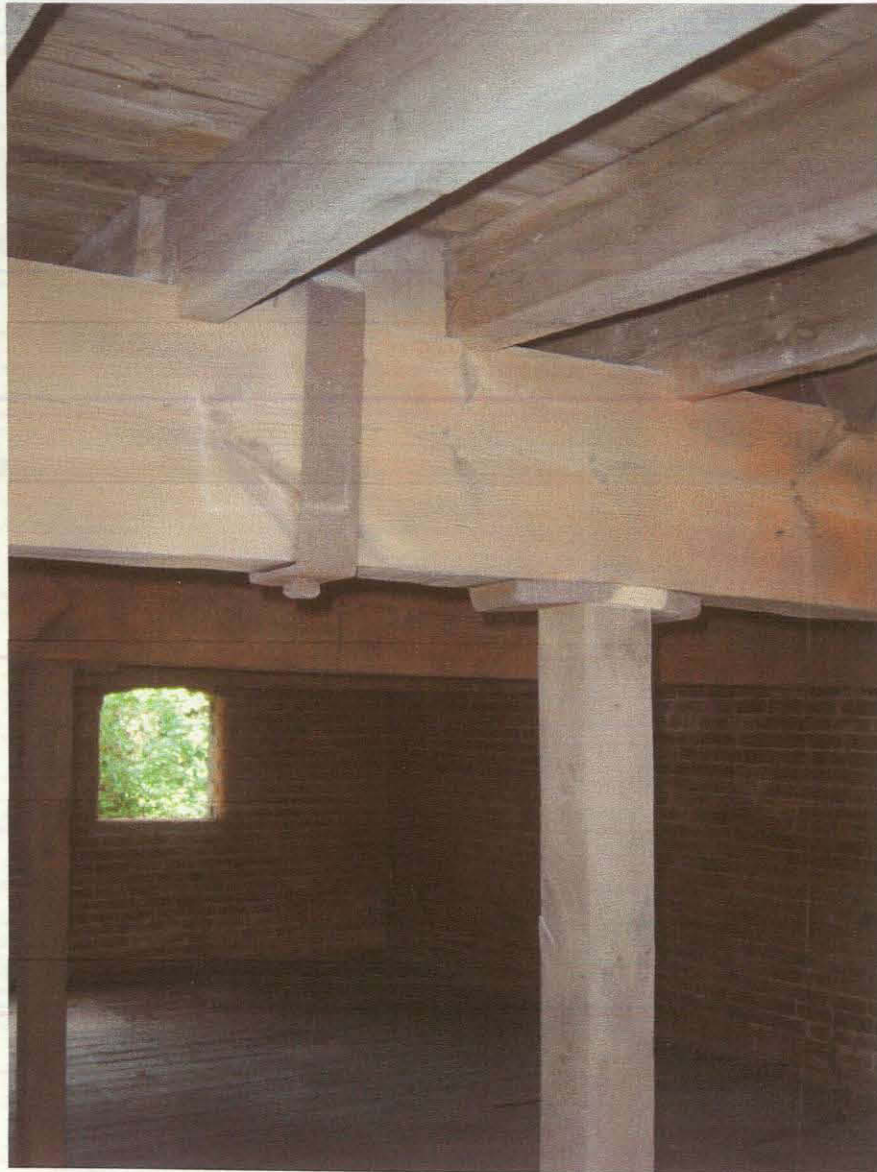
Photograph Number 9
Shows the connection between the oak stanchions to the bottom chord of the truss.
Also shows the steel strapping connecting bottom chord to the truss posts.

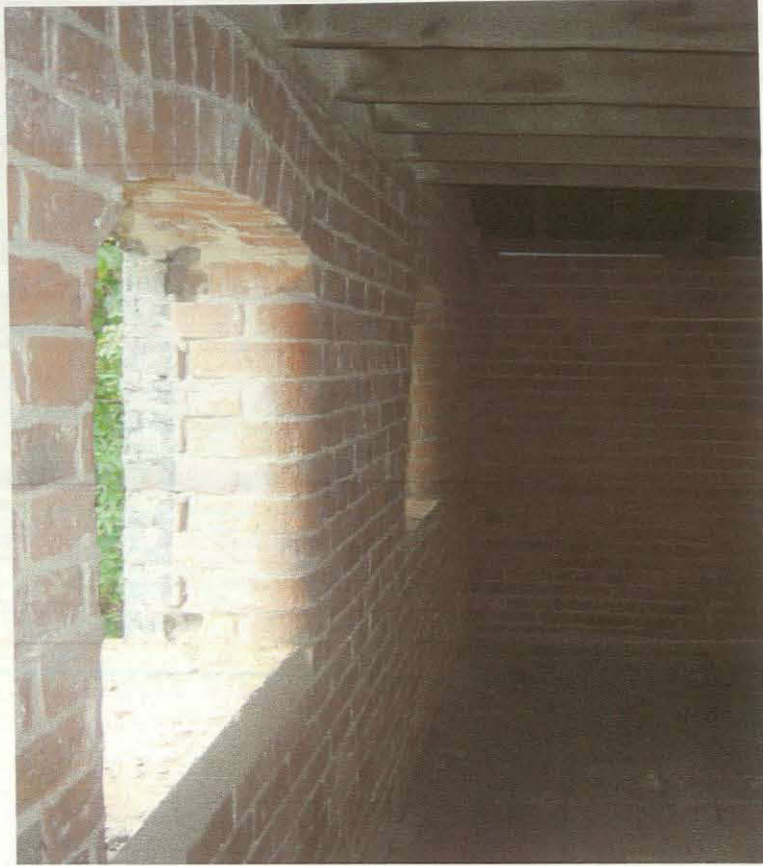
Photograph Number 10

Shows existing openings along rear elevation, which are to be retained in this development.

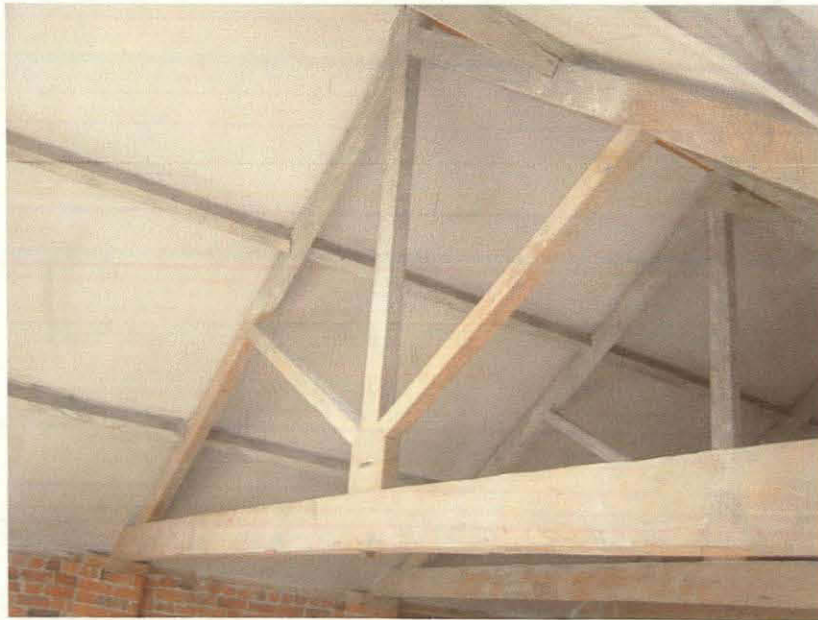
Photograph Number 11

Shows timber trusses and purlins that form the roof structure to the two storey section.
Note the bull-nosed brickwork pillars on the end bearing of the trusses.
The trusses are to be retained in this development and left semi-exposed in kitchen/living areas.

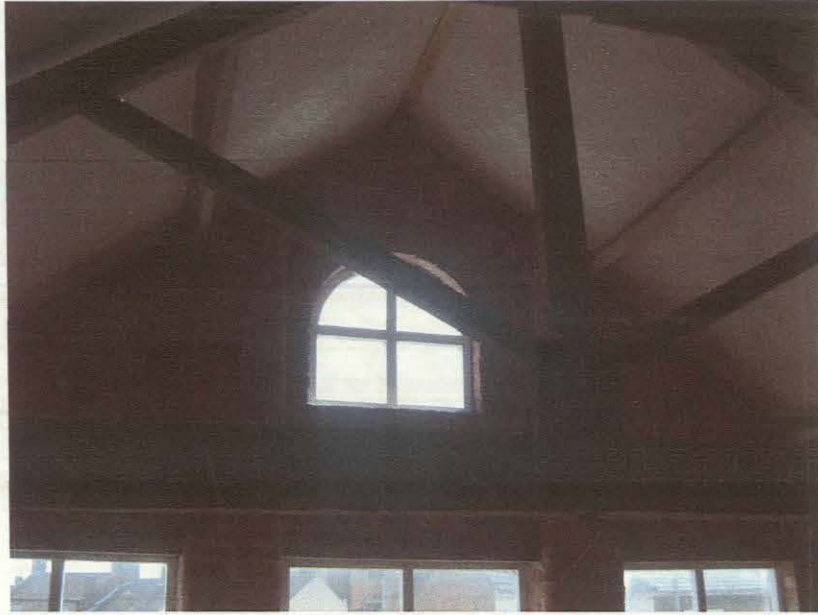
Photograph Number 12
Showing the high level window
New Aluminium windows to be installed in all openings and window to be retained in this development. Window will provide light to living/kitchen areas.

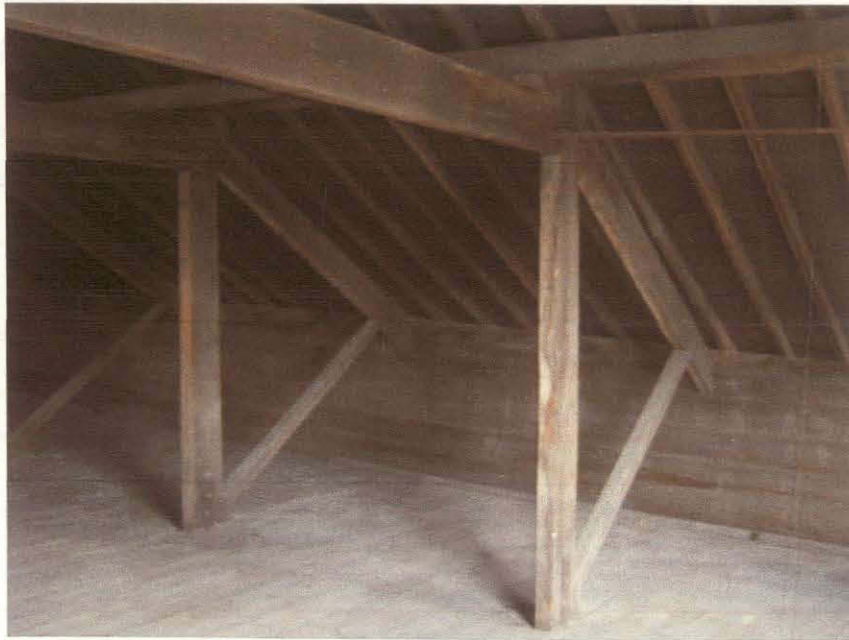
Photograph Number 13
Shows existing truss and rafters to second floor.

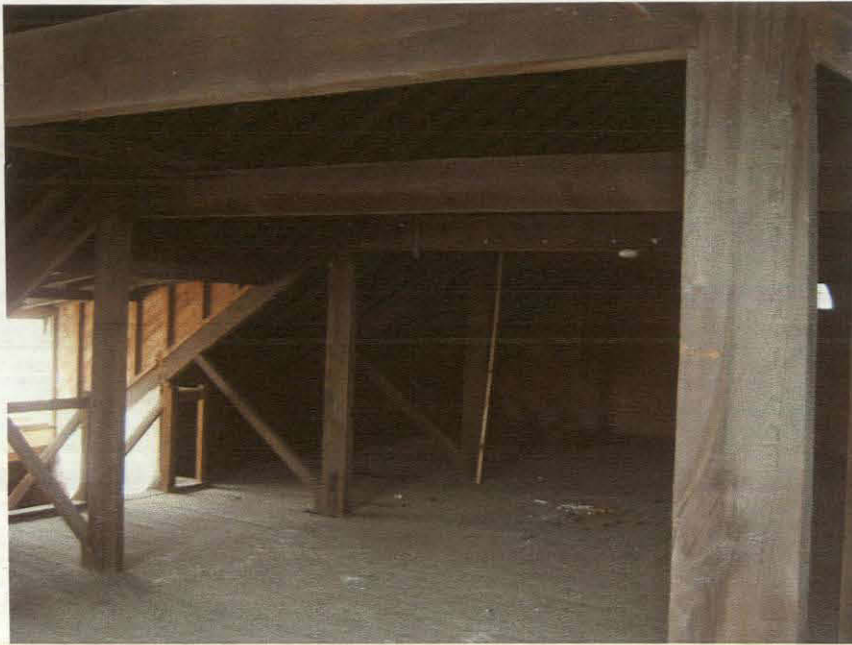
Photograph Number 14
Shows trusses at second floor and the exiting dormer and stair well.
Trusses to be retained and dormer modified in height only to provide additional headroom.

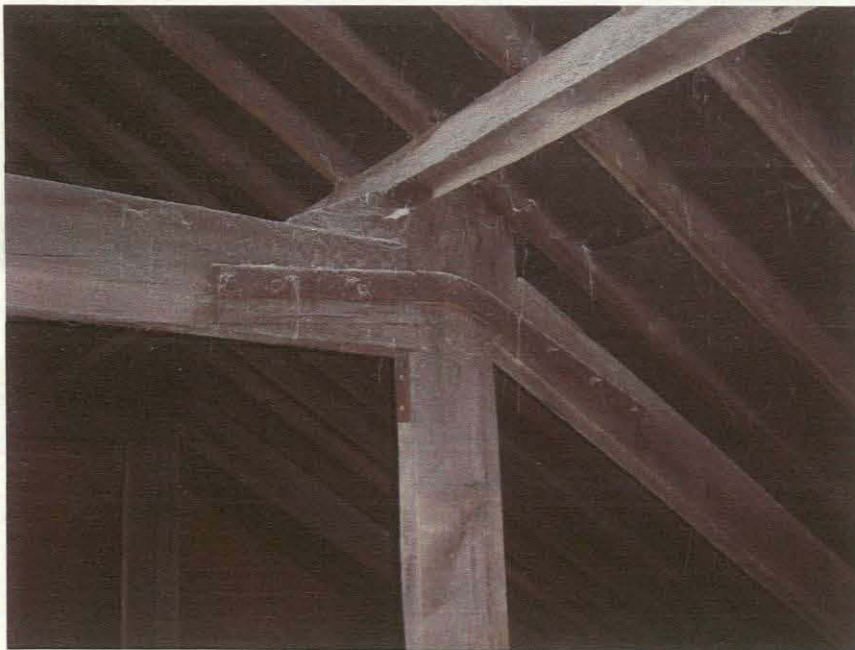
Photograph Number 15
Shows junction between truss and purlins at second floor level.

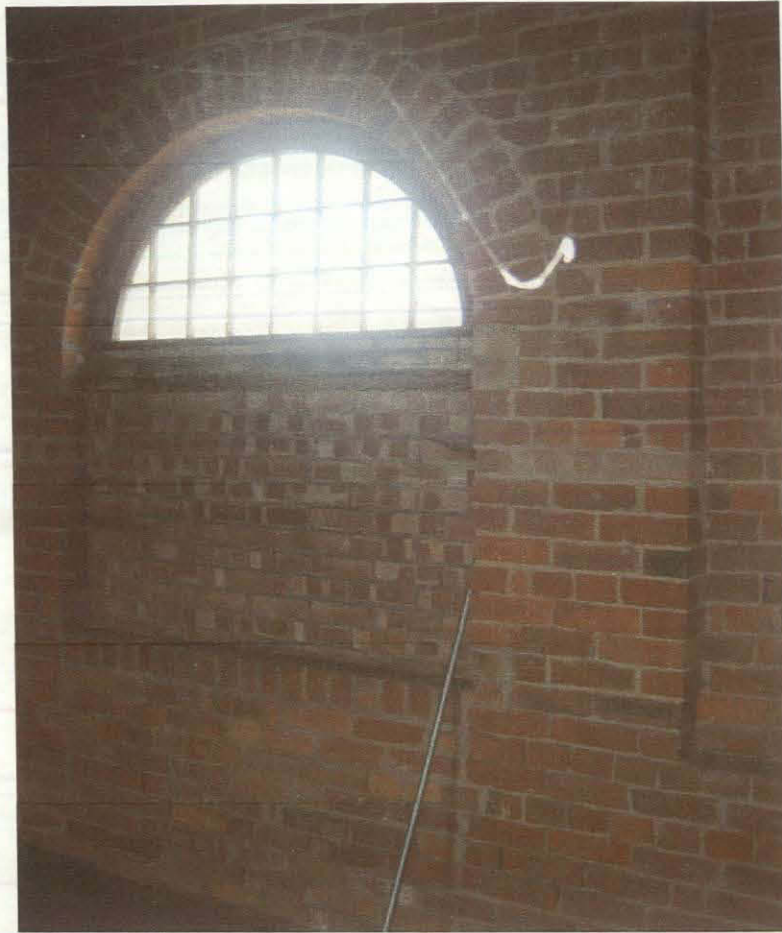
Photograph Number 16
Shows existing openings on rear elevation.
Window openings to be reformed to existing sill level in this development.

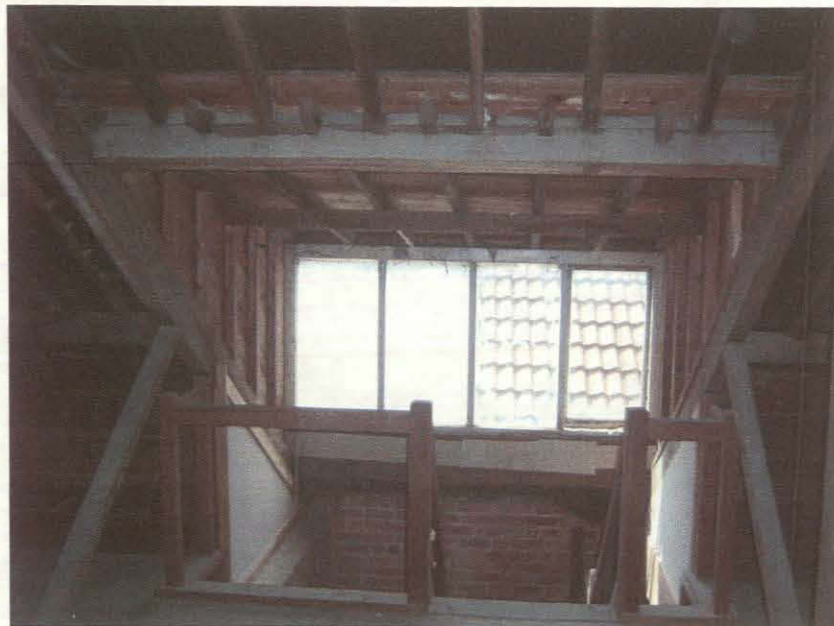
Photograph Number 17
Shows existing dormer above stair well.
