Historic Building Report

Proposed conversion of granary to provide living accommodation and extension to dwelling.

South View Farm
South View Lane
South Cockerington
Louth
Lincolnshire
LN11 7ED

Tom Cannon BSc(Hons)
For and on behalf of CDC Architecture Limited

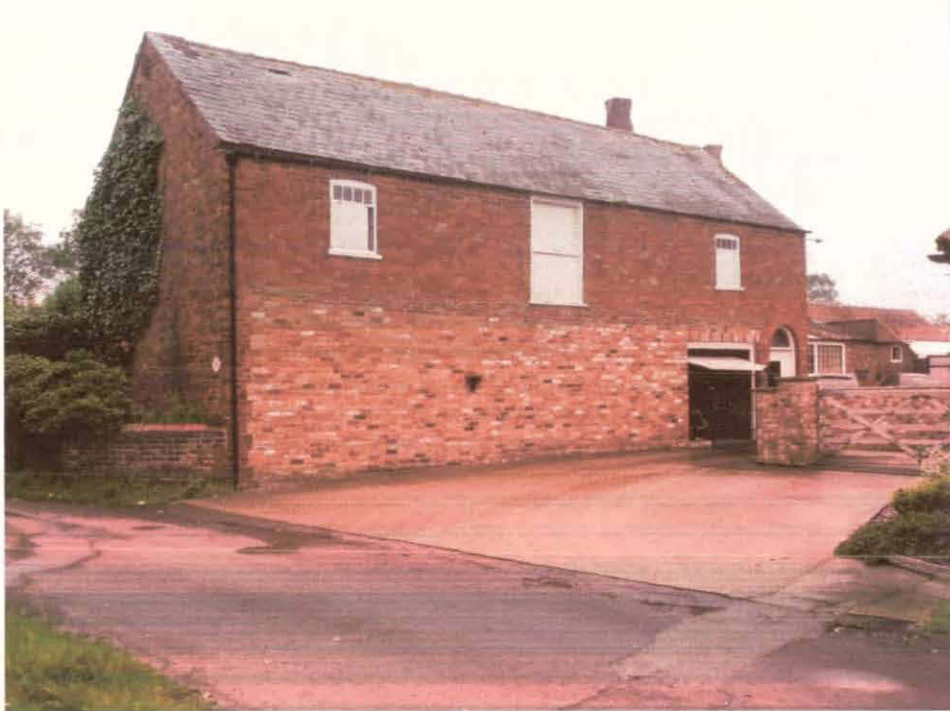
It should however be noted that there appears to be an outward 'lean' at the top of the middle section of the East facing wall. There is a gradual outward 'bow' to the brickwork that is most severe to either side of the first floor loading door. It is possible that this has been caused by gradual settlement caused by the weight of the roof structure, and could be the reason why 'remedial' timber ties have been added at the middle section of the roof.

i) East elevation as viewed from South View Lane

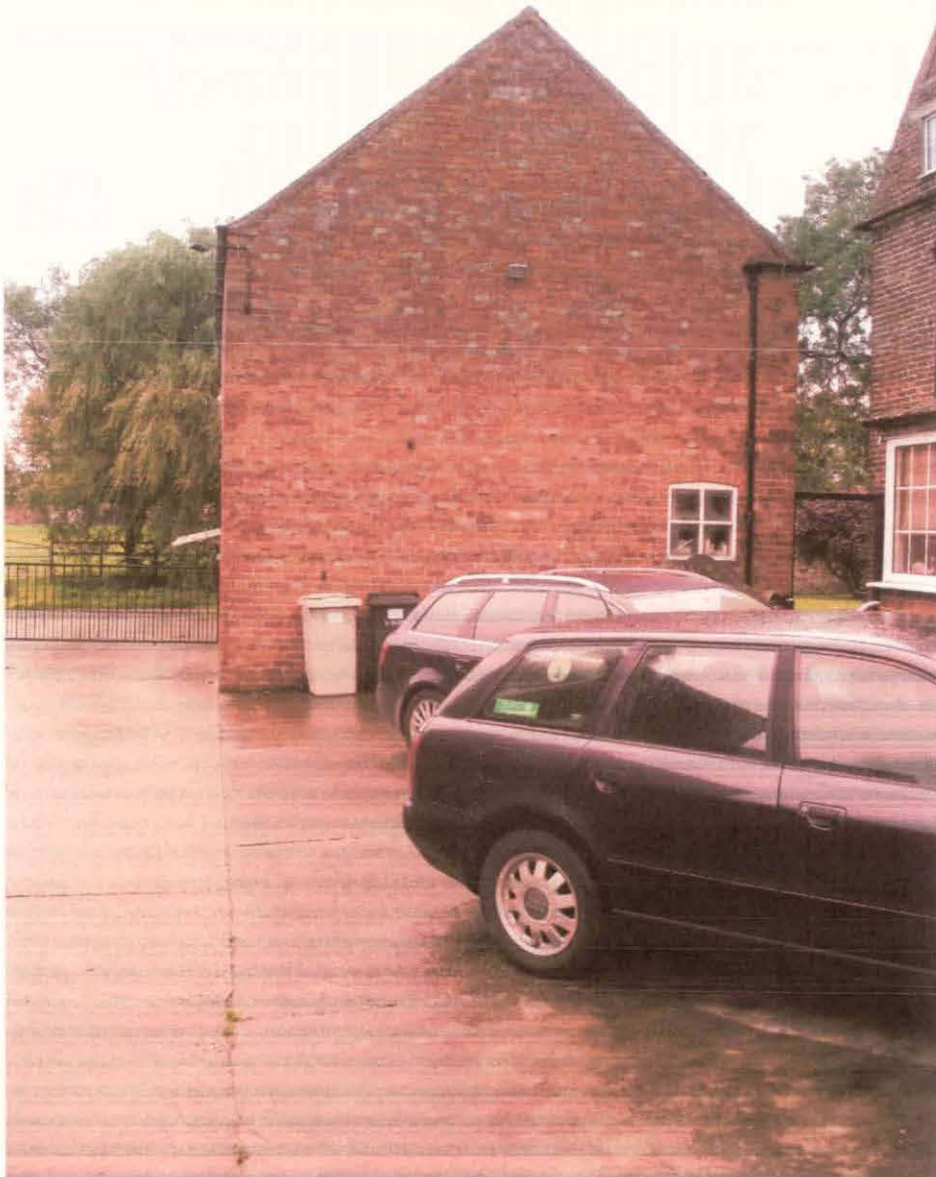
iii) North elevation

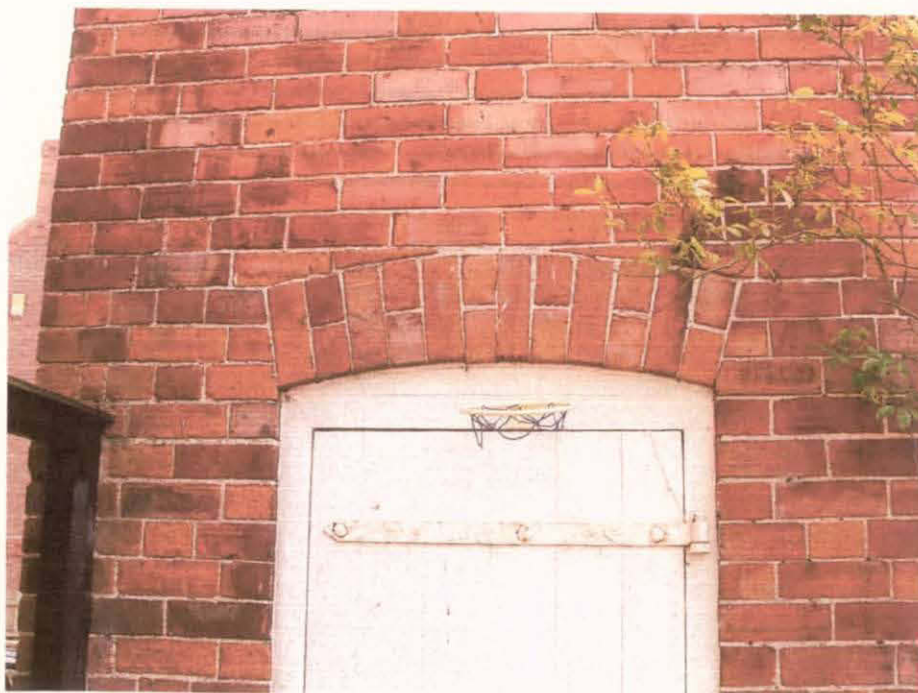
v) Detail – brick arch above West facing door

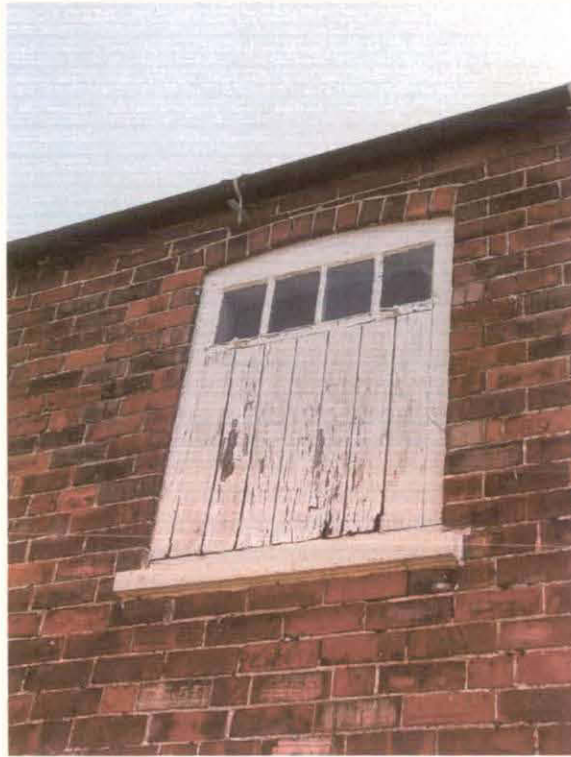
The windows to the first floor, first and foremost, are to provide ventilation and air movement – an important requirement for when the building functioned as a granary. These are tall rectangular windows, with only the top most section glazed, the remainder being a top-hung timber shutter to allow variable amounts of ventilation. The first floor also has a wide single leaf loading door ('stable' type, with top and bottom sections hinged separately) on the East Elevation. It should also be noted that there were 2 first floor windows on the south elevation but these have at some point been neatly bricked up.

- vi) First floor shuttered ventilation window.

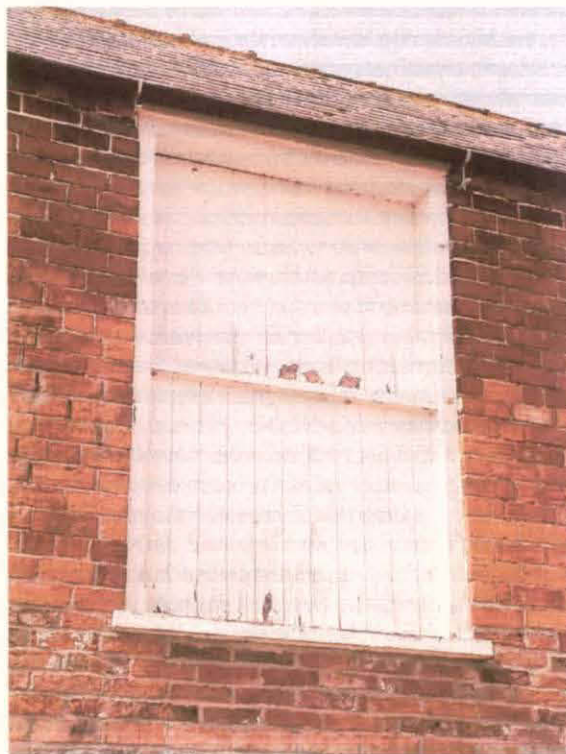
- vii) First floor loading door.

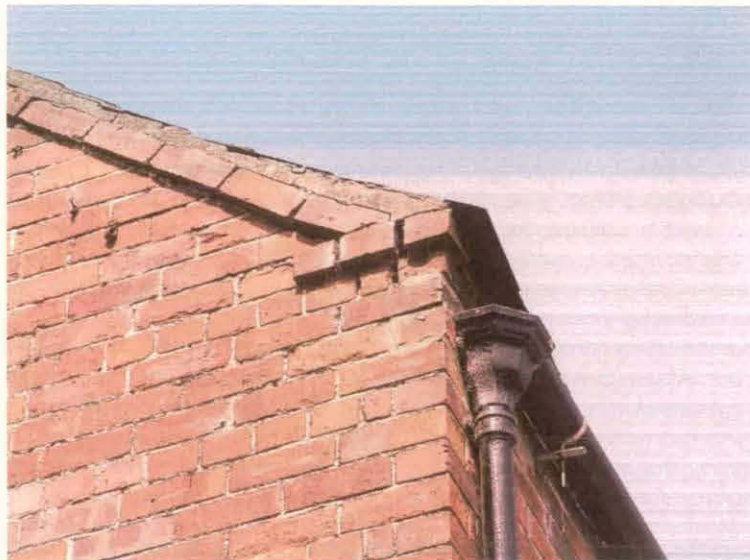
viii) Detail - Eaves and Verge

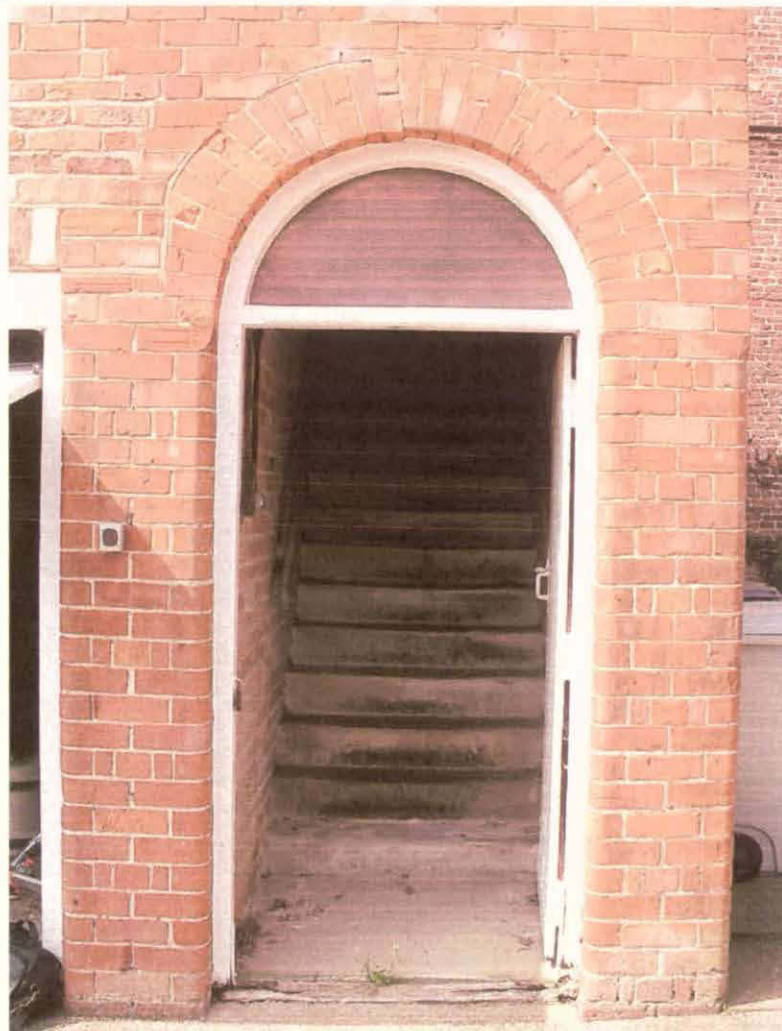
ix) East facing door giving access to granary stairs

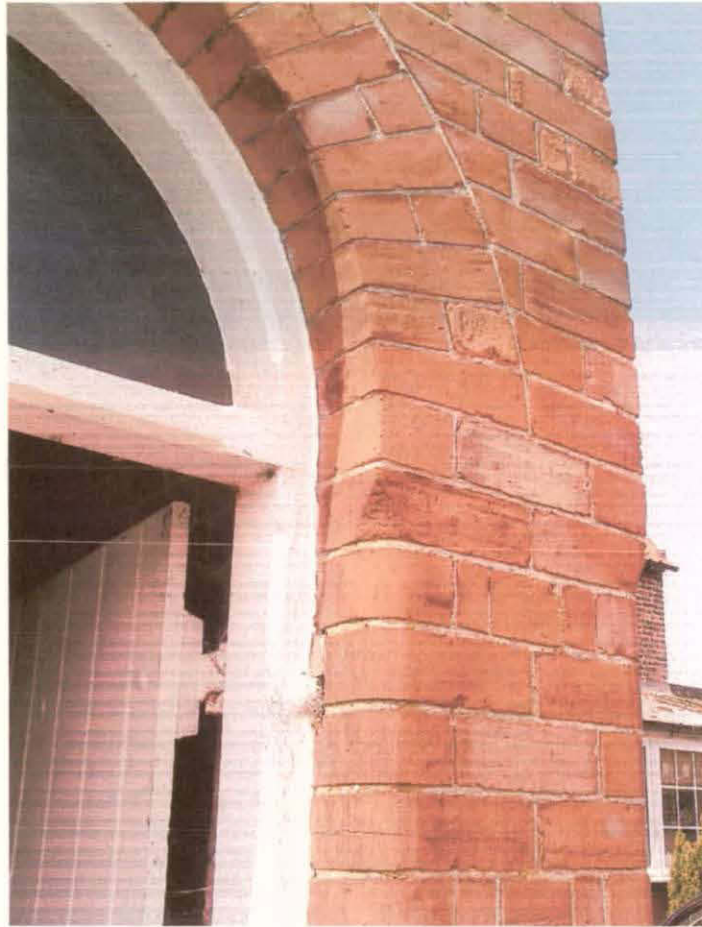
- x) Detail – East facing door showing bullnosed bricks and stop-chamfered door frames.

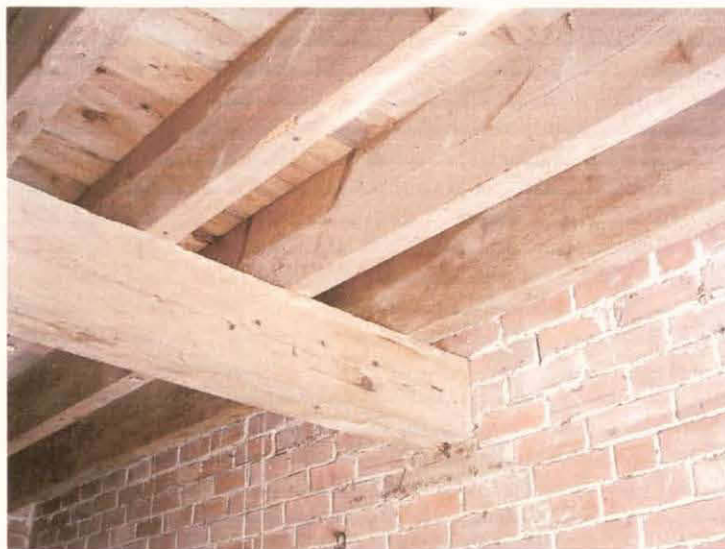
- xi) Floor joists above garage

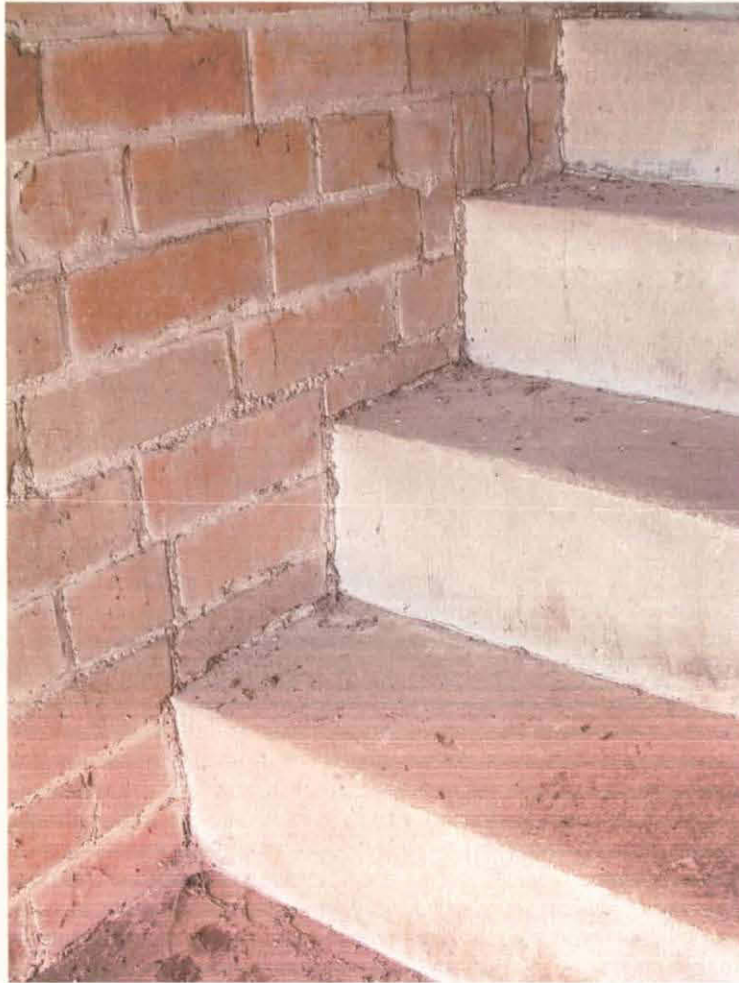
The first floor is accessed by a straight flight of solid stone stairs. These appear solid and unembellished, with the tooling marks being visible. A simple solid timber handrail is provided to one side, fixed directly to the brickwork. This is continued at the first floor 'landing' area to provide a simple ballustered guardrail.

- xii) Detail – solid stone stairs showing tooling marks

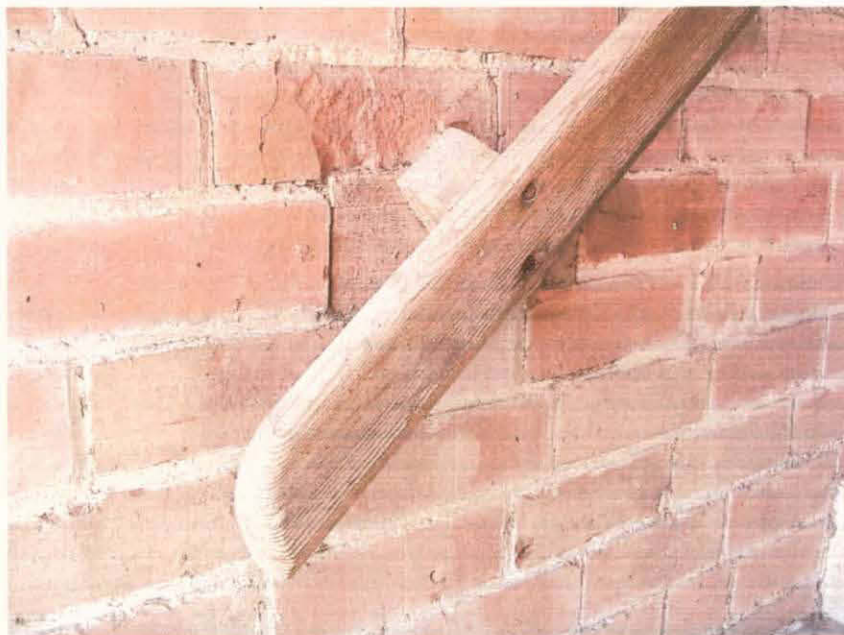
- xiii) Detail – stair handrail

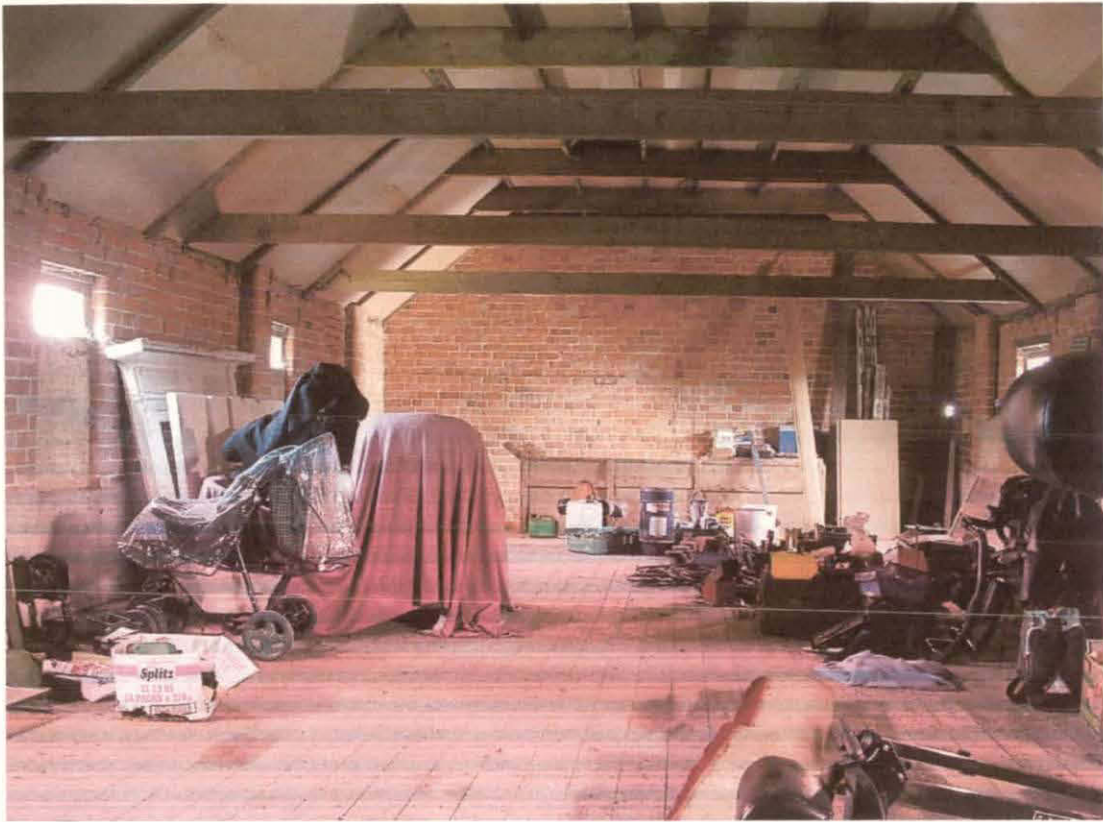
xiv) First Floor interior looking towards North Gable

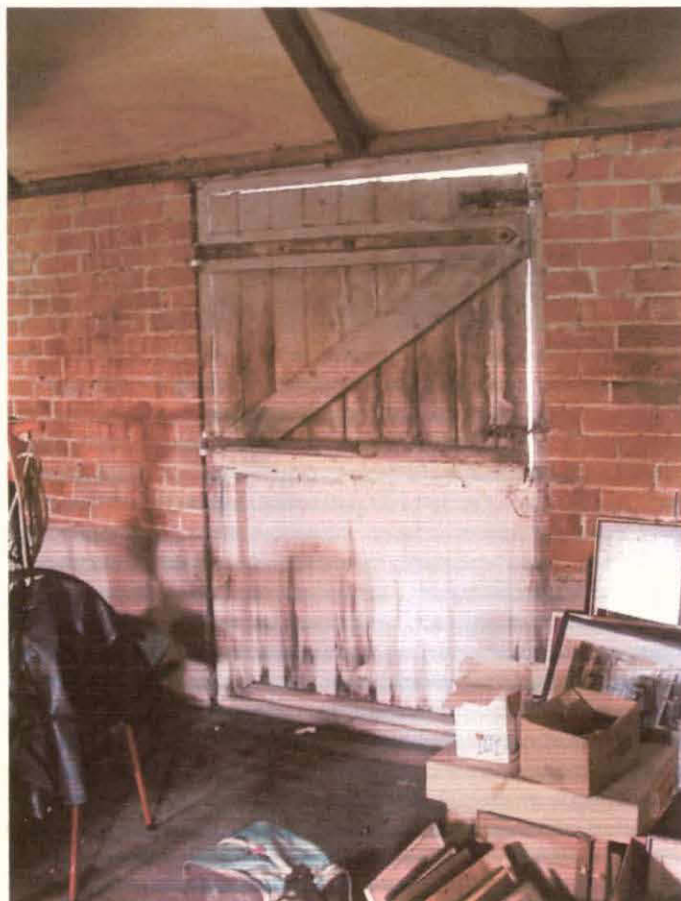
xv) Loading door viewed from inside.

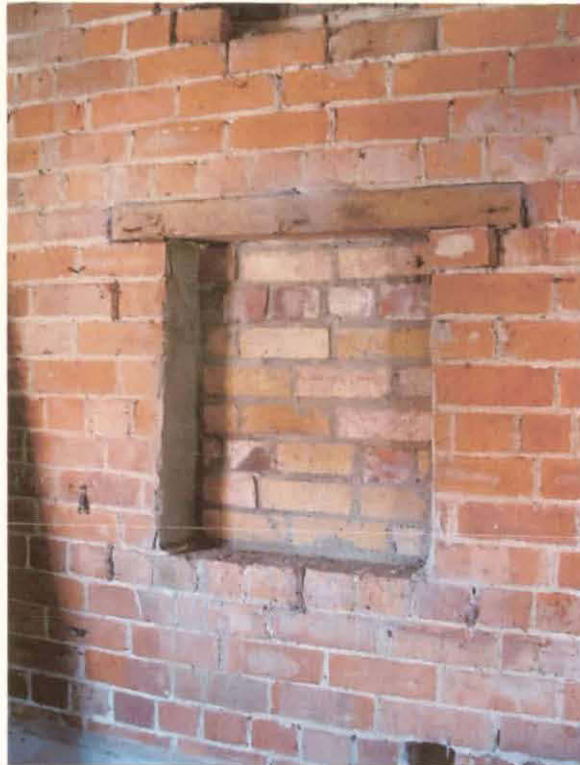
- xvi) Window (1 of 2) in South gable bricked up, timber internal lintel left in place.

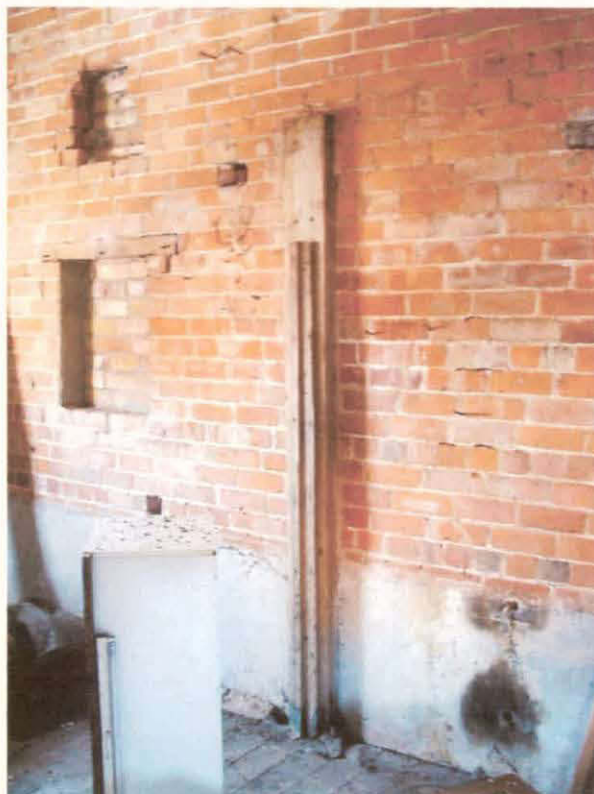
- xvii) Retaining rail for grain boards.
