Historic Building Recording

**Tattershall Lodge
11 Market Place
Tattershall
Lincolnshire
LN4 4LQ**

Change of use to Chinese Restaurant
Planning Approval Reference S/175/01557/08
Grid Reference: Easting 521213, Northing 357863

Project No. 07022

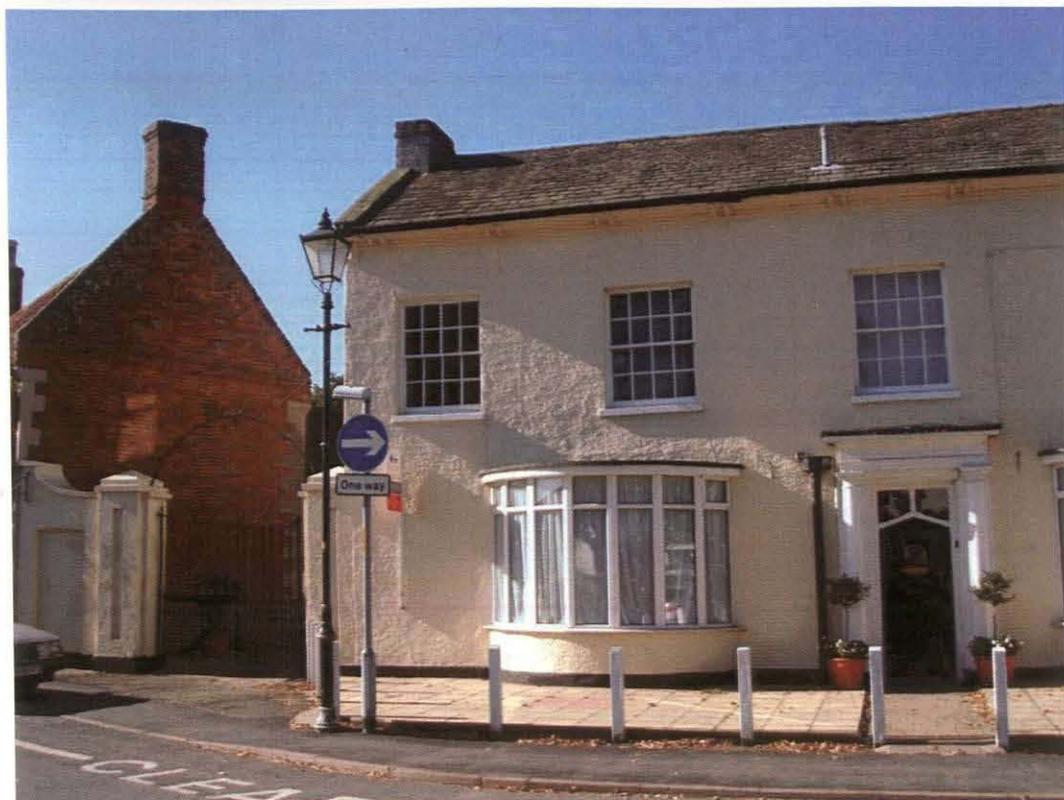
Photo 3 Front Elevation showing gates & No.10

Note: photo 3 was taken at an earlier date but is used in the report to show how No. 11 relates to No 10 and shows the first floor sash windows quite well.

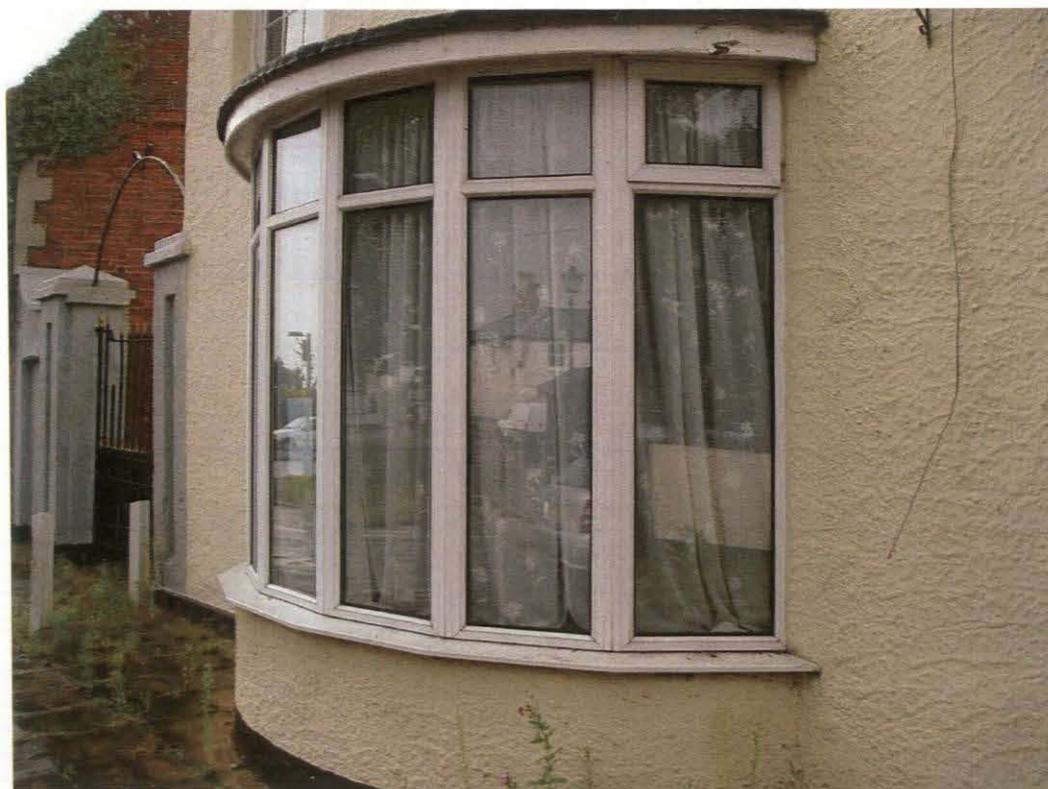
Photo 4 Semi-Circular Bay Window

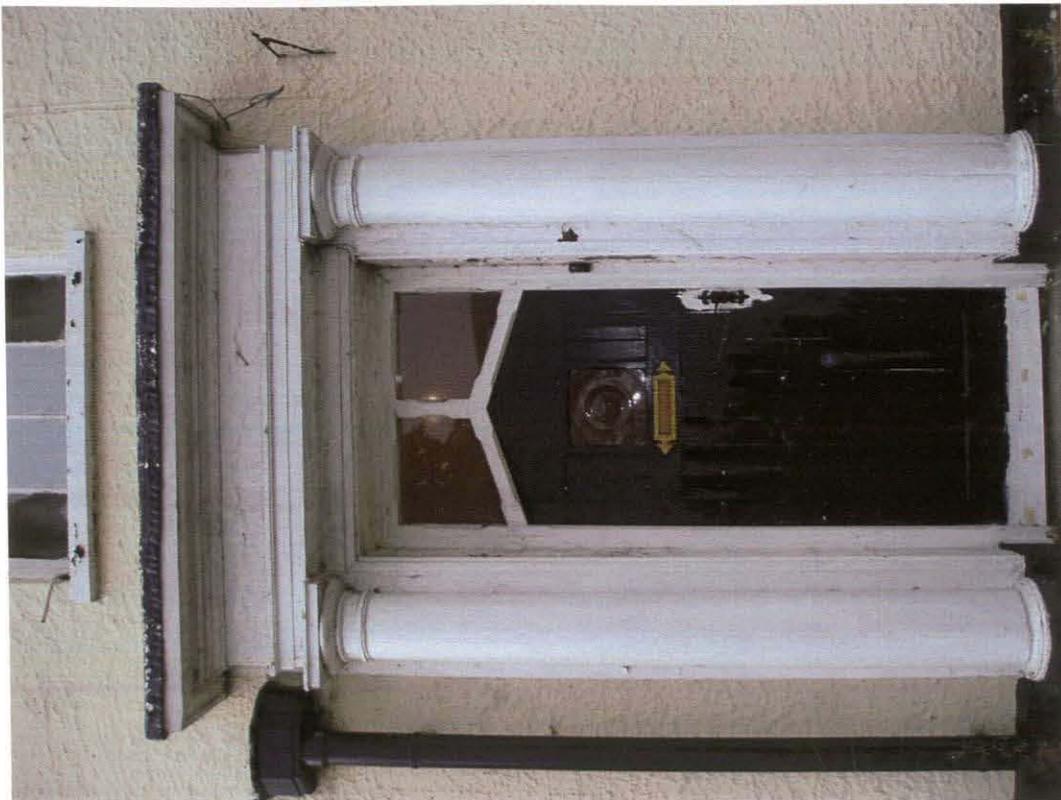
Photo 5 **Front Entrance Door**

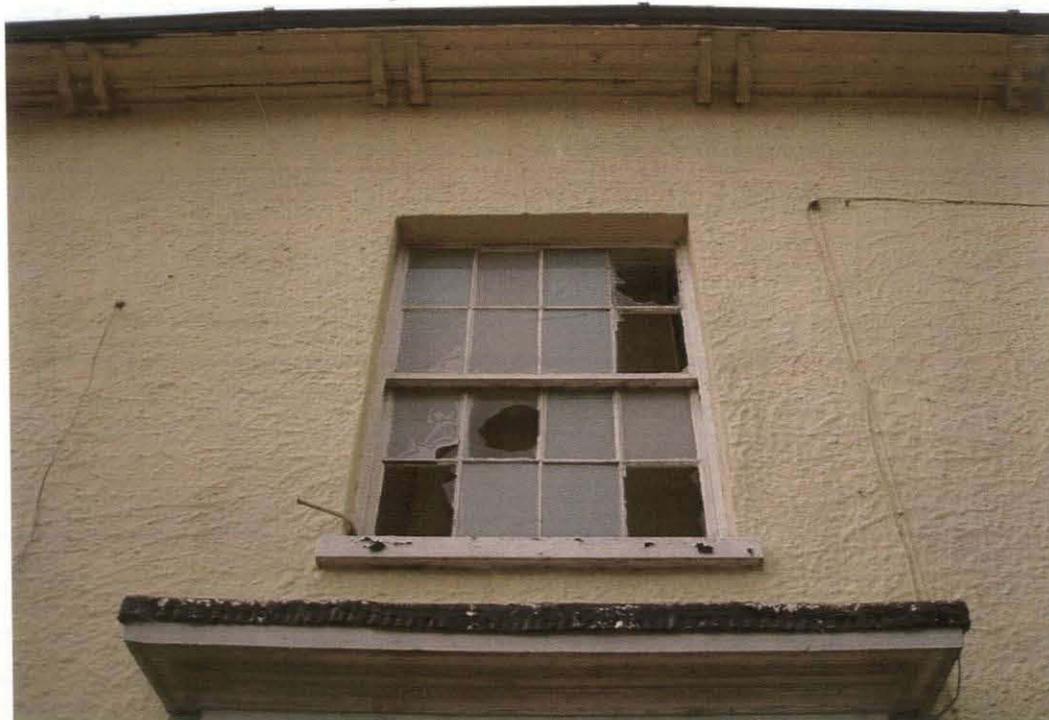
Photo 6 **Sash Window Front Elevation**

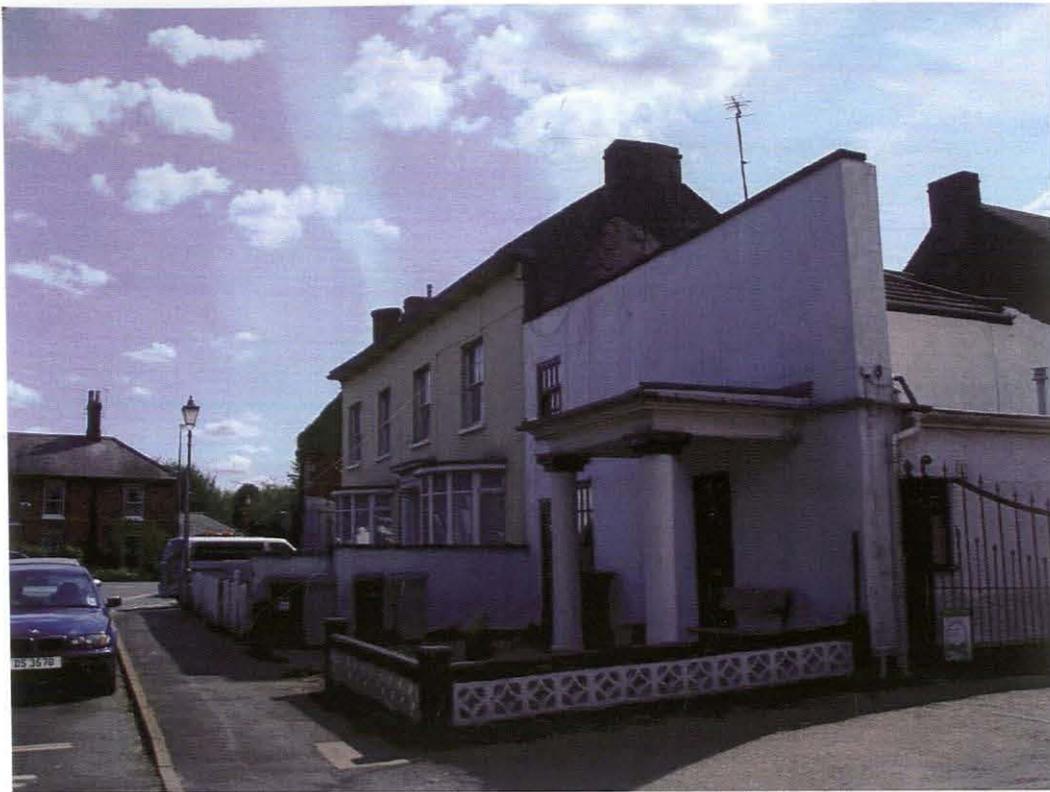
Photo 7 Side Elevation from No. 12

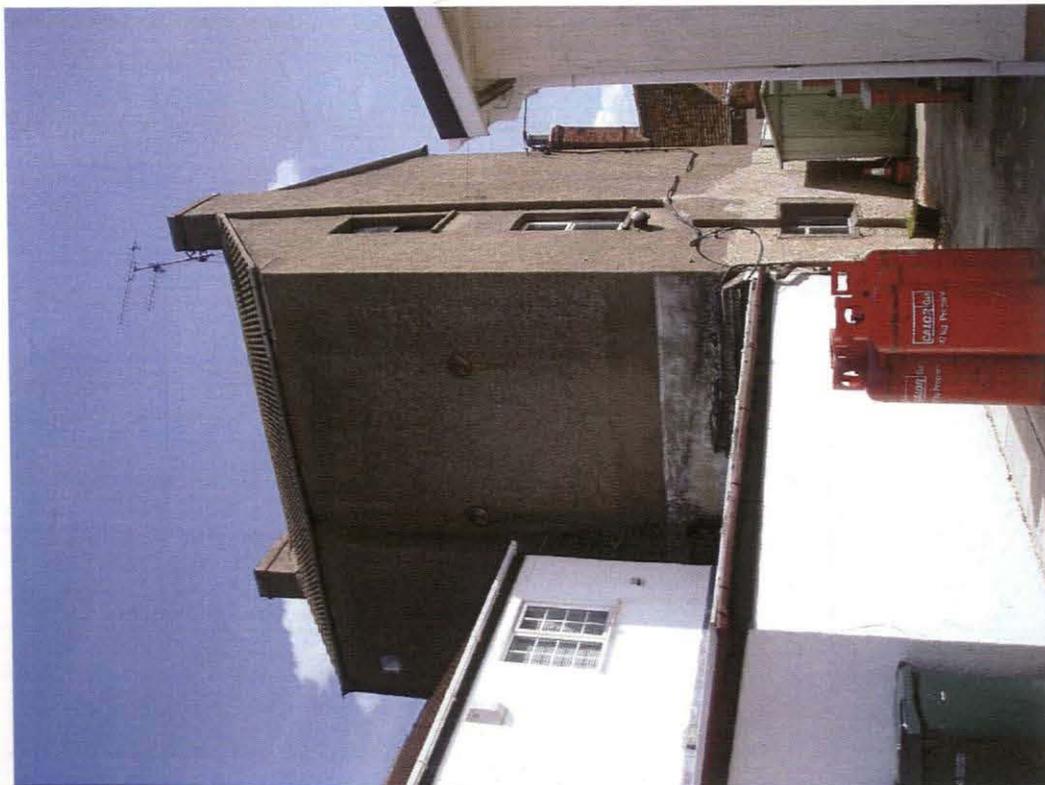
The furthest rear part of the building is a full three storeys high (beds 6, 7 & upper living), with its ridge running the opposite way to the front roof. The gable ends do not have parapets but they do have central chimney stacks like the front chimneys. The roof space above the 3 storey element is low and has a very small loft hatch therefore inspection of this roof structure was not carried out. (See photos 8, 9, 10, 32, 33, 34 for this part of the building)

Photo 8 Side & Rear Elevation of 3 storey element from Lodge Park driveway

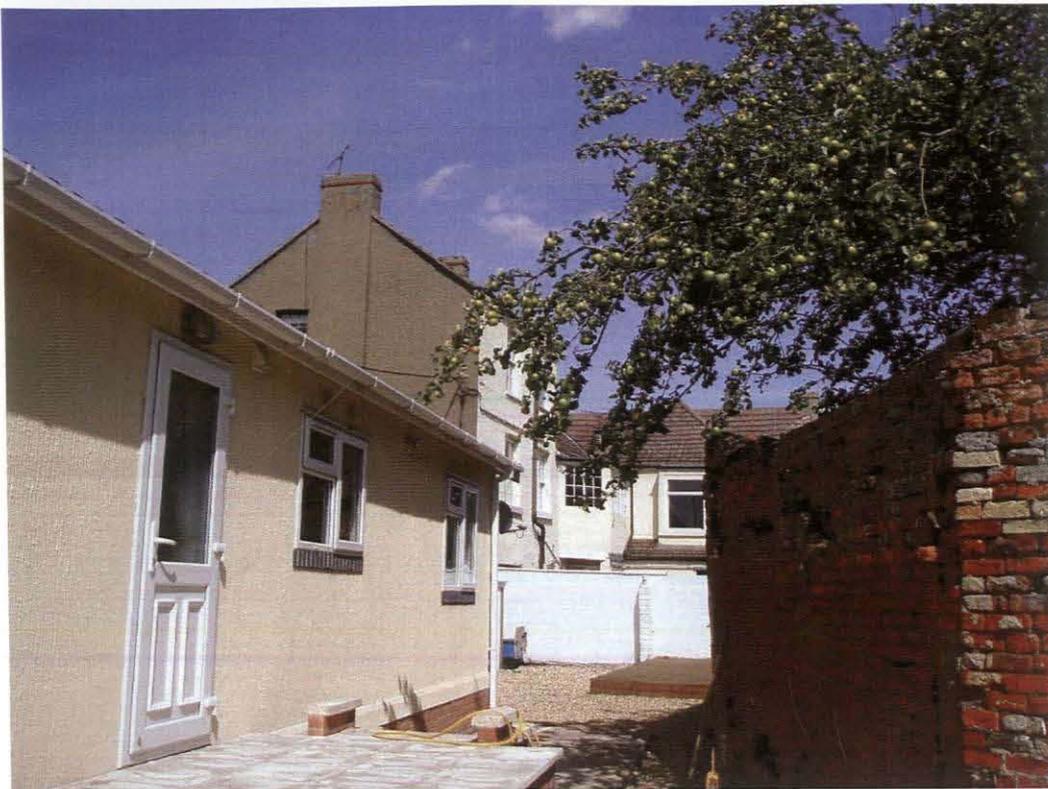
Photo 9 Rear Elevation as viewed from No. 1 Lodge Park

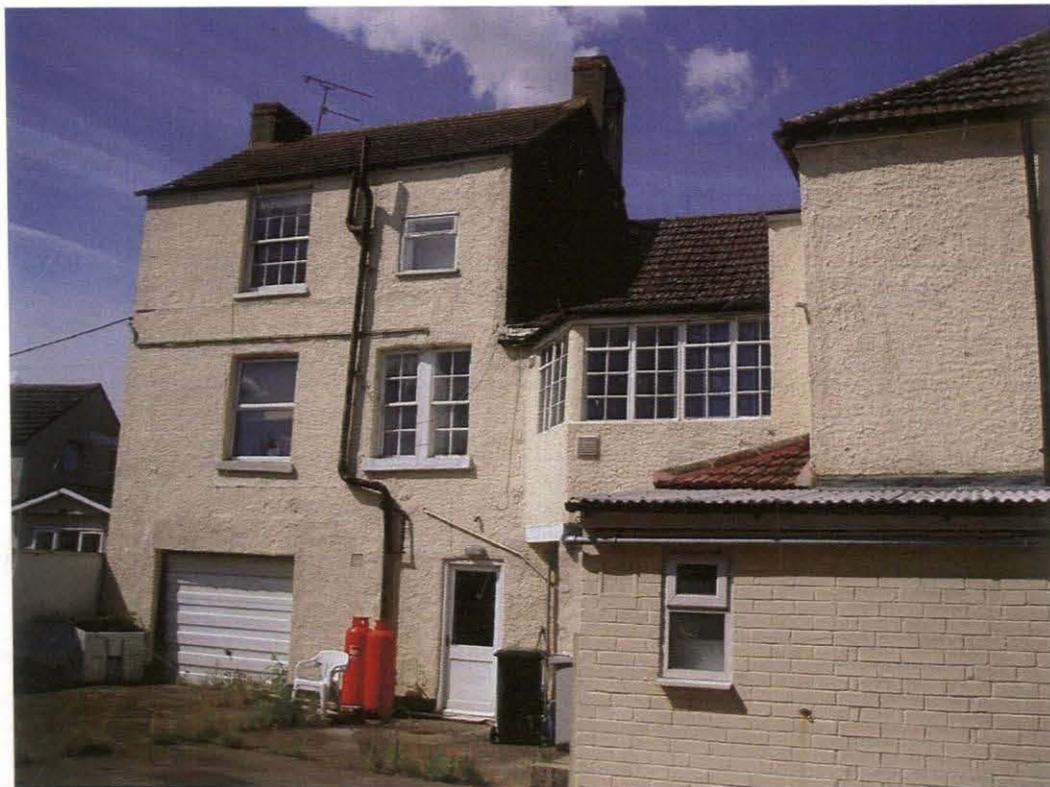
There is also a flat roofed projection to the first floor living room creating a large window flying over a kitchen extension below, also a small flat roofed projection to bedroom 3 containing a window (see photos 10, 11, 12).

Photo 10 Side Elevation as viewed inside Yard

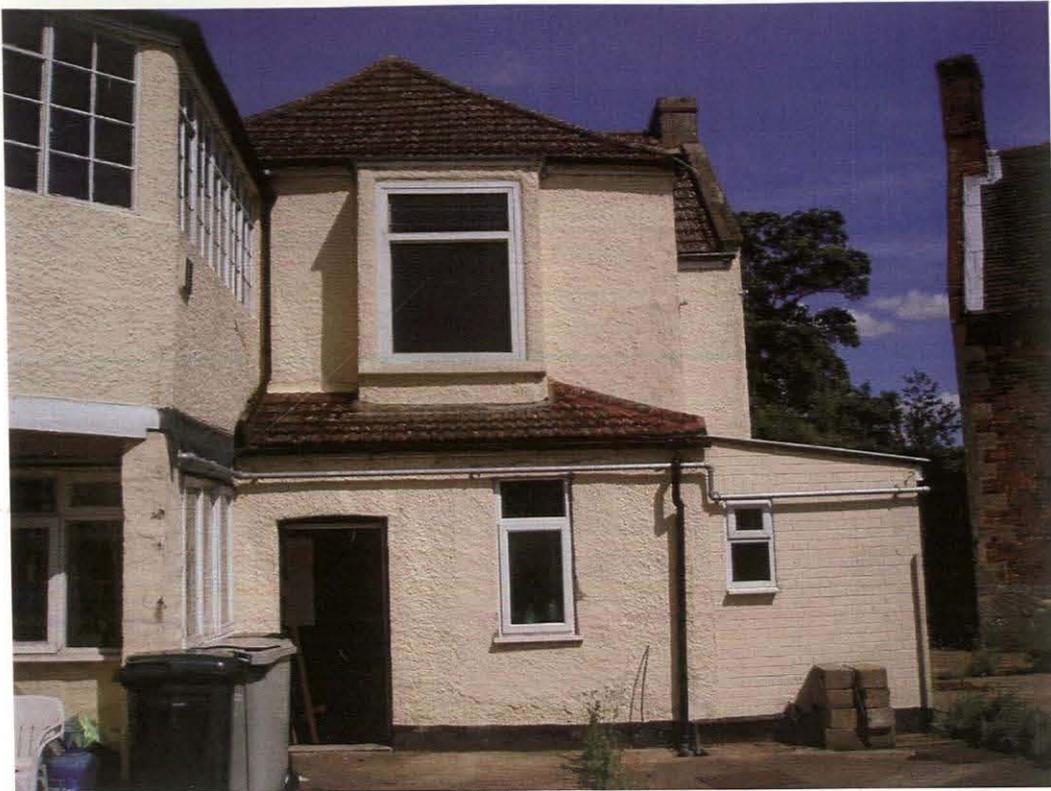
Photo 11 Rear Elevation as viewed inside Yard

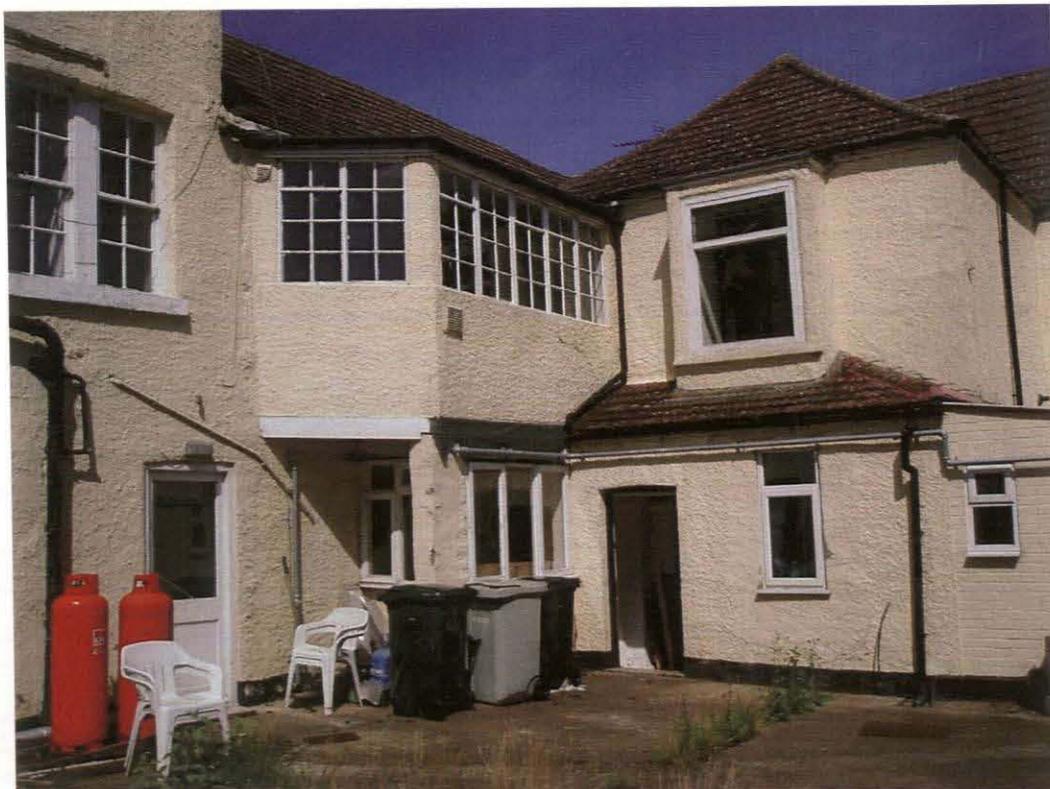
Photo 12 Rear & Side Elevation as viewed inside Yard

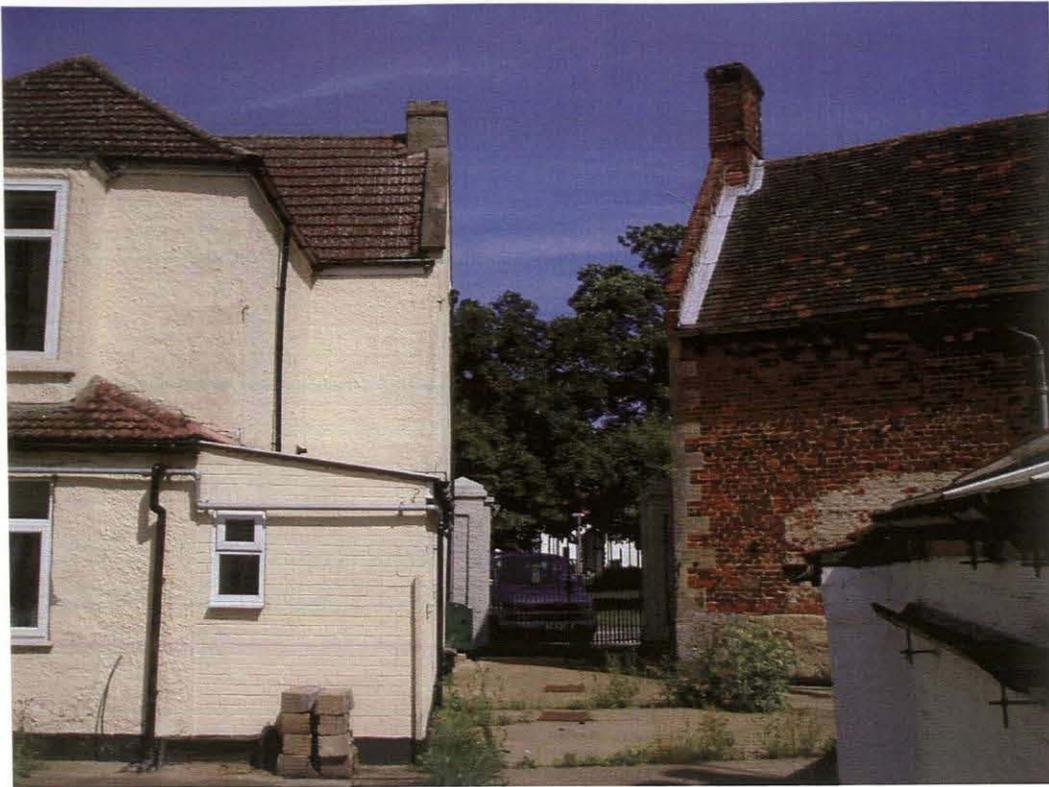
On the south side is a very basic modern single storey toilet extension, built half brick thick in stretcher bond, painted cream to match the render with a wiggly tin roof (see photos 13 & 14).

Photo 13 Rear Elevation from inside Yard also showing gates & No. 10.

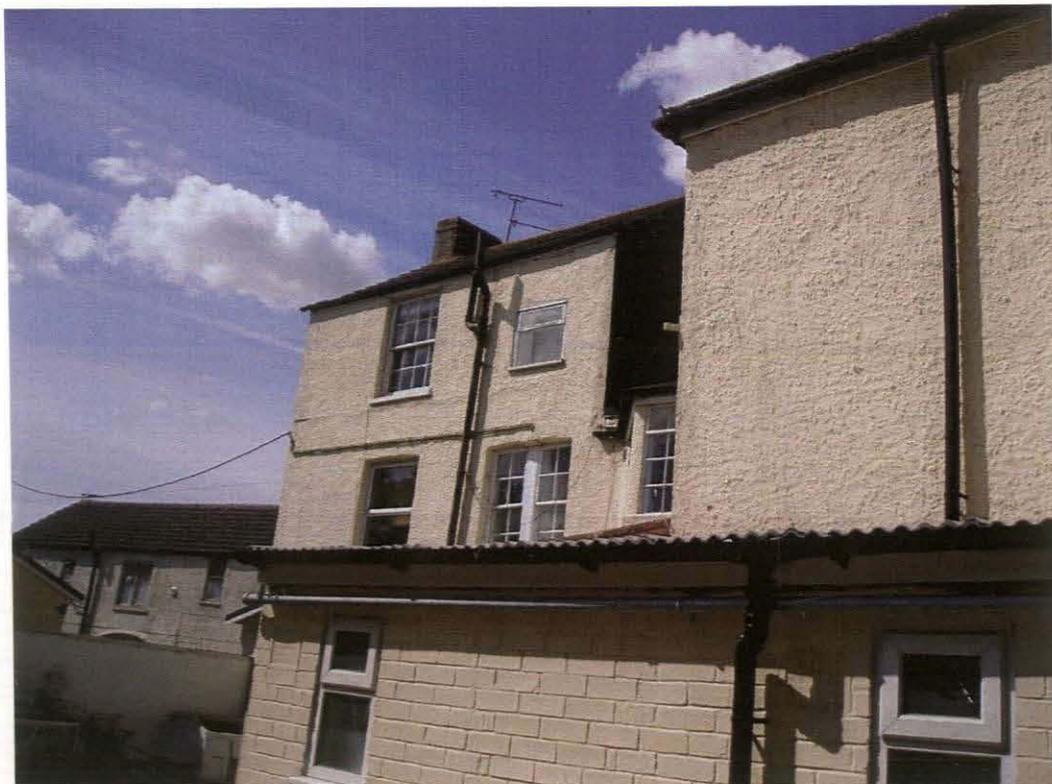
Photo 14 Side Elevation from inside Yard

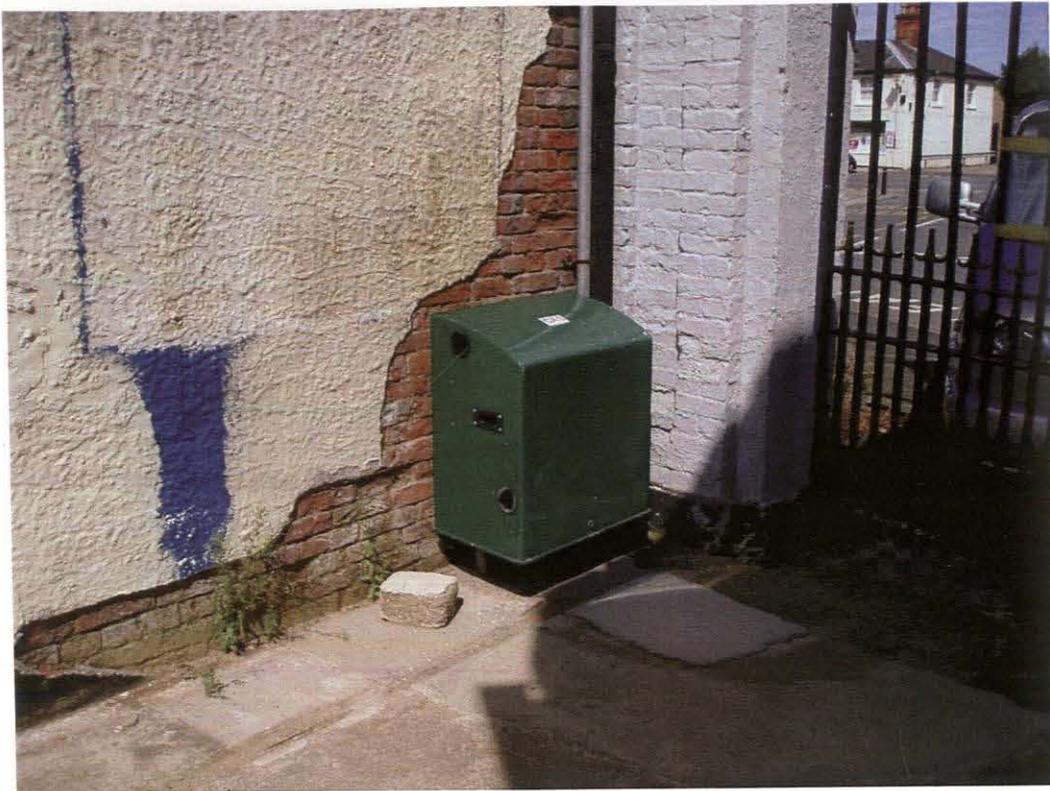
Photo 15 Wall where render removed near gate

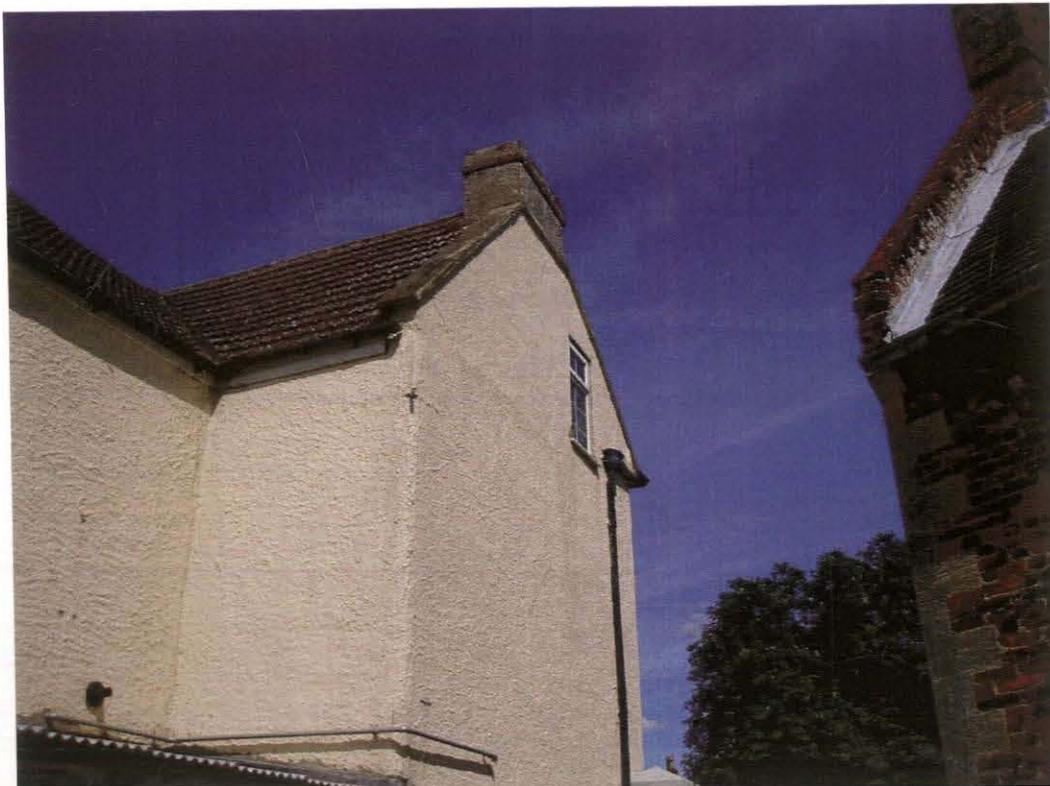
Photo 16 Gable End Attic Window

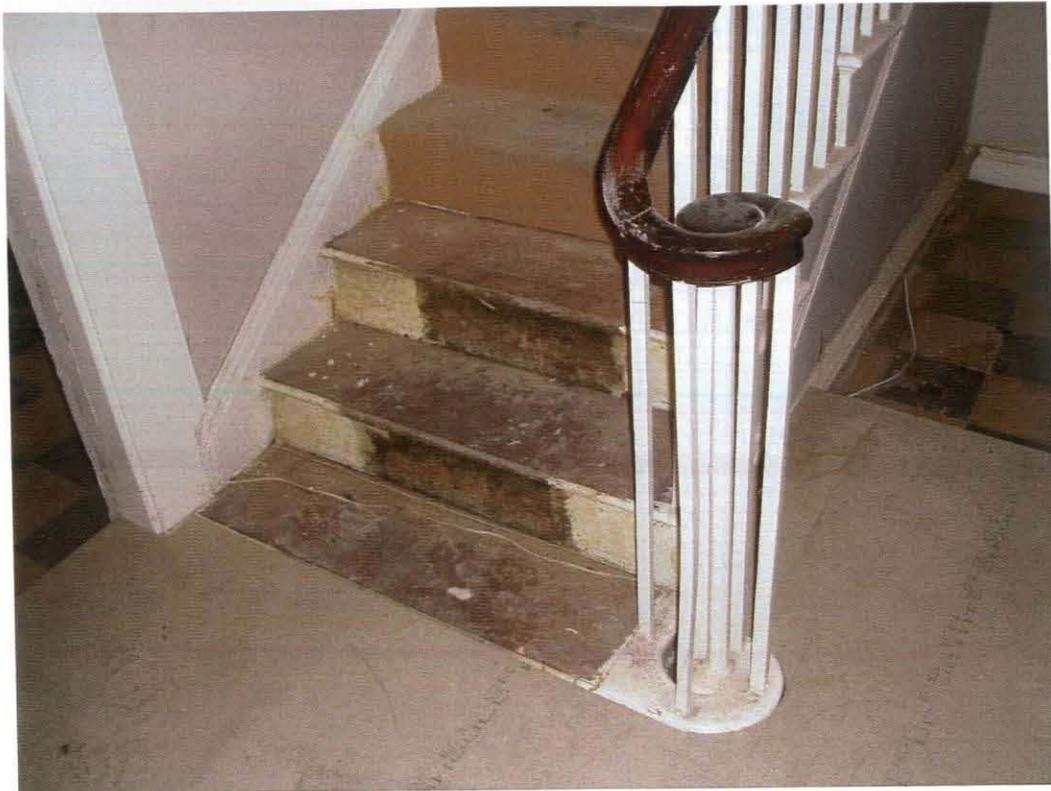
The staircase is one of the best features of the building but even this does not have the original timber spindles – they have been replaced with metal but they are in the same plain style. (See photos 17, 18, 28).

Photo 17 **Staircase**

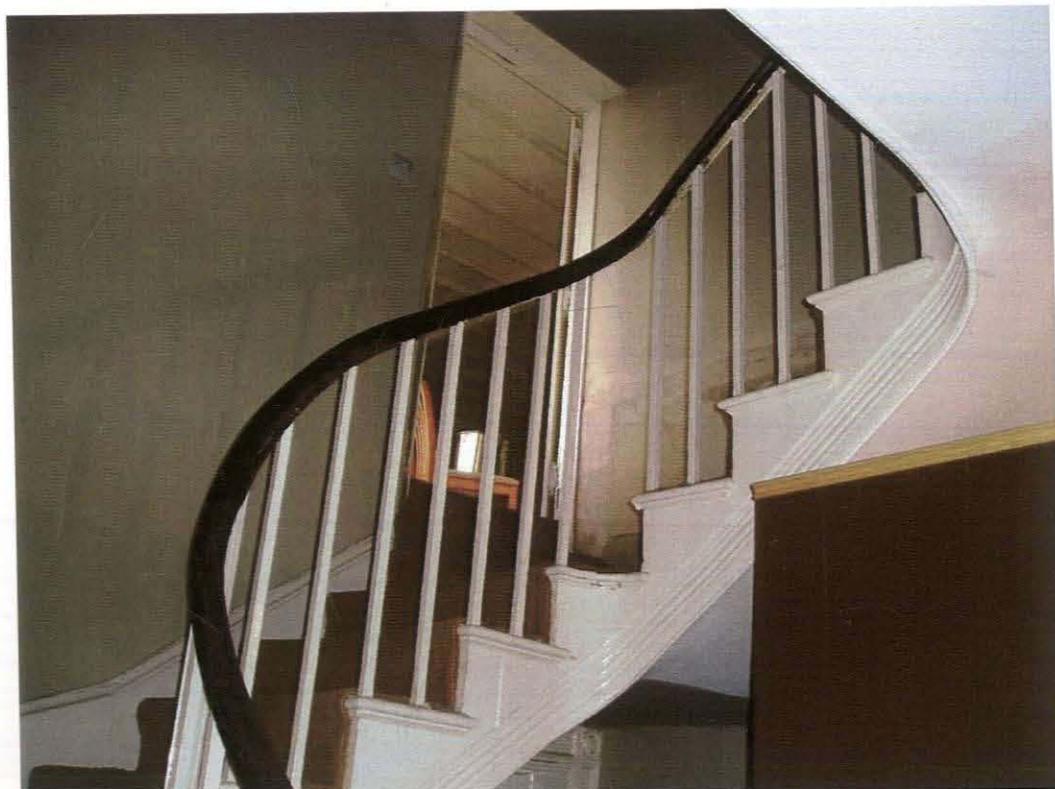
Photo 18 **Staircase**

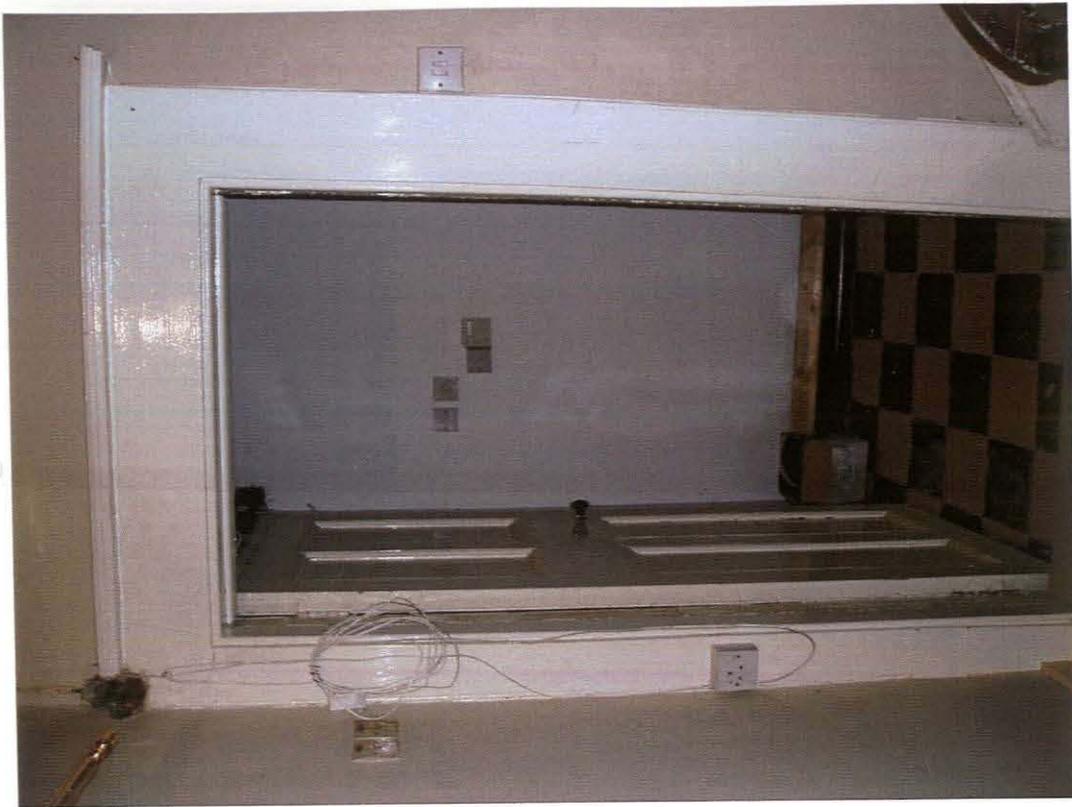
Some of the old internal doors still remain in place. Some are 4 panelled with door knobs, others boarded ledged and braced with latches. (See photos 19, 30, 31, 32)

Photo 19 Internal door at bottom of stairs

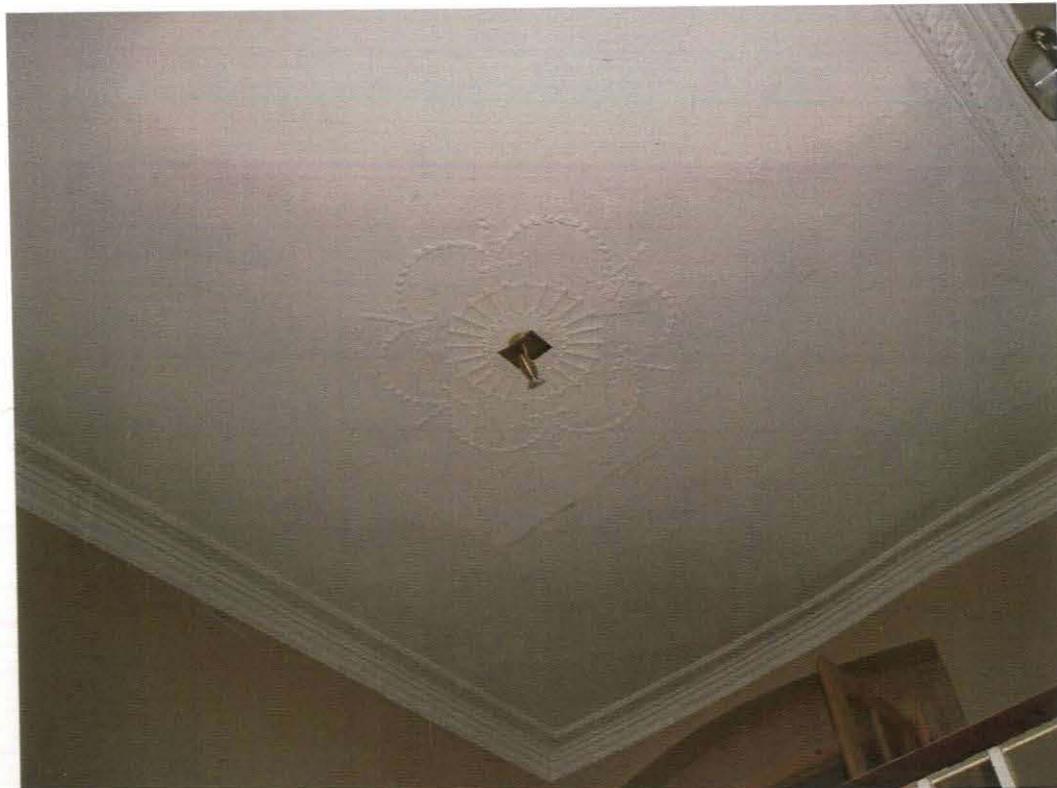
There are some decorative ceiling roses. (See photos 20, 21 27)

Photo 20 Ceiling rose above staircase

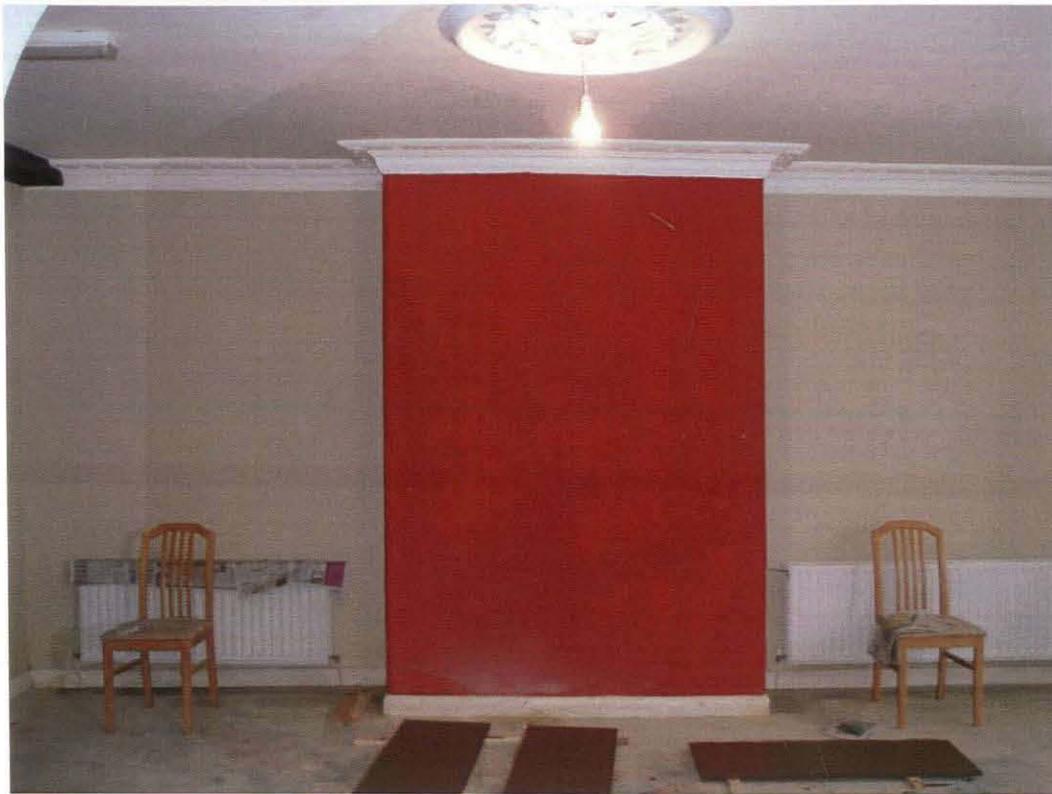
No original fire places remain. All fireplaces are covered over apart from the upstairs living room which is an open fireplace with an exposed brick chimney breast that looks like a fairly modern re-build. (See photos 21, 29, 31, 33).

Photo 21 **Restaurant Area**

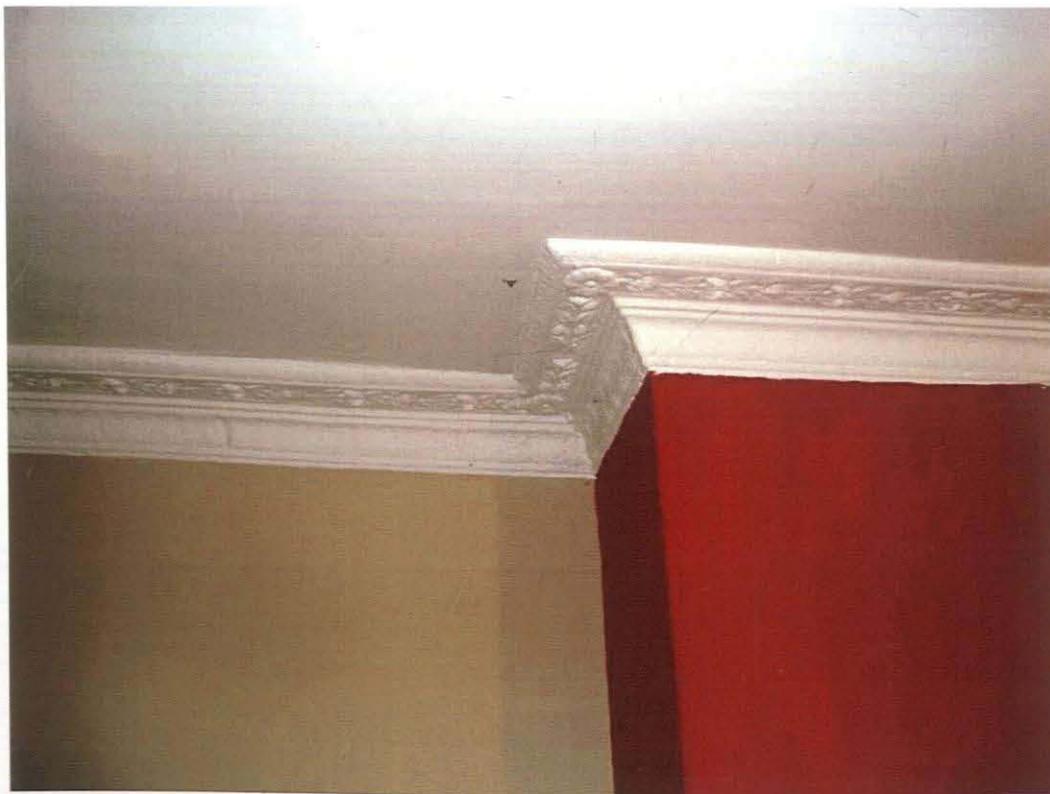
Internally very few original features remain. There are some original cornices but the styles vary and no cornices are complete around the whole room. Some of the cornices project onto the ceiling as well as onto the wall. (See photos 20 – 25)

Photo 22 **Restaurant Area Cornice**

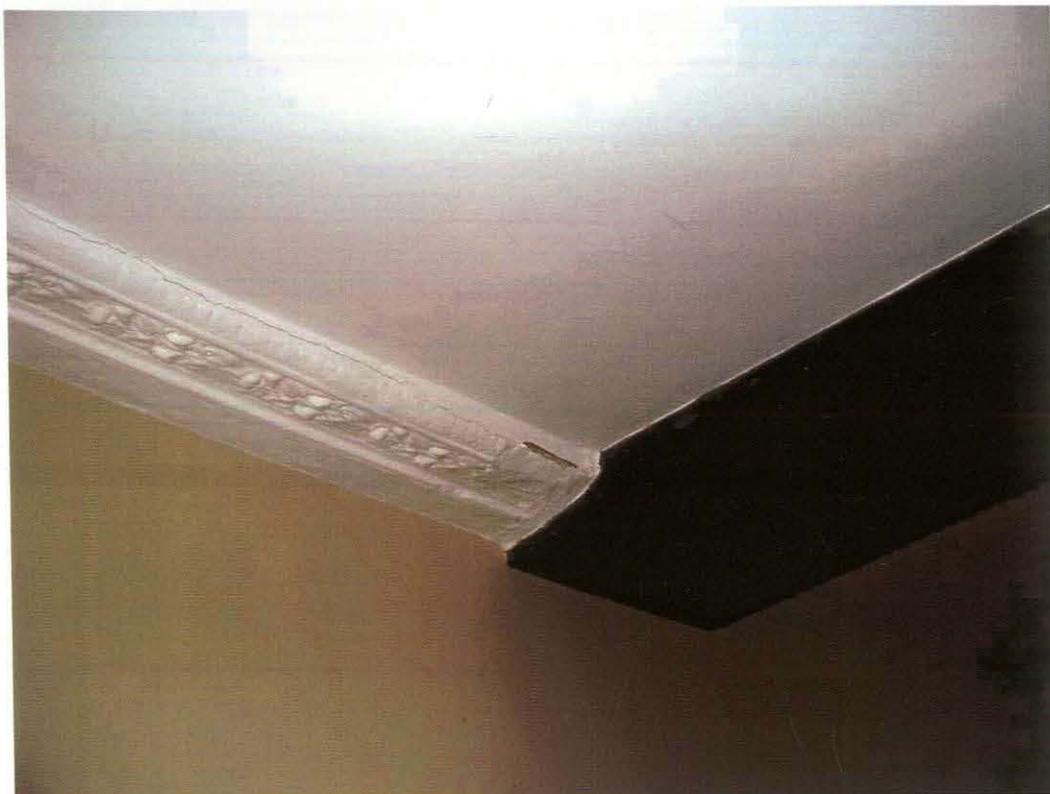
Photo 23 **Restaurant Area Cornice**

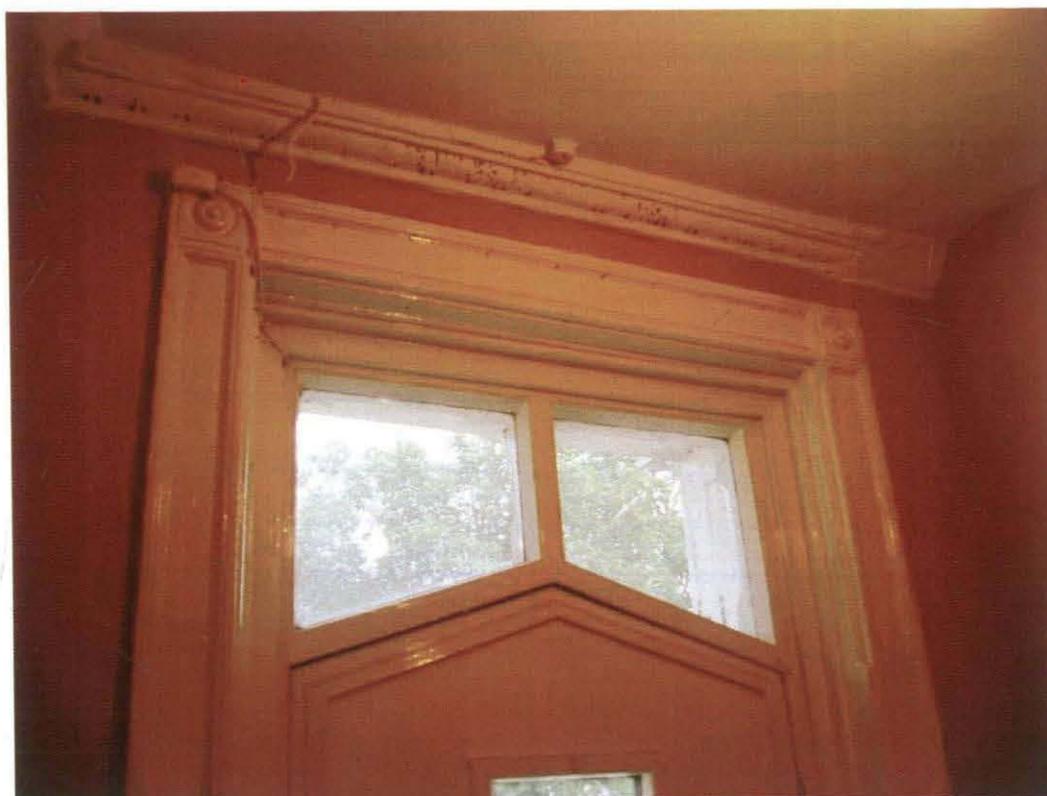
Photo 24 **Inside view of Front Entrance Door, surround & cornice**

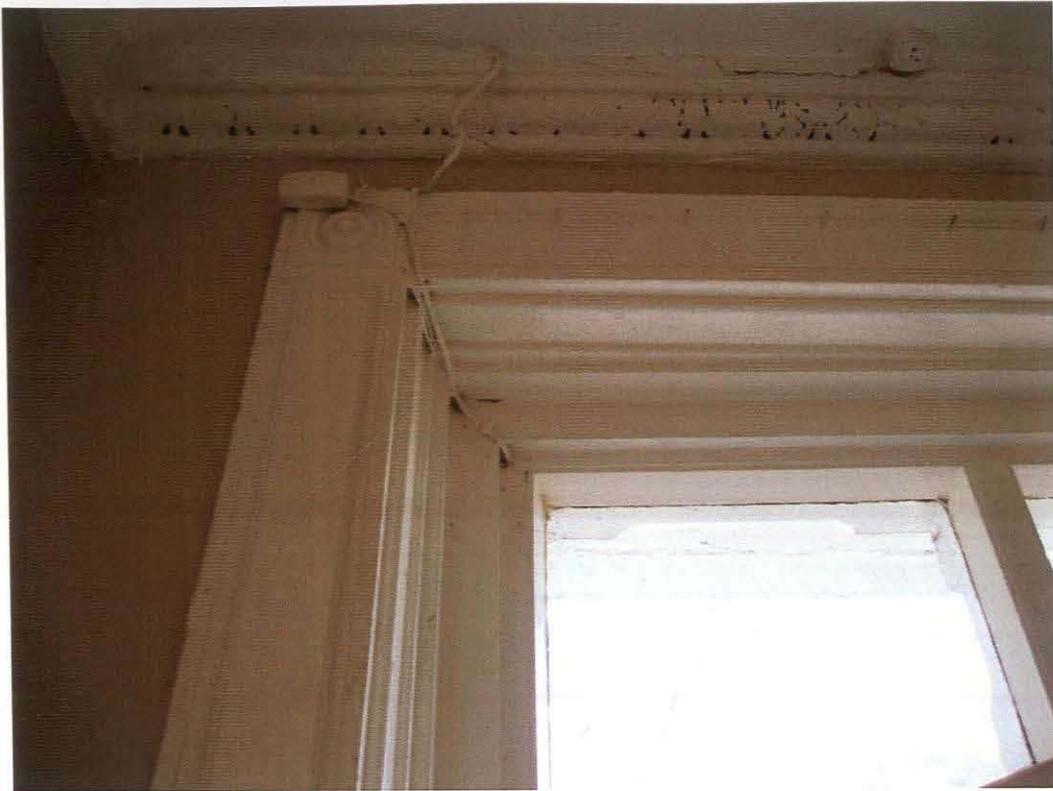
Photo 25 Front door surround & cornice internal detail

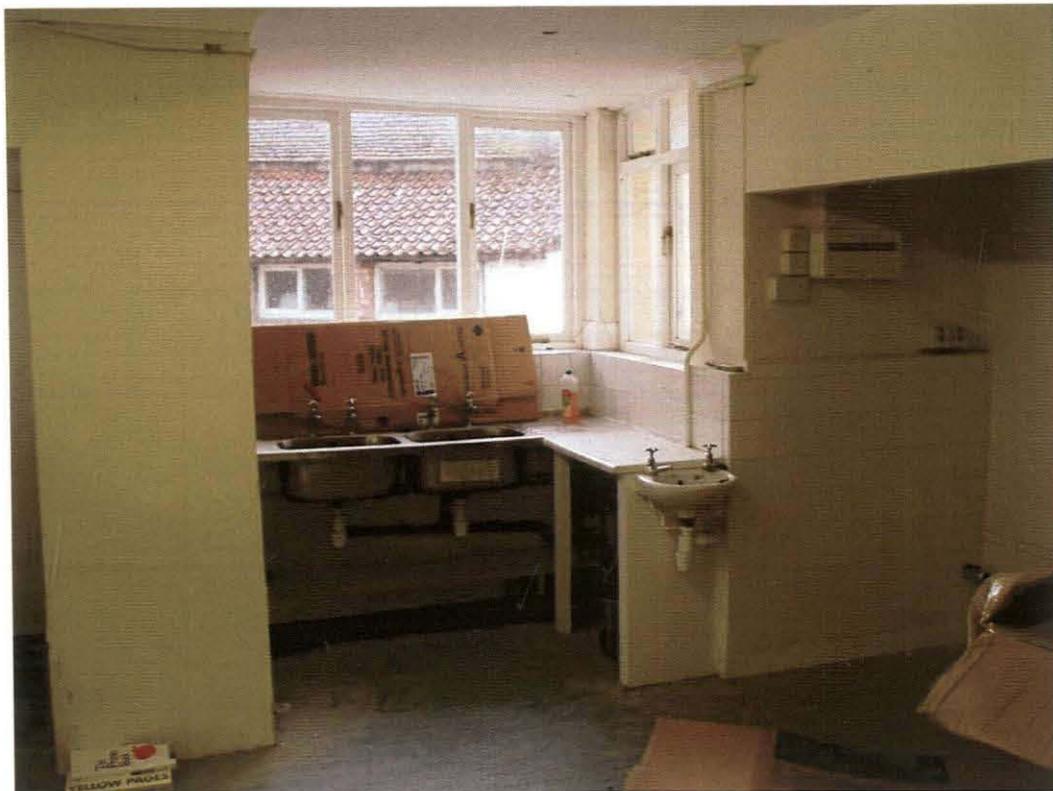
Photo 26 Kitchen Sinks

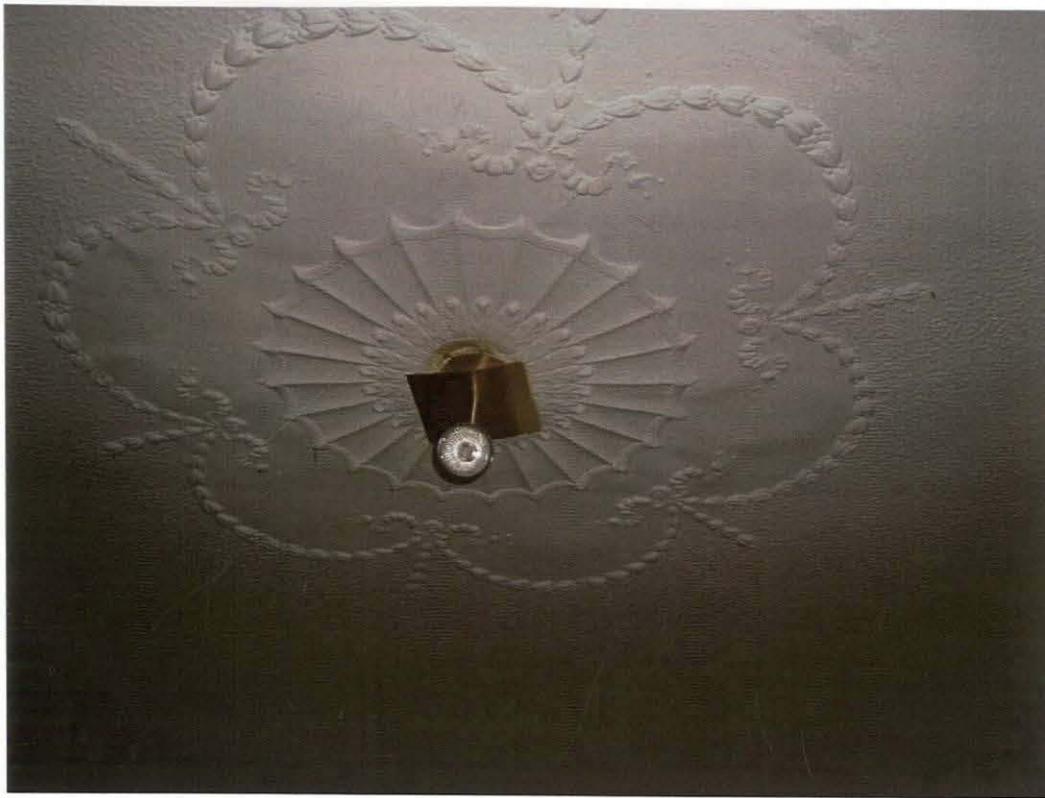
Photo 27 Ceiling Rose detail above stairs

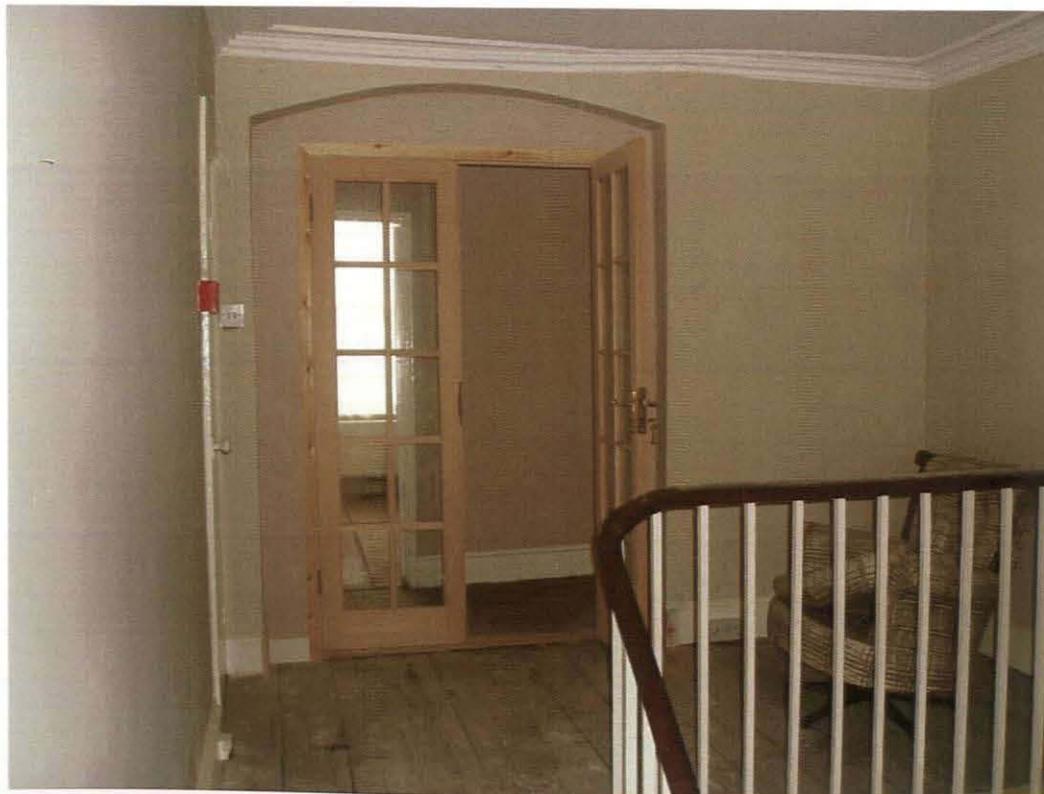
Photo 28 Landing
