Historic Building Recording

**Tattershall Lodge
11 Market Place
Tattershall
Lincolnshire
LN4 4LQ**

Change of use to Chinese Restaurant
Planning Approval Reference S/175/01557/08
Grid Reference: Easting 521213, Northing 357863

Project No. 07022

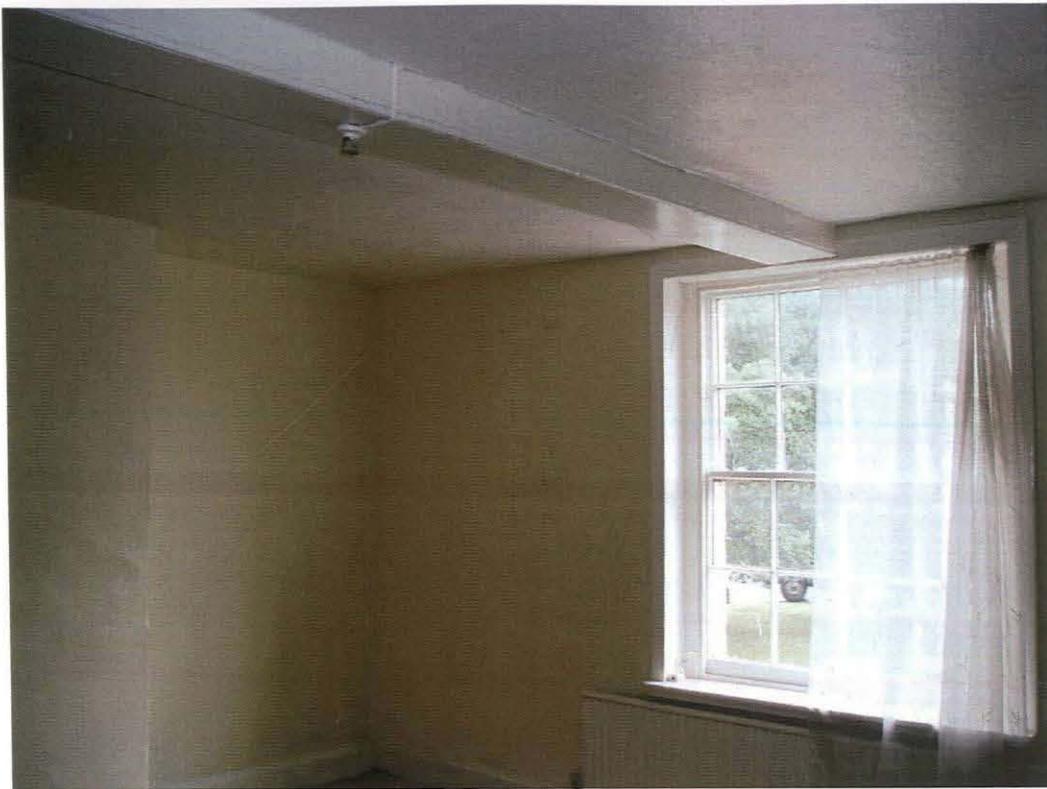
The windows are a mixture of materials and styles. Timber sash windows 4 over 4 on the front elevation first floor, and to some rooms in the 3 storey rear part of the building. There are also metal windows with top openers, and various styles of top and side opening casements in timber and PVCu. (See photos 1-16 for windows externally, 29 & 33 sash windows inside)

No original fire places remain. All fireplaces are covered over apart from the upstairs living room which is an open fireplace with an exposed brick chimney breast that looks like a fairly modern re-build. (See photos 21, 29, 31, 33).

Photo 29 Bedroom 1

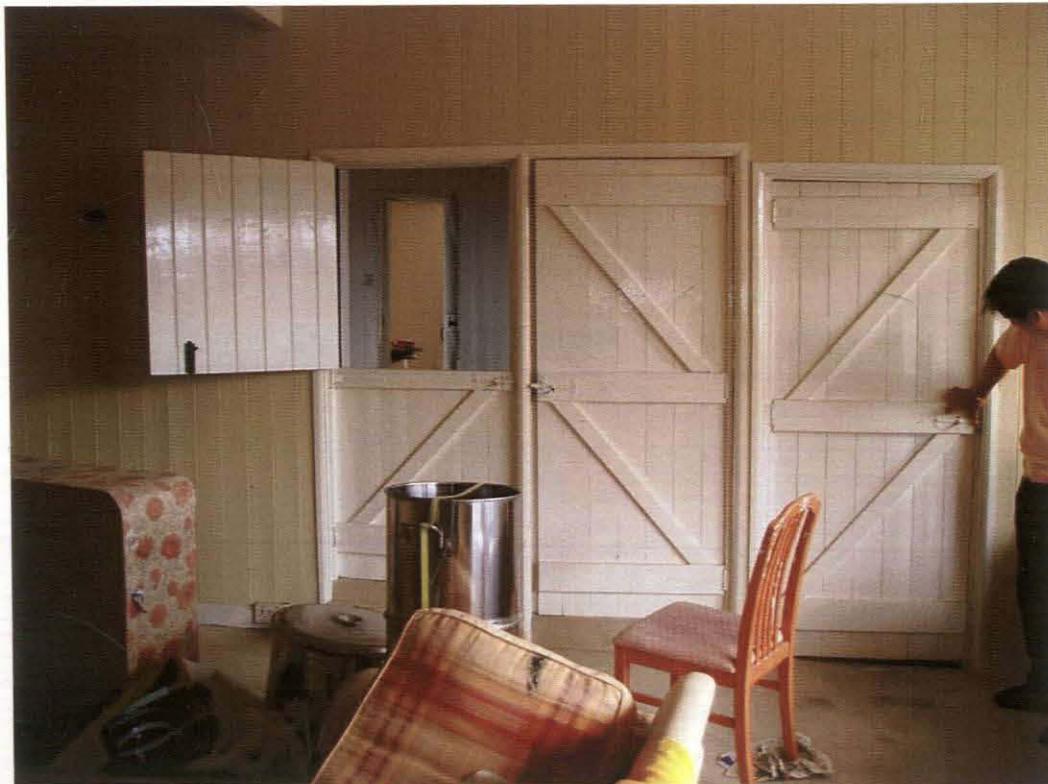
Some of the old internal doors still remain in place. Some are 4 panelled with door knobs, others boarded ledged and braced with latches. (See photos 19, 30, 31, 32)

Photo 30 Living Room

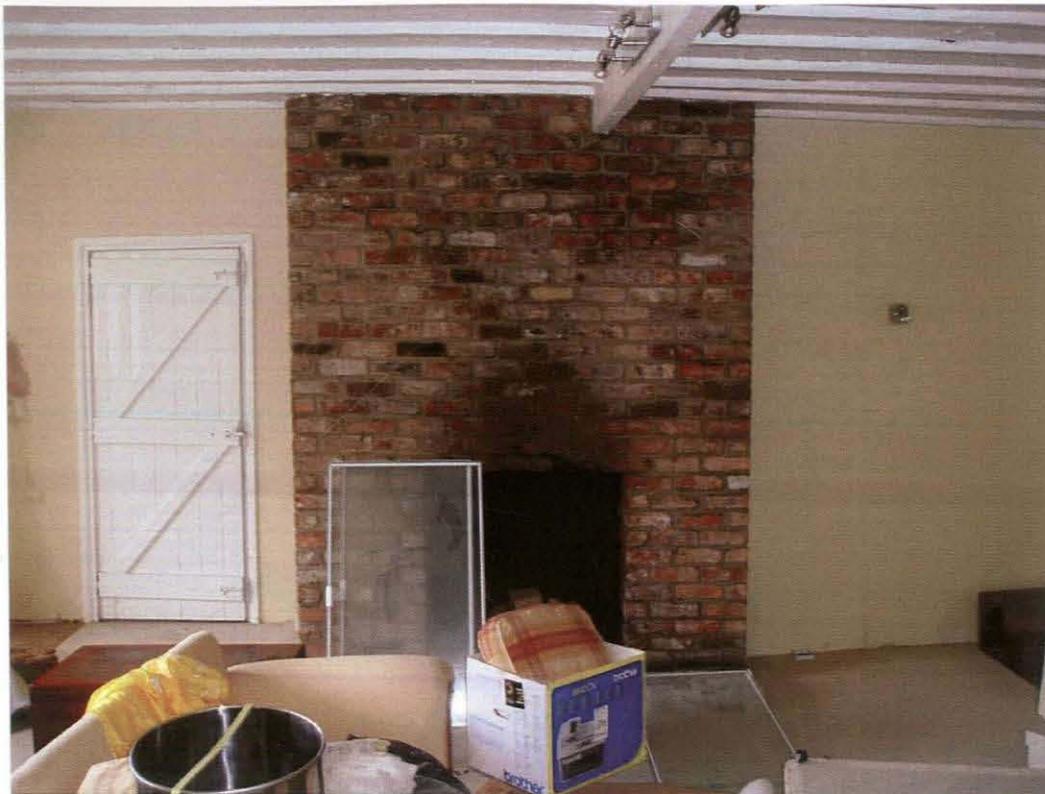
Photo 31 Living Room Fireplace

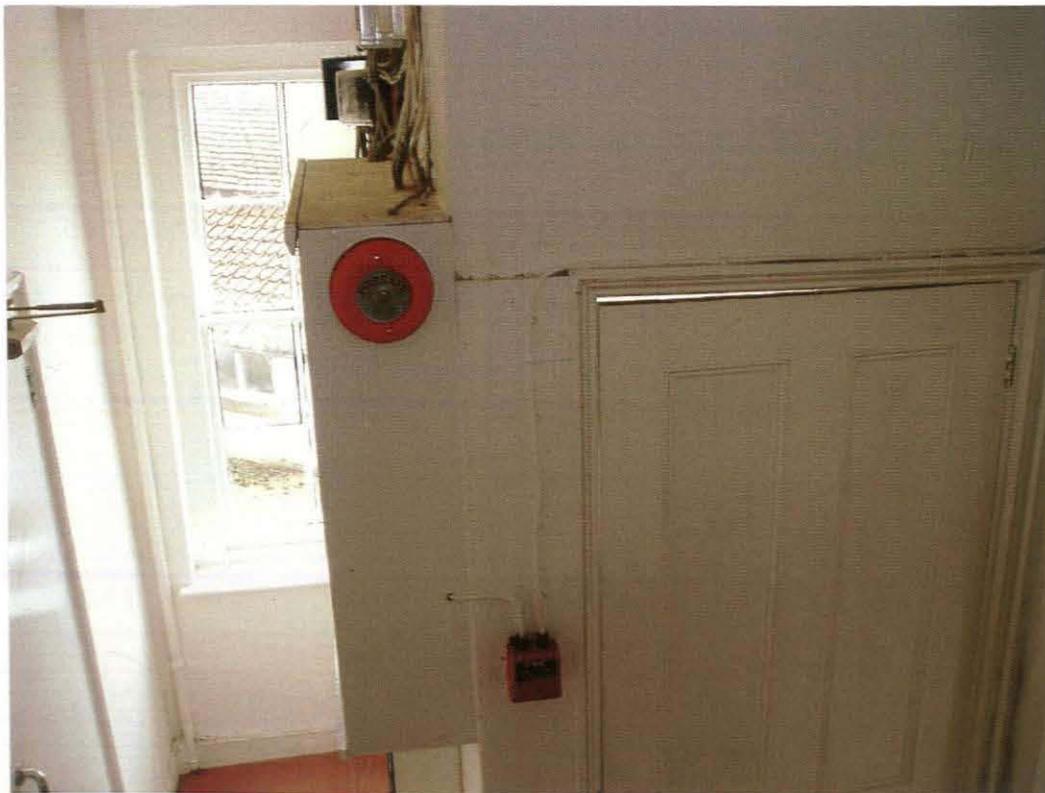
Photo 32 Rear Stair Lobby on First Floor

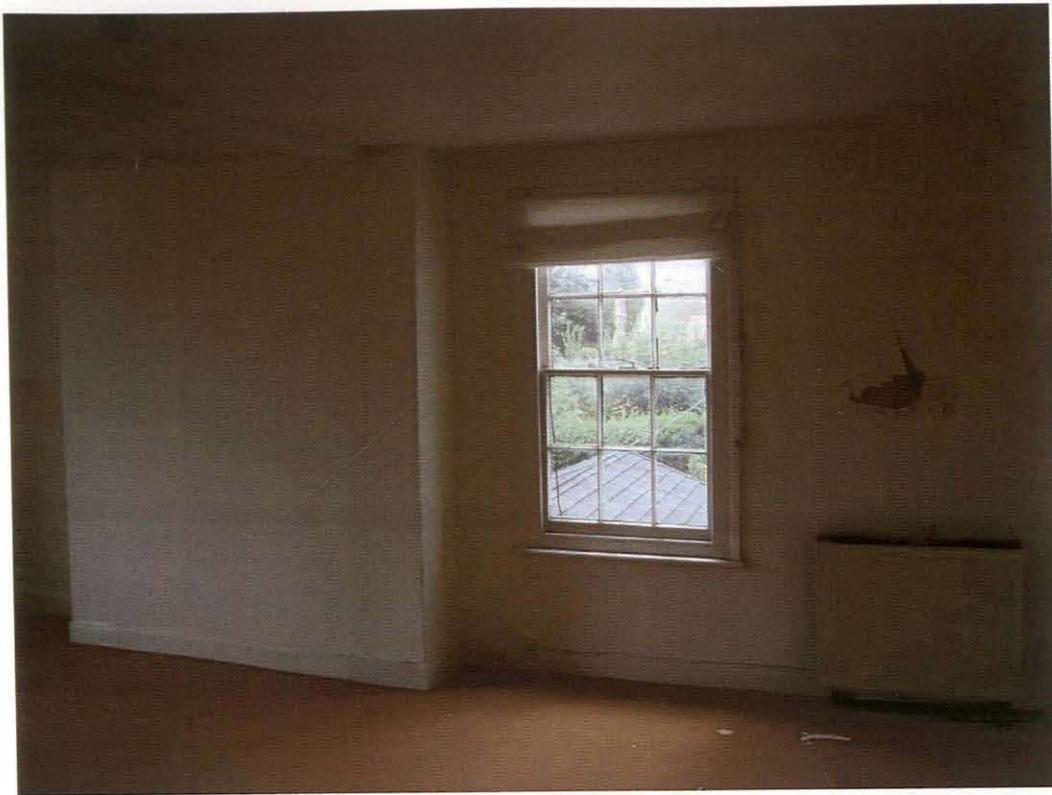
Photo 33 Upper Living Room

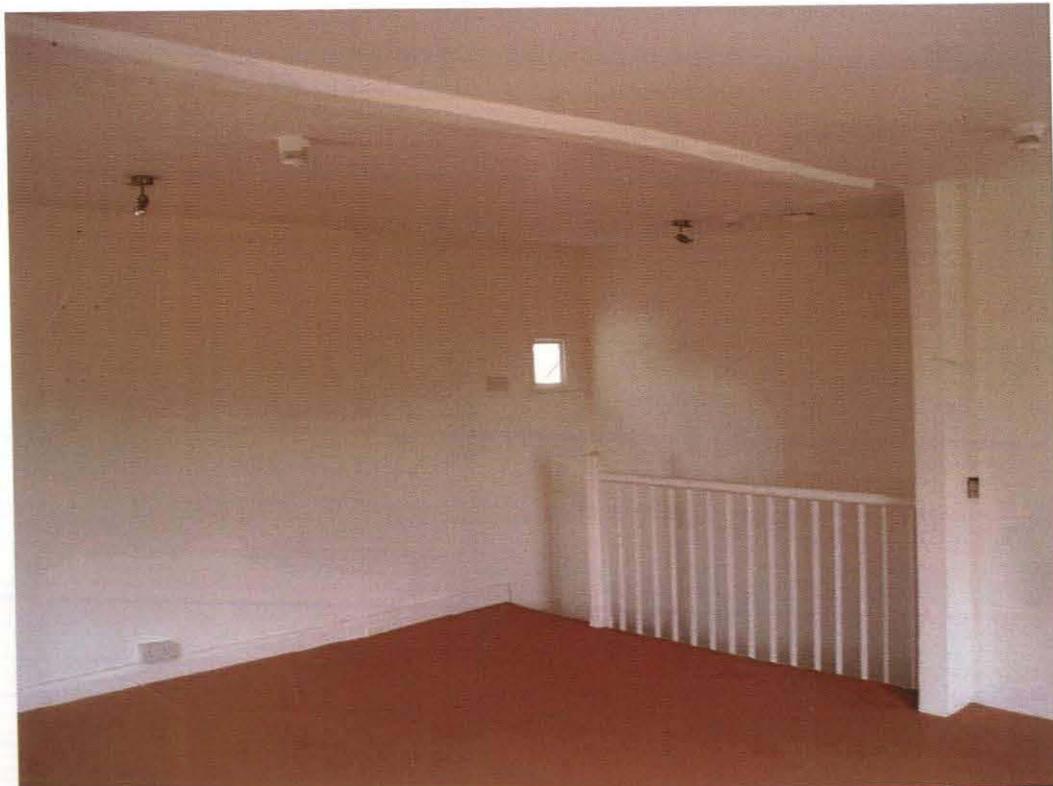
Photo 34 Upper Living Room

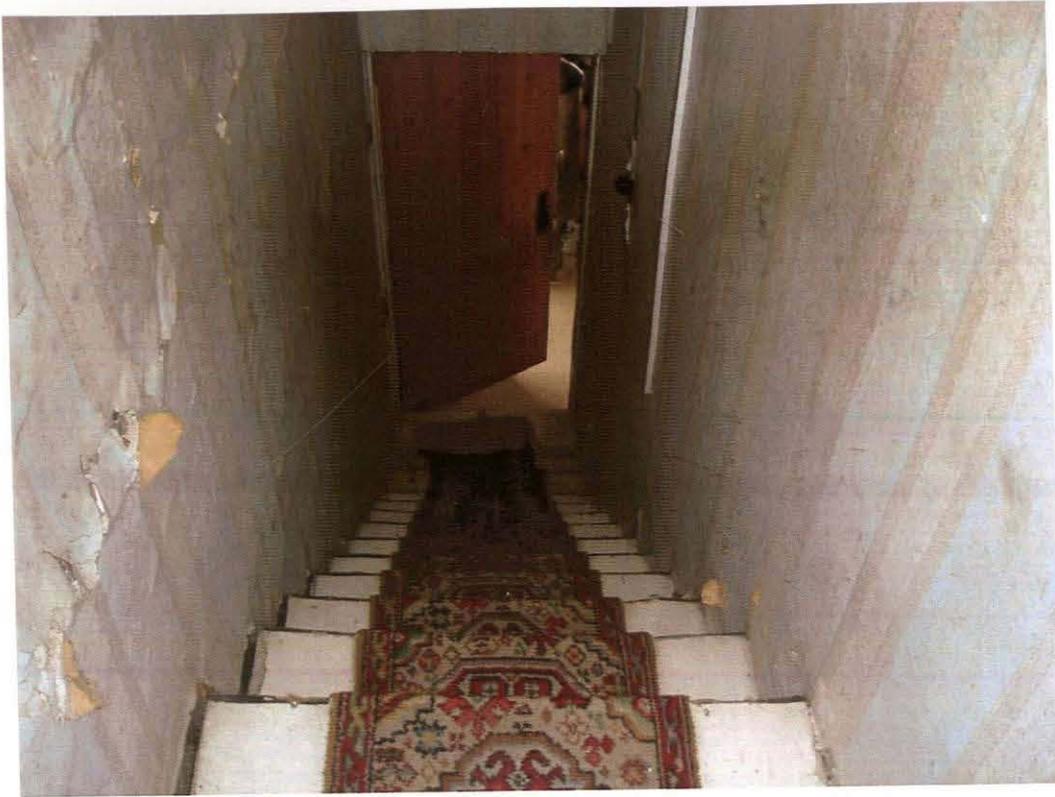
Photo 35 Attic Staircase

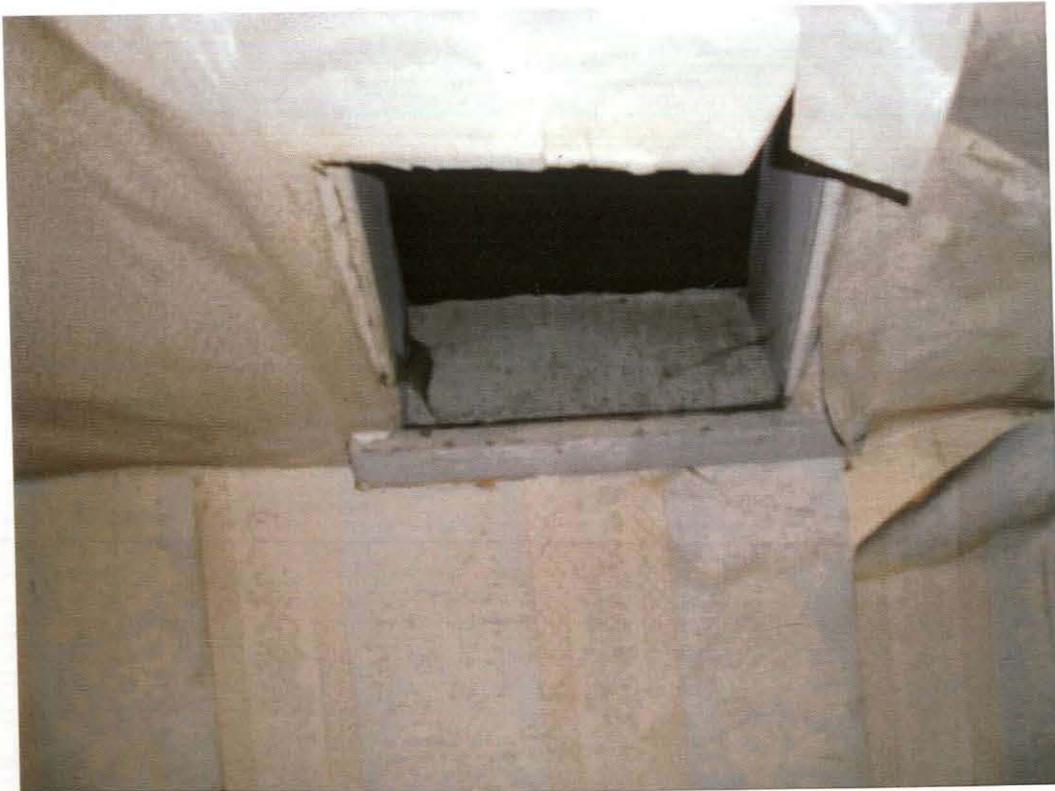
The front section of Tattershall Lodge (beds 1, 2, 5 & bath) is two storeys high plus an attic, with its ridge running parallel to the frontage. The 2 gable ends have parapet walls and central chimney stacks. The front roof has an attic room accessed by a narrow staircase and there is a small dormer facing the rear and gable end window facing No.10 (dormer just visible on photo 9 behind apple tree branches and gable window shown on photo 16). On the attic staircase is a small opening that could have been an old roof light (see photo 36) It wasn't possible to see any evidence of this roof light from outside standing at ground level.

Photo 36 Old Rooflight ?

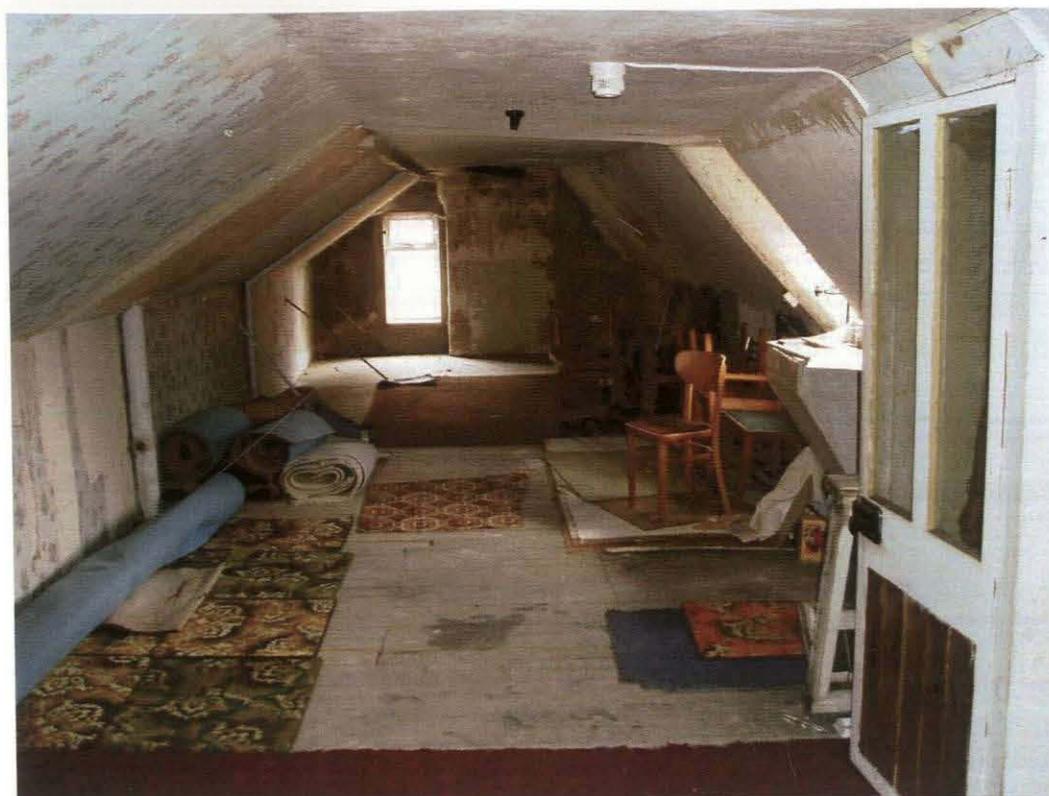
Photo 37 Attic

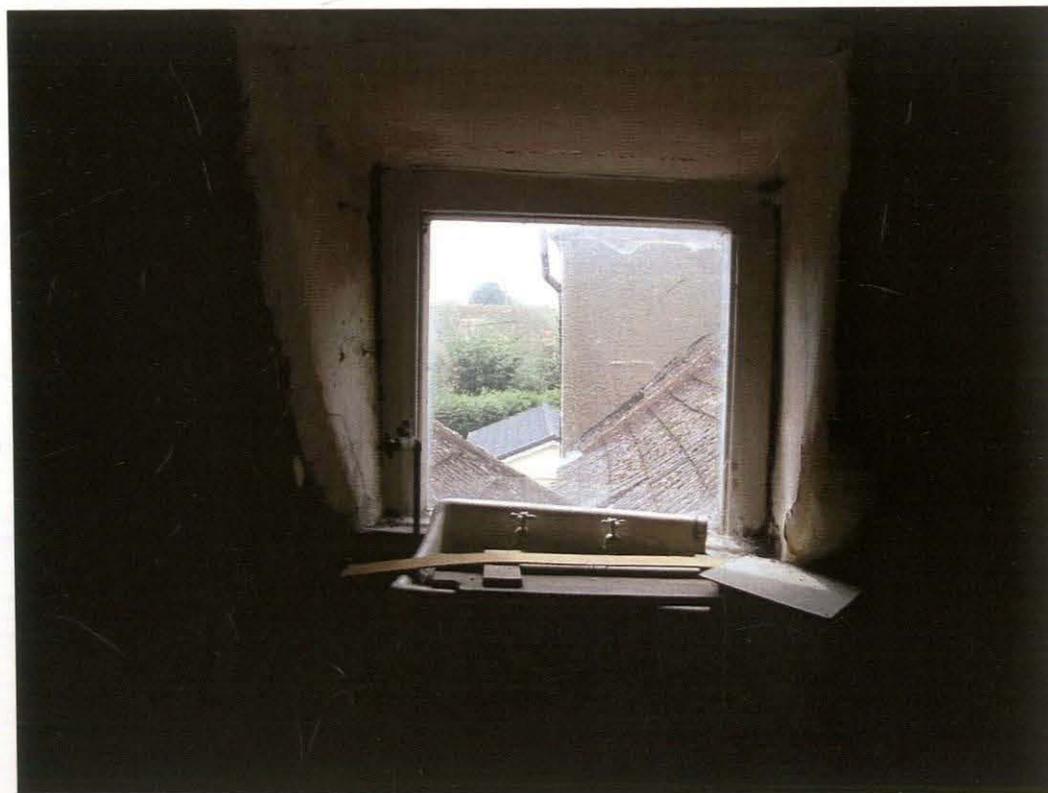
Between the above main elements there are two roofs over the first floor living room, bed 4, landing & bed 3. These roofs link back into the front roof just below ridge level. The attic dormer is located between these roofs looking down the valley gutter (see photo 38).

Photo 38 Dormer above valley

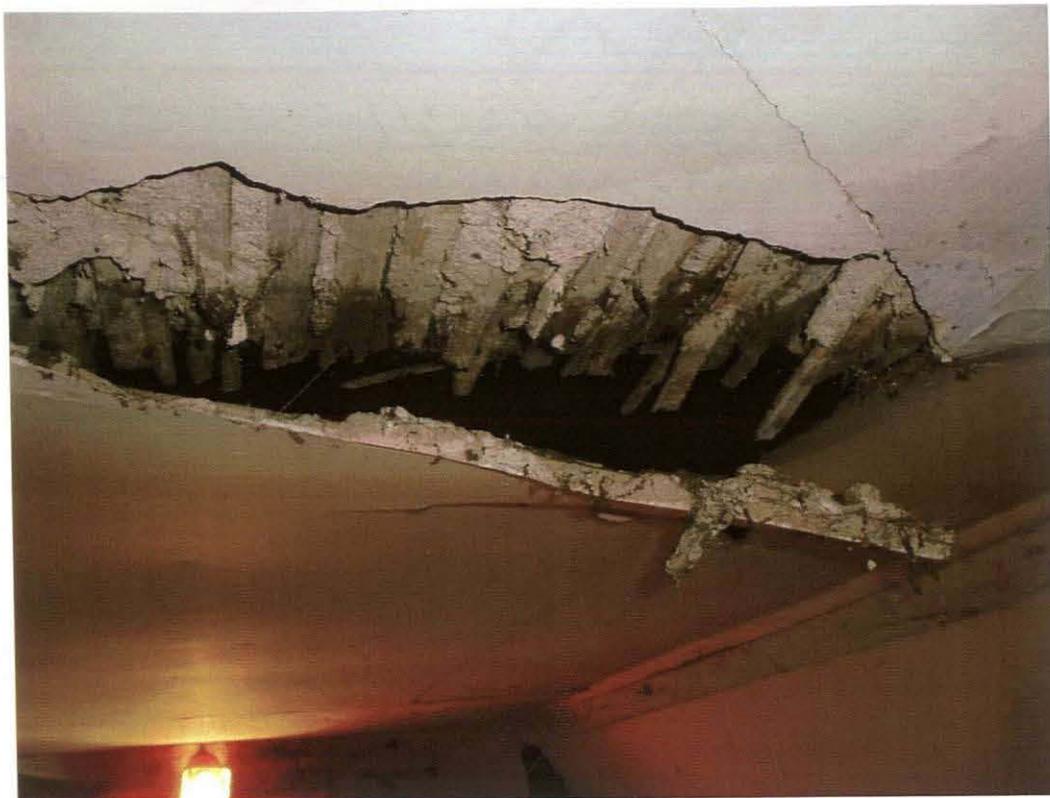
Photo 39 Attic Ceiling

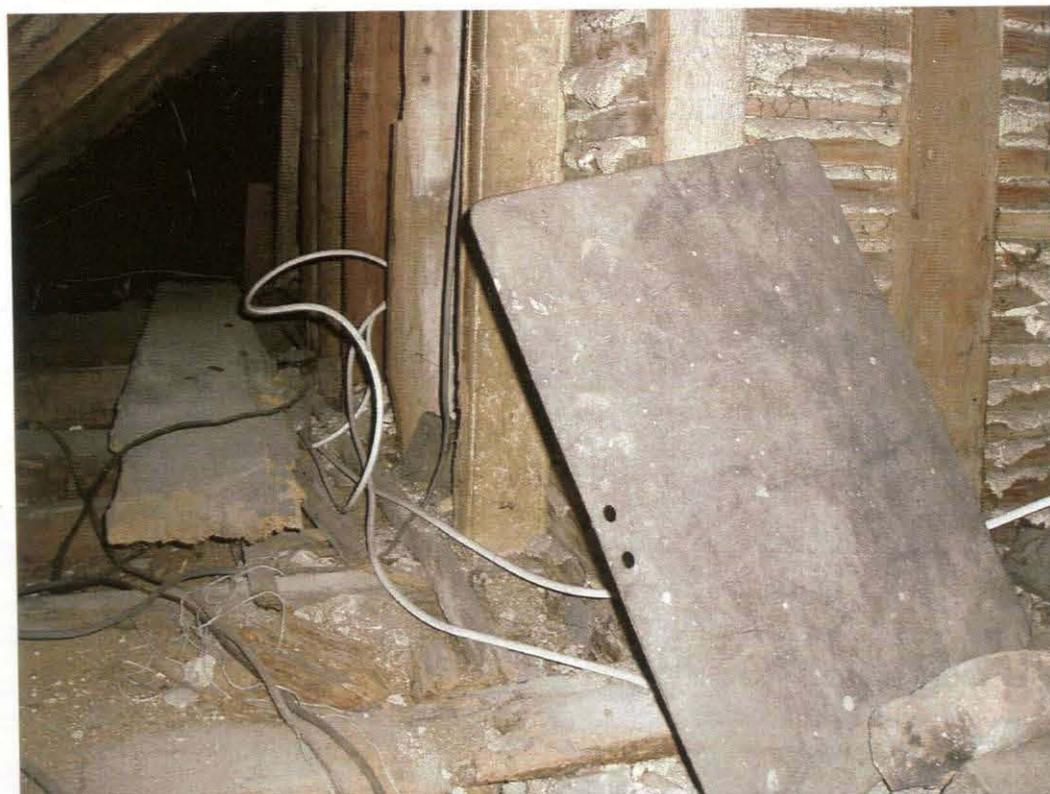
Photo 40 View from attic into roof space above landing
