ARCHAEOLOGICAL BUILDING
INVESTIGATION
ALFORD MANOR HOUSE
ALFORD

SITE CODE: AMH02

REPORT

FIELD ARCHAEOLOGY SPECIALISTS LTD

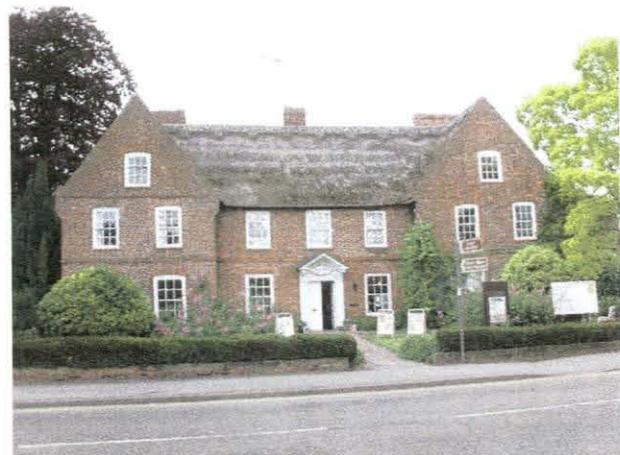
The south elevation (Figure 2, Plate 1) represents the front facade of the building and is constructed mainly from brick. It consists of two projecting gabled wings to either side of a central range. The components of the elevation have been broken down and discussed separately below.

Plate 1 South elevation

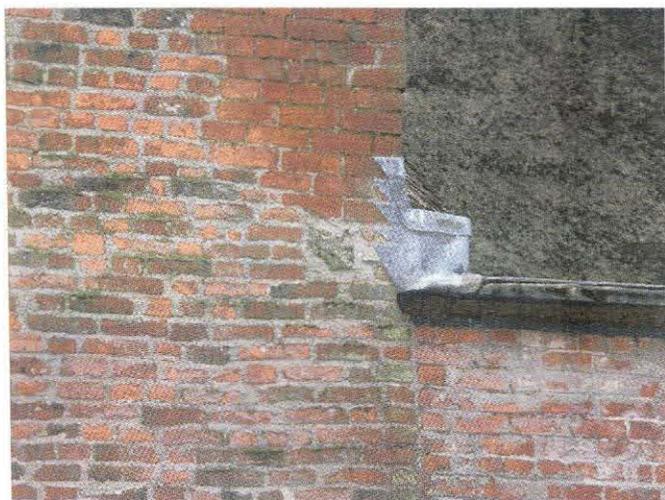
Plate 2 Exposed end of wall plate (centre of view), north wall, east wing

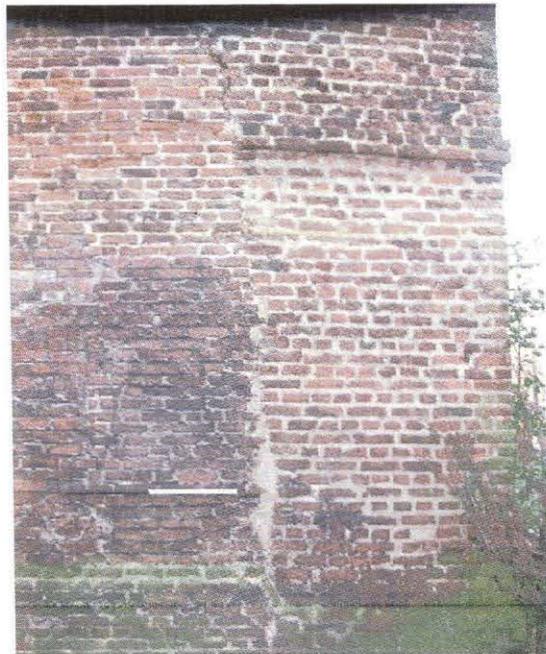
The southern part of the west elevation includes a brick plinth with chamfered top running across its base. The plinth is offset 1.5m from the south corner, sloping by -0.35m. Directly above the offset, a straight joint runs from the plinth up to eaves level. To the south of this joint, and terminating against it, a stringcourse between the ground and first floors continues from the south elevation (Plate 3), thereby suggesting that the straight joint is a result of the remodelling of the south elevation of the west wing. At ground-floor level are a further three straight joints running parallel to one another, which may indicate the position of an original window, subsequently half-blocked, and the insertion of a taller, more classical, window, since removed. At first-floor level, another straight joint is found to the immediate south of the outshut, indicating the position of another blocked window which lit a closet in the southwest room on the first floor (Room F1). A straight joint relating to a corresponding window jamb is visible in the outshut at first-floor level (Room F18).

Plate 3 South end of west elevation (scale 0.5m)

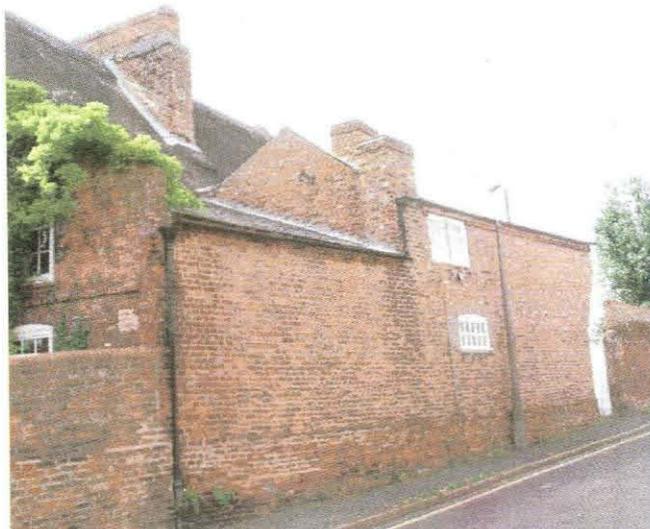
The east elevation (Figure 5, Plate 4) is represented by the land estate offices. The south half of this elevation has no openings, and is of one and a half stories with a slate lean-to roof. The northern half of the elevation has a single ten-pane window under a segmental brick arch at ground-floor level, and a Yorkshire

Plate 4 East elevation

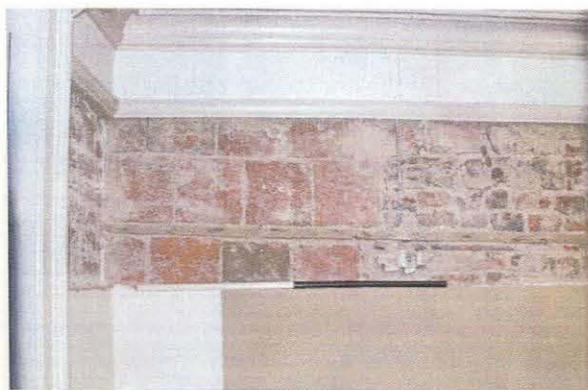
Plate 5 Exposed brickwork after plaster removal, Room G1, southwest corner (scale 0.5m)

Removal of a strip of plaster from the southwest corner of Room G1 was undertaken to establish the form and sequence of construction in this part of the building as implied by the external elevation. It was hoped that such exposure would reveal further timber posts in this area. Instead, the exposed fabric demonstrated that the west wall had been internally thickened with brick, tile and timber binders (Plate 5), probably to reinforce the structure. A timber fixing and pipe for a gas fitting were also exposed.

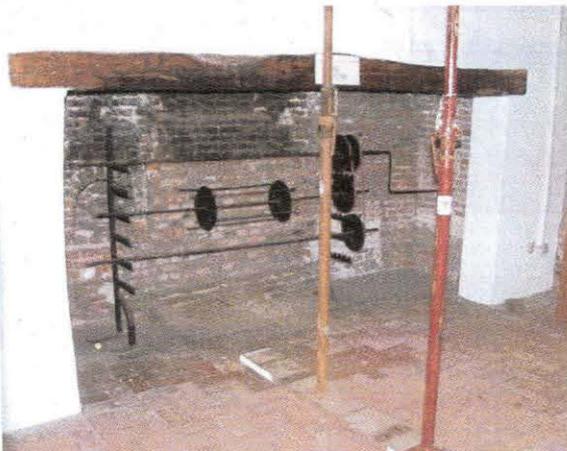
Plate 6 Fireplace in Room G16

A very large fireplace in the south wall has a timber lintel with chamfer and stops (Plate 6). The fireplace is brick-lined, although the fire back includes large amounts of replacement brick. Two arches span the fire hood and back, with dwarf walls above, effectively dividing the lower part of the flue into three segments. An arch-headed recess built into the fire back was probably used for keeping tobacco or salt dry.

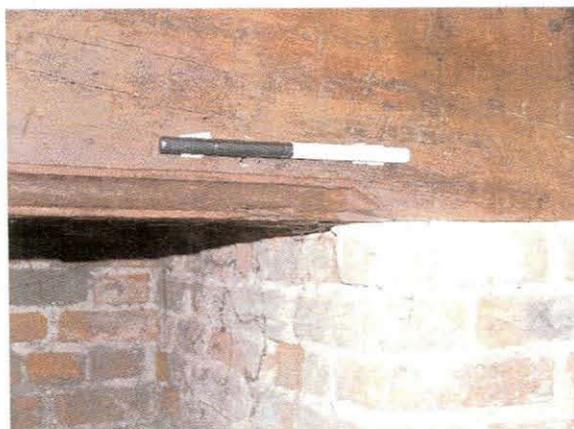
Plate 7 Moulding and stop on fireplace lintel, Room G3 (scale 0.25m)

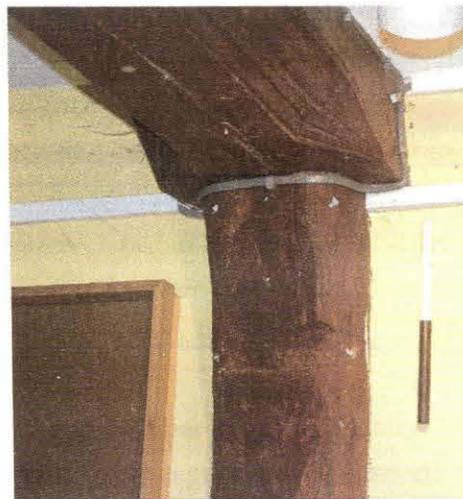
The room is spanned by a bridging beam running east to west. The beam is heavily moulded and stops are visible at either end (Plate 8). The west end of the beam is supported on a jowled timber post - a further post probably supports the east end of the beam, but this is not exposed. The moulding detail compares favourably with that on the lintel of the fireplace (Figure 7), indicating a contemporary date.

Plate 8 Moulded bridging beam supported on post, Room G8, west wall (scale 0.25m) G3.

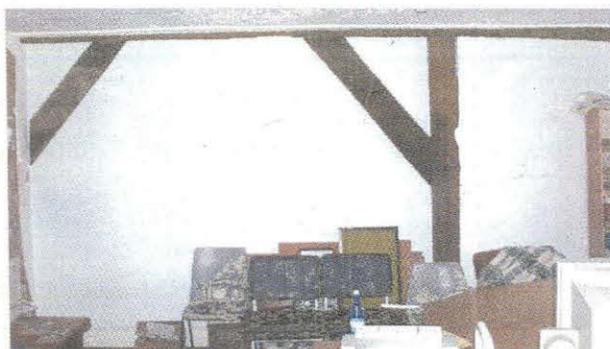
Plate 9 Timber framing, Room F1, east wall

The east wall contains a significant amount of exposed timber framing (Plate 9). A wall plate runs the length of the wall at ceiling height, probably supporting the joists of the floor above and also the east side of the roof structure covering the west wing. The north end of the plate is supported on a post, with bracing. A mid-post is braced to the wall plate. A further post must have been provided at the south end of the plate, the mortice for which remains, but this has since been removed.

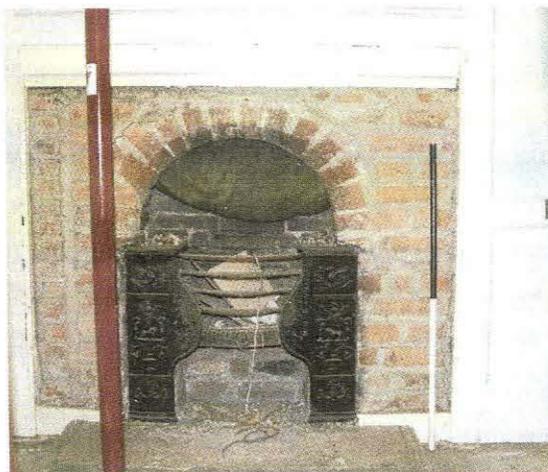
This room (Figure 8) is entered from a door opening to the south, accessed from the west stair landing (F2). The south wall includes a large panelled chimney breast. Prior to the recent works, the fireplace had been blocked with a hardboard panel - this was removed to expose the fireplace (Plate 10). The cast iron insert appears to be of 18th century date. The head of the fireplace is formed in brick, and is both arched and chamfered. However, the jamb of an earlier fireplace was also exposed, visible as a vertical junction in the brickwork to the east of the current fireplace (Plate 10). This would imply a much bigger fire opening, more consistent with a 17th century date.

Plate 10 Exposed fireplace in Room F17, south wall (scale 1.0m)

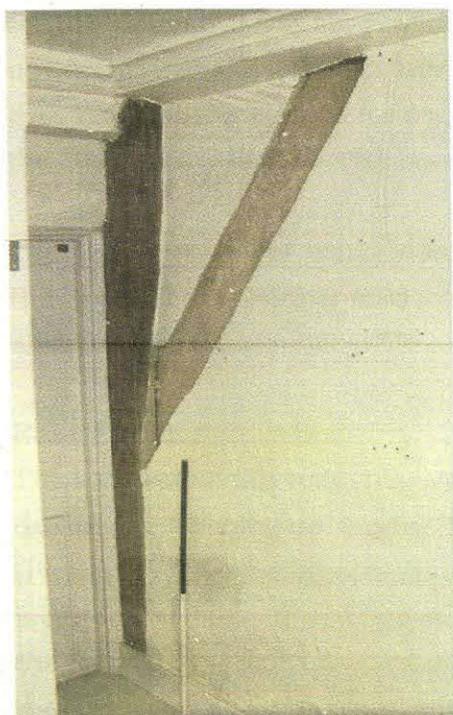
Plate 11 Exposed arch brace in Room F17 (scale 1.0m)

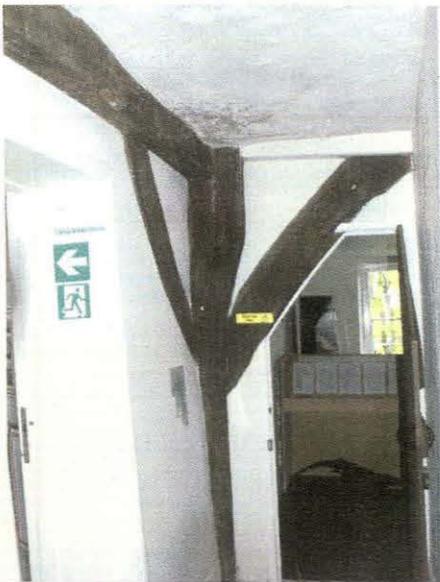
Plate 12 Former location of closet in Room F11 (looking south)

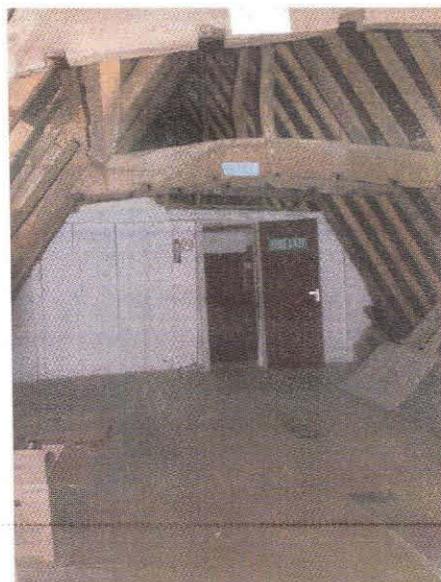
This attic room (Figure 13, Plate 13) is currently entered from doorways to both east and west. The change in floor level between the east wing and the central range suggests that the eastern doorway has been inserted. This is confirmed by the 1964 survey of the house by B P Bates, which omits the door opening in this wall. In contrast, the west door appears to be original, including its panelled door. The door has been provided with a small circular opening near its bottom edge with a sliding shutter - presumably for a 'mouser'.

Plate 13 Central attic room (Room A4) before removal of floorboards, looking east

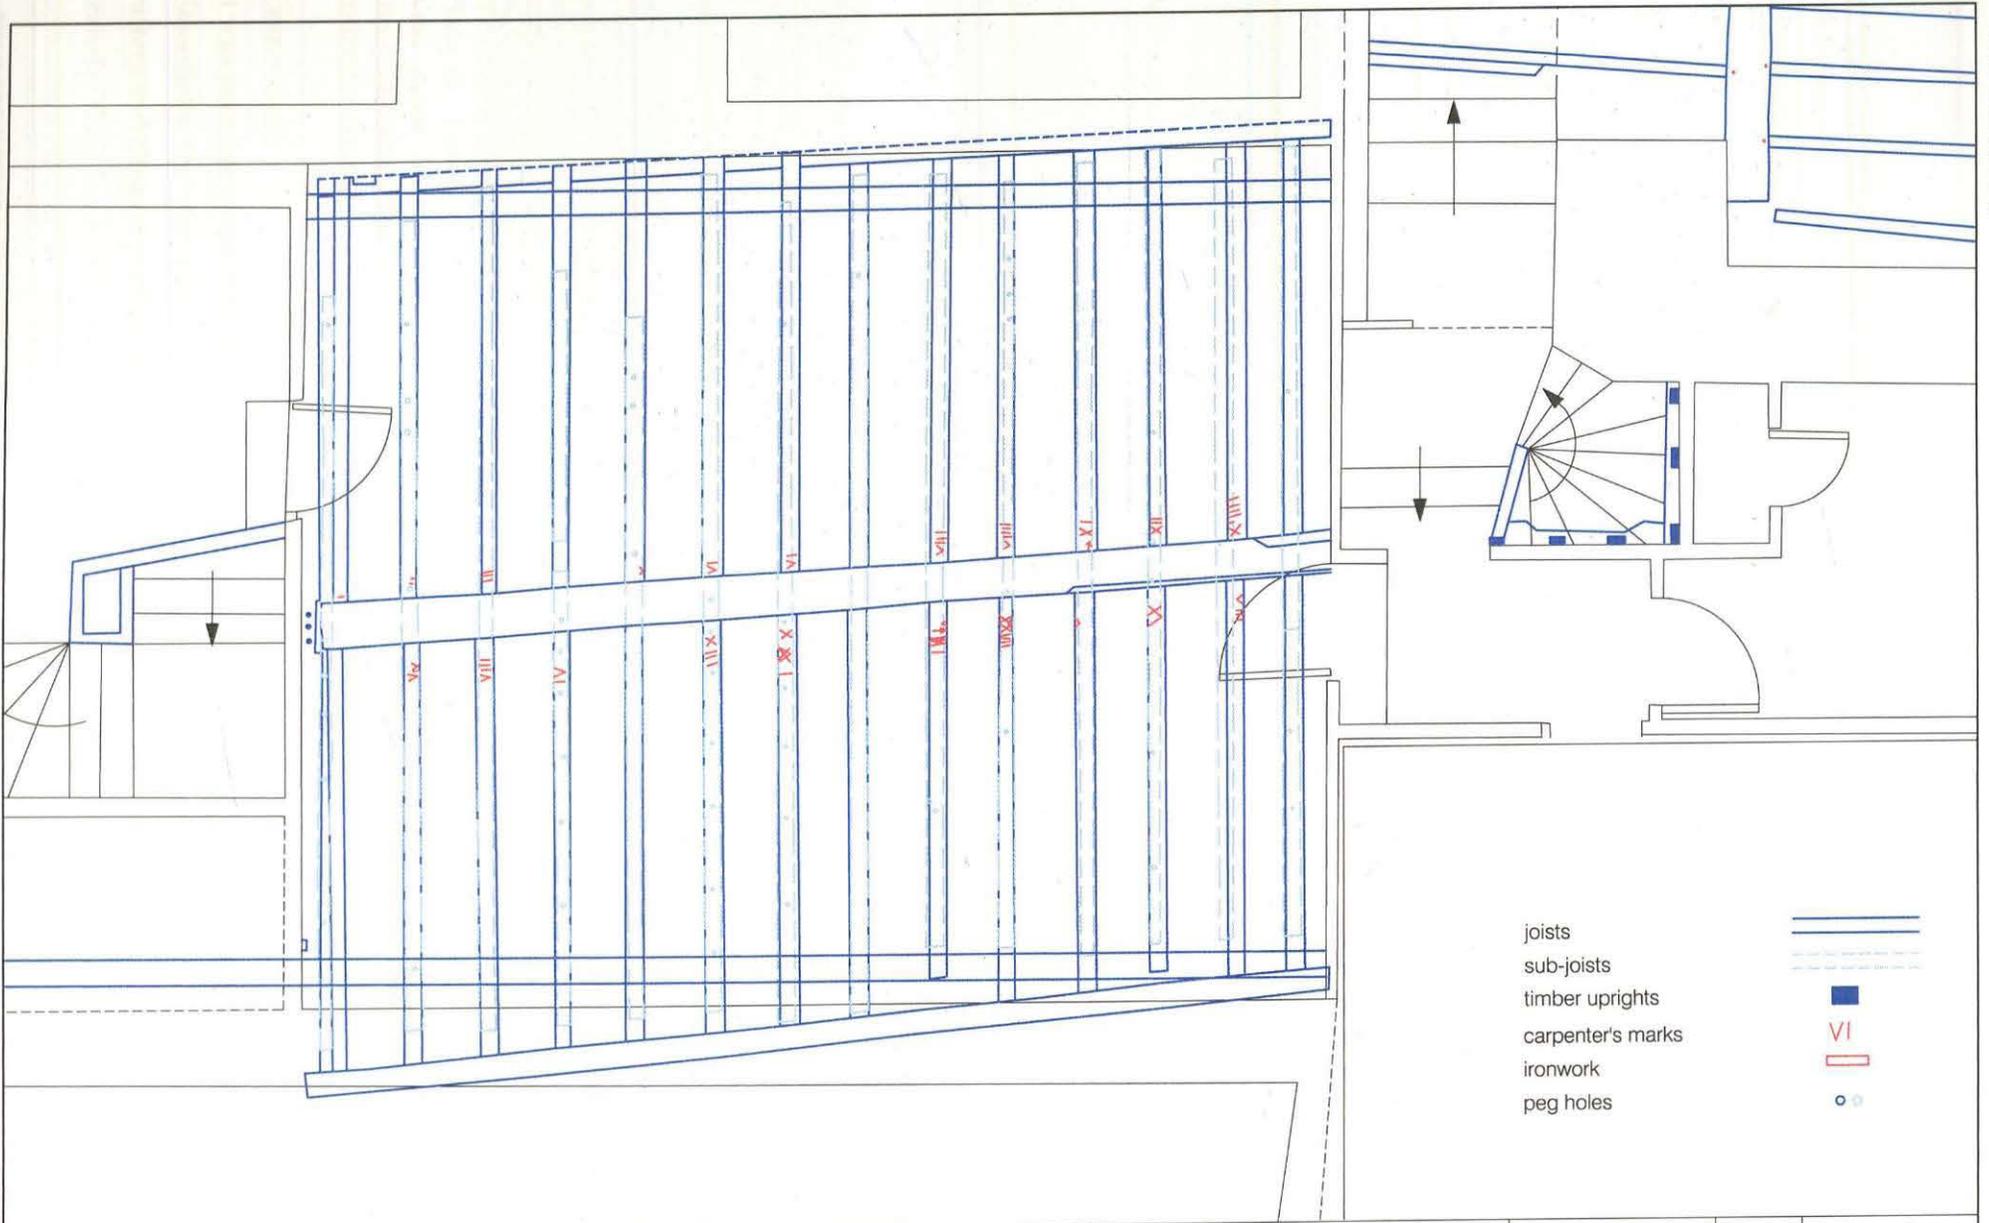
Room A4 joists

The floorboards in this room were removed to permit an examination of the floor structure (Figure 19). A central bridging beam runs east to west, with joists jointed into it and resting on wall plates along the heads of the north and south walls. Wall movement and extensive decay of the wall plates have left some of the joists unsupported at one end.

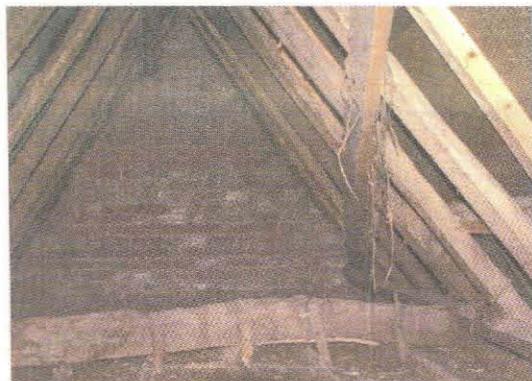
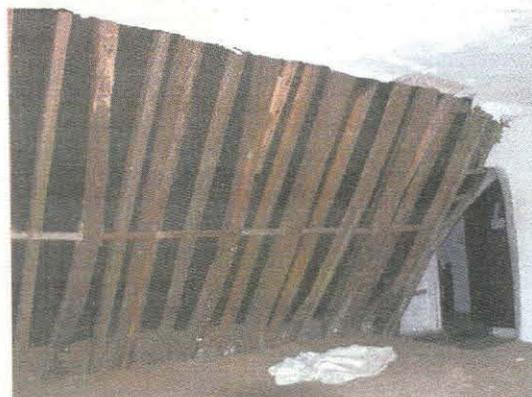
Plate 14 Roof structure of west wing

Plate 15 Lower part of roof structure in west gable, looking southeast (original common rafters, wall plate and secondary common rafters)

The roof form is of simple and light construction (Plates 14 and 15). A basic A-frame is formed by common rafters, set directly onto the wall plates. A wall plate acts as a tie beam at the north end of the roof. The frame is further tied by collars, with clasped purlins. An additional collar would have been located in the gable wall, but this has since been removed - presumably when the upper part of the gable wall was rebuilt in brick. The rafters clasping the purlins with the collars would normally be of greater size (a principal rafter) than those adjacent, but this is not the case at Alford. Little additional tying is provided.

Additional purlins and common rafters have been erected on top of the original roof structure as part of a recent repair. Similar work appears to have been carried out on all of the roof structures of the house.

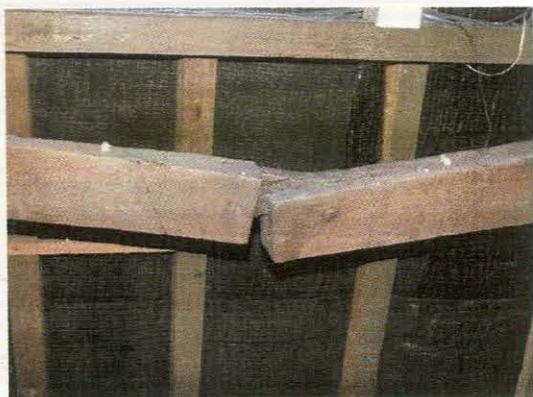
Plate 16 Bridle scarf joint on purlin

known along the north wall. It is assumed that the same number existed along the south facade, although all appear to have since been removed. The purlins are formed from lengths of timber linked with bridle scarf joints (Plate 16), most showing some sign of movement.

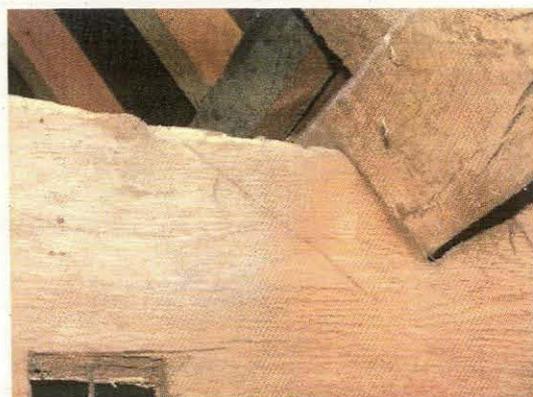
Plate 17 Levelling mark on collar

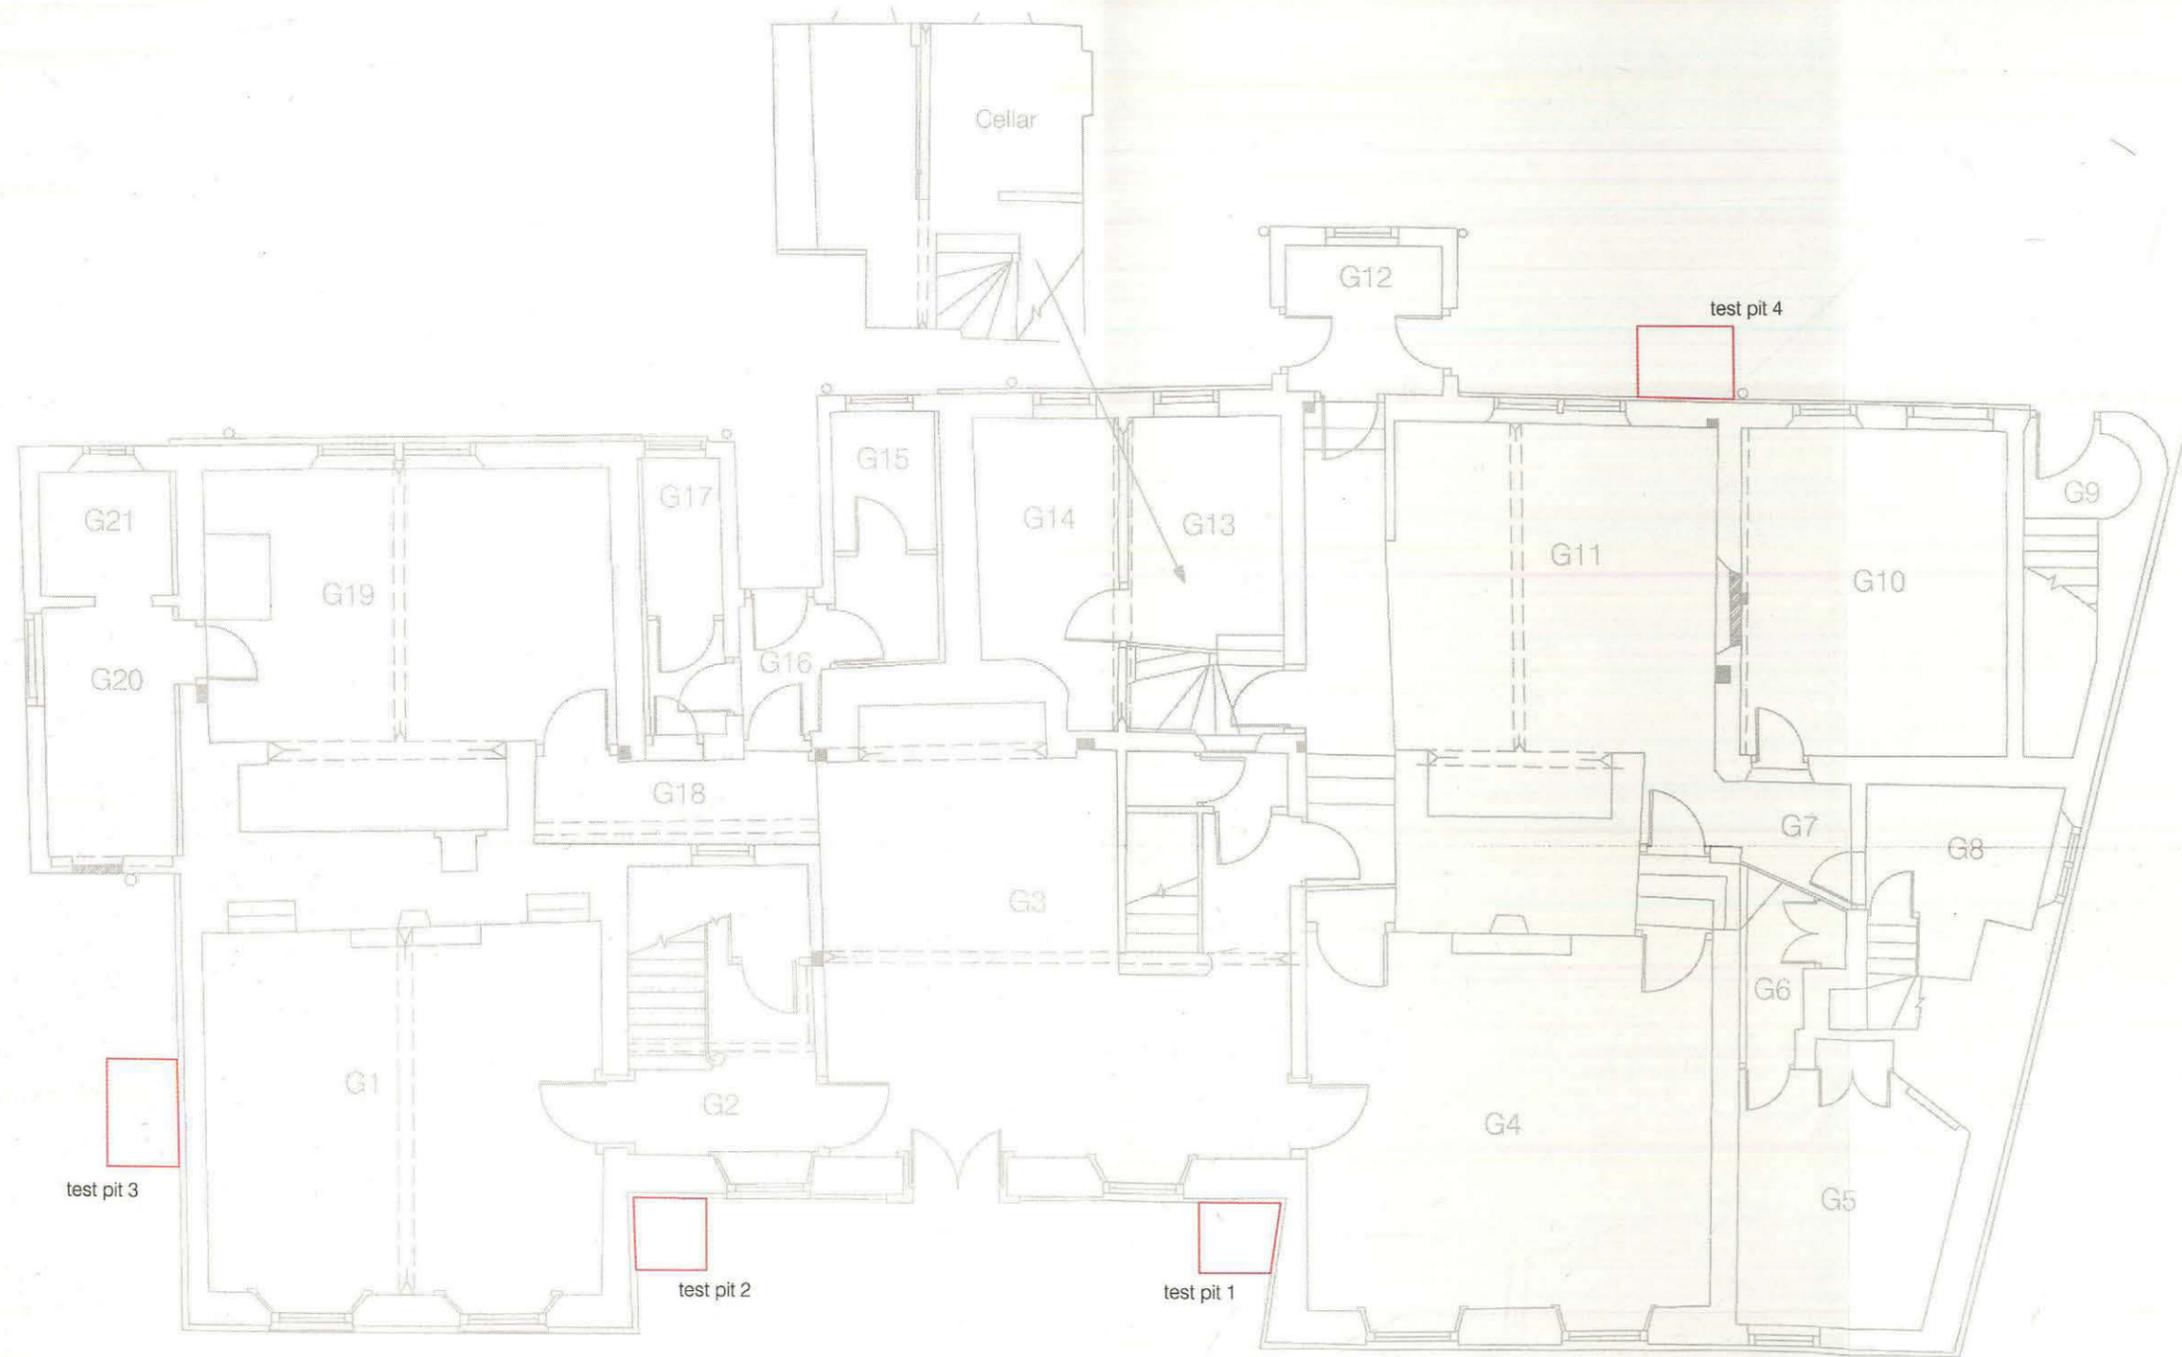
Test pit positions

Test pit 1 was excavated at the junction between the east wing and central range against the south elevation. Surprisingly, the foundations extended to a depth of little more than 0.2m, on both elevations.

Test pit 2 was excavated at the junction between the west wing and central range against the south elevation. The footings of the central range were of slight depth as observed in Test pit 1. However, those of the west wing were constructed to a greater depth and were formed of stepped bricks courses.

Test pit 3 was excavated against the west elevation of the west wing along the line of a clear break in the fabric above. The footings extended to a depth of c.0.5m to the south, sloping upwards to the north. The junction observed in the superstructure was not carried through into the footings, suggesting that the footings must predate any alterations to the elevation.

Test pit 4 was cut against the north elevation of the east wing, where cracks and junctions in the fabric of the ground could be observed. The exposed footings consisted of stepped brickwork extending to a depth of at least c.0.5m. No junctions were observed in the subsurface fabric. During excavation a quantity of loose building rubble was encountered, consisting mainly of brick fragments (predominantly 19th century stock brick). This appears to have been part of a recent attempt to create a French drain.

The highly mixed nature of the deposits in all trial holes indicates that the ground has been the subjected to recent disturbance. The great variation in the depth of the footings cannot be explained in terms of different building phases of the superstructure. It is more likely that the original builders excavated foundation trenches through the sub-soil until they encountered firmer clay deposits. Therefore the variation in the depth of the footings reflects the underlying topography of the local geology.
