Condition survey of St Matthew's Church, Holbeach St
Matthew, Lincolnshire

431.20
18 January 2010

1 INTRODUCTION

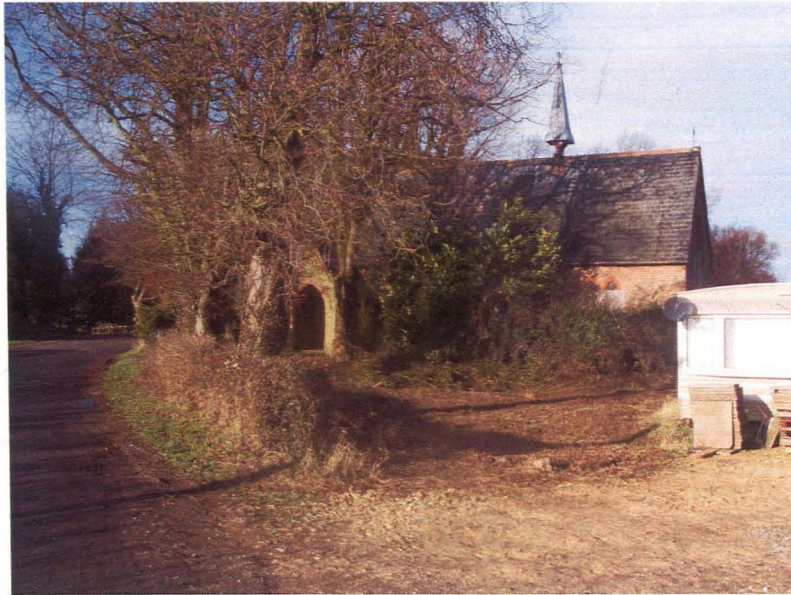
Figure 1
General view of church from south, showing highway, hedge and railing boundary, cleared ground and static caravan.

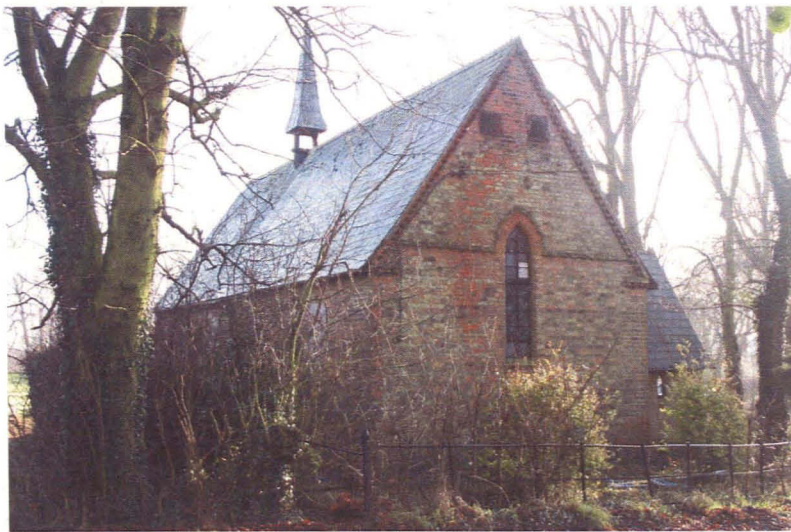
- 2 North (slate roof covering): Main slate roof covering shows biological growth, particularly to upper third of covering and beneath fleche (Fig. 2). Verge slates to east and west of reduced width (i.e. not slate and a half width) and with risk of uplift. At least 4 no. slates, including a number held by remedial clips (tingles), have become displaced beneath ridge over an assumed vent (i.e. west side of flèche) (Fig. 6). Vent with assumed mesh cover and mortar to perimeter. Likely rainwater penetration with consequential risk of timber decay. Number of slates beneath ridge to west appeared to be lifted, caused either by uplift from verge and/or movement of cross. Similar to east, with evidence of previous repair beneath the cross. Number of tingles present, particularly around assumed vent and to upper west roof. Eaves line is reasonably straight, although with a small number of lower course slates having become displaced and dropped into eaves gutter

- 1 North (general): Red brickwork laid to English bond with two-stage buttress (B1), battered lower wall and ventilation grilles visible through vegetation (Figs. 2 and 12). Brickwork appears in reasonable condition relative to its age, construction and exposure. Assumed slate damp-proof course as observed to south elevation

Figure 2
General view of north and west elevations, with hedge and railing boundaries and mature trees. Note absence of boarding to window (W9).

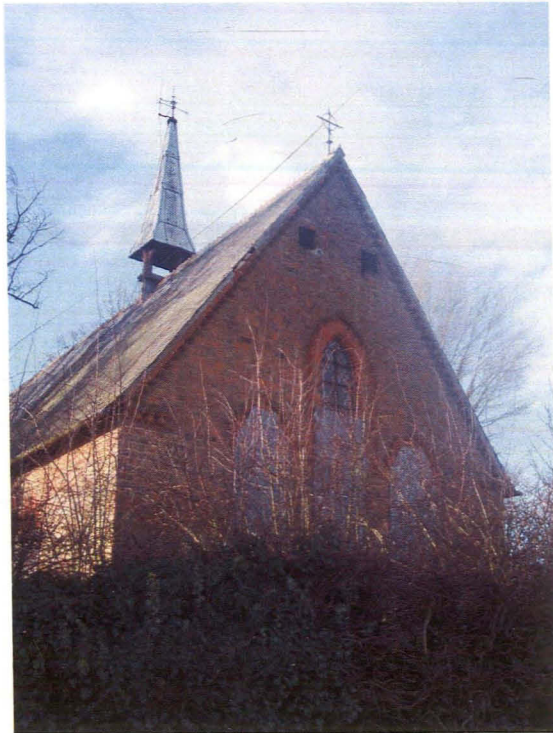
- 6 East (chancel): Gable elevation with 2 no. projecting brick courses beneath verge, with lower course set at angle and with returns at eaves (Fig. 3). Assumed ferrous metal ventilation grilles (2 no.) with mesh at high level beneath gable apex showing failing mortar and/or brick displacement possibly associated with corrosion (Fig. 17). Redundant ferrous metal fixing(s) to brickwork. At least 2 no. ventilation grilles in battered lower wall and return face of stone block to north-east corner. North and south eaves project with timber boards over rafters supporting lower slate courses. Significant ivy growth at low level

Figure 3
General view of upper east elevation, with hedge and boundary. Note boarding to window lights, excepting upper part of middle lancet (W5).

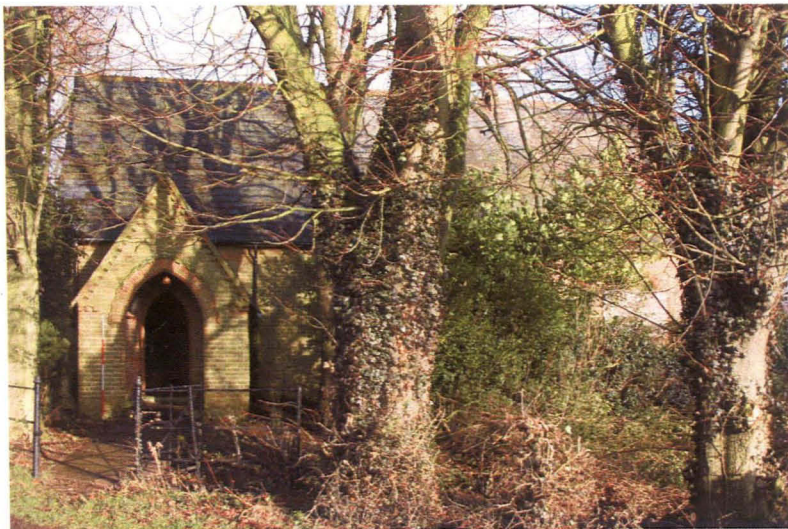
- 11 South (nave): Biological growth to brickwork to east side of porch and to buttress (B2) with evergreen tree foliage causing shading of elevation (Fig. 4). Invasive ivy and vegetation growth at low level, together with moss indicating saturation around downpipe. Open and/or defective joints adjacent to the downpipe and small number of spalling bricks (at least 1 no. between windows W6 and W7). Likely open and/or defective joints around ventilation grilles. Lightning protection down conductor clipped to brickwork to west of buttress. Elevation to west side of porch shows previous crude cementitious repairs to upper south-west corner and small number of open and/or defective joints (Fig. 5). Biological growth behind downpipe, with likely damage to brickwork associated with ferrous metal fixings to remaining length of cast-iron downpipe and assumed removal of lower downpipe length

Figure 4
General view of south elevation, with path to porch and mature trees.

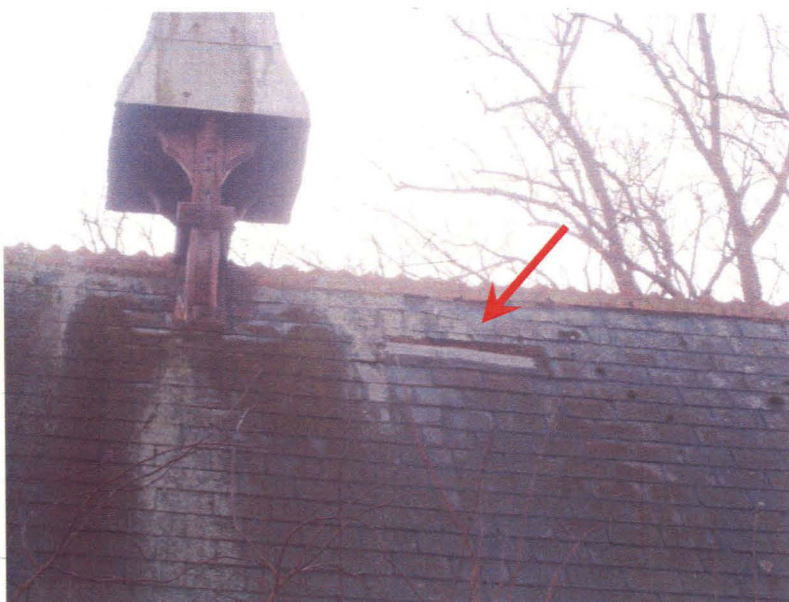
Figure 6
North nave/chancel roof covering, showing displaced slates and remedial tingles over assumed ventilator (arrow).

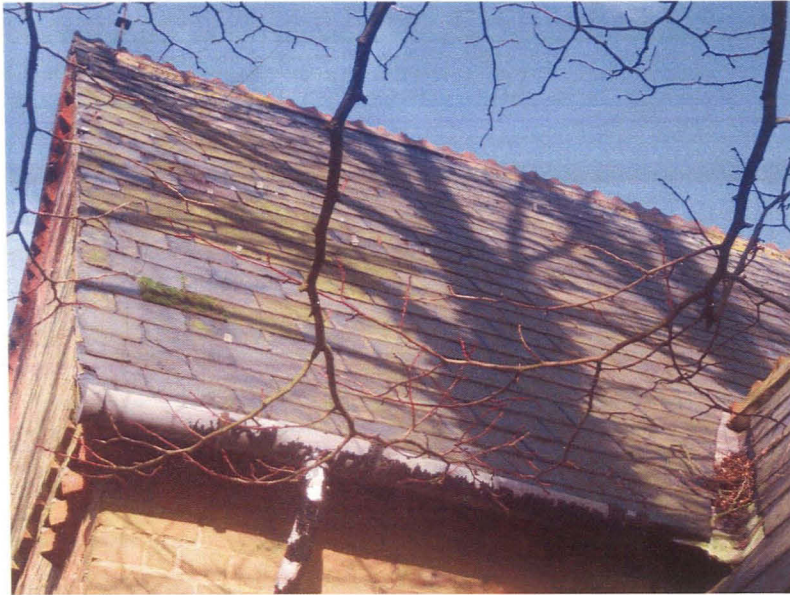
- 6 South (slate roof covering): At least 5 no. displaced slates adjacent to west verge, together with tingles indicating previous repair (Fig. 7). Some displaced slates to east verge. Such localised damage may be associated with wind uplift and/or physical contact with tree branches. Area of displaced slates and slates held with tingles around assumed vent to west side of flèche (similar to north slope) with risk of rainwater penetration and timber decay (Fig. 9). Assumed rope penetration to west of fleche for assumed bell chiming, also with potential risk of moisture penetration

- 3 South (west bay): Short gutter length to west side of porch with swan neck discharging into assumed black painted cast-iron downpipe (showing red paint beneath black) and shared plastic hopper (Fig. 7). Both gutter and hopper blocked with debris from overhanging tree branches. Gutter is not full length of eaves and discharges into valley. Plastic downpipe with failing black paint enters ground without gully (i.e. assumed connection to below-ground drainage system) and runs to unknown outfall

Figure 7
South nave/chancel roof covering, showing remedial tingles to slates and debris to porch valley gutter.

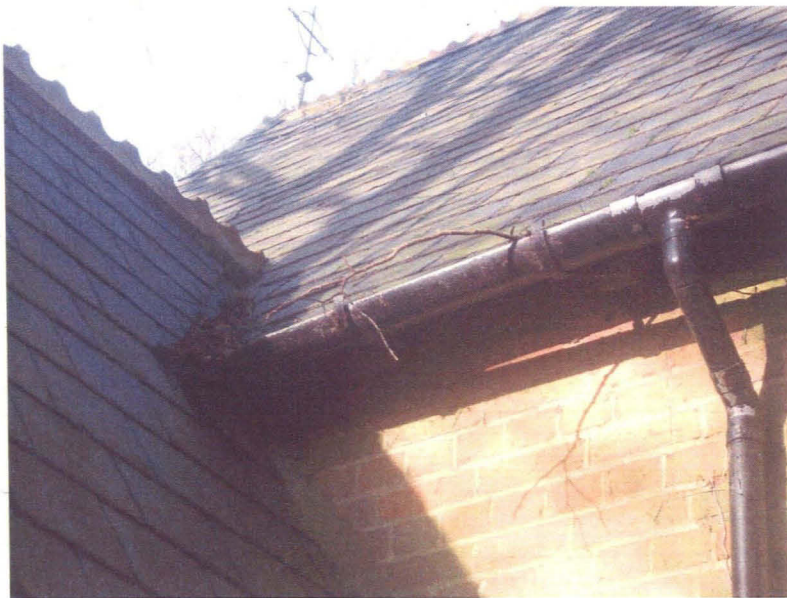
Figure 8
South nave/chancel roof covering, showing debris to porch valley gutter.

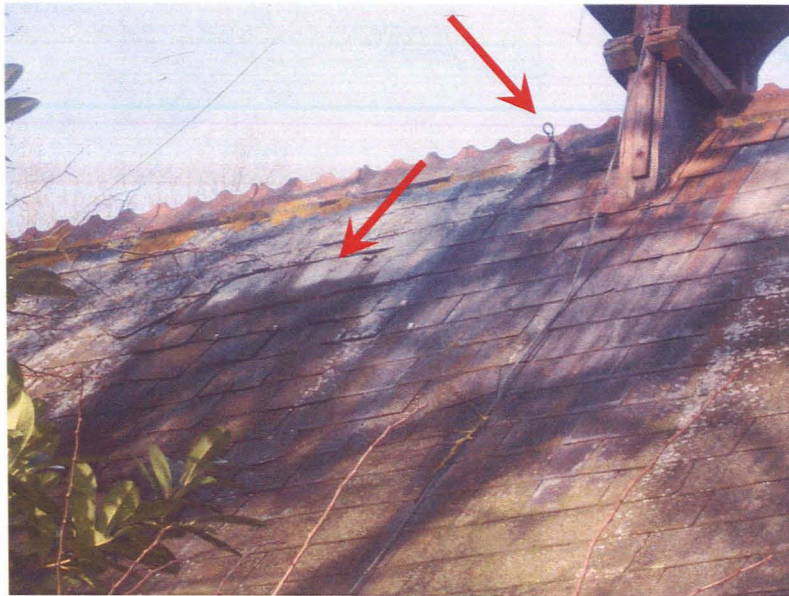
Figure 9
South nave/chancel roof covering, showing displaced slates and remedial tingles over assumed ventilator to west of flèche (lower arrow). Note lightning protection down conductor from flèche and assumed rope penetration for bell chiming (upper arrow).

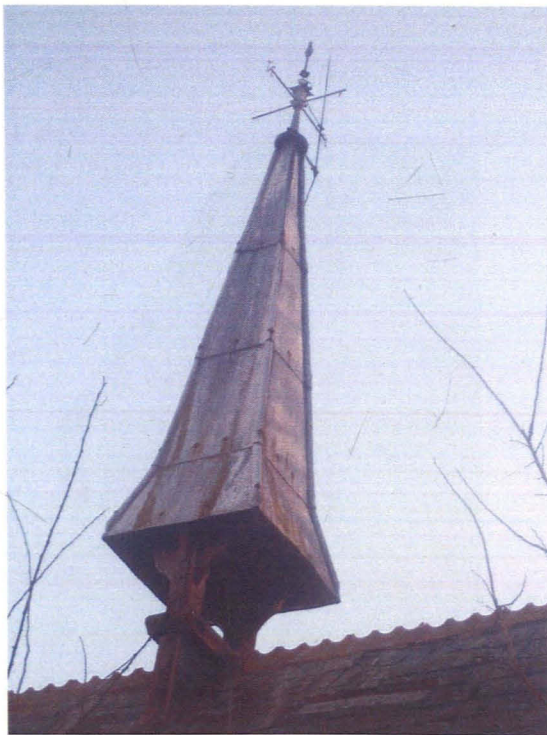
- 2 Roof covering: Steep pitched roof above flared base with 4 no. bays of assumed lead sheet showing corroding ferrous metal fixings with washers and limited distortion (Figs. 10, 11 and 17). Wind vane showing damage. Lightning protection down conductor clipped to south roof slope and timber structure, descending to run loose over main roof and clipped to elevation to east side of buttress. Limited distortion of leadwork, particularly to upper roof beneath wind vane, suggests possible movement associated with timber decay

Figure 10
General view of fleche, showing north and west faces. Note staining to assumed lead sheet roof covering.

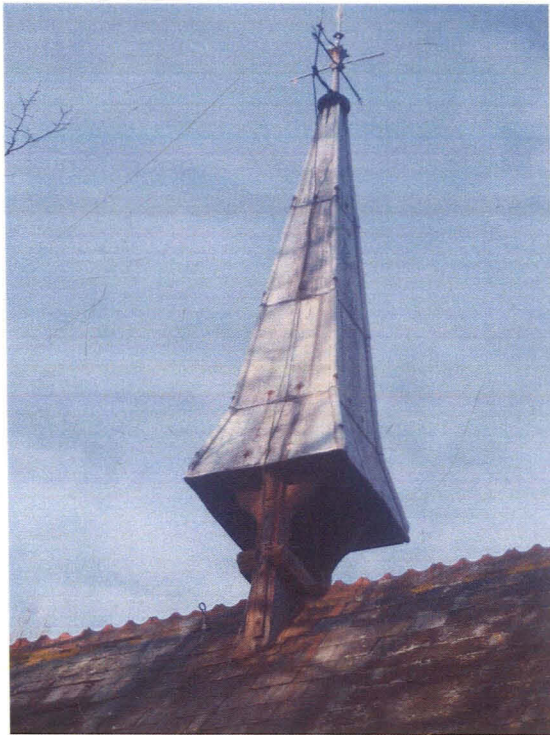
Figure 11
General view of flèche,
showing south and east
faces, with lightning
protection down conductor
to south.

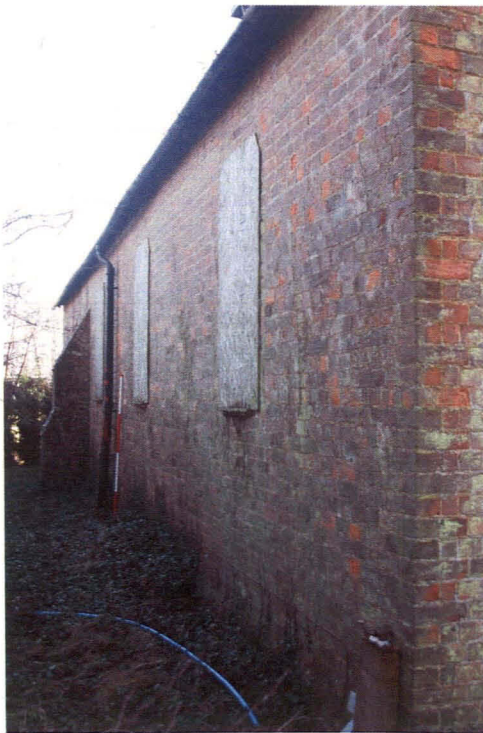
Figure 12
General view of north
elevation, looking east
and showing adjacent hedge
boundary, service pipe on
ground surface (see Fig.
13) and boarding over
windows.

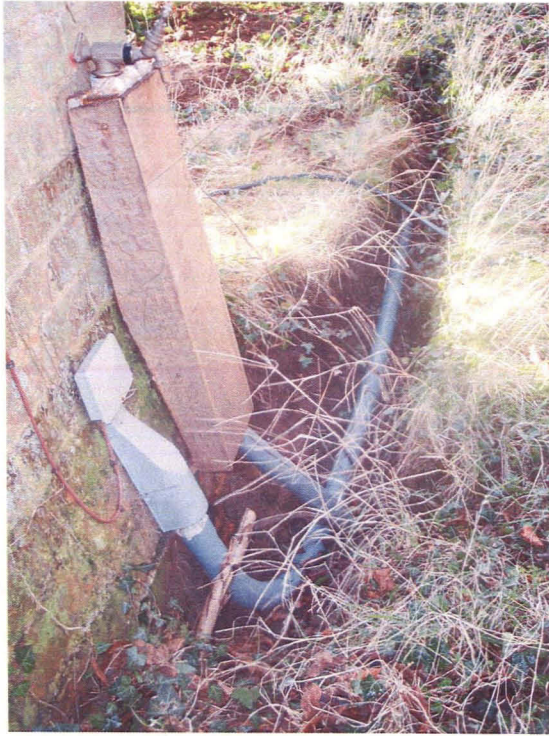
- 4 North (nave): Lower north-west corner of elevation exposed in open excavation and shows exposed brickwork at least 300mm below ground level (Fig. 13). Assumed continuation of wall down to footings/foundations or for direct bearing on ground strata. Ground conditions not investigated. Lower 1.0m of elevation largely obscured by vegetation, including invasive ivy growth and raised ground level (Fig. 16). Clipped cable running across elevation and turning through wall beneath window to west side of buttress. Small number of open and/or defective joints at high level beneath projecting eaves, particularly to west, and with redundant fixing adjacent to north-west corner. Pointing appears original and to be of a coarse lime-based mortar showing little erosion, although with likelihood of possible weathering and erosion at lower level where obscured by vegetation growth. Likely open and/or defective joints around ventilation grilles

Figure 13
Nave north elevation,
showing open excavation to
north-west corner of
building with service
connections.

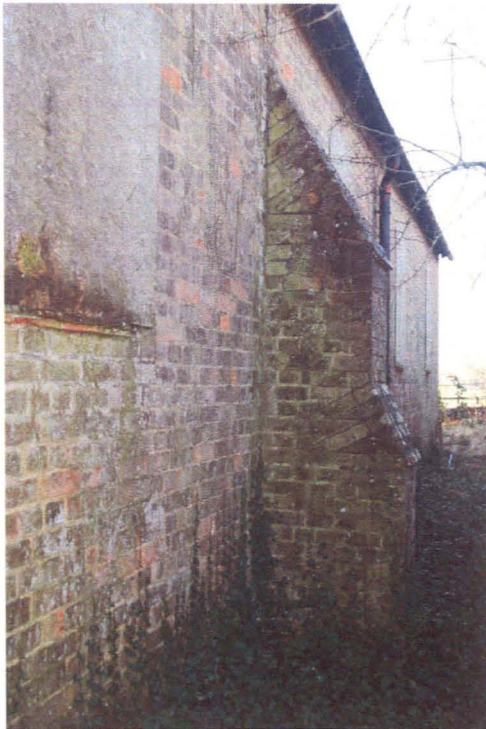
- 3 North (buttress B1): Two-stage buttress shows damage to upper stage weathering with direct water penetration and invasive vegetation growth (Figs. 14 and 15). Staining indicates saturation of buttress with risk of dampness and soluble salt migration to interior. Lower stage weathering shows a damaged brick with later cementitious pointing over damaged faces, together with small number of open and/or defective joints

Figure 14
Chancel north elevation,
looking west and showing
buttress (B1). Note staining
and biological growth to
buttress, being indicative of
saturation and with risk of
lateral moisture penetration
to interior.

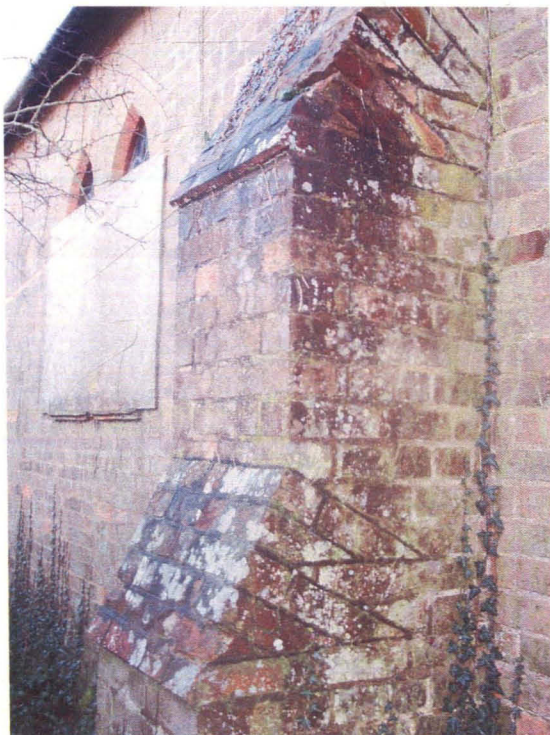
Figure 15
Chancel north elevation, looking east and showing boarding over window (W1), buttress (B1) with damage to upper offset. Note staining to buttress, being indicative of saturation and with risk of lateral moisture penetration to interior.

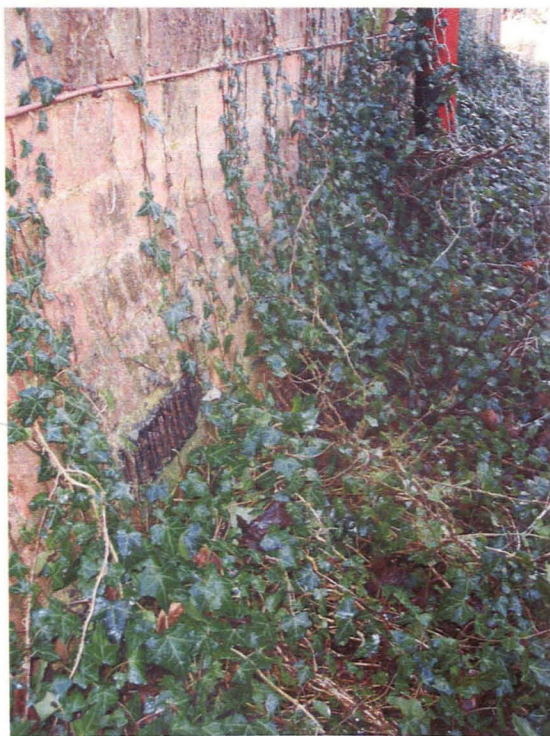
Figure 16
Nave north elevation, showing battered lower brickwork and invasive vegetation growth. Note partial blockage of ventilation grille serving internal sub-floor voids.

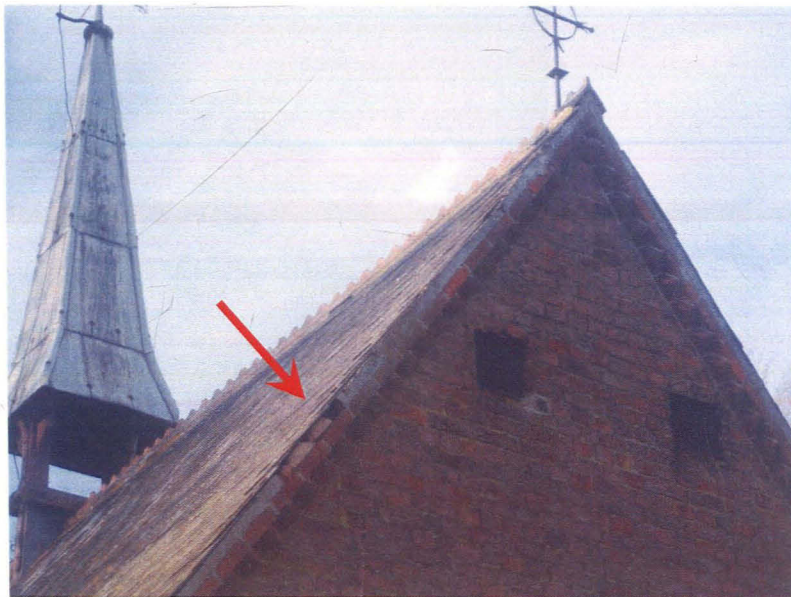
- 8 South (verges): East verge shows mortar failure and voids with risk of water penetration and exposed ends of timber boards supporting lower slate course (Fig. 17). West verge is similar and shows missing mortar with potential rainwater penetration, particularly at upper level, and exposed ends of boards supporting lower slate course

Figure 17
Upper chancel east elevation, showing damage to verge mortar (arrow) and failing mortar and/or brick displacement possibly associated with corrosion around ventilators.

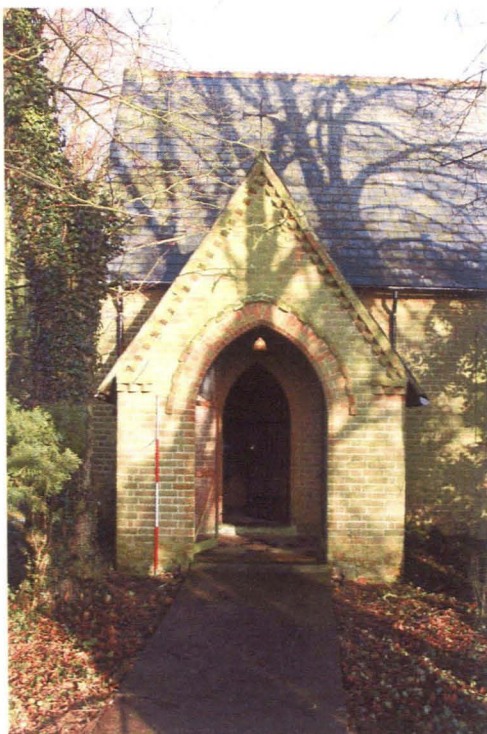
The ground around the church is rough and vegetated, with invasive growth on to lower walling. The site opens out to the south, with mature trees and pathway from the site entrance to the porch. Evergreen trees are shading parts of the south elevation and the path has been damaged by assumed tree-root action

Figure 18
Porch south elevation, showing damaged path leading from gate to archway (D1).

Remove vegetation. Repair path to porch

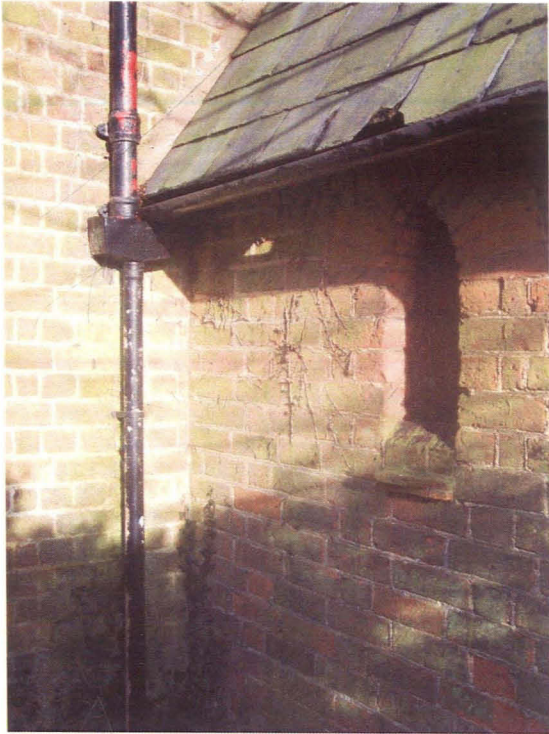
- 7 West (eaves): Staining, biological growth and beetle emergence holes to visible timber board and rafter feet, with fungal decay beneath 2 no. broken lower course slates (Figs. 19 and 20)

- 1 East: Grey plastic eaves guttering with failing black paint discharging via open north end into shared hopper. Assumed ferrous metal rafter brackets. Gutter filled with debris. Algal and slime growth on shared lower downpipe indicating failure with risk of saturation to adjacent brickwork (i.e. nave, porch) (Fig. 21)
- 2 West: Grey plastic gutter with failing black paint supported on single bracket with open south end supported on shared hopper (Fig. 19). Gutter shows debris

Figure 19
Nave south elevation,
showing shared rainwater
hopper head and damaged
eaves slate course to porch
west slope (see Fig. 20).

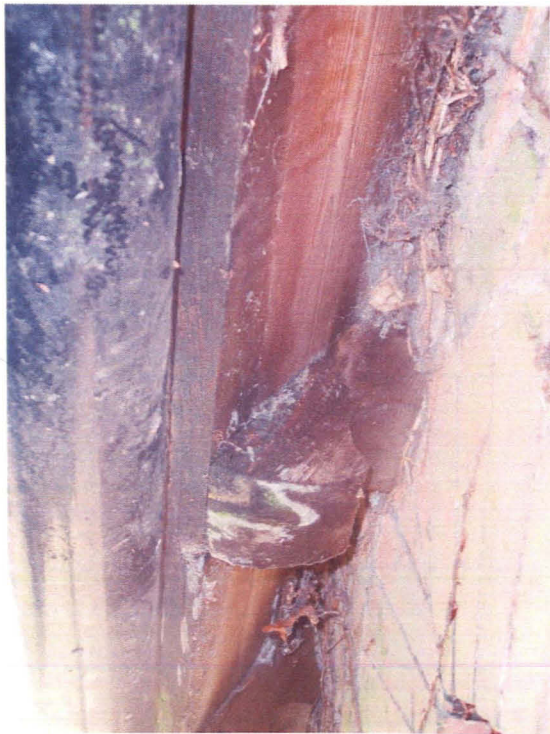
Figure 20
Underside of projecting
eaves to porch west slope,
showing staining and fungal
decay to rafter feet and
sarking board beneath
damaged eaves slate
course (see Fig. 19).

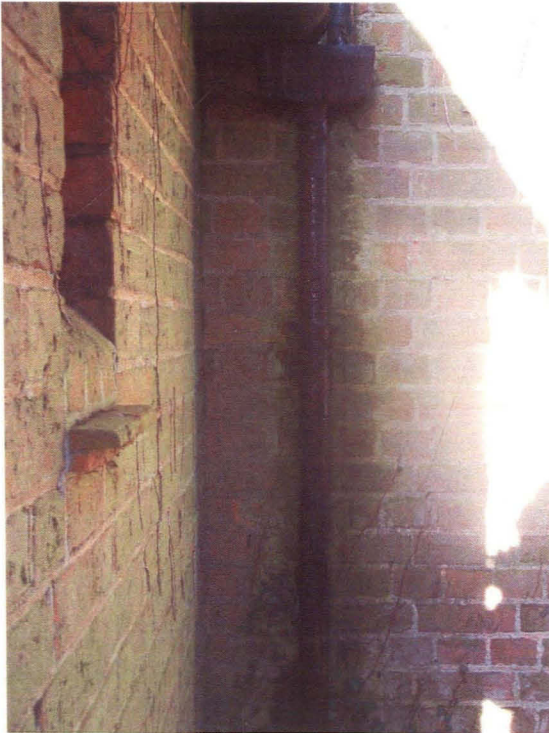
Figure 21
Nave south elevation,
showing biological growth
around downpipe to east
side of porch.

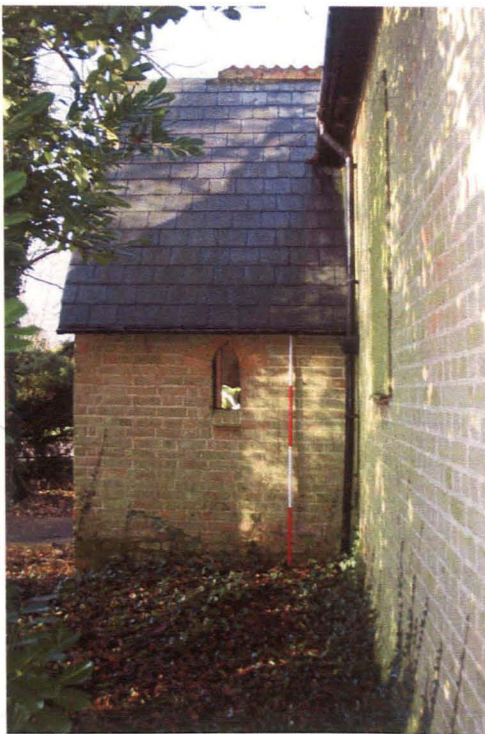
Figure 22
Porch east elevation,
showing missing south
ridge tiles.

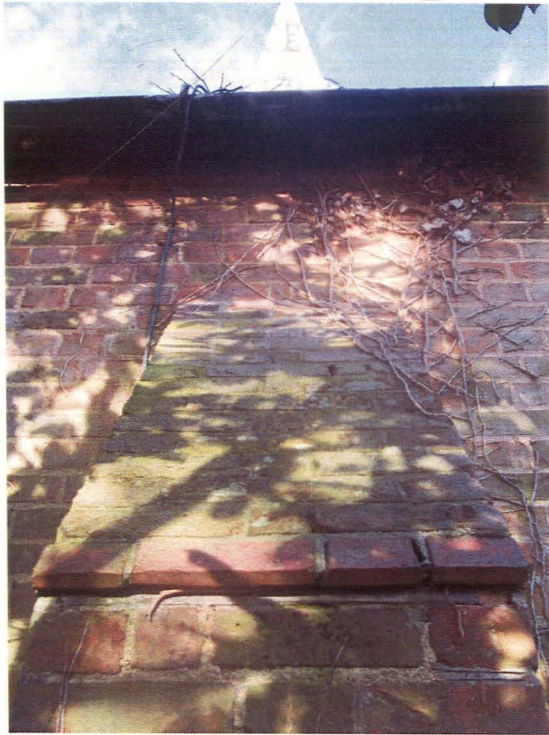
- 10 South (buttress B2): Limited number of open and/or defective joints to both stage weatherings with likely water penetration and risk of dampness to interior (Figs. 23 and 24)

Figure 23
Nave south elevation,
showing buttress (B2) with
open and/or defective joints
to upper offset.

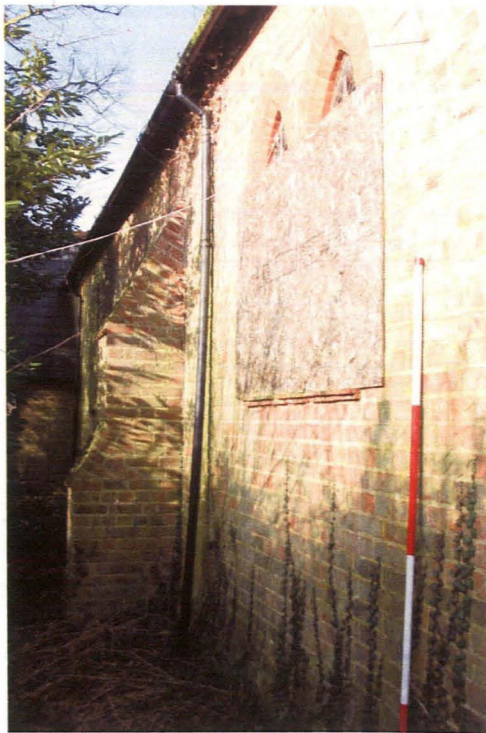
- 8 South (general): Red brickwork laid to English bond with two-stage buttress (B2), battered lower wall and ventilation grilles visible through vegetation (Fig. 24). Brickwork appears in reasonable condition relative to its age, construction and exposure. Evidence of slate damp-proof course (assumed two courses with staggered joints) in joint beneath observed ventilation grille

Figure 24
Chancel south elevation,
looking west and showing
buttress (B2) and rainwater
downpipe.

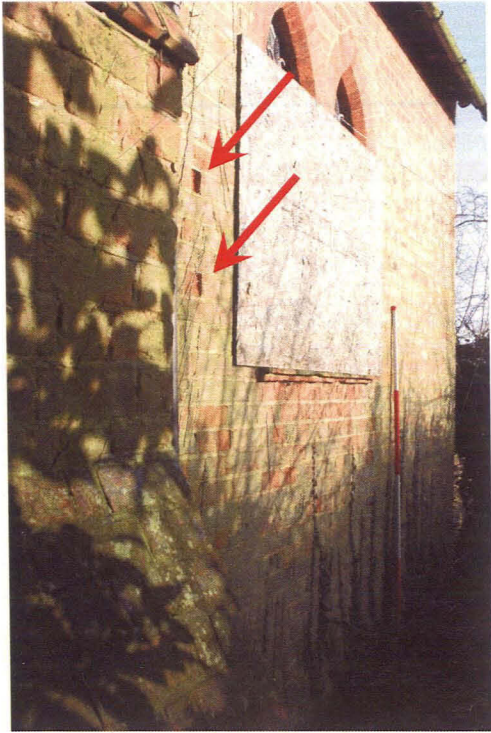
Figure 25
Chancel south elevation,
looking east and showing
boarding over window (W8).
Note individual spalling
bricks (arrows).

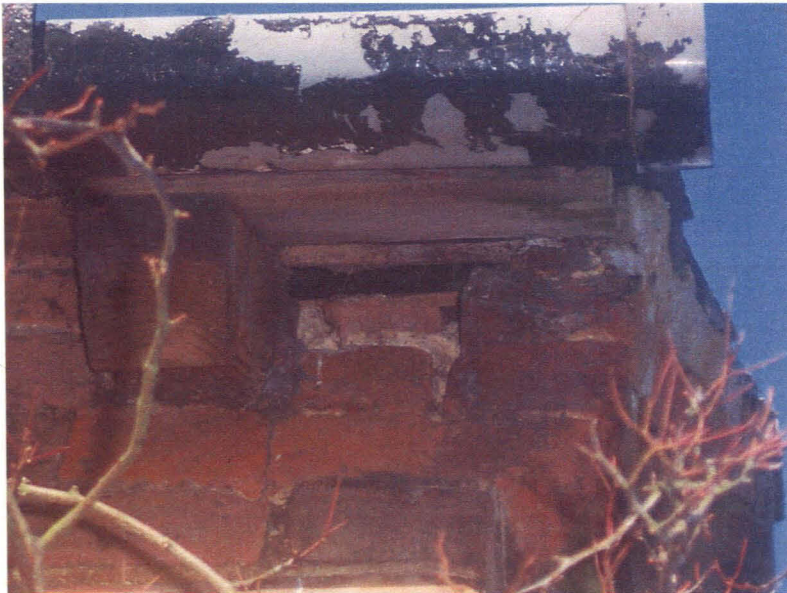
- 9 South (chancel): Void with possible loss of half brick, together with open and/or defective joints, to upper south-east corner reducing support to eaves board (Fig. 26). Small number of open and/or defective joints, particularly associated with previous downpipes fixing to east side of buttress (B2), and small number of spalling bricks (at least 5 no. bricks) adjacent to downpipe (Fig. 25). Dead vegetation adjacent to buttress and biological growth at low level around downpipe indicating saturation

Figure 26
Upper chancel south
elevation, showing gap
beneath projecting eaves.

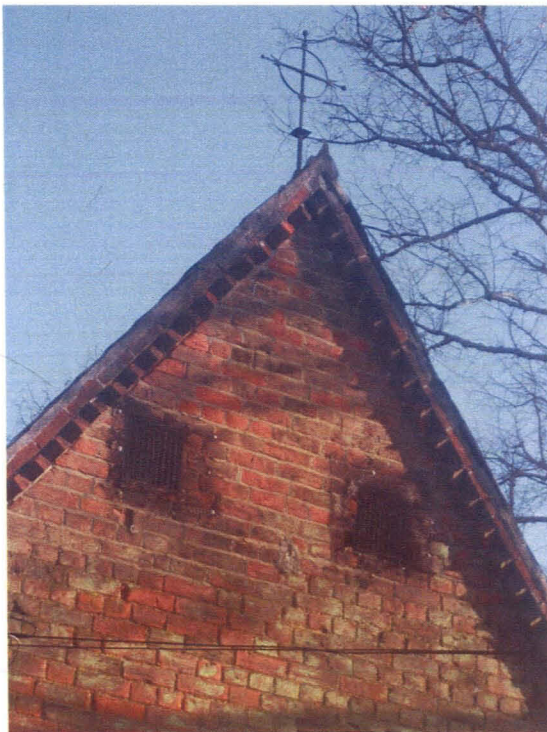
Figure 28
Upper nave west elevation,
showing failing mortar
and/or brick displacement
possibly associated with
corrosion around
ventilators.

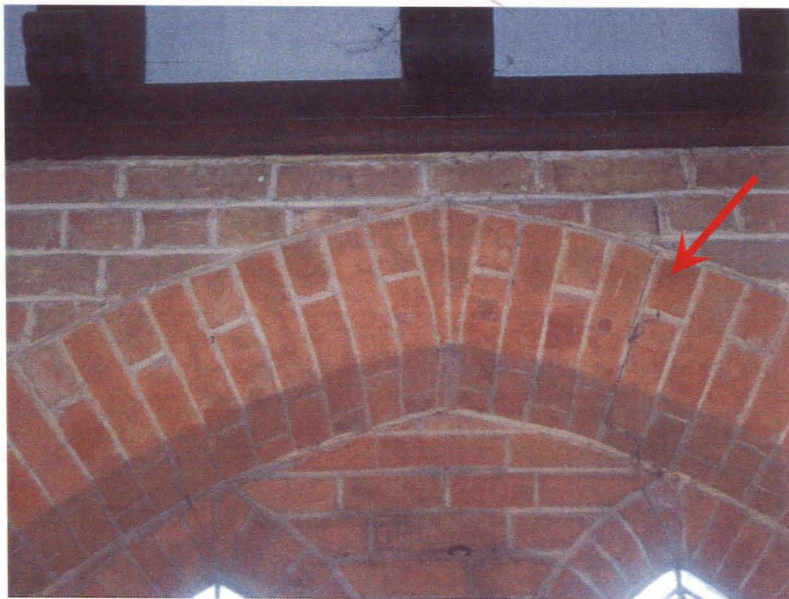
Figure 33
Chancel north wall, showing cracking over window (W1) (arrow).

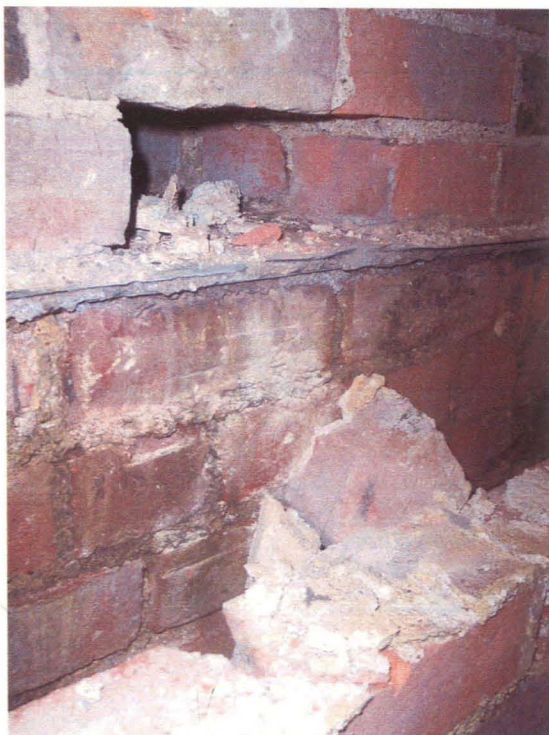
Figure 34
Nave north wall, showing slate damp-proof course and ventilation grille below floor level, with staining and soluble salt crystallisation to lower wall within sub-floor void. Note sleeper wall and 100mm gap with debris.

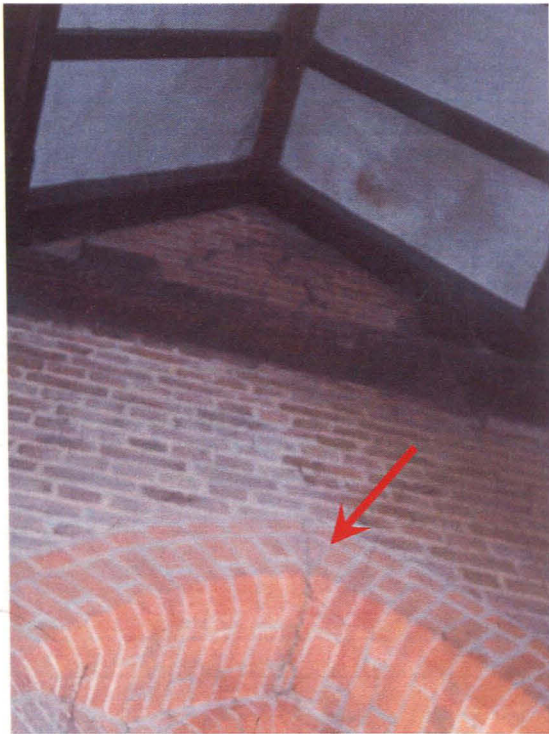
Figure 36
Porch north wall, showing cracking over doorway (D2) (arrow). Note staining to porch ceiling panels, being indicative of dampness.

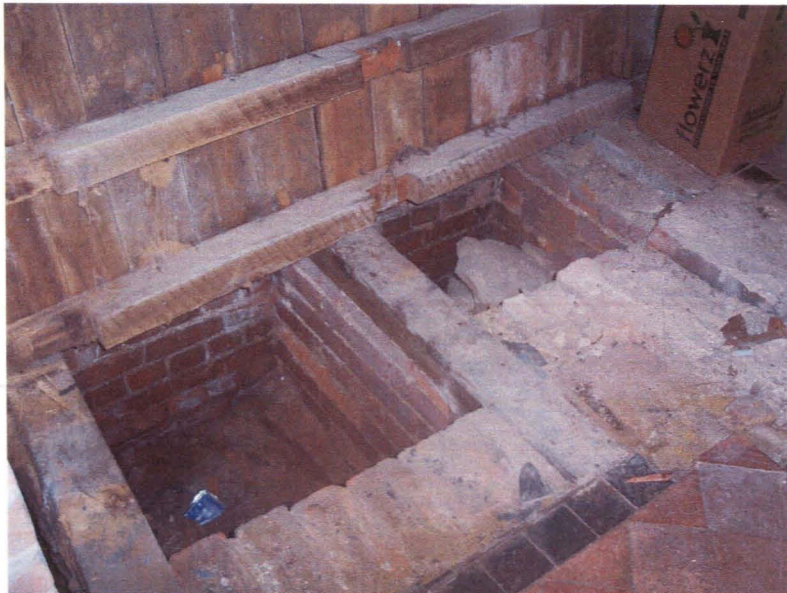
Figure 40

Nave floor, showing lifted flooring to south-west corner to expose timber plates on sleeper walls with voids and debris. Note coloured edging tiles around floor.

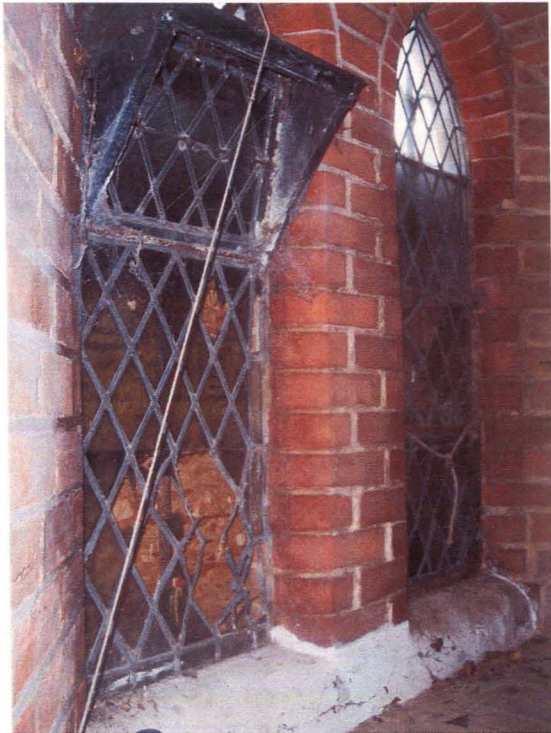
Figure 43
Chancel paired window,
showing damage to leaded
lights and corrosion to
frames and ventilation
hopper/slider.

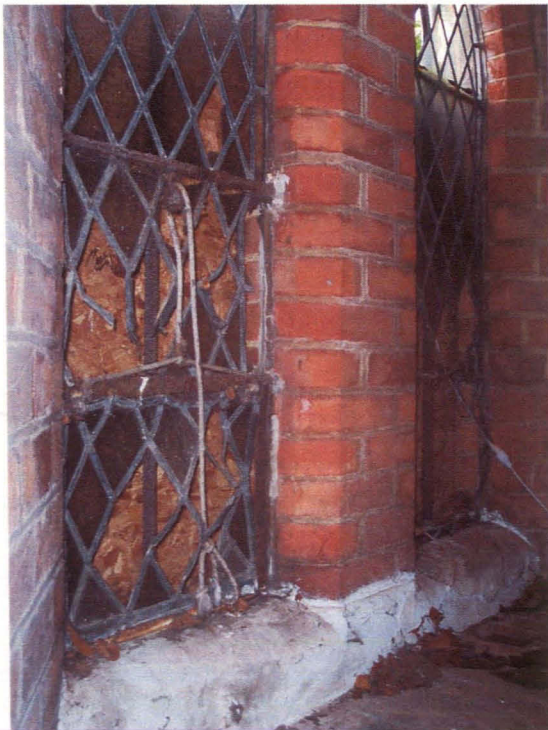
Figure 44
Chancel paired window,
showing damage to leaded
lights and corrosion to
frames and ventilation
slider.

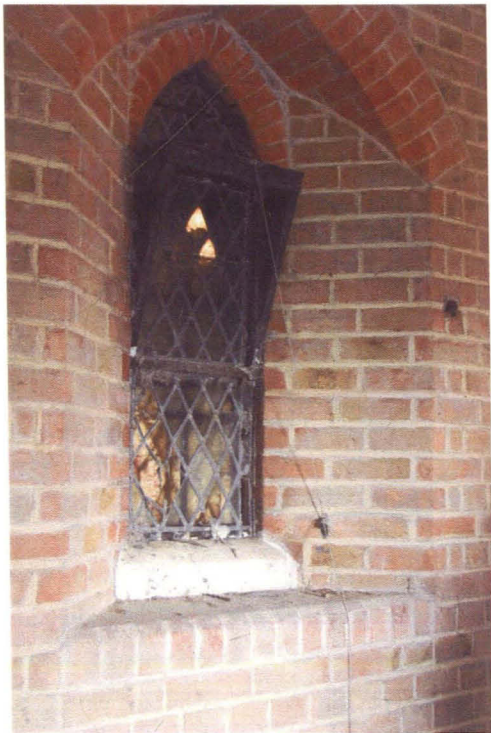
Figure 45
Nave window, showing
damage to leaded light and
corrosion to frame and
ventilation hopper.

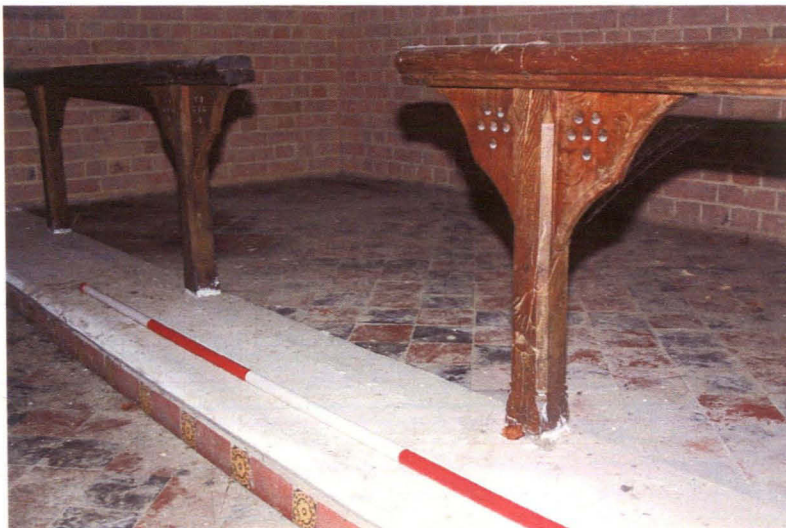
Figure 46
Altar rail with missing
hinged central section, with
decorative ceramic tiles to
step riser and tiles to
chance/sanctuary floors.
