GNR FOOTBRIDGES

LINCOLN TO GRANTHAM LINE

**SOUTH COMMON CUTTING
LINCOLN**

**Industrial Archaeology Section
University of the Third Age (Sleaford Branch)
July 2002**

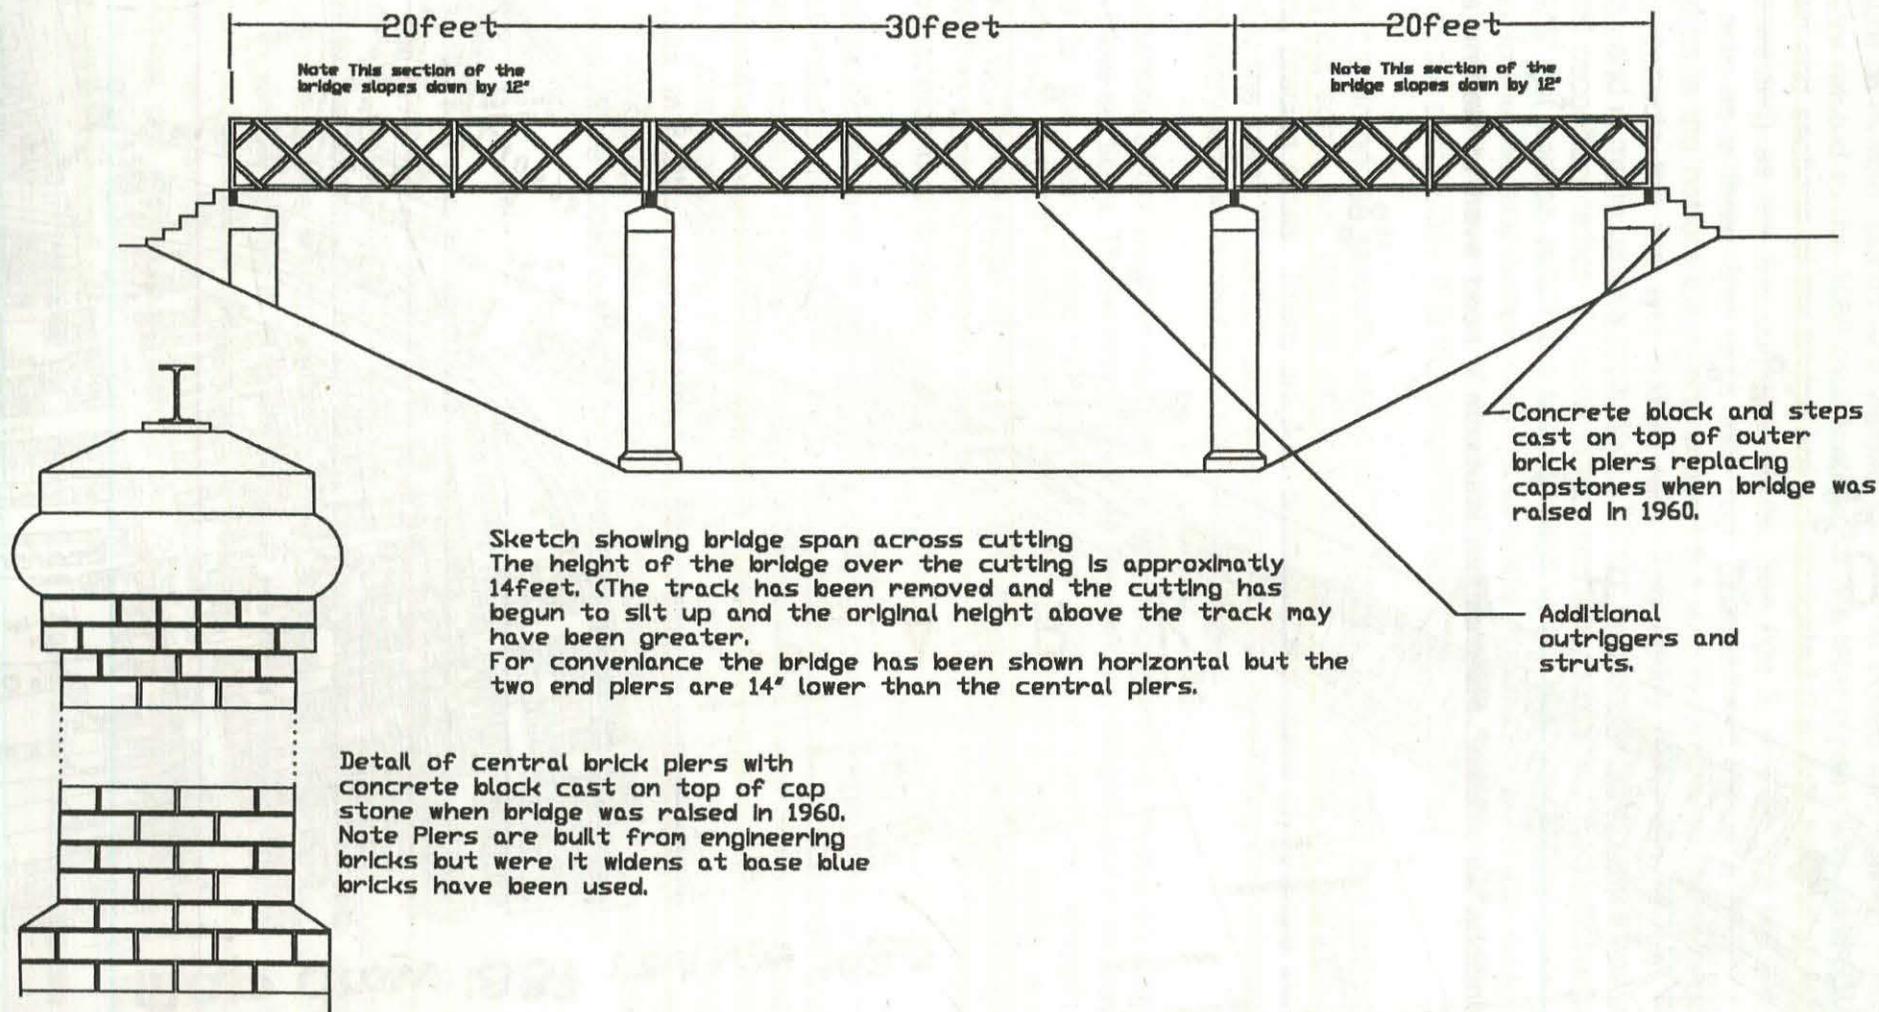
Cross section of cutting looking west showing Bridge support Piers.

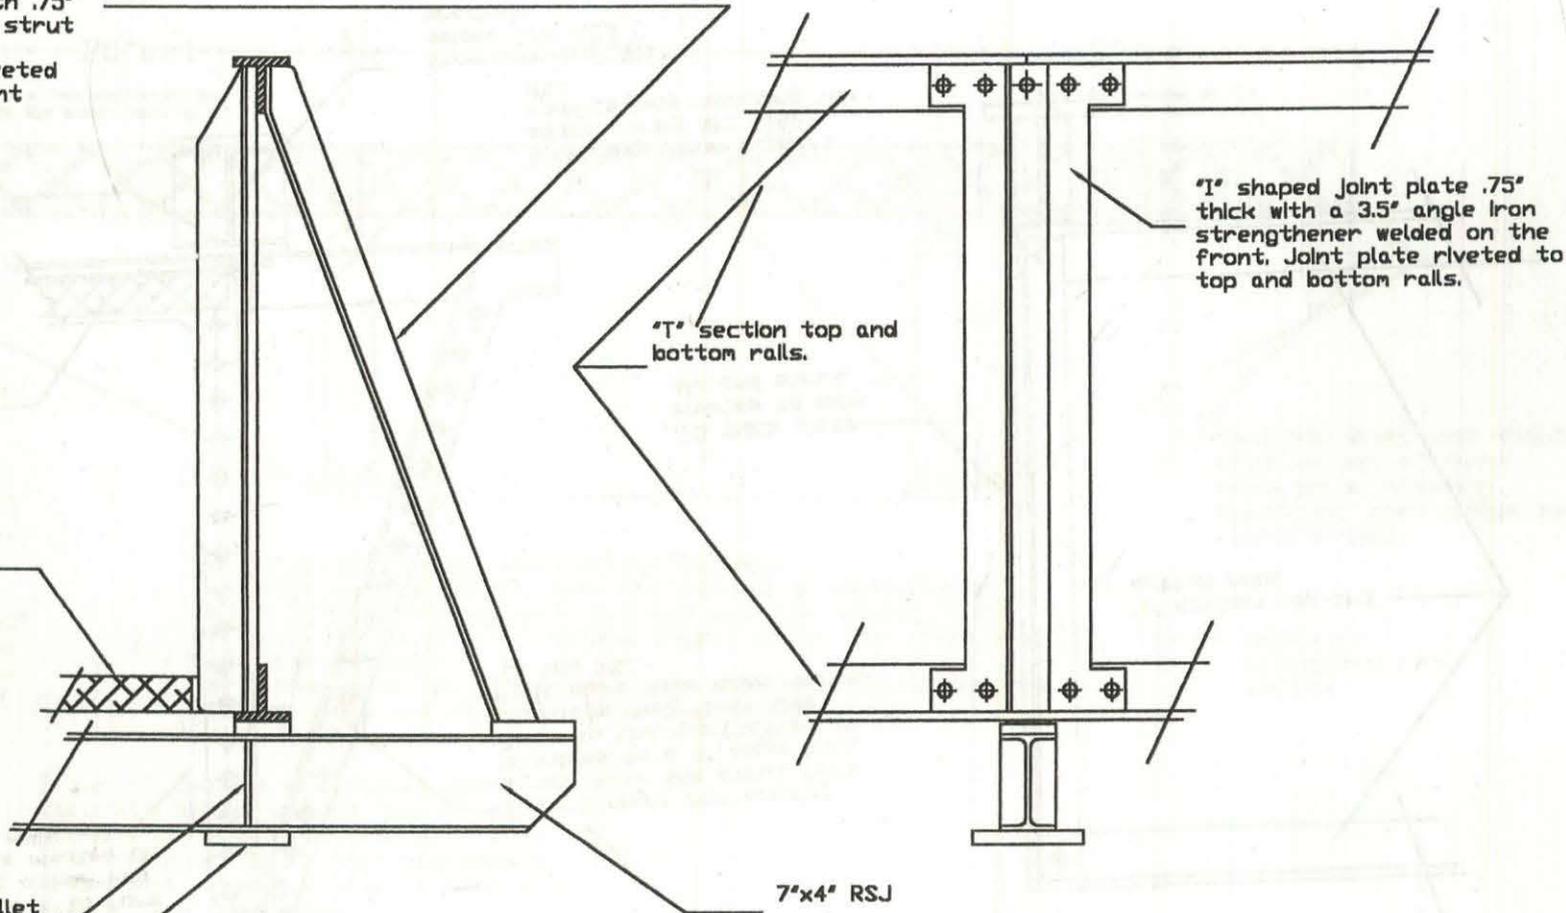
Fig 3

3.5" angle iron section bent to form a "U" shaped main tie at either end of the bridge. This tie is riveted on to the top and bottom rails.

3' bent angle iron bracing strut. Note the strut foot is welded to a 4" angle iron. Prior to the modifications in 1960 it is likely that this foot would have been riveted to the RSJ.

"T" section bottom rail welded to the 4" angle iron support and to a 7"x4" RSJ bracket. The bracket has a packer welded to the top and a foot welded to the bottom to fix it the concrete block, which has been cast on top of the end pier. It is likely that this bracket was originally an RSJ, similar to the one on the centre piers but was modified to form the bracket in 1960.

4"x4" angle iron support added during the 1960 modifications replacing the RSJ.
Strengthening fillet welded into RSJ bracket.

.75 thick plate riveted to main tie and strut.

3" angle iron strut with .75" foot weldon. Note the strut foot is welded to the supporting RSJ and riveted at the top to the joint plate.

Strengthening fillet welded into RSJ

Foot welded onto RSJ through which four bolts per foot are used to fix the RSJ to the top of the brick built piers.

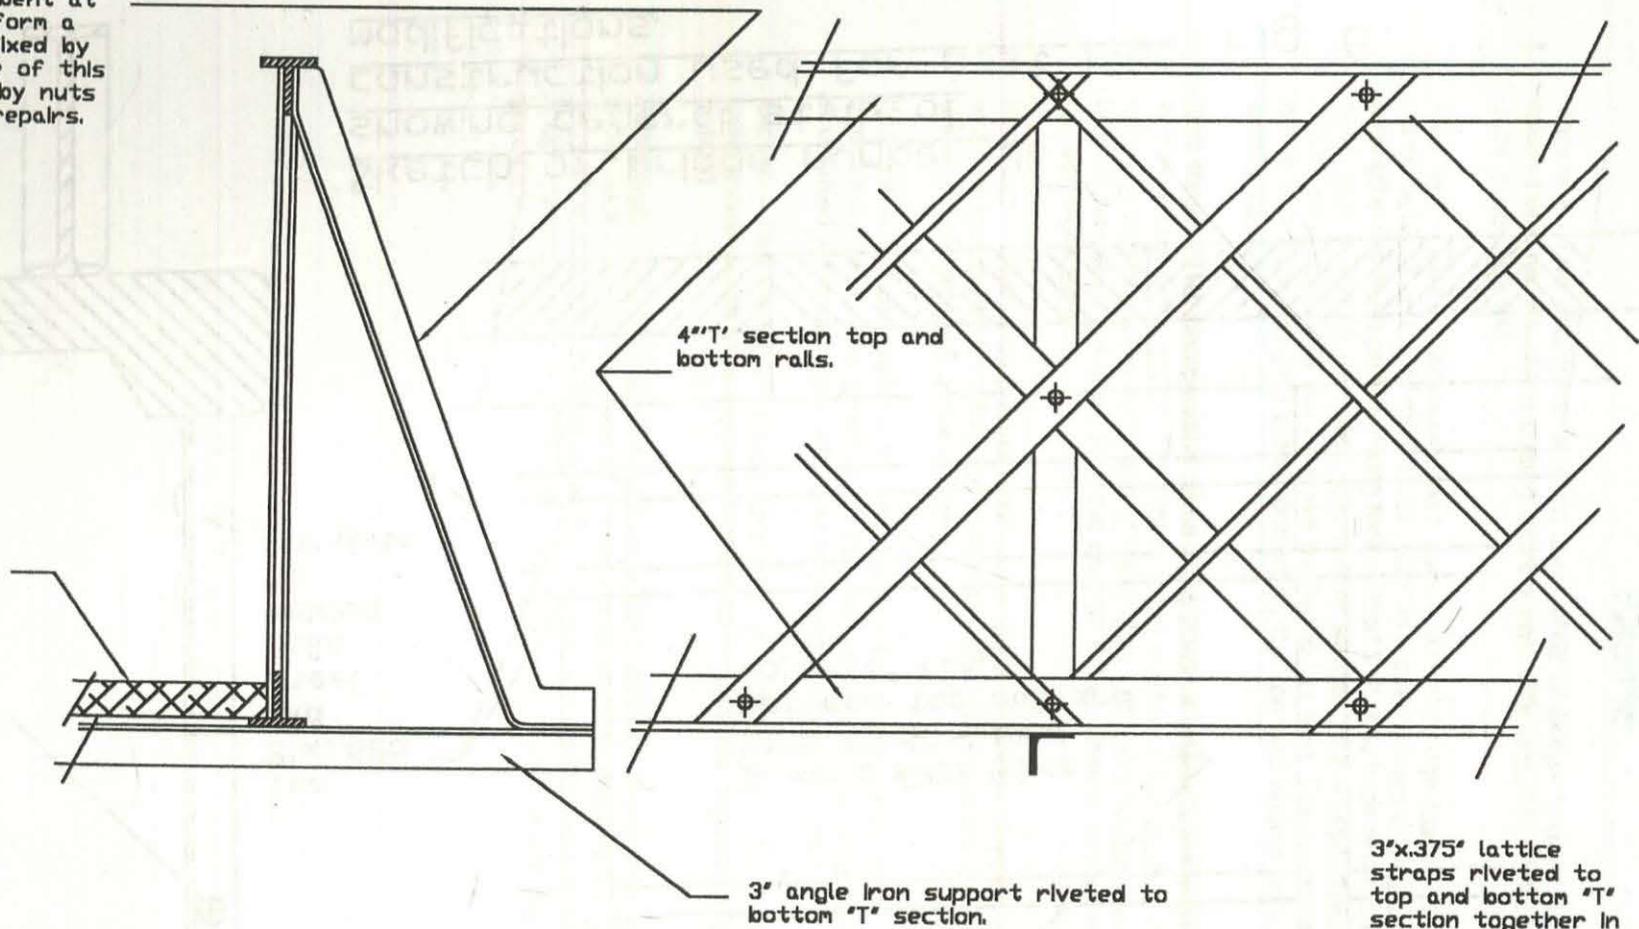
"I" shaped joint plate .75" thick with a 3.5" angle iron strengthener welded on the front. Joint plate riveted to top and bottom rails.

7"x4" RSJ

Detail of Bridge support on Central Piers and outriggers. (Lattice rail detail omitted)

3" angle iron strut bent at top and bottom to form a foot. The strut is fixed by rivets although some of this have been replaced by nuts and bolts as later repairs.

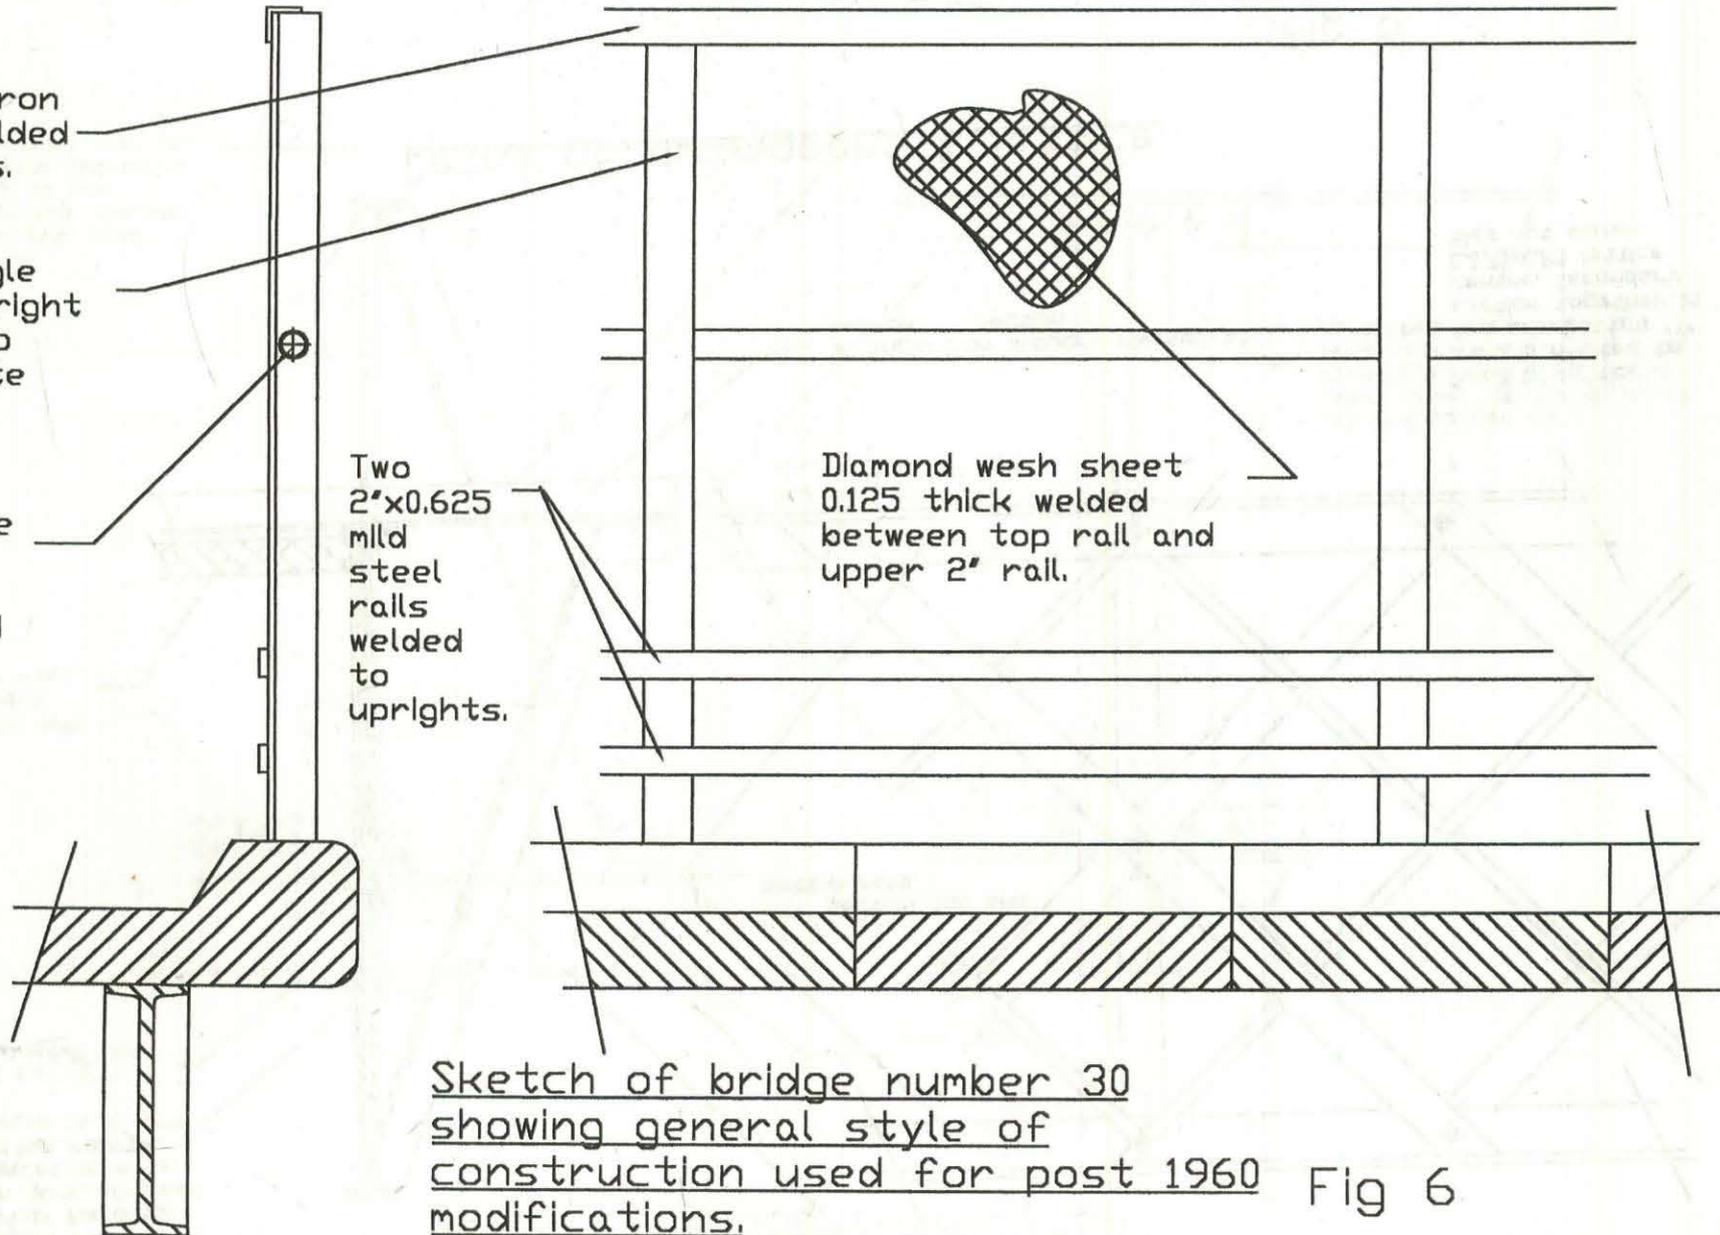
Fig 5

2.5" angle iron
top rail welded
to uprights.

3.5" angle
iron upright
set into
concrete
slabs.

2" dia tube
passing
through
and welded
to each
upright.

Two
2"x0.625
mild
steel
rails
welded
to
uprights.

Diamond mesh sheet
0.125 thick welded
between top rail and
upper 2" rail.

Sketch of bridge number 30
showing general style of
construction used for post 1960 Fig 6
modifications.

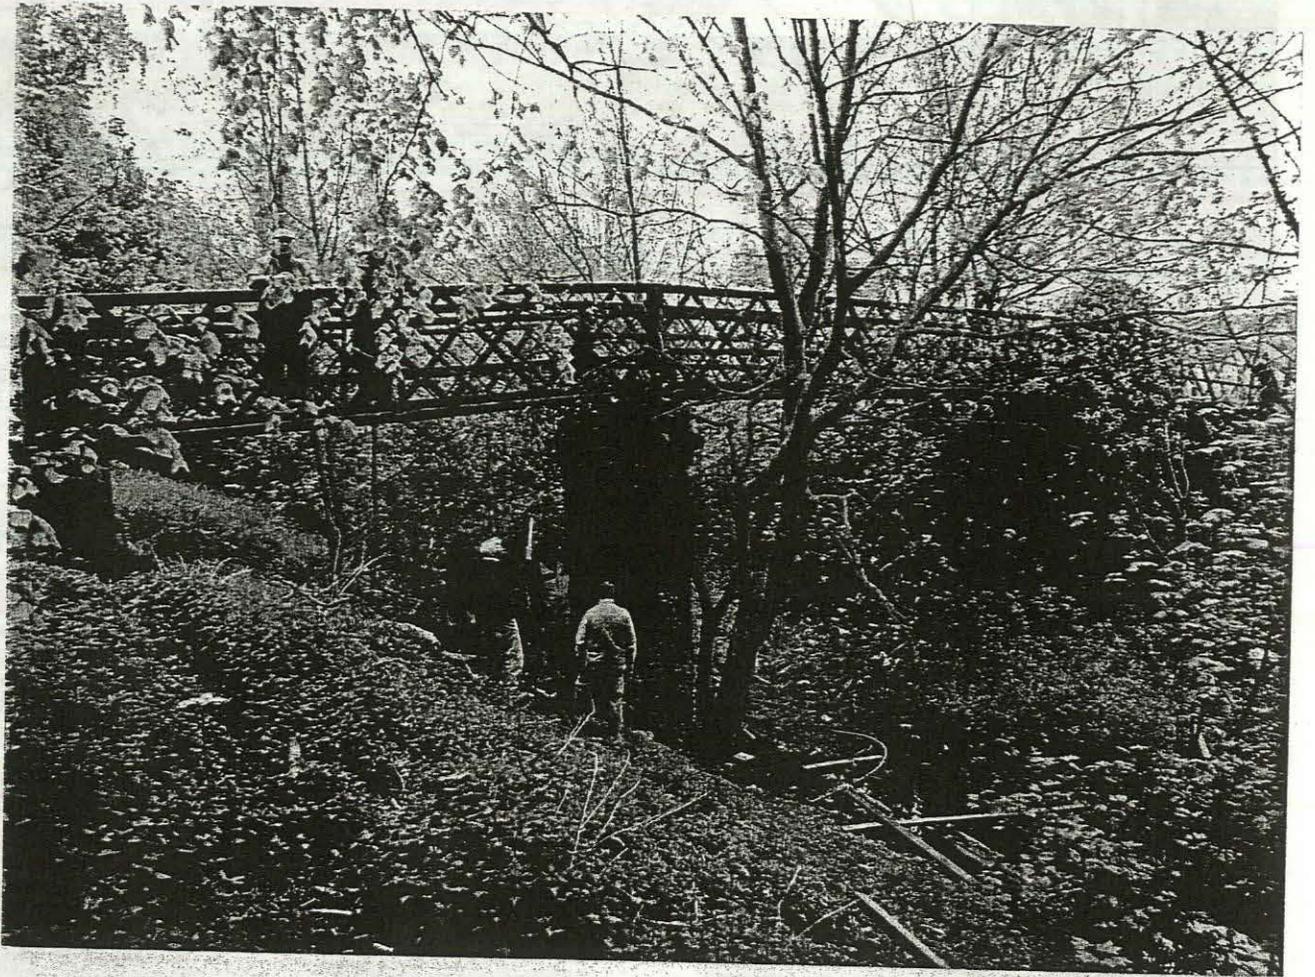
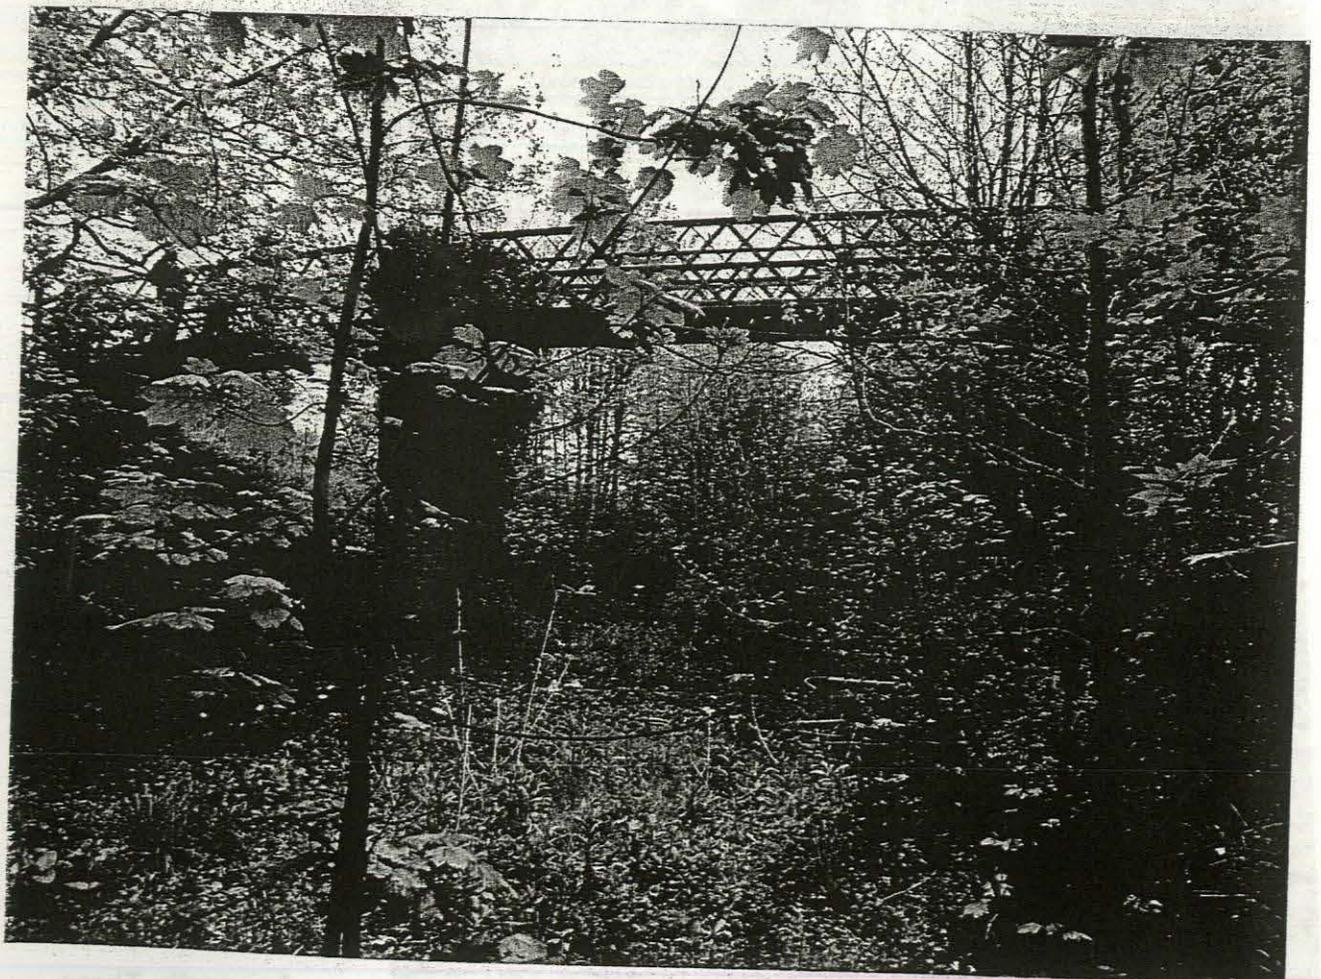
Appendix One

Item one - Two photographs taken June 2002 of Bridge Number 31. The first photograph is taken from the top of the cutting looking east. The second is taken from the bottom of the cutting looking west.

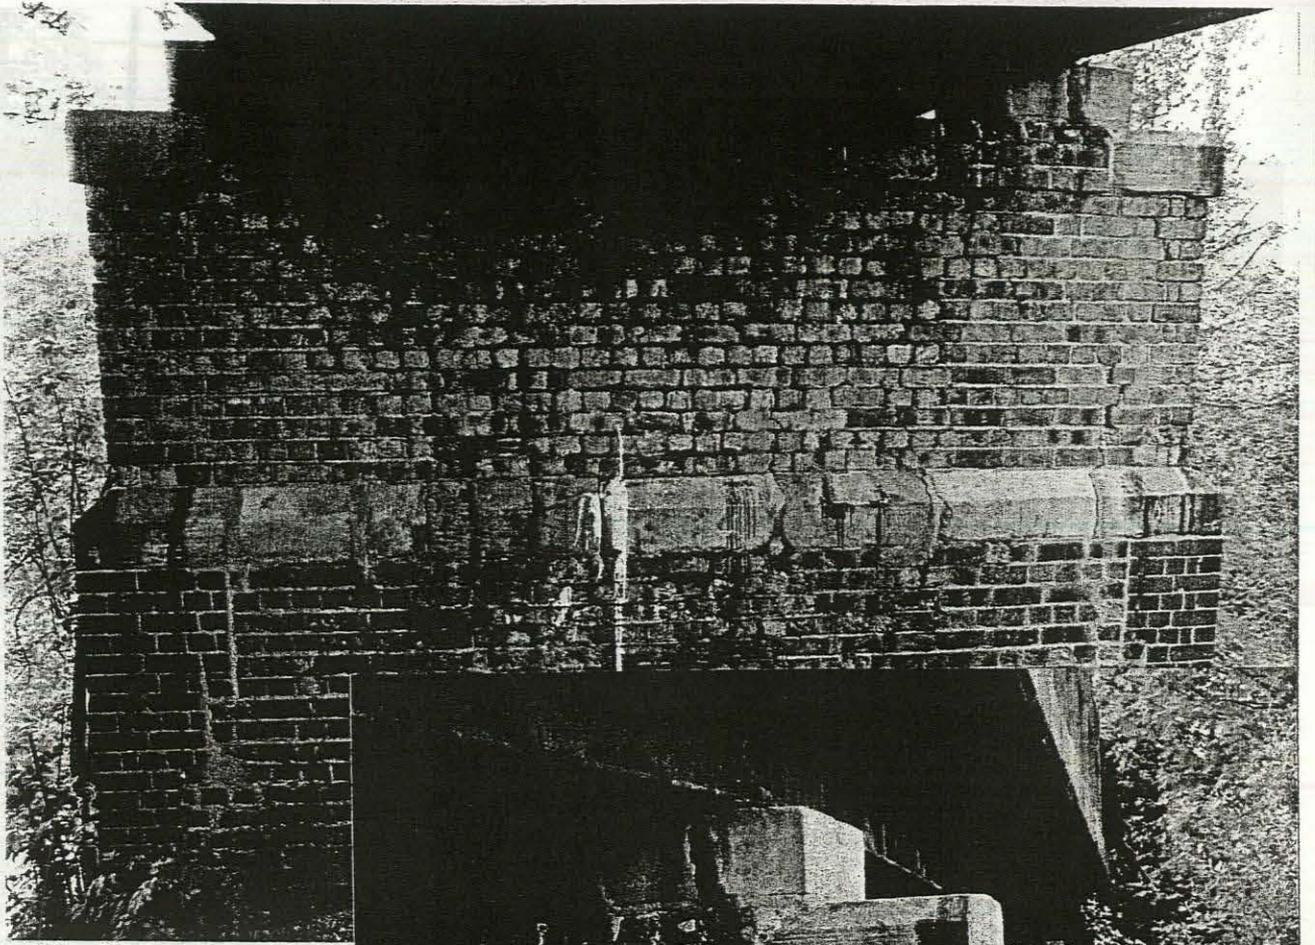
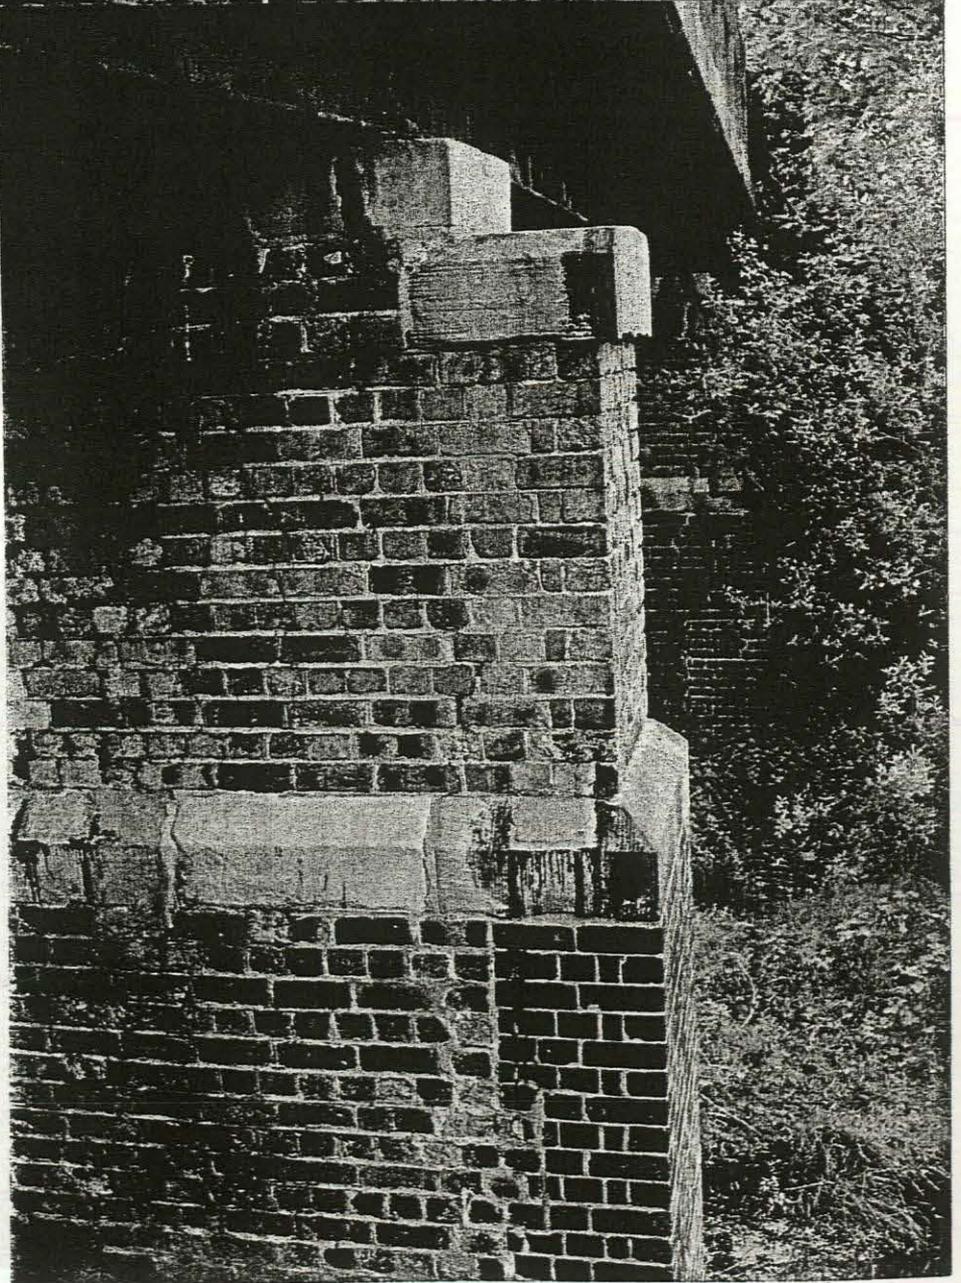
Appendix Six

Item six - Two photographs take June 2002 of Bridge Number 30. These are both show taken looking east. Apart from the piers there is no trace of the original bridge, which was replaced in 1960.
