STRUCTURAL SURVEY  
OF  
CATHEDRAL CLOSE WALL  
POTTERGATE  
LINCOLN  
LCW98

Undertaken for  
the Dean and Chapter  
Cathedral Works Department  
Lincoln

June 1998

A.P.S. Report No. 44.98

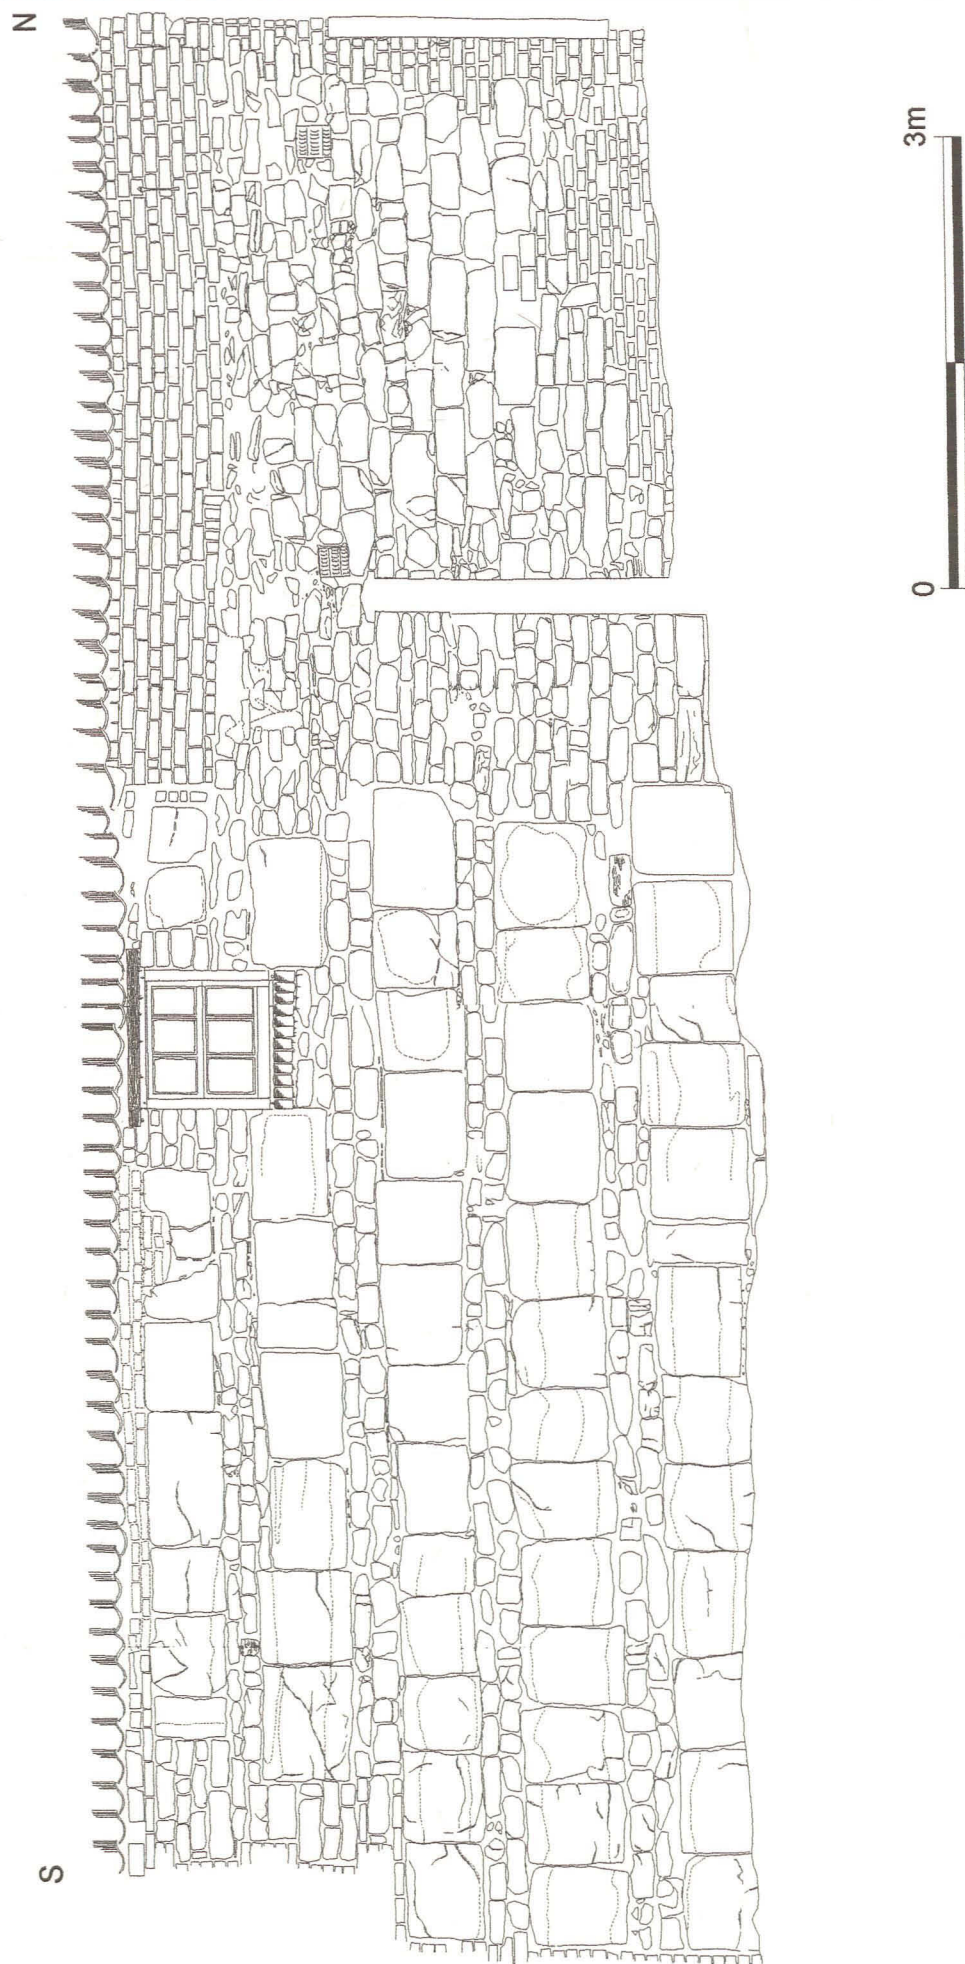
Figure 4 East facing elevation of the Cathedral Close Wall, Pottergate.

brickwork of this wall can be seen at the northern extremity of figure 4.

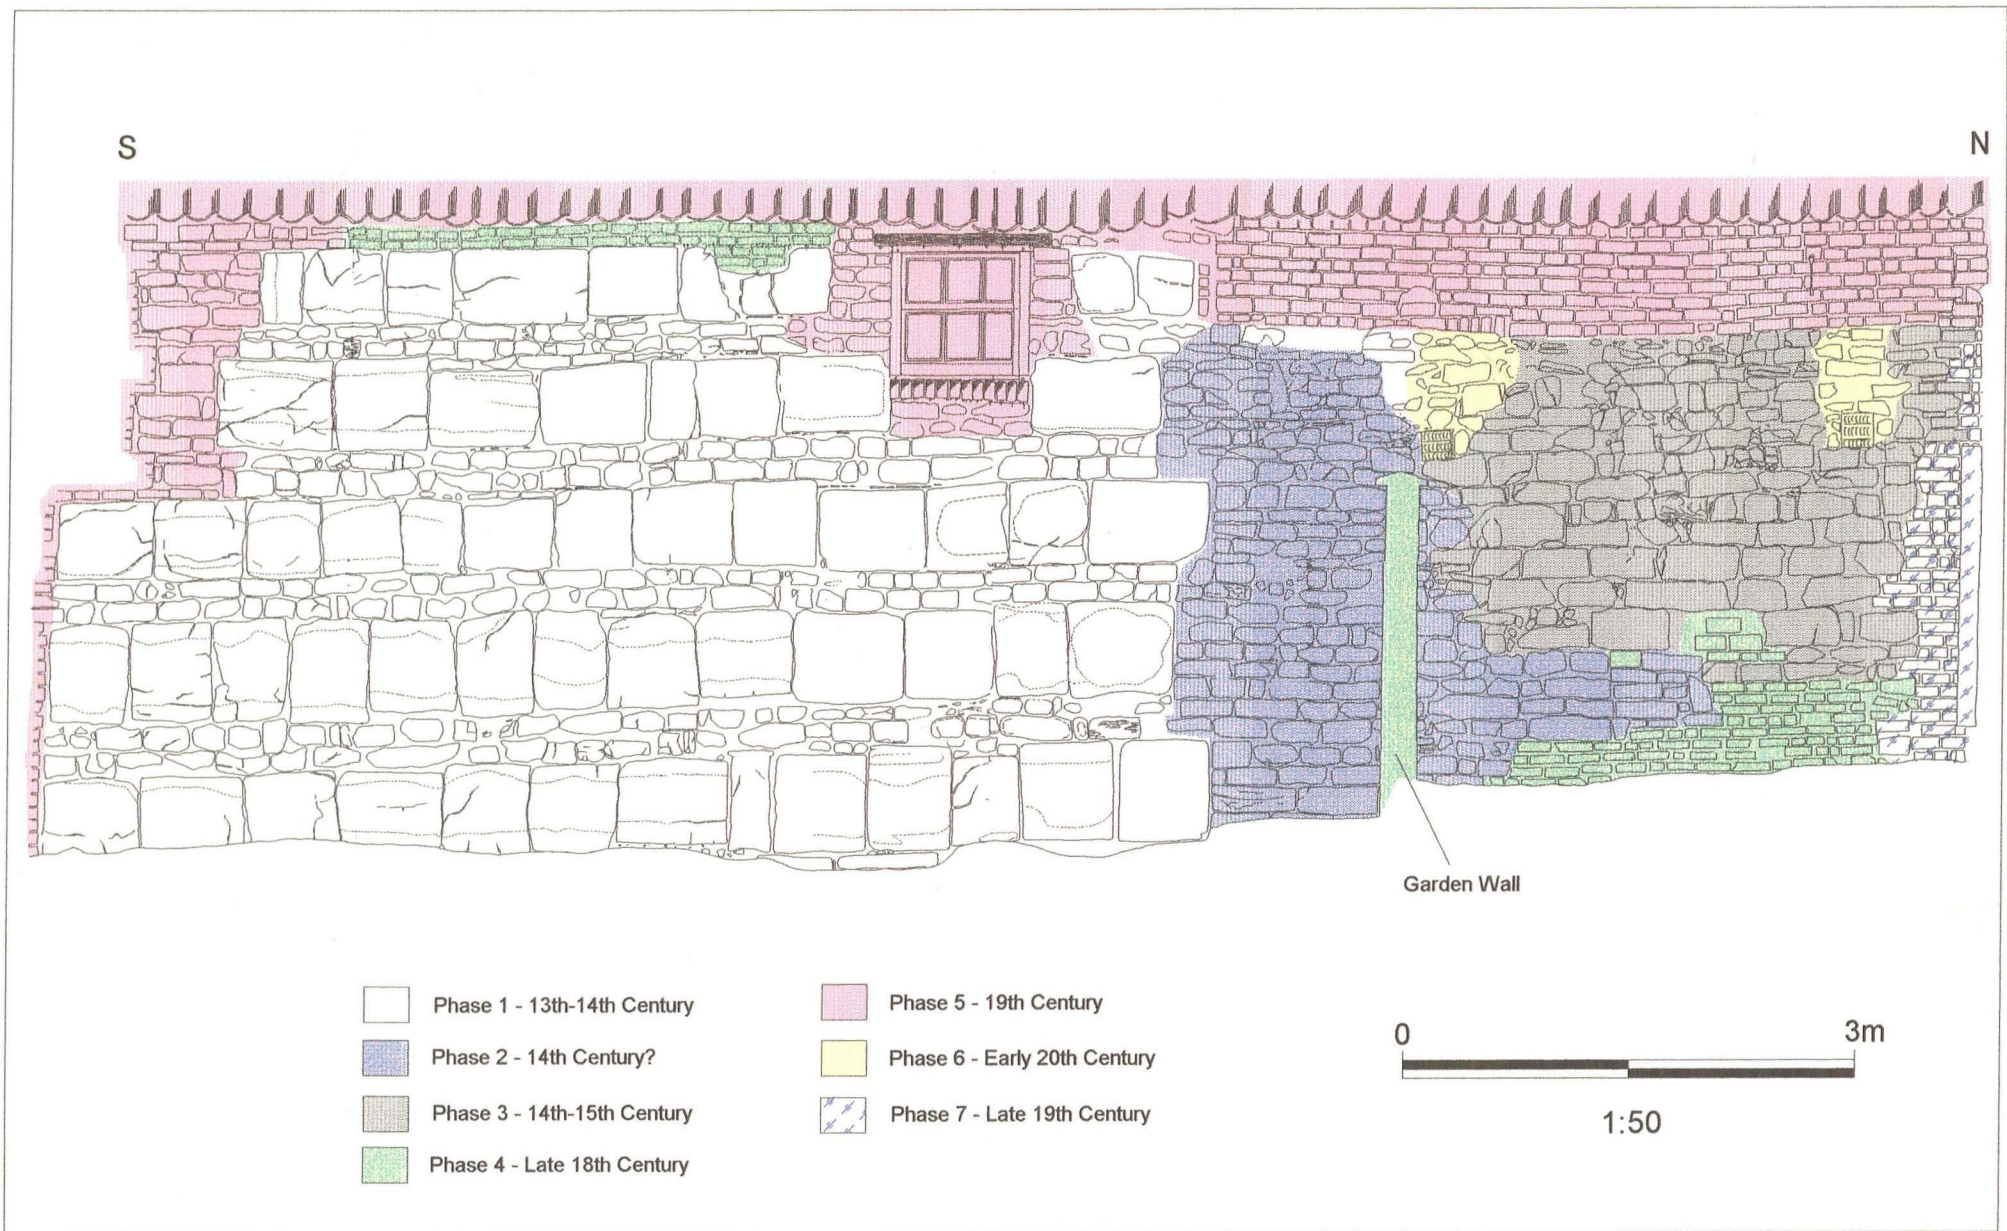
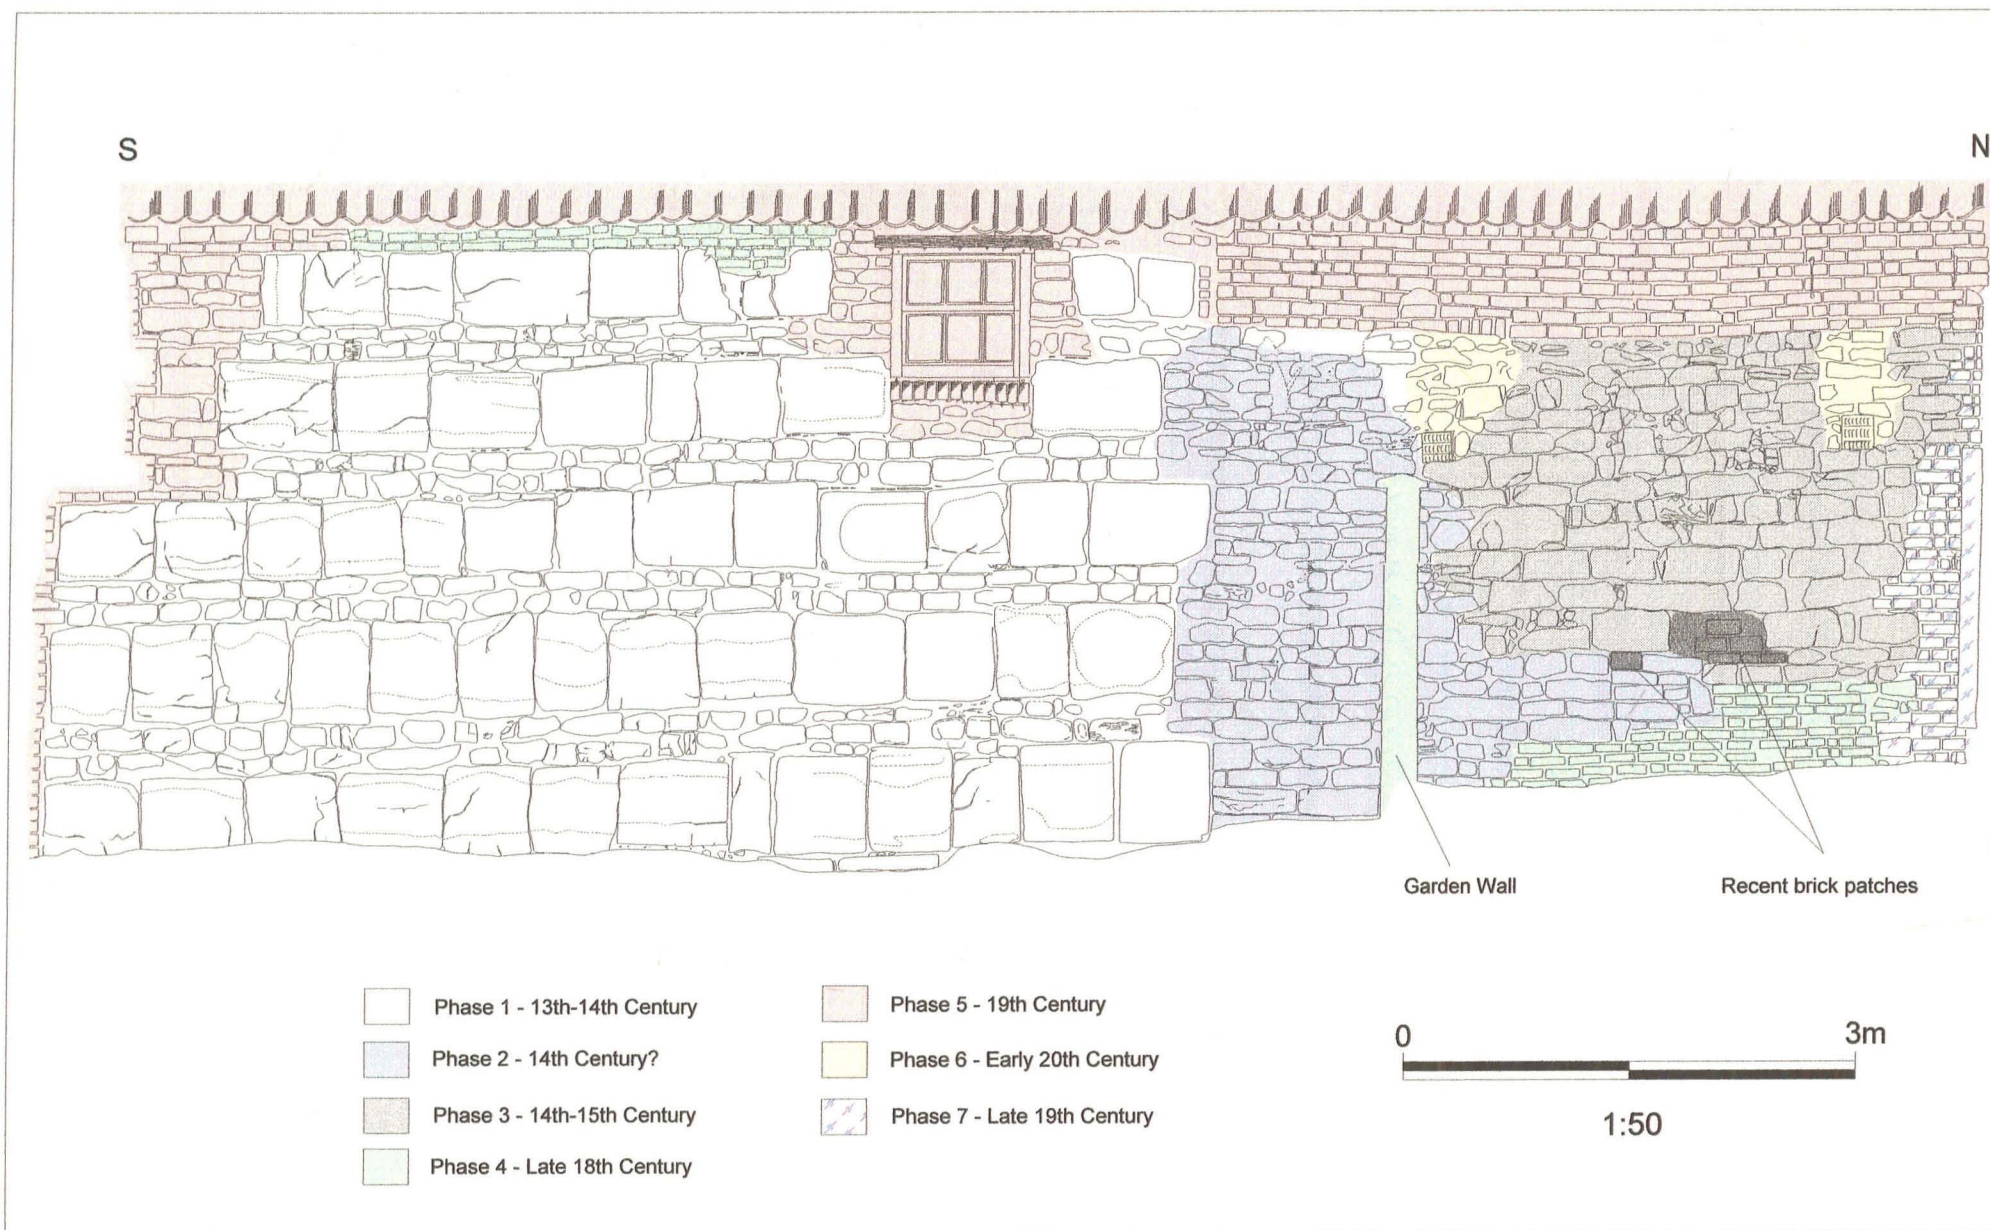
Figure 5 East facing elevation of the Cathedral Close Wall, Pottergate.  
Main phases of construction.

The stonework of Phase 1 extends 7.5m from the south end of the wall, and occupies just over half of the total area recorded (Fig 5). Apart from two courses of bricks at the top of the wall, the masonry from this phase reaches almost to the full height of the structure.

Damage to this phase of wall is mainly limited to the west edge and lower two courses which display concave recesses in the centres of the larger stones, presumably caused by weathering. However, less severe erosion was noted to much of the Phase 1 stonework.

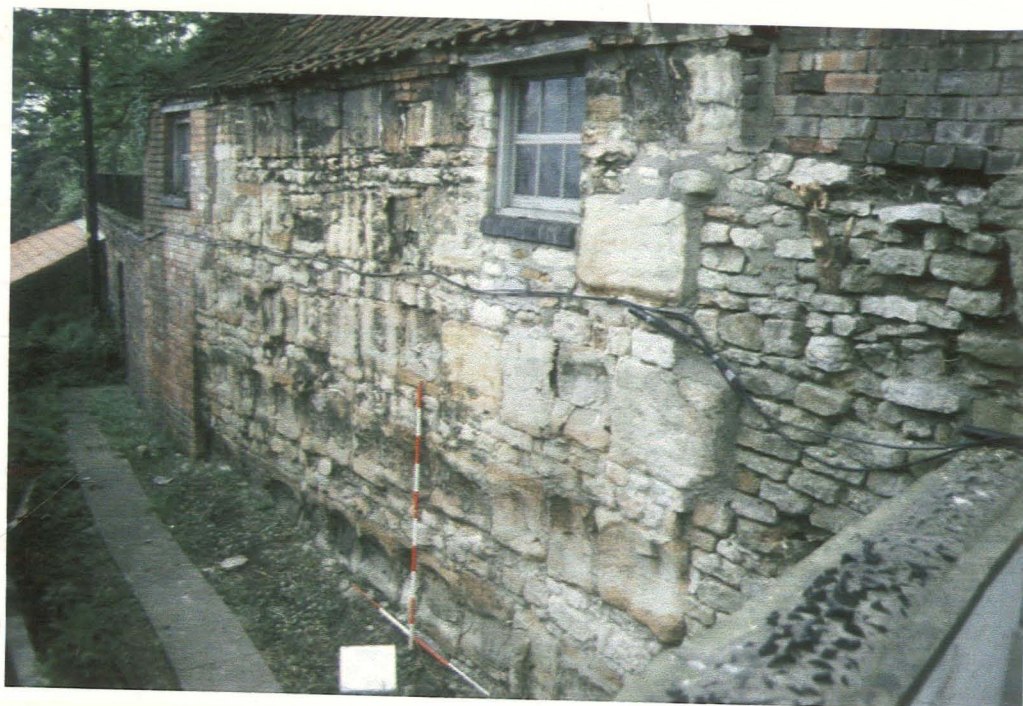
▲Plate 1 East Facing  
Elevation. Phase 1 and 2,  
from northeast.

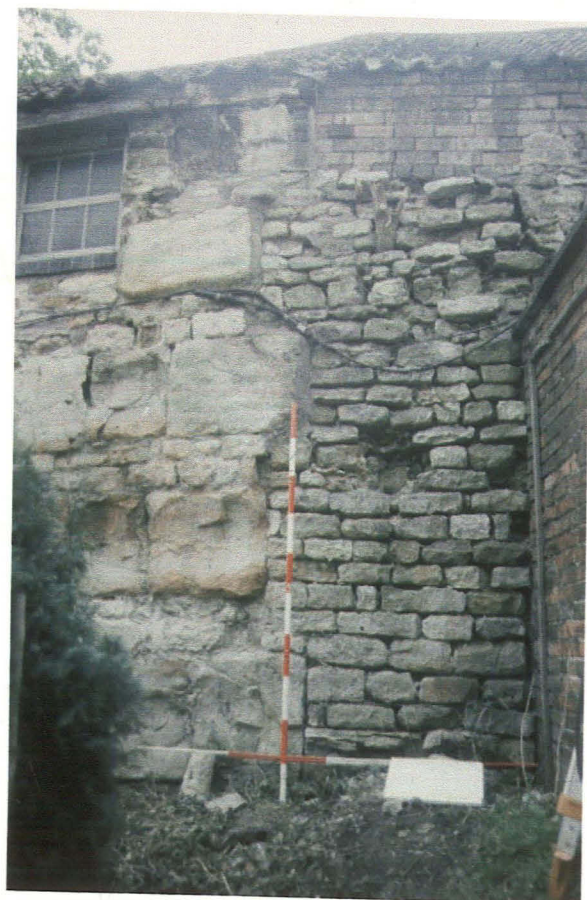
◀Plate 2 Phase 1 and 2,  
from east.

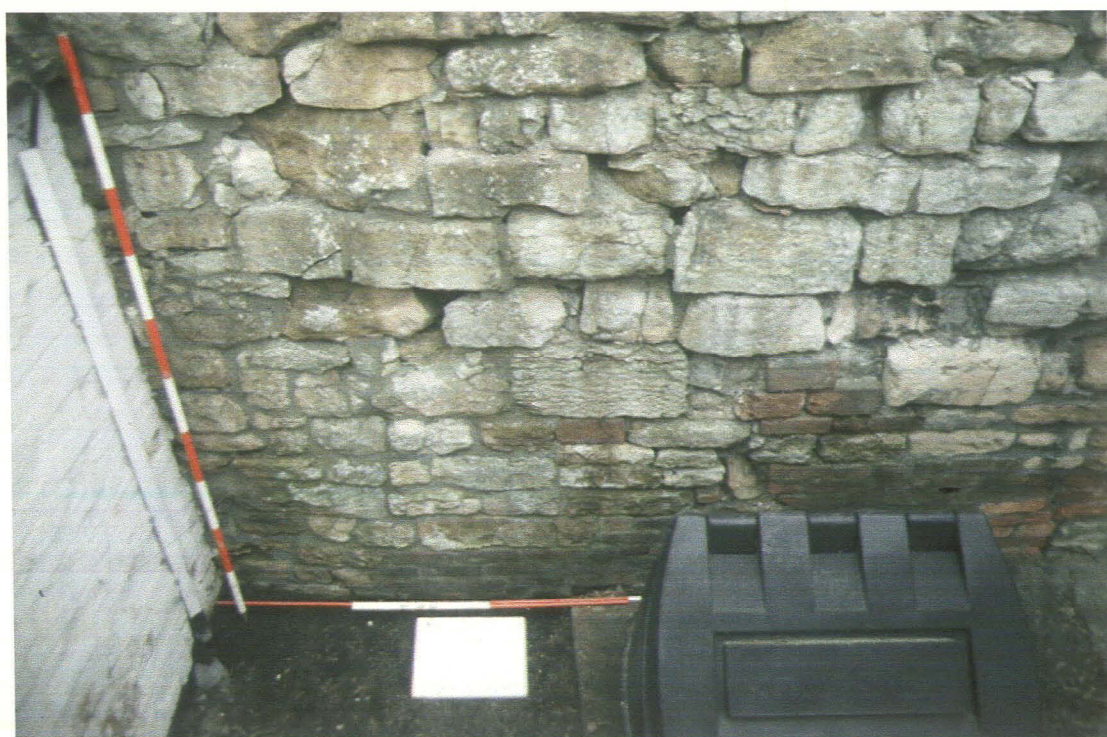
Phase 3 construction is located near to the north end of the wall, meeting Phase 2 masonry to the south and extending almost to the northern limit of the structure. The limestone used is slightly larger than that of Phase 2, although of the same rough hewn variety. The top northwest corner of Phase 3 has bowed out of alignment and is in danger of collapsing.

A very fragile and badly disintegrated, mid brown lime mortar formed the matrix between the stones of Phase 3.

Phase 3 probably represents a repair to the fabric of the wall, although the size of the stones is different to those used in the earlier phases, indicating that the existing, fallen masonry was not re-used. This might suggest that some time had elapsed between the damage and the repair. This is the only phase when worn ashlar blocks were used, presumably taken from damaged or demolished buildings within the city.

Plate 3 Phase 3, (repair adjacent to Phase 2) from east.
