# **Millpool Farm barn, Goldsithney, Cornwall**

## **Historic Building Record**

2011R048

Millpool Farm barn, Goldsithney, Cornwall  
Historic Building Record

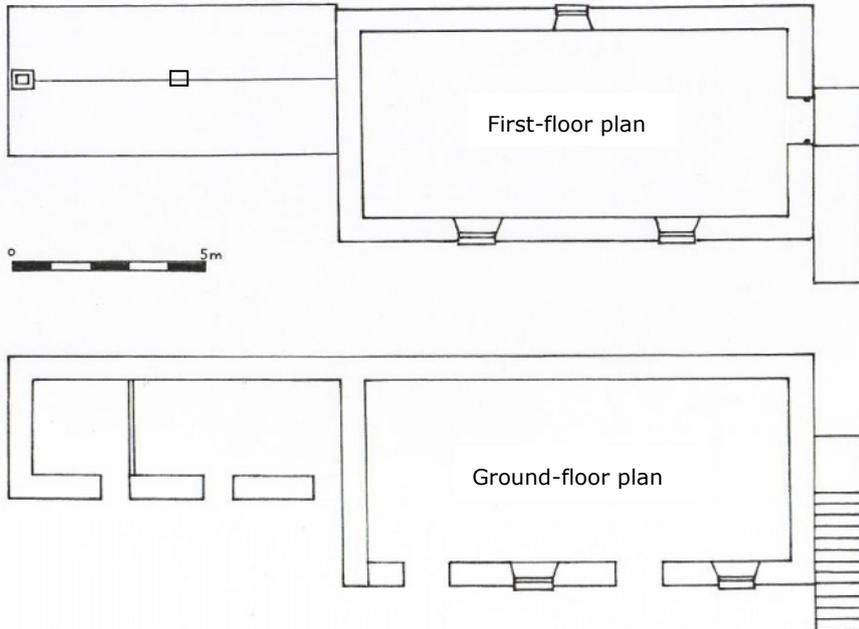
Fig 6 Floor plans

The building is a single-phase structure with most openings to its south-east front (see Fig 6). There is a 2-storey rectangular barn at the north-east end and a smaller (narrower and more shallow) plan pigsty building set back at the south-west end. The barn has a wagon bay at its left-hand (SW) end with a wide doorway at the front (later partly blocked). The loft of the barn has a doorway at its north-east end. The pigsty has evidence that the left-hand (SW) end was designed as a swill kitchen. The remaining two thirds of the building display evidence that it was originally divided into two pens.

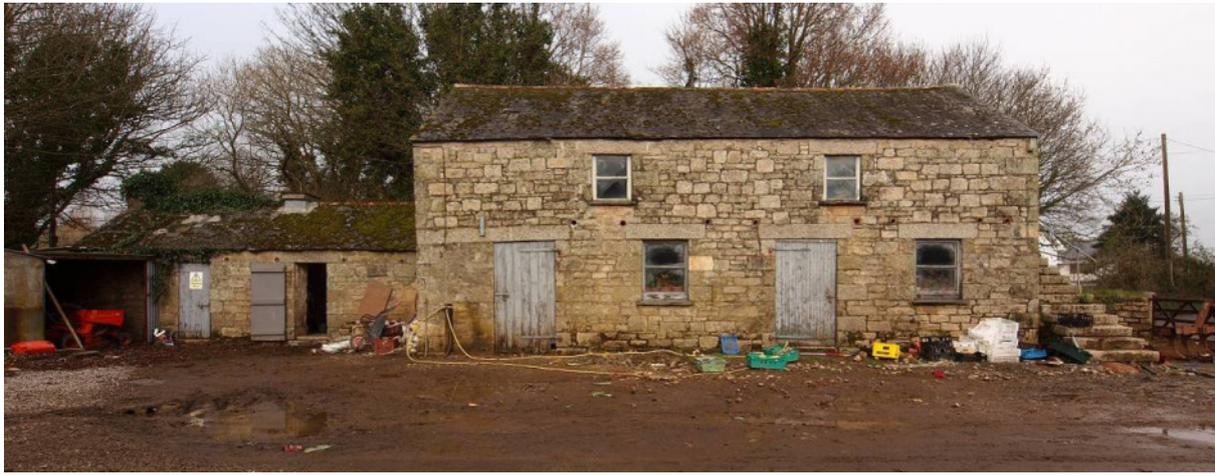
The SE front elevation of the barn (Fig 7) has a partly blocked wide doorway on the left (former wagon house) and a narrower doorway flanked by two window openings to the former shippon part. The doors are old and ledged and braced. They hang from original strap hinges offset at the outer ends to fit iron pintails held in the front face of granite jamb-stones. Two first-floor window openings are regularly disposed with respect to the whole elevation. The front windows are old but not original.

The front elevation of the pigsty (Fig 7) has three doorways with old narrow ledged doors with hinges similar to those of the barn. There are earthenware vents under the eaves (front and rear elevations).

*Fig 7 Front (SE facing) elevation  
(note wide doorway to ground-floor left of barn partly blocked)*

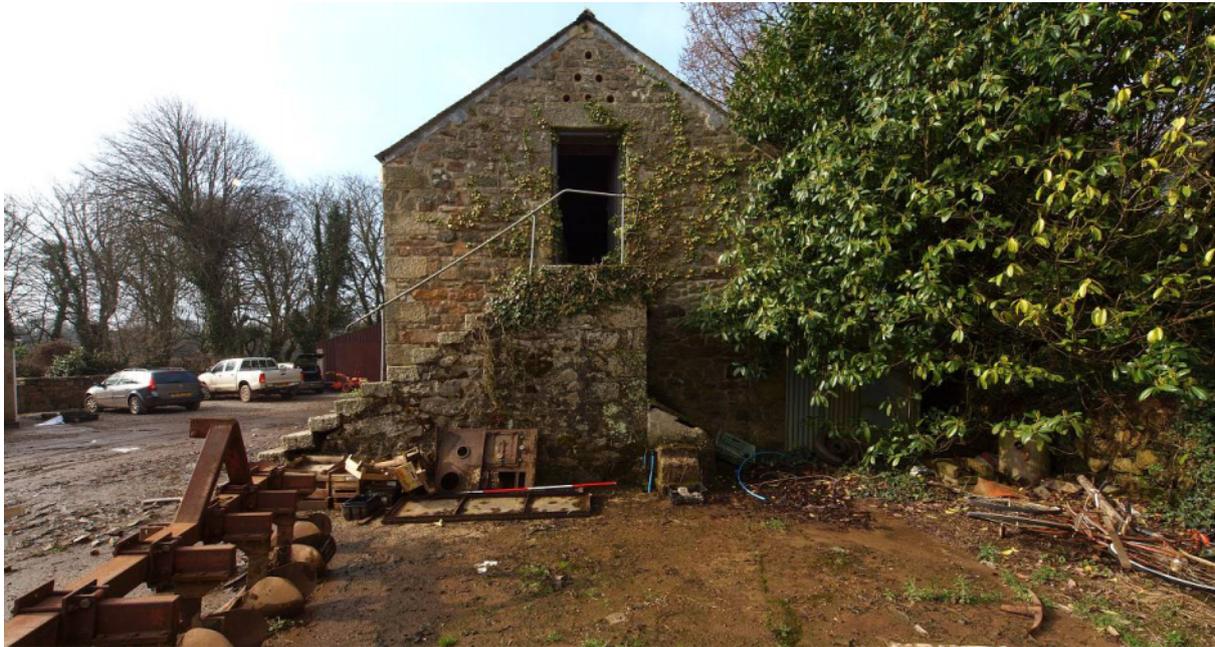
The north-east elevation (Fig 8) has a large flight of steps rising from the front of the building to a central loft doorway. The gable ends contain earthenware ventilators.

*Fig 8 Barn NE end with granite steps leading to loft doorway*

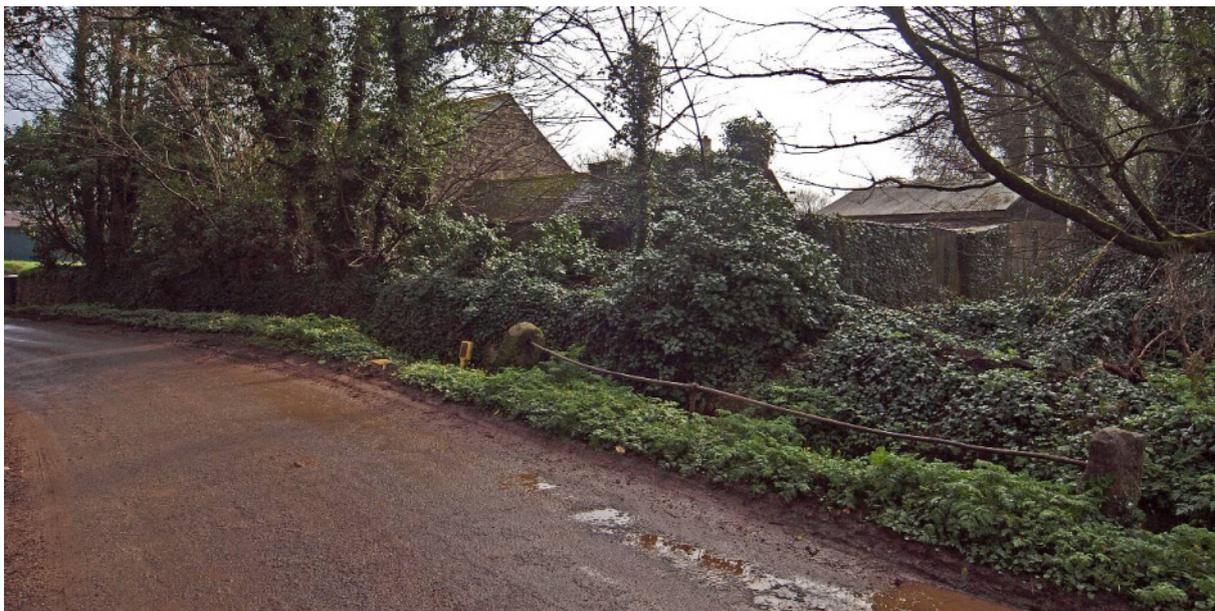
*Fig 9 Rear of barn and pigsties from west (note 'bridge' in foreground)*

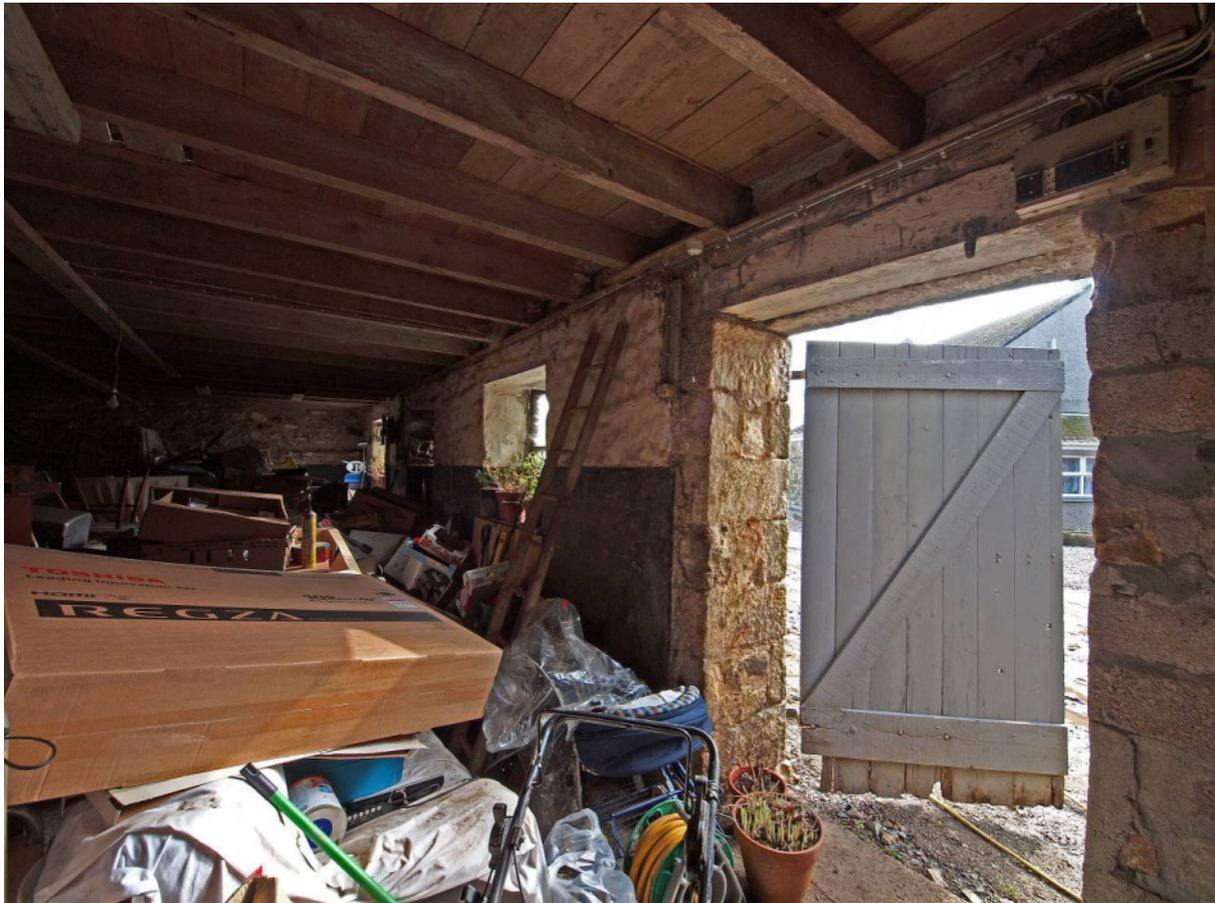
*Fig 10 Barn interior ground floor from west*

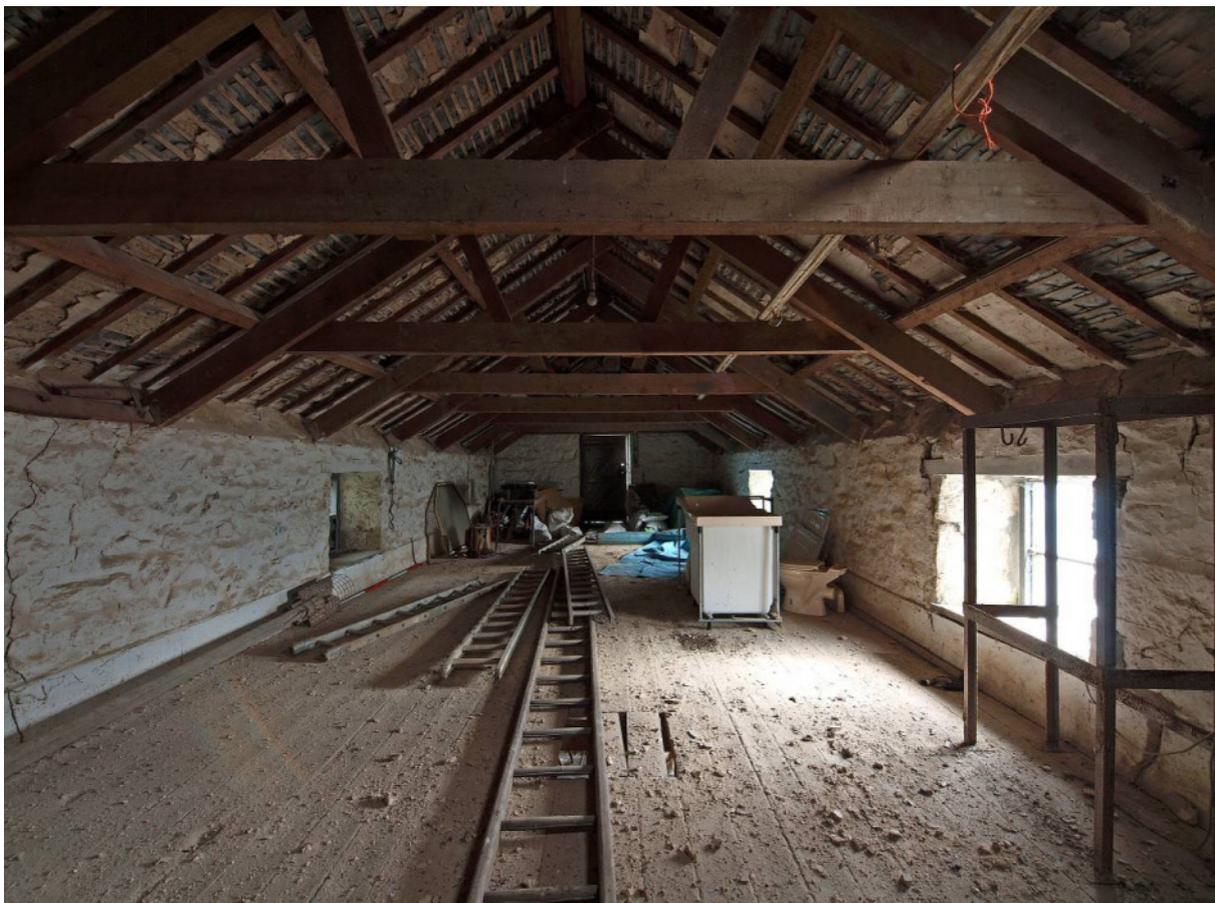
*Fig 11 Barn loft from south-west*

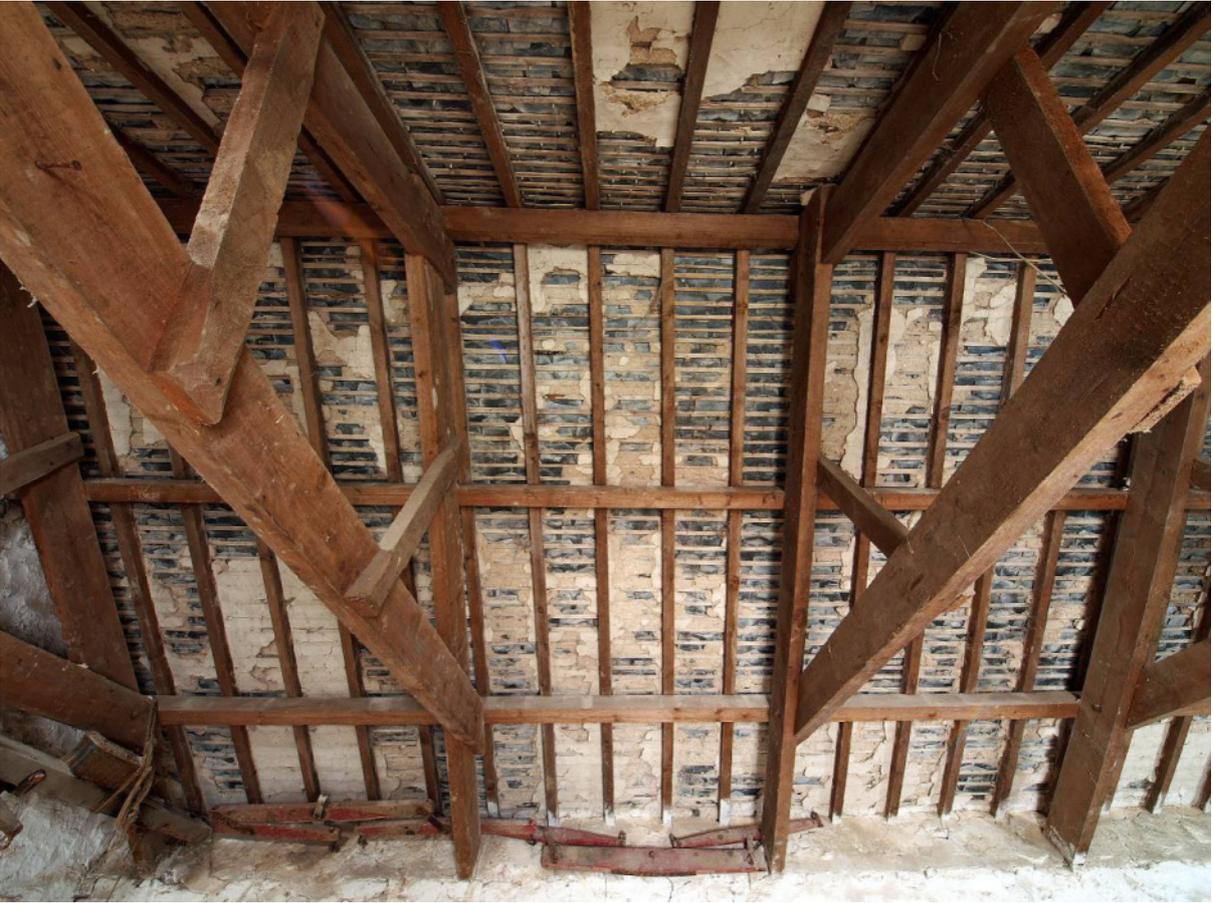
The internal walls are lime-washed. Original roof structures are coeval with each other but trusses are different in their constructional detail as a design response to the different spans that they bridge. The wider-span barn 7-bay roof has collar trusses with angled queen struts. The collar joints are bolted, and the strutted and crossed apex joints are nailed. The pigsty has a 5-bay roof with tie-beam trusses. There are two old, possibly original small floor hatches in the loft floor of the barn. Otherwise, there are no surviving original fittings but there is evidence for the location of former partitions in the rear wall of the pigsties. A concrete block partition now separates the former swill kitchen from the former pigsties.

*Fig 12 Barn roof NW slope SW end from SE*

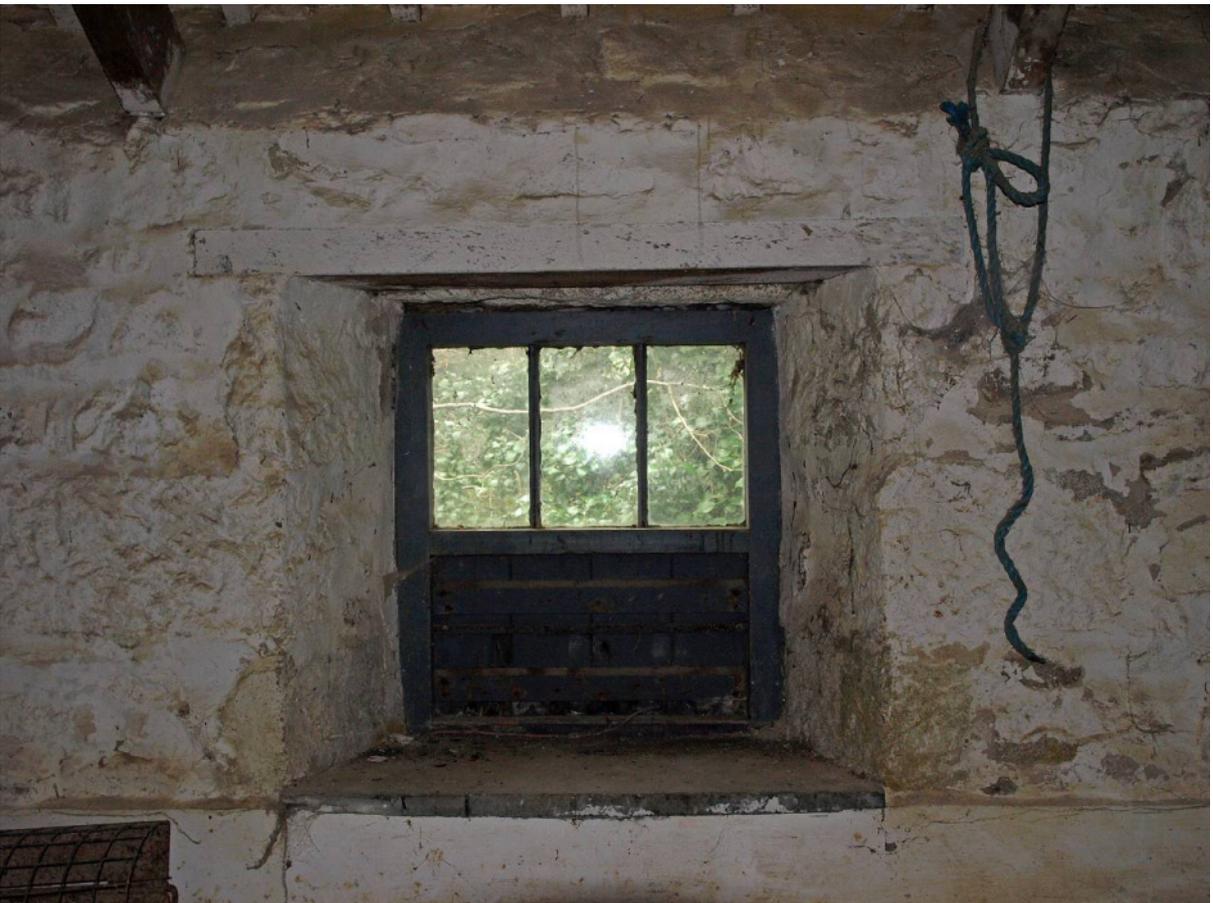
The rear elevation of the barn has a central first-floor window opening that contains an original shuttered and glazed window (Fig 9).

*Fig 13 Barn original central rear window*

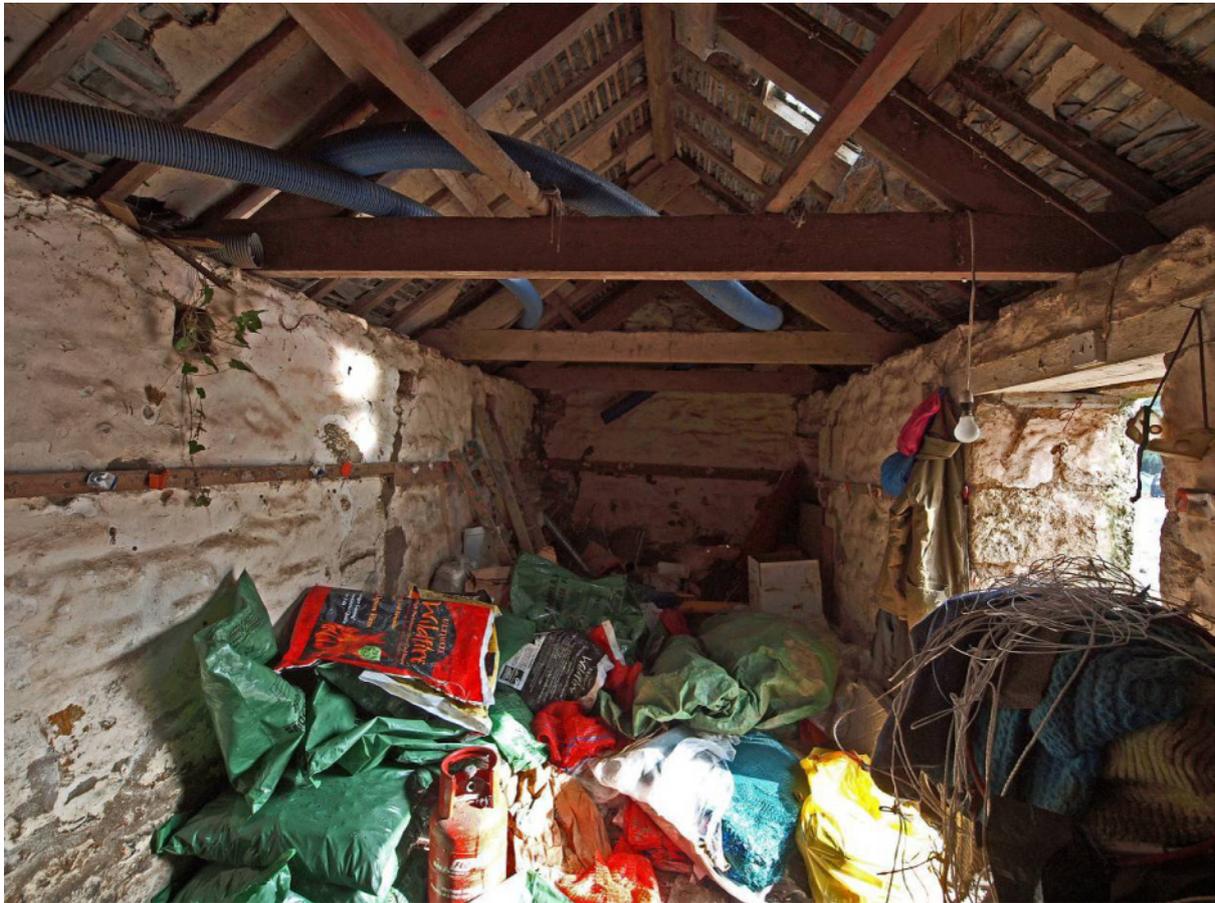
*Fig 14 Pigsty interior from south-west*

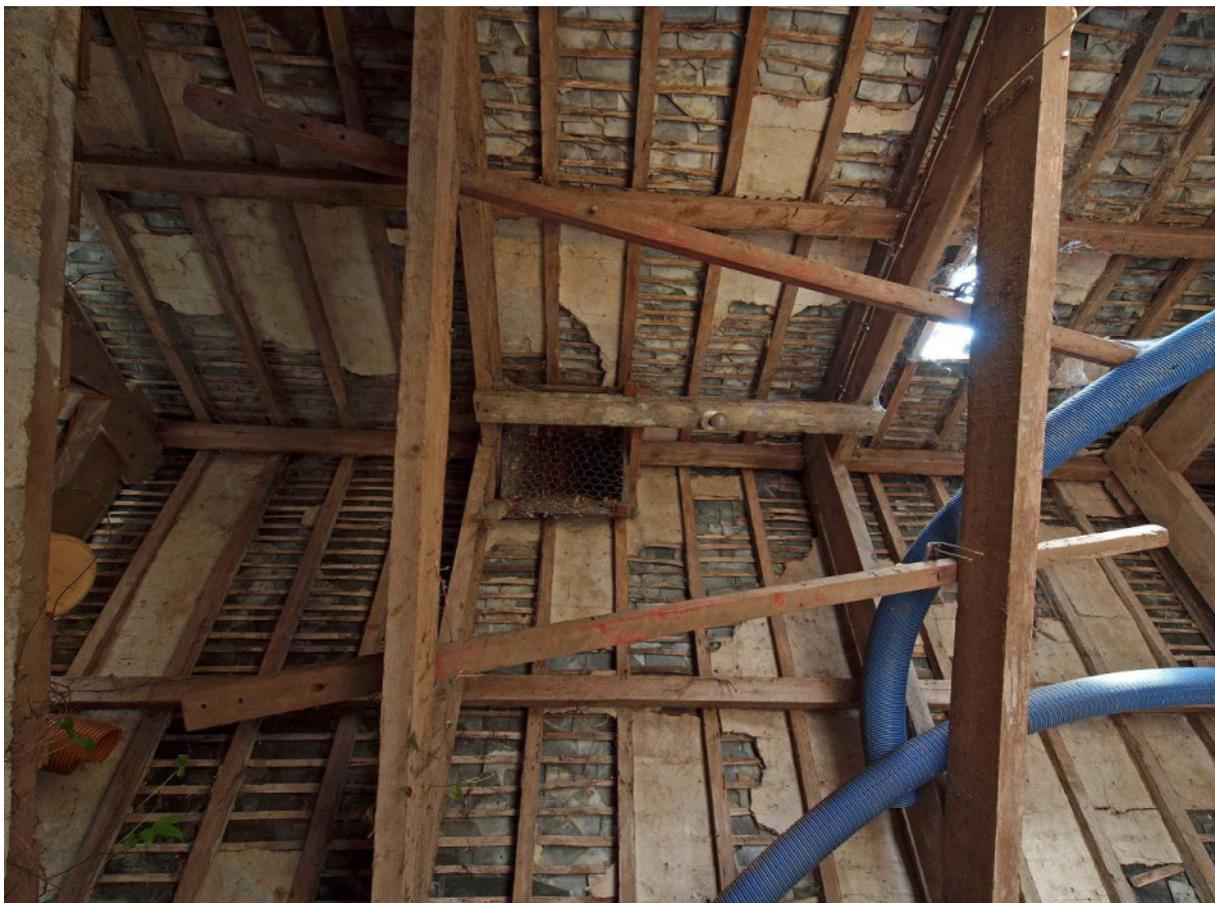
The principal building material for the walls is well selected and semi-coursed granitic elvan rubble bedded in earth mortar. Granite is used for quoins, ground-floor lintels, and jamb-stones where used to hold iron pintails. A flight of external steps at the north-east end of the barn has dressed granite steps. Dressed granite is also used for threshold stones. Window cills are slate monoliths. Gable-ended roofs are laid with original scantle slate and there are red clay ridge tiles. There is a small brick chimney stack that serves the former swill kitchen at the south-west end of the pigsty. A central ventilator to the pigsty roof is a later fitting (Fig 15).

*Fig 15 Pigsties roof from underneath*
