Historic Building Record
Former Cottage and attached Barn
Boundary Farm, Newburgh, Lancashire
NGR SD 4881 1029

Prepared by
C.J.O'Flaherty MRICS, MSc
June 2008

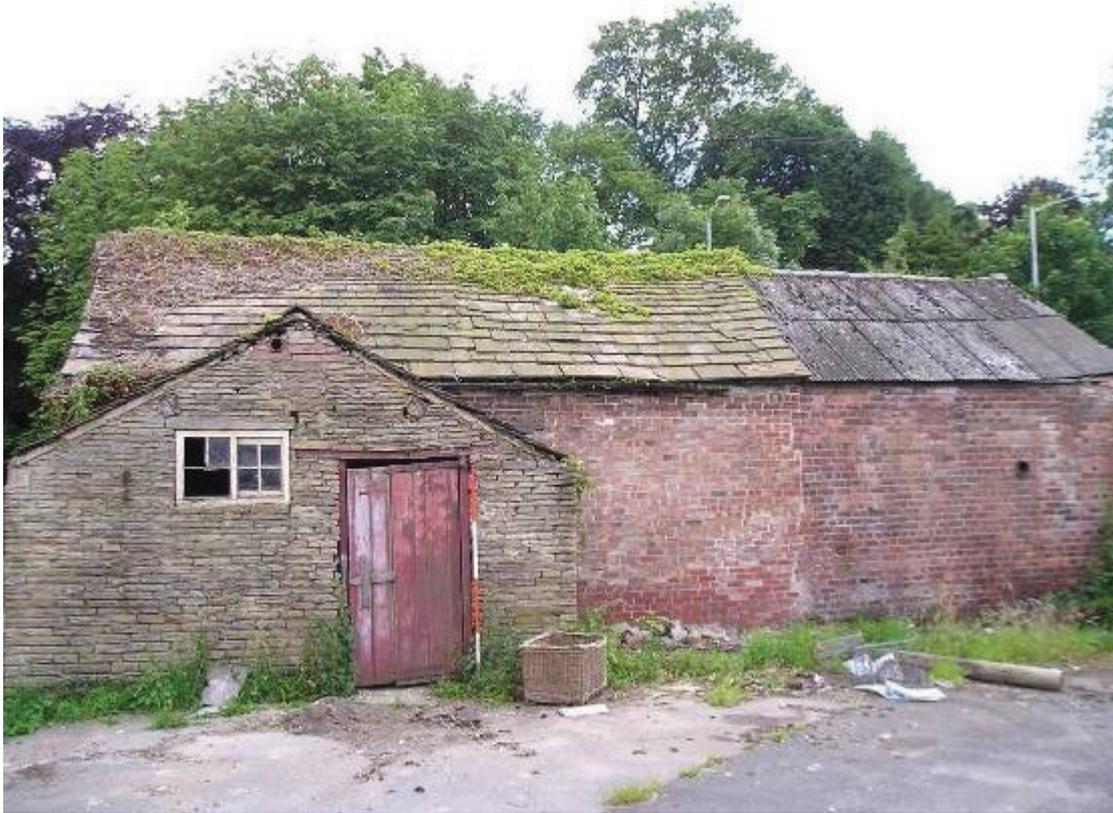
Figure 3. Rear elevation with stone outshut to the left foreground and three bay building behind. The stone slate roof covers the central and eastern bays. The brick wall to the central bay appears to have been either rebuilt or perhaps this was once a full height cart entry door

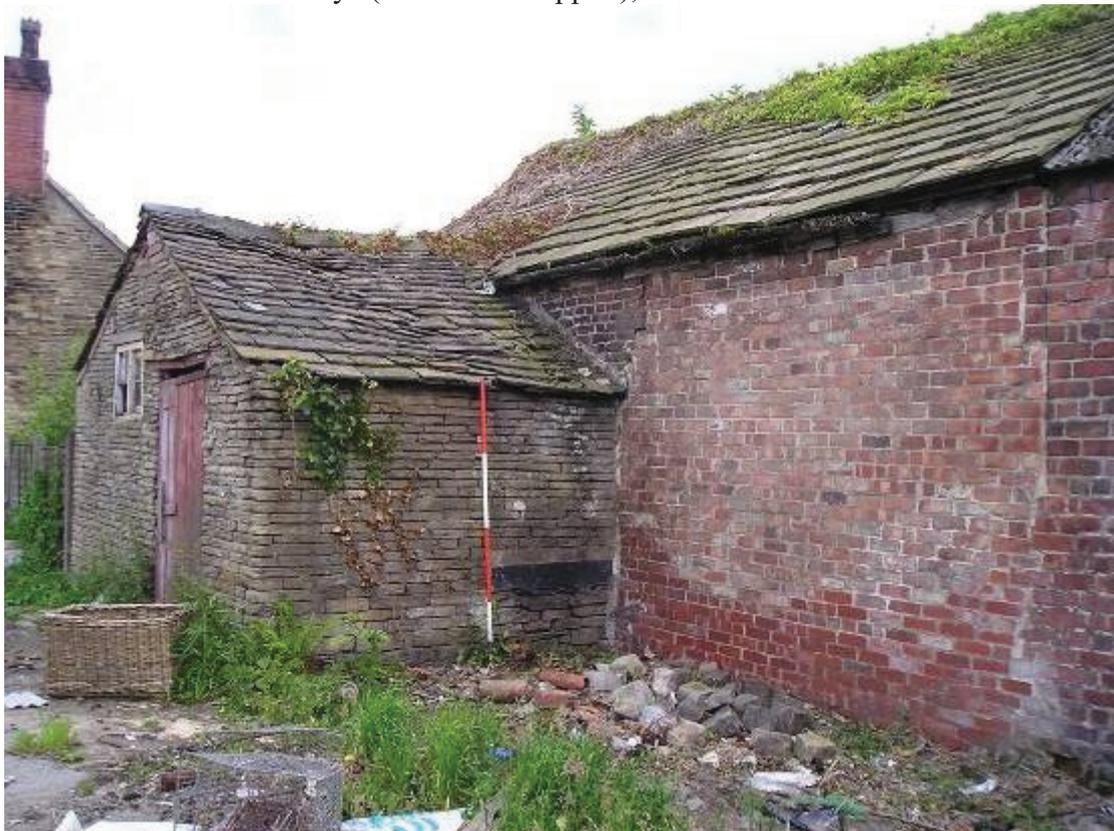
6. Western return wall of outshut showing possible former lintel at low level. This suggests that the ground against the building may have been banked up and that the outshut, as is the case at the front of the building, was formerly two storey in height

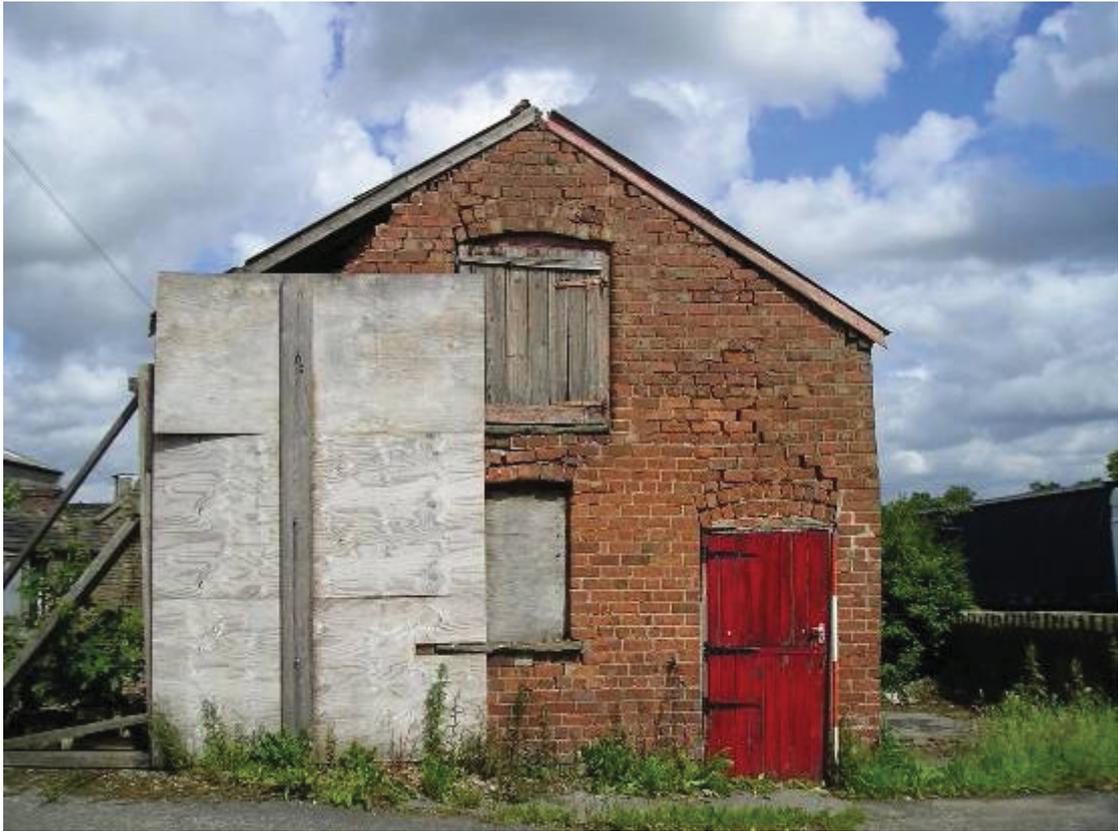
7. Western gable with shippon door to the right and loft pitching door above. Note the segmental arches to the openings. The hoarding conceals vehicle damage (a truck recently hit the building). This elevation of the building appears to be an extension

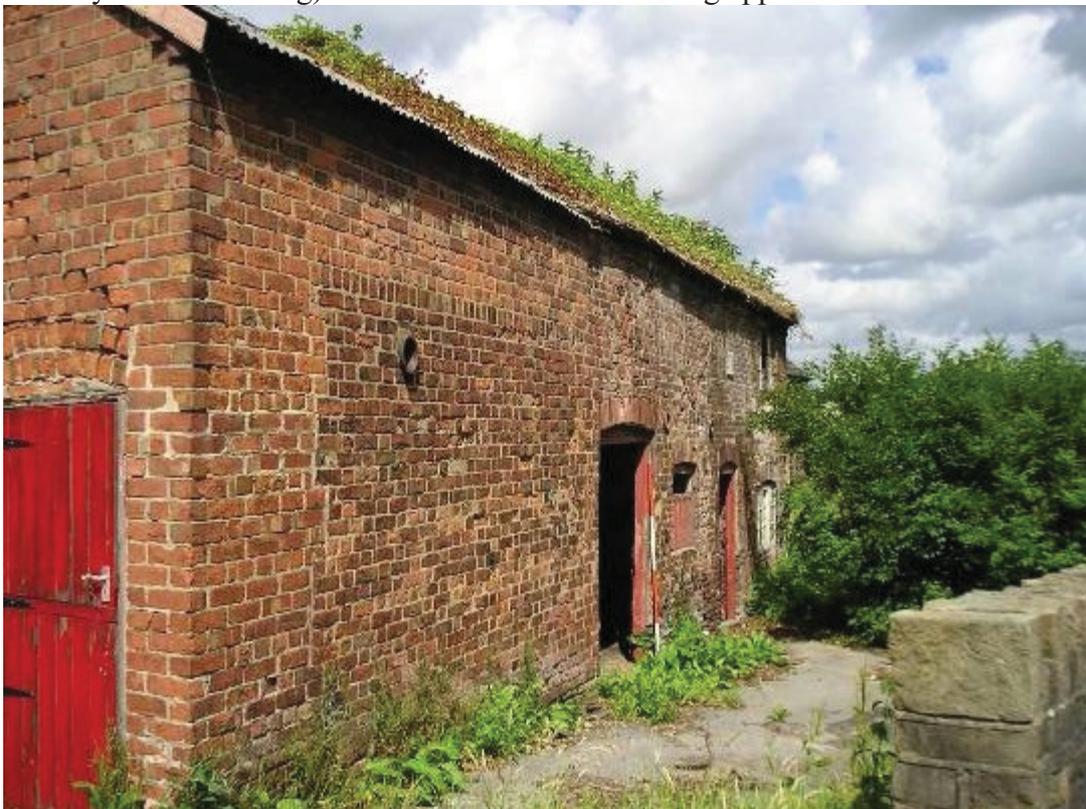
8. The front elevation viewed from the west. This shows the shippon bay in the foreground with the outline of a smaller, lower building evident (see also fig 10)

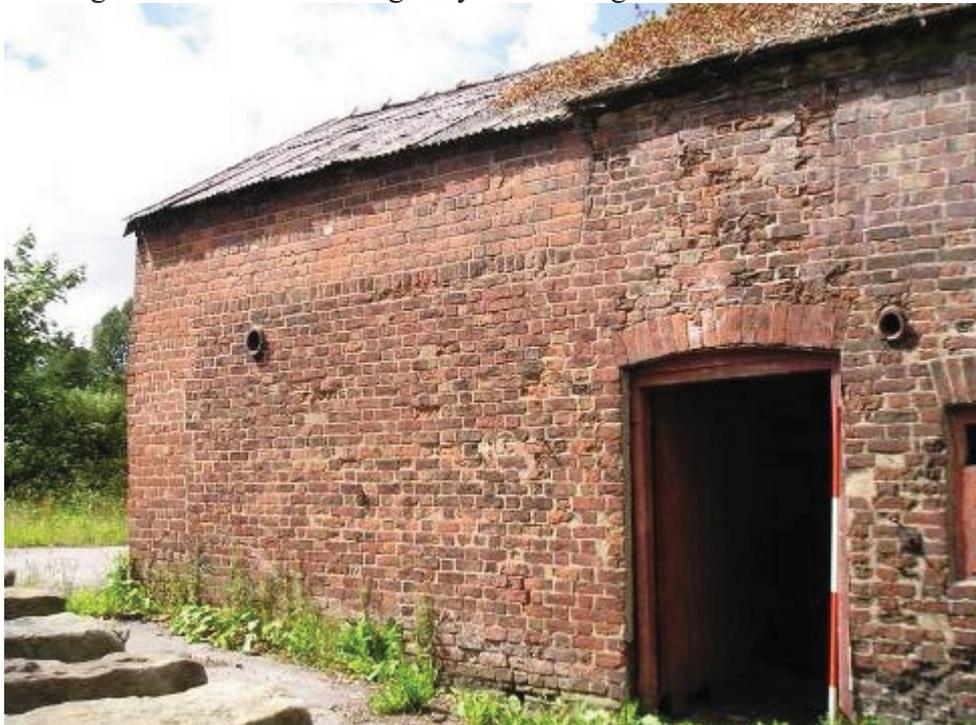
10. Western (shippon) bay with central stable door to the right. This shot shows the probable raising and lengthening of the shippon part where Flemish bond changes to garden wall bond

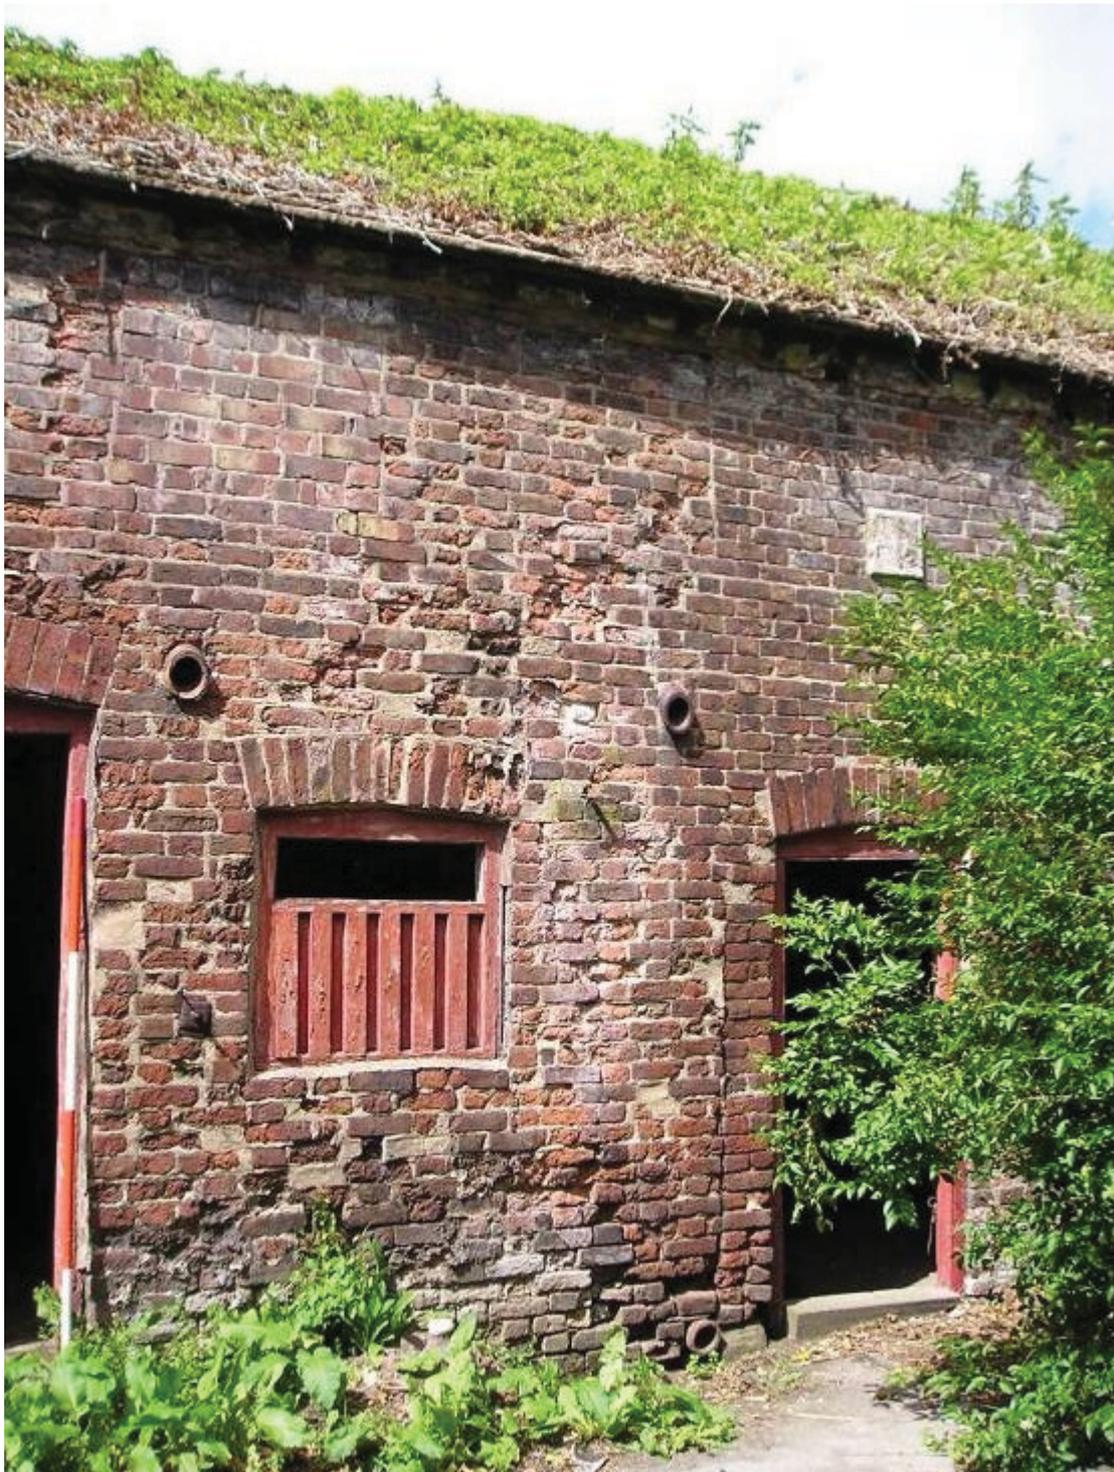
11. Central bay: evidence of alteration at higher level where former window(s) may have been blocked

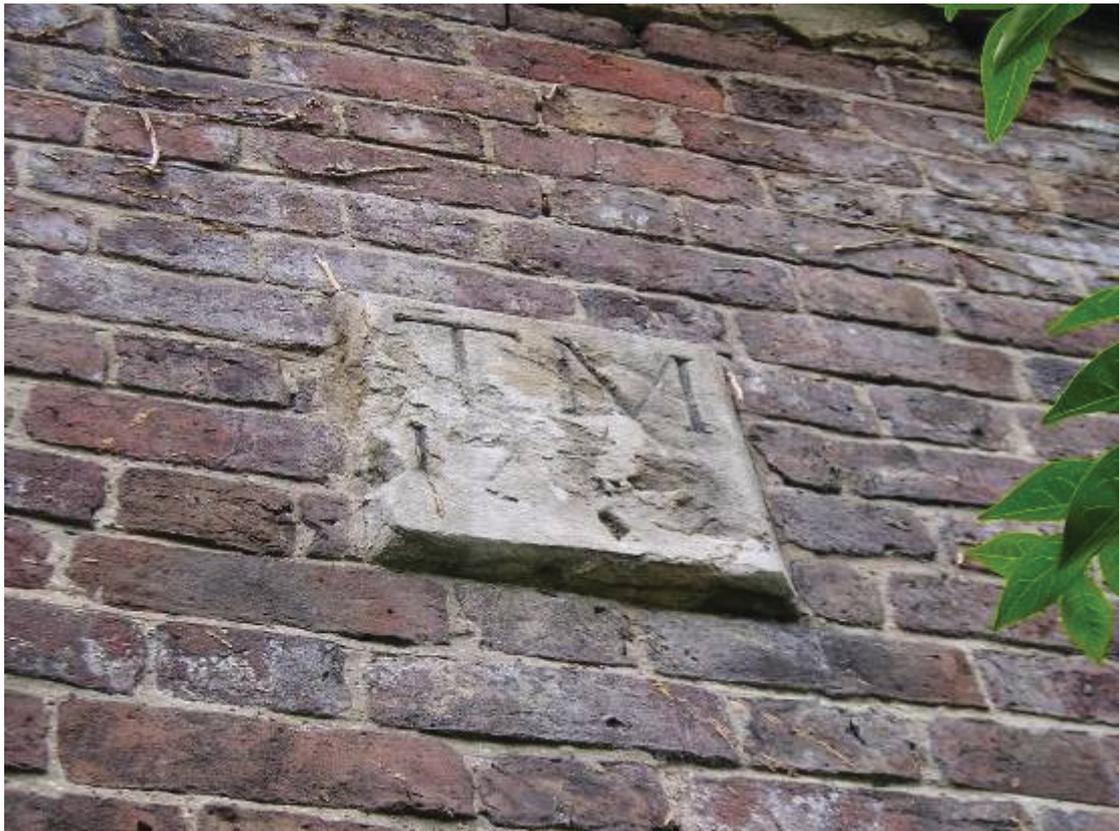
12. Datestone over the cottage bay door: the carving reads 'TM 1739' (as recorded on listing description – deterioration of the stone makes the numbers difficult to decipher)

The datestone over the cottage entrance is of course good evidence as to the age of the building. There can, however, be no certainty that the date of 1739 relates to initial construction since the incorporation of a date stone could in theory commemorate the date of some significant alteration work. In this instance such alteration might relate to the conversion of the cottage bay into a dwelling having formerly been merely the end bay of a barn or other such non-domestic structure. Conversely, the cottage might in fact be a reduction in the original domestic footprint, the stable having occupied what was formerly part of a larger house. Unfortunately the physical evidence that remains on site paints a rather confusing picture as to past changes and, whilst it is clear that significant alterations/repairs have been carried out, the sequence and purpose of these is difficult to determine.

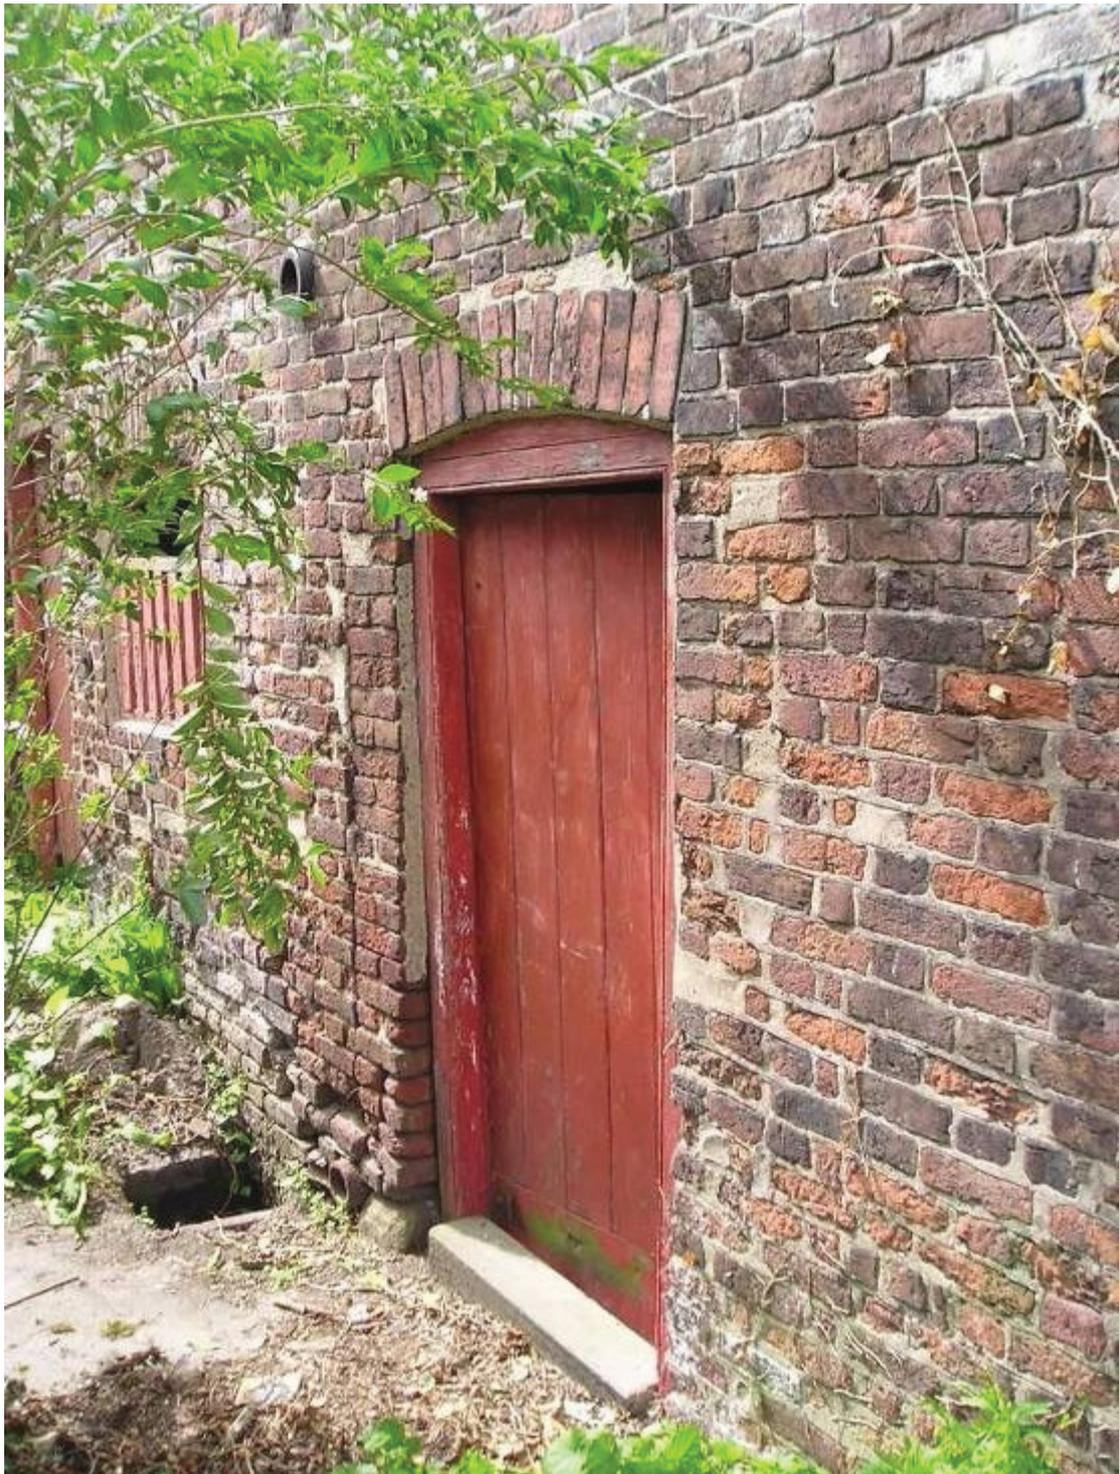
14. Detail of door to cottage bay showing vertical brick joints either side of the opening. These suggests the door may have been made narrower or was formerly flanked by decorative stone framing.

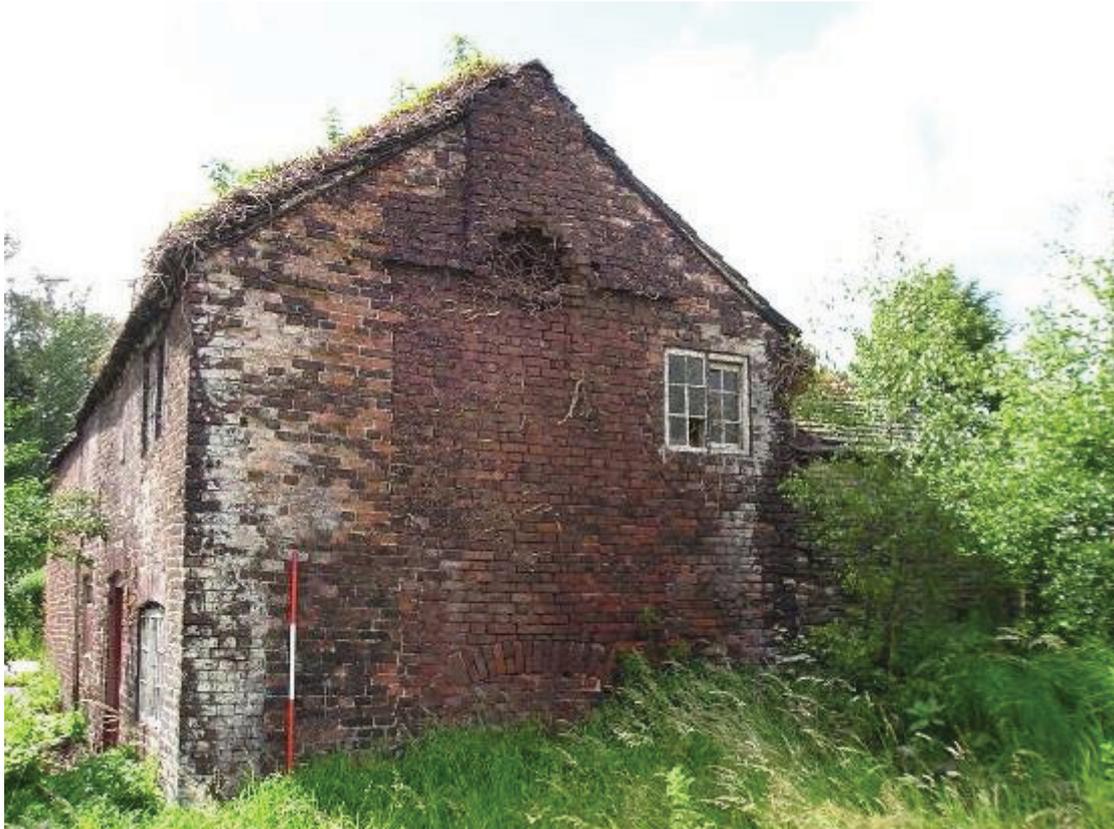
15. The eastern gable. This elevation bears evidence of either past alteration or rebuilding, particularly to the left side where the brickwork appears of a different age and also has a vertical joint where it meets the chimney flue. The window appears to have been inserted and at low level there is a segmental arch to the back of the interior fireplace: the purpose of the arch is unclear

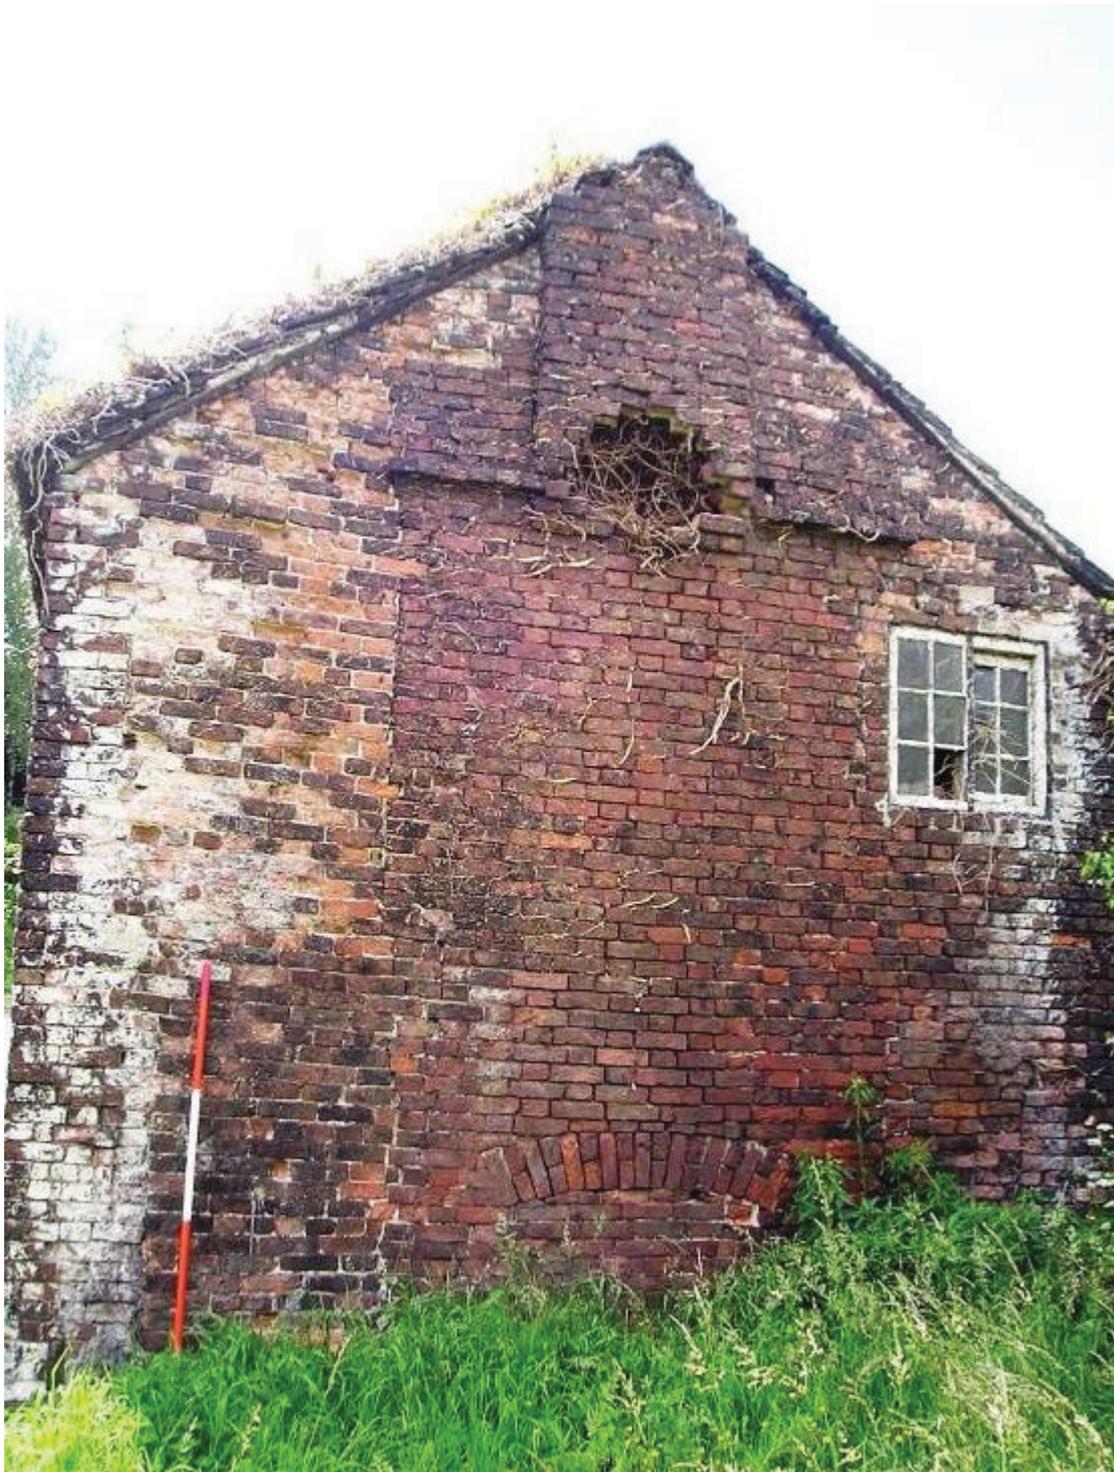
16. Detailed view of eastern gable: note that the brickwork to the left of the vertical joint is of garden wall bond rather than Flemish (this again suggests partial rebuilding)

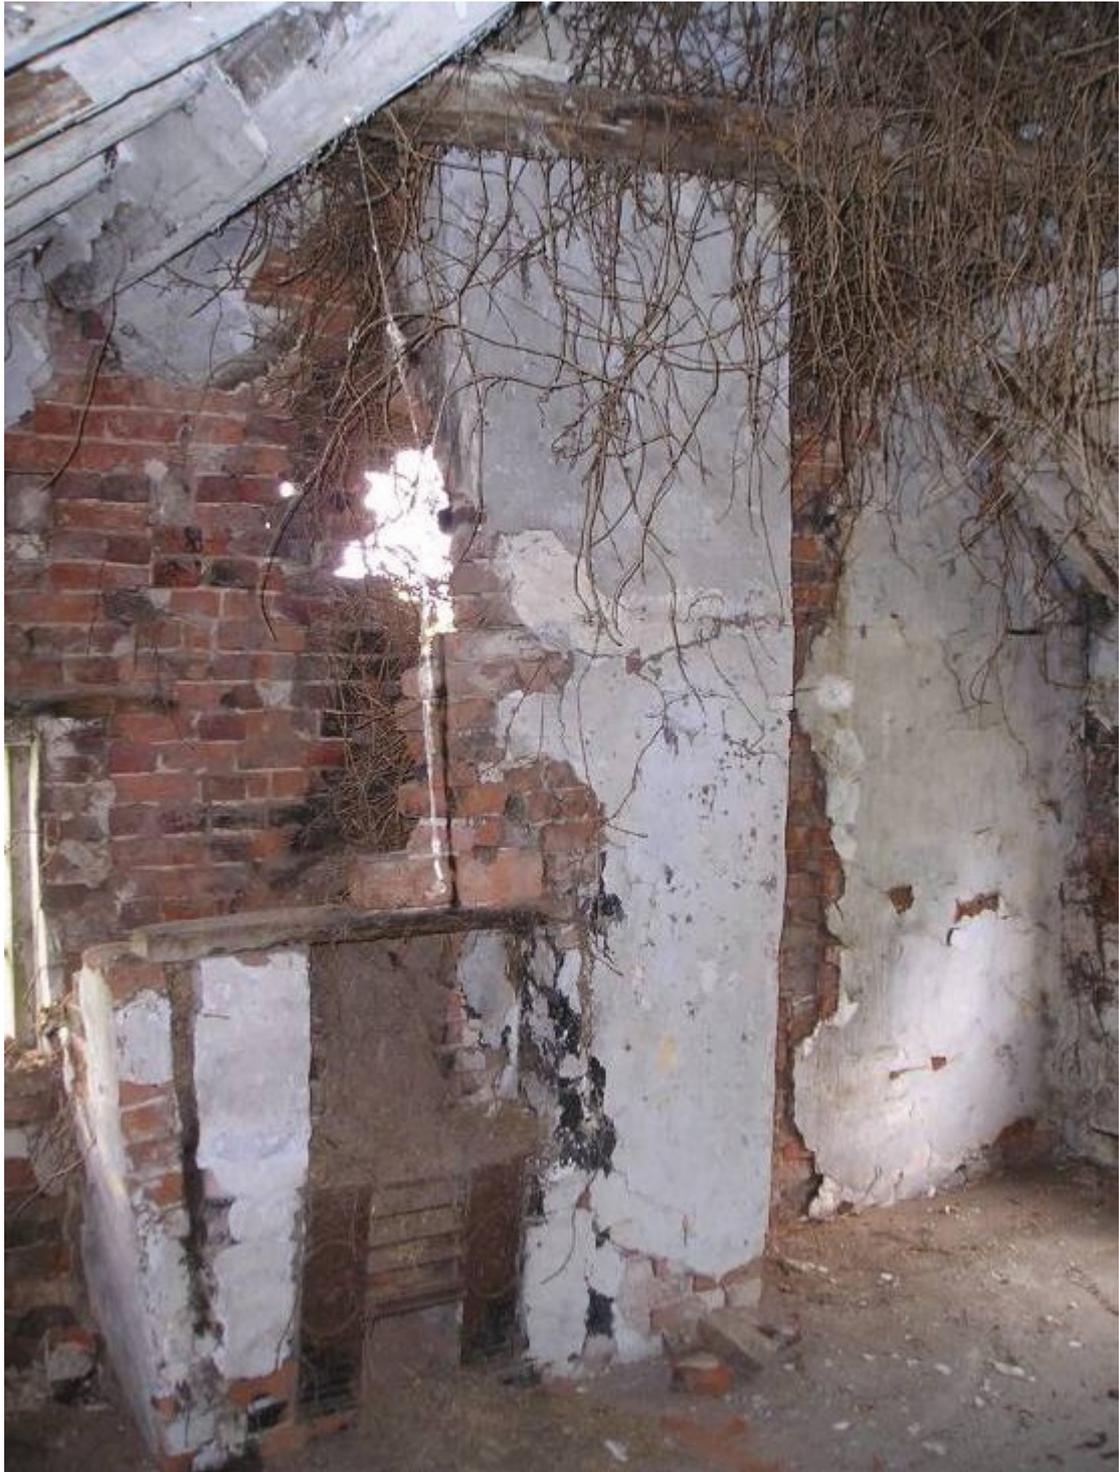
23. First floor of cottage bay looking to blocked fireplace. The chimney above has partially collapsed revealing that the chimney structure is not tied into the gable

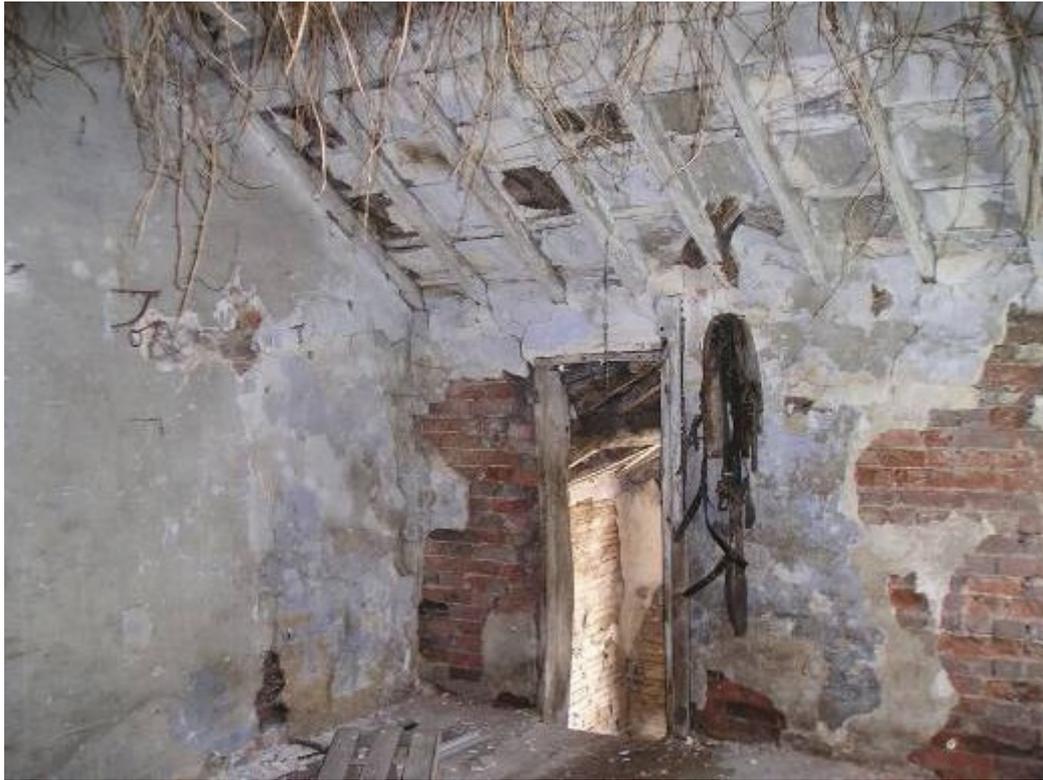
26. View back to door into first floor of cottage bay from outshut: note blocked former door to the left wall which is the brick division wall to the central bay

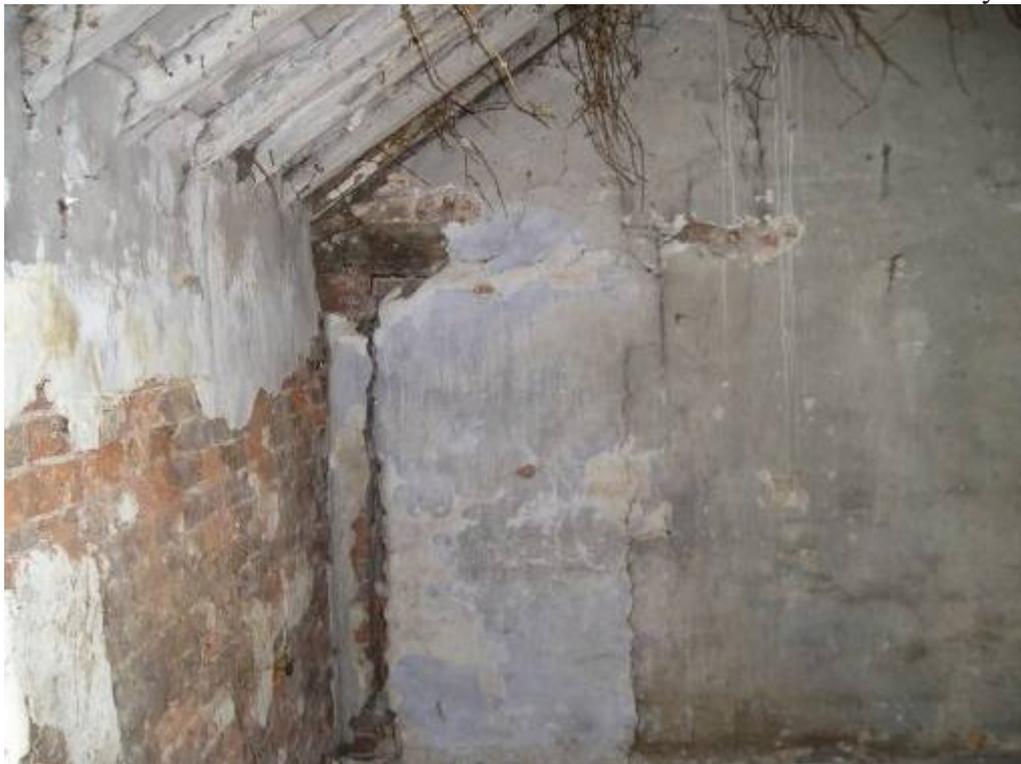
27. Blocked door in first floor cottage bay to front part of division wall with centre bay (i.e. same wall as shown in figure 26). Note also the partially exposed lintel over the door, similar to that present to the opposing end of the wall (26) and possibly the ends of a former truss tie beam (the central section of which may have been reused as shown in figure 37). See also figure 28 below

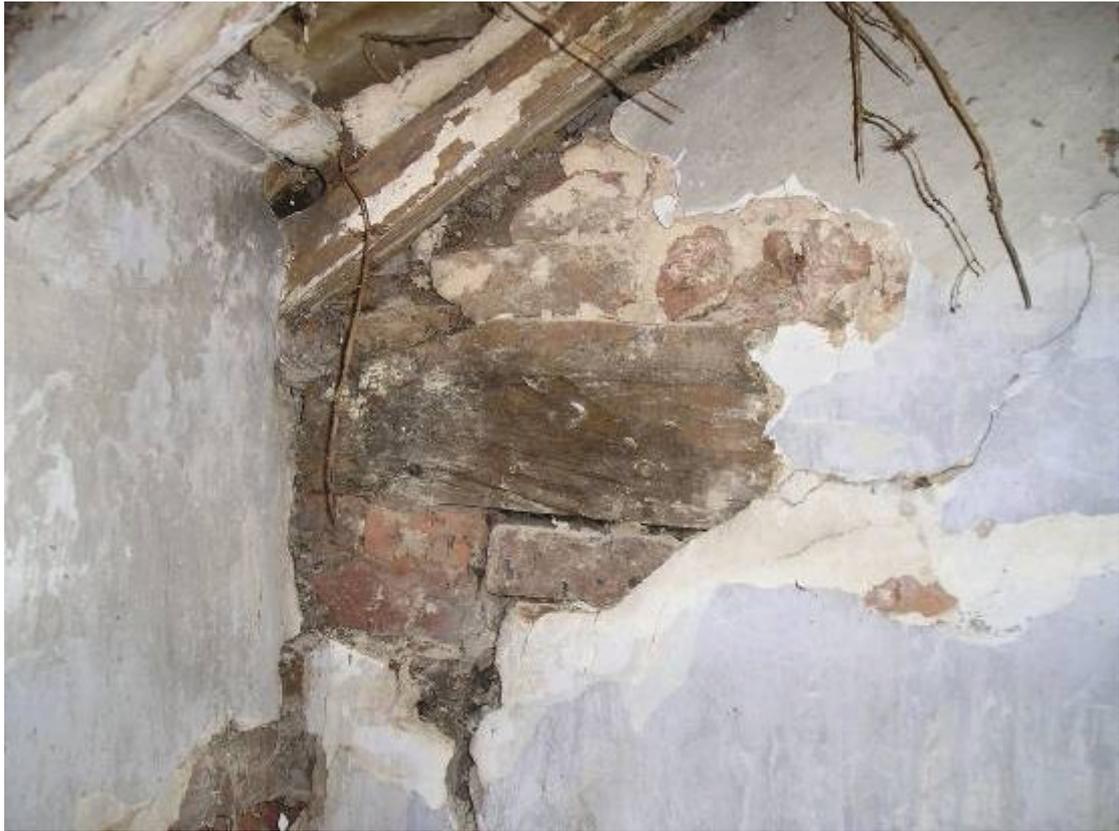
28. Lintel over door shown in figure 27. Note tapered end which suggests this might have been a former truss tie

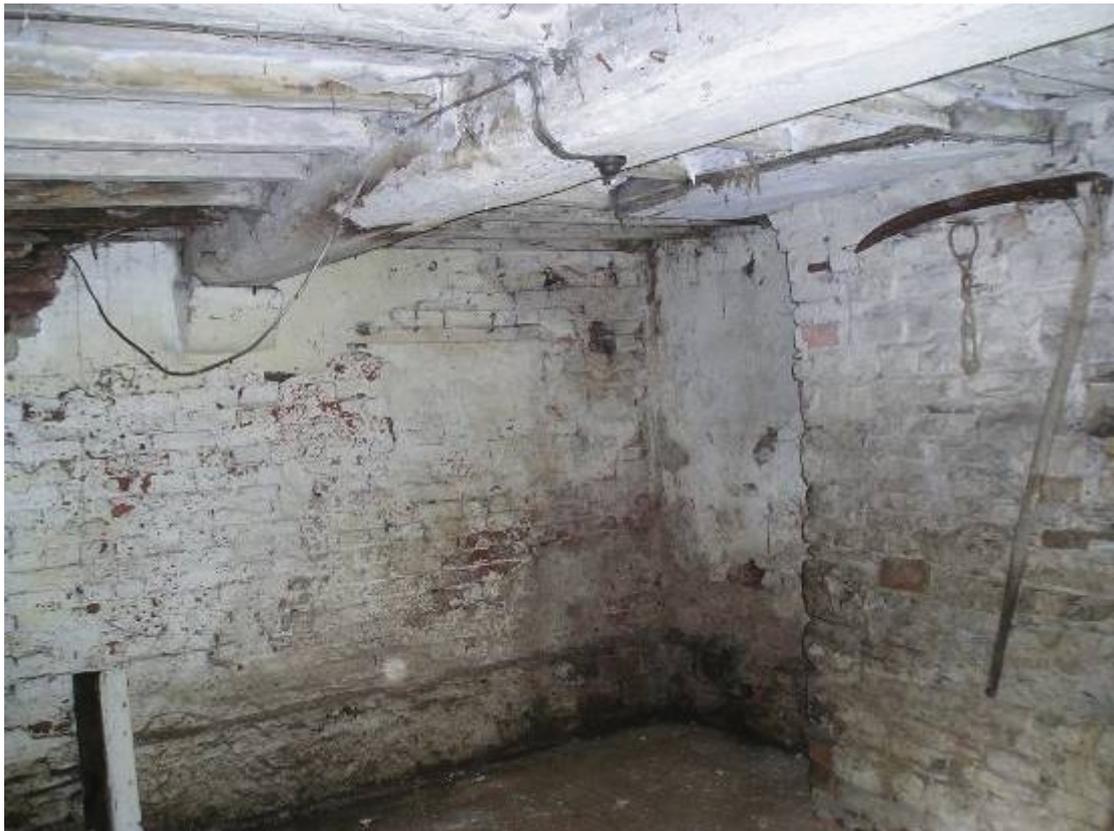
32. Opposing end of beam shown in 29 and 30. Note possible blocked former window/door to rear wall just right of the beam corbel

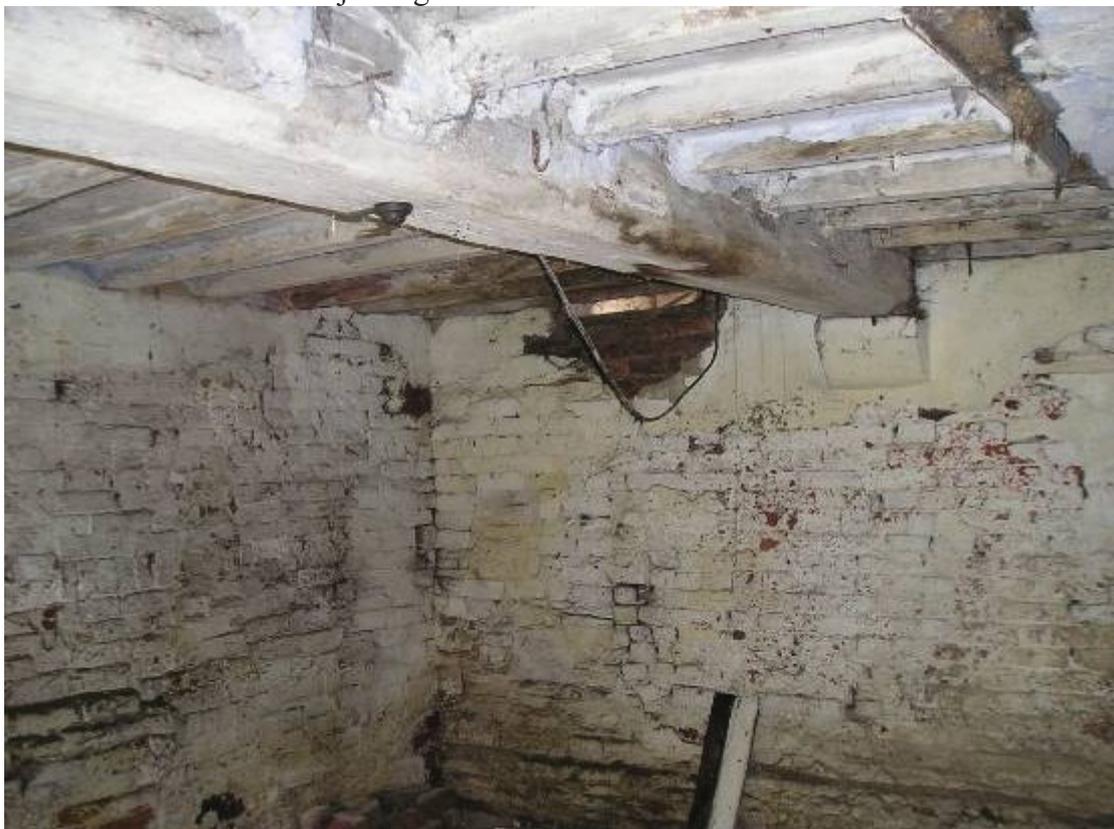
33. View to rear left corner of cottage ground floor room showing butting of division brick wall (left) to rear wall. This suggests the division was inserted.

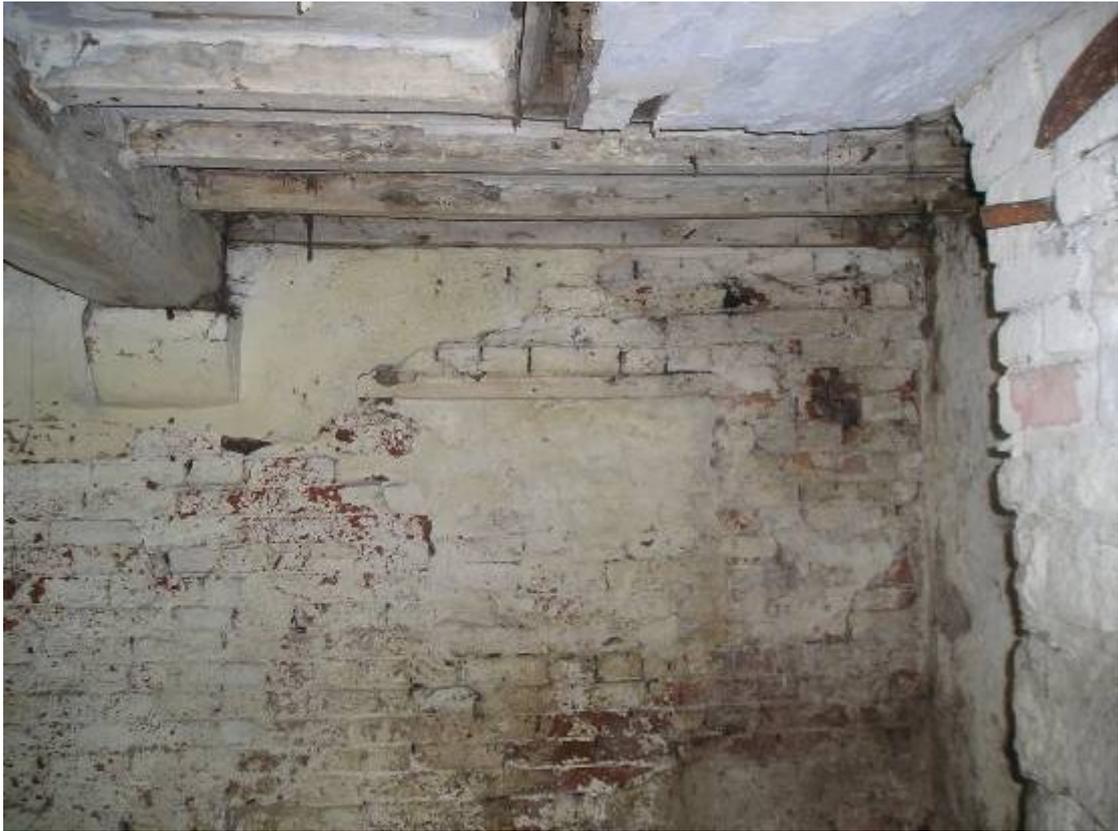
34. Possible blocked former window to rear wall as shown in figure 31. Note also trimmer supporting hearth to first floor above.

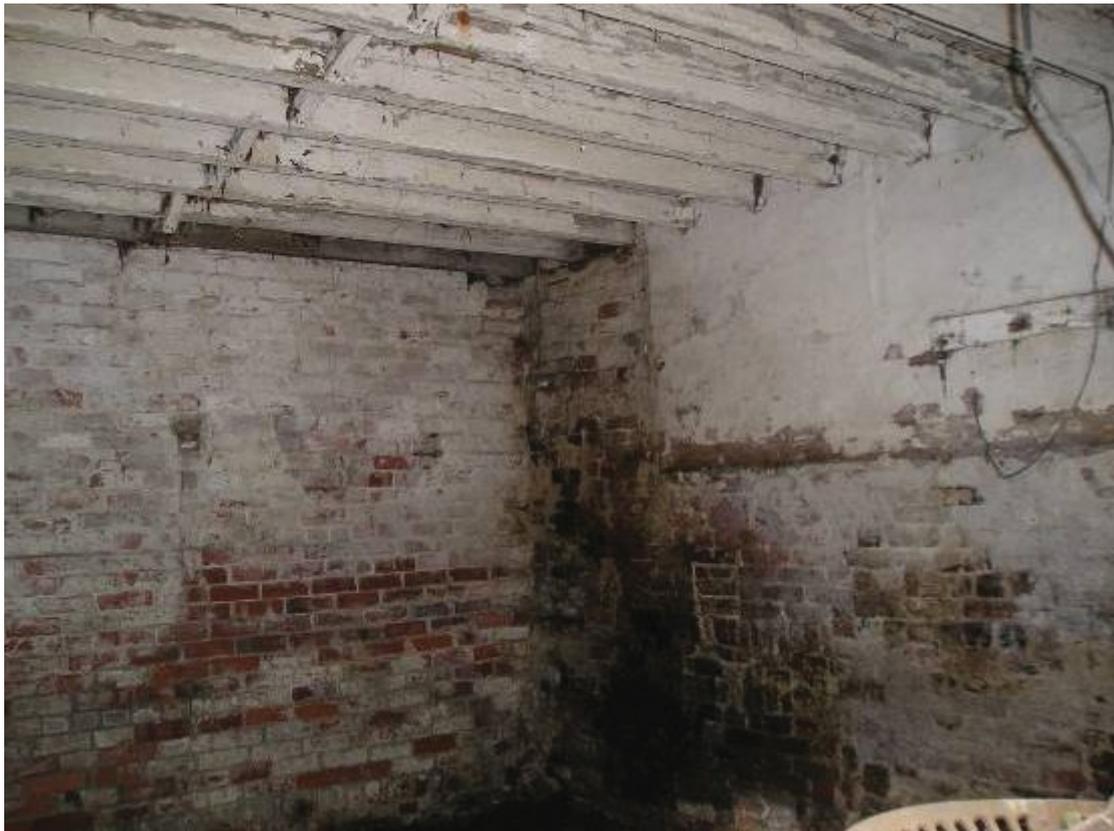
36. View into ground floor central (stable) bay. Note the bottom of the blocked former door to the division wall (right) as shown in figure 26. The level of the door threshold suggests that the stable loft floor was formerly at a much lower level. The loft floor has therefore been raised and the timbers are of more recent

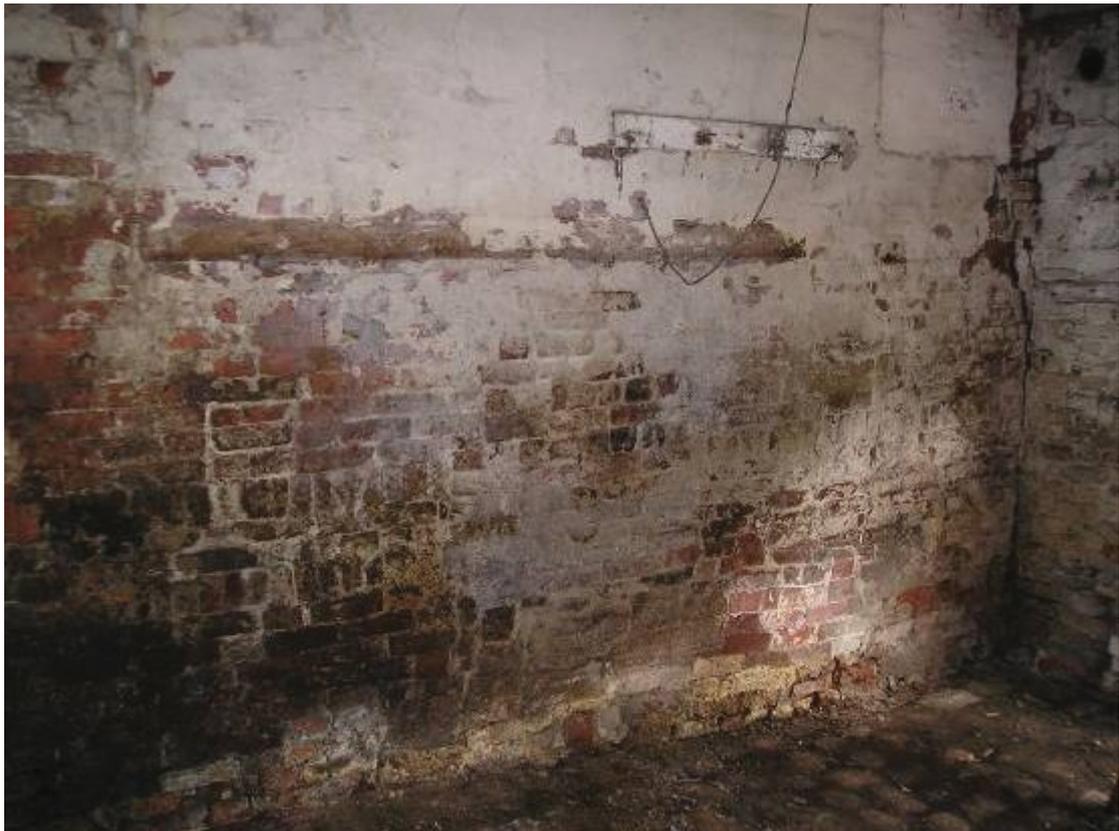
38. Stable bay: division wall with cottage showing central horizontal piece of timber which may be the cut out tie beam as referred to earlier in figure 27. The outline of the former door to the front end of the division wall (27) can also be seen upper right

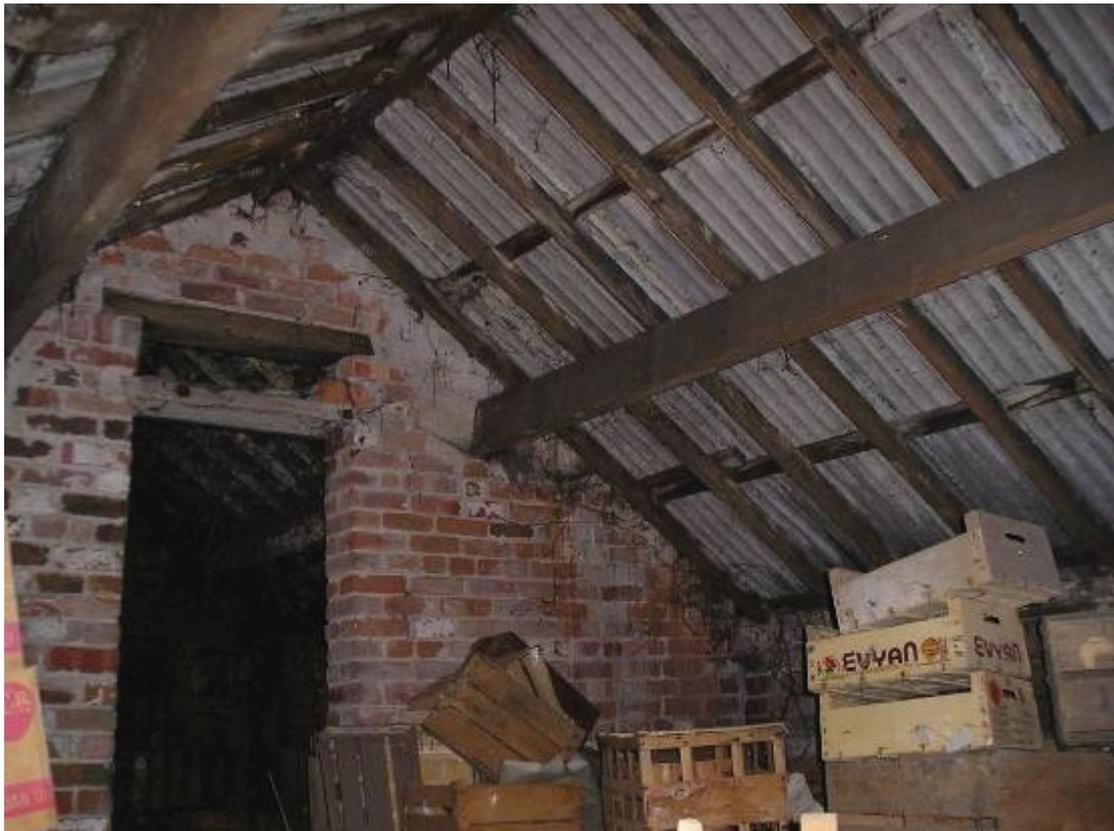
44. Loft over shippon looking to doorway through to loft over stable. Access to this part was not possible due to hazardous condition of floor. Note purlin and rafter roof with replacement sheet covering. The roof timbers here are clearly newer than those to the opposite end bay (cottage) and appear newer also than those to the stable bay.
