Historic Building Record Barn at Butlers Arms Farm Churchtown, nr Garstang NGR SD 48820 43250

Prepared by C.J.O'Flaherty MRICS, MSc September 2008

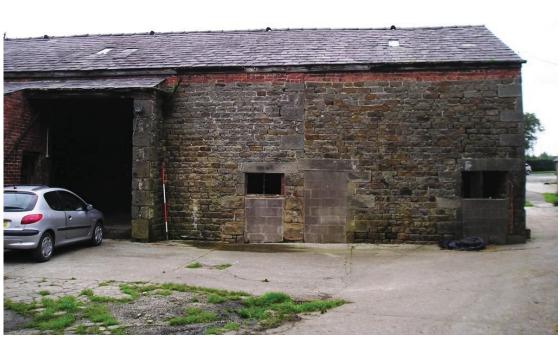
Figure 3. Front elevation showing the extension bay to the right and cart entry to the left. Note the quoins showing the extent of the original barn immediately to the left of the blocked door. The blocked door was the entry to a former feed passage of a shippon in the ground floor of the extension. The half blocked door to the right was a former drain passage; that to the left was probably a combined feed/drain passage access beneath a loft

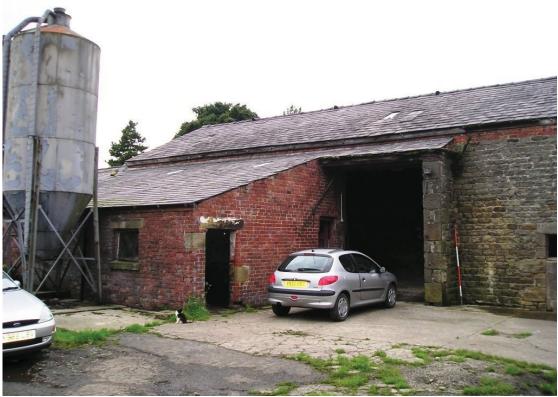
Figure 4. Front elevation showing brick shippon addition and cart entry door. The tow doors to the shippon addition gave access to feed (right) and drain passages (left) with the window to the front wall illuminating the interior space. The provision of a window to a purpose built shippon indicates construction in the later nineteenth century period (or after) when developments in husbandry brought light and well-ventilated cattle sheds as opposed to the tradition for dark, 'snug' spaces.

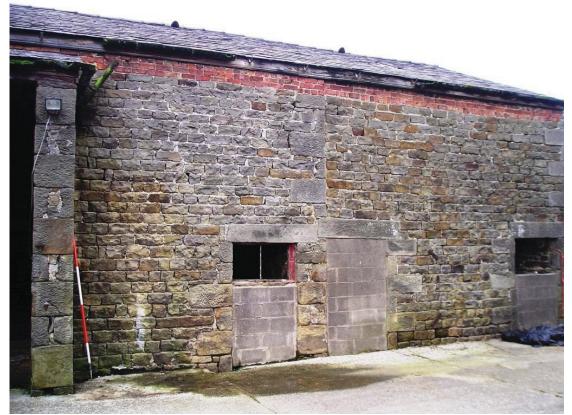
8. Detail of abutment joint between original building (left) and extension. Note also the upper brickwork showing how the barn has been raise din height

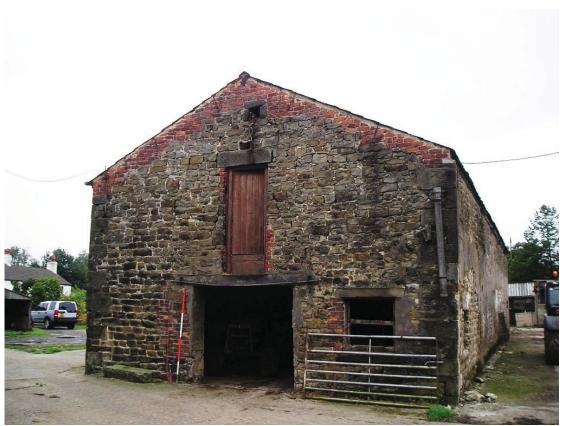
11. North eastern gable wall (extension bay) with inserted wide opening at ground level, pitching door to the loft above and owl hole to the apex. The window to the right is an insert, having brick rather than stone reveals.

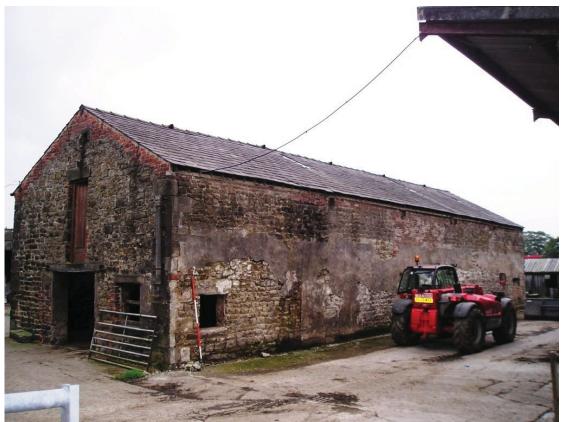
13. The barn viewed from the north with the full bay extension to the left foreground. The remains of plaster to the rear elevation indicate where a twentieth century lean-to addition has been removed. This addition is thought to have been a shippon.

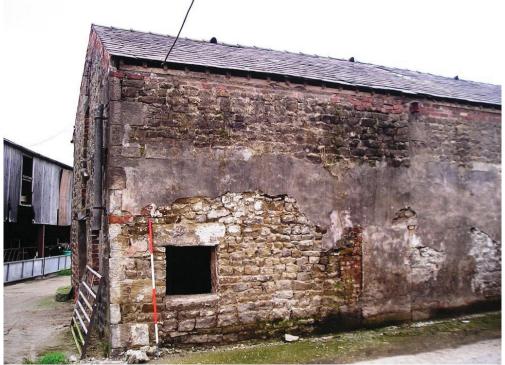
14. Rear elevation – extension bay. The ground floor window illuminated a former drain passage to the shippon within,. This faces a blocked door to the front as shown earlier

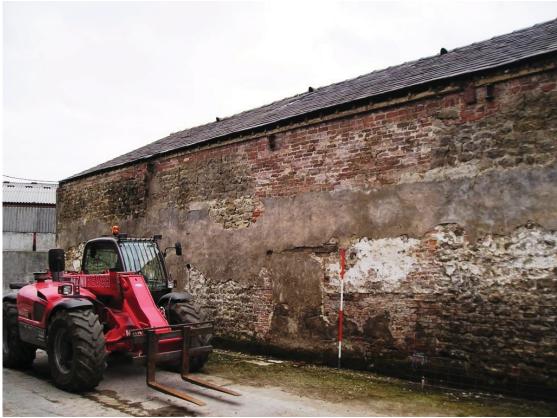
15. Rear elevation centre part with blocked door to the left of the ranging pole. As seen better to the inside (later) this door is in fact contained within what was originally a large cart entry opposing that to the front elevation. The brickwork at upper level on the shot shows the width of the cart entry.

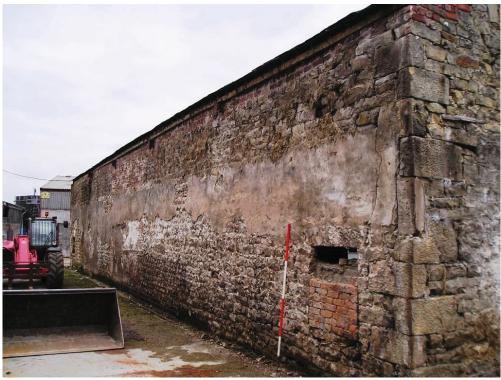
17. Rear elevation – south western end with part-blocked former window which formerly illuminated an original shippon feed passage within the barn.

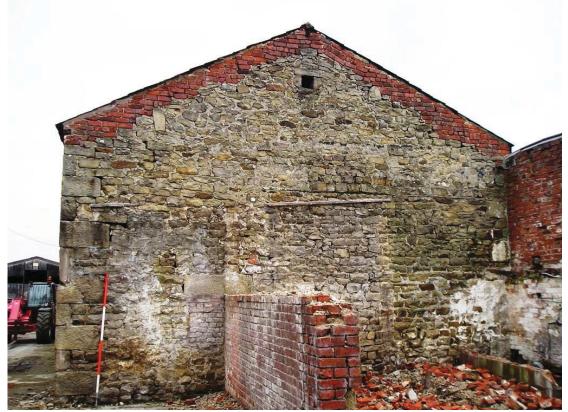
18. South western gable end with remains of demolished adjoining structure (C20th). Brickwork at the head of the wall again shows how the building has been raised. Note also the apex owl hole

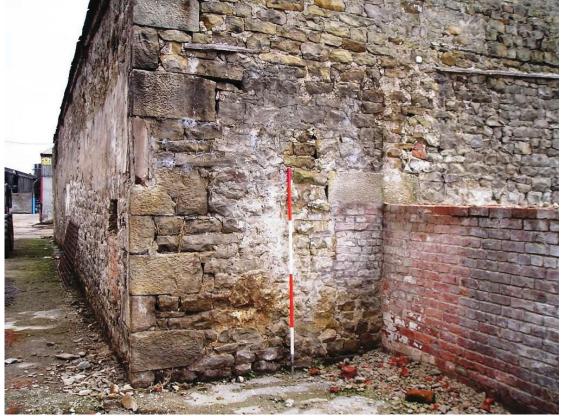
20. South western gable – lintel to the right of the poll shows the position of a former blocked window (visible also to the interior – see later)

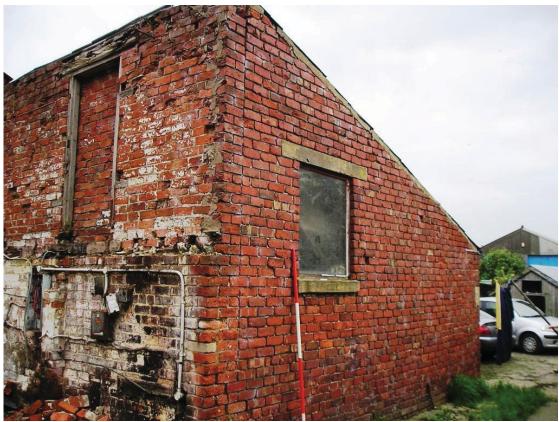
21. South western end of the brick shippon extension with end window. Note also the upper pitching wall to the rear wall which shows former connection between the shippon and the demolished structure against the gable (presumably used for storage and passage of feed)

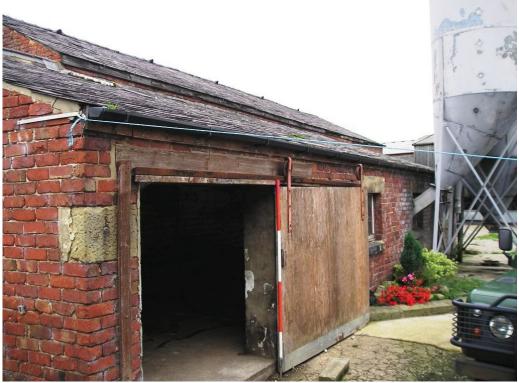
22. Front elevation of the shippon extension showing inserted/widened cattle door to the south western end.

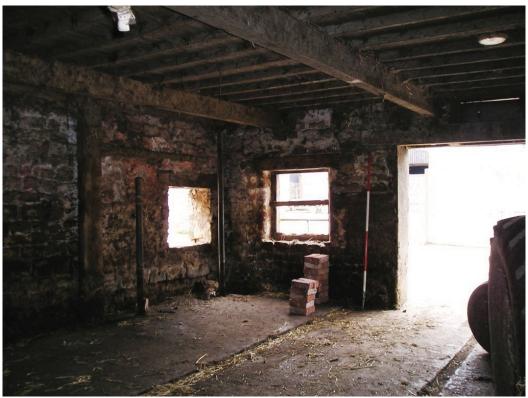
23. Extension bay looking to end gable. Note the drain channels to the floor that show the interior of the shippon was re-arranged to have cattle stalls facing the front and rear walls having formerly been arranged facing the main barn (as indicated by the perimeter doorways). Note also the beam carrying the loft floor above. It is presumed that this floor was raised in height when the roof level was raised (as described elsewhere)

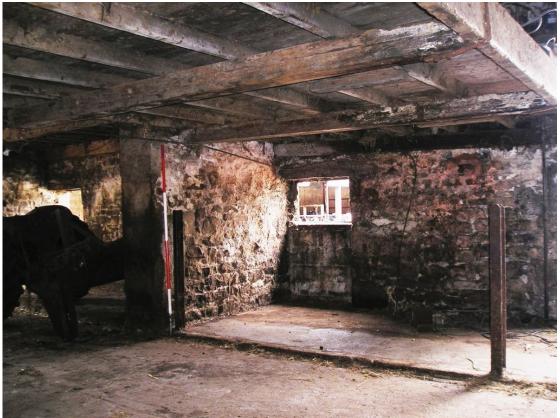
27.Original barn, beneath the loft to the north eastern end with opening through to the extension bay blocked door central. The loft floor is a replacement positioned above the level of the original structure

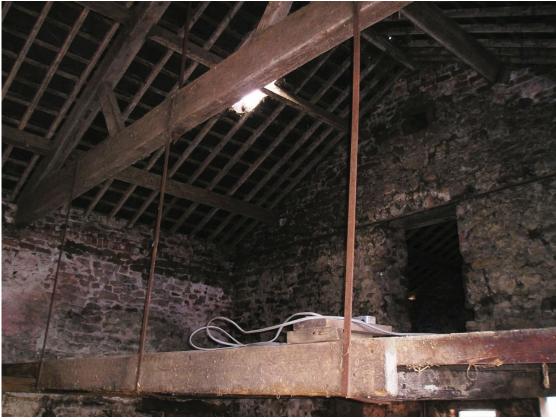
29. View onto the loft (not safe for full access) showing straps supporting end beam by hanging connection to roof truss. The door is the former gable pitching door, now giving access to the extension loft (not accessible)

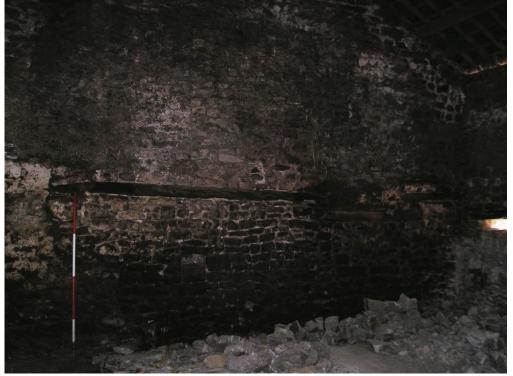
32. Inner face of south western gable showing built in timbers and blocked former window. The horizontal timber is possibly the bearing for former loft beams

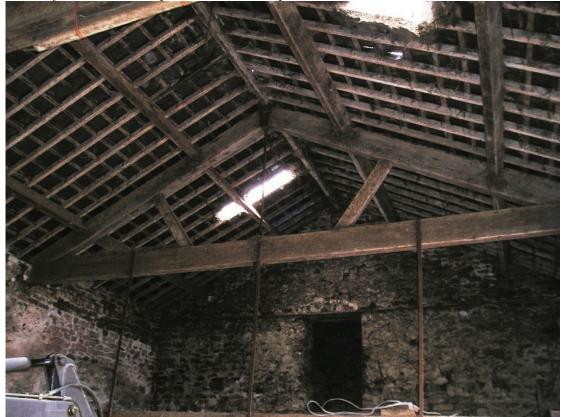
34. Alternative view of truss. The trusses are presumed to be C19th replacement installed when the roof level was raised.

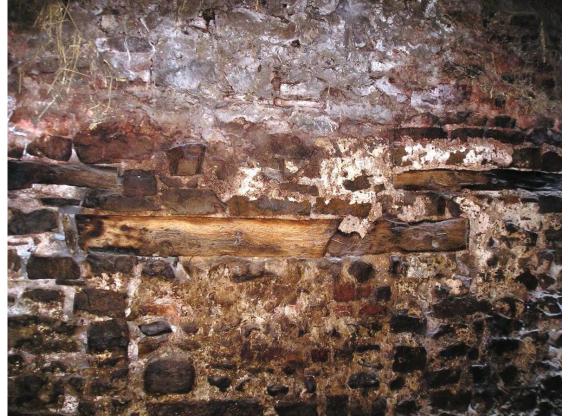
36. Detail of timbers built into the gable (see 32). The main piece is a lintel of a blocked window with a cut out channel showing that it has been re-used
