Historic Building Record

**Old Crookhey Farmhouse,
Garstang Road, Cockerham,
Lancaster**

Prepared by
C.J.O'Flaherty MRICS, MSc
January 2009

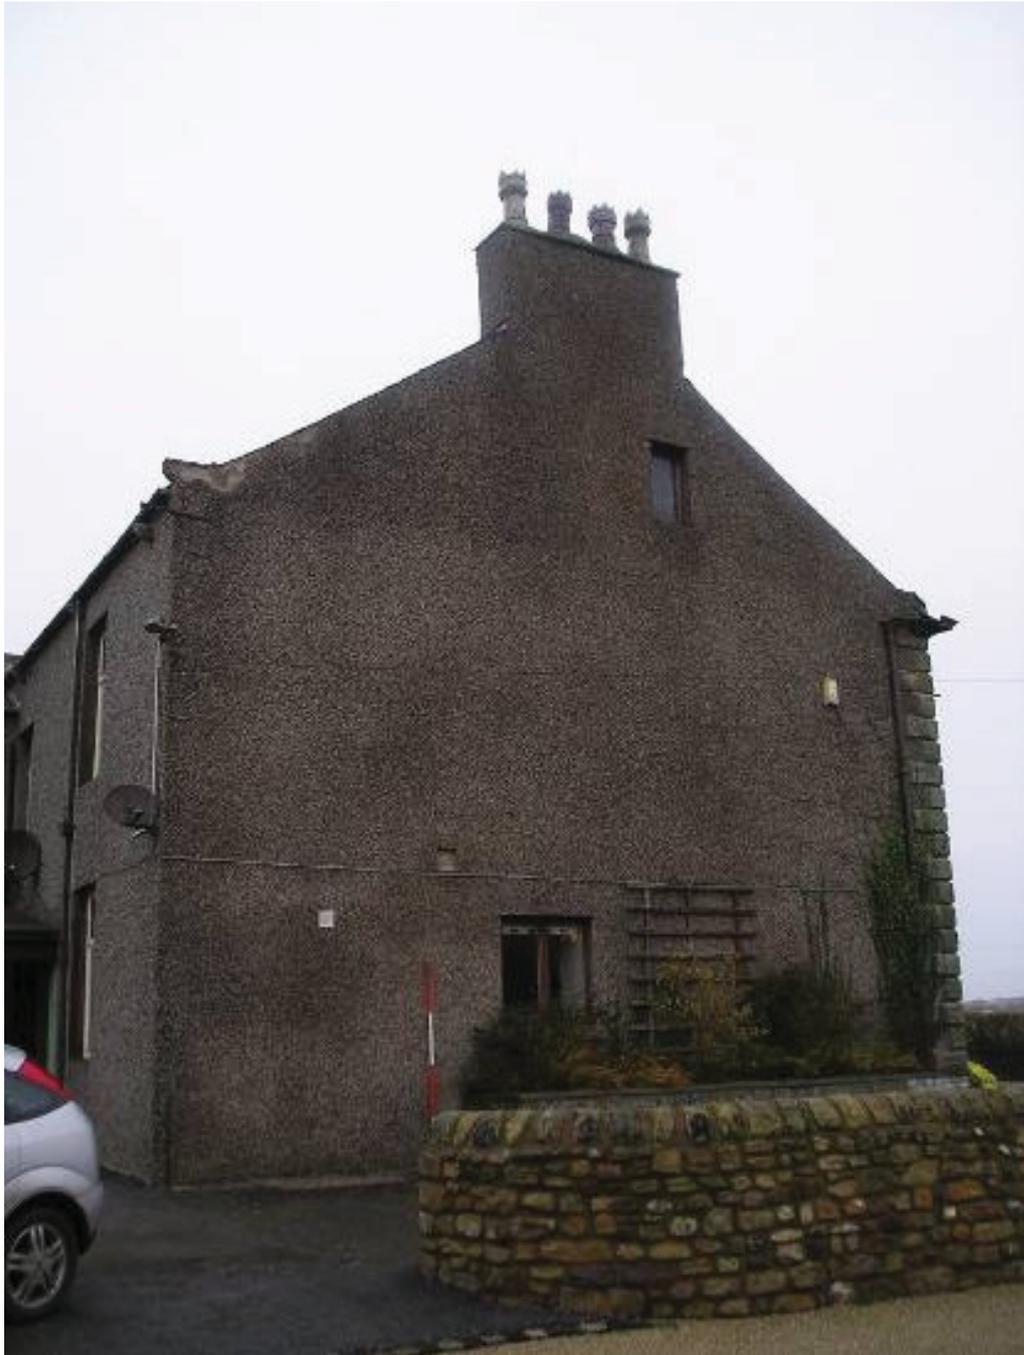
6. Left gable of main front house part, with ground floor window and attic window. Four flue chimney serving fireplaces to two Ground and two first floor rooms. Remnants of roof edge kneelers Can be seen top left. Rusticated quoins to the left corner of the front Elevation visible to the right of the gable

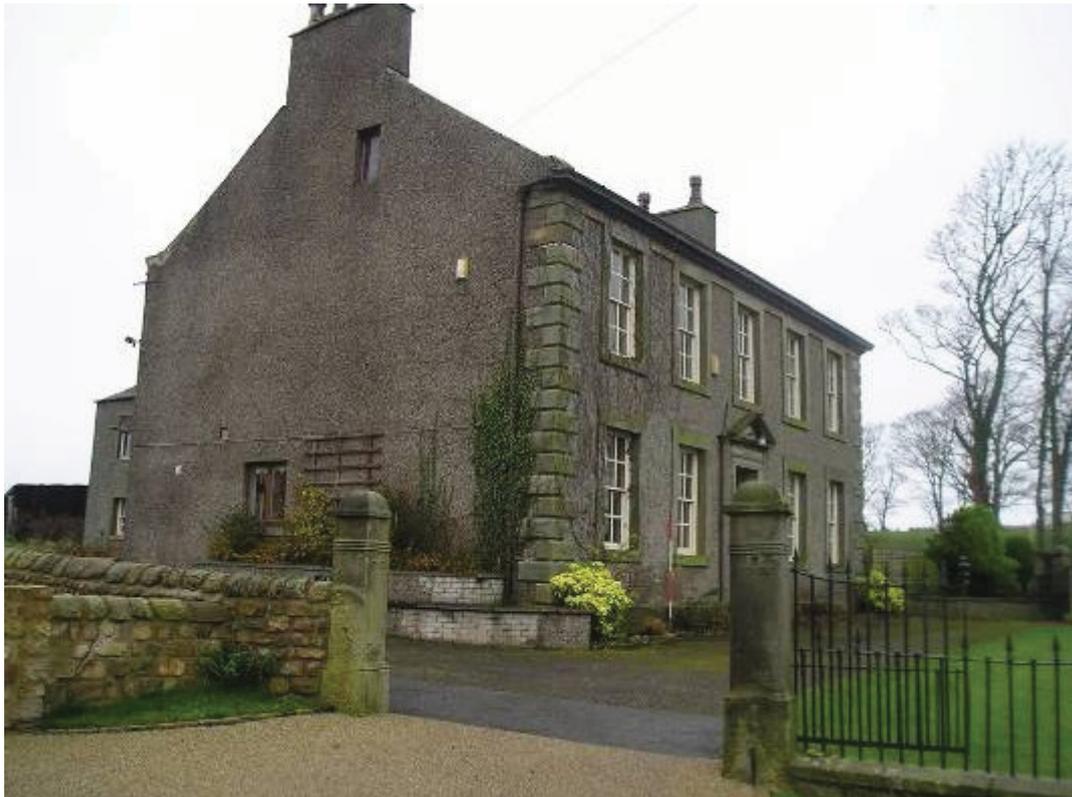
7. Main house façade and left gable viewed through the southern drive gateway. The drive sweeps in front of the house and exits via another gate to the north.

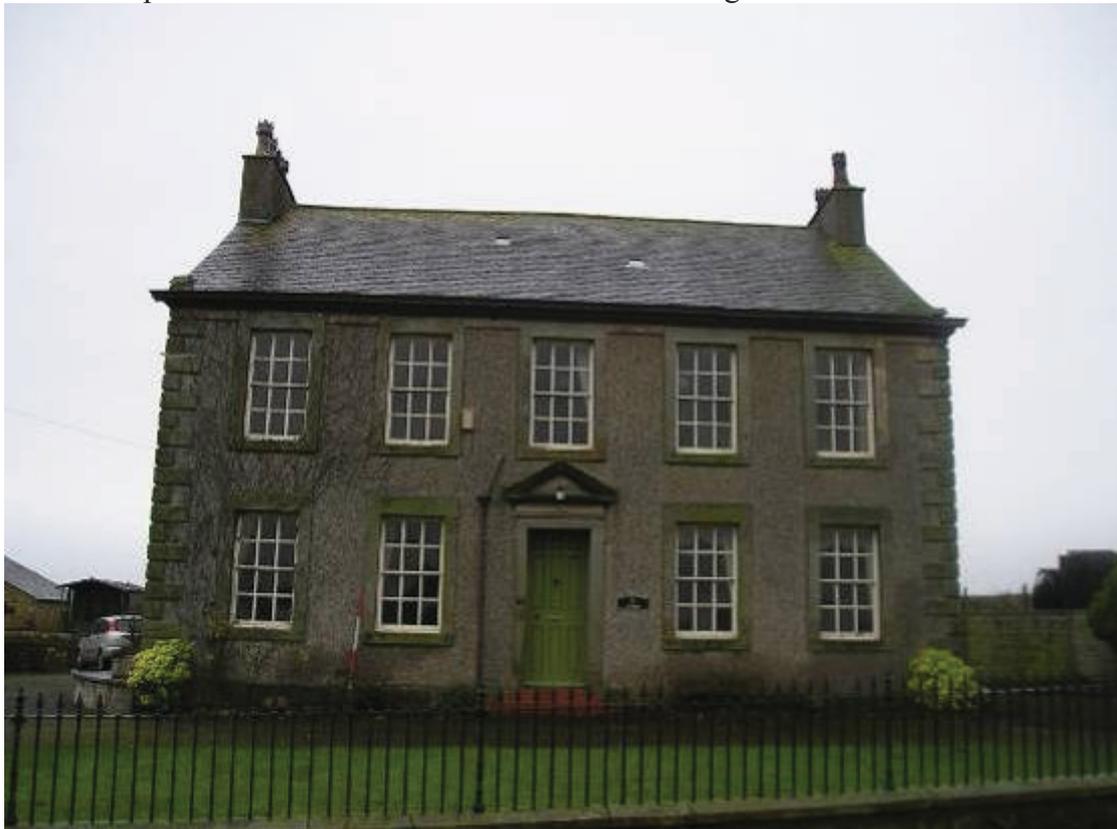
8. Main façade facing the road. Five bays with central door having pediment and shouldered lintel. The twelve light (six over six) sashes have matching plain surrounds

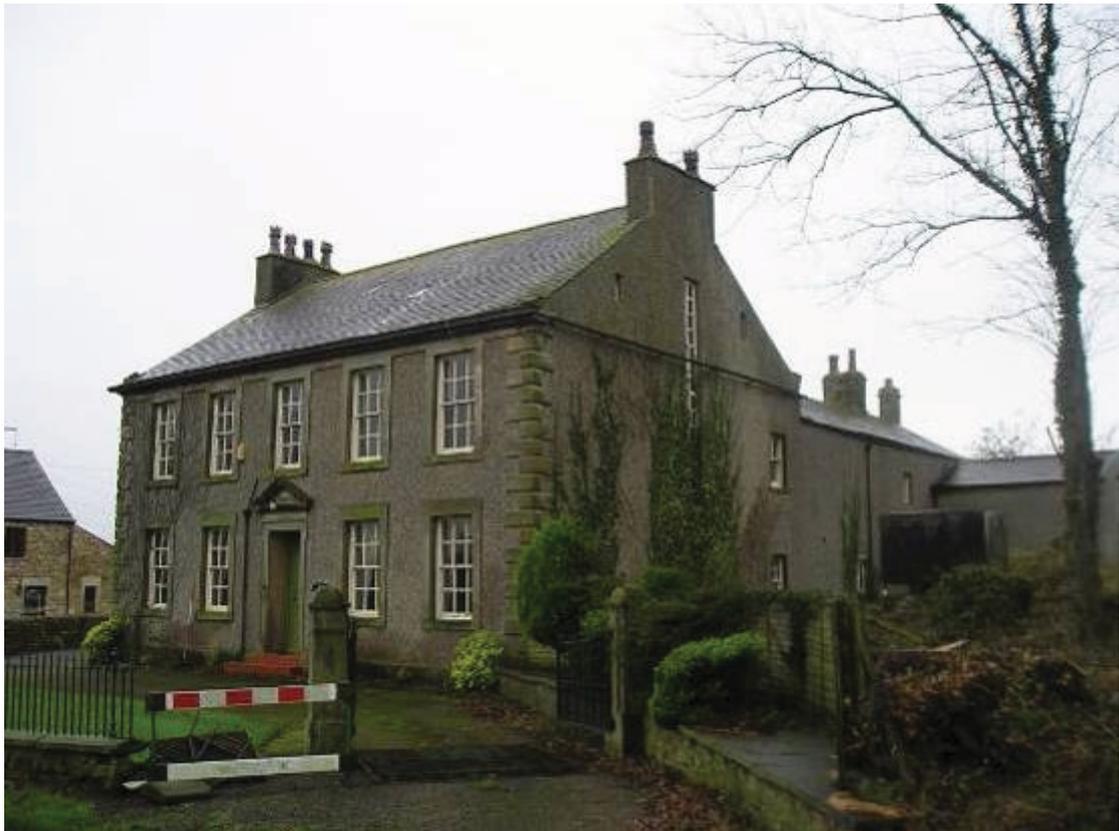
9. Main façade with right gable and rear wing extending away to the right viewed through northern gateway

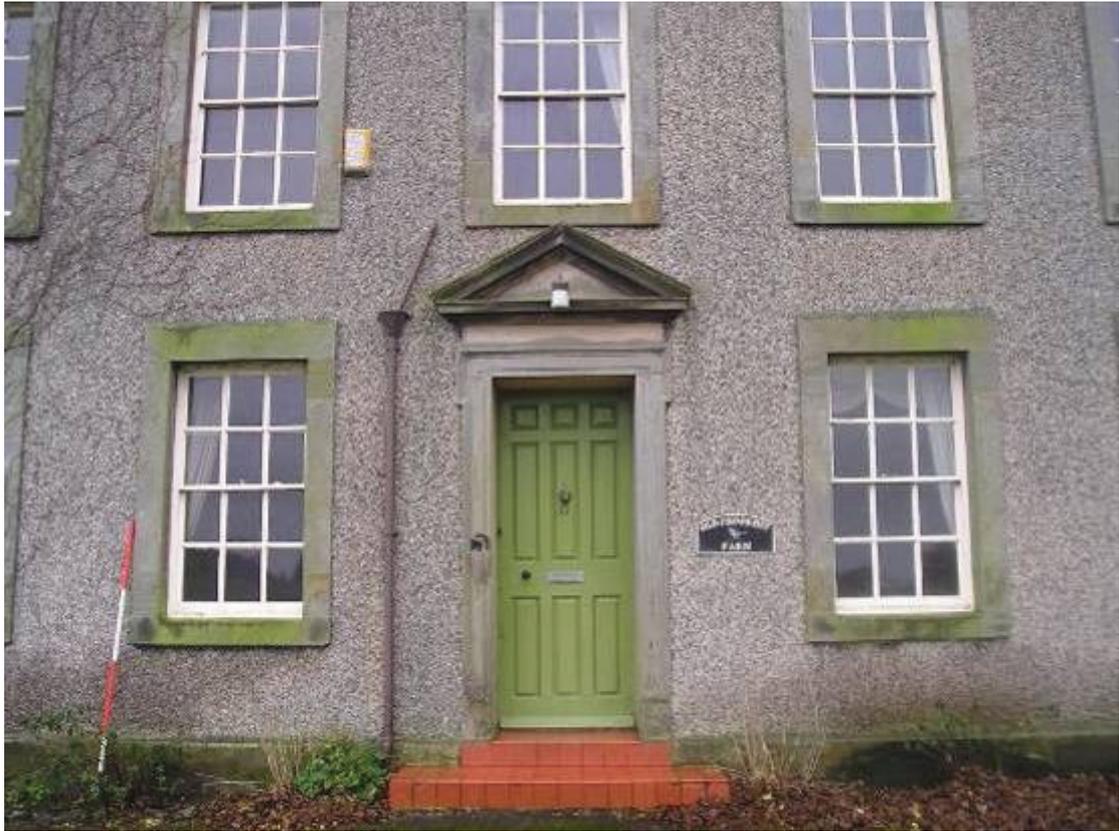
12. Detail of front façade showing main entrance door shouldered lintel and pediment and plain raised surrounds to the sash windows

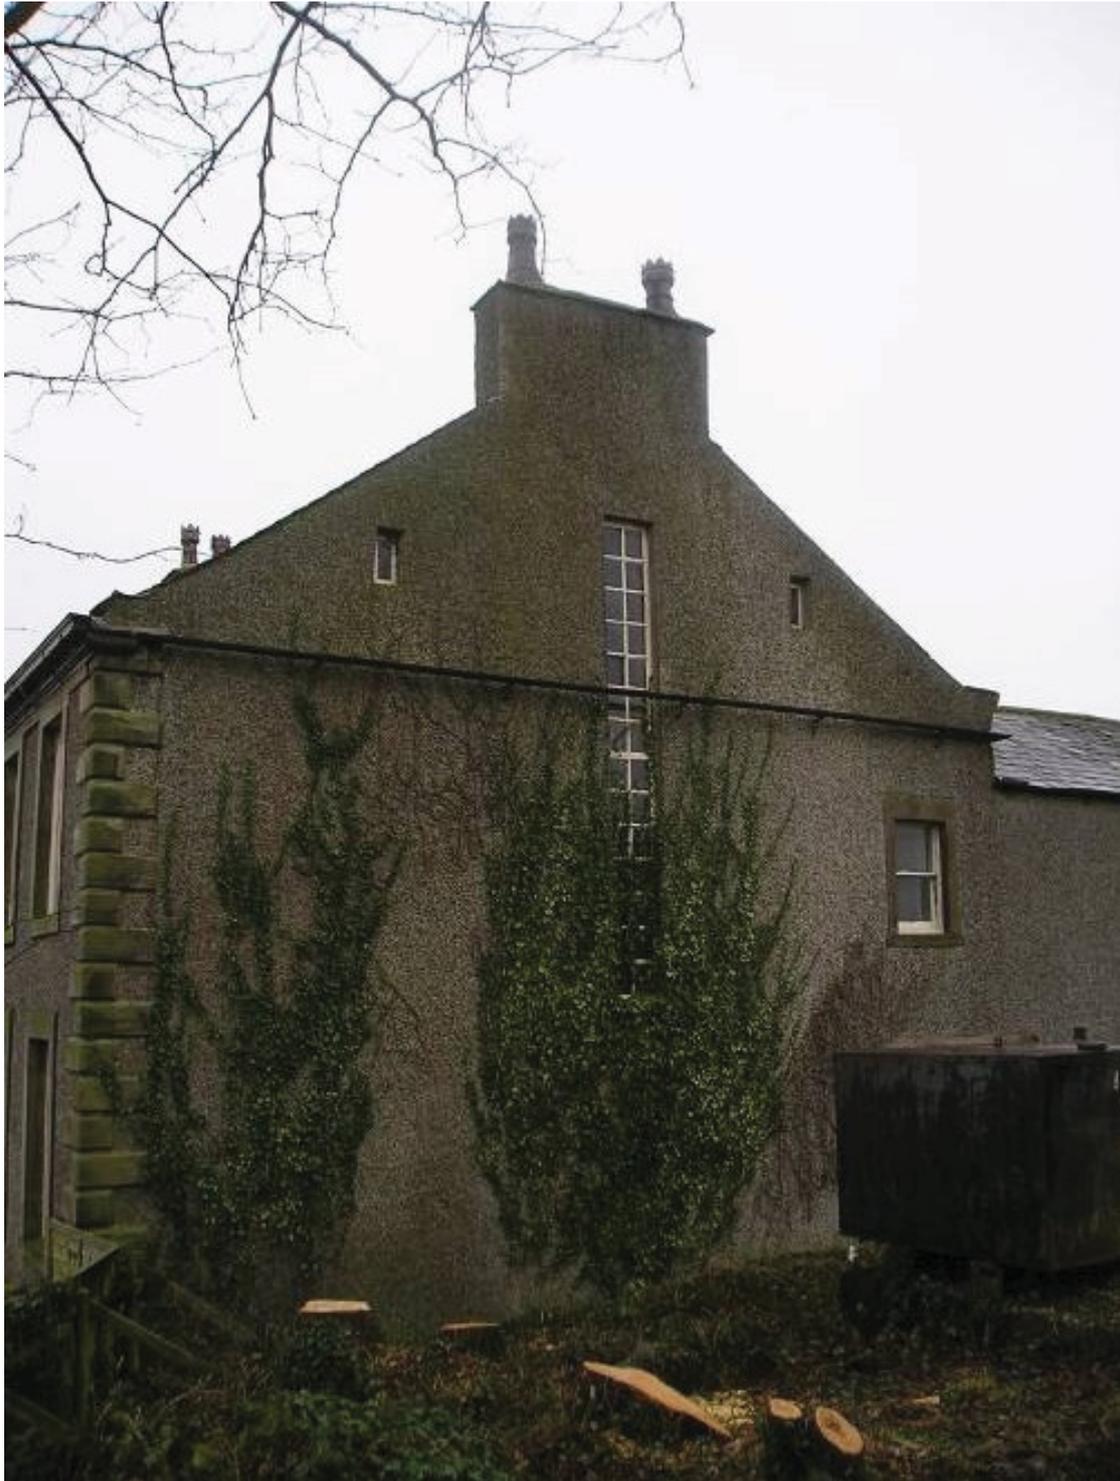
13. Right gable of the main front part with tall stair window serving service stair.
Note the two small attic windows serving attic rooms

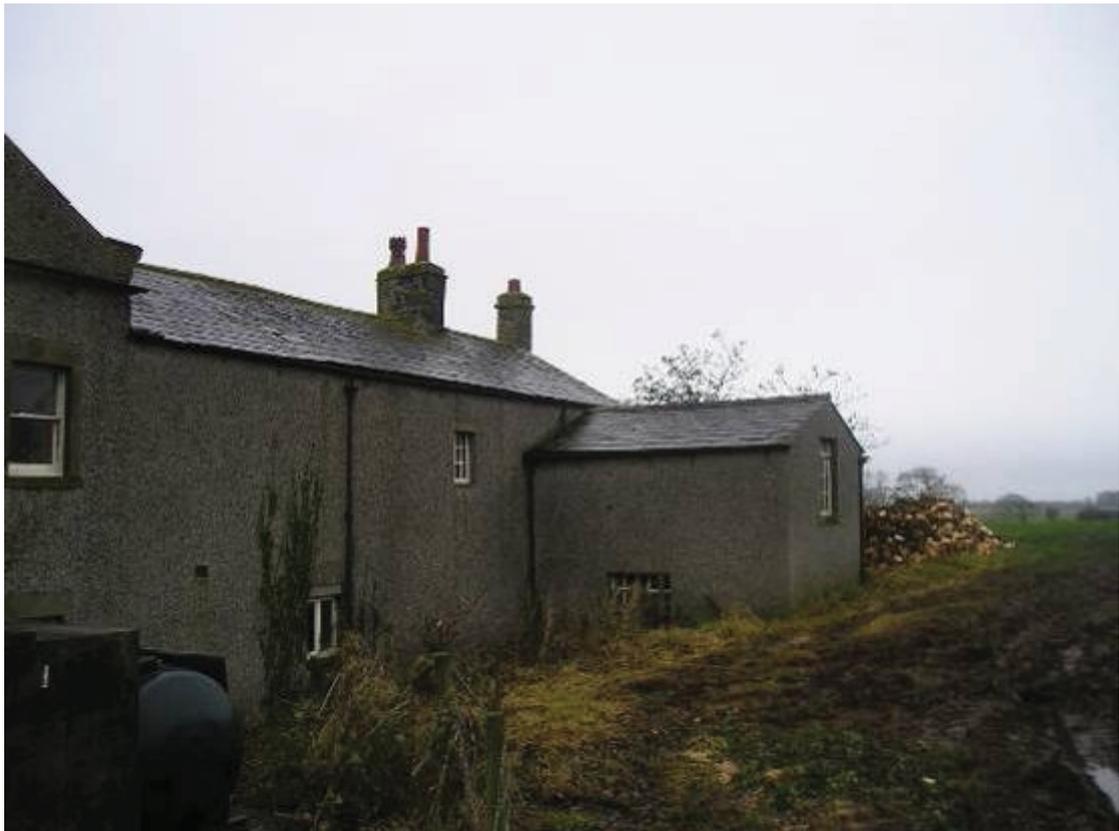
14. View along the rear wing, north side, with projecting addition housing the cold store/pantry at ground level where the structure is built into the ground

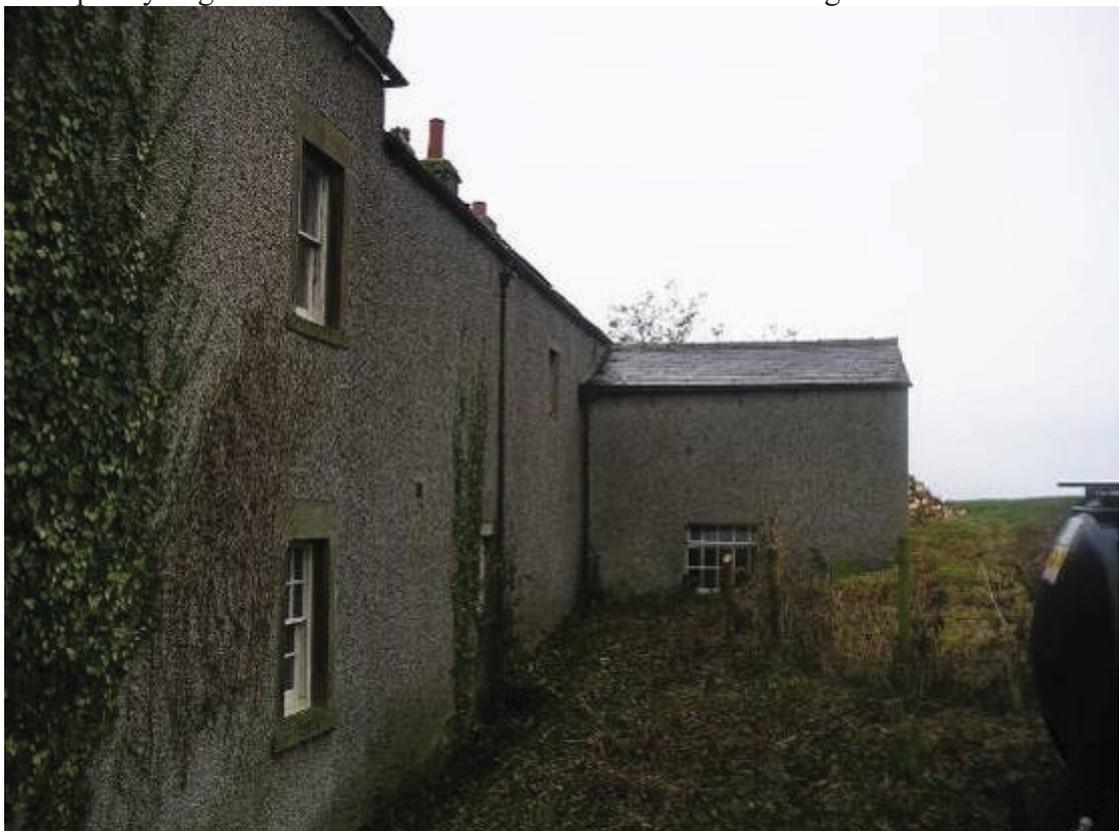
15. As 14, alternative view

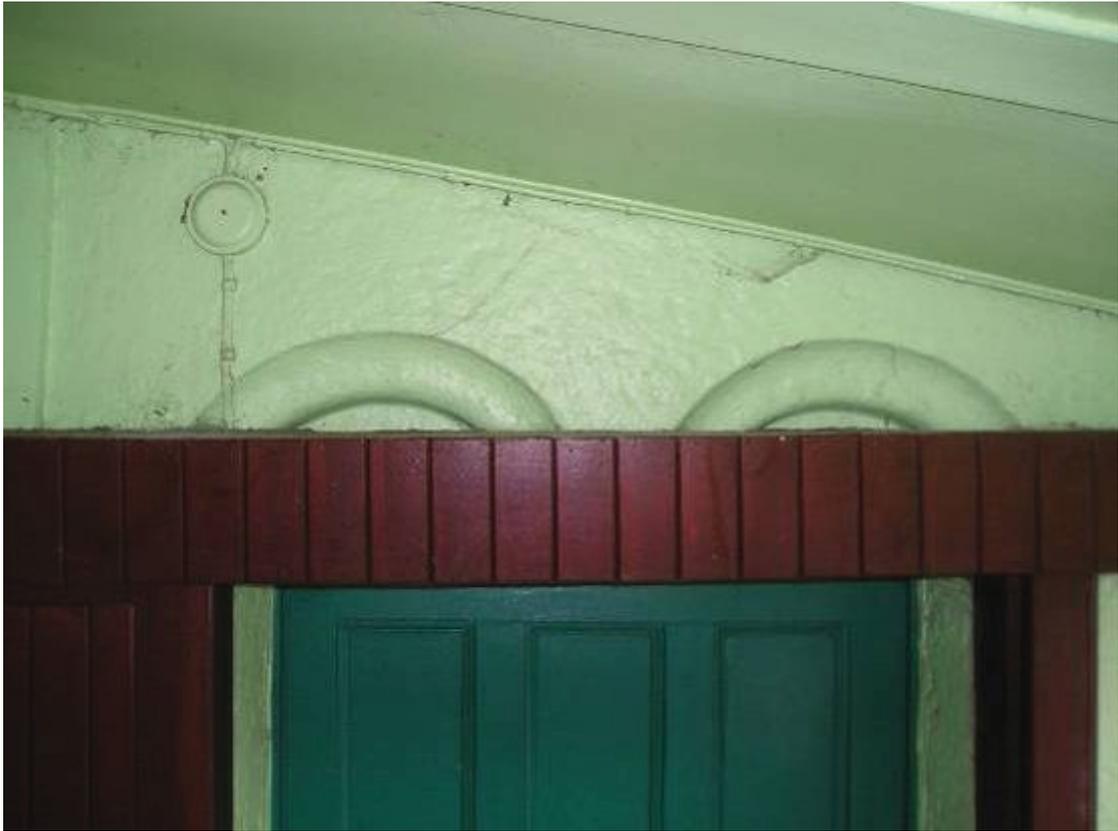
16. Rear elevation of main house – detail of obscured carved stone lintel which is a remnant of an older building

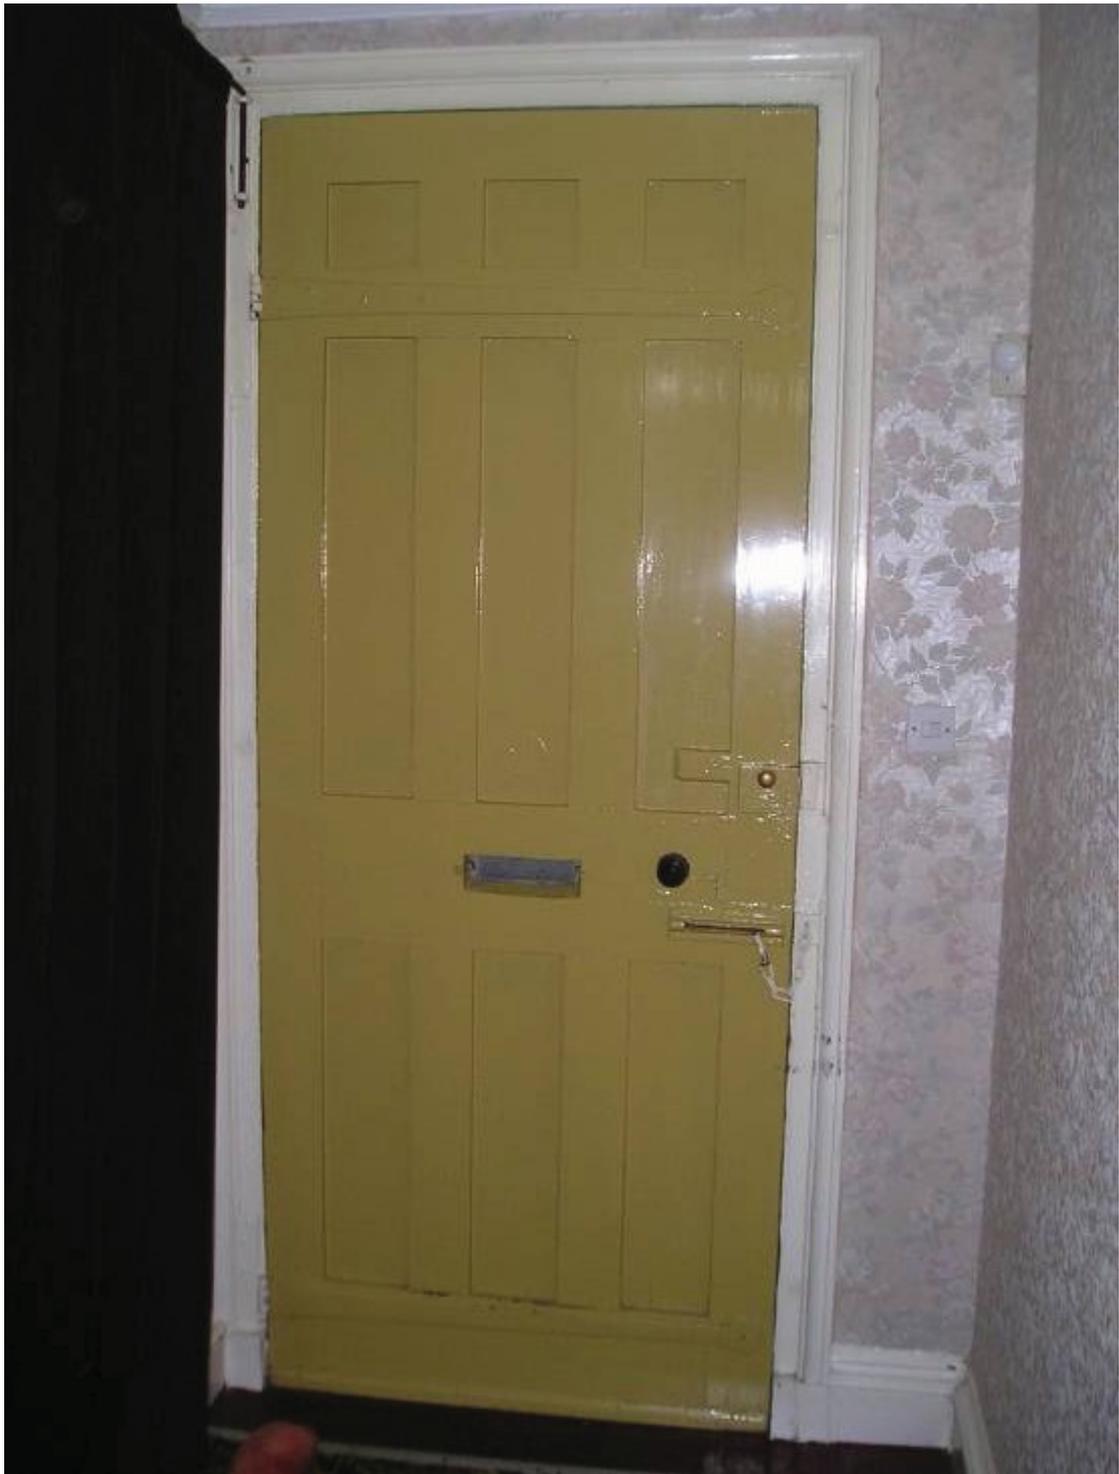
18. Interior, inner face of main entrance door, nine panel with long wrought hinges and moulded architrave surround

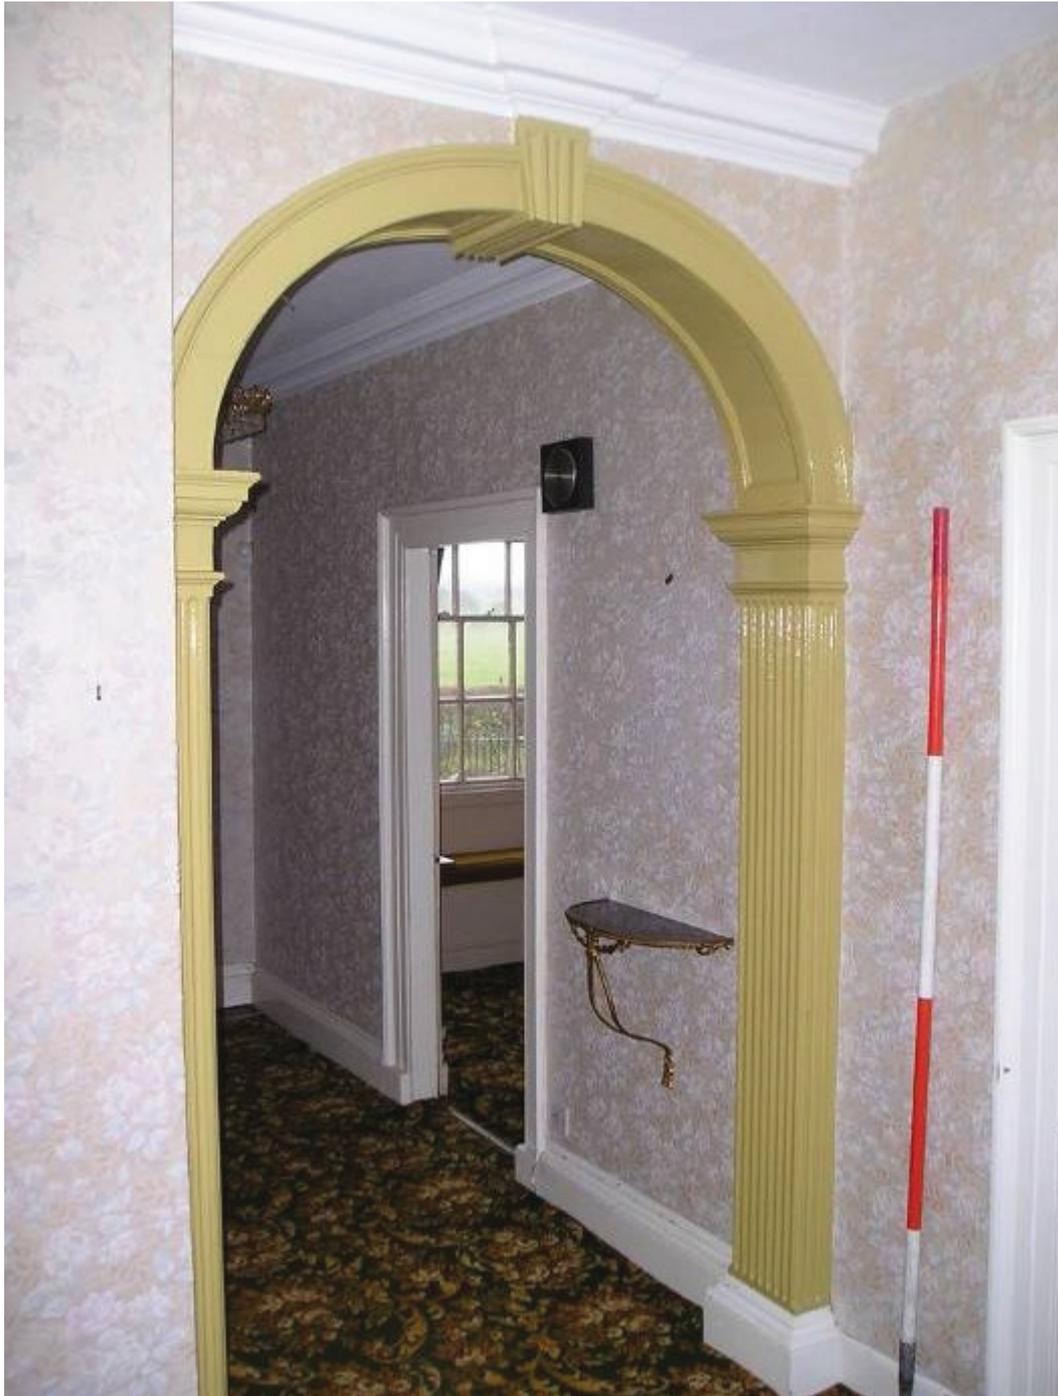
19. Plaster arch between the staircase and main entrance door with fluted pilasters, moulded capitals and keyed arch that continues into the cornice moulding above. The visible doorway enters the front left main reception room (see 20)

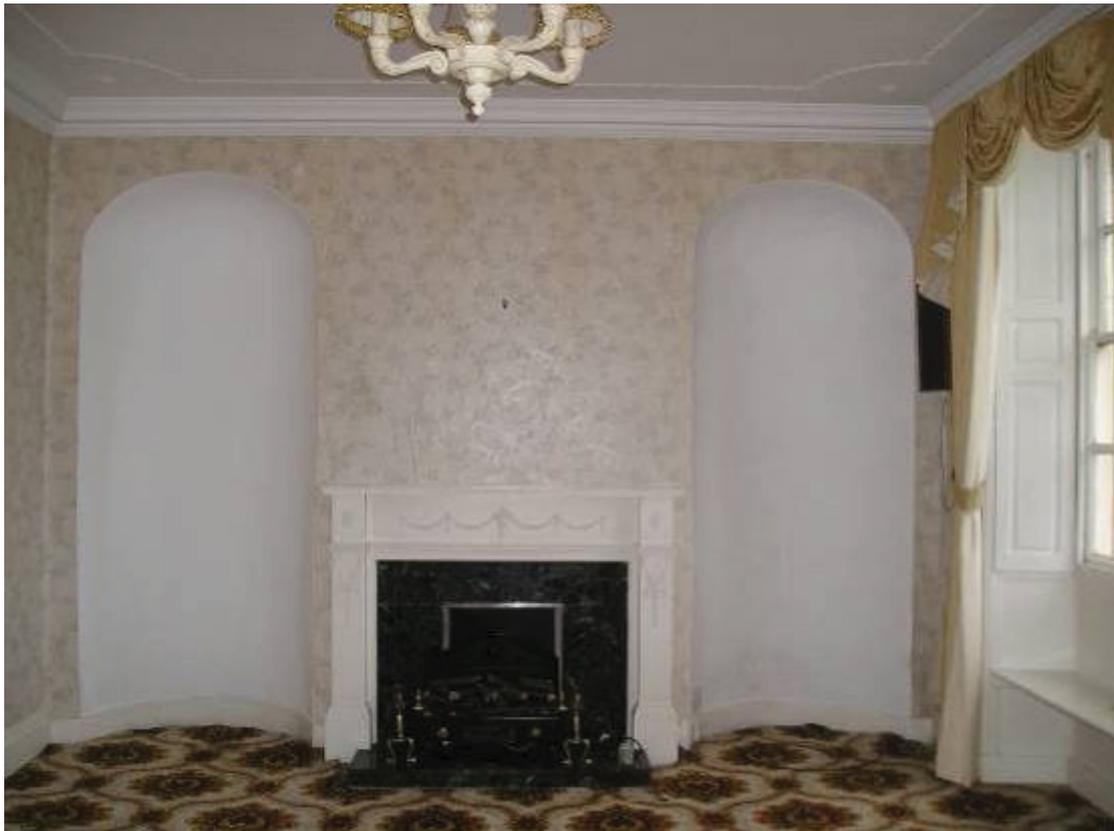
23. Front right reception room looking to fireplace with niches to the right wall. The neo-classical fireplace surround (painted wood) is unlikely to be an original feature

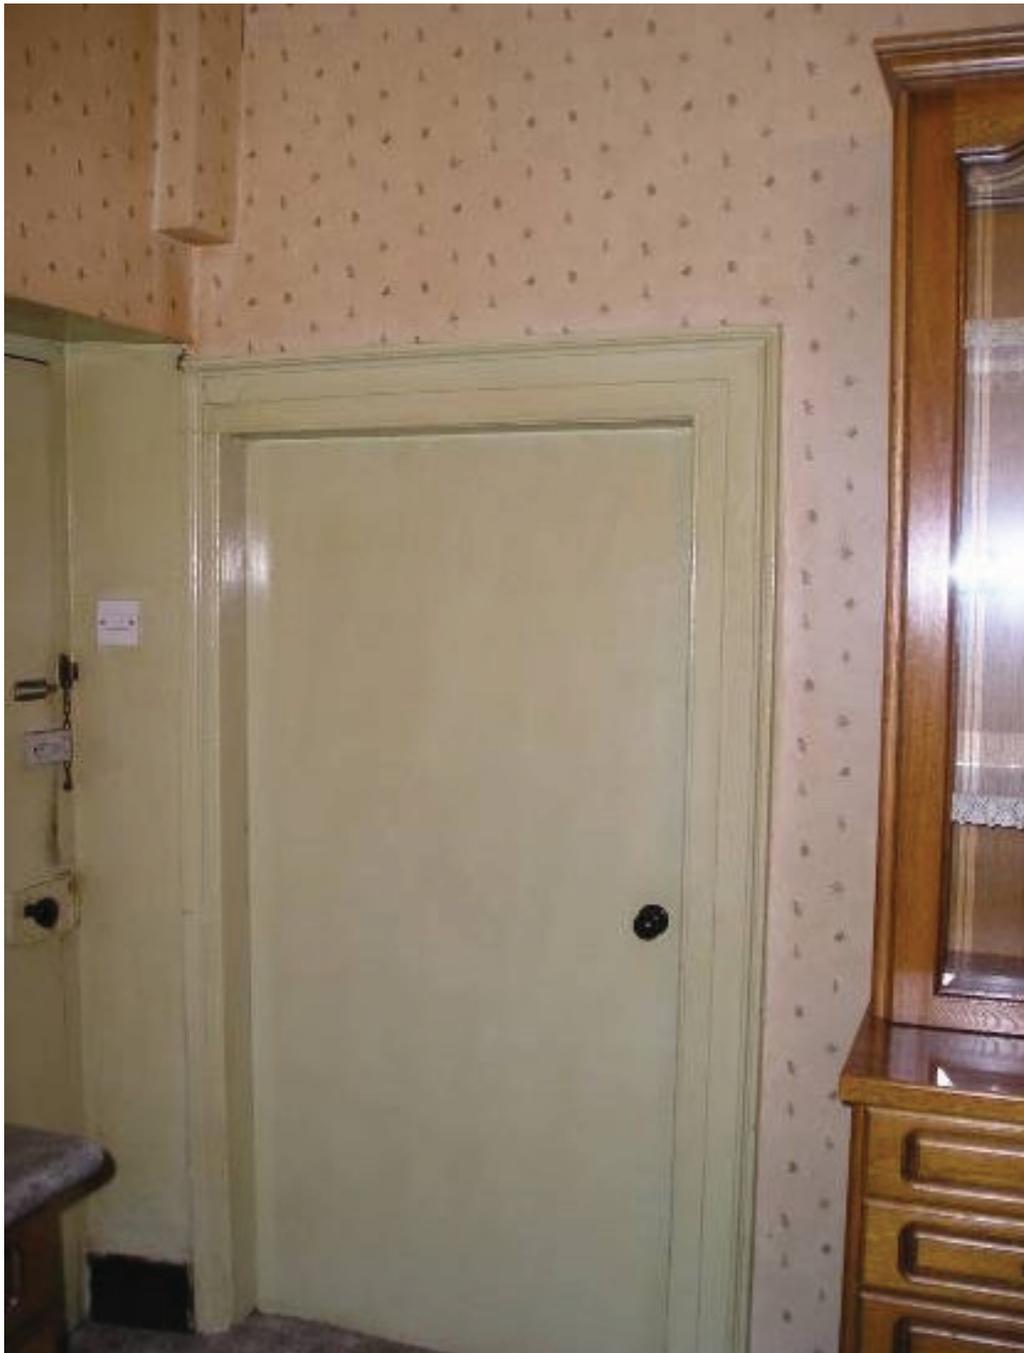
29. Door from kitchen to understair area which then leads to service part (rear right of the main house part)

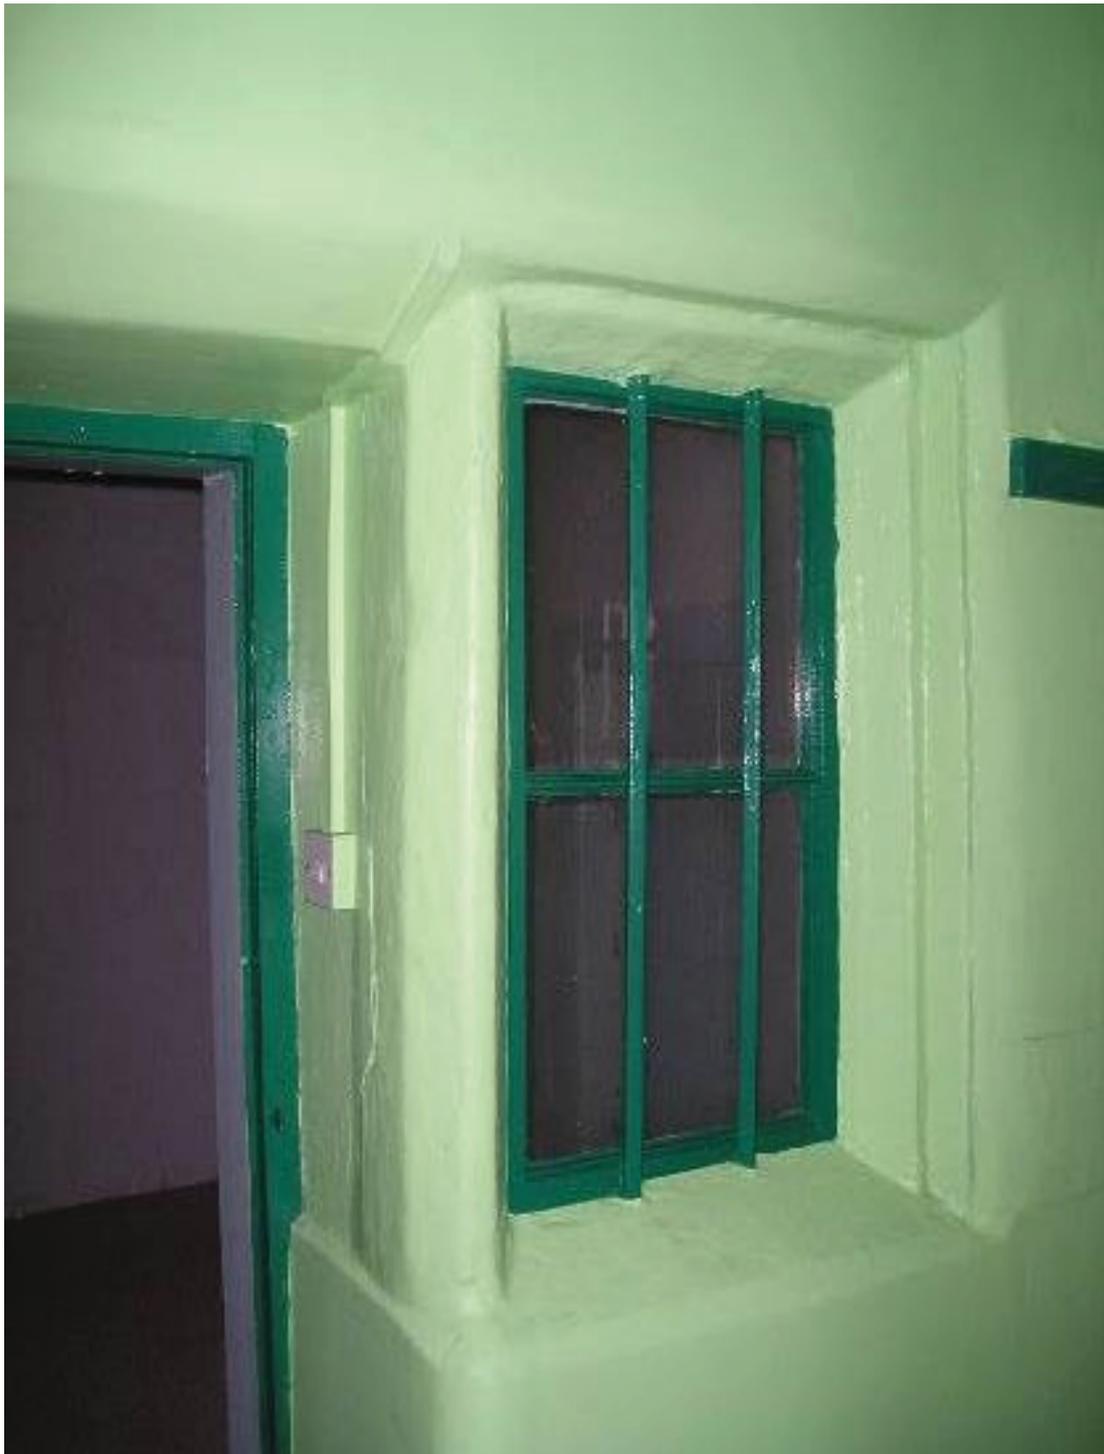
35. Detail of former mullion window, double recessed and chamfered, altered to form doorway (left) as discussed above (34) and viewed from within the rear space adjoining the kitchen. This wall was presumably an exterior wall before the construction of the rear wing

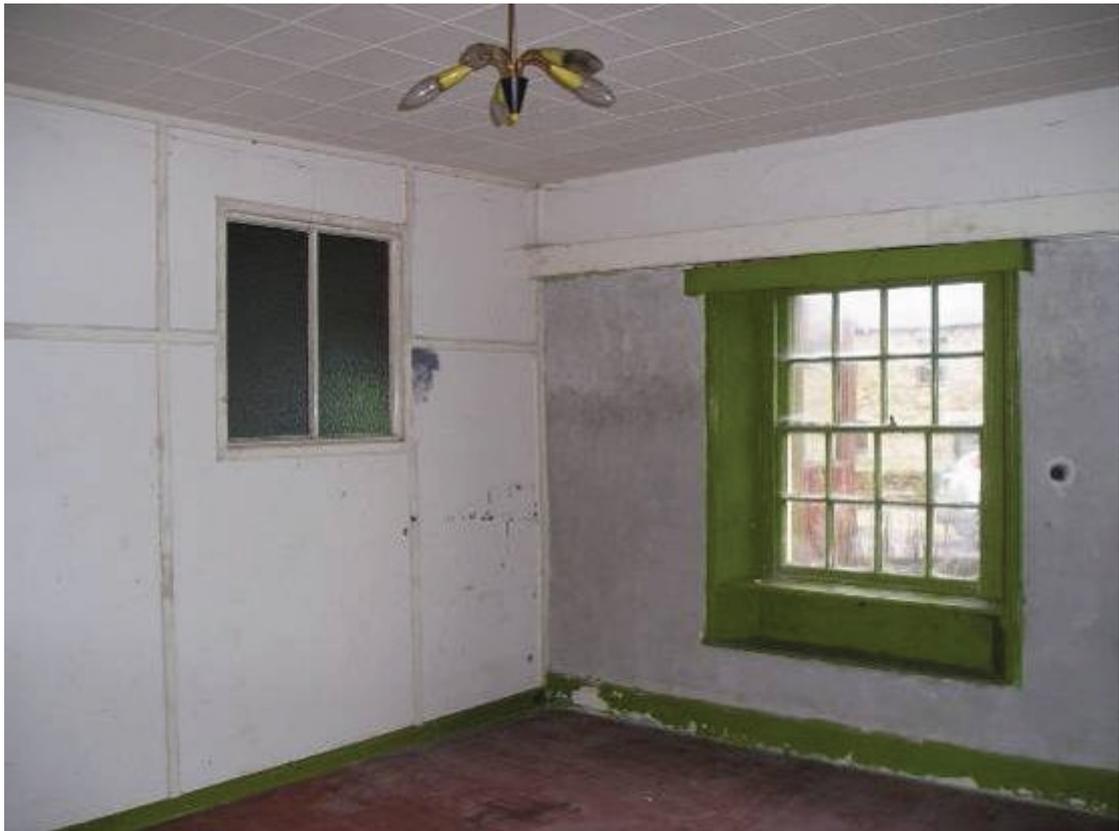
73. Front most ground floor room with inserted partition left forming entry corridor into separate rear dwelling

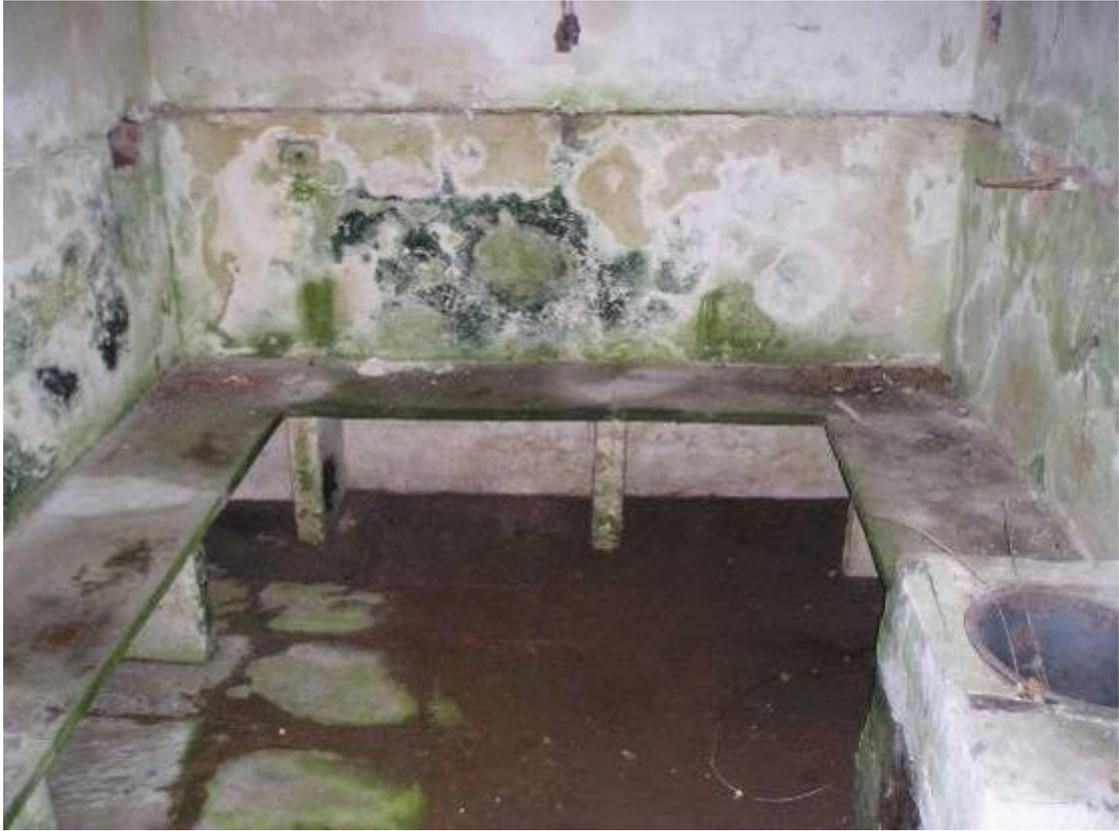
75. View into rear right pantry/cold store with stone perimeter shelving

The rear annexe will require extensive refurbishment due to its poor condition. It is likely to require recording before any consented works are carried out. For example, the pantry/buttery would certainly need to be recorded as it is unlikely to remain in its present form.

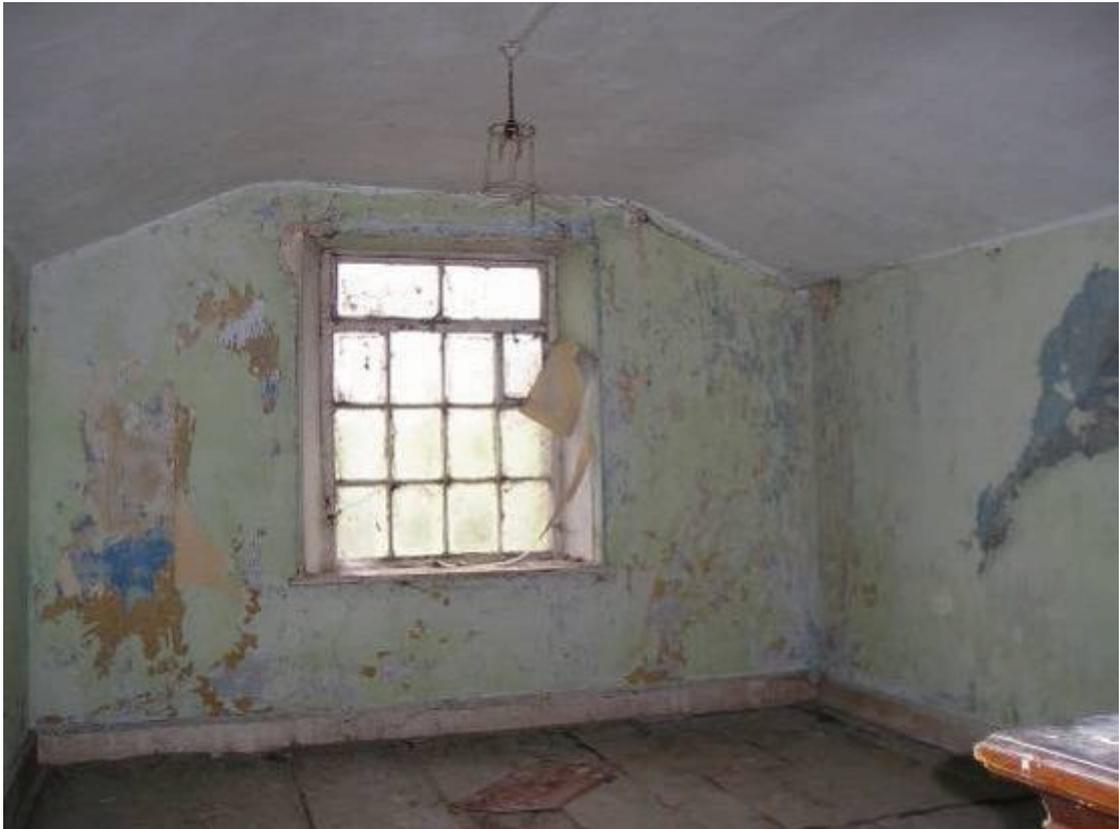
78. Room over cold store

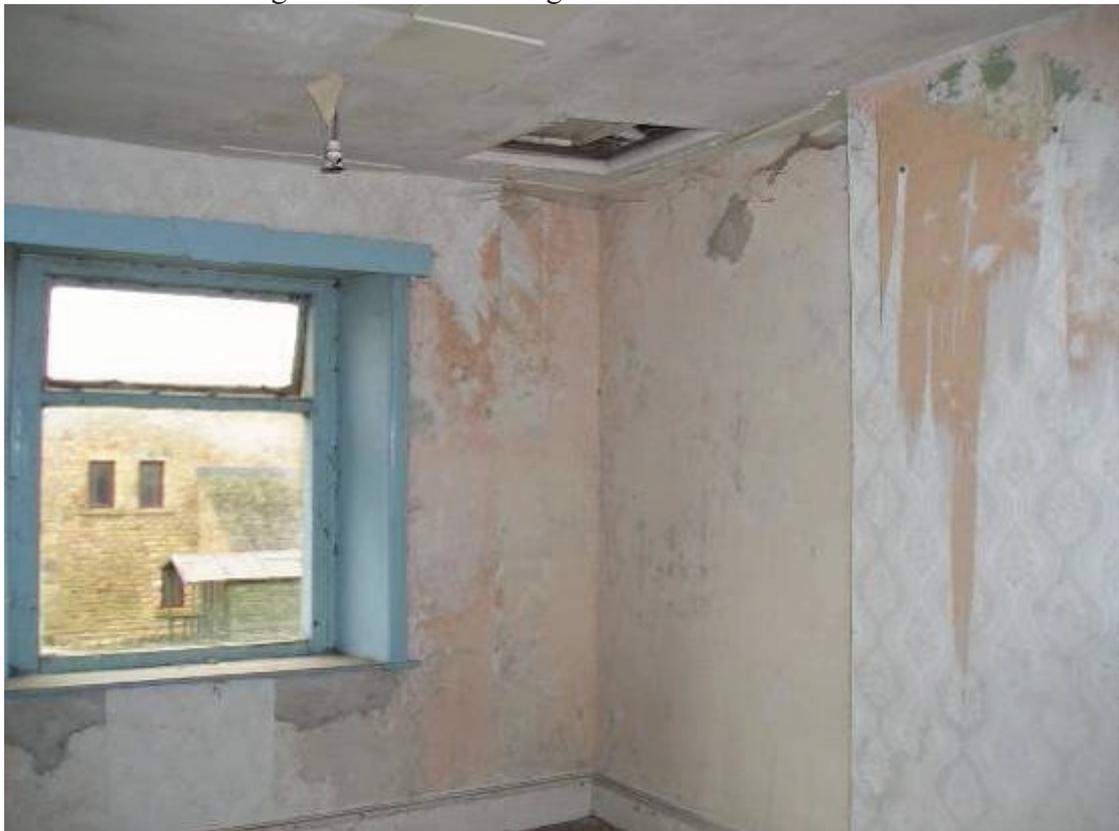
80. Rear bedroom (rear wing)
