Ironbridge Archaeological Series No. 342

Archaeological Watching Brief during Investigative Works at the Iron Bridge

July 2016

Ramboll on behalf of English Heritage

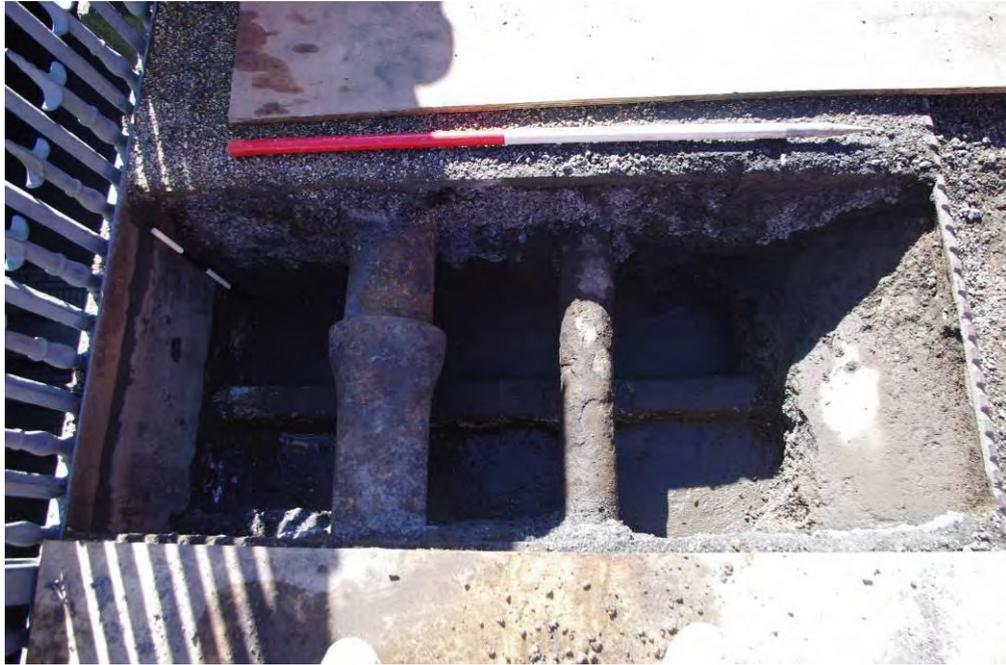
Plate 12: TH02 from the north

The deck plate upstands, which ran east-west through the midpoint of the trench, were 70mm high and 25mm wide. The gap between the deck plate upstands was found to be approximately 20mm wide and filled with caulking. Interestingly, during the excavation of this trial hole, water was found to be pooling on the western side of the trench on the north side of the upstands (see Plate 13).

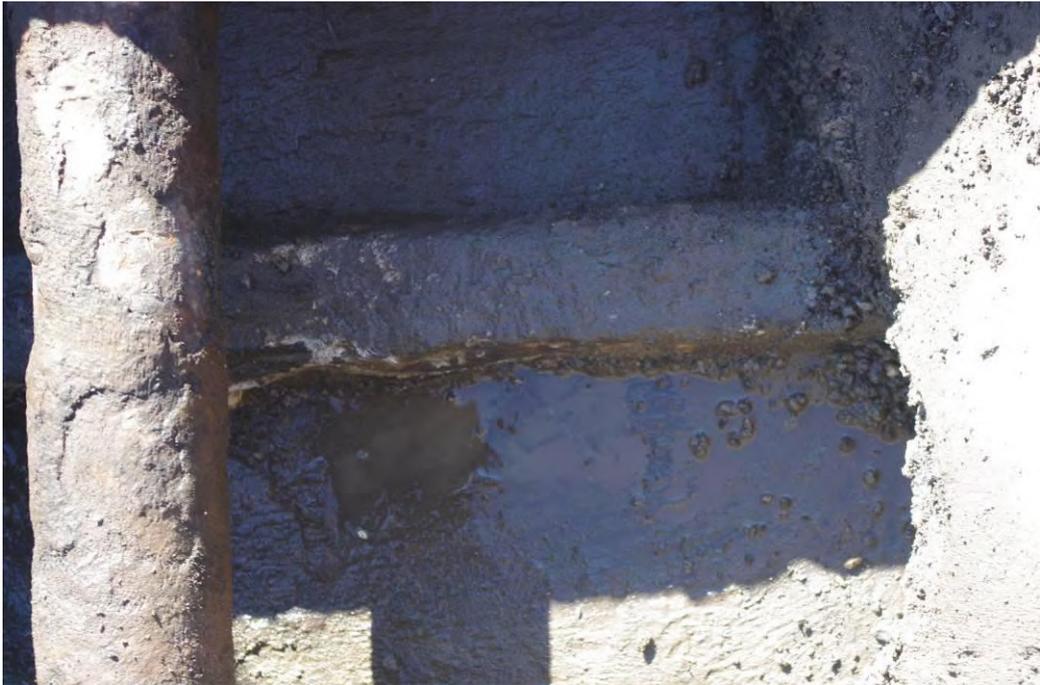
Plate 13: Water pooling in TH02

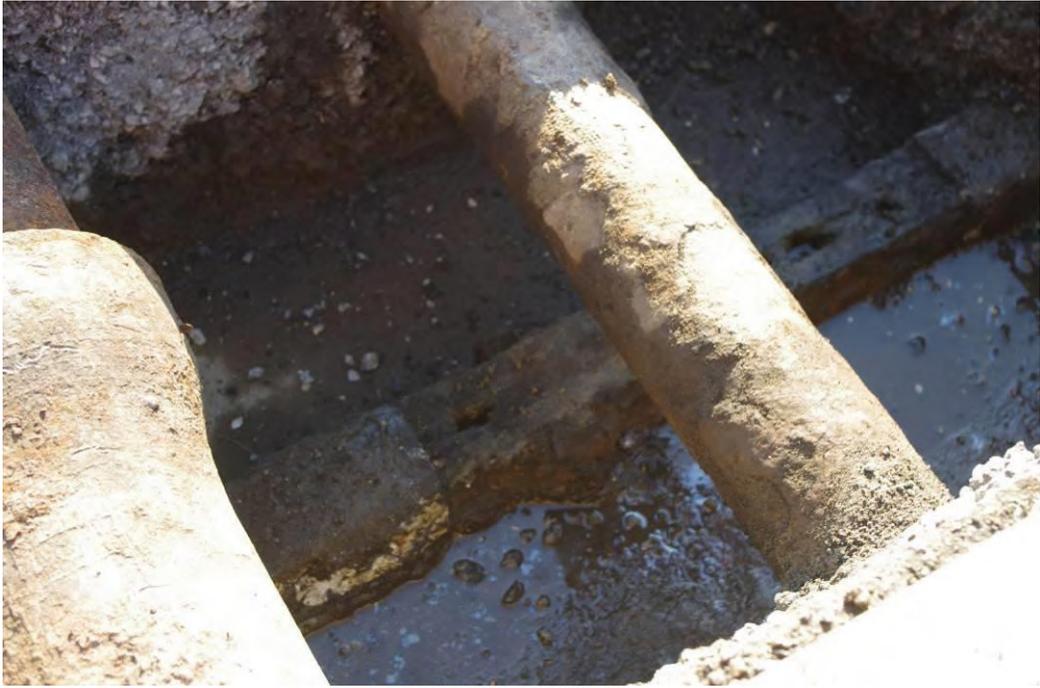
Invasive exploratory works were undertaken by the contractors with a view to better understanding the nature and extent of the caulking (see Section 6.3 above for details of the methodology employed). It was found that the 'gap' between the deck plate upstands was filled with a material that resembled 'iron cement'. This was overlain by a plug of a bitumen-type material, which was approximately 3-4mm thick. This was sealed with flashband tape, which covered the horizontal and vertical sections of the caulked upstands and the adjacent deck plates for approx. 55mm. The flashband tape and the deck plates were coated with a brittle sealant layer (see Plate 14).¹³

Plate 14: Part way through attempts at removing the sealing and caulking material from the upstands in TH02. Note flashband tape and sealant to the left of the photo

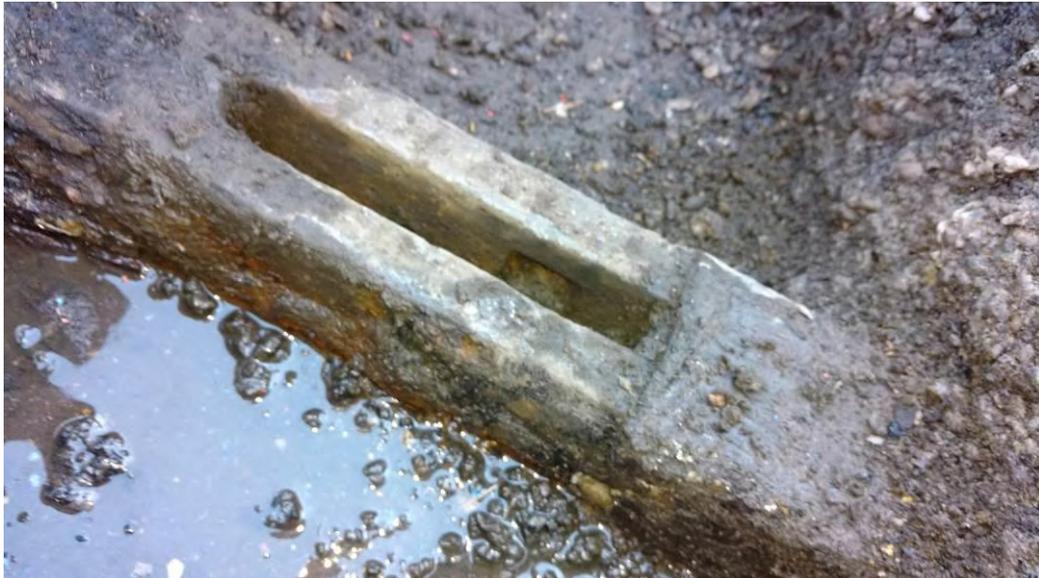
When the caulking material had been cleaned out a square notch was observed on the corresponding internal faces of the upstands. It is possible that these had been used to help lift the deck plates into place (see Plate 15).

Plate 15: The gap between the deck plate upstands in TH02. Note the notch on the inner face.

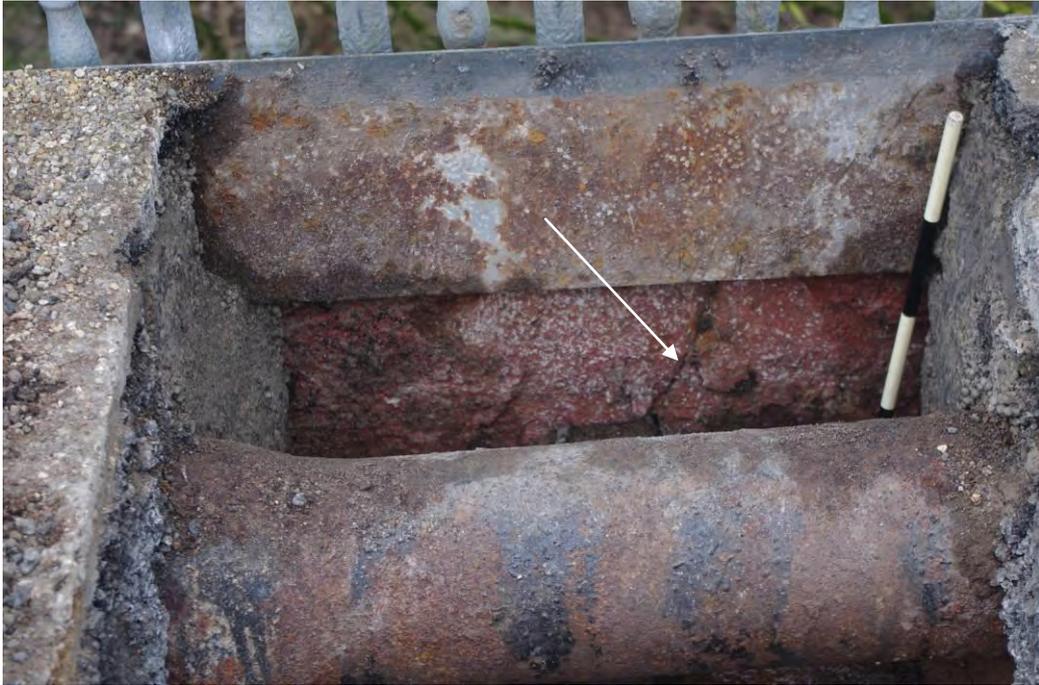
The upstands were found to be bolted together approximately 45mm to the east of the western edge of the trial hole, *i.e.* the bridge edge plate, which had a sizeable crack, and was found to be coated with what appears to be red lead (see Plate 18). Further bolt holes through the upstands approximately 20/30mm in diameter, 2.05m to the east of the bridge end plate do not quite line up and may never have been used for that purpose.

Plate 18: Crack in the bridge edge plate in TH01 from the east

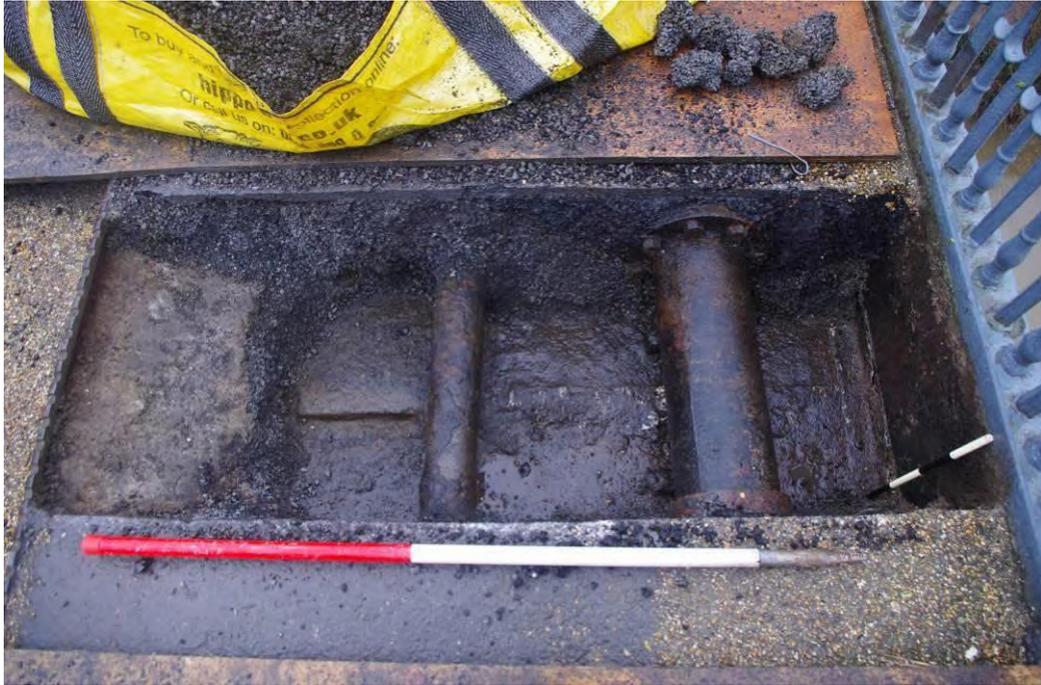
Plate 20: TH08 from the south

As this trial hole was located on the main arch of the bridge no deck plate upstands were found to be present. The gap between the deck plates was filled with a hard bituminous-type material similar to that recorded in TH02 and TH01 above, and covered over with flashband tape (110mm wide). Samples of this were removed by the contractors who noted that it was only possible to expose c.15mm of the material as the join between deck plates grew tighter at depth. This was possibly due to the fact it was observed that the north plate was 6 to 8mm higher than the south plate at the join.

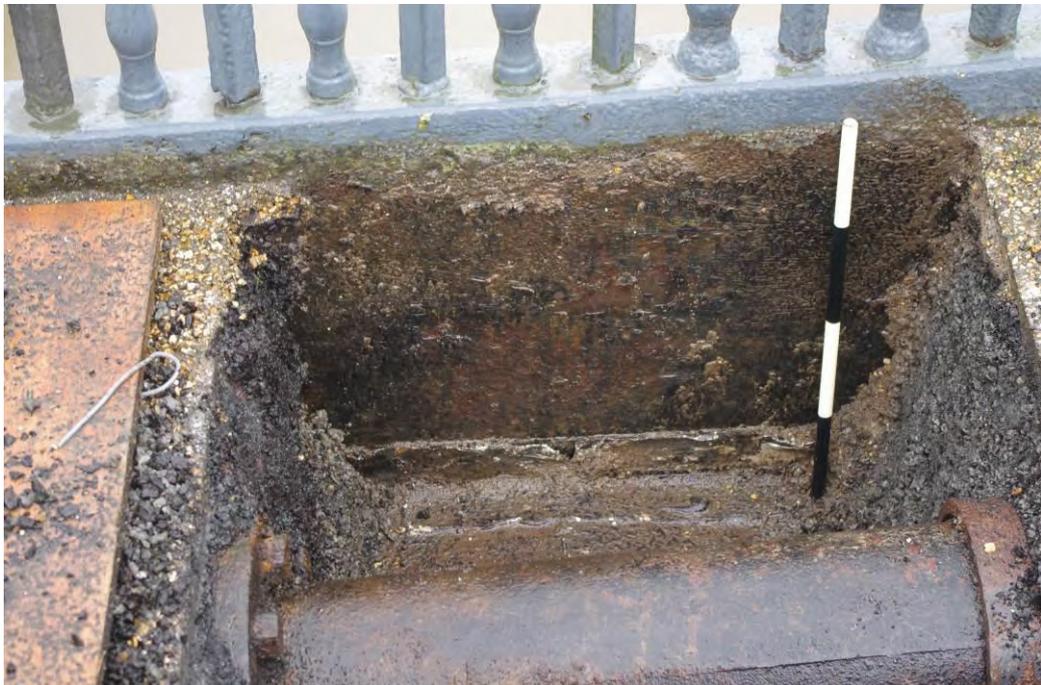
The deck plates and the wedges were coated with a thin and brittle sealant layer. The joint between the deck plates and the bridge edge plates was also sealed with flashband tape (see Plate 21).

Plate 21: Sealing at the joint between the deck plates and the bridge edge plates in TH08 from the west

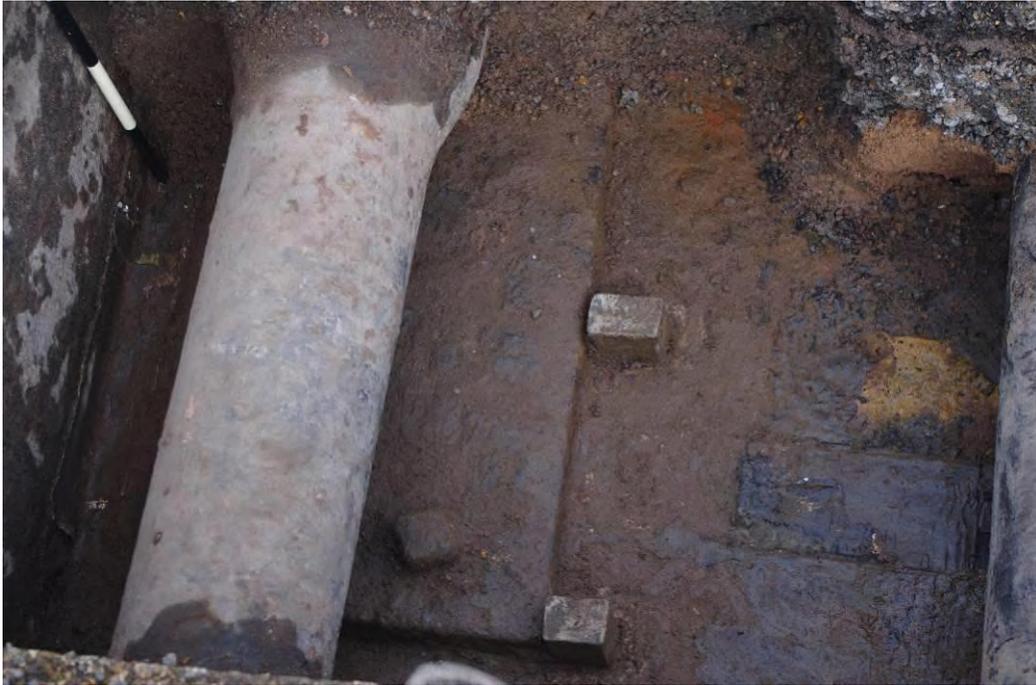
Two MIO coated pure iron wedges, which were installed in 2011 (see Ironbridge Archaeology 2011), were uncovered towards the western side of the trench. These were located approximately 440mm to the east of the bridge edge plate. Some corrosion was observed on the deck plates in the around the wedges, presumably where waterproofing had been removed.

Plate 23: Pure iron wedges in TH09

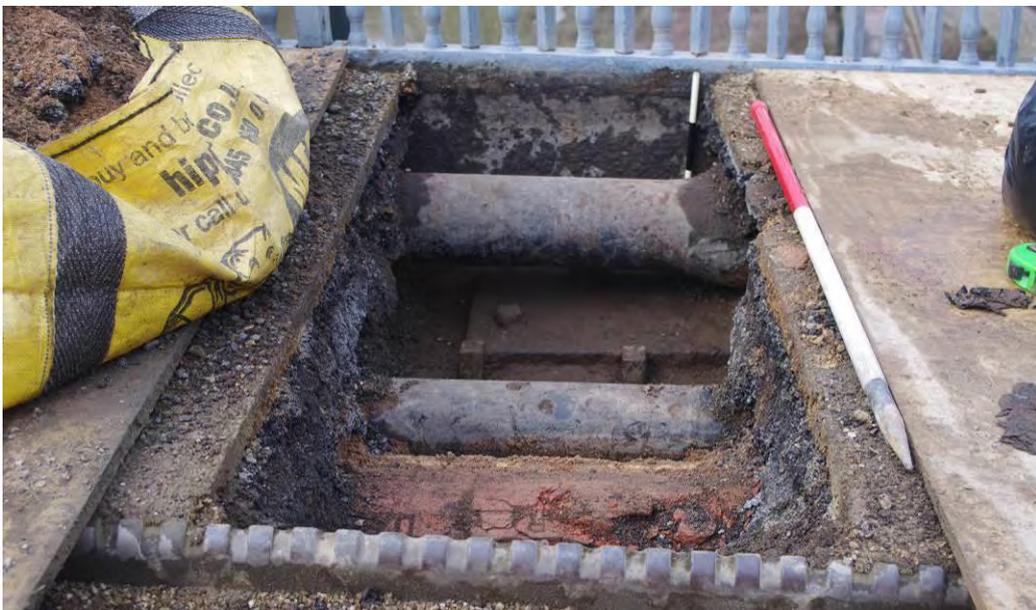
Immediately to the west of these wedges was a repair plate which was secured to the deck plates with square headed bolts. This was located approximately 70mm from the bridge edge plate and was 370mm wide (east to west) and c.500mm long (north to south). The plate was found to be 38mm thick (see Plates 22, 23 and 24).

Plate 24: TH09 from east. Note repair plate on west side of trench

The only other features of particular note were the repair plate found in TH09 (Plates 22, 23, and 24) and the repair plate found in TH05 (Plates 28 and 29). David de Haan, the author of the Iron Bridge Conservation Plan, has highlighted a photograph of the underside of TH09 which shows a crack across the corner of the deck plate. This is what he believes the repair plate was aimed at reinforcing. He also noted that the bolt on the plate is directly over the deck bearer and therefore will not be visible from below. He suggests that it is a coach bolt screwed into a tapped hole, and it could have been installed in 1902-3 or 1926. With regards to the repair plate encountered in TH05, he believes that the repairs were undertaken when the road material was last removed in 1975.

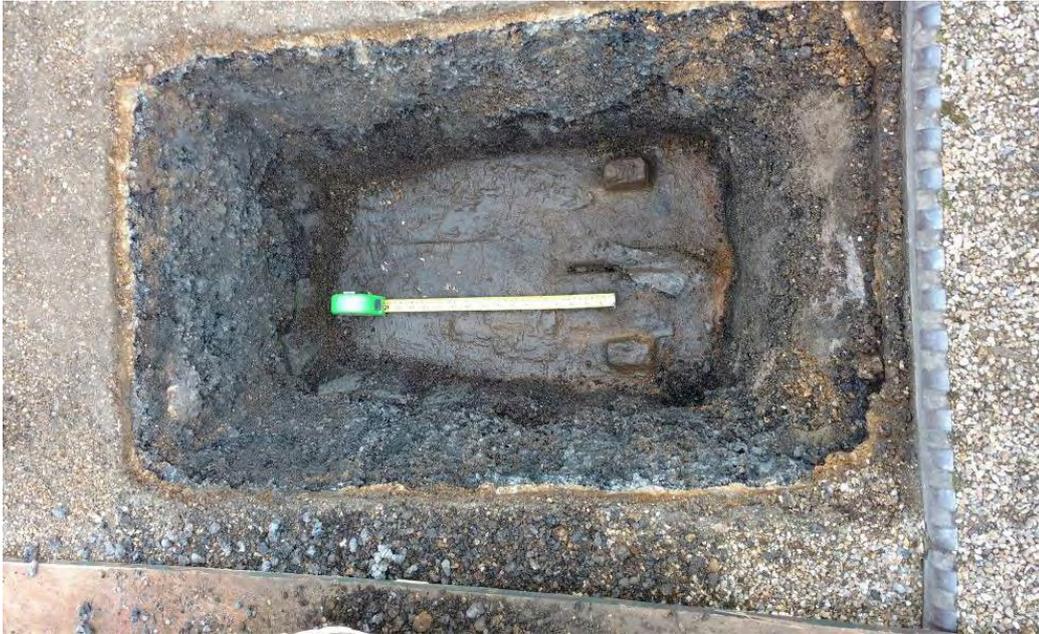
caulking material, which was consistent with that described above had been deliberately removed. The aggregate over this area was less compacted than that on the eastern side of the trench, again suggesting some form of disturbance (possibly as part of the works carried out to assess the condition of the wedges in 2007). Where present, flashband tape 110mm wide covered over the gap between the deck plates. Caulking material was found to be similar to those that above.

Plate 26: TH06 from above showing partially removed sealant and caulking as uncovered by the excavations

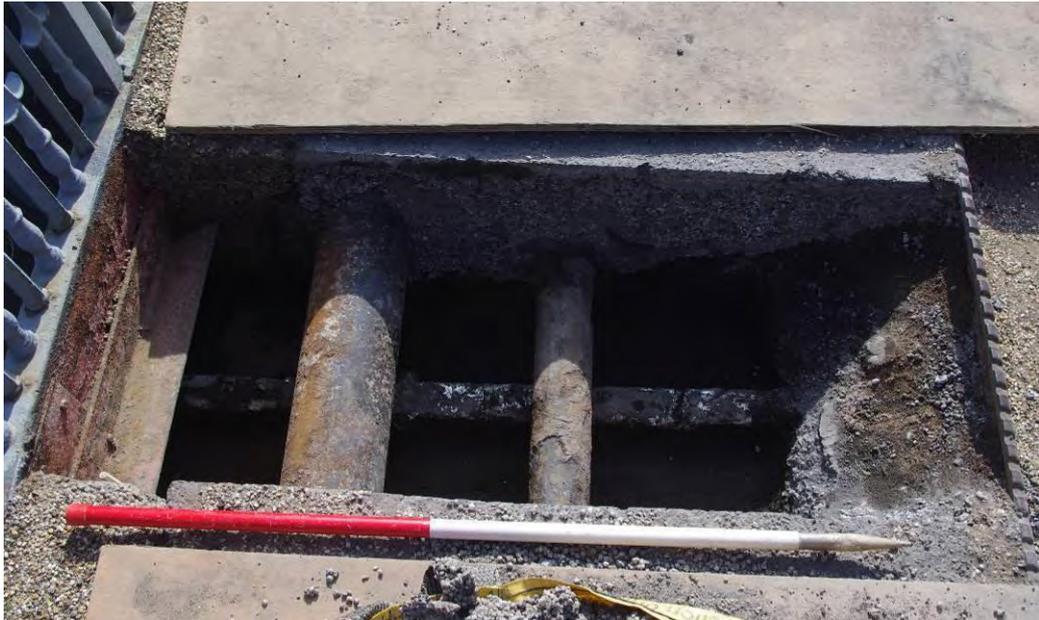
Plate 28: TH05 from the north

An L-shaped brace and repair plate were found at the deck-edge plate, both of which were coated with red lead (see Plates 28 and 29). This corresponds with an area of darker paint on the river-side section of the bridge at this point (see Plate 30). It is unclear what these relate to at this stage. They may be historic repair or have some link to the raising of the bridge deck surface level to accommodate the services at this point. David de Haan (pers comm) notes that in 1999, from a scaffold, he observed a fracture at this point on the outside of the bridge. He believes that this repair was exacted in 1975 when the road material was last lifted.

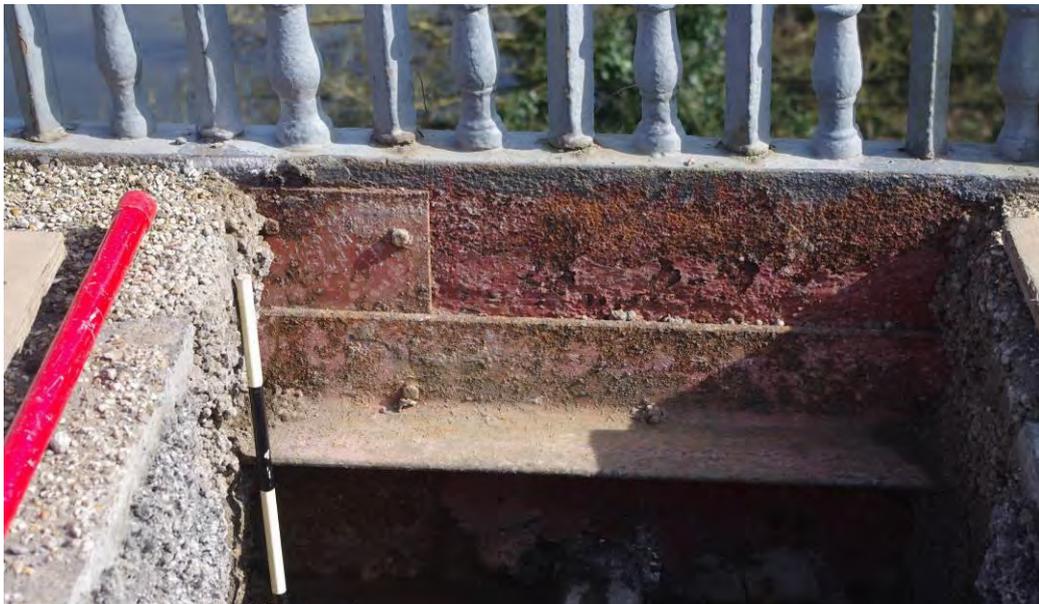
Plate 29: L-shaped brace in TH05 from west

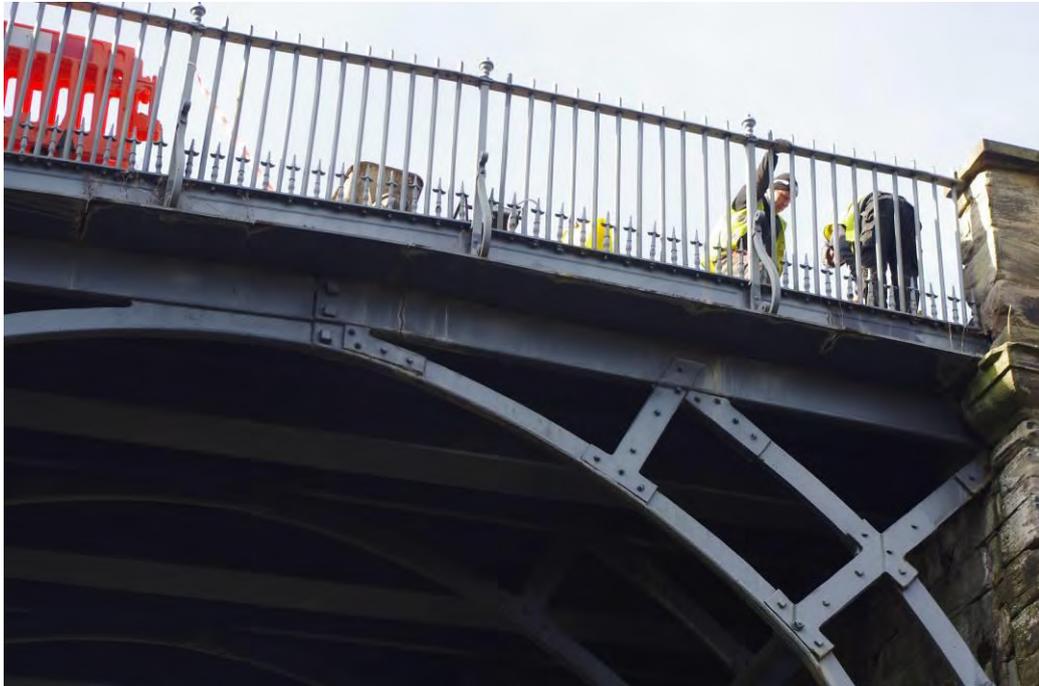
Water pooling was observed in the western side of the trial hole to the north of the upstands. No water pooling was observed on the eastern side, presumably as water has found means of egress through gaps around the upstands at the bridge edge plate.

Plate 30: Dark area of paint corresponding with the L-shaped brace and plate (where the contractors are working)

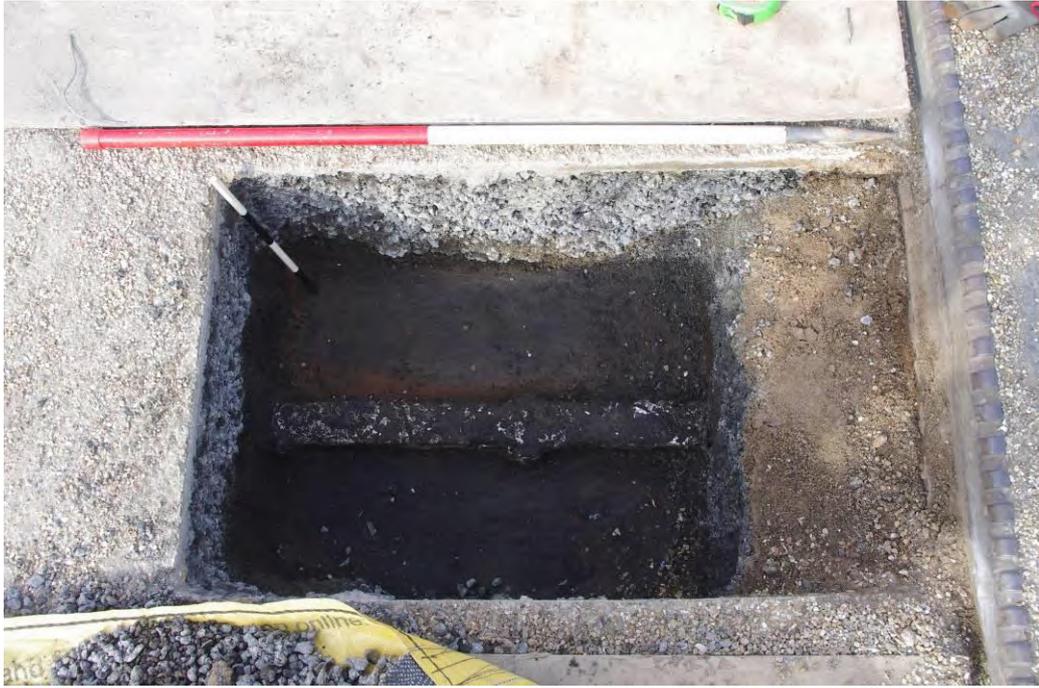
Plate 32: TF04 from the south

The trench revealed the deck plate upstands which were found to be c.70mm high and 22mm wide with a 20mm gap in between, which had been filled with a caulking as detailed above. The upstands were bolted together (approx. 500m from both ends of the trial hole) and sealed with flashband tape with a thin brittle coating as in the other trial holes described above.
