Archaeological Survey of Westcliffe Hospital Turnhurst Road, Stoke-on-Trent

June 2008

<p>Ironbridge Archaeology</p> <p>Historic Building Recording at Westcliffe Hospital, Stoke-on-Trent</p> <p>Ironbridge Archaeological Series No.220</p>	
Checked by Author	
<p>Anna Wallis</p> <p><i>Archaeology Supervisor</i></p>	<p>Date</p>
Passed for Submission to Client	
<p>Paul Belford</p> <p><i>Head of Archaeology</i></p>	<p>Date</p>

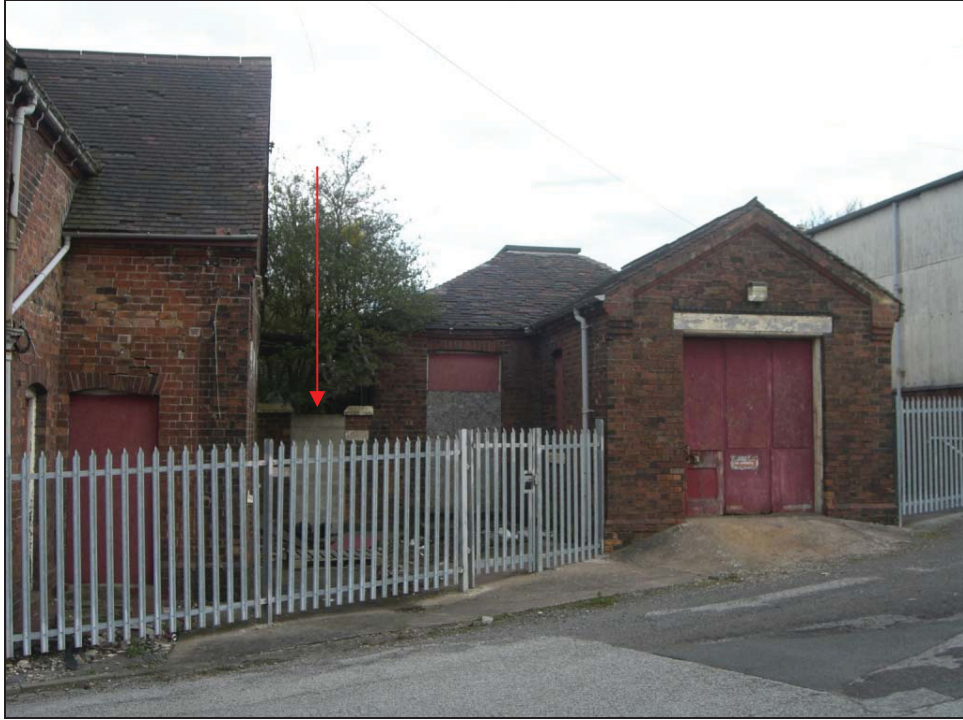
Figure 11: The wall connecting The Lodge and the Vagrants' Ward (opening sealed with breeze blocks)

The wall which connected The Lodge and the Vagrants' Ward joined The Lodge on its east facing elevation (see Fig. 11). Beyond this wall the Lodge had a single doorway (see Fig. 12) with a broken up tiled surface in front of it (see Fig. 13) and a light above it (see Fig. 14).

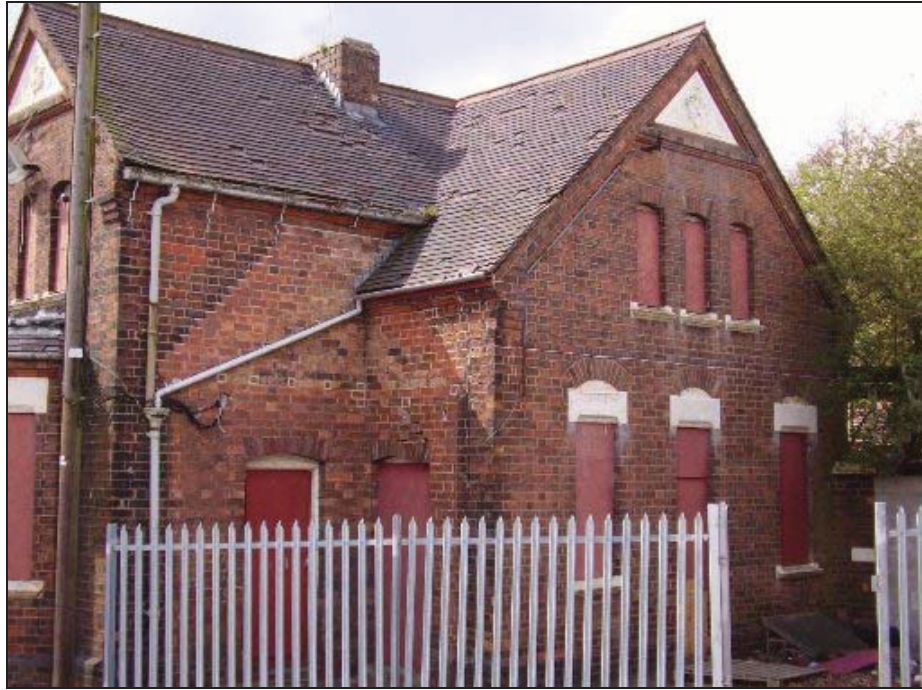
Figure 17: Scarring around east entrance

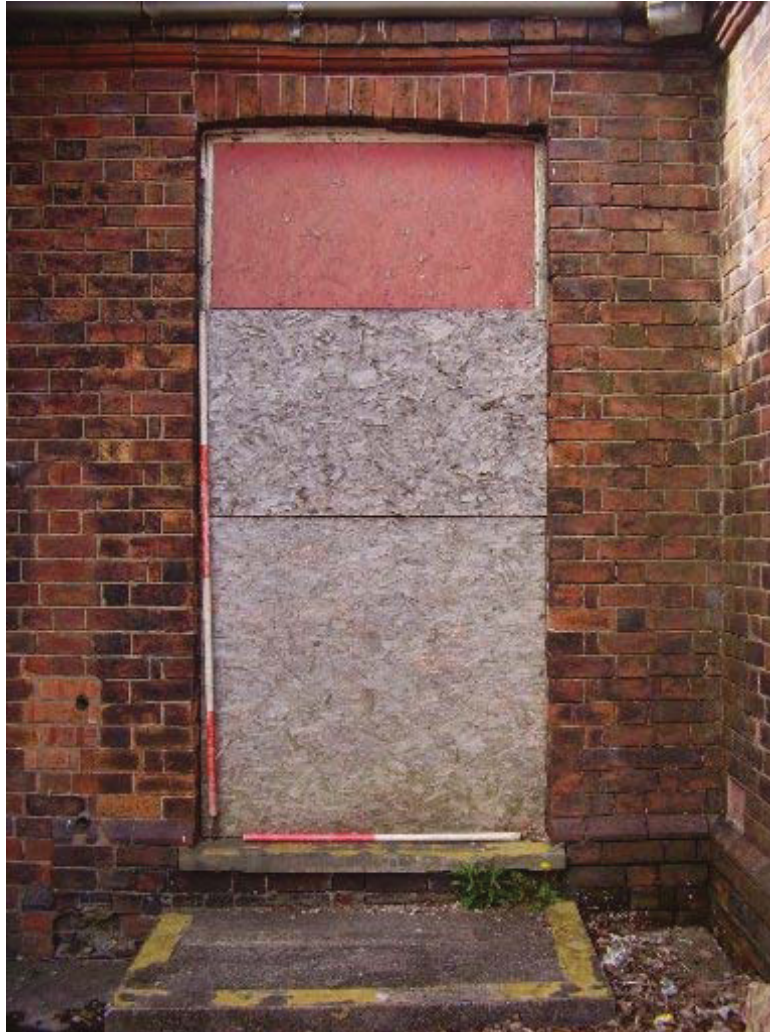
There was brickwork to the left side of the single doorway and to the left of the doorstep which suggested there may once have been a wall or partition here (see Fig. 22). Next to the window in the wing was brickwork which suggested there was once a doorway here (see Fig. 23). The step to this door remained and a drain was later built over it (see Fig. 24).

Figure 22: Brickwork to left side of door

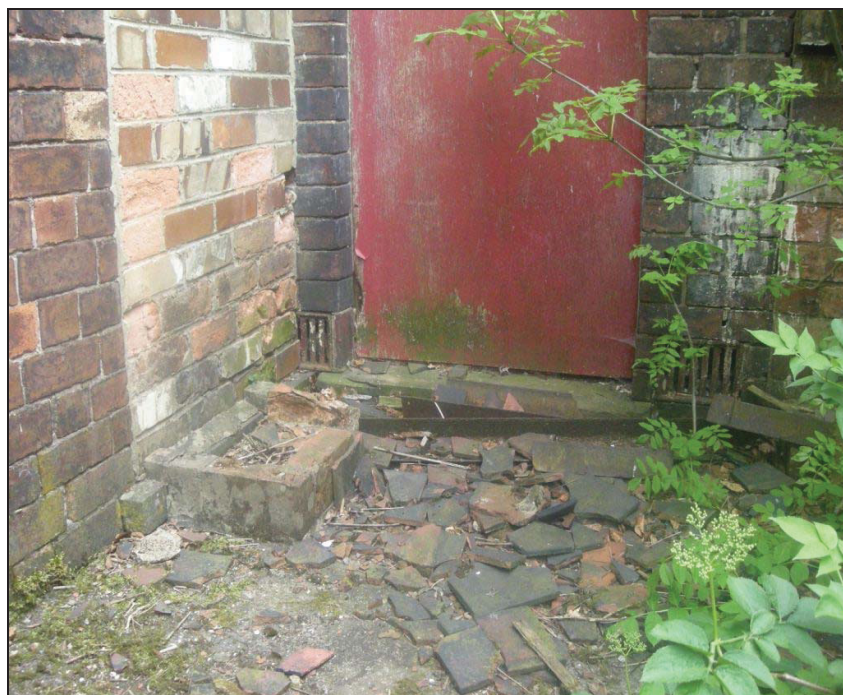
Figure 24: Drain built over doorstep

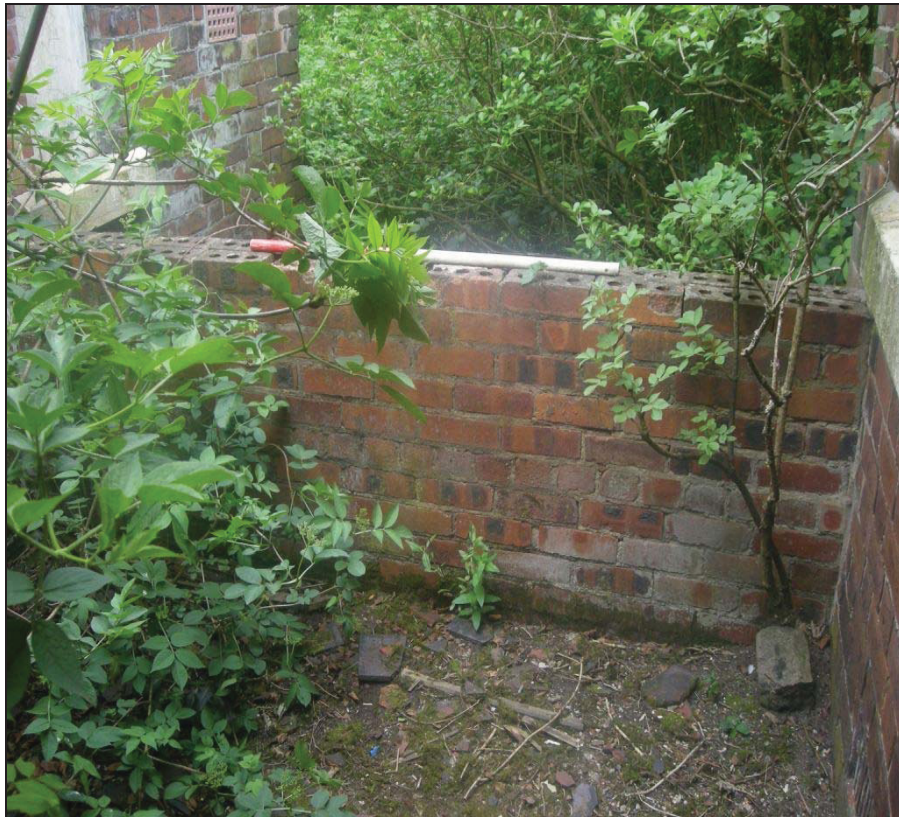
In addition to the wall which connected the east and west facing walls of The Lodge and the Vagrants' Ward, there was a second wall which joined the north facing elevation of the Lodge with the south facing elevation of the wing of the Vagrants' Ward (see Fig. 34). This wall was divided by a toilet block which also ran east-west across the courtyard and effectively divided it into two parts (see Fig. 36). The section of north-south running wall located south of the toilet block was a later construction but scarring on the south facing elevation of the Vagrants' ward suggested there was an earlier wall here (see Fig. 35).

Figure 34: North-south running wall

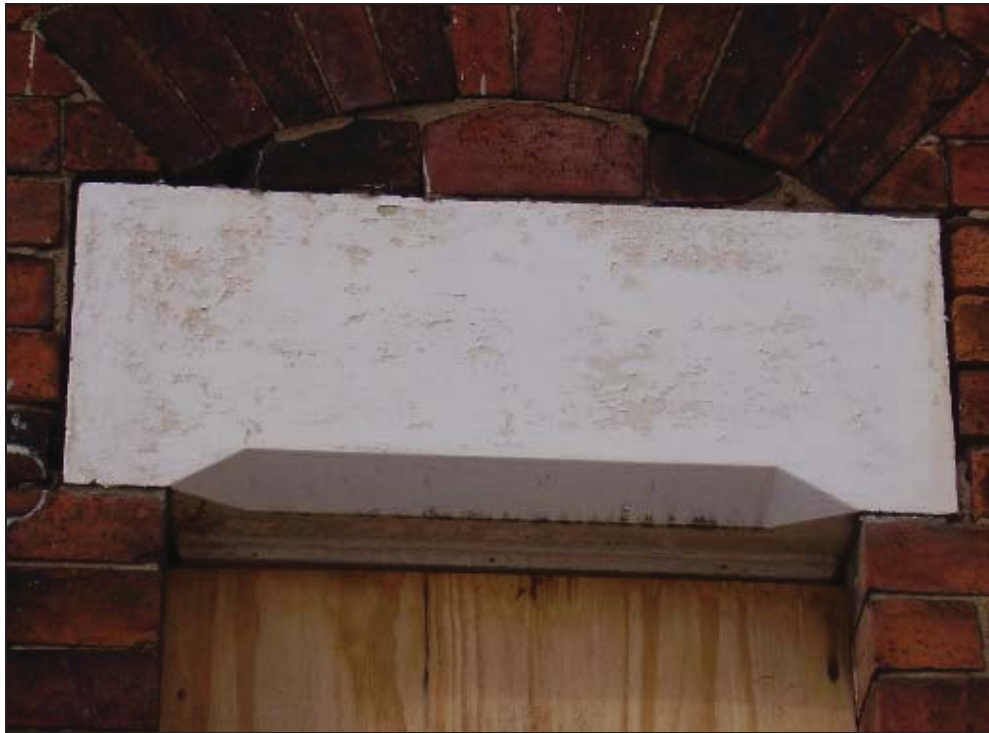
Figure 45: Undecorated arch above lintel

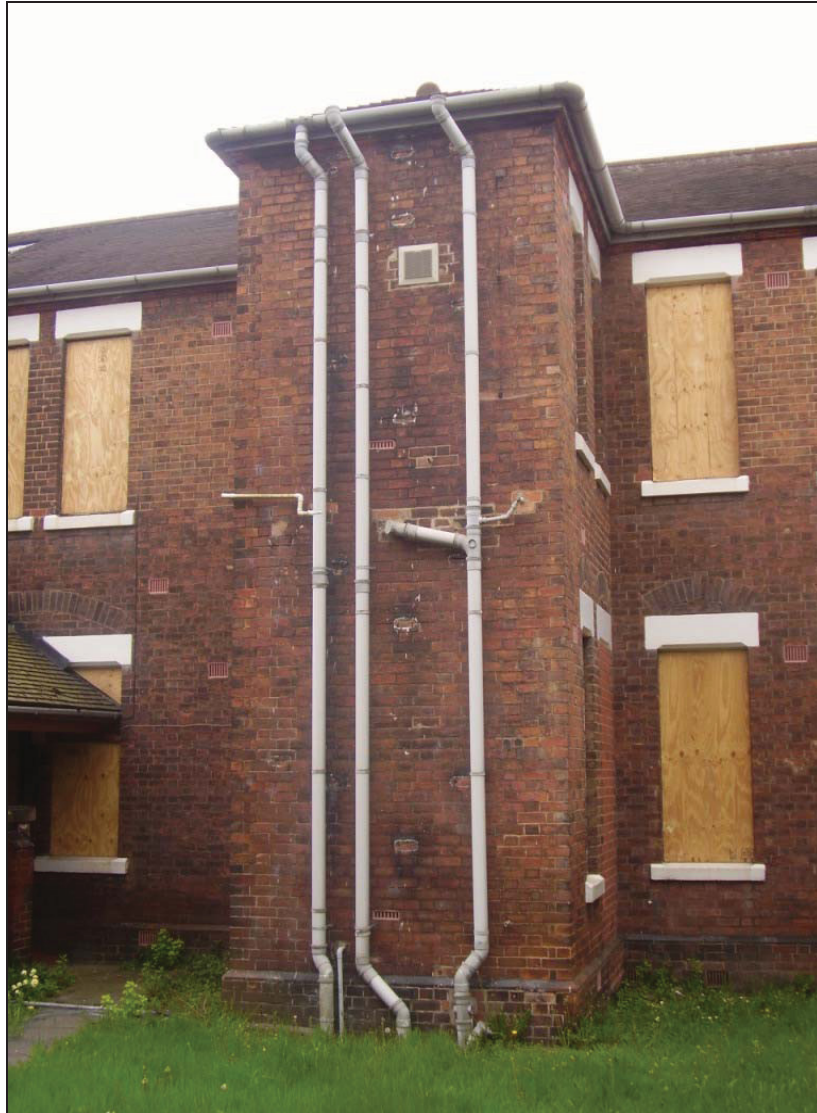
Figure 60: Drainpipe marks

On all elevations of the New Infirmary there were marks which served as evidence for earlier drainpipes which had been removed and replaced by the round plastic pipes which could now be seen (see Fig. 60). The guttering was presumably also replaced and it is likely that the original guttering was the same as that which was still visible around The Lodge. The round metal pipe on the south facing elevation suggested there were at least three phases of drainpipe and guttering: the square metal pipes like those on The Lodge, the round, metal pipes and the modern plastic pipes.

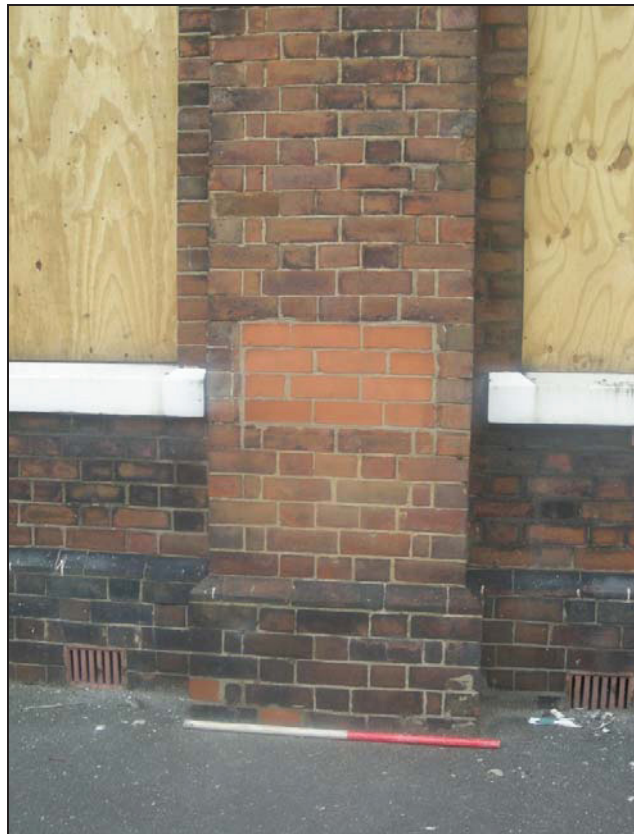
In between towers C and D there was a brick buttress with clear patching in at the bottom (see Fig. 61). The reasons for this were unclear.

Figure 61: Brickwork on buttress

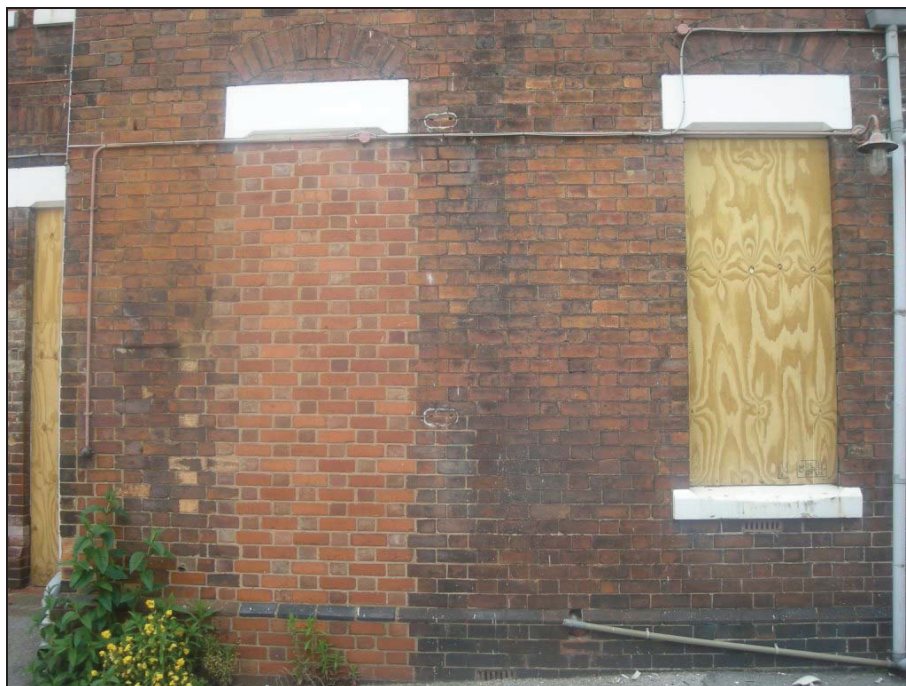
Figure 62: Bricked up doorway, central section

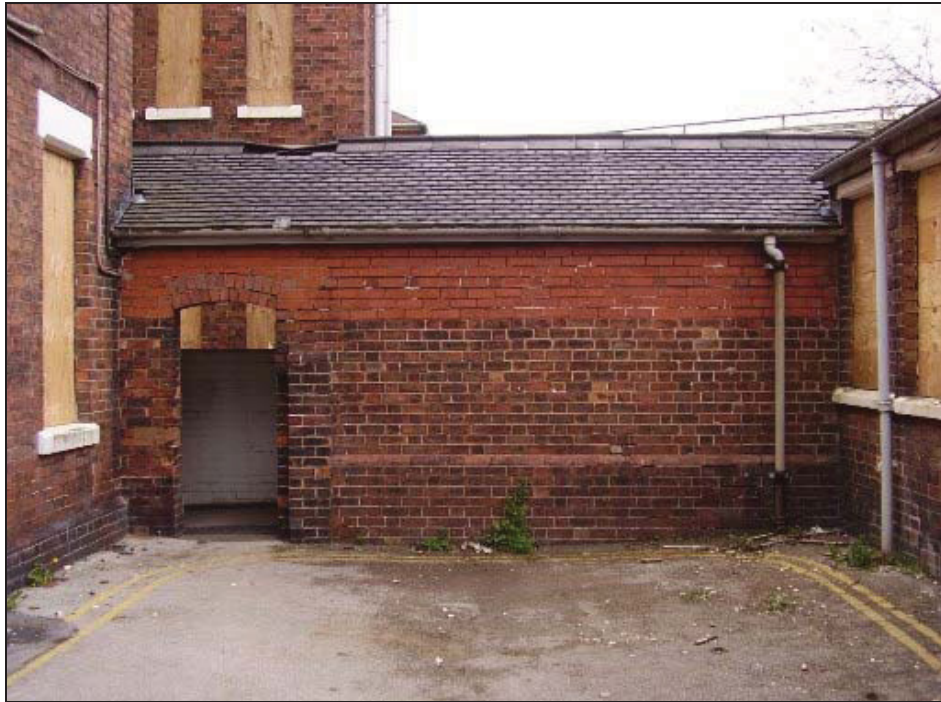
in it to give access to whatever originally lay on either side. This wall came to form part of the walkway (See Fig. 82).

Figure 82: Phase 1 wall with phase 2 addition to wall and roof

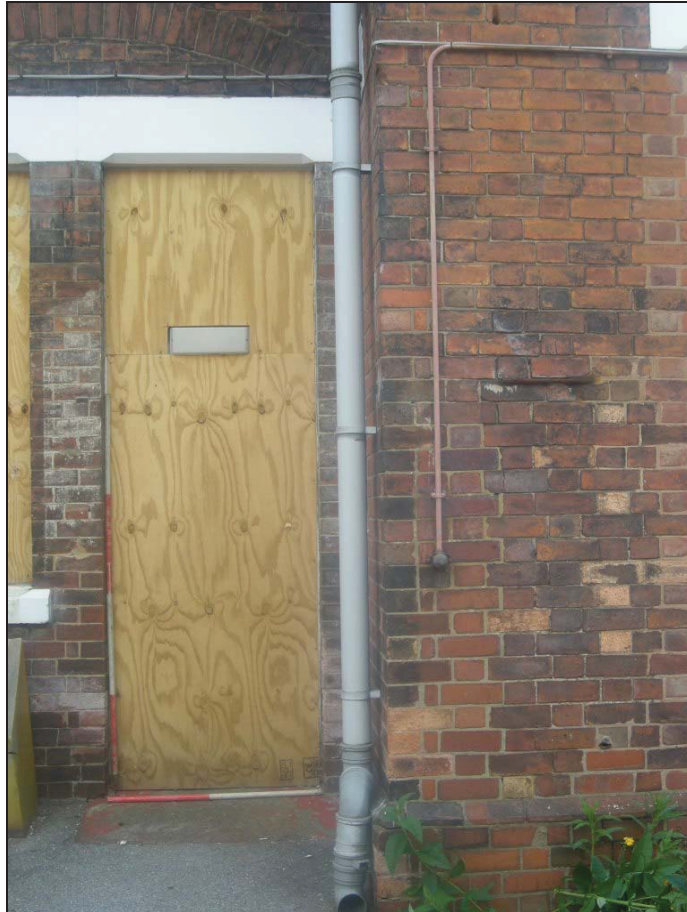
Brickwork on the rear of the New Infirmary and on the small building behind served as evidence for the existence of another walkway which ran parallel with the south side of this one (See Fig. 85).

Figure 85: Scarring around doorway and on wall to the north
