Warship *Hazardous*

Site Evaluation Report and Statement of Research Potential

Warship *Hazardous*: Site Evaluation Report and Statement of Research Potential

November 2014

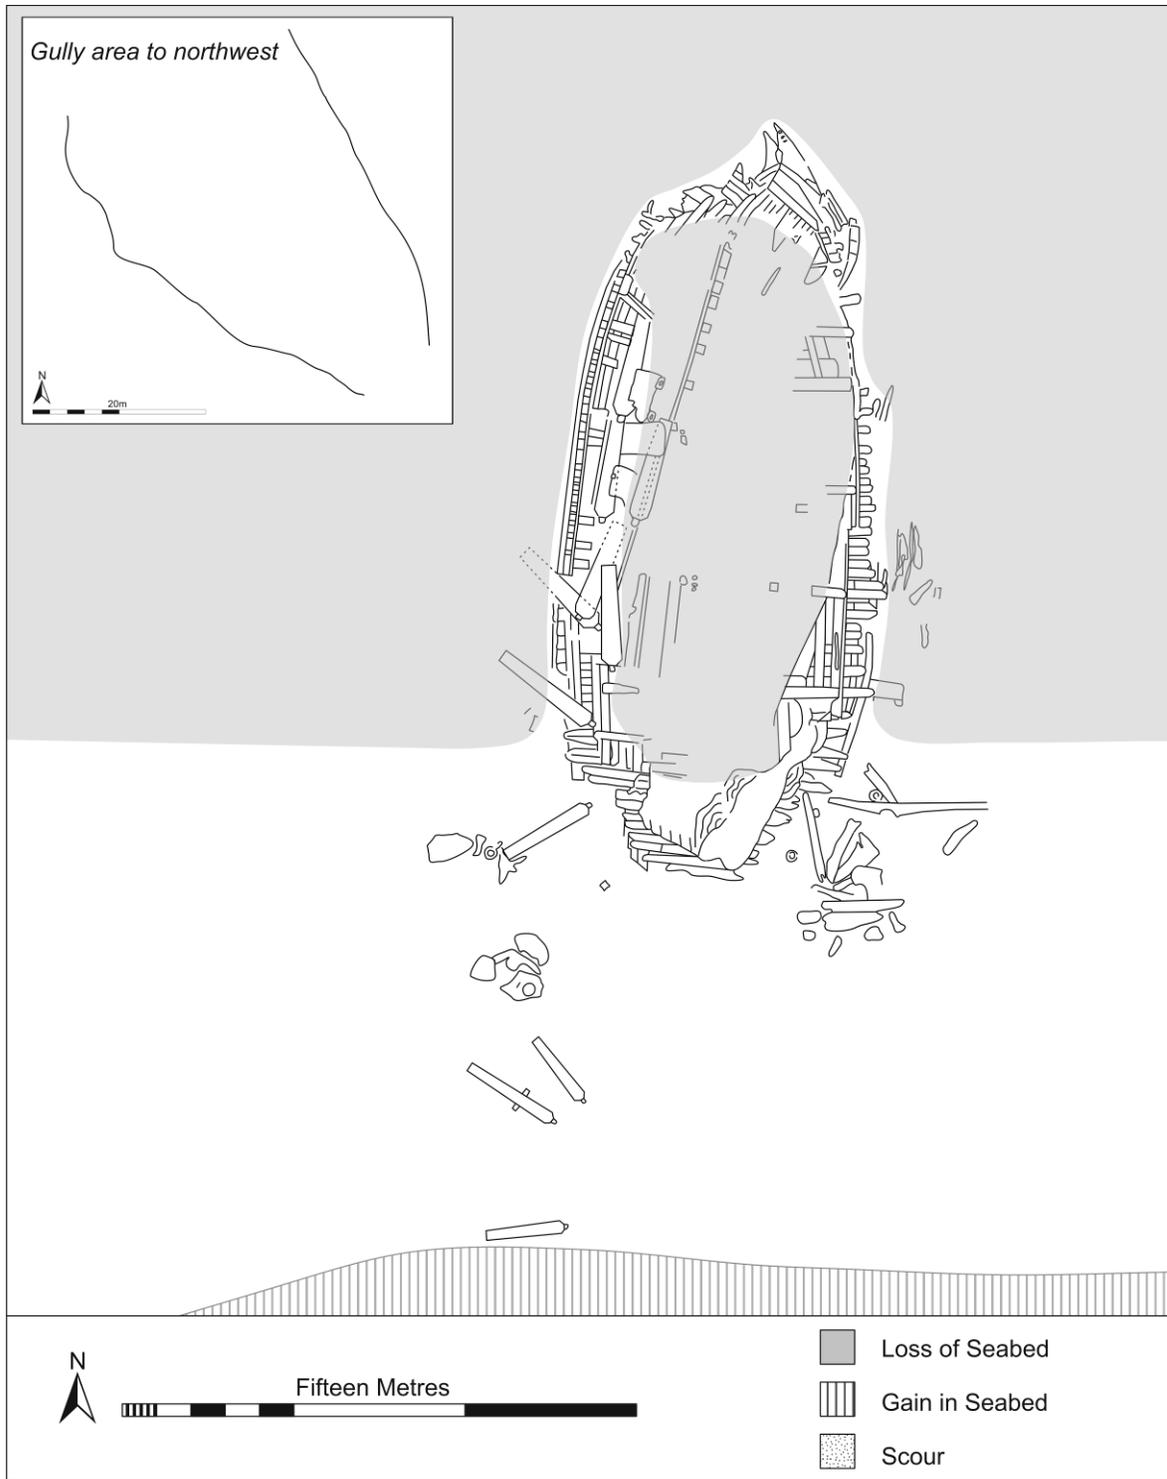
Figure 3.1 Changes on the Warship Hazardous wreck site recorded in 2007

The 2006 season had witnessed reduction in seabed levels in some areas around the site, however, diving in 2007 found extensive changes had occurred over winter. In particular the following observations and measurements were taken:

- Scour had occurred in the north of the site with a drop in sand level both inside and outside the hull along the west and east of the site.
- Outside of the hull there was a loss of up to 0.5m of sand, causing undermining of the hull, in some places the underlying Bracklesham Bed form geology was visible. The reduced levels of sand continue up to 10m away from the bow to the north and more than 20m to the west of the site.
- A gun carriage axle with wheel attached was discovered loose on the seabed north of the beak. This was in good condition and had not been affected by gribble worm suggesting recent exposure (this has since been recovered and is undergoing conservation by the HPG).

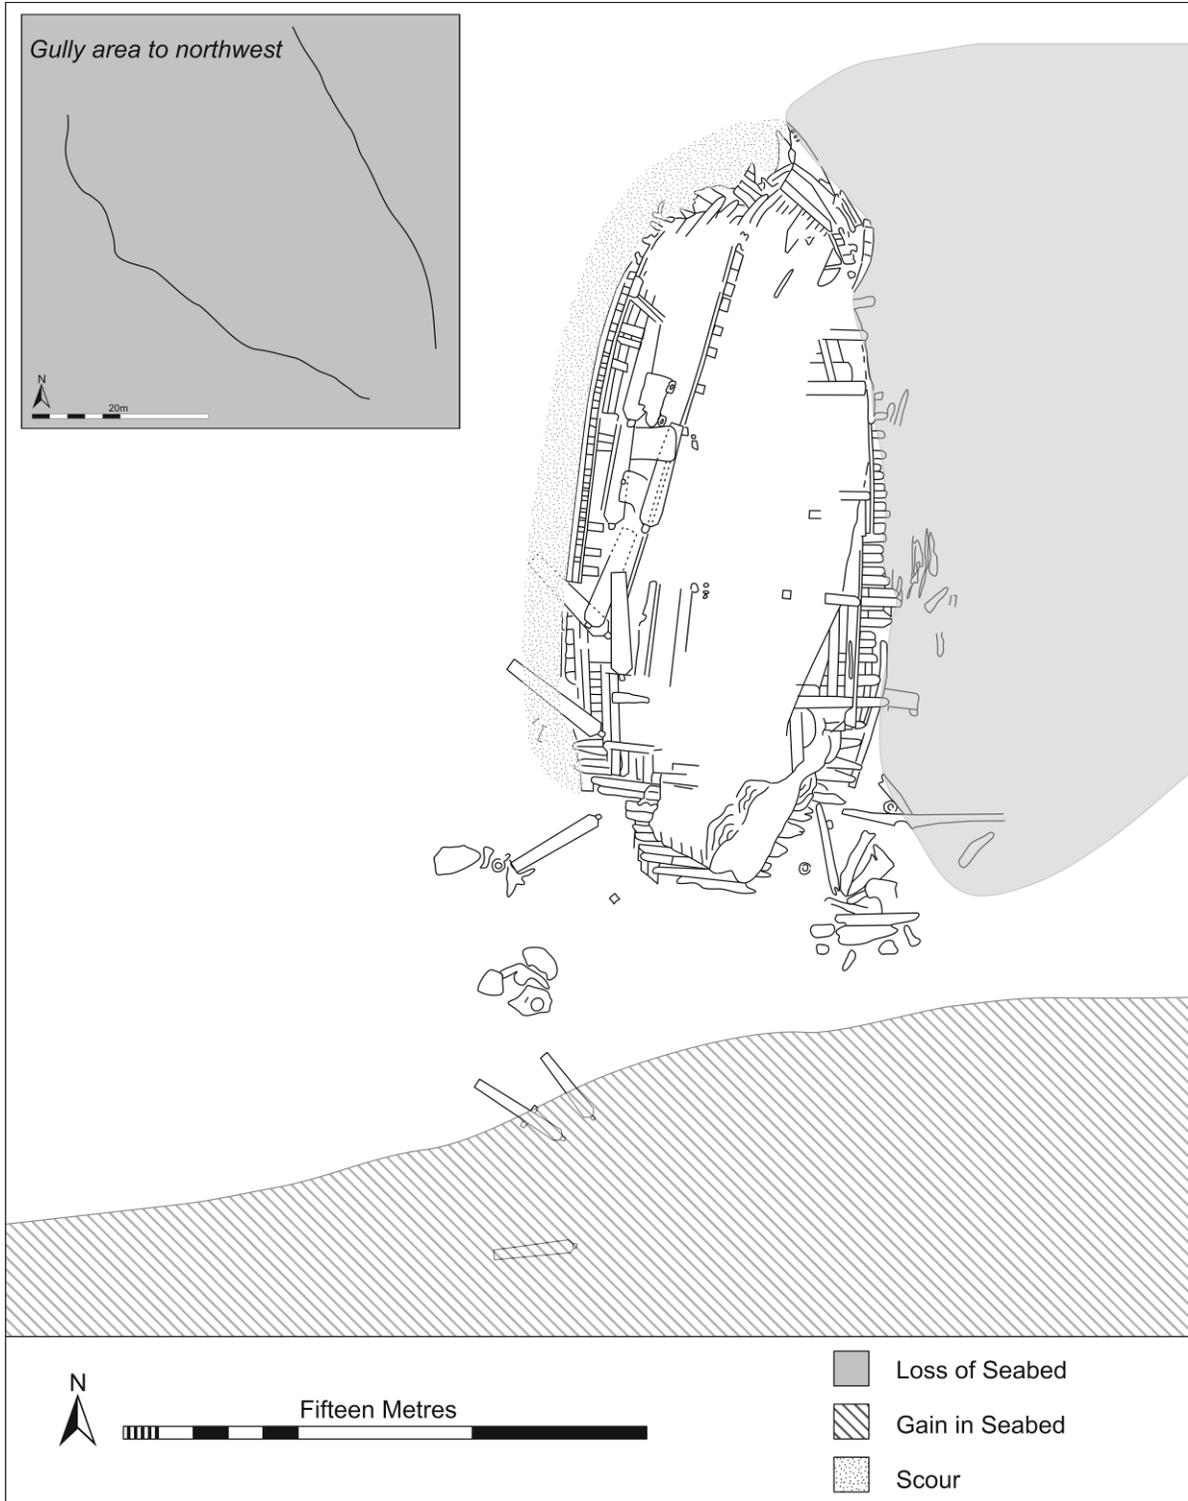
Figure 3.2 Changes on the Warship Hazardous wreck site recorded in 2008

In 2008 there was a reduction of sediment in the north and west of up to 0.5m, while the centre of the wreck was relatively stable. To the south of the wreck there was a further extensive build-up of sand. The seabed loss to the north and west of the wreck caused gullies in the underlying geology to be exposed.

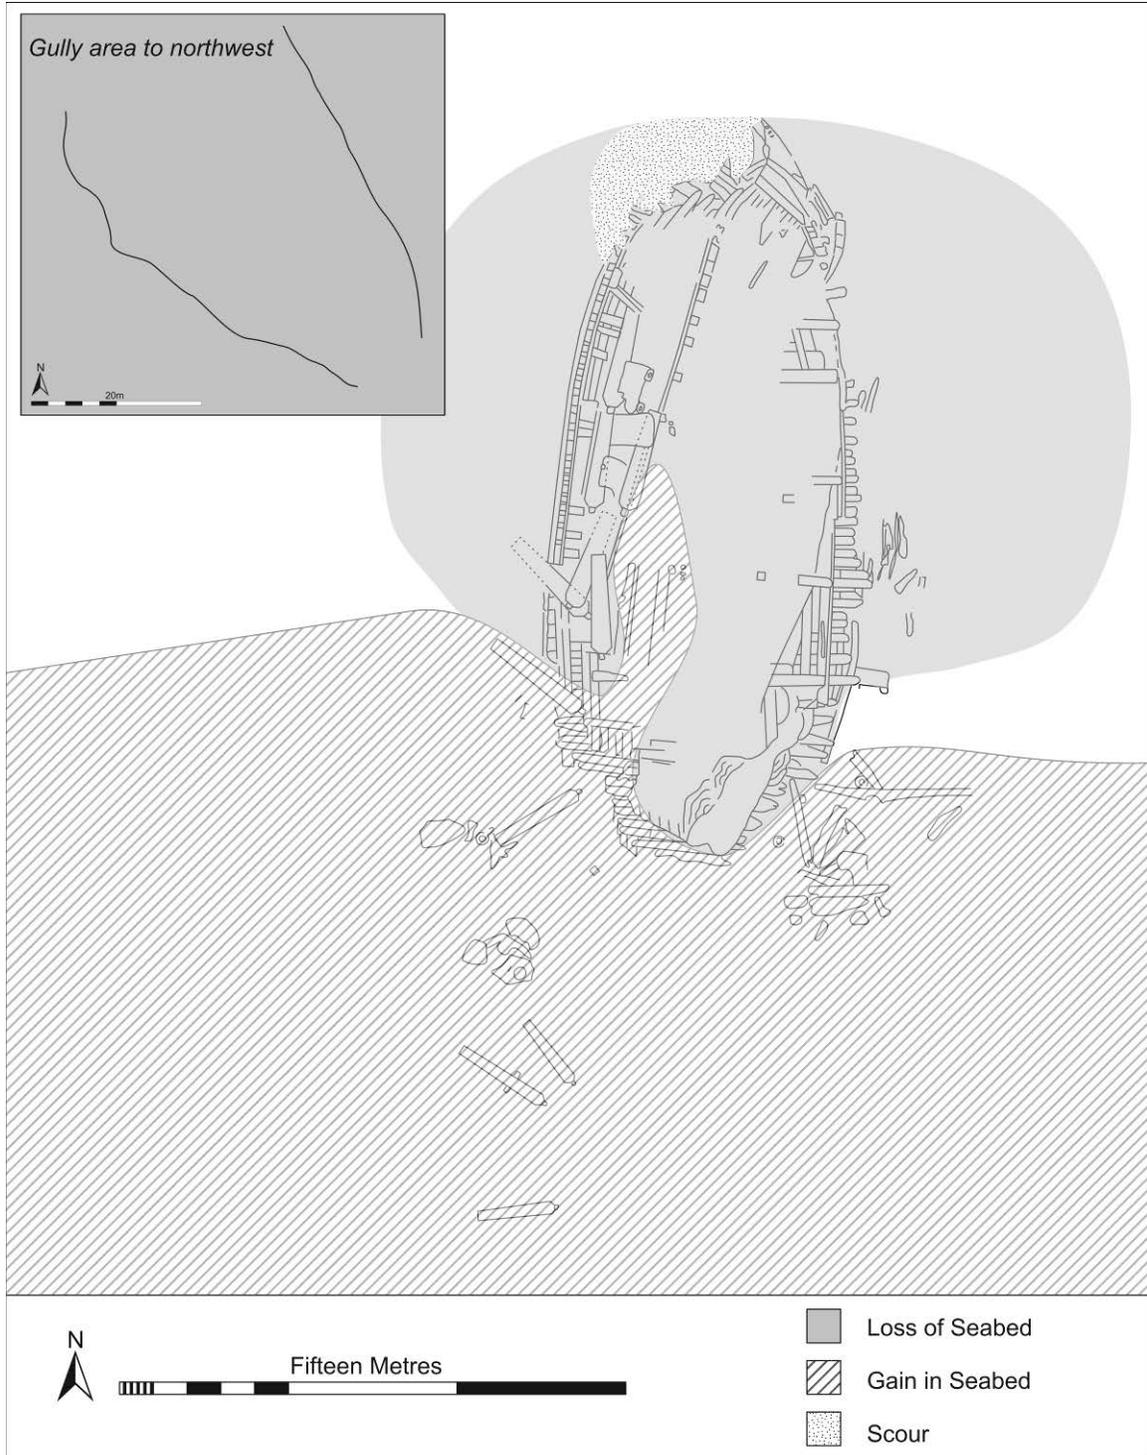
Figure 3.3 Changes on the Warship Hazardous wreck site recorded in 2009

- Early in the season it was reported that the sand encroaching from the south appeared to have increased in extent and depth as the three guns to the south were now buried as were the barrel staves in the centre of the site. The lower of the three guns in a pile, was now touching the sand again (0.2m – 0.3m increase) in this area. However, it should be noted that diving in September recorded that sand levels in the centre of the site were beginning to drop again.

- East and north of the site there had been a reduction in seabed levels, this caused scour around the beak, and full exposure of an area of frames and planking off the north east side of the main hull. The area between the bow and cannonball mound remained at the same level as in 2008.

- There also appears to have been further loss of sediment to the west of the site.
- The area of the clay gullies to the north west of the wreck site remained uncovered and a small further drop in sediment levels had occurred. The reduced seabed level in this area has led to degradation of artefacts and features noted in this area and had uncovered further iron concretions.

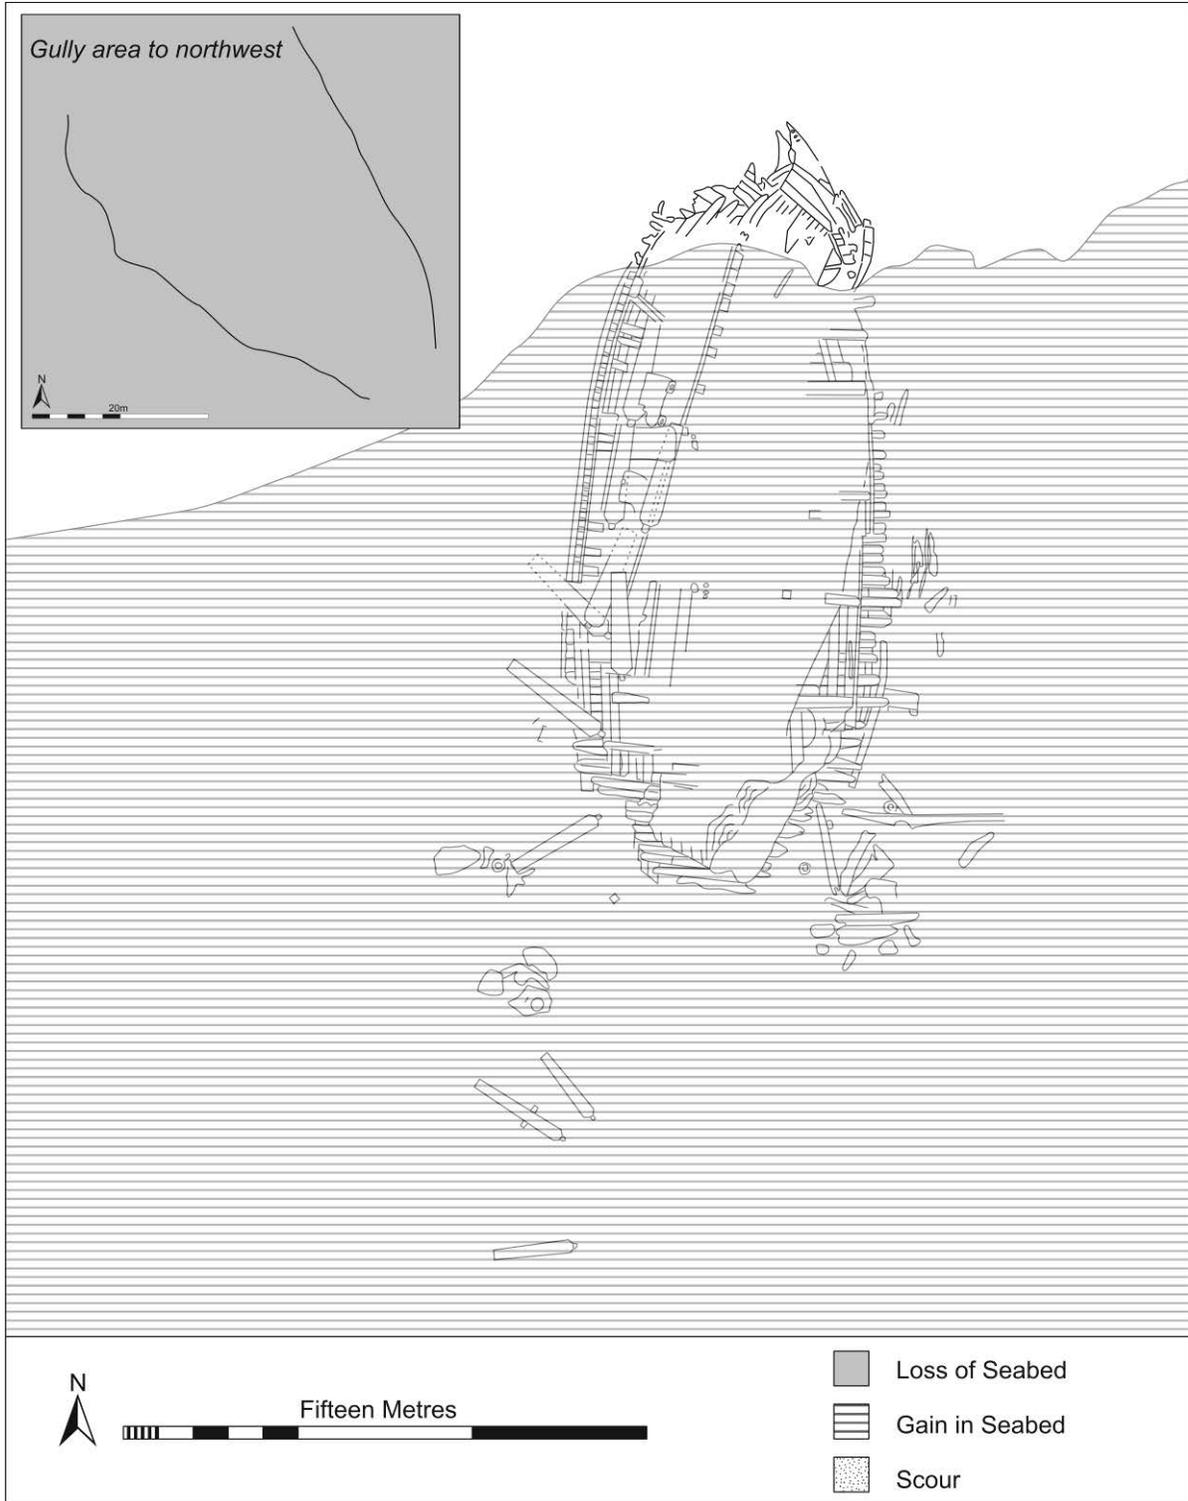
Figure 3.4 Changes on the Warship Hazardous wreck site recorded in 2010

Winter 2009/10, and continuing through the 2010 season, saw very large changes to seabed levels with a significant increase in deposits. Such a large change had not been witnessed previously. Further measurement taken across the six months of the diving season demonstrated that changes were continuing through the summer season.

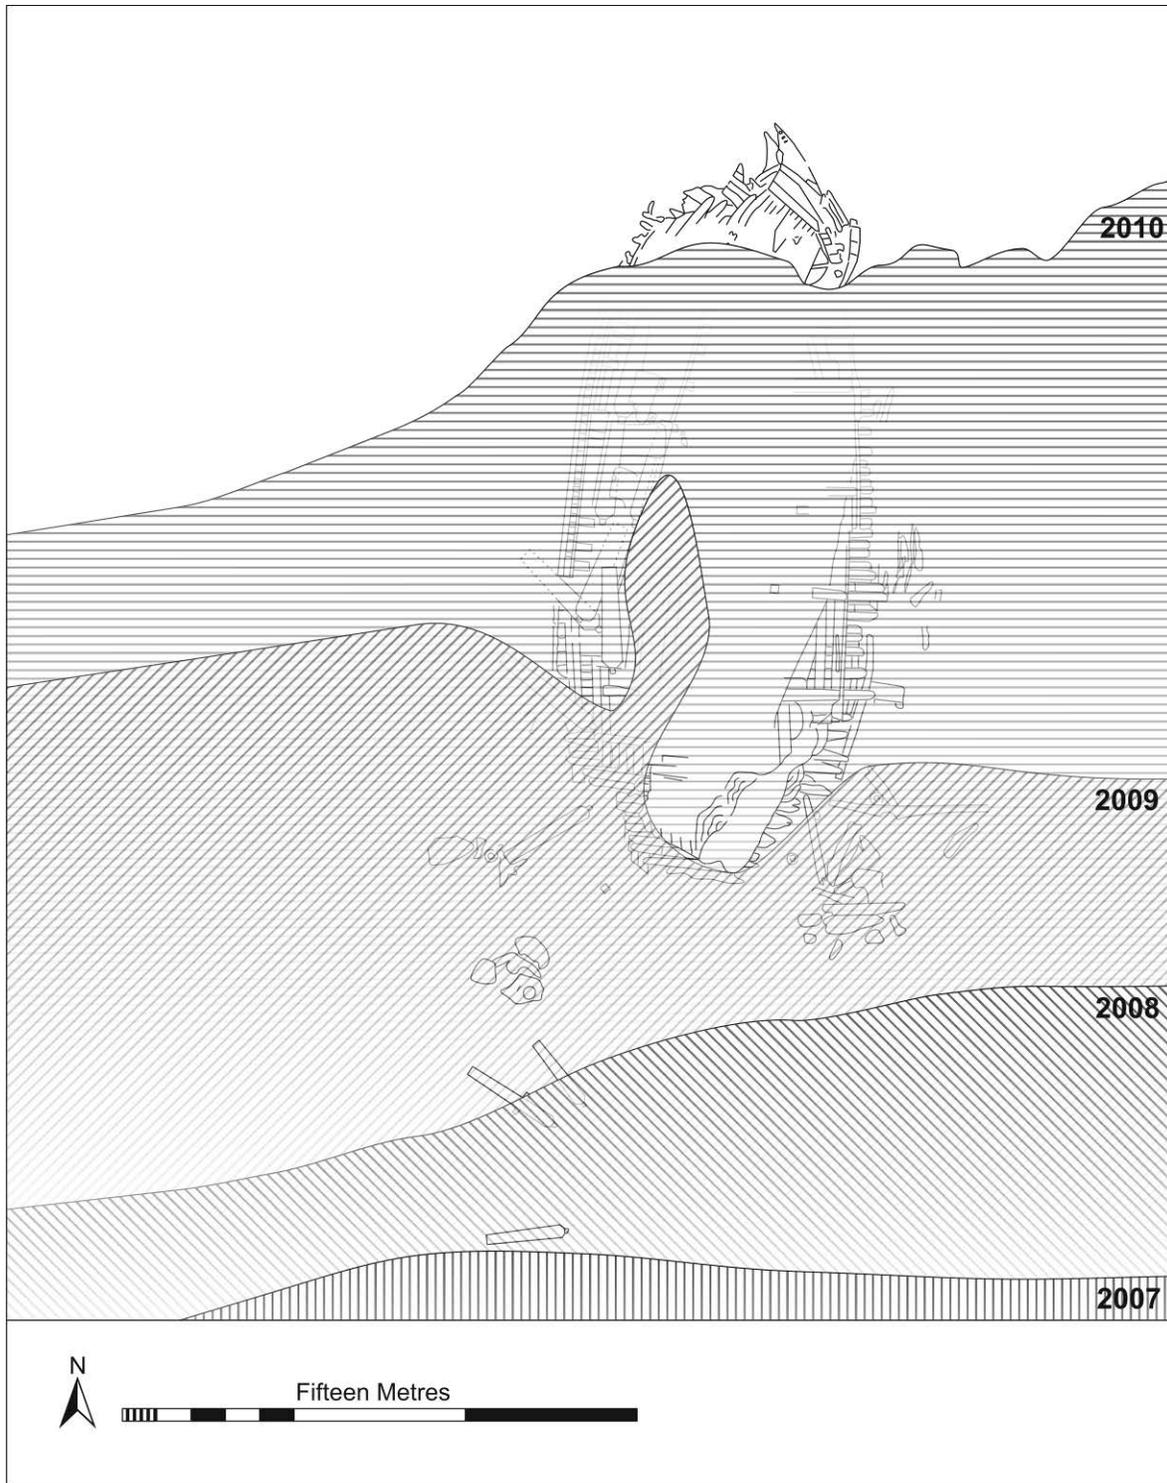
Extensive changes occurred to the *Hazardous* site area of gullies and surrounding areas between 2006 and 2010. Figure 3.5 shows all of the changes during this period to provide a representation over the longer term. In summary, winter 2006/07 saw a large reduction in seabed levels causing areas of structure and previously unseen wreck features and contents to be exposed. The main movement of sediment over winter had been a reduction in the north and west with some increases to the south of the site.

Figure 3.5 Site plan showing areas of significant change in each season 2007 – 2010

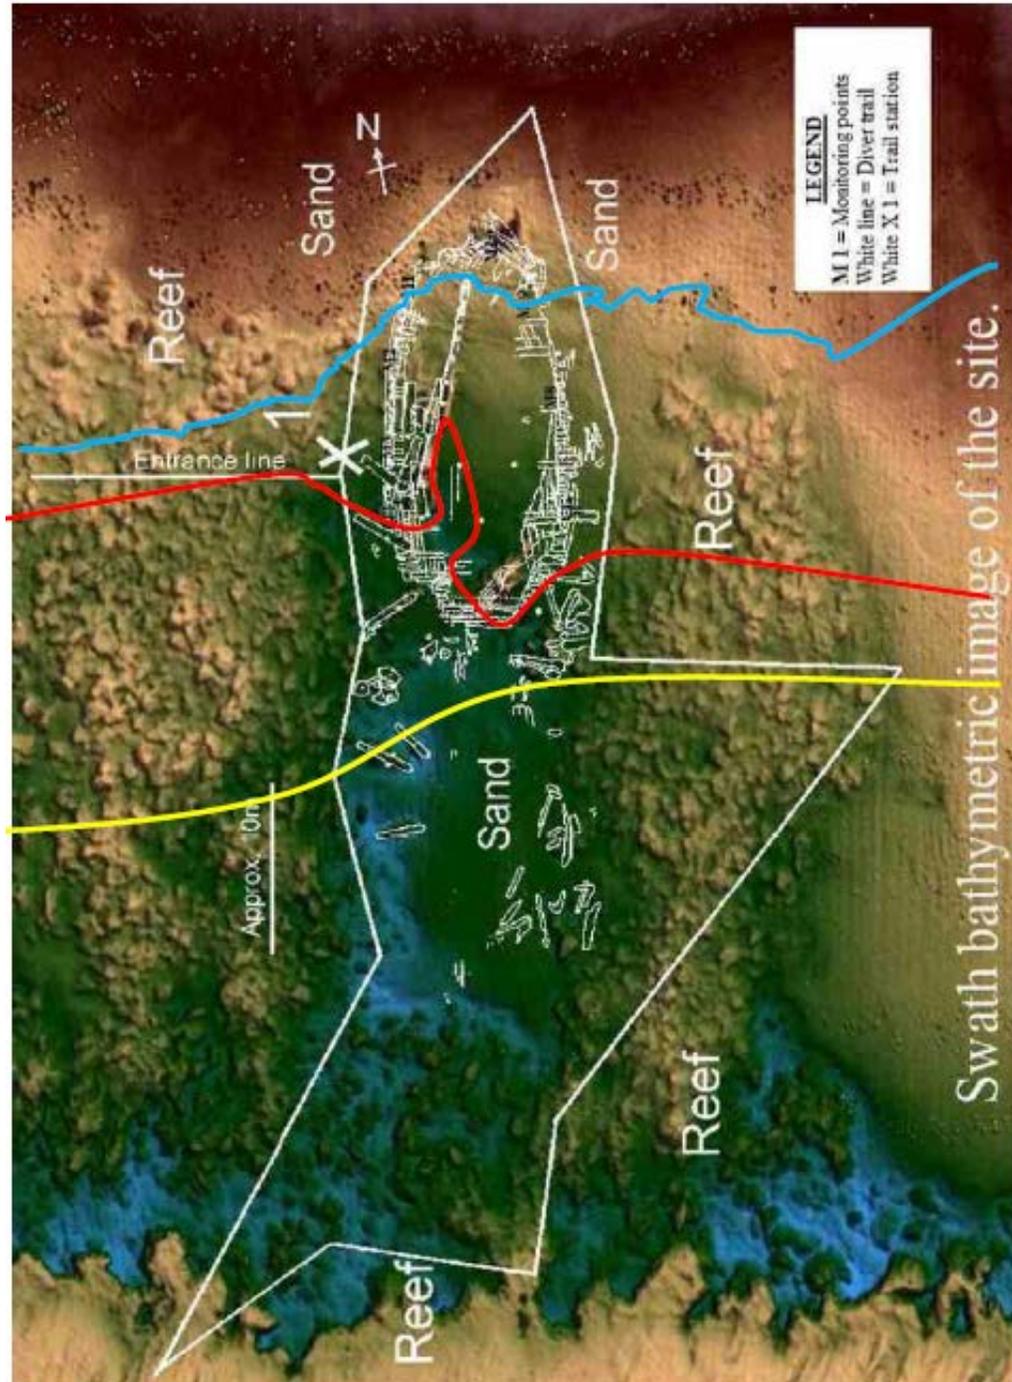
Figure 3.6 The position of sand which is encroaching from the south across the Hazardous site on an annual basis shown over a swath bathymetric image of the site, Yellow line = 2008, Red line = 2009, Blue line = 2010 (Composite image produced by Iain Grant, underlying geophysical survey English Heritage/ Wessex Archaeology).

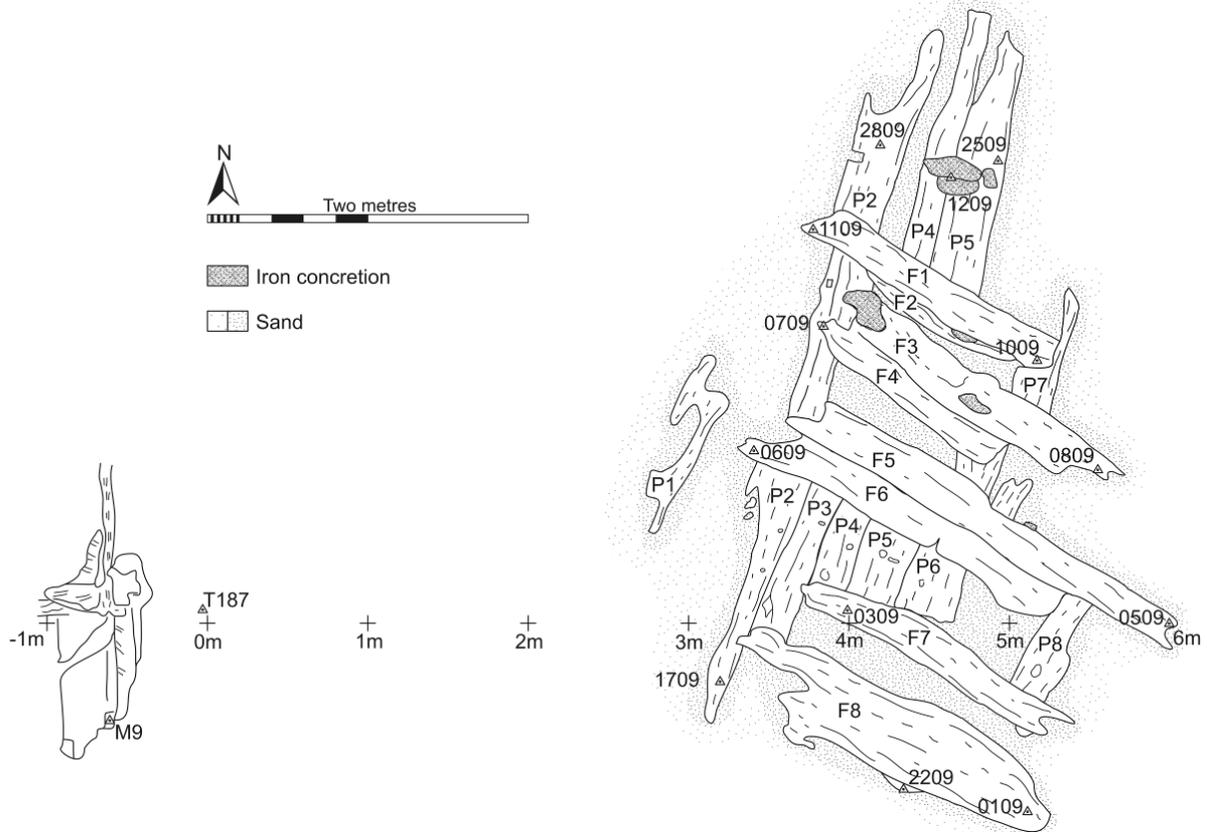
The structure represented in this area appears to be a section of hull which has broken away from the hull. Parts of eight (possibly nine) frames are uppermost (Table 3), with remains of outer planking below them. The remains of eight hull planks are visible (Table 4).

Figure 3.10 Plan of timbers exposed to the north east of the main site

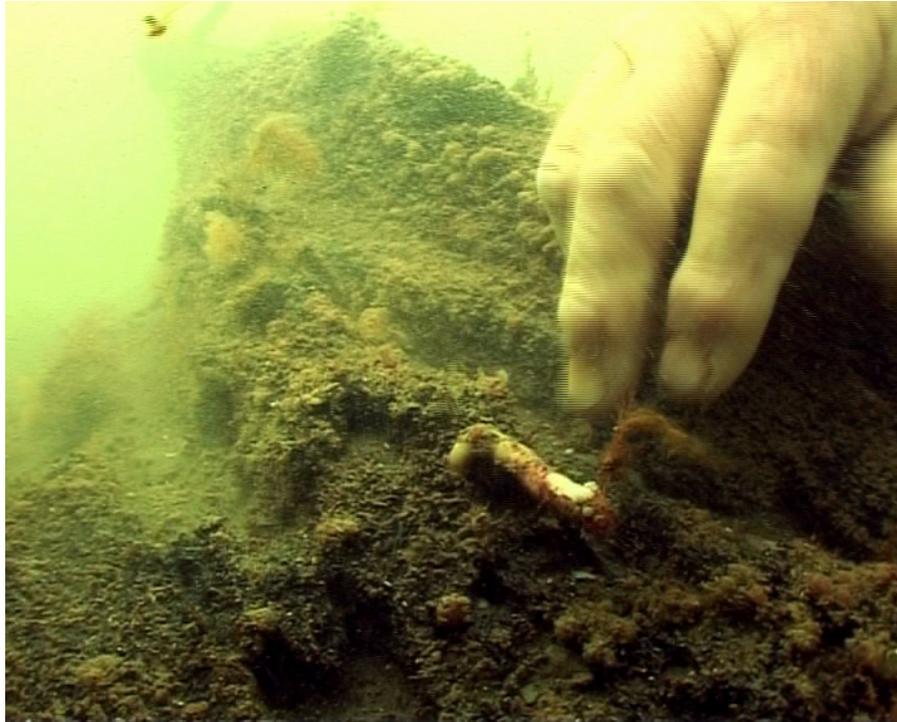
Framing: The surviving frames have been affected by erosion and attack by wood boring organisms - gribble and teredo. Gribble worm in particular have caused the wood surface to become degraded from its original surface (Figure 3.11). However, it is possible to see a clear pattern of paired frames. It is likely that there would have been another frame to the north as a pair to F1 as the timber which has been labelled F2 is too small to be a frame remnant. There is also a frame missing that would have been to the north of F7 to form a pair. The fastening holes that would have held this frame are visible on the planking below. The timber labelled F8 has been drawn as a single piece but is thought to be two adjacent timbers. Its size and the shape of the western end of the timber gives further weight to this interpretation.

Figure 3.11 Close up of west end of Frame 1 showing effect of gribble worm across timber surface and a teredo worm cast in centre

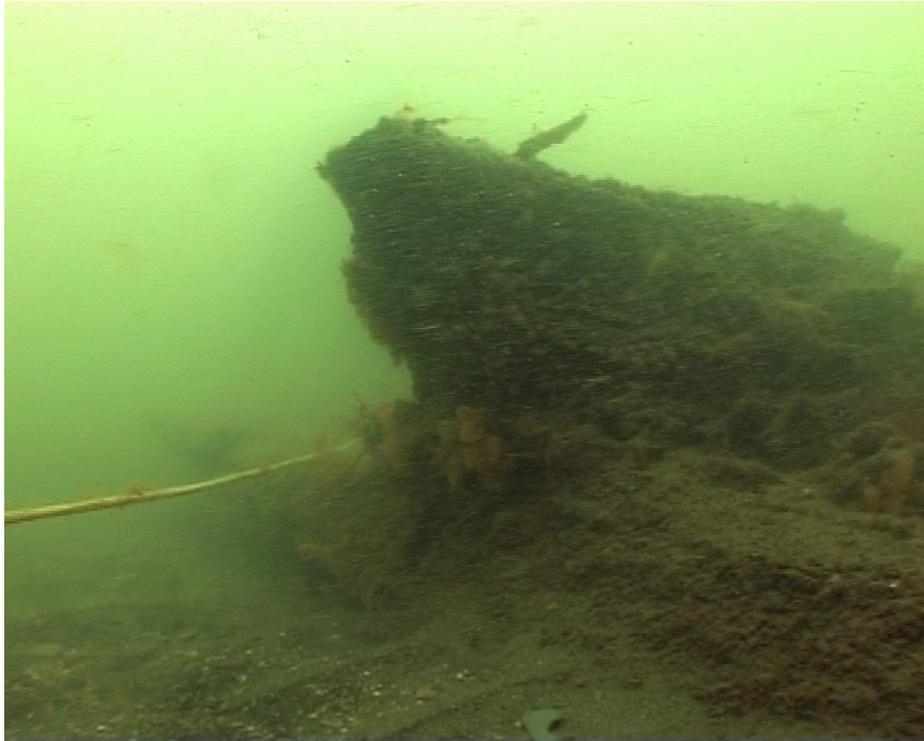
Figure 3.12 Looking north showing the western end of Frame 1 and the edge of Plank 2 beneath

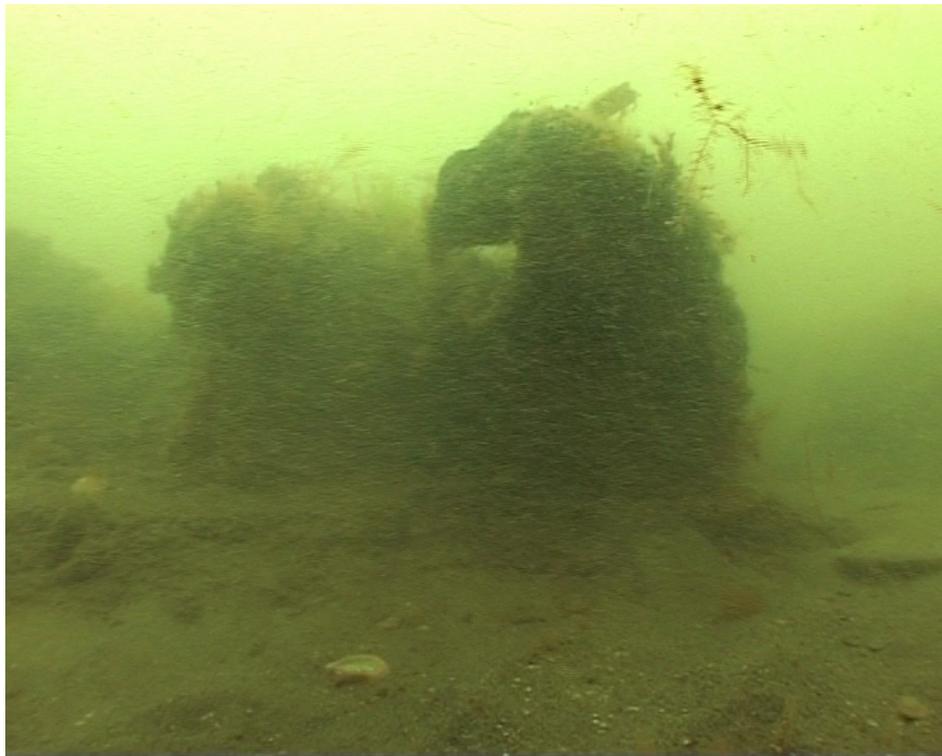
Figure 3.13 Looking east showing the western ends of Frames 6 and 5 (Frame 4 is visible in the background), the edge of Plank 2 is visible beneath the frames

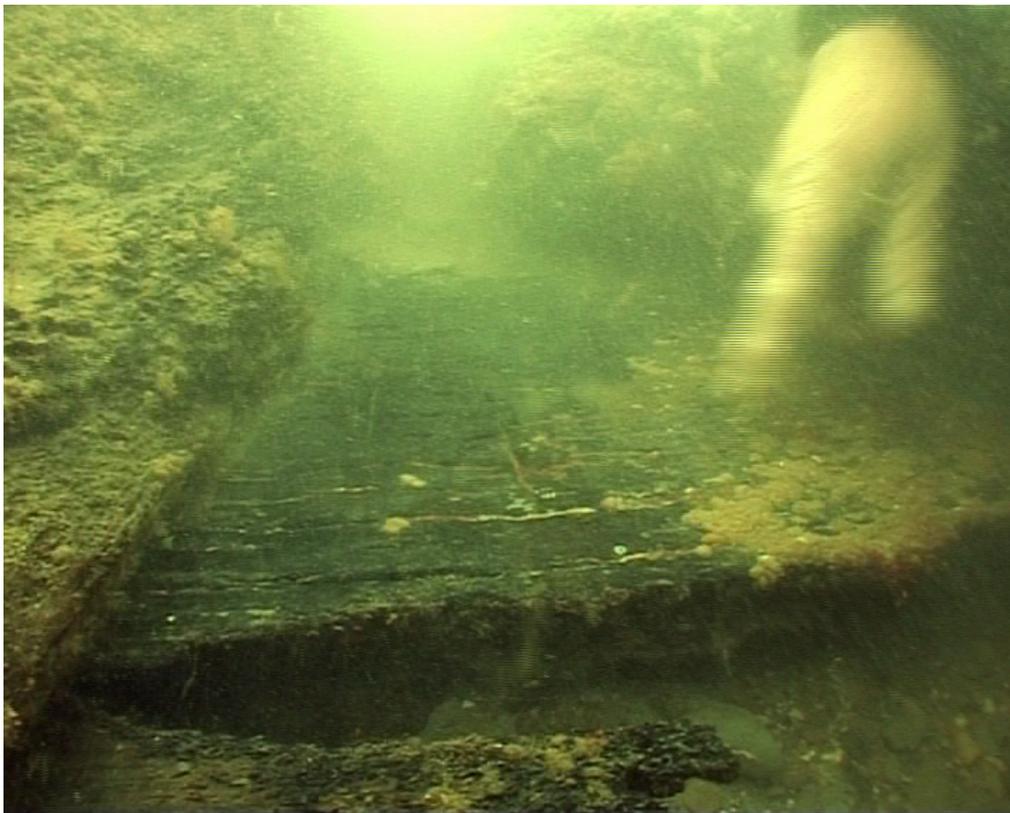
Planking: the sided dimensions of the planks is between 0.23m and 0.40m, with 0.30m being the average width (see Table 4). Discrepancies in the width of some planks may be due to the fact they were not completely uncovered from the surrounding sand. Figure 3.14 shows plank P6 which was visible between frames F4 and F5, where the sediment has very recently been removed by hand fanning to facilitate planning. The surface of plank P6 is much better preserved than the adjacent frames where marine boring organisms have affected the surface and marine growth is attached. Beneath the divers hand on the right of the image marine growth can be seen encroaching on the plank. An interesting feature in this area of plank P6 is what appear to be three incised lines running perpendicular to the grain, two of these lines are just visible in the photograph in the centre and centre left. These marks appear to be contemporary with the ships use, but it is unknown whether they are related to construction, re-build or the vessels use. Further areas of planking are expected to be preserved in the area adjacent to the structure.

Figure 3.14 Exposed area of plank 6 between frames 4 and 5, with incised marks just visible (looking north west)

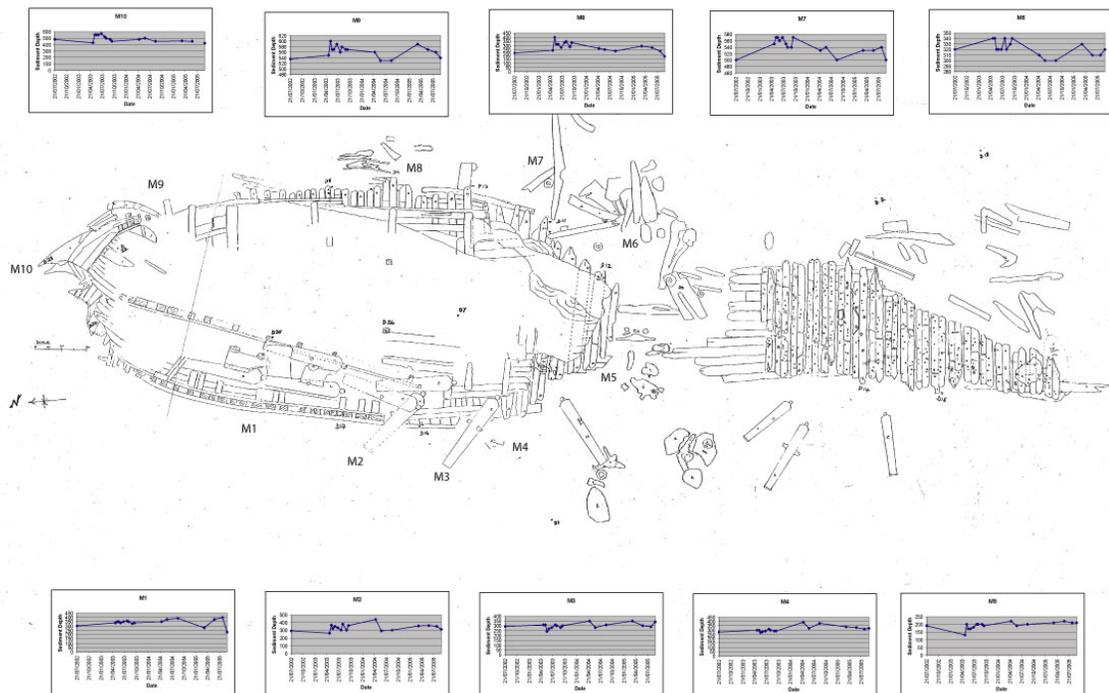
Figure 4.1 – Location of the Hazardous monitoring points and associated data

Figure 4.1 includes graphs which reflect the sediment movement recorded at each Monitoring Point (M) from 2002 to 2005. It is apparent that along the western side of the site (M1 to M5) and the northern edge of the site (M10) there are small degrees of sediment movement occurring, although localised scouring does occur. Along the eastern side of the site (M9 to M6) the sediment processes are more dynamic with large changes of accretion and scouring. These dynamic changes also affect the amidships section of the site (M6) and to a lesser extent (M5).

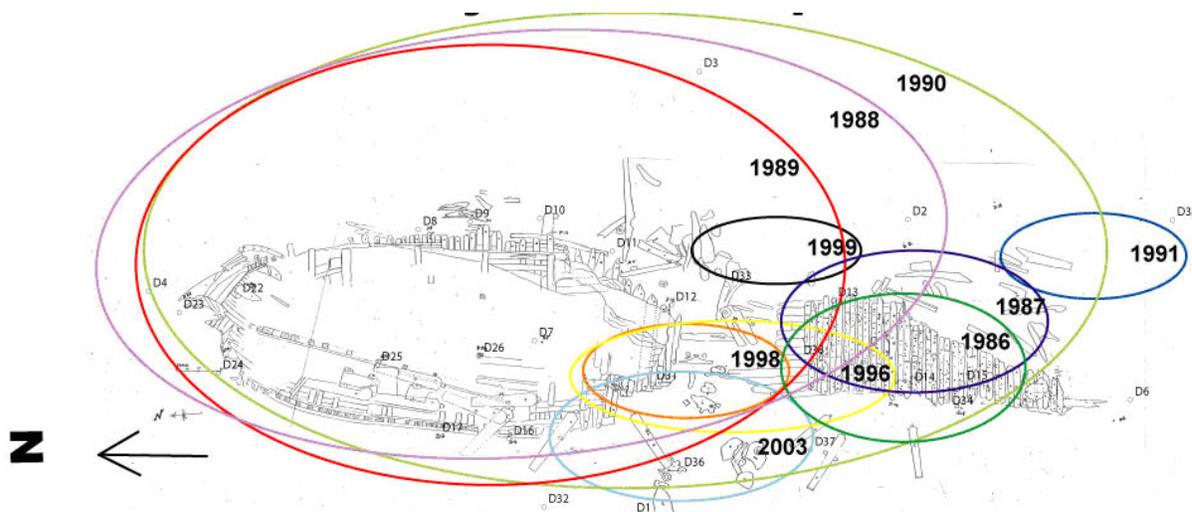
“In the early years of 1986 and 1987 there is a spread of artefact exposures at the southern end of the site. However for 1988, 1989 and 1990 this spread is much wider, with larger quantities of artefacts being recovered and a larger area being exposed. Through comparison with the dive logs it becomes apparent that the cause of this is storm events during these years. After these storm events the general spread of artefacts tends to centre more along the amidships section. It would appear that the general scouring effects on *Hazardous* were initially in the southern end of the site and have gradually progressed north into the amidships area where scouring is now having a significant effect.” (Satchell & Van Rensburg 2007: 3-37)

Figure 4.3 Distribution of artefact exposures from 1989 to 2003
