# THE STABLE BLOCK

CHARLECOTE PARK, WARWICKSHIRE

## Historic Building Record and Assessment

**Project Type:** Historic Building Survey and Assessment

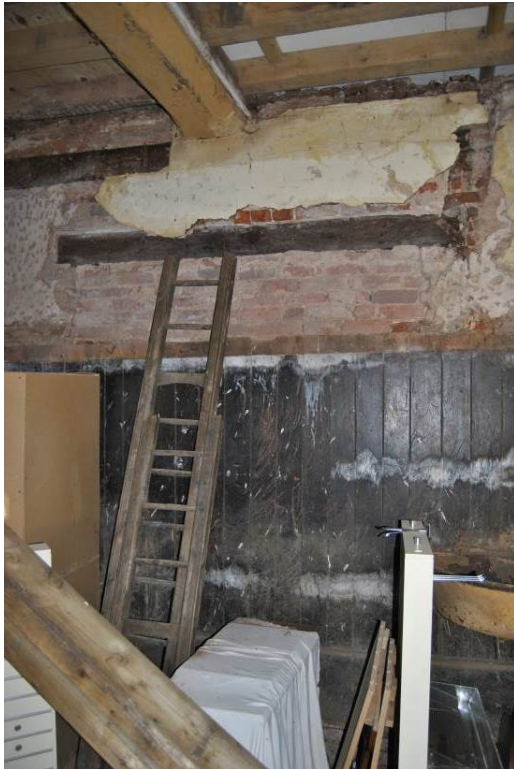
**Plate 27:** Blocked window below timber lintel in west wall of loose box 2.

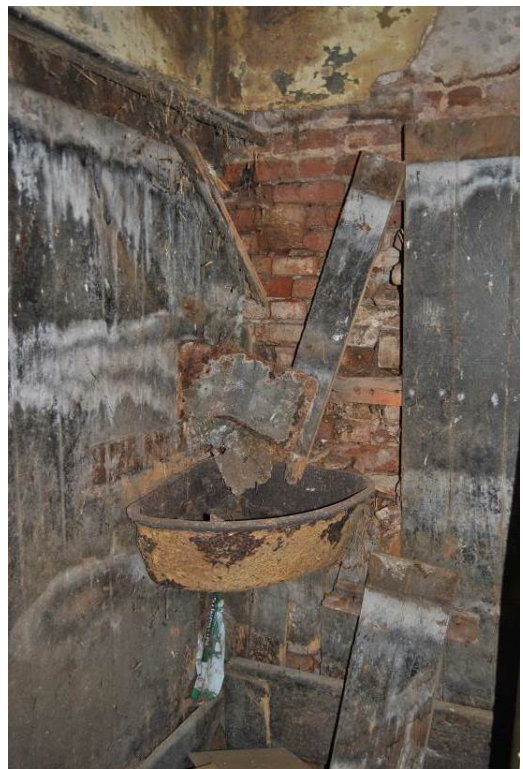
**Plate 28:** Early brickwork exposed behind T&G lining at south end of west wall (loose box 2).

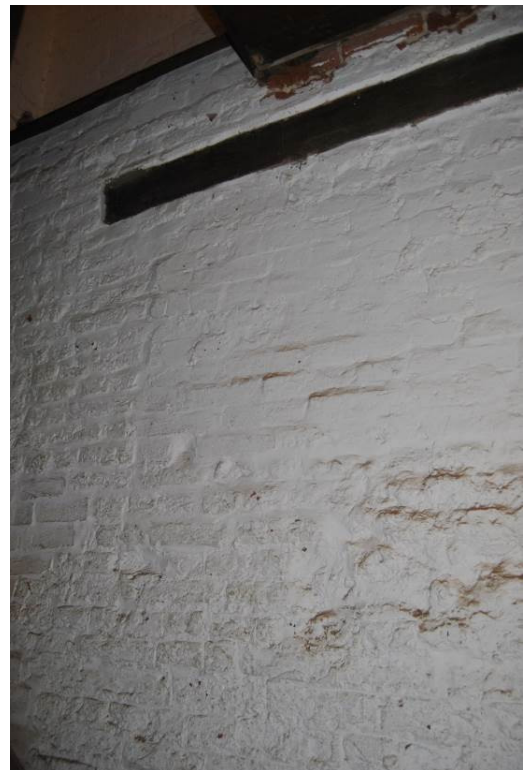
Plate 42: Blocked primary window beneath timber lintel in west wall of [G.03].

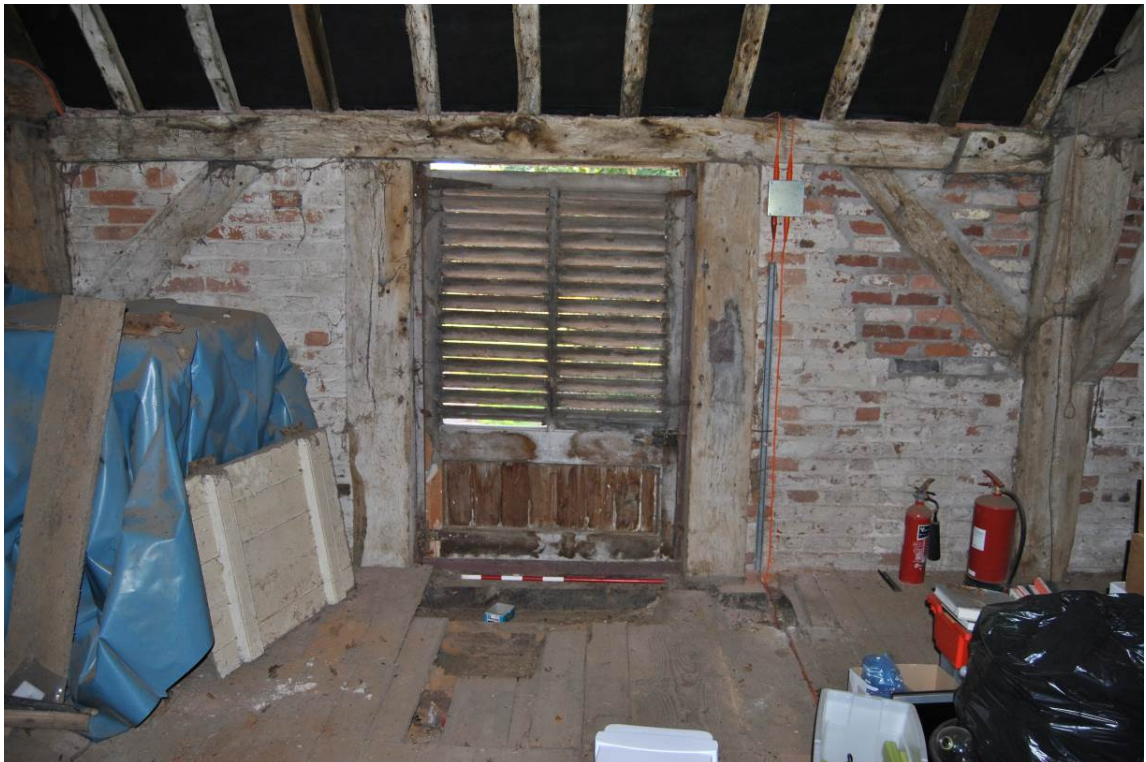
**Plate 47:** Surviving primary timber-framing at Bay 5 (east) with inserted, louvred door **NB.** double peg holes to inner edge of intermediate studs evidencing former mid-rail.

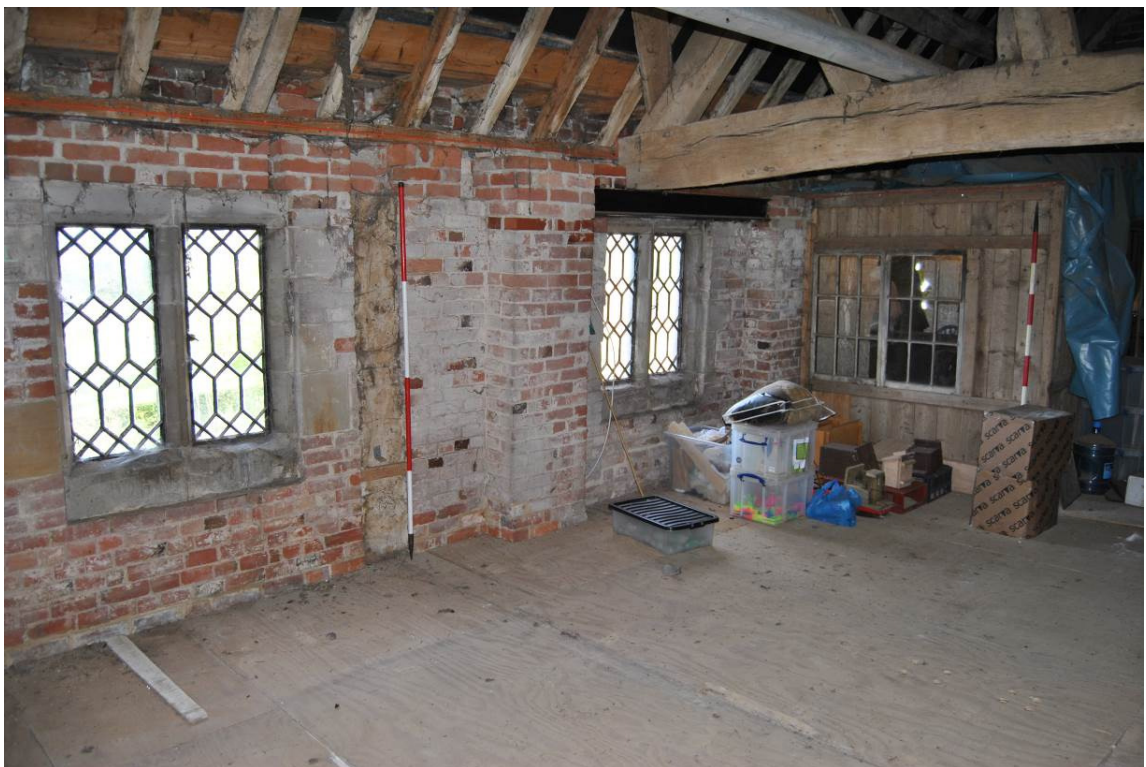
**Plate 49:** Rebuilt west wall at Bays 4/5; **NB:** surviving intermediate stud to left of photographic scale and tie of truss T5 supported on paired RSJs over inserted window.

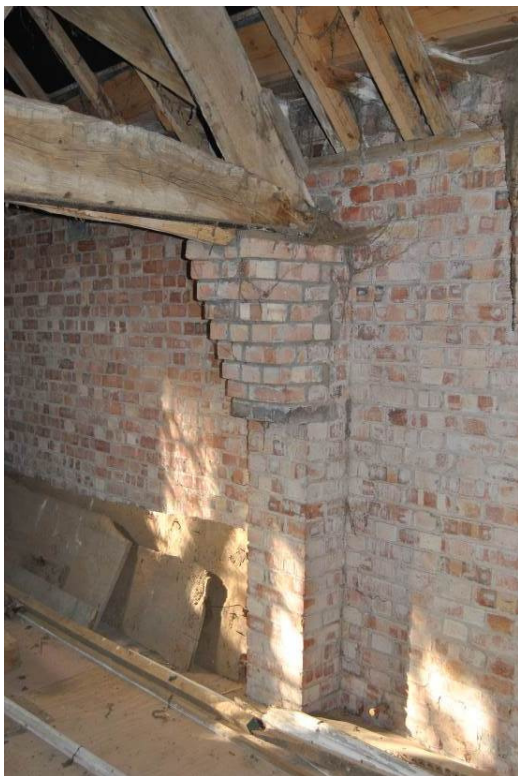
**Plate 50:** Corbelled brick pier at T2 (W) – 1940s.
