FORMER LAUNDRY BLOCK

Heartlands Hospital, Bordesley Green East Birmingham, West Midlands

Historic Building Record

[Report No. 2012.016]

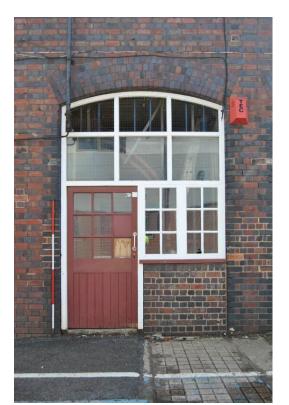
Plate 10: Partially blocked arch at [B.009].

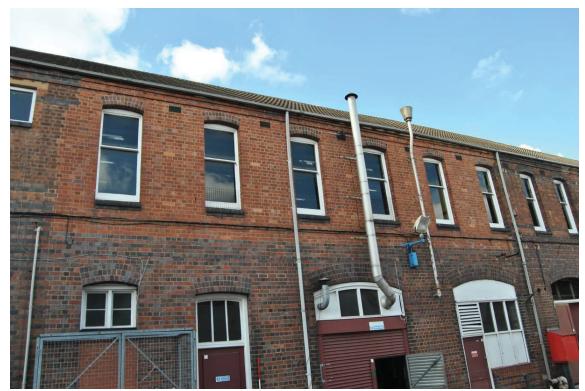
Plate 12: Renewed upper ground floor walling and windows at Bays 12 - 15 (see Figure 9a)

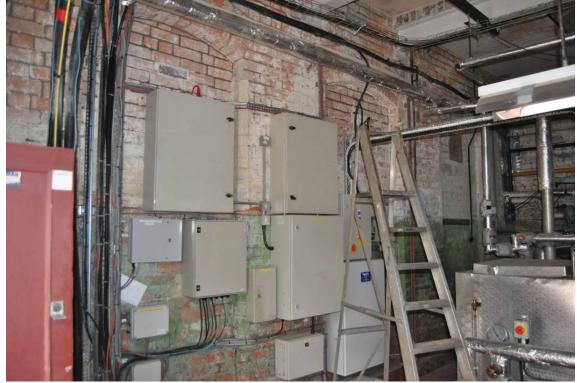
Plate 19: [B.011]; blocked archways of east wall.

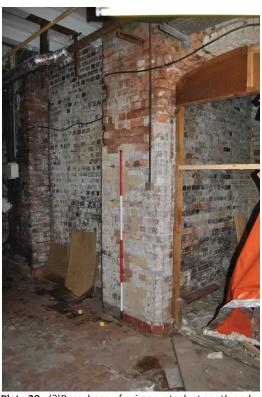
Plate 28: (?)Poss. base of primary stack at south end of [B.008].

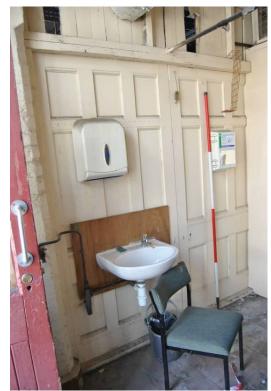
Plate 30: [B.009]; re-used door infill panels.

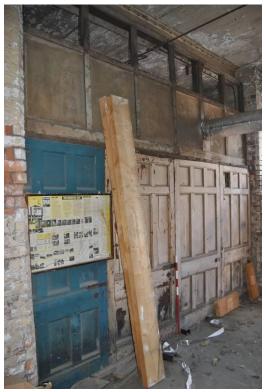
Plate 33: Infill panelling of re-used doors, [B.008].

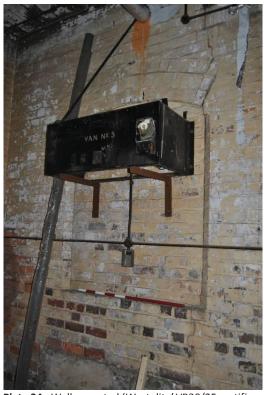
Plate 34: Wall-mounted 'Westalite' VR30/25 rectifier; **NB**: fixed to blocking of primary window opening.

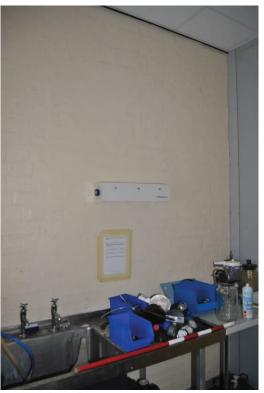
Plate 40: [B.005] blocked door in east wall.

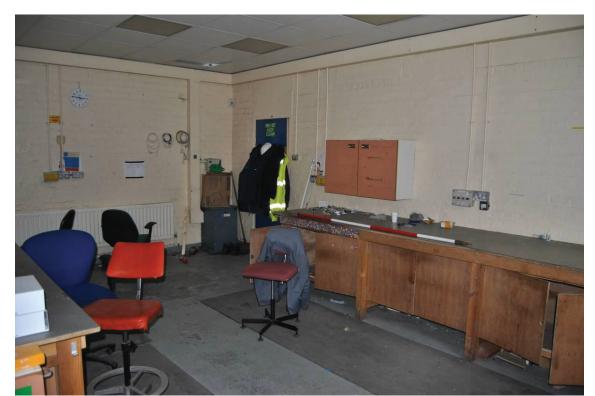
Plate 43: [B.003]; blocked door, south end of west wall.

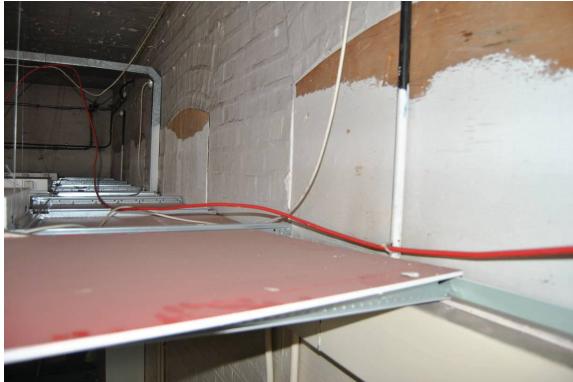
Plate 44: [B.003]; blocked windows of western gable visible above suspended ceiling.

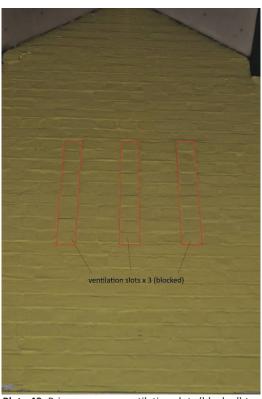
Plate 49: Primary range; ventilation slots (blocked) to eastern gable.

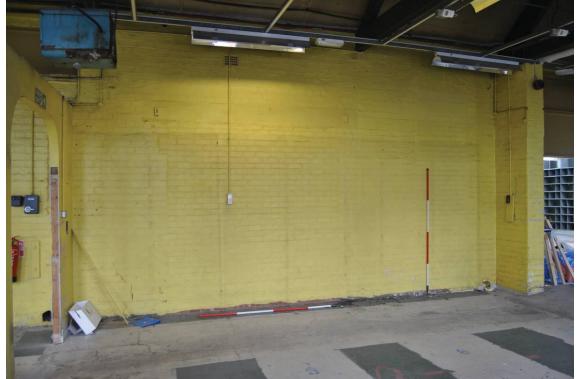
Plate 50: Section of primary south wall at Bays 10/11 with two blocked doorways.

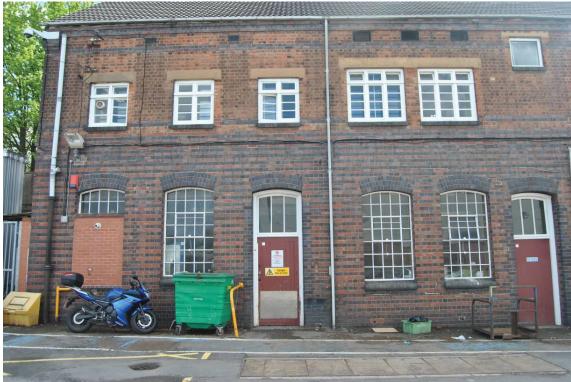
Plate 55: Phase II extension, north elevation. NB: clear disturbance to brickwork above three left hand windows.

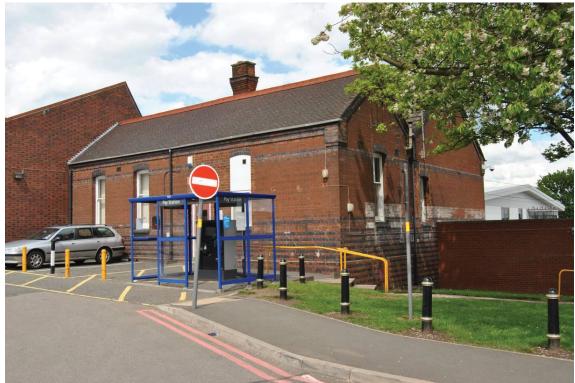
Plate 56: Phase II extension, south elevation and eastern gable end, looking north-west (NB: stack rising above valley).

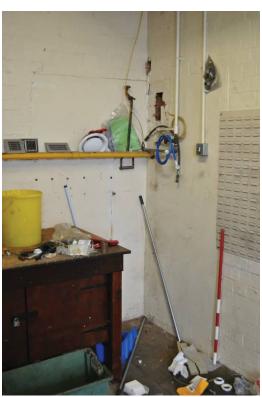
Plate 59: Workshop [B.015]; patching to wall suggesting location of former fireplace.
