CHARLECOTE PARK, WARWICKSHIRE

Woodyard, Service Ranges
and associated Outbuildings

Historic Building Record and Analysis

National Trust

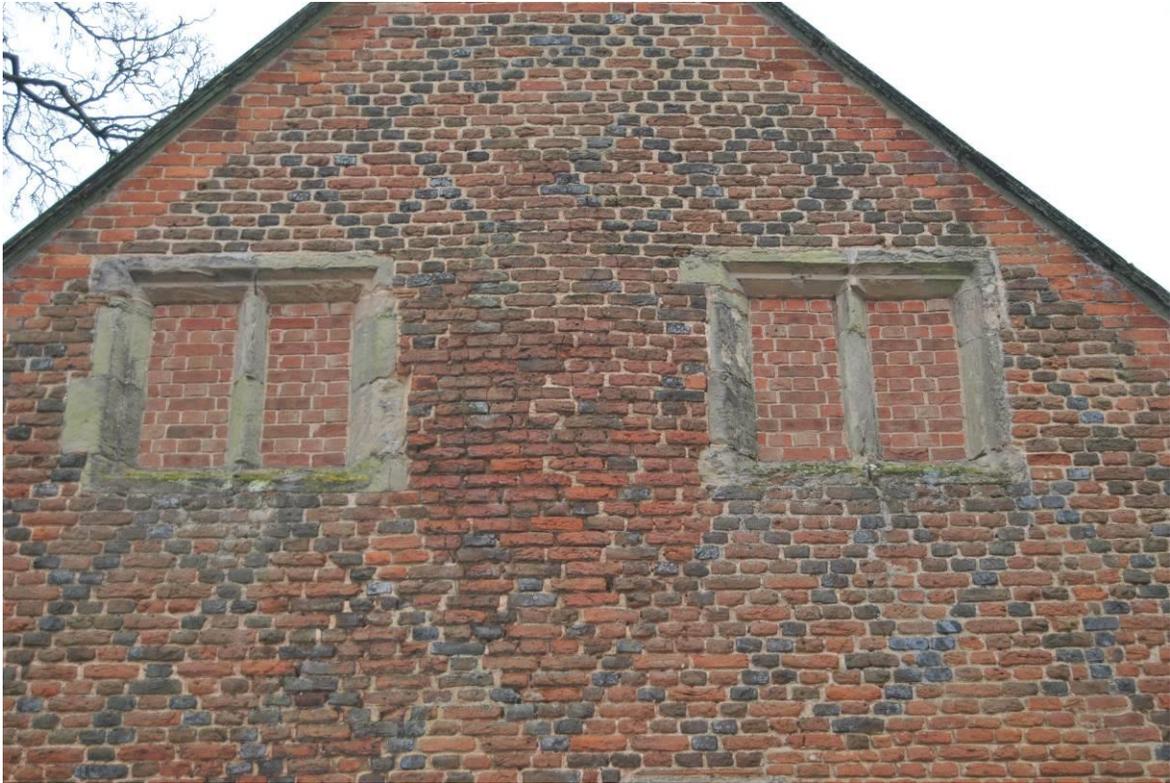
Plate 24: Primary, two-light stone-mullioned windows [w26/27] to second floor (attic) level. **NB.** raised/rebuilt parapet and disturbed diaperwork patterning between windows.

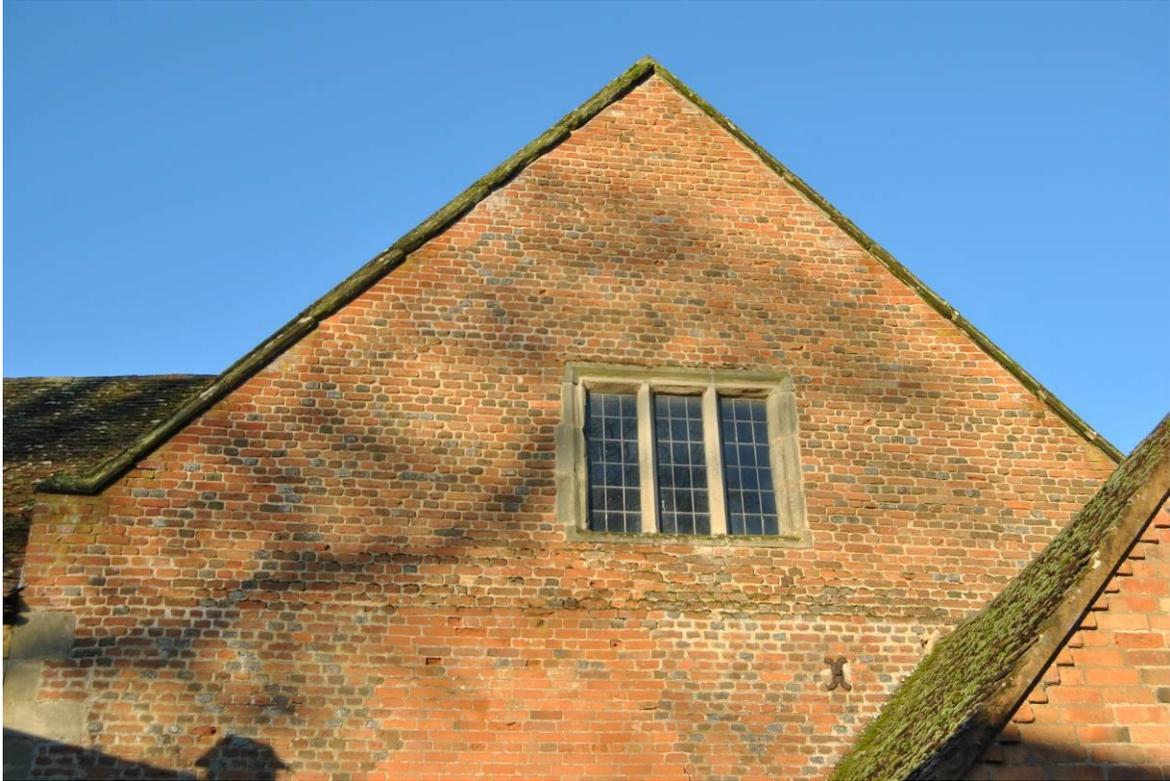
Plate 27: Rebuilt upper gable.

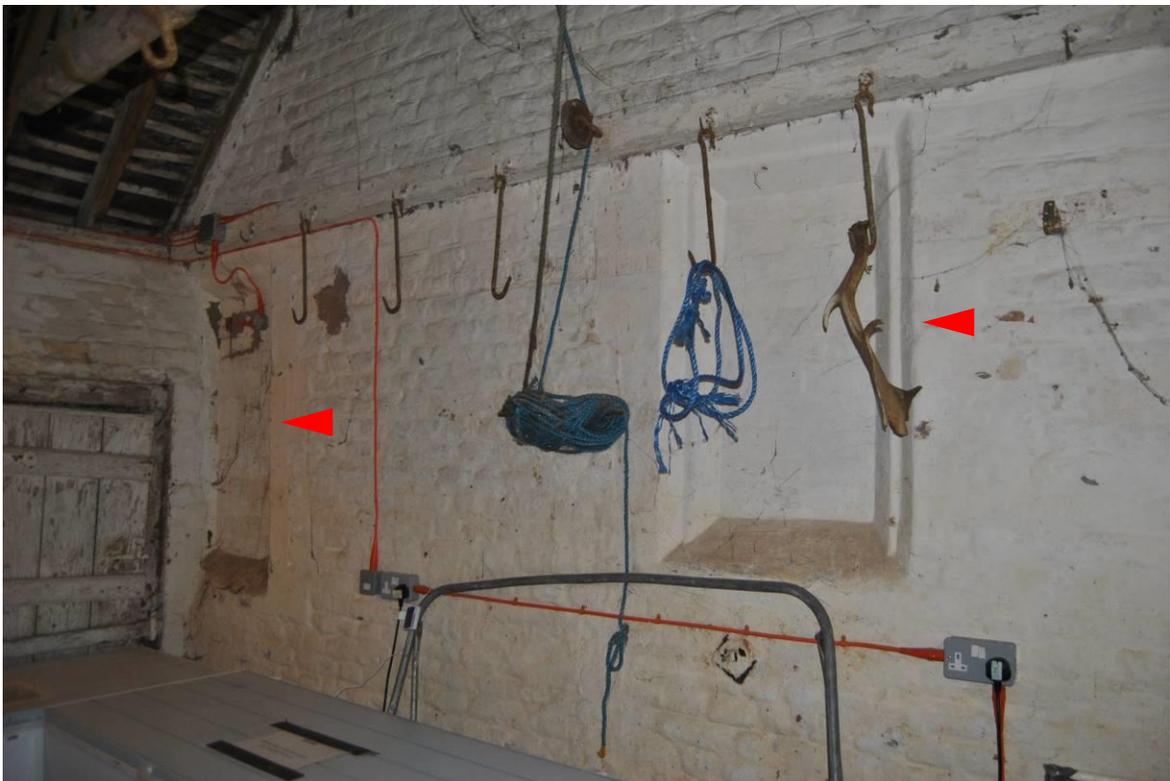
Plate 28: Two blocked single-light windows (arrows) visible within slaughterhouse G (compare 'Beighton' view of 1722).

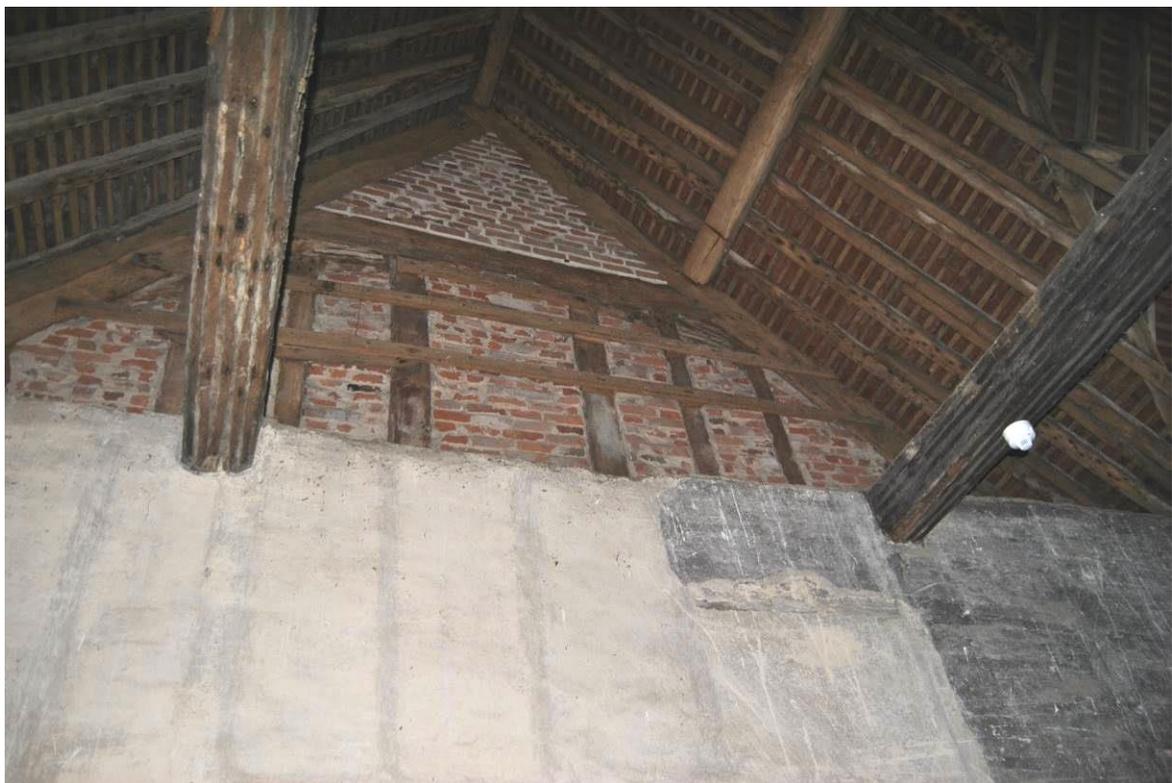
Plate 42: West face of infilled truss TVII above brewhouse, **NB.** central blocked door formerly serving attic floor.

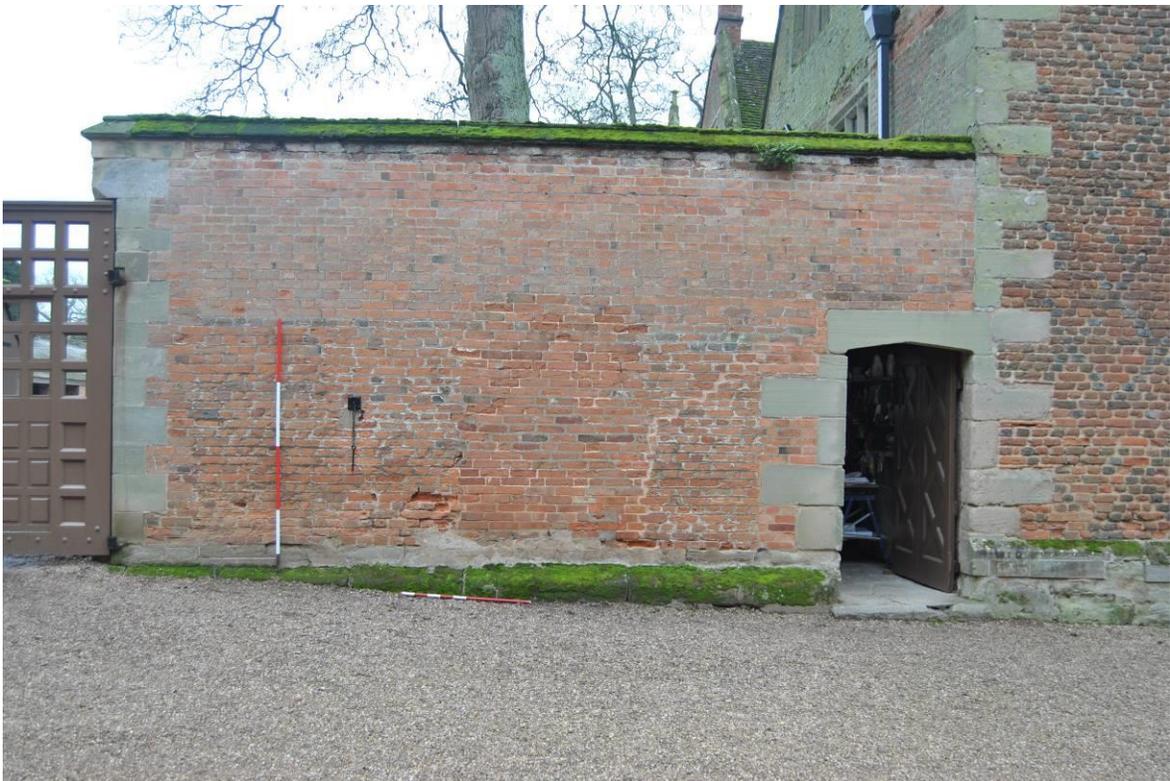
Plate 157: Western woodyard wall (south end), forming west side of bottle store L. NB. blocked door to centre.

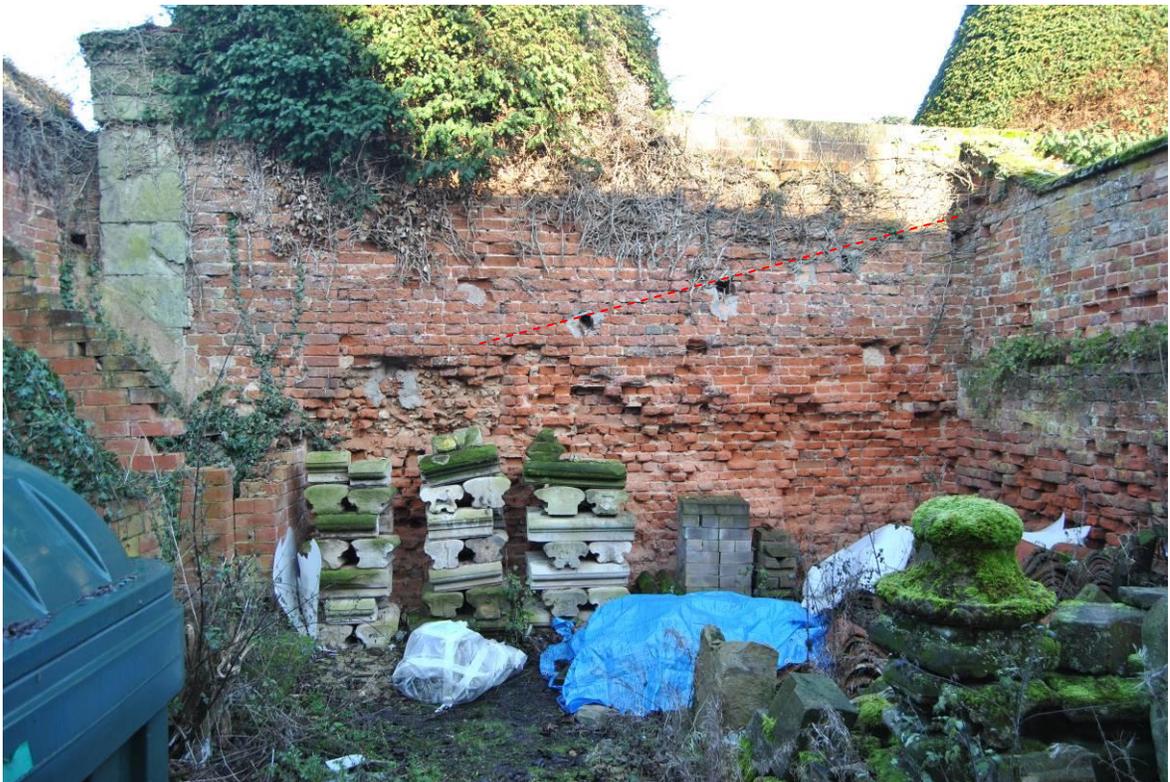
Plate 161: Yard **M** looking north-east **NB.** sloping line of sockets indicating former lean-to roof (marked).

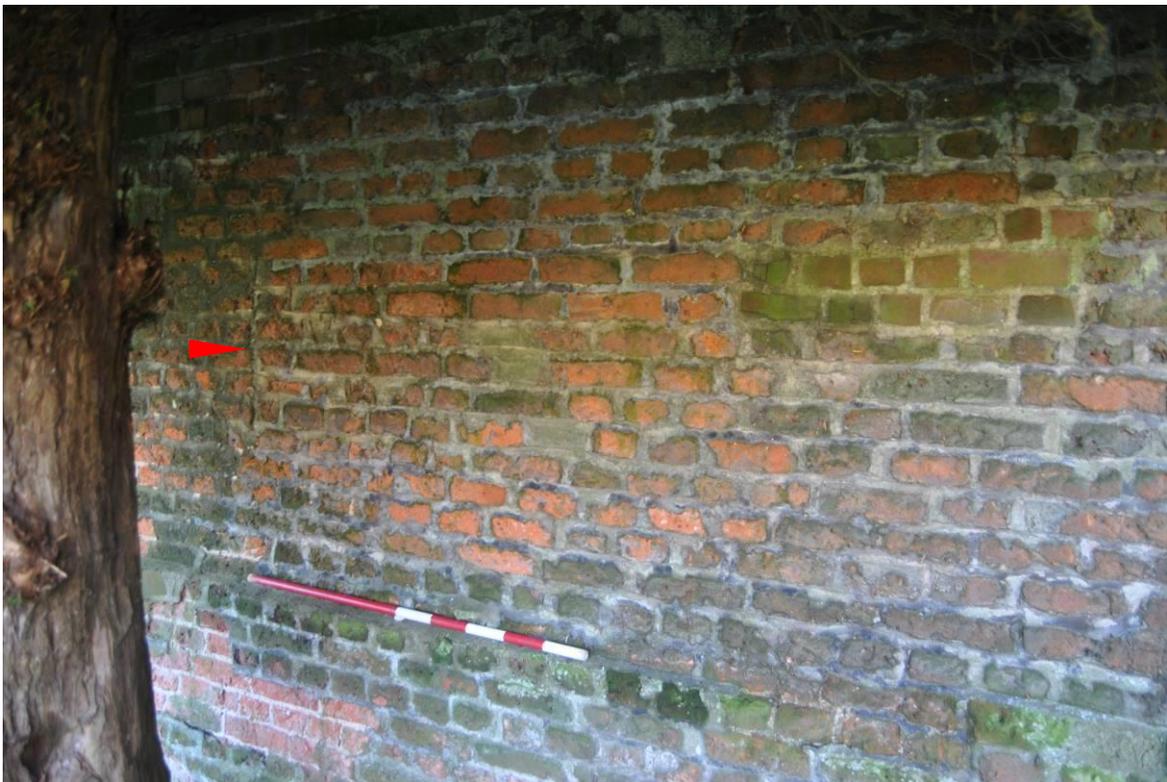
Plate 163: Vertical straight-joint (arrow) and blocking material related to opening as visible within Greencourt.
