Historic Building Recording

**THE CHURCH OF St JOHN THE BAPTIST,
WOODLAND, DEVON**

By R. W. Parker

REPORT No. 2012.03

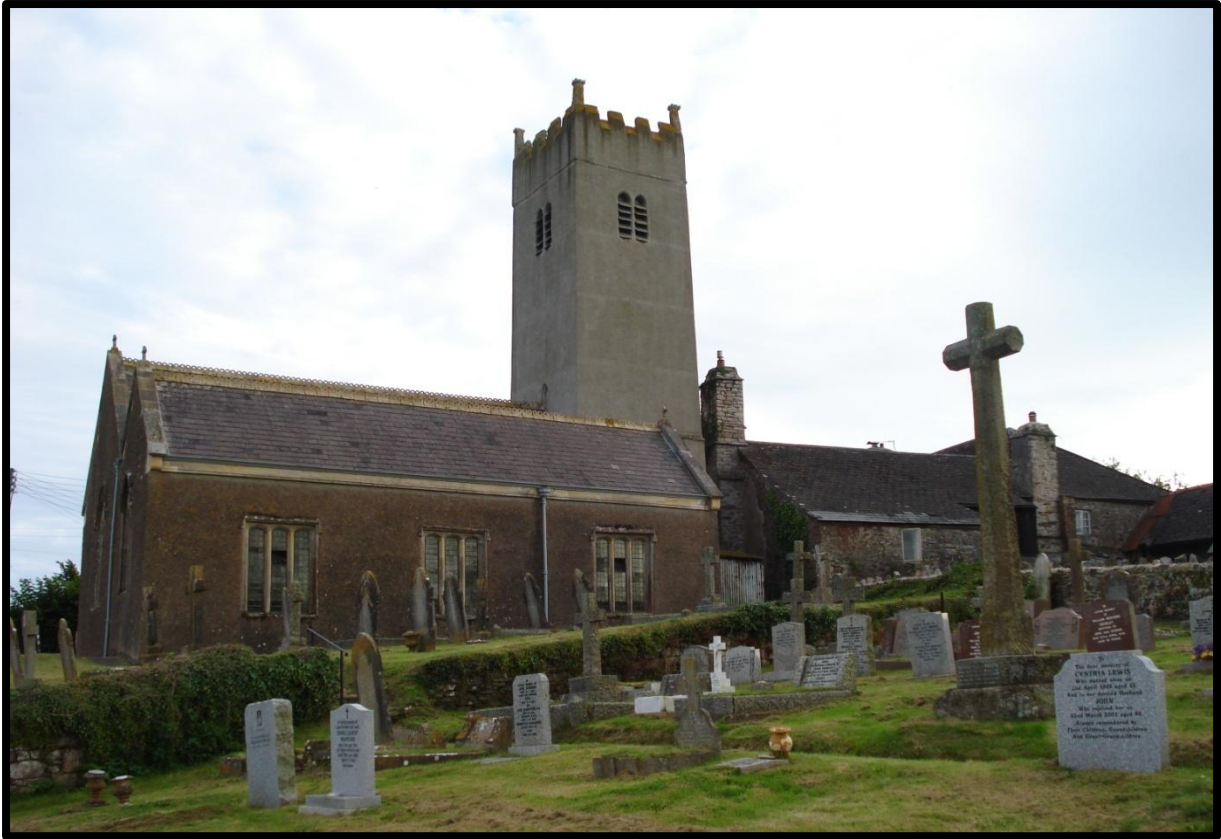
Fig. 1 Woodland Church from the north, showing the aisle and nave roofs extending unbroken to the east end and the proximity of the manor house to the west.

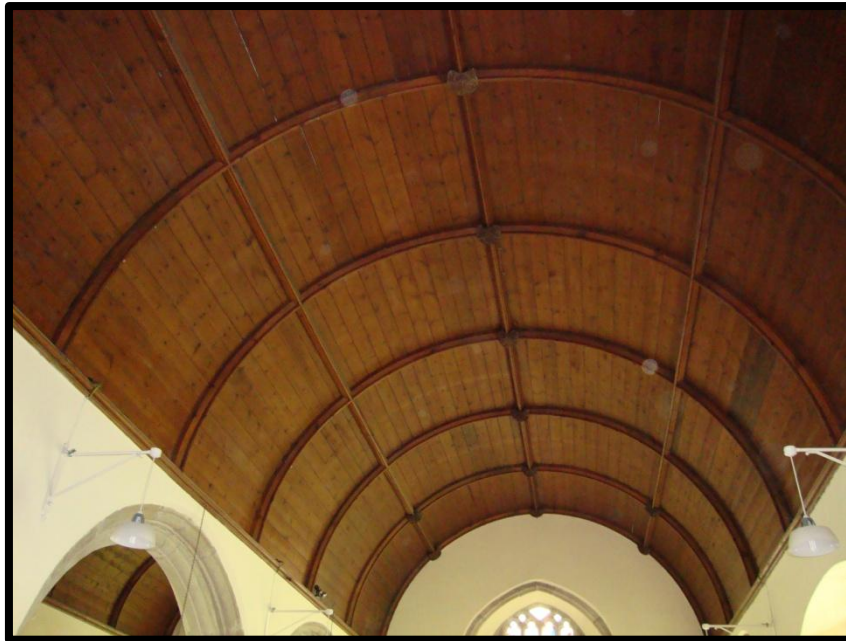
Fig. 2 View of the underside of the nave roof showing modern ribs and boarding, with ?reused bosses ornamenting the ridge rib and forming a celure over the sanctuary

Both the roofs of the nave and the aisle are boarded internally, and divided into panels in the manner of a traditional Westcountry ‘wagon roof’ by moulded ribs. The boarding and the ribbing all appear to be of 19th-century or perhaps early 20th-century date. Both roofs retain some bosses, which might be medieval and reused in these positions. Most of these are disposed along the ridge ribs; others are fixed to the side ribs near the east end of the nave to form a ‘celure’, or canopy of honour, over the sanctuary. There is no evidence of vine scroll carving on the wall plates or cornices of either roof (Figs 2, 3).

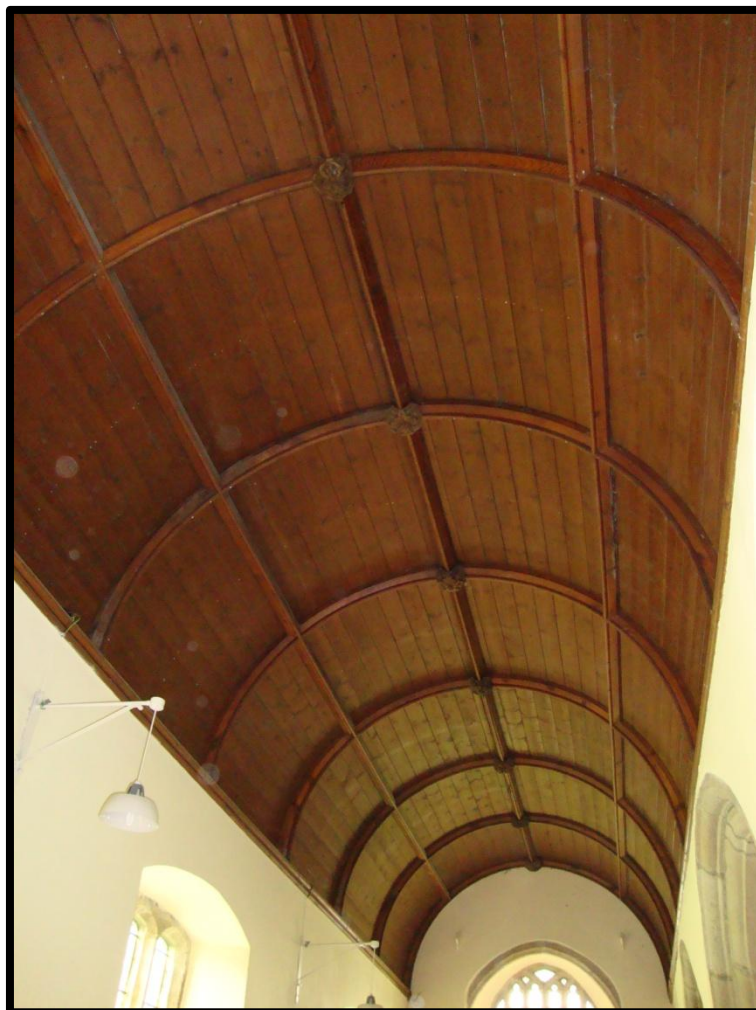
Fig 3. View of the underside of the aisle roof showing ?reused bosses ornamenting the central rib.

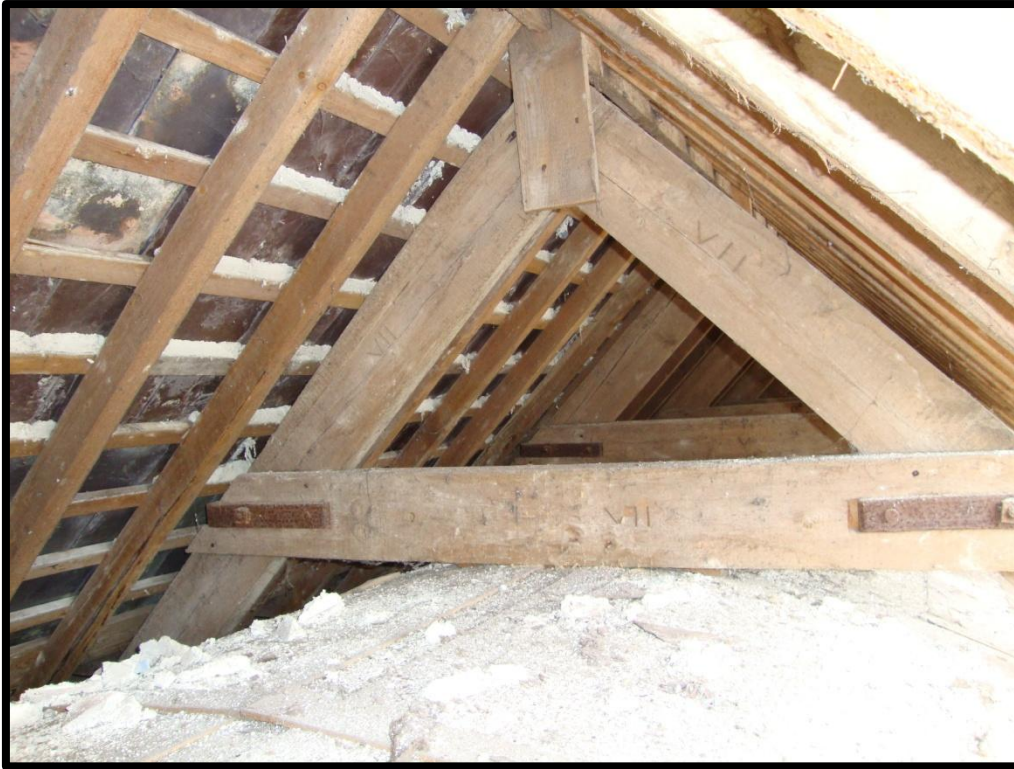
The present roof over the aisle imitates the appearance of this type of roof, but is wholly different in structure (Fig. 4). It is divided into bays by ‘A’-frame softwood trusses set at wide intervals, with high-level collars secured to the principals by metal straps. The ridge-

Fig. 4 View of the inside of the aisle roof at Woodland, above ceiling level, showing a 19th-century roof structure of widely-spaced 'A'-frame trusses supporting a boarded ceiling imitating the curved form of a traditional wagon roof.

tree is a narrow timber of slight scantling supported by a yoke at the apex of each truss. The principal rafters are marked with boldly-incised carpenters' marks in Roman numerals. The common rafters, of slight scantling, are supported on purlins slightly trenched into the principal rafters, approximately mid-way up the roof. The feet of the trusses appear simply to rest upon the wall tops (Fig. 5) and there are no arch braces. The wall tops appear not to retain earlier wall plates or cornices, but a rebate which may have been intended to house these timbers remains, filled with debris, and it is possible that some fragments of the original wall or eaves plates may yet survive in parts of the roof not yet examined. The structure of the barrel ceiling remains uncertain, and its relationship with the 'A'-frame trusses is unclear. Bands of curving timber are visible at intervals in the upper side of the ceiling, and it is likely that these represent curved timber 'hoops' supporting the boarded ceiling. Although these hoops may be expressed as ribs on the underside of the ceiling they do not appear to retain any medieval fabric.

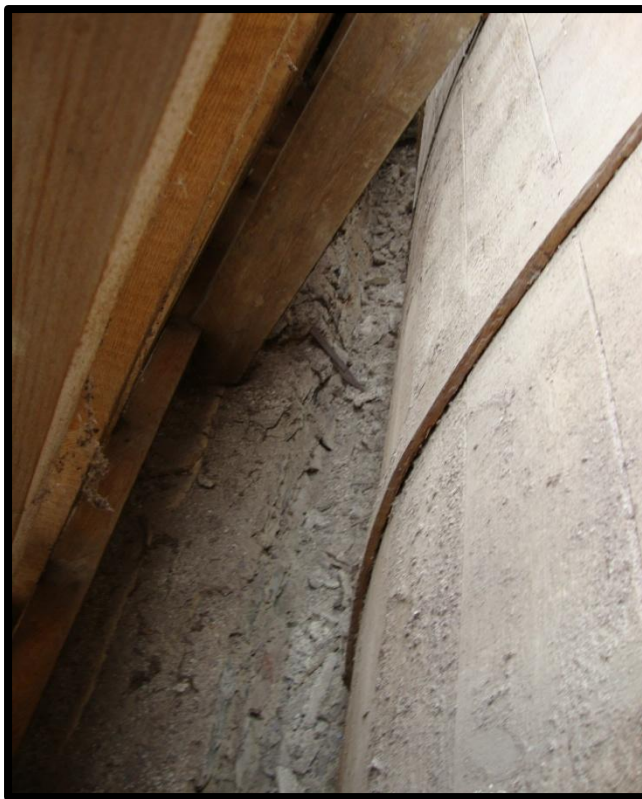
Fig. 5 Detail of the eaves on the northern side of the aisle showing the absence of arch bracing and the slight rebate in the wall top, perhaps for the former wall plates.

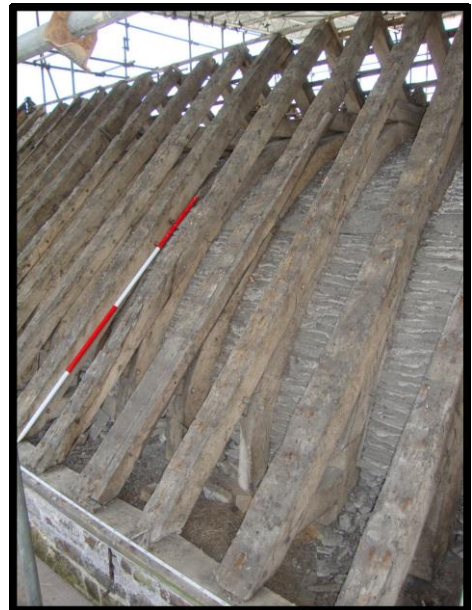
A traditional wagon roof consists of common-rafter trusses, each with a full set of arch braces, set at closely-spaced intervals along the length of the roof (Fig. 6). There are many variations in form in roofs of this type: the arch-braces may be seated in decorated wall plates and the roof is often divided into bays by ‘principal’ trusses expressed within the church by projecting mouldings. There are rarely any purlins; racking was restrained by moulded ribs applied to the curved underside of the roof structure, often replicating the mouldings of the ‘principal’ trusses and thus dividing the underside of the roof into square panels. The intersections of the ribs were often ornamented by bosses. The original roof of the aisle at Woodland (as described by Davidson, Glynne and Worthy) was clearly of this type. Earlier wagon roofs seem to have had less ornament and in many of these examples there was no ribbing, all the trusses being identical. It is possible that the nave roof at Woodland, which appears to have had neither ribs nor bosses, was of this type. Boarding or ceiling over these roofs with timber or plaster appears (in almost every case known to the author) to be a post-medieval addition, except in those cases where a celure occupied the area over the Rood.

Fig. 6 An authentic C15th wagon roof (at High Bickington), showing the regularly-spaced, closely-set arch-braced trusses forming a curved roof structure above a later ceiling

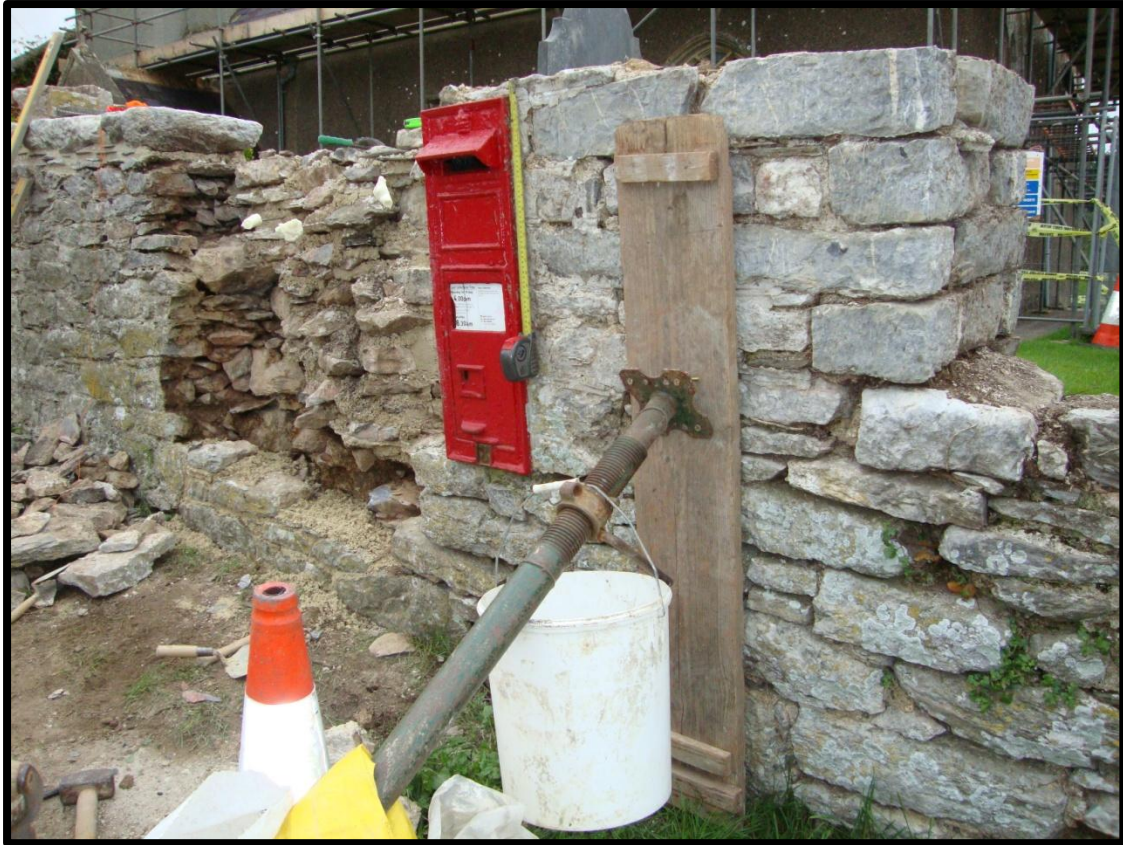
Fig. 7 View of the churchyard wall prior to rebuilding, showing the collapsing section of walling containing the Victorian post box and the Harris memorial. The church, under scaffold, lies in the background ($\frac{1}{2}$ metre scale).

The post box and a large memorial slab immediately behind it were accommodated within a raised section of walling which, by 2010, had begun to collapse. This section of wall contained larger blocks of masonry than the other parts of the wall and had perhaps been rebuilt in the 19th-century when the post box was inserted into the wall. There were no signs of any building breaks suggesting the wall was earlier. To the rear of the post box was a larger recess in the wall surface incorporating a large, early 19th-century memorial slab to members of the Harris family of Pulsford Farm. The slab had presumably been built into the wall with the post box, since the rear of the slab was in direct contact with the rear of the box. The reason for the inclusion of this slab with the walling is uncertain- perhaps it had been built into an earlier wall on the site, or had been ejected from the church during a period of restoration. Disturbance to the earth during the reconstruction of the wall was very limited in extent and no evidence of a cut for the wall was observed. The lower part of the slab was entirely obscured by the raised ground levels, which suggests a considerable amount of accumulation against the wall since the slab was set in position, and the excavation did not go lower than these levels.

The slab has now been reset in the same position and the wall rebuilt around it. No other observations of archaeological interest were made in these areas.

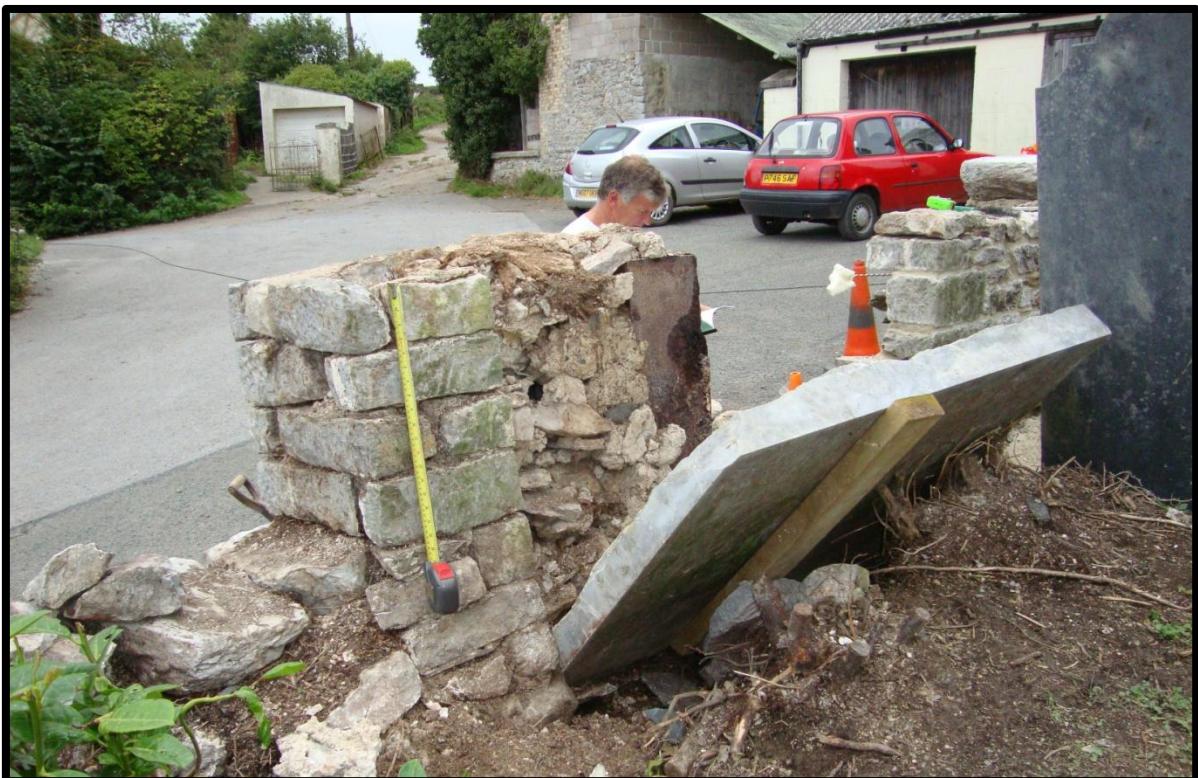
Fig. 8 Detail of the recess in the raised section of walling, designed to accommodate both the Harris memorial and the Victorian post box. The Harris memorial is shown temporarily supported during the works ($\frac{1}{2}$ metre scale).
