*Historic Building Survey*  
*of*  
**BROADCLYST HOUSE,  
BROADCLYST, DEVON**

*By R.W. Parker*

REPORT No. 2010.01

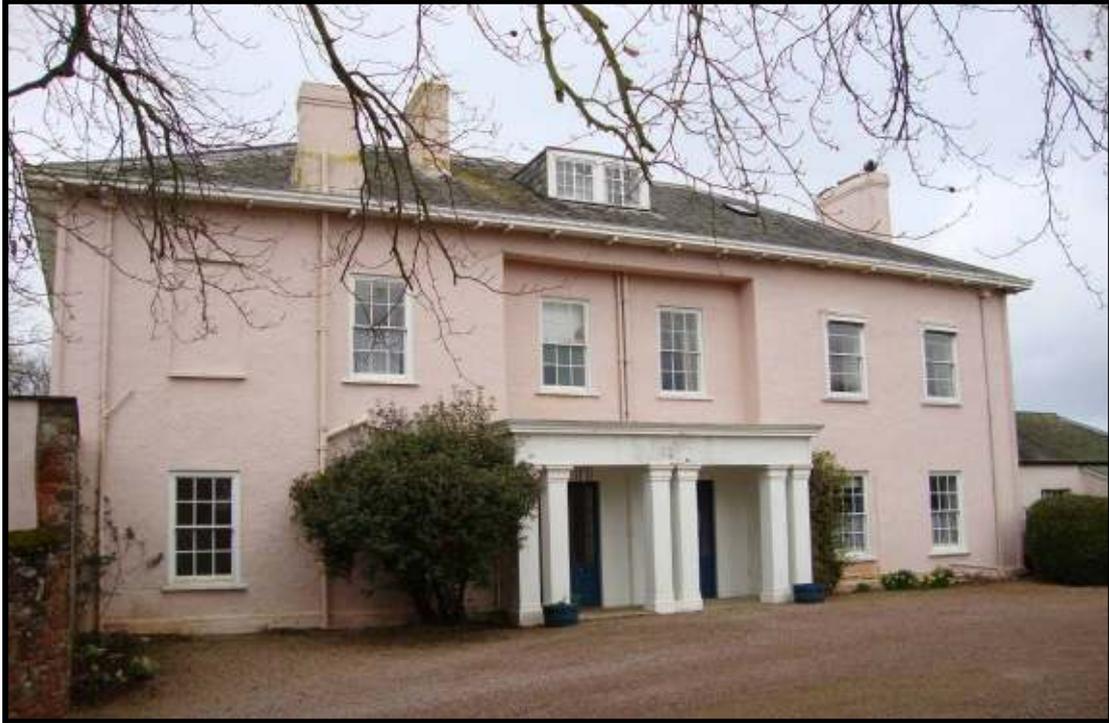
Above the porch, at first-floor level, the central section of the façade is slightly recessed, emphasising the outer bays as though these were projecting wings. The roof and bracketed eaves above this ignore this recession and continue unbroken over both the centre and the ‘wings’. This strongly suggests that the present roof is a replacement, perhaps superseding an earlier one which respected the recession of the central bays. The recessed part of the elevation has two sash windows without horns, flush with the face of the wall; these are probably of early 19th-century date.

Fig 7 The east front of the house, showing the recessed centre and the anomalous positions of the chimney stacks.

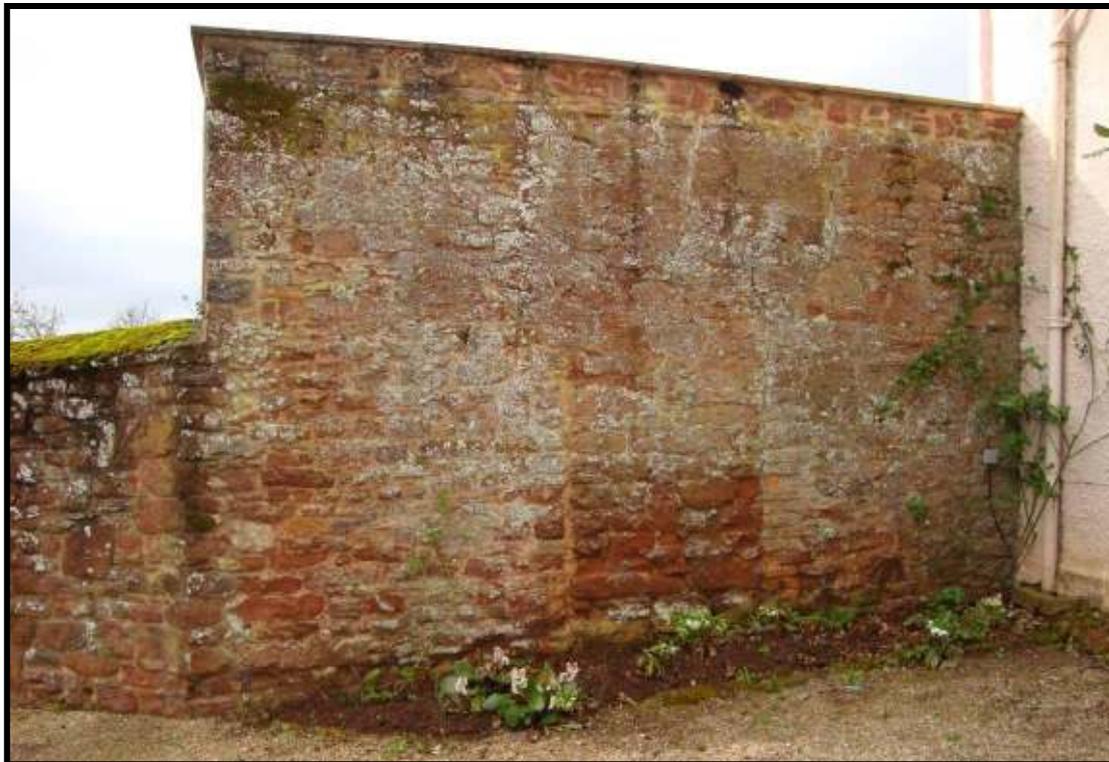
To the south of the main façade a short wall projects at right angles to the façade (Fig. 8). This forms the rear wall of a conservatory extending along the south side of the house. The earliest fabric, in the lower section of the wall, is constructed of red Triassic sandstone with occasional blocks of breccia. This is broken at the centre by a doorway with jambs of red hand-made brick, now infilled by later stone blocking.

Fig. 8 Fragment of walling, containing a blocked doorway, extending to the east from the southern corner of the façade.

The wall has been raised in height at a later period and this masonry extends downwards to block the doorway. The original wall may thus pre-date the construction of the conservatory and possibly also the early 19th-century remodelling of the house. It appears to relate to an outbuilding shown in this position on the Tithe map of 1843 (Fig. 6).

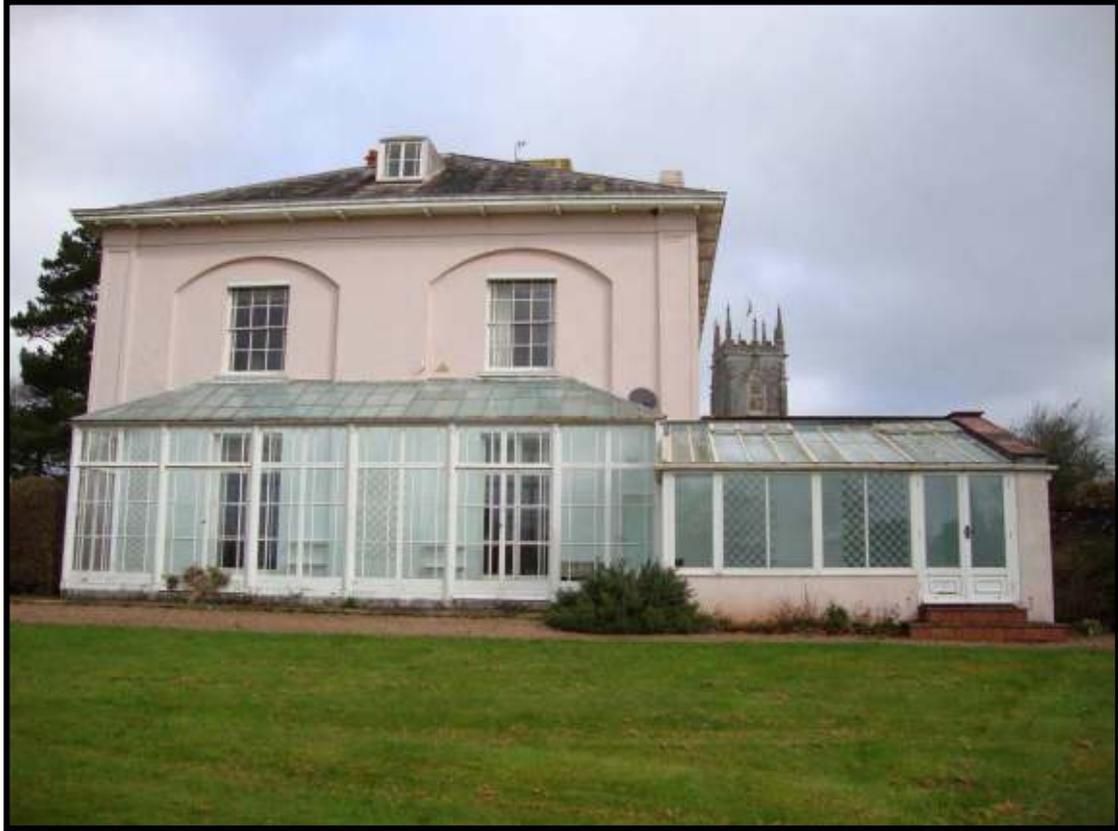
The south front of the house is clearly of a single phase of construction and of consistent design. It is shown on the early 19th-century plans as ‘new’, and the specifications for building works describe this wall of the building as ‘decayed’. It may therefore be assumed on documentary as well as on stylistic grounds that the wall was rebuilt or remodelled in the early 19th century. It may have replaced the east front as the principal façade of the house at this period.

Fig. 9 South front of the house showing the arched recesses and the 19th-century conservatory.

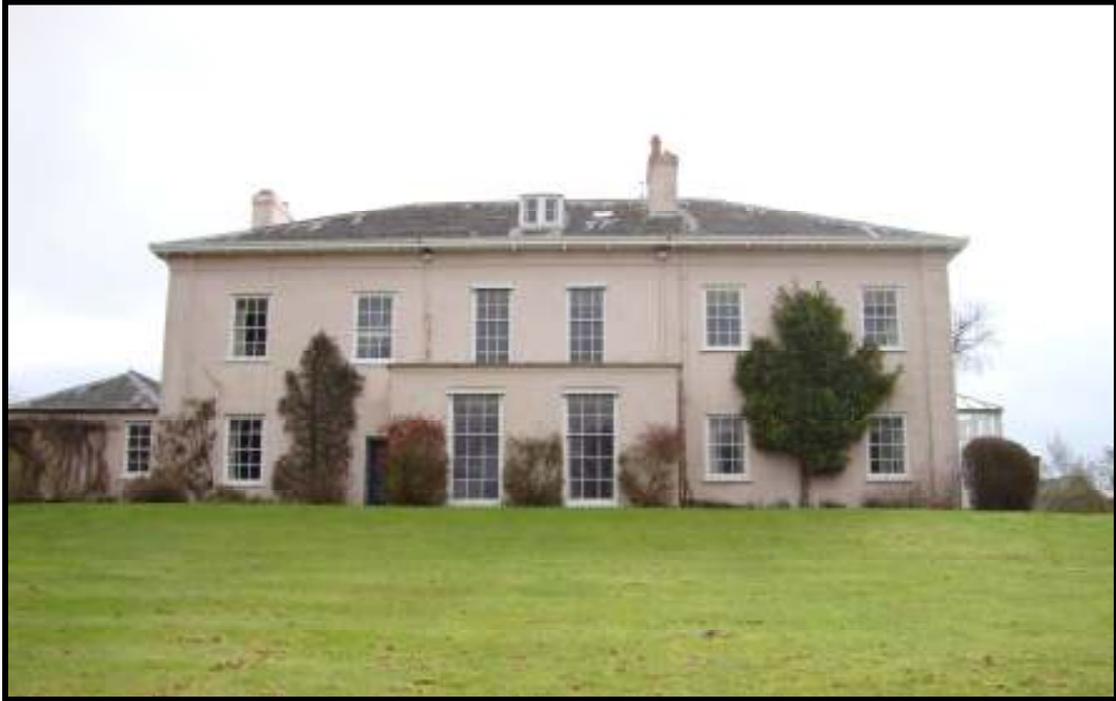
The central bays project forward at ground-floor level under a flat roof. This area is shown as 'new' on the 1820s plans and seems stylistically consistent with this date. The rooms within are lit by tall sash windows without horns, extending to the ground. The first-floor windows in this section of the façade are also taller and grander than those in the end bays, showing that these were important rooms. Both sets of windows have decorative pelmets for external blinds. In the roof a single central dormer window lights the attic rooms.

The northern bays have hornless sashes to the ground and first floor, somewhat larger than those in the southern bays and almost certainly of earlier date. One of these windows conflicts with the landings of the service stair rising against the west wall of the house; it seems likely that the window opening predates the insertion of the staircase. On the ground floor is a doorway with deep, panelled reveals with raised fielded panels, opening upon the hallway serving the service stair. The door has six panels of an unusual pattern, with taller panels above and below a middle section of smaller square panels. This is perhaps of early or mid 18th-century date and is of some grandeur; it may represent the original front door of the house, reused in this position in the early 19th-century alterations.

Fig. 10 West front of the house showing the projection at the centre, the varying sizes of windows and the anomalous position of the chimneys.

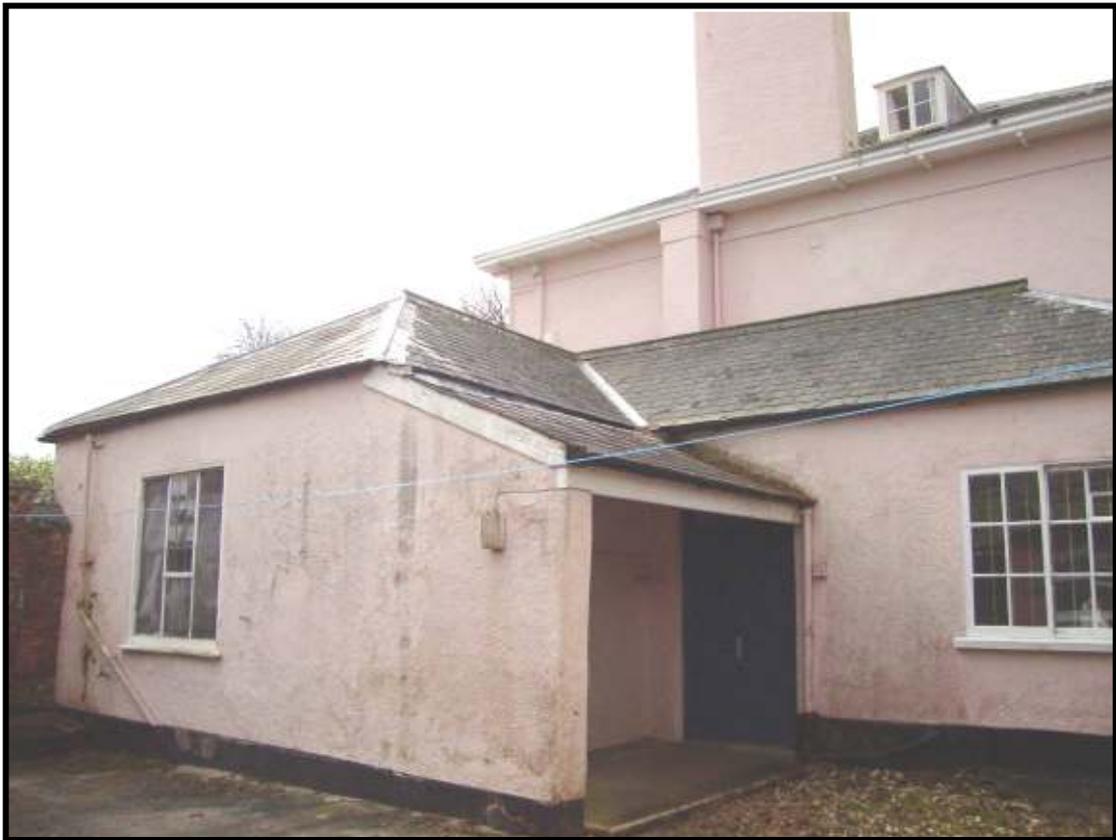
Fig. 11 North elevation of the house from the service yard, showing the low service wing featuring mullioned and horizontally-sliding sash windows.

The outbuildings to the north of the main house are shown as 'new' on the early plans. The service wing is 'L'-shaped, the eastern part projecting northward of the western part. The former section contains a large three-light window with timber mullions, the leaded lights (now mostly missing) being protected and secured by very substantial iron stanchions and saddle bars. Most of the casements have been replaced by metal mesh which is presumably designed to ventilate the larders or pantries. This window looks earlier in date than the rest of the building and may well have been salvaged from an earlier structure. The narrow moulded mullions suggest a late 17th- or an early 18th-century date. Although older styles of fenestration were frequently employed in the service areas of buildings in the 18th and early 19th century the dimensions of the ironwork would be unusual for this period and it is most likely that this window has been reused.

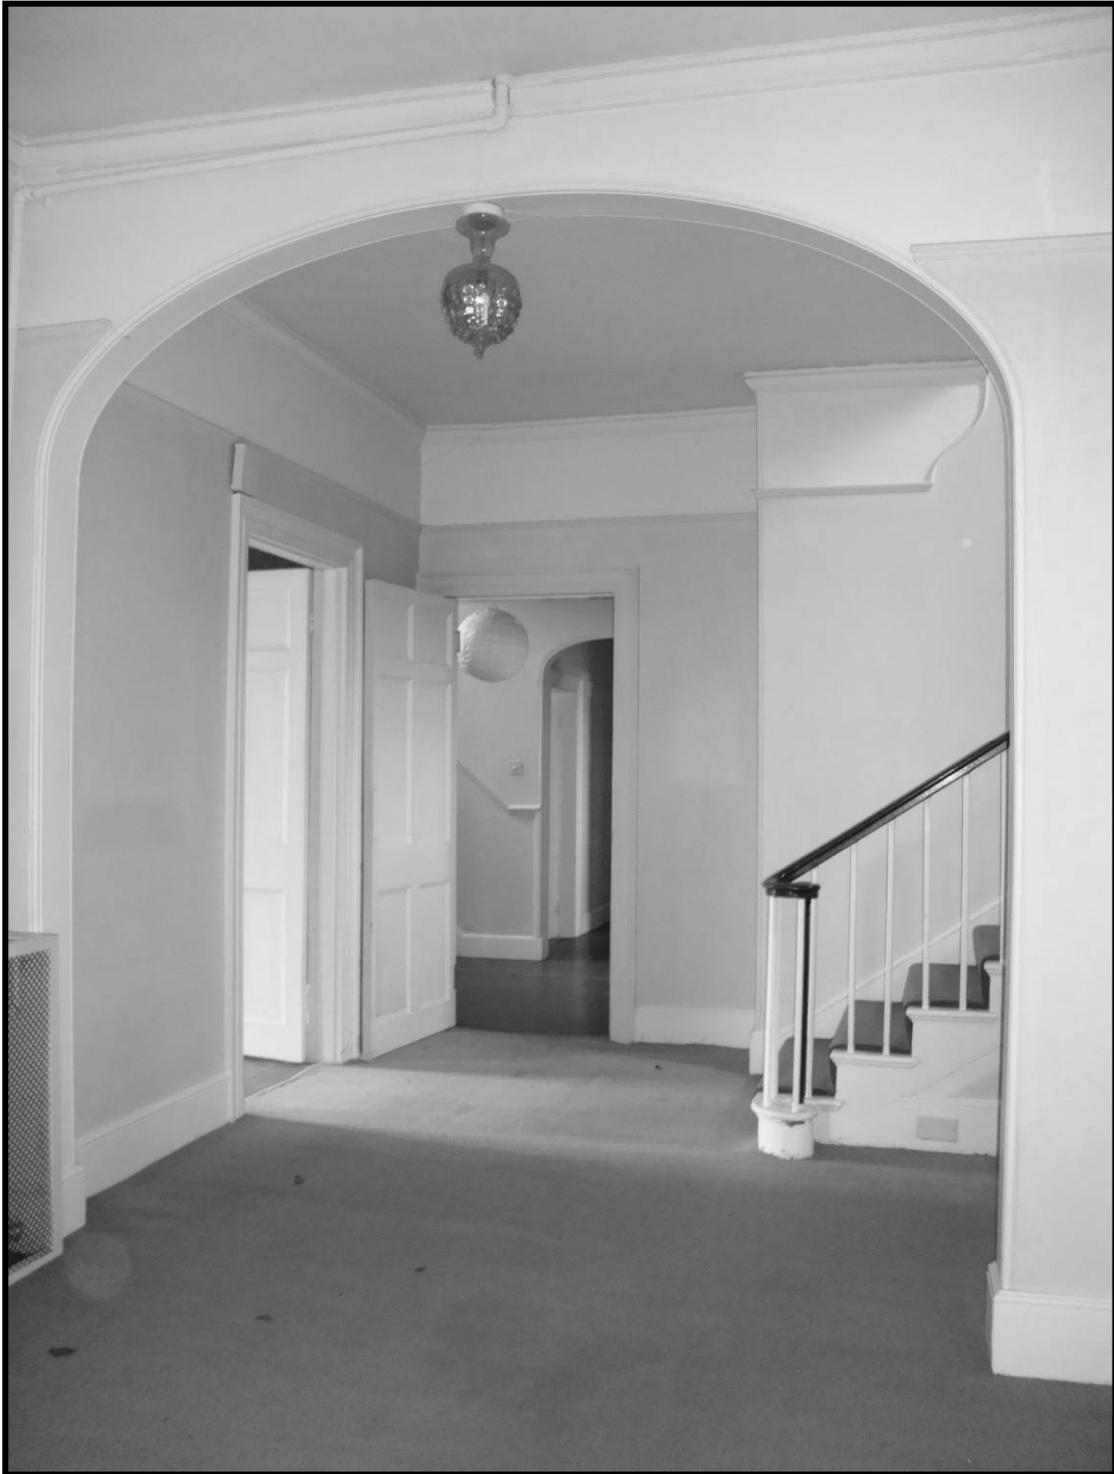
Fig. 12 View of the entrance hall, looking towards the service wing, showing typical early 19th-century detail.

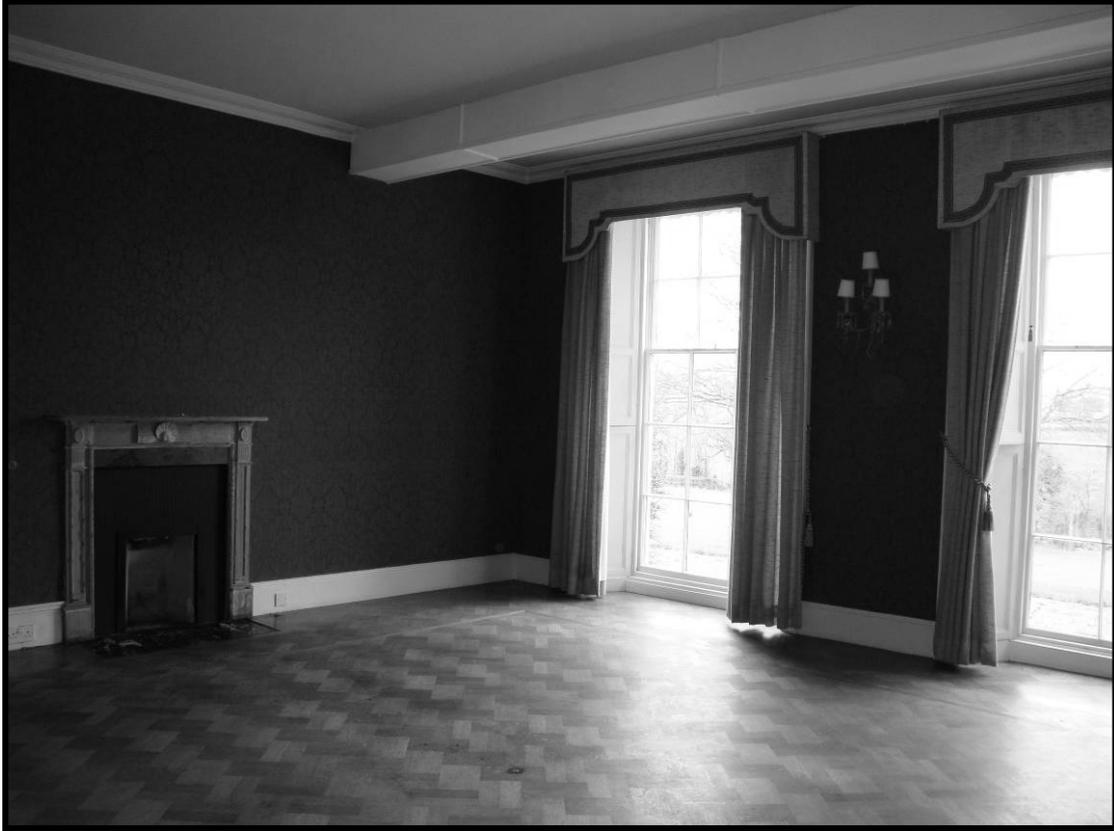
Fig. 13 View of the central room on the ground floor, showing the beam inserted to bear the upper part of the west wall and the reused 18th-century fireplace.

usual early 19th-century style. The fireplace is central to the south wall and must thus have been inserted at the same time as the addition of the western projecting bay. The present chimneypiece is possibly a genuine 18th-century example, but it has been moved to this position in the 20th century and ‘dressed up’ with applied ornaments to make it grander.

The windows retain their shutters which, both in the configuration of their panels and in their iron furnishings, are of a slightly different form to those in the southern rooms. These shutters have a smaller rectangular panel roughly at the middle and longer panels above and below this. It is possible that this pattern of panels was intended to reflect the 18th-century doors which survive in the house, such as that noted previously in the doorway from the garden to the service stair (above). Although the windows and shutters are probably of early 19th-century date, it is possible that they slightly pre-date the alterations of 1820; they may relate to an earlier refurbishment of the house and were perhaps reset in this position when the projecting bay was added. The ceiling is crossed by boxed-in beam or girder, which was presumably inserted in the 20th century to reinforce the structure and support the wall above. The girder cuts the cornice, showing that it is almost certainly a later addition.

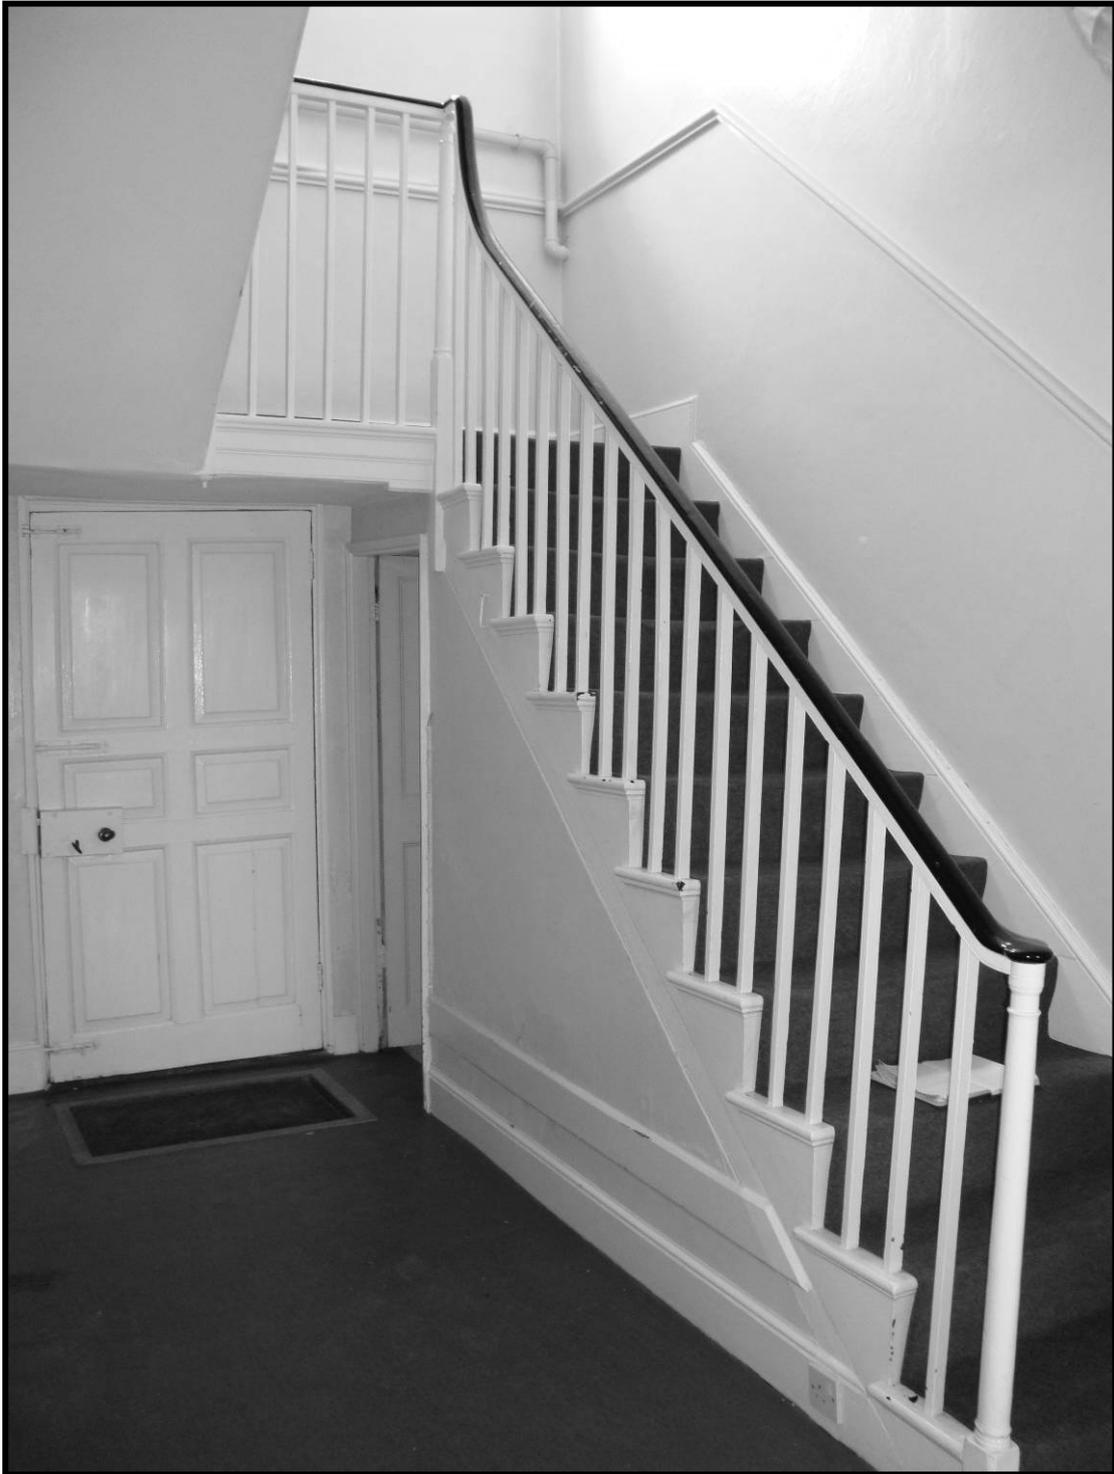
Fig. 14 Detail of the service staircase, showing early 19th-century detail, with an earlier, 18th-century door alongside opening upon the gardens.

From this stair-hall handsome doors with bold, raised-fielded panels open upon the gardens to the west and upon the Pantry to the east. Both doors are probably of early-mid 18th-century date and are grander than seems appropriate for their present situation in the service areas of the house: they must surely pre-date the early 19th-century alterations. The eastern door almost certainly remains in its original position.

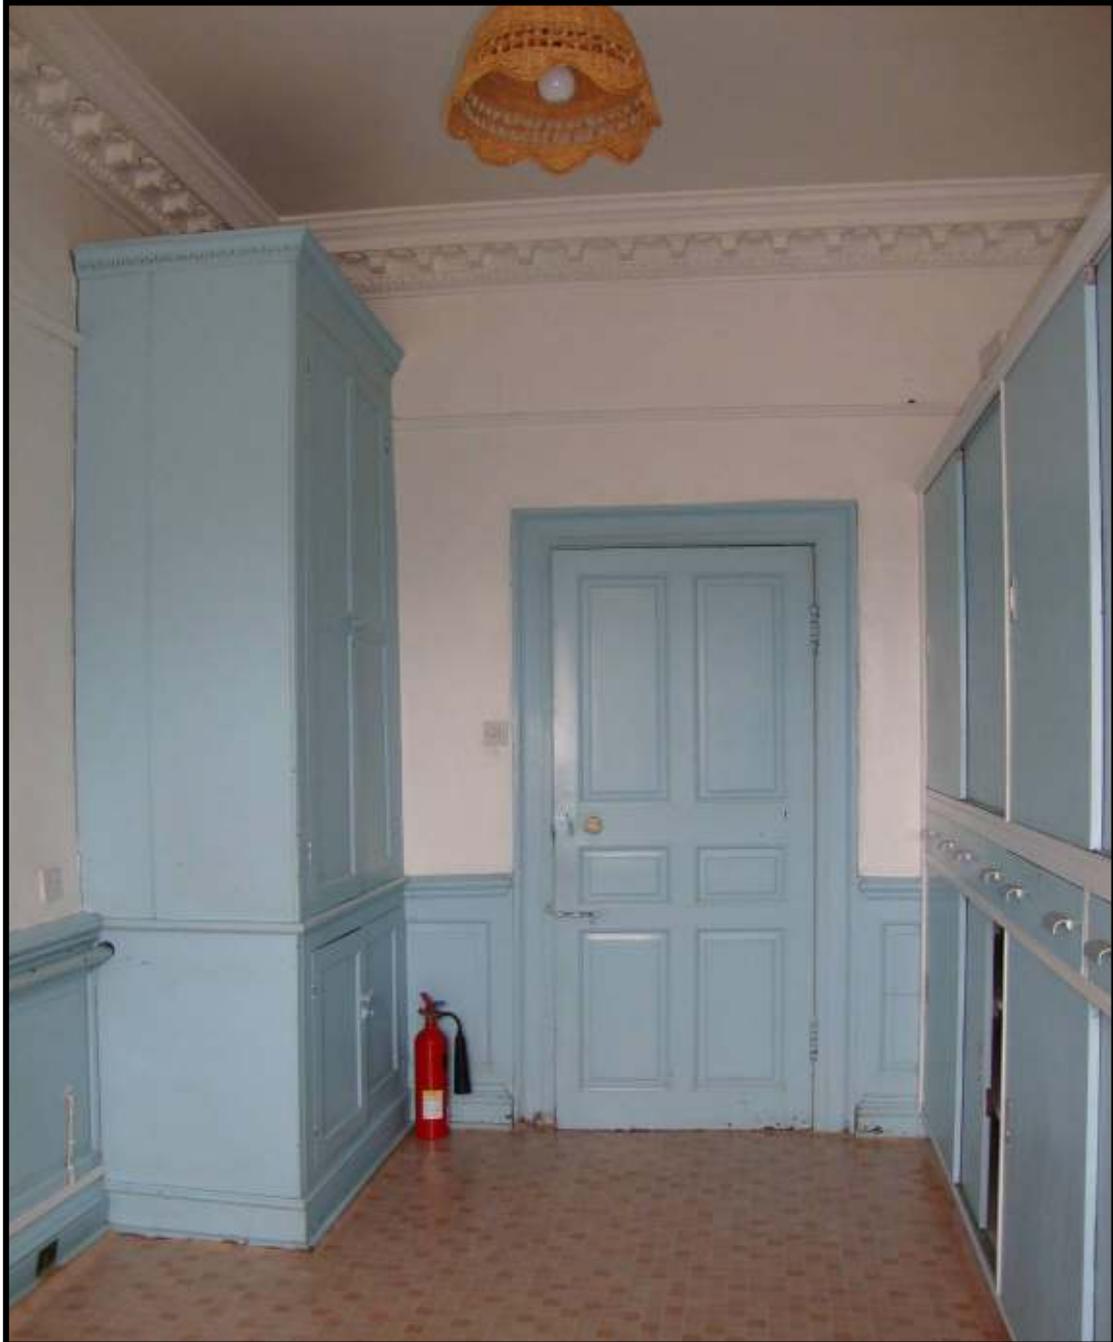
This room has such rich decorations that it cannot originally have been a service room, but rather one of the state rooms of the 18th-century house. The room has an exceptionally elaborate modillion cornice and a dado of raised fielded panels which survives intact around three walls. On the fourth side the dado is covered by modern kitchen units and it is uncertain whether or not it has survived. The window in the east wall has shutters with raised-fielded panels and is also likely to be of 18th-century date. The doorway to the pantry is of the same period and was presumably the original entrance to the room. It has six raised-fielded panels, the central panels being small and square, and ornate, decorative terminals to the hinges. All the other door furniture is modern. In the south-western corner of the room is a tall, early 19th-century cupboard with a decorative cornice. It is likely that this cupboard was installed when the room was subdivided.

Fig. 15 View of the 18th-century door, panelling and plasterwork in the present kitchen (and also in the adjacent pantry), surviving from one of the original state rooms.

The northern part of this room, now the Kitchen, also retains many grand 18th-century features. The panelled dado survives around the western and northern walls of the kitchen, and the cornice around three sides of the room. The window also preserves its shutters with raised-fielded panels, though these have been sealed shut. The chimney breast in the north wall has been enlarged to accommodate a wider fireplace, no doubt to accommodate a kitchen range, fortunately without damaging the cornice. The original chimneypiece must have been removed at this time. A splendid 18th-century china cupboard in the north-western corner of the room may suggest that the room originally functioned as a dining room.

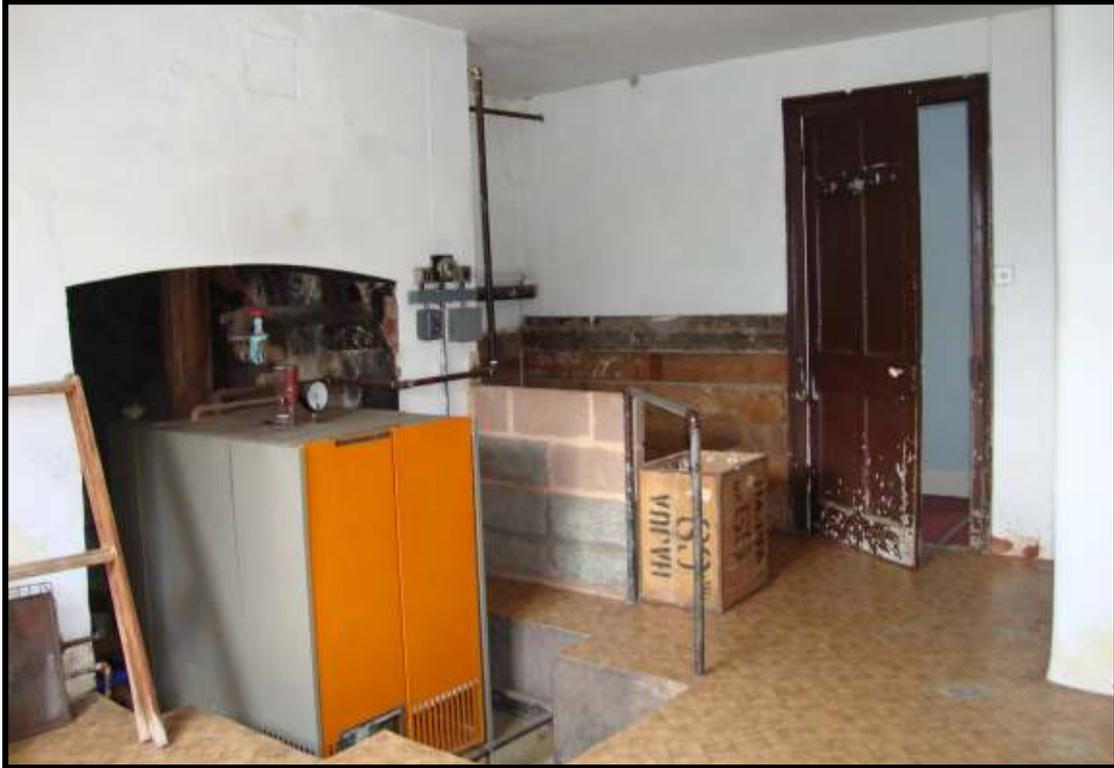
Fig. 16 View of the boiler room in the service area of the house, showing the absence of decorative features.

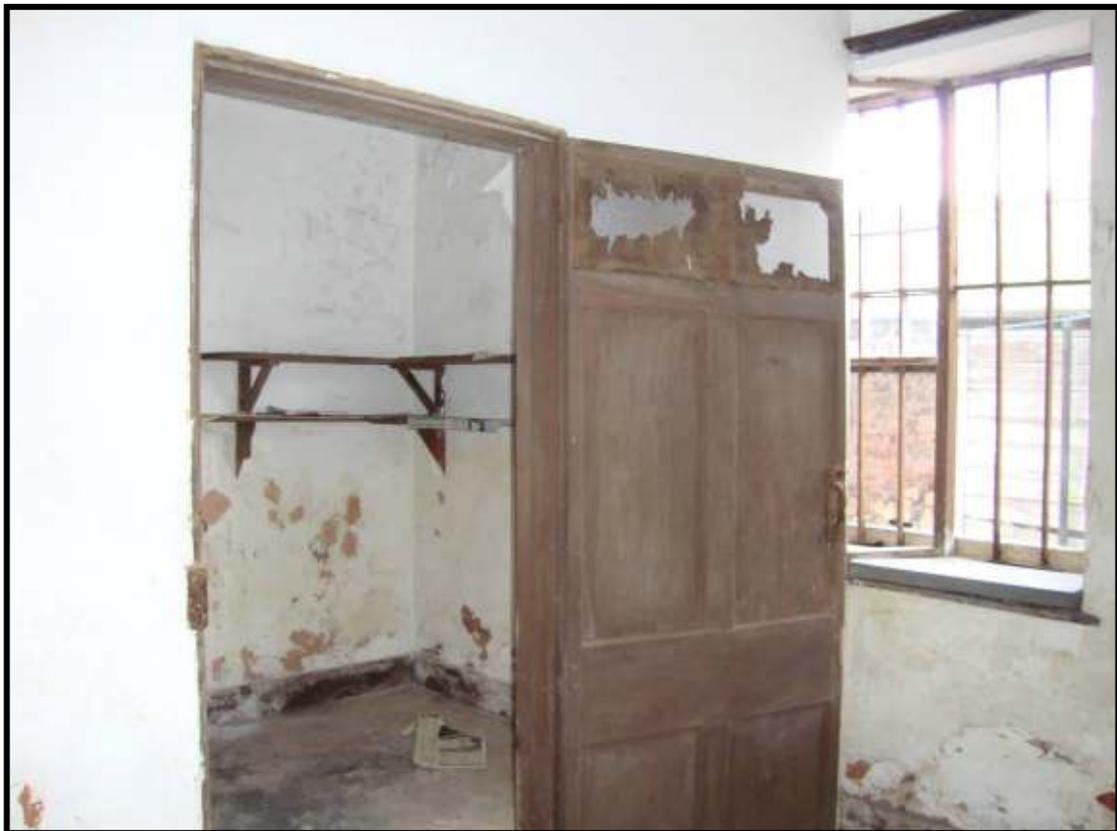
Fig. 17 View within the 'coal-house', dairy or game larder showing the inserted partition crossing the window to the service yard.

erected in the early 20th century. There is evidence of a further opening in the north wall which may have been intended as a window. This opening would have been obscured by the adjoining part of the range, which is shown on the 1820s plans as a Coal House. We may conjecture that the service range was erected in two phases and that the northernmost room was added after plans for a window in the north wall had been abandoned. The present angled corridor linking the main service corridor to the northernmost room also seems likely to be an addition.

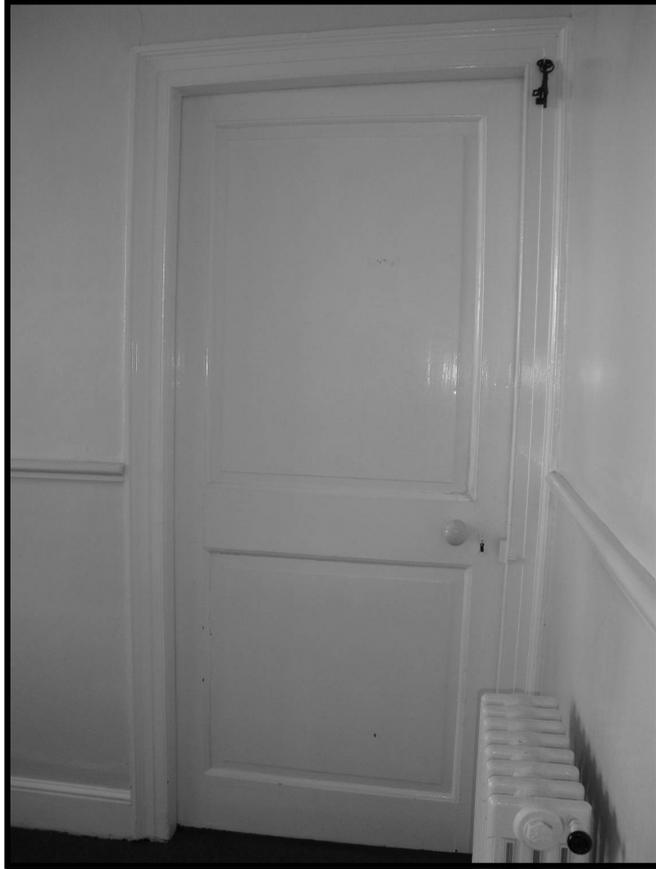
Fig. 18 A typical 18th-century door in the northern part of the first floor.

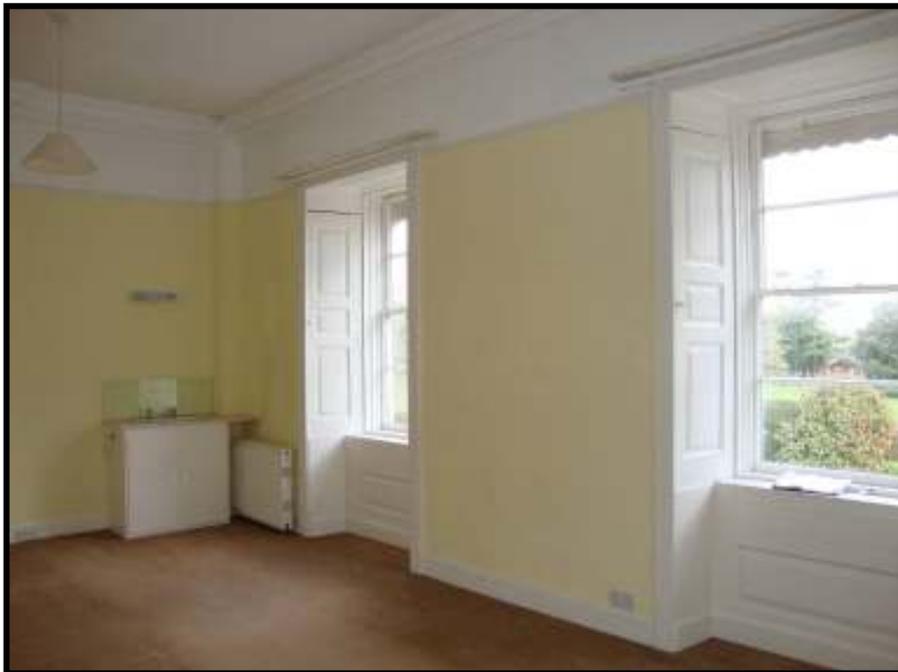
Fig. 19 Shutters and cornices of 18th-century date surviving in the northern parts of the house.

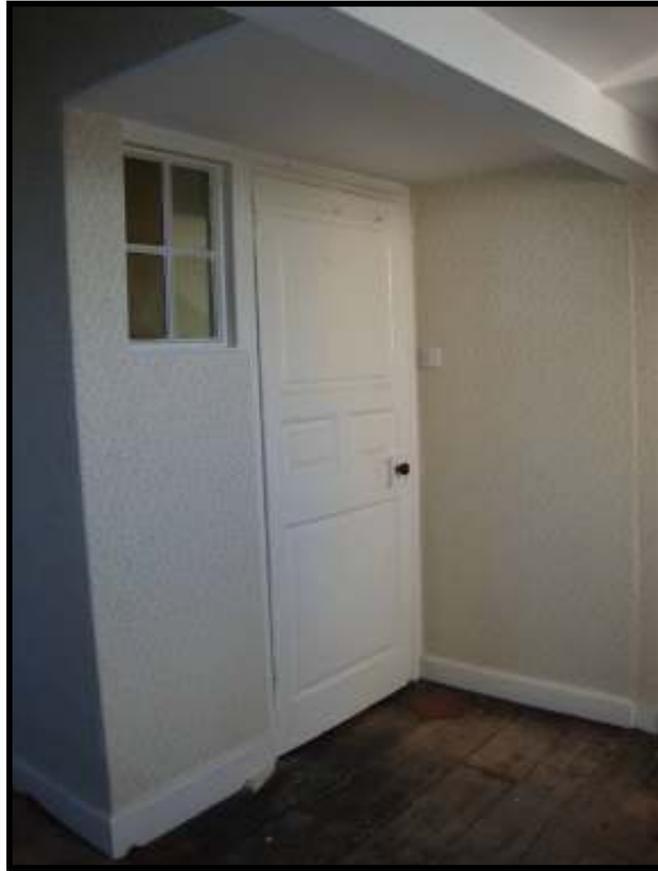
The attic storey consists of eight small rooms, most of which are entered through 18th-century doors. These doors have all been reused from elsewhere. They have four raised-fielded panels, arranged with single larger panels above and below a pair of small, square, central panels. They are thus similar in design to the grander doors in other parts of the house, and of the same period, but presumably came from less important areas, perhaps from the first-floor rooms.

Fig. 20 A reused 18th-century door in one of the attic rooms.

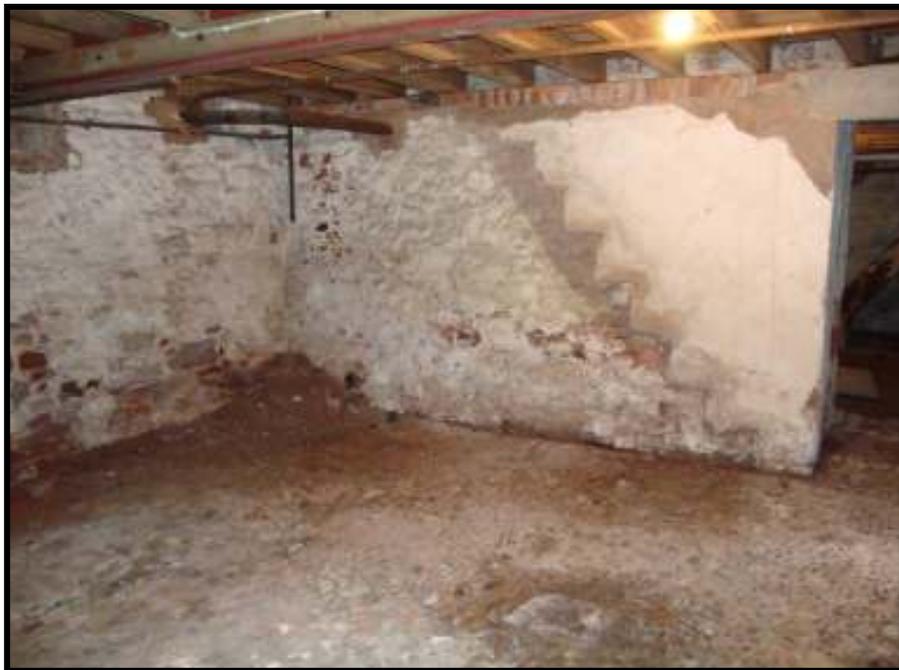
The cellars lie under the north-western rooms of the house and are now approached by a staircase under the service stair. The large cellar under the main block of the house has unplastered walls which have unfortunately been whitewashed, though some of the blocks appear to be of red Triassic sandstone. The brick floor and the brick wine bins are probably of

Fig. 21 View of the cellars showing the scar of a former staircase.

18th- or early 19th-century date, but the ceiling structures are modern replacements. There is no visible dating evidence for the cellars and it is impossible to say whether or not they contain fabric relating to earlier structures

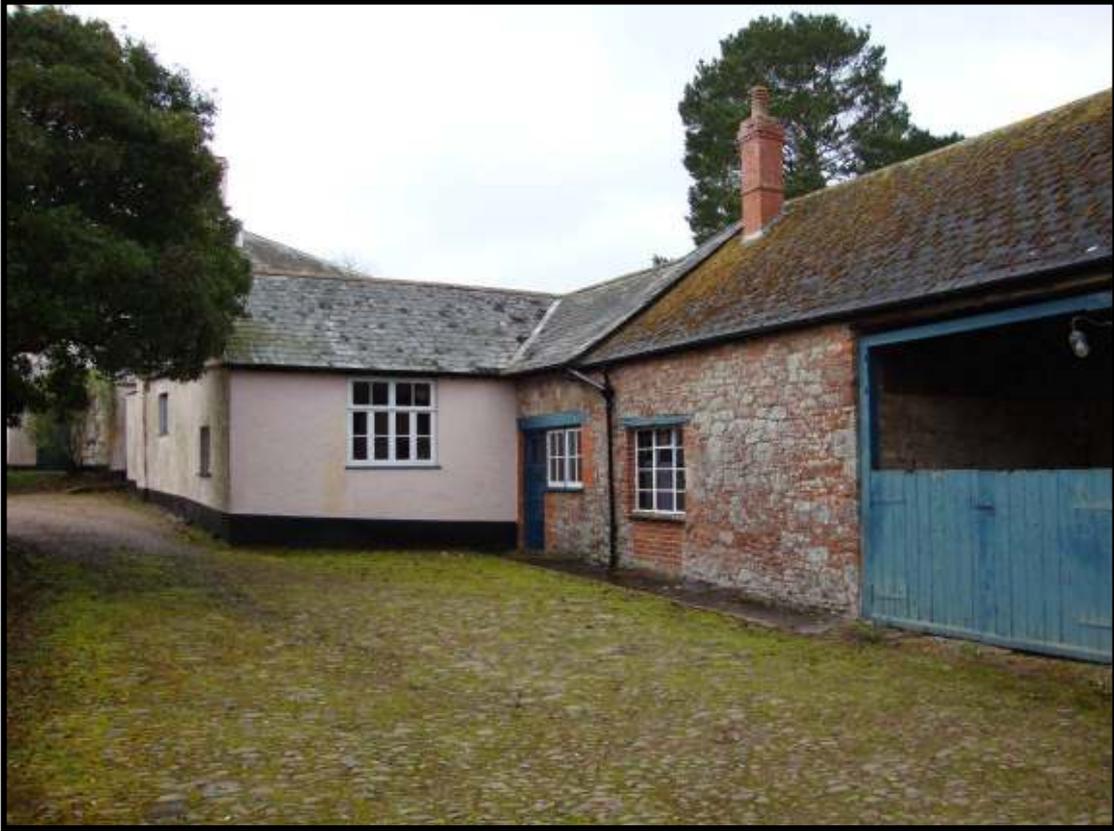
In the north wall of the cottage, within the covered way it is apparent that the original width of the stone-built section of this range was only 4m; the present width of 7.3m is the result of a later extension, shown by a clear vertical break in the masonry. The masonry to the east is rendered, but stands on a foundation of hard, 20th-century red brick, incorporating ventilator bricks. This brickwork continues the length of the west-facing elevation, which incorporates metal-framed Crittall windows probably dating from the 1950s or 60s. The north western section of the cottage thus seems to represent a modern extension or rebuilding, apart from a short section of the south end, where a row of projecting rafter ends at eaves level seem to show that the cottage had already extended into this area.

Fig. 22 View of the cottage from the stable yard, showing blocked features in the eastern wall.

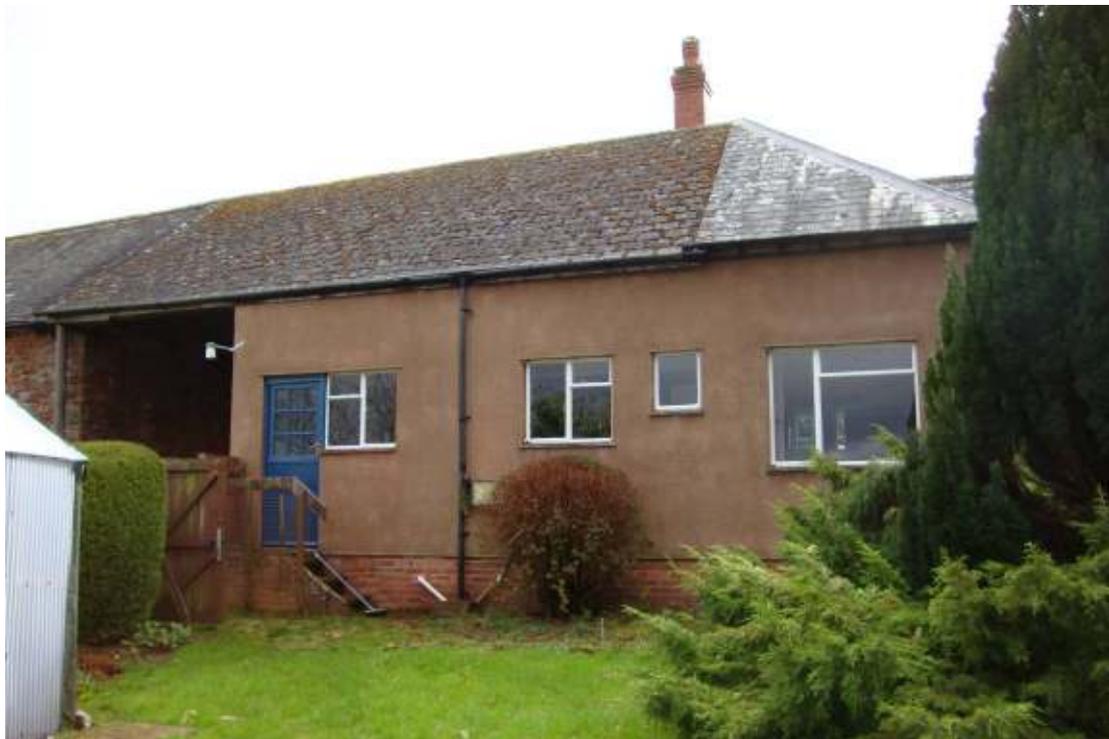
Fig. 23 View of the cottage from the west, showing the rebuilt western wall. This represents 20th-century enclosure of a former shed or linhay. Traces of an earlier phase of encroachment are betrayed by a change in character of the eaves.
