**Historic Building Surveys**  
*of*  
**BUILDINGS AT DULVERTON,  
SOMERSET**

For the Exmoor National Park Authority

REPORT No. 2011.02

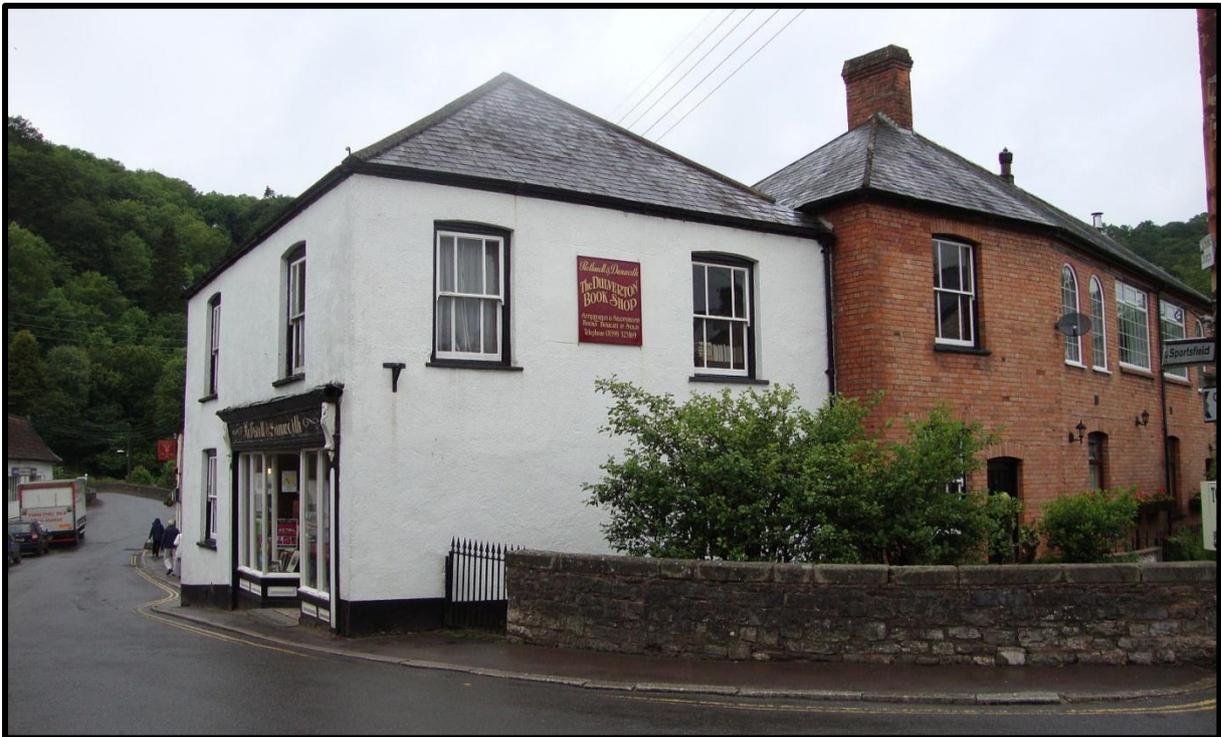
Fig 1. General view of the bookshop from the bridge over the Mill leat, showing the two distinct sections of the building and its position on the street frontage.

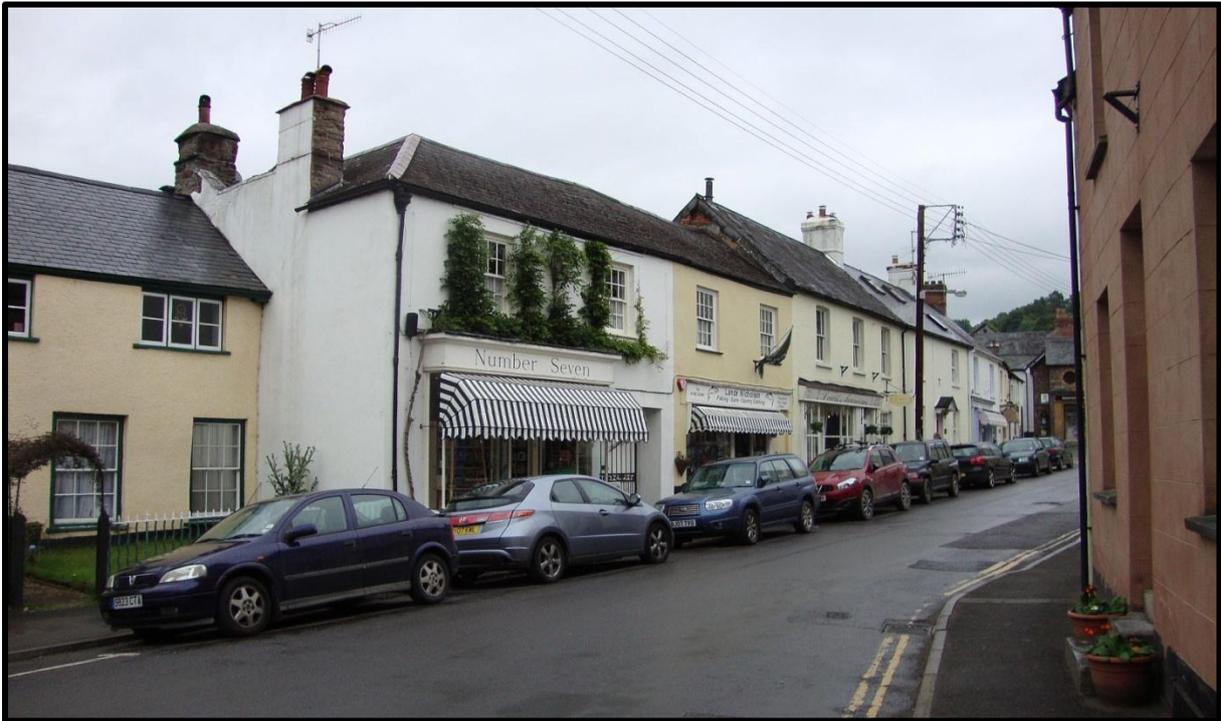
Fig. 2 View of the properties on the north-western side of High Street from the leat bridge, showing the funnel shaped form of the street as it approaches the leat, with the building line to the north offset (left) and the High Street terrace projecting forward at centre.

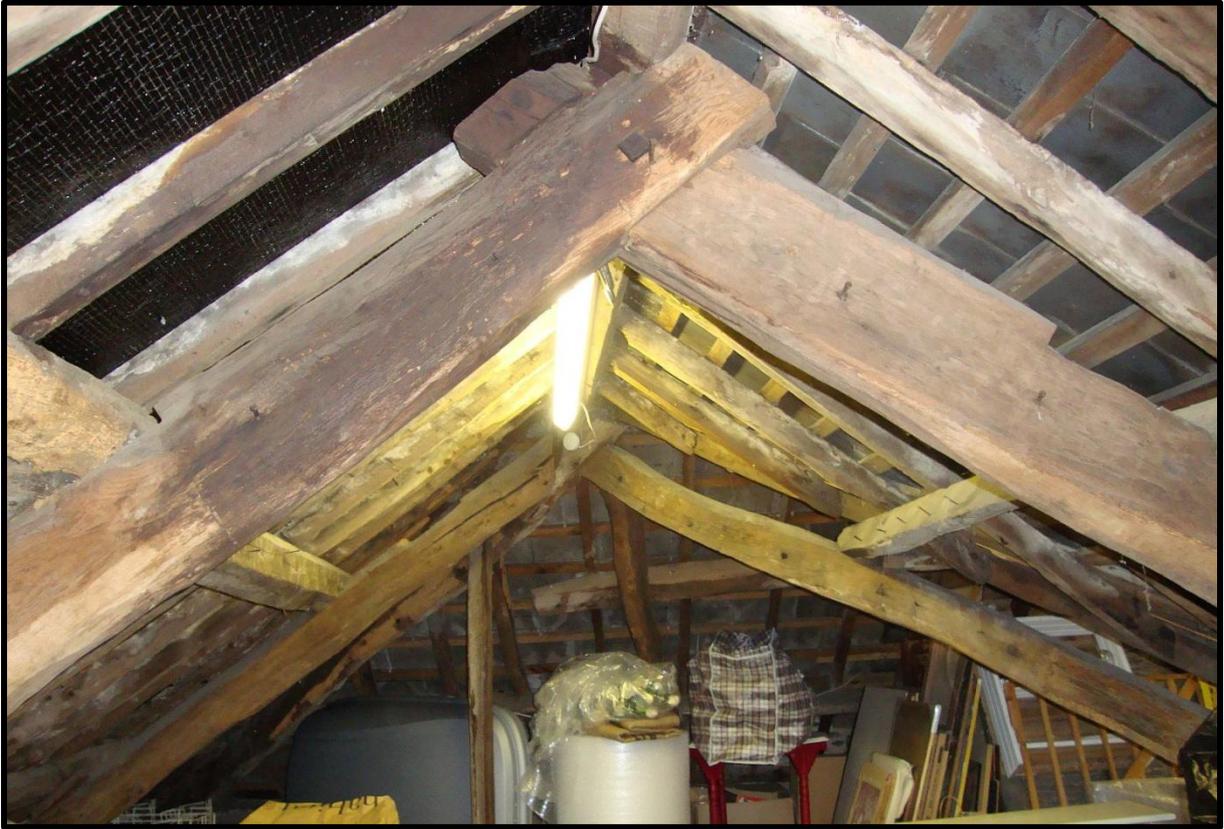
Fig. 3. View of the roof structure over the front range of No. 7 High Street, showing the softwood roof trusses crossed and bolted at the apex and the junction with the contemporary roof over the rear range beyond.

The roofs are supported by very crude softwood trusses, without collars and with their principals crossed and bolted together at the top, forming a cradle for a diagonally-set square ridge tree. The feet of the principals are presumably set in the tops of tie beams concealed in the ceilings, as there is no visible provision for collar beams or other horizontal ties. There are traces of a diagonal tie running across the building at the point where the roof structure turns the corner to extend over the rear range. The hip rafter and the rafter supporting the valley at this point are of smaller scantling. The purlins are crudely squared timbers running over the backs of the principals. These timbers appear to be contemporary with the main trusses, as are the common rafters in most parts of the roof. The character of the carpentry suggests a date for this structure in the very late 17th century at the earliest, and most probably in the 18th century.

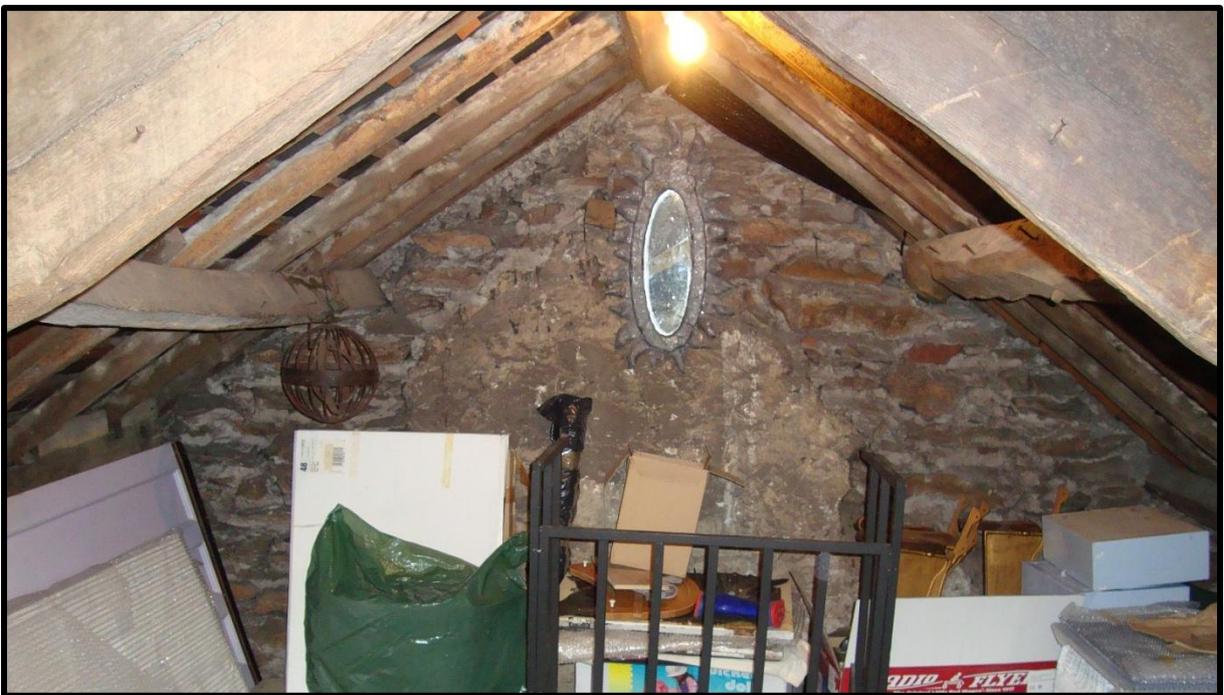
Fig. 4 Detail of the gable at the north-eastern end of the front range of No 7 High Street, showing the evidence of an earlier and slightly steeper gable of cob underlying the later masonry associated with the present roof.

Evidence of an earlier house on the site is provided in the north-eastern gable wall, where a steep triangular gable of cob underlies the later masonry supporting the timbers of the present roof. The earlier building must have had a lower roofline and, probably, lower internal floor levels. This conjecture is supported by the sawn-off beam end below first-floor level in the same party wall, visible within the arch of the vehicular entry.

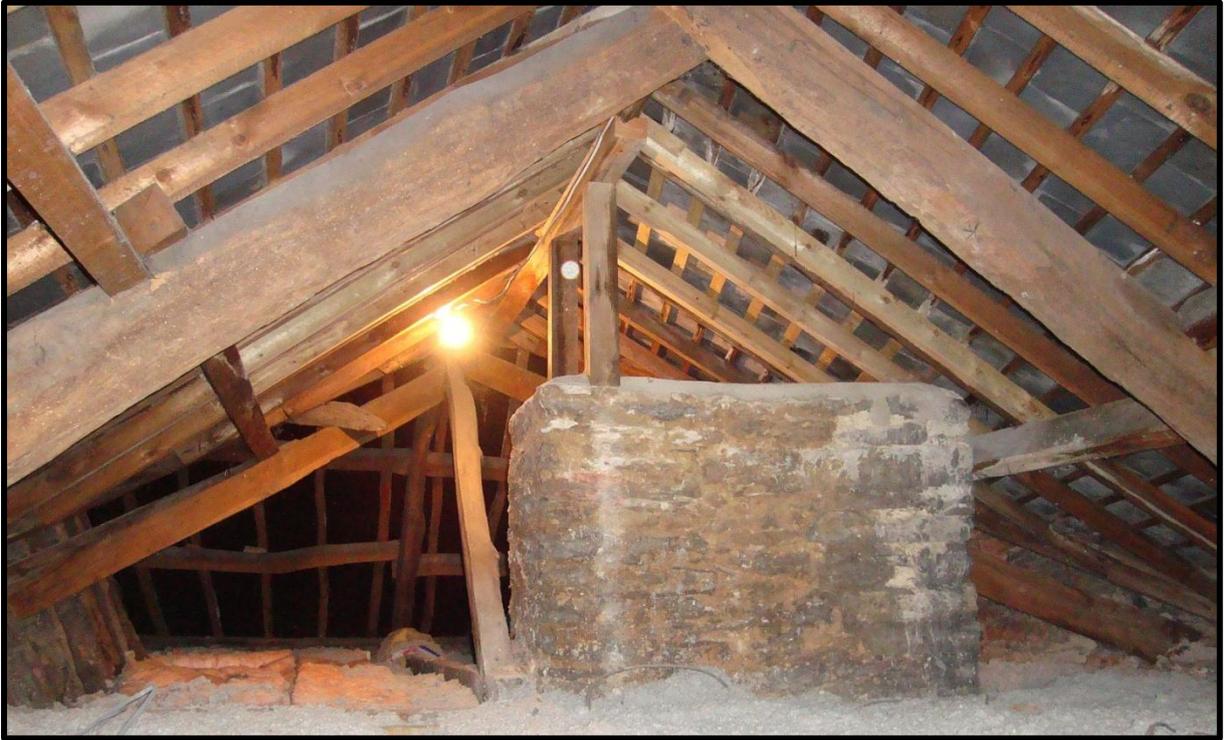
Fig. 5 The roof space at Lance Nicholson's premises, looking towards the front of the property from the rear range, showing the truncated lateral stack attached to the rear wall of the front range and the roof structure of the front range beyond.

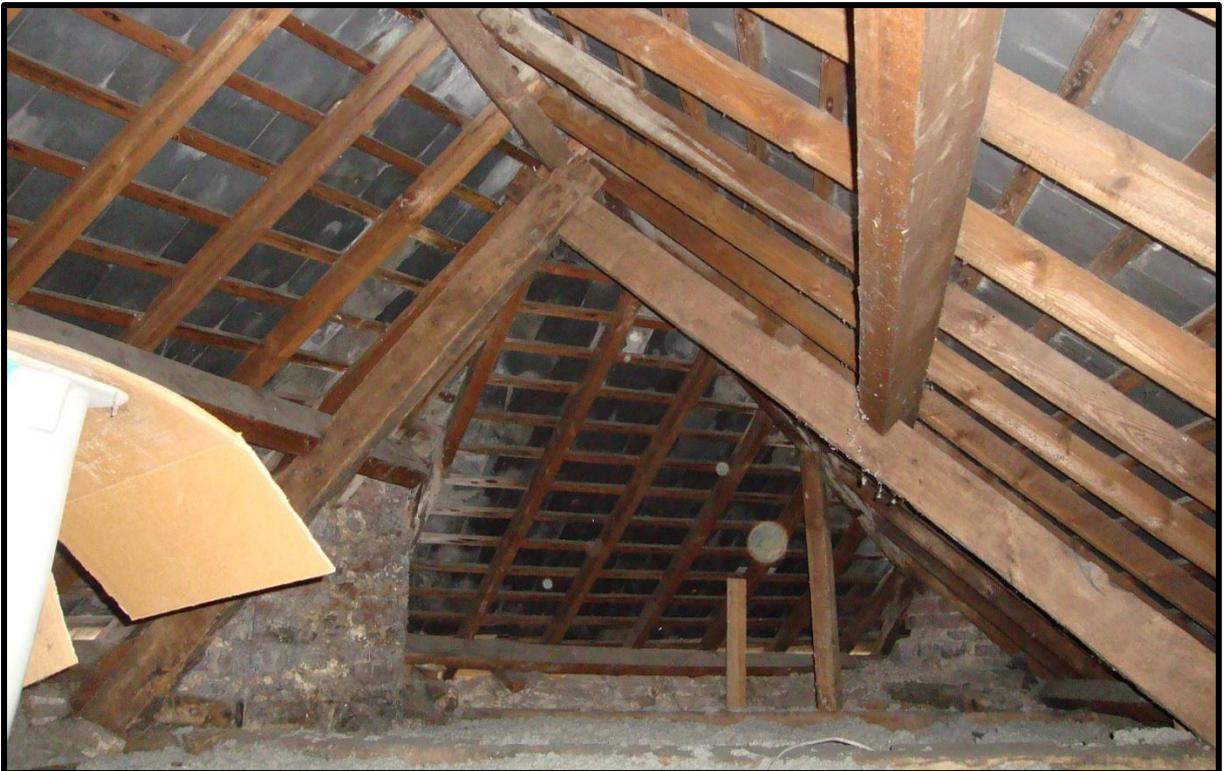
Fig. 6 View within the rear part of the rear range at Lance Nicholson's premises, showing the 19th-century roof and the unusual angled end of the building with evidence of two further chimney stacks.

The original limit of the range is not known. The base of a stone chimney stack is visible in the north-western part of the roof space (Fig. 6) and beyond this the angle of the roof changes. The base of a further chimney, of brick, is visible at the limit of the building. A small roof truss, of similar form to the originals (but of better-prepared timbers), stands close to the chimney stack. It is likely that this truss, together with the new purlins and ridge was added when the range was extended to its present extent.

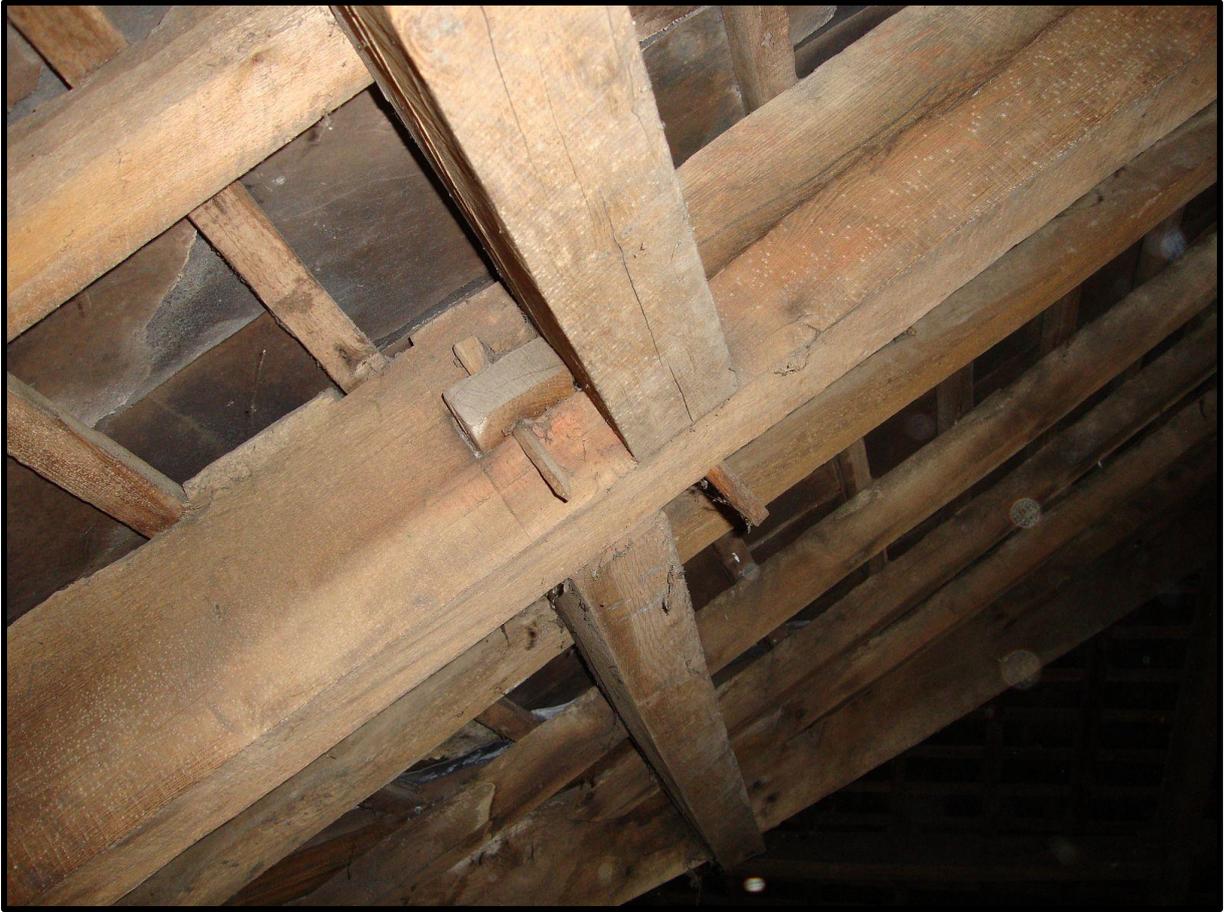
The roofs also show signs of modification. The roof structures were originally arranged in an 'U'-shape, with staggered purlins tusk-tenoned through the principals (Fig. 7) and a central gutter draining towards the rear.

Fig. 7 Guvenor House: detail of one of the four roof structures showing a typical joint of the staggered purlins with the principal rafters.

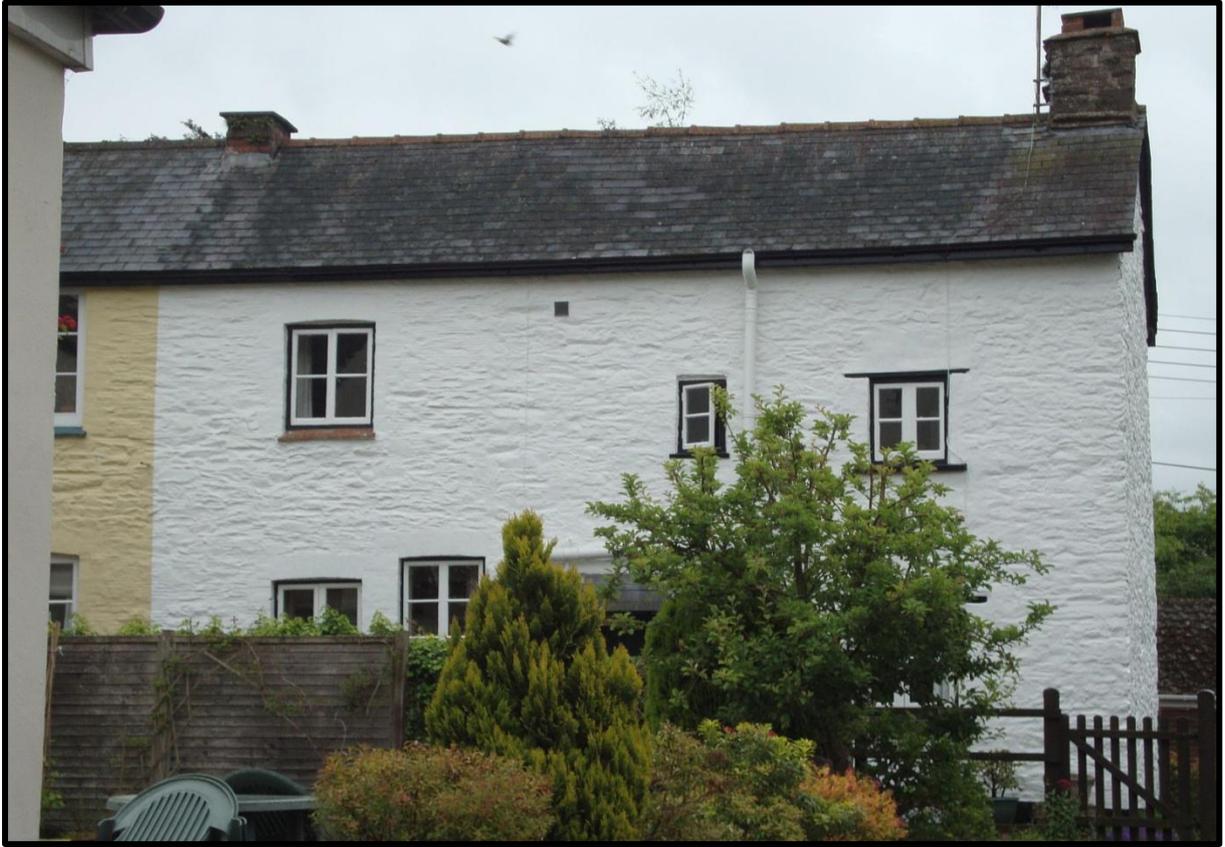
Fig. 8 Dubray Cottage or No. 2 Lamb Back, seen across the former inn yard, showing the highly irregular fenestration, which betrays unusual internal floor levels. The building may have been converted from industrial use.

The cottages occupy a very tall, narrow range of buildings with a relatively low-pitched slate roof, the walls being constructed of random rubble and painted (Fig. 8). The cottages have no formal façades towards the inn yard, but have very irregular fenestration betraying unusual internal floor levels. No. 2 Lamb Back is a double-fronted cottage with a central doorway which opens upon a small lobby from which the stairs extend to the first floor. The southern room has a chimney in its south-western wall, serving a very large fireplace with an unmoulded, unchamfered timber lintel. On either side of the fireplace are cupboards with raised-fielded panelled doors. A similar door with raised-fielded panels closes the cupboard under the stairs. The room to the north is now a modern kitchen; the casement windows in its north-eastern wall have lintels at two different heights, suggesting either that one of the openings was formerly a doorway or that the room was at one time subdivided into separate areas.

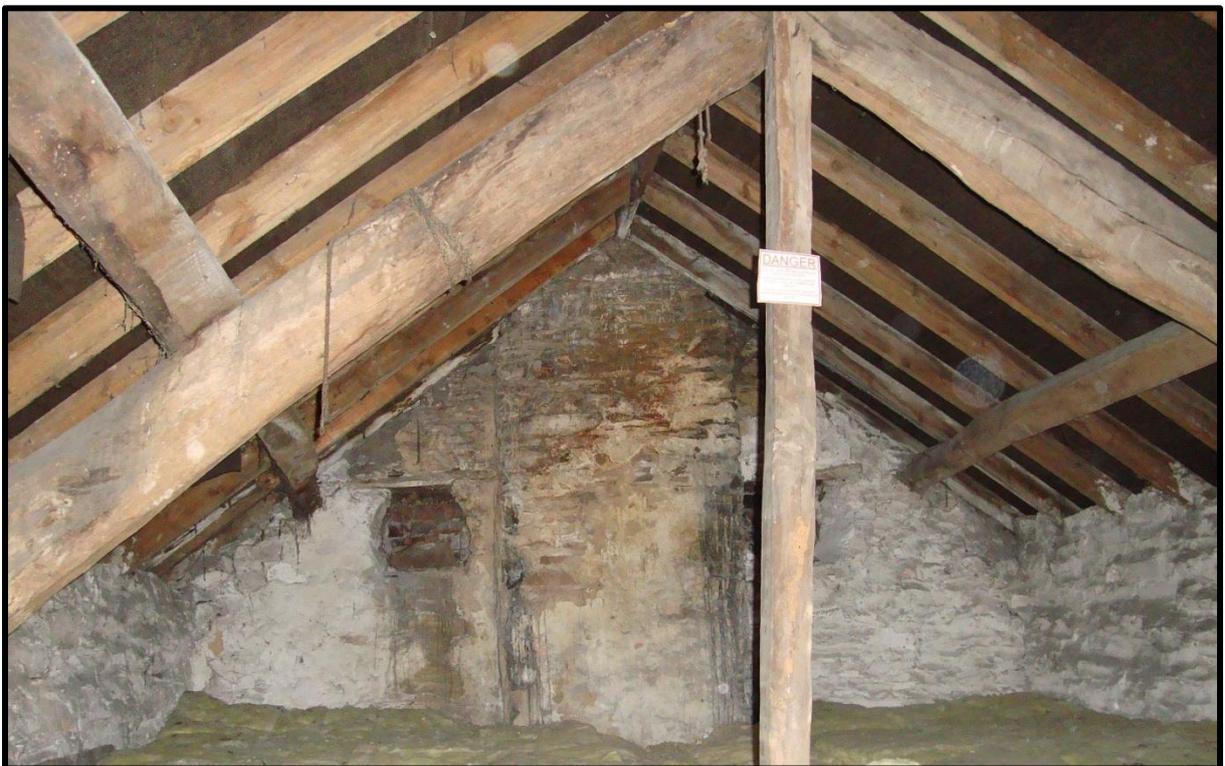
Fig. 9 View within the southern part of the roof of Dubray Cottage, showing the unusual circular windows flanking the chimney stack in the south-western wall and the rough, rendered finish of the walls.

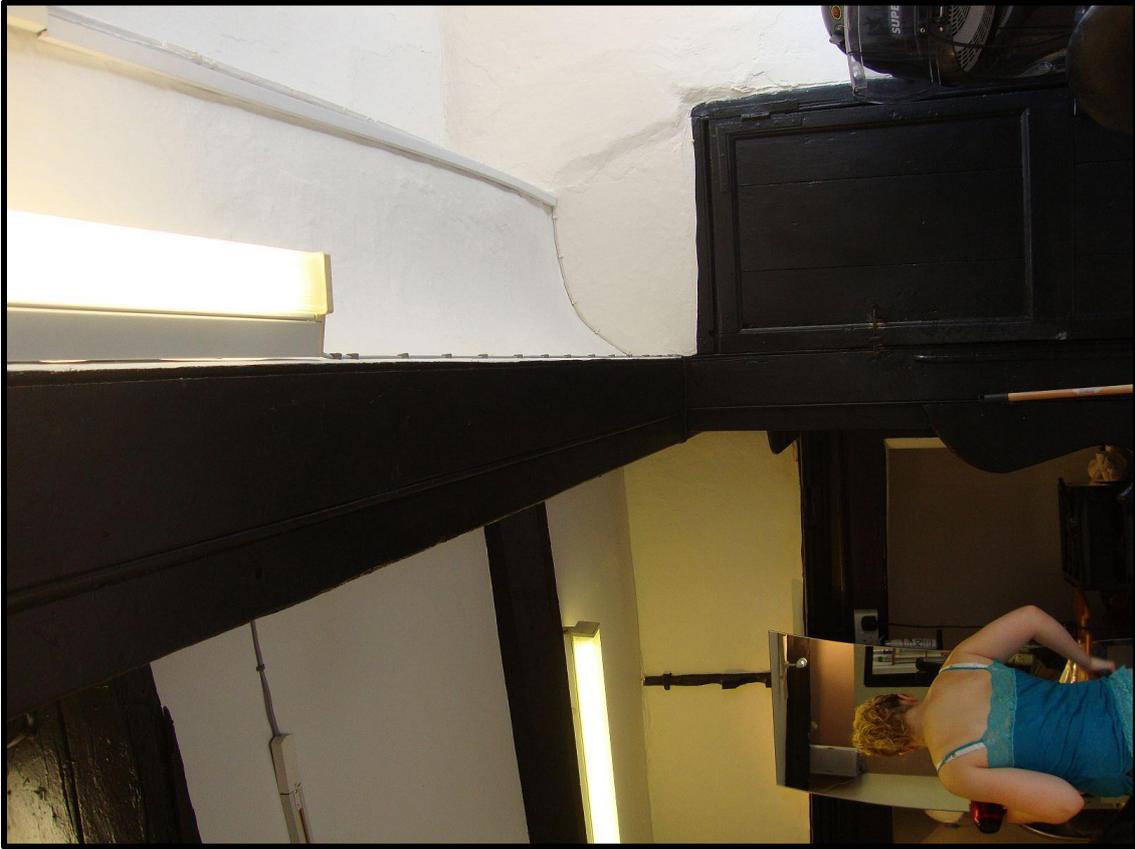
Fig. 10 View within the 'High Society' Hair Salon showing the evidence for a jettied frontage to High Street, represented by a later covered ceiling, and the 17th/18th-century features within the projecting part of the frontage..

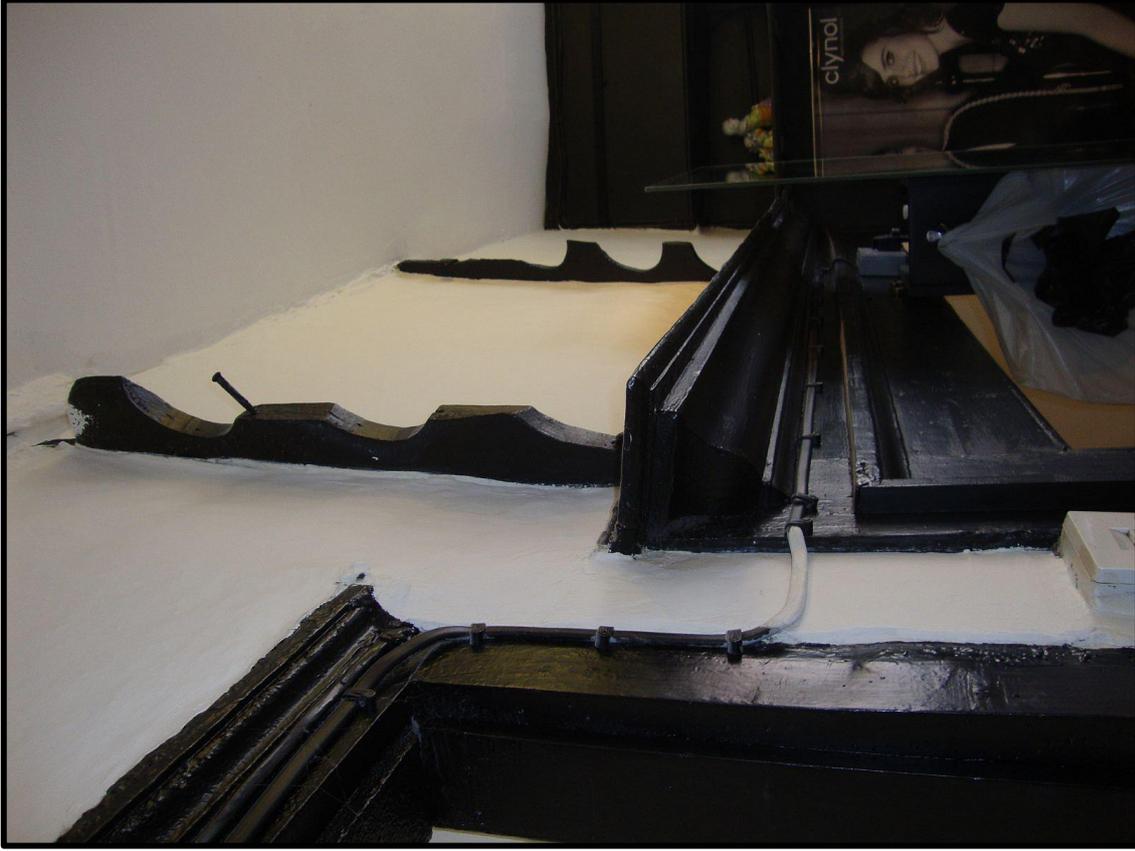
Fig. 11 Oblique view of the fireplace in the north-eastern wall, showing the moulded mantelshelf and the remains of a rack or rail above it, of uncertain purpose

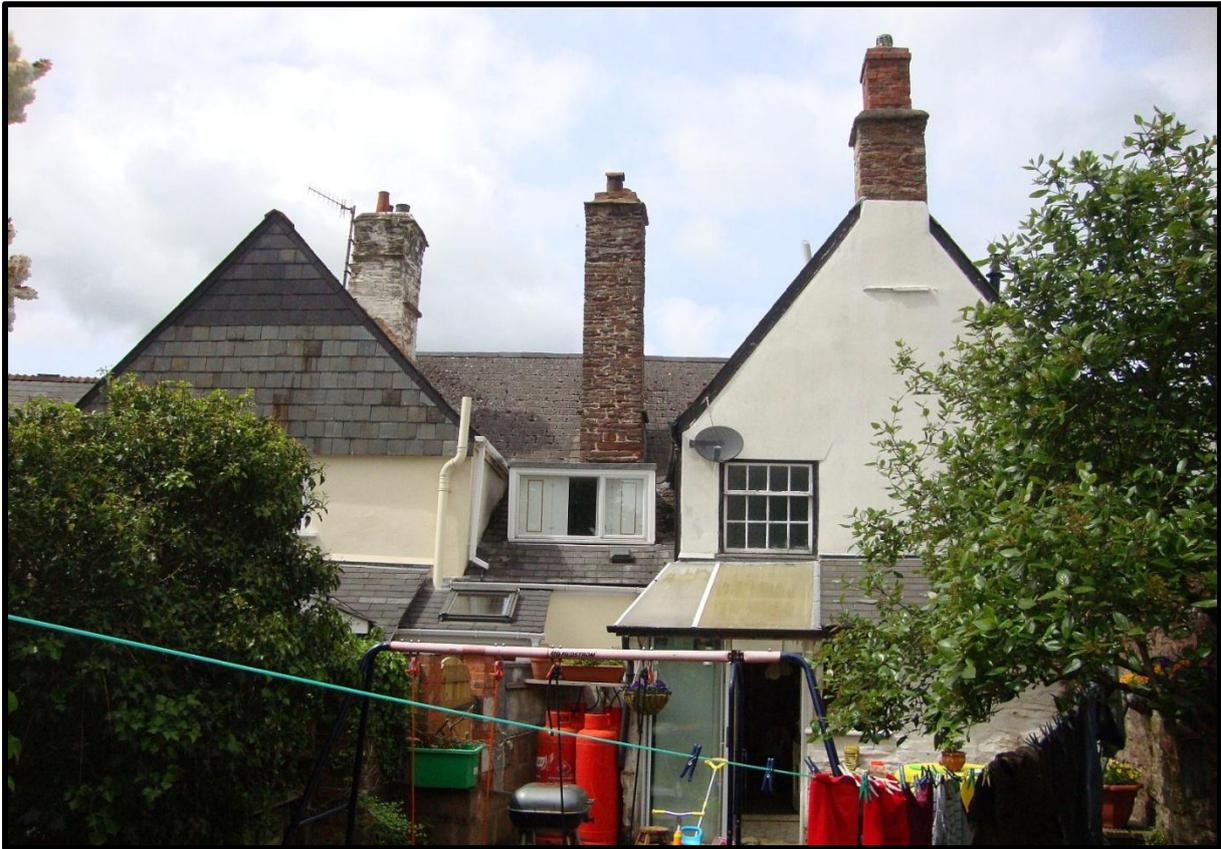
Fig. 12 Rear view of No 42 High Street ('The Vet's House') showing the two gabled ranges projecting to the rear and three of the early chimney stacks.

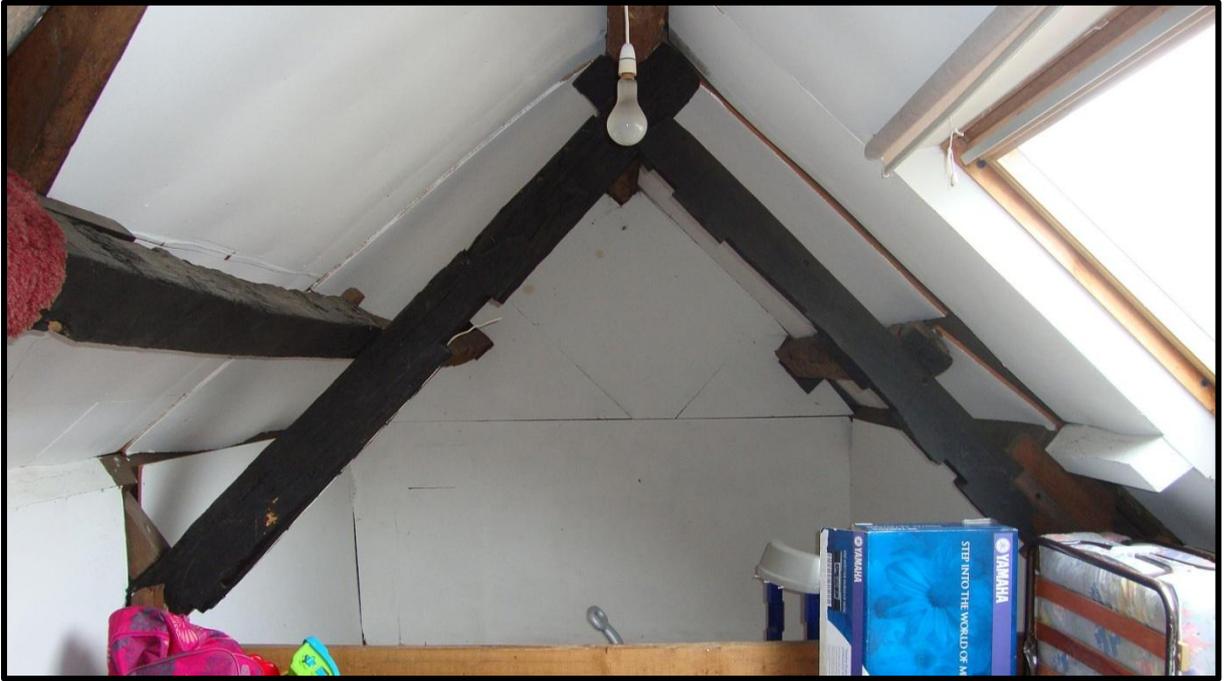
The roof structure of the front range consists of parts of an earlier roof structure which has been dismantled and reassembled, badly, to provide new trusses (Fig. 13). Among the timbers reused in this way are some of the original principal rafters of an early roof. These were supported by jointed crucks featuring deep sockets for very large rectangular trenched purlins and long sockets or housings for side-pegged cruck blades. Part of the head beam of a plank-and-muntin screen has also been inverted and reused and many of the purlins also survive reutilised in other parts of the roof. The original roof may have been of 16th- or 17th-century date. It was probably rebuilt in its present form in the 18th or 19th century.

Fig. 13 One of the trusses in the front range of No. 42, utilising parts of an earlier roof.

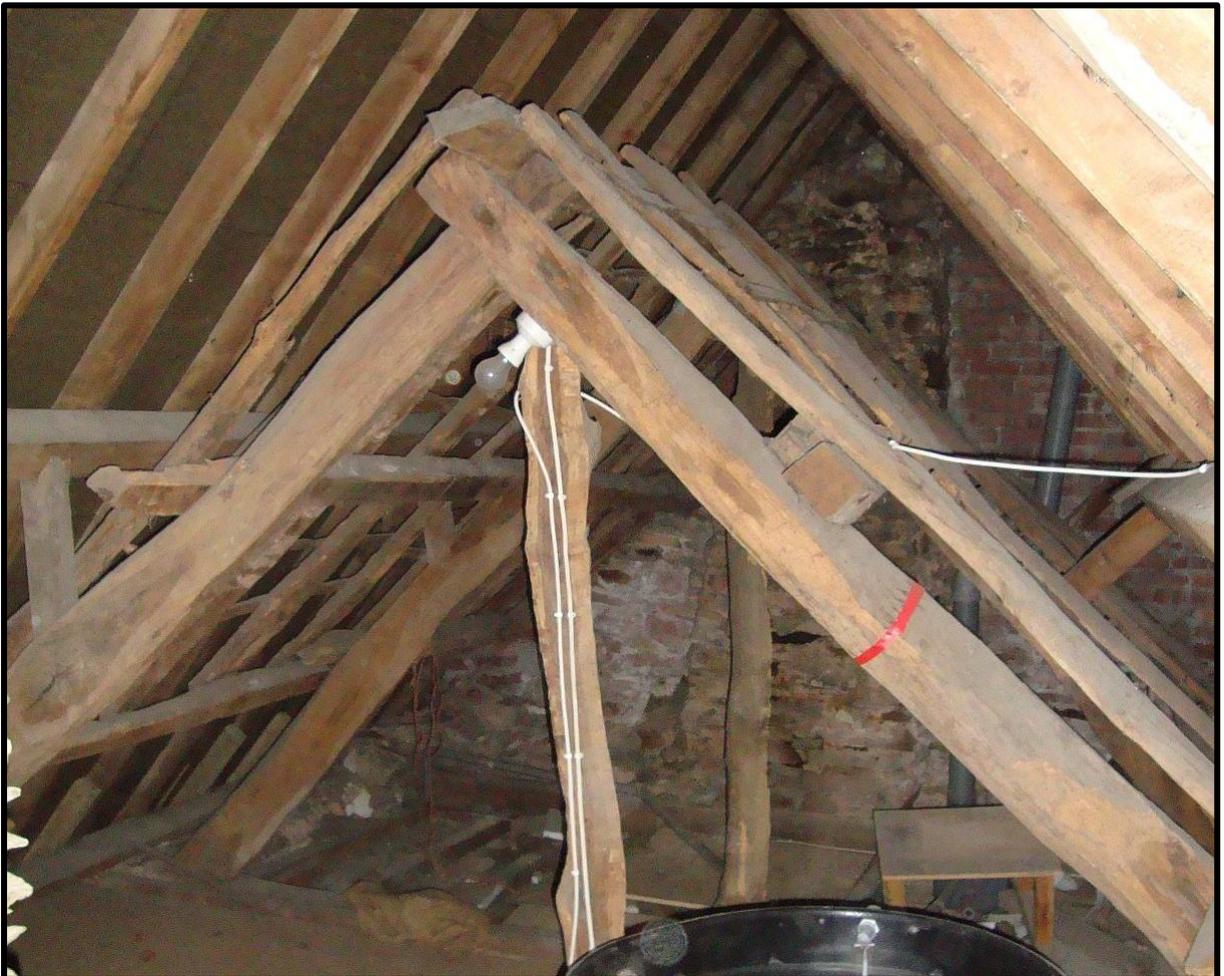
Fig. 14 View of the historic roof structure underlying the modern roof of the north-eastern rear range of No. 42, with carpentry details datable to the 17th or 18th centuries.

The roof of the rear range is modern, but overlies a much earlier roof structure, now in poor condition (Fig. 14). Only two bays survive, supported by two trusses with principals crossed and pegged at the apex, cradling a diagonally set ridge. This roof may date from the late 17th or early 18th century.

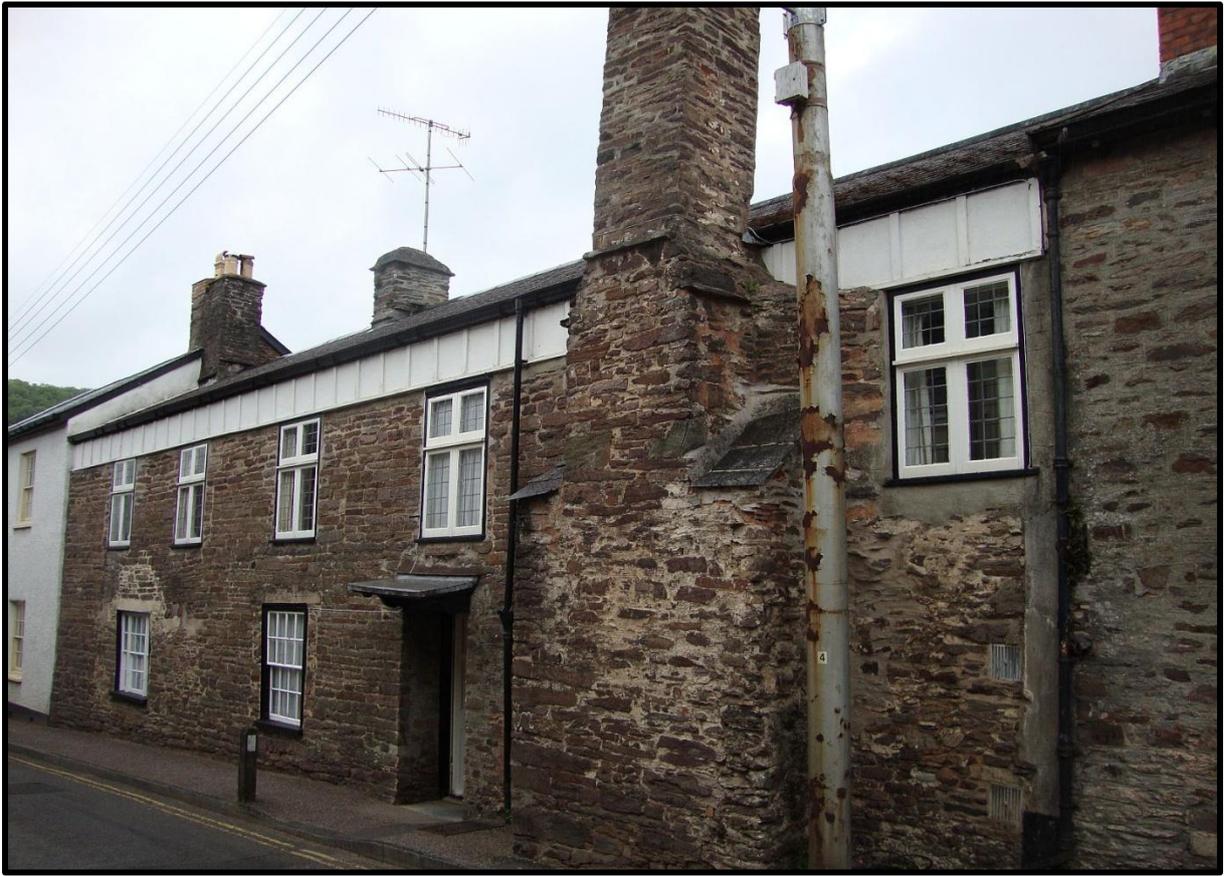
Fig. 15 View of the south-eastern elevation of Sydenham House towards High Street, showing the large lateral stack and the replica mullion-and-cross windows.

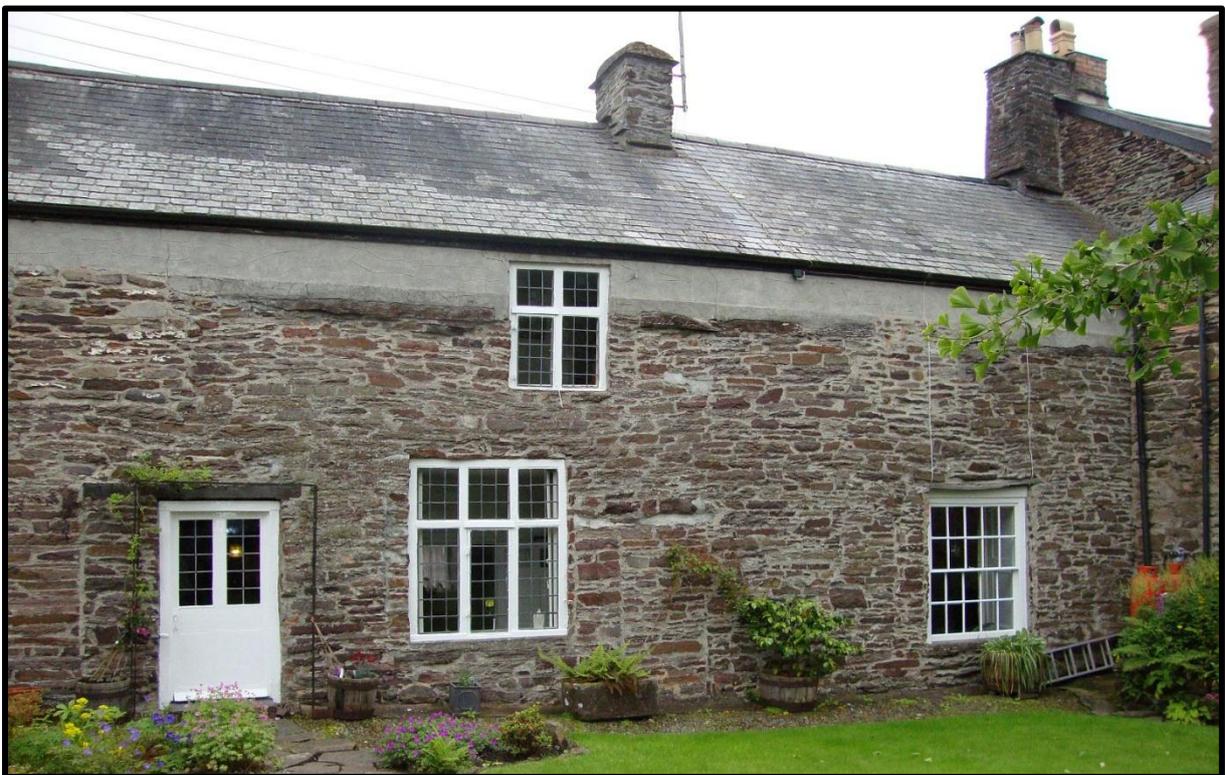
Fig. 16 View of the rear elevation of Sydenham House showing blocked features and evidence of raised eaves.

The rear elevation of the building towards the garden (Fig. 16) shows similar features, with handsome mullion-and-cross windows replacing earlier and wider openings and evidence of a raised eaves line. Traces of a timber eaves plate remain visible, showing that the early roof is likely to be preserved. The windows retain very fine, ornate, casement stays and catches. One of the first-floor windows extends into the area of the raised eaves and, unless this window has been reset, it is likely that there was formerly a small chicket or half dormer window in this position, and there may have been others, giving the house a picturesque spiky roofline typical of the 17th century. The present back door replaces a wider opening which may betray the position of the cross passage.

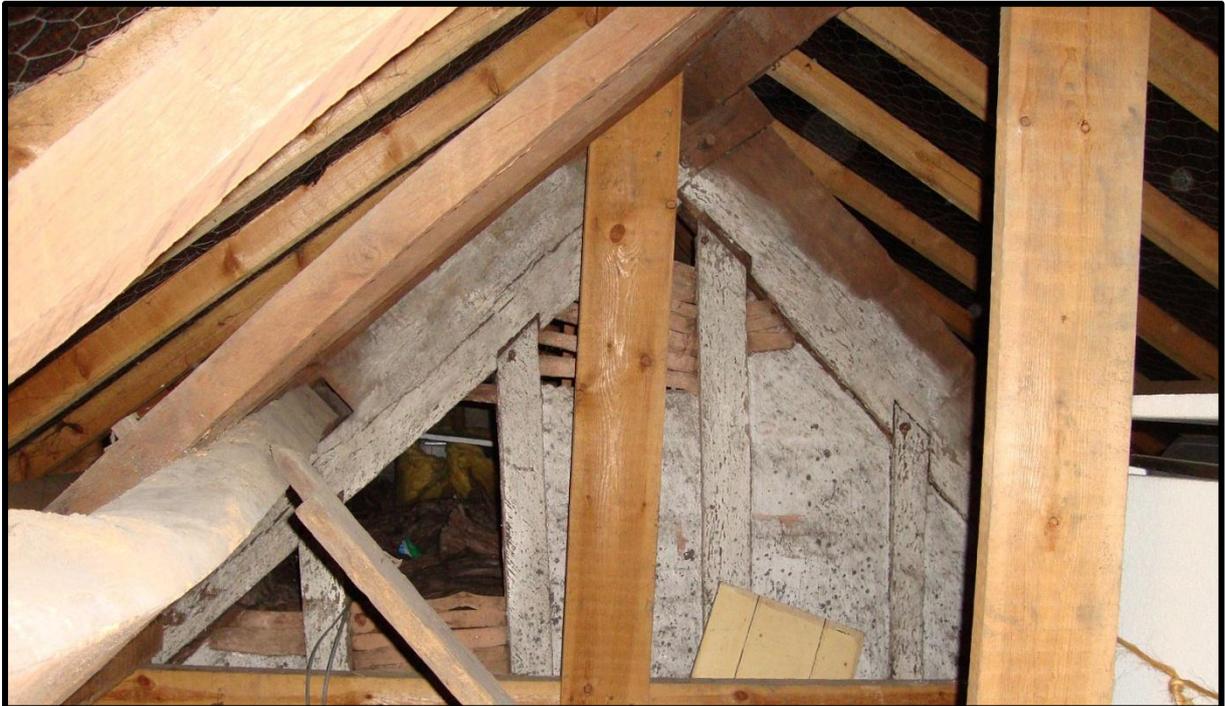
Fig. 17 View within the roof space of Sydenham House, showing an early (but secondary) partition of 17th-century date infilling an earlier truss.

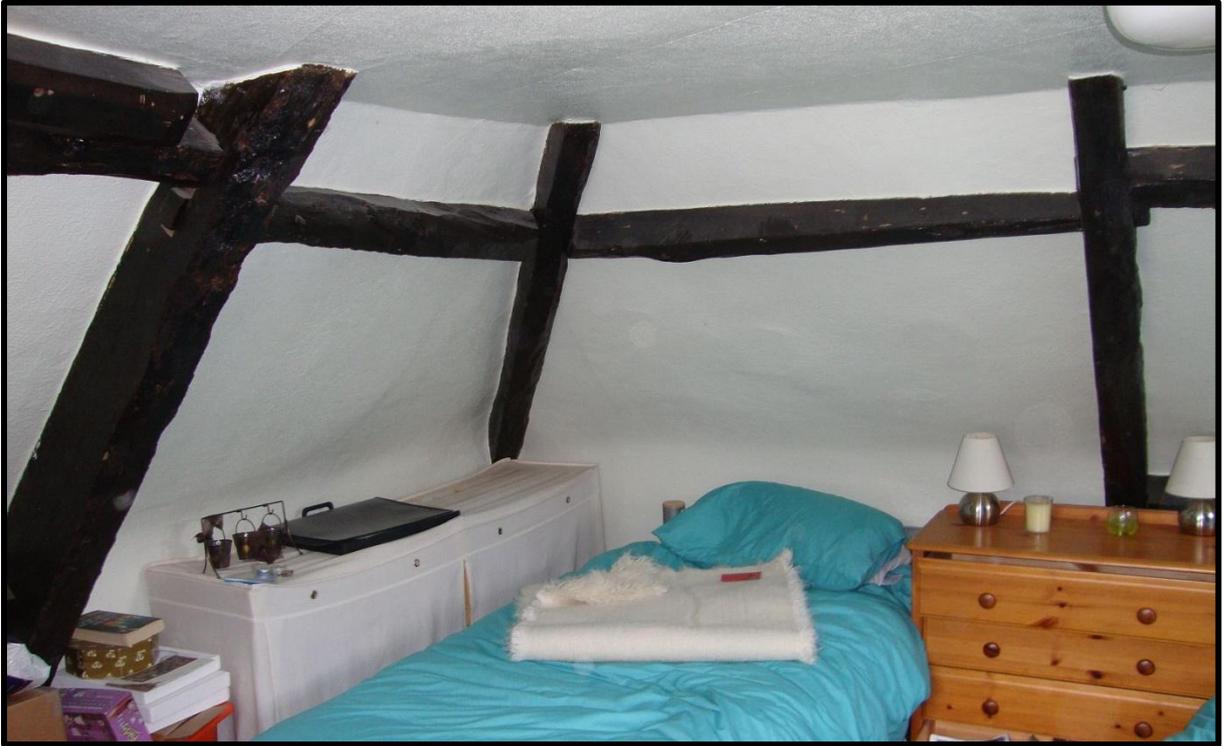
Fig. 18 The early part of the roof of the front range, looking south, showing staggered purlins threaded through the principal rafters.

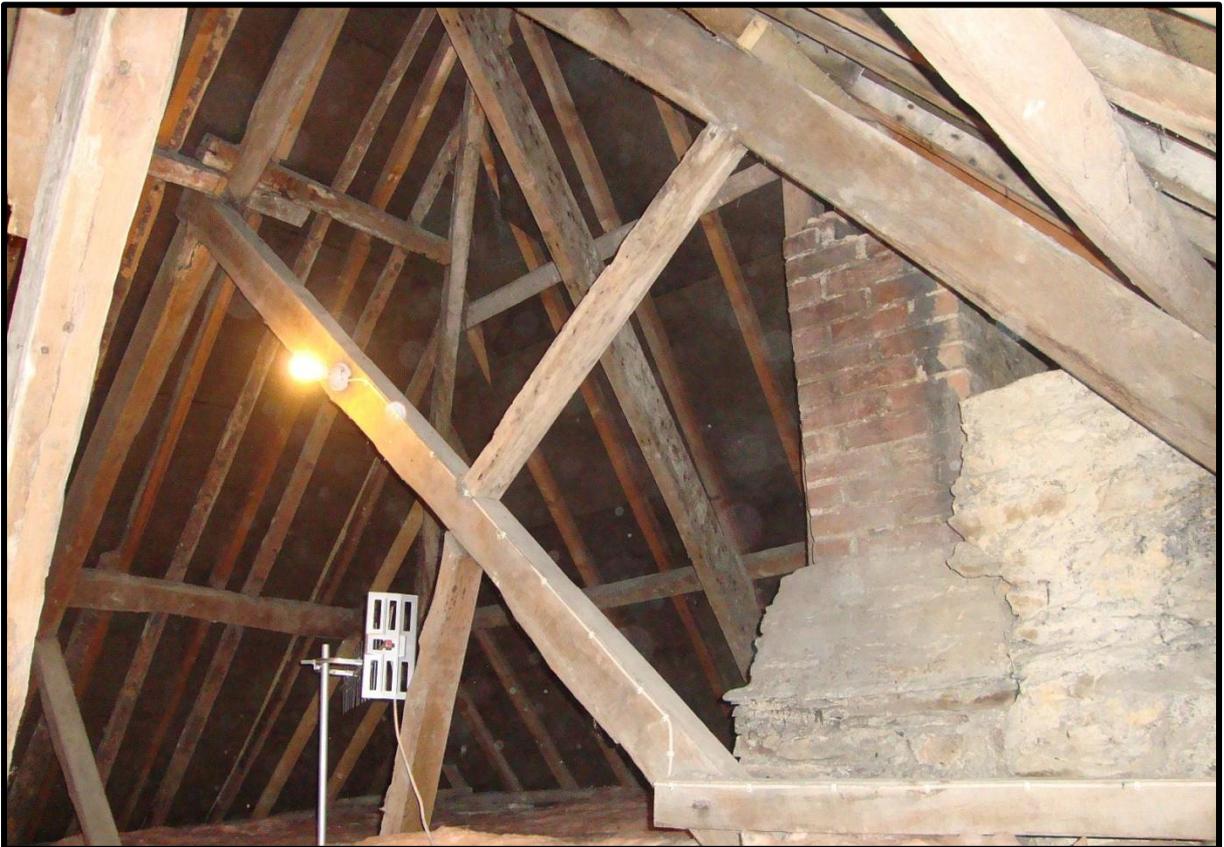
Fig. 19 View within the south-western part of the roof showing the later 18th- or early 19th-century roof structure and (right) the remains of an early chimney stack with a battered cap below the present roofline.

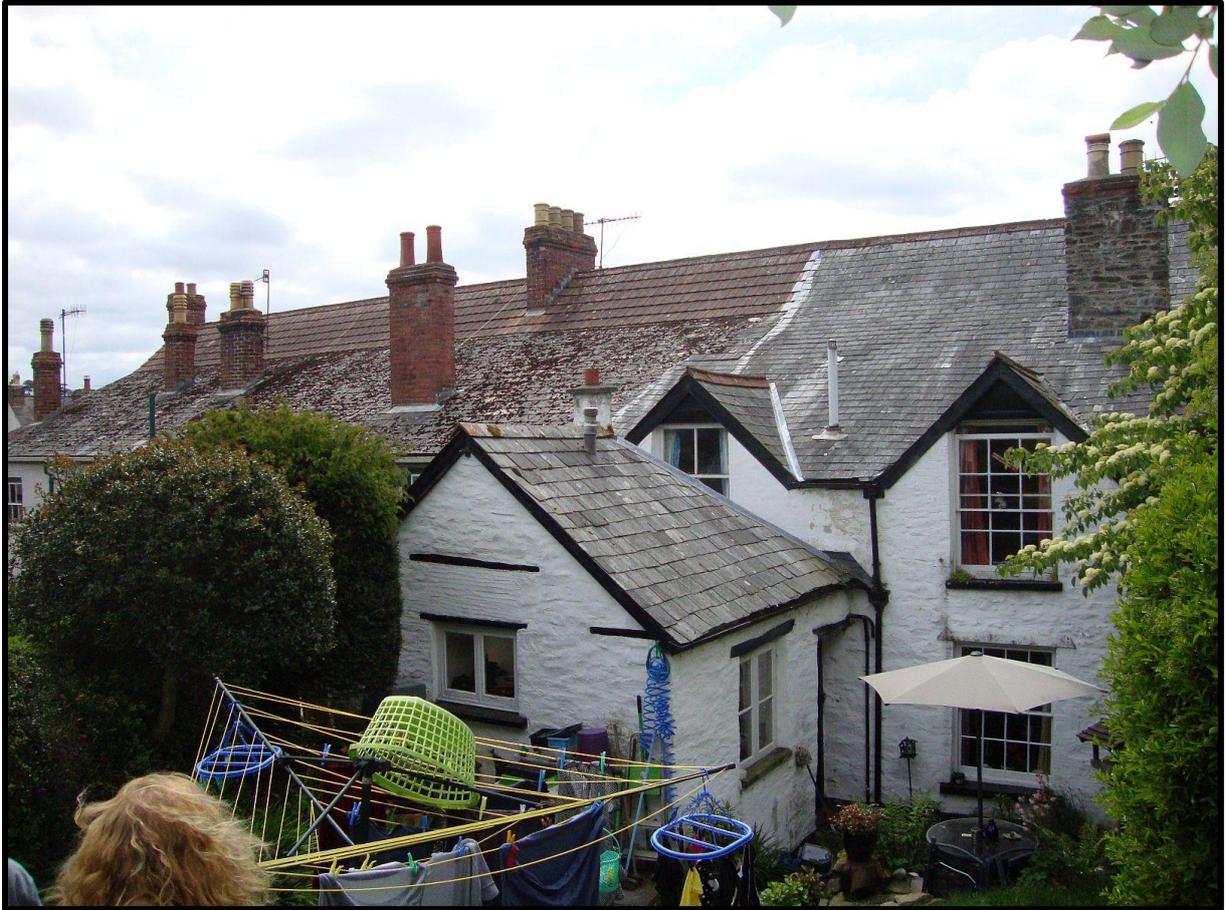
Fig. 20 View of the rear of the houses in Church Lane, showing the lateral stacks to the rear of each house and the similarity of the rooflines and roofing materials, suggesting a common origin of the terrace or remodelling of the whole terrace uniformly by one landowner.
