Historic Building Survey and Watching Brief

OLD MAIDS' COTTAGE, LEE, ILFRACOMBE, DEVON

By R.W. Parker

REPORT No. 2013.03

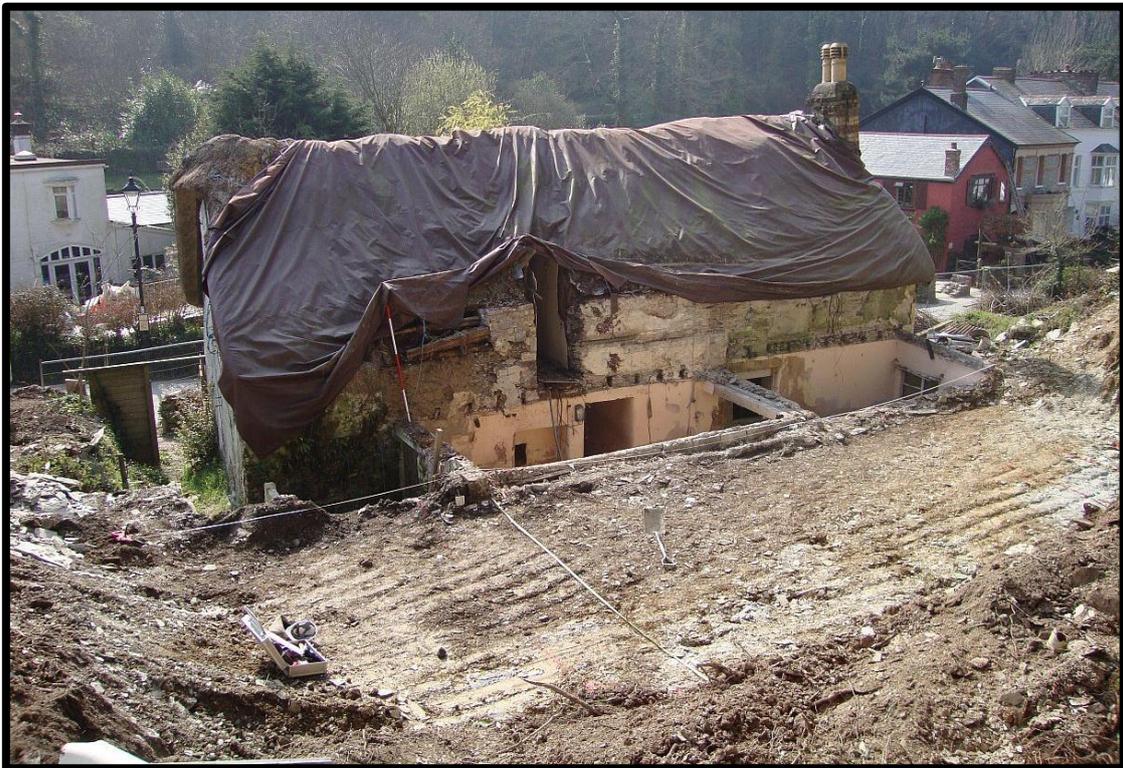
The demolished building was a large, single storey structure with a flat roof, which had been linked to the older house by a passage cut through its rear wall and roof at first-floor level, truncating the large chimney stack which had risen through the building between its eastern and western rooms (Fig. 5). The building overlay the lean-to structures at the rear of the house. These seemed initially to have been cut into the rising ground to the north, the earth being revetted by walls at the rear of the building. These lean-to structures had already partially collapsed by the time of the survey in 2009, but such evidence as remained showed that they were modern structures of any historic interest. They appear to have occupied the sites of an earlier extension to the rear of the cottage, from which the revetment walls presumably survived. Nineteenth and early 20th-century early maps (Fig 1) show a projecting structure at the centre of the rear wall of the cottage which must represent the earliest of the lean-to structures.

Fig 5. The house from the rear, looking south west, showing the excavated site of the new building and the 20th-century passage cut through the rear wall through the site of the former chimney stack (centre).

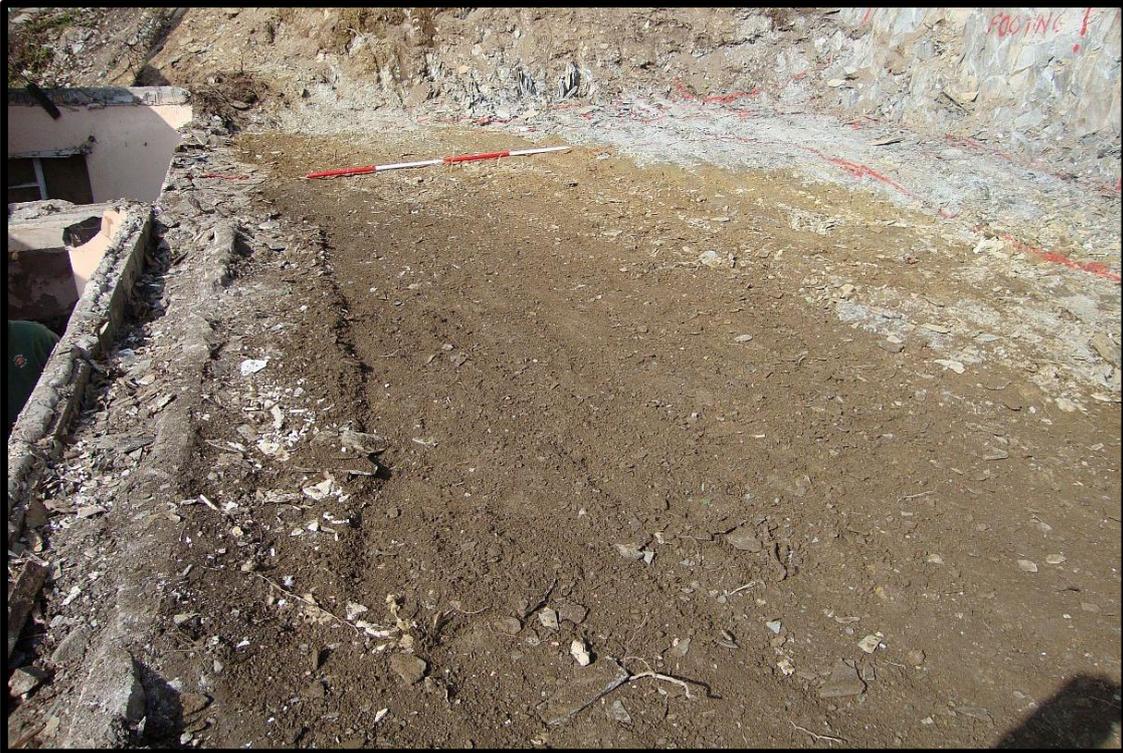
Fig. 6 The cleared site of the 20th-century extension during cleaning, looking west showing the band of yellow clay crossing the site diagonally.

The deposit is probably a modern dump or levelling layer, designed to create a level surface for the construction of the recently-demolished 20th-century extension at the rear of the house. Any earlier ground levels are assumed to lie at a much deeper level. The upper parts of the buildings at the rear of the house may originally have stood either wholly or partially above ground. They may have been buried to a degree by natural slumping and build-up of debris from the hillside above as well as by modern dumping to level the ground for the construction of the extension.

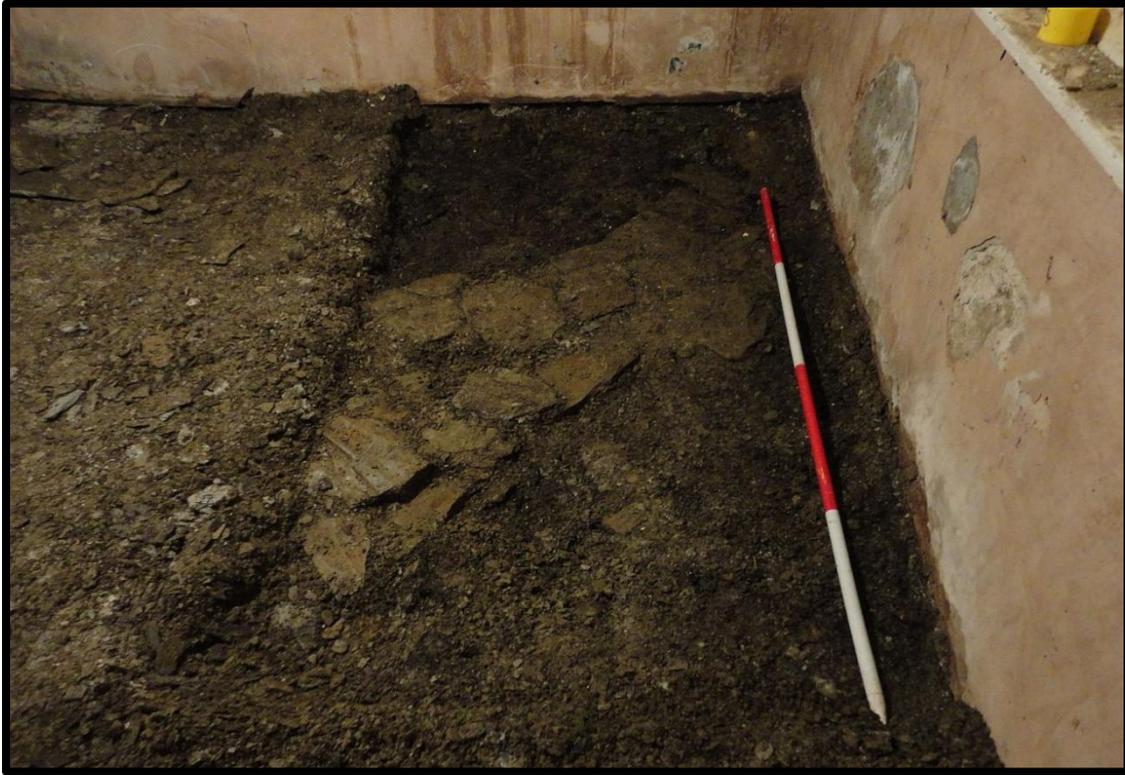
This trench was dug in the north-eastern corner of the eastern room and measured 2m x 3.5m. Under the flagstones was a deep, make-up layer of mixed demolition material 0.06m deep, including many large, well-squared Delabole slates. Although these retained the impress of mortar they had not been pegged, but nailed into place, which suggests that they are unlikely to be earlier in date than the 18th or 19th centuries. It is possible that they had been imported from elsewhere to form a make-up layer for the flags, though they might, of course, have been derived from an earlier roof of this building pre-dating the thatch. Underlying this layer was a dirty layer of dark, silty shillet fragments, 0.005m deep, very loosely packed, overlying the natural bedrock. The bedrock had been crudely truncated to a level surface, but protruded in places in irregular outcrops. Cut into the surface of the bedrock was a shallow linear feature capped with large, flat slabs of stone, aligned diagonally from the centre of the room towards its north eastern corner (Fig. 9). There was no evidence of a cut for this feature in the loose material overlying the bedrock, and it is presumed that the feature is contemporary with this material. Lifting of the capstones revealed that the feature consisted of a shallow, dished channel cut into the bedrock and packed, indeed, almost filled with loose slabs of shale and shillet. The rest of the feature was choked with a dark, organic silty material.

This feature may be interpreted as a drain; probably constructed in an attempt to reduce dampness of the floor. The drain was capped with large slabs and then covered with loosely-packed shillet, before the layer of demolition material forming the make-up layer for the flagstones was laid over it. Although no dateable finds were recovered the large size of the slates may suggest that the Enlargement of the trench to establish the course of the drain showed that it turned at about 45° at the centre of the wall and continued under the front wall of the house. Clearance of the drain showed that, rather surprisingly, instead of draining southwards towards the front of the house and the valley bottom, it drained northwards towards the rear of the house. After the removal of the silty infill and slate fragments the water flowed freely to the north east. It may have drained into a well which was later revealed at the rear of the house, in the region of its north western corner. This well was recorded by the contractors and the architects but was not observed archaeologically due to considerations of cost.

Fig. 8 Trench 3, at the north-western corner of the western ground-floor room, showing the drain as originally exposed and before the removal of the capstones.

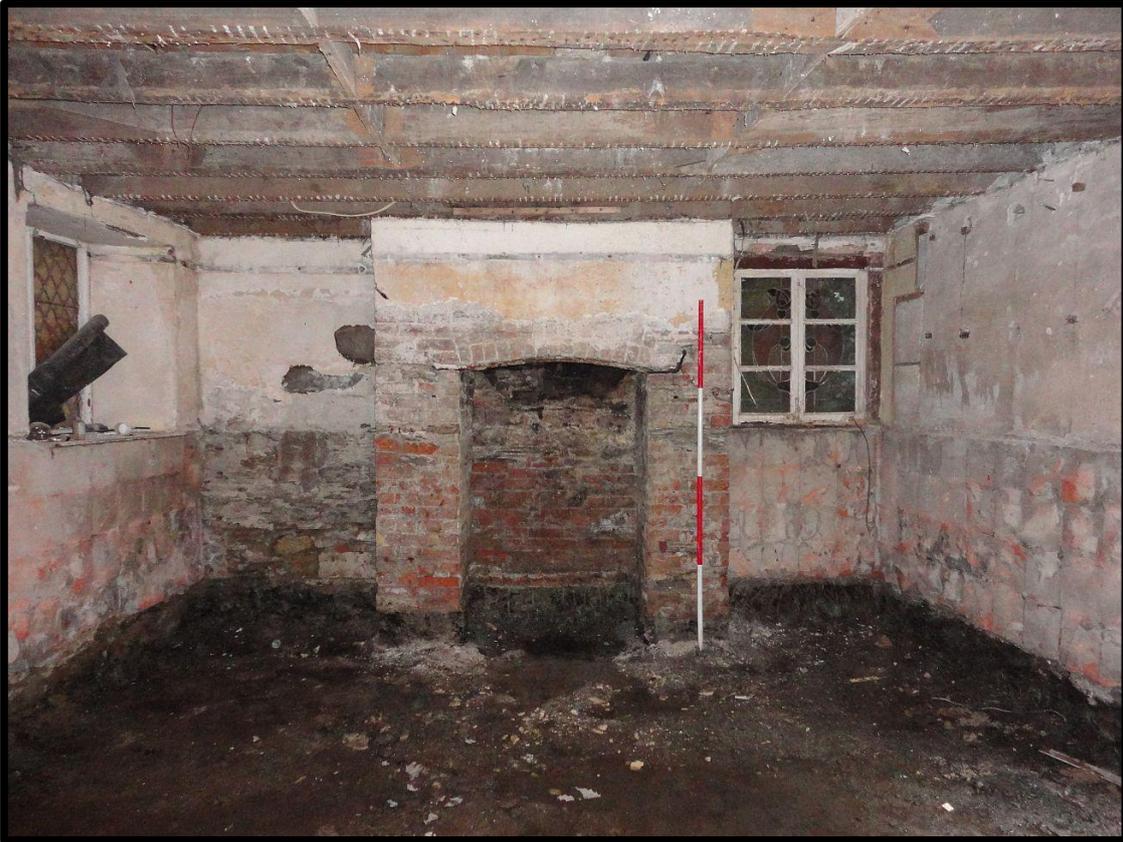
In the western ground-floor room the tiled dado and chimney piece had been removed from the lower part of the walls, revealing that the large fireplace and chimney breast in the western wall were constructed of red bricks, with a low, arched head to the opening (Fig. 10). The bricks might date from the early 19th century and it was assumed that the fireplace was integral with the stone walling. The opening was large enough to have housed a small kitchen range or hob grate. The fireplace in the first-floor room, above, appeared to be cut into the earlier walling and was faced up with red perforated bricks. This fireplace appears to have

Fig. 10 Interior of the western room on the ground floor following stripping, showing the 19th-century fabric of the fireplace.

been introduced in the late 19th century, probably during improvements to the accommodation.

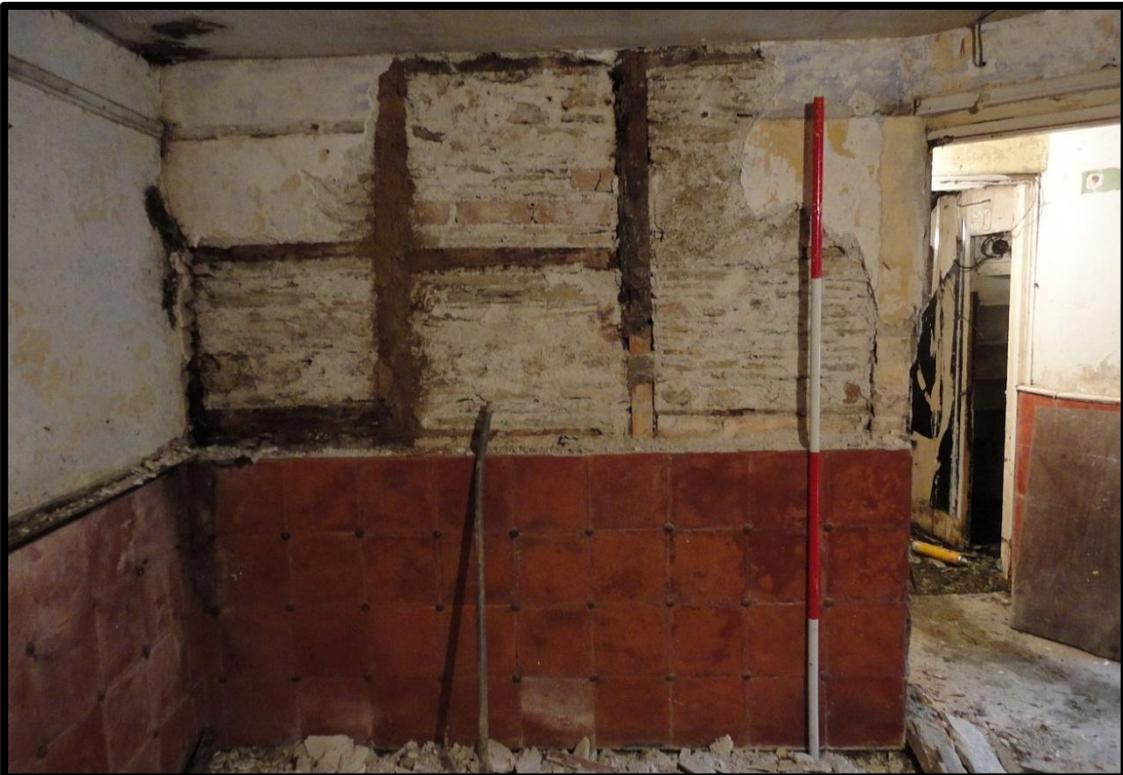
Fig. 11 Detail of the stone-nogged timber partition or spere within the western room, showing the vertical timbers and red bricks which gave the false impression of a doorway.

The construction of the spere or partition forming the northern part of the entrance passage was also exposed during these alterations, prior to removal (Fig. 11). This had been partially stripped during the previous survey, revealing two vertical studs and red brick blocking which appeared to suggest the presence of a blocked doorway in this part of the wall. Following stripping of the whole partition, the red bricks were found simply to be an anomaly; there was no blocked doorway in the wall. The partition may be dated to the late 19th century. It has since been entirely removed.

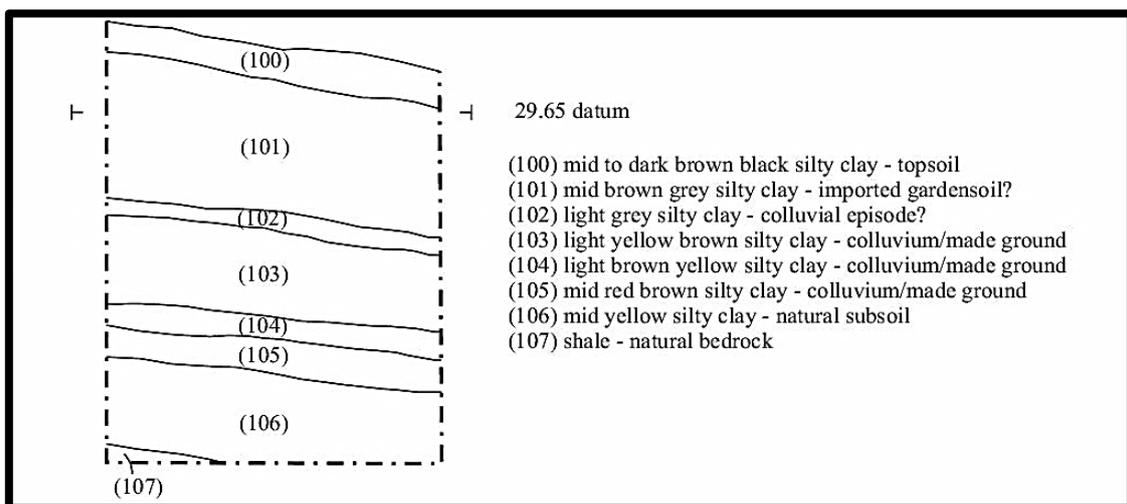
The ground works for the new driveway and parking areas were monitored by Marc Steinmetzer in October 2011. The initial visit on the 7th of October proving abortive, two further visits were made on the 10th and 11th of October. The ground was excavated by the contractors to a considerable depth, of 1.8m in places, revealing one small area of shale bedrock. The rest of the site was deeply buried by overlying colluvial deposits. Because of the topography of the site, all the excavations monitored during the watching brief stayed within colluvial deposits. No archaeology was exposed and no finds recovered. Further site visits to monitor a proposed drainage/cess pit and a large garage block were anticipated, but these visits were never commissioned. In view of the negative results from the watching brief it is considered that these works are unlikely to have exposed significant archaeology. The following section (Fig. 12) illustrates the character of the deposits.

Fig. 12 Section 1, showing the character of the deposits observed in the watching brief. The location of this section is shown in Fig. 4 (M. Steinmetzer).

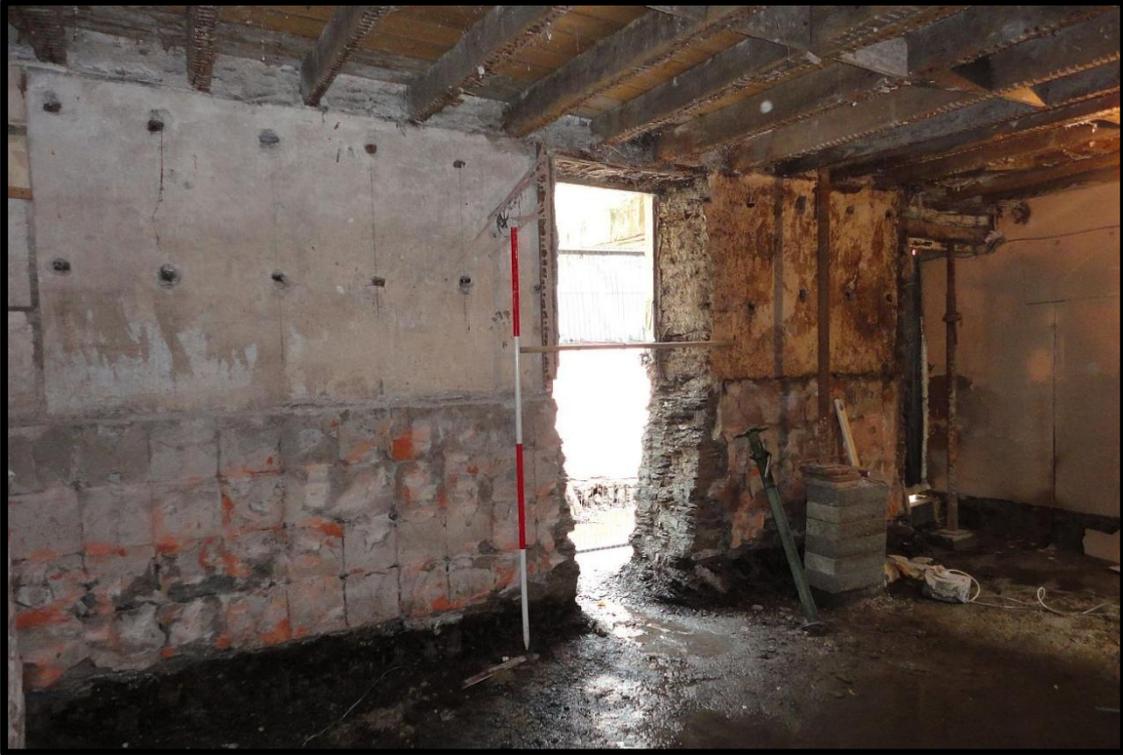
The opening in the north wall of the room seems to have originated as a small window (Fig 13). The eastern part of the wall is partially of cob, standing over stone footings rising to a height of about 1.25m. The western part of the wall, to the west of the window opening, appears to have been rebuilt in stone in the late 19th century. The window has been cut down through the stone masonry of the lower part of the wall to form a doorway and has now enlarged to form a wider opening.

Fig. 13 View of the opening in the north wall of the western room prior to enlargement, showing the stone and cob fabric of the wall suggesting a phase of rebuilding.

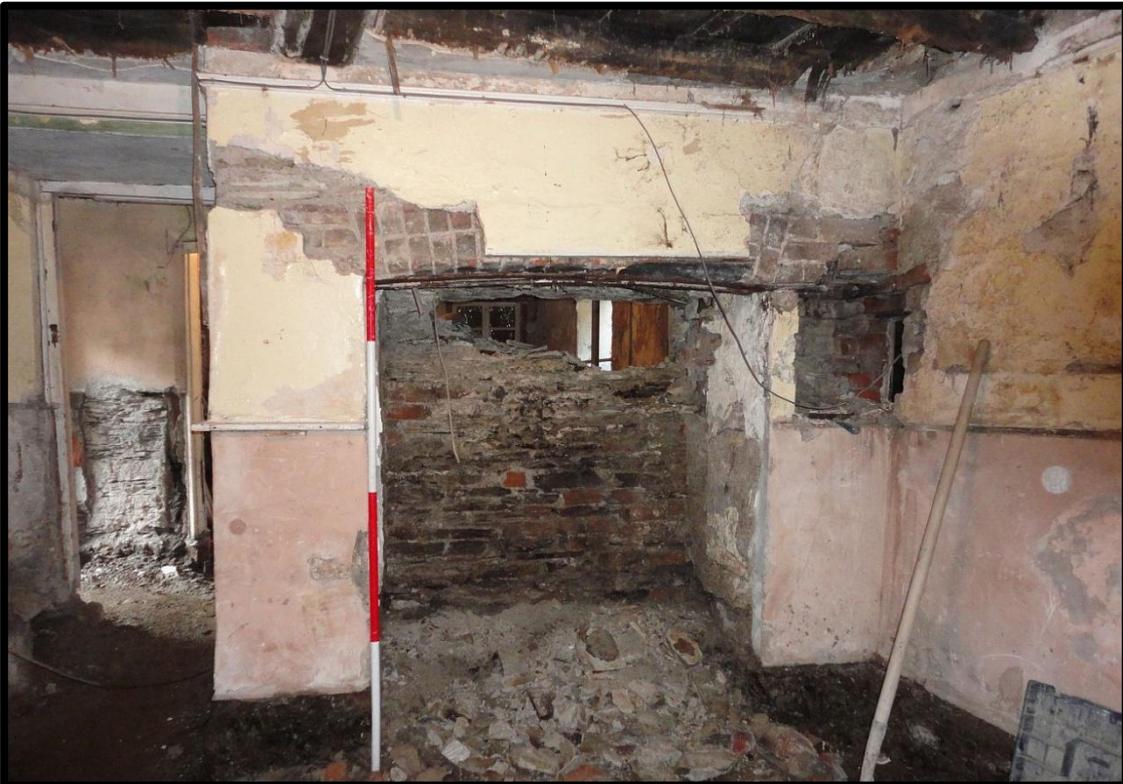
The eastern room had also been stripped of most of its plasterwork, and the rear wall of the fireplace demolished to form an opening between the eastern and western rooms (Fig. 14). The rear wall of the fireplace was largely constructed of stone rubble but also incorporated much perforated red brick. This appeared to confirm that the chimney was of late 19th-century construction. It was probably constructed to replace an earlier chimney in the west wall of the original house, which may have been removed when the original west wall was demolished, perhaps to create the passage was linking the entrance doorway in the south wall with the 19th-century rear lean- to. No evidence of an earlier chimney remained, but the absence of any form of fireplace from the other walls of the room, strongly suggests the possibility that this feature was accommodated in the west wall. The excavations of the floor in this room, described above, revealed no evidence of a central hearth or any form of open fireplace and the room may therefore be presumed to have been either unheated or served by a chimney.

Fig. 14 View of the fireplace in the eastern room during the demolition of its rear wall to create a new opening. The fireplace probably dates from the late 19th century and may replace an earlier fireplace in the west wall of the original house.

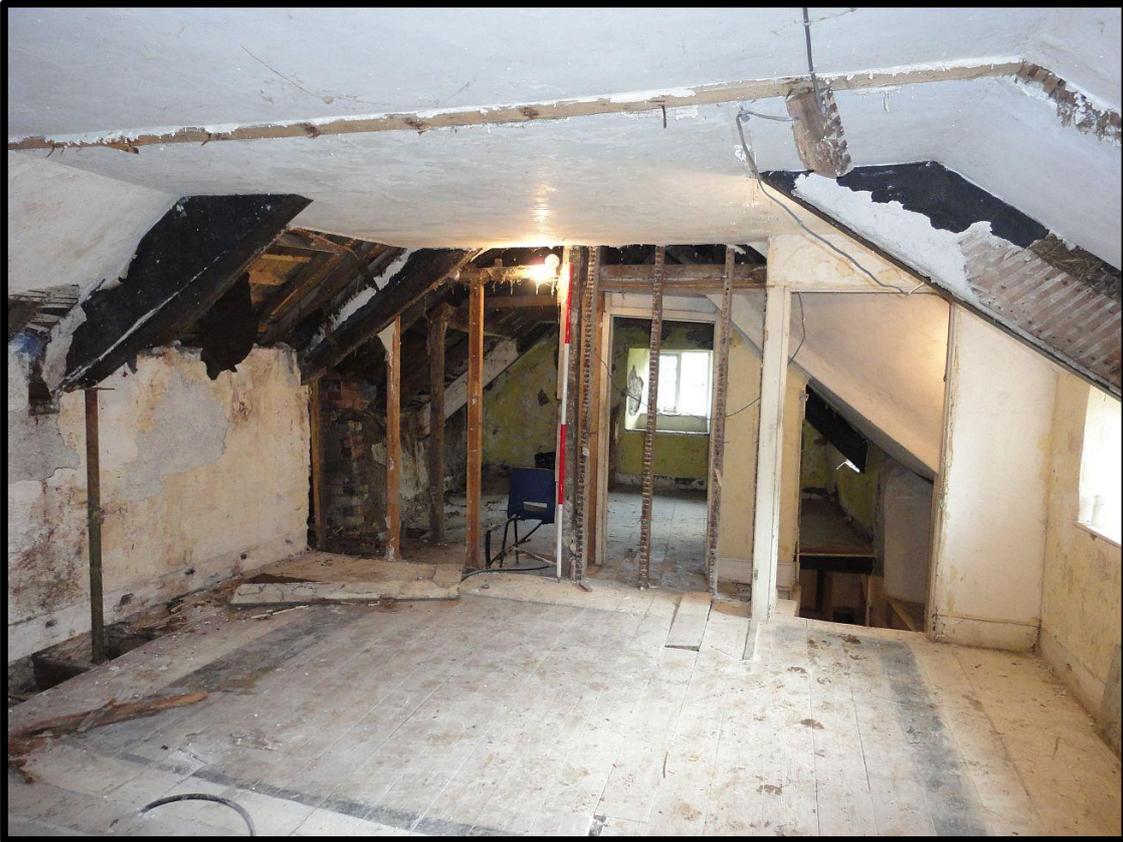
The first-floor rooms had also been stripped out (Fig 15) and most of the internal partitions had been removed. The partitions dividing the passage from the western room and eastern rooms were of modern construction, installed following the demolition of the central chimney stack rising through the building.

Fig. 15 View of the first-floor rooms following stripping out.

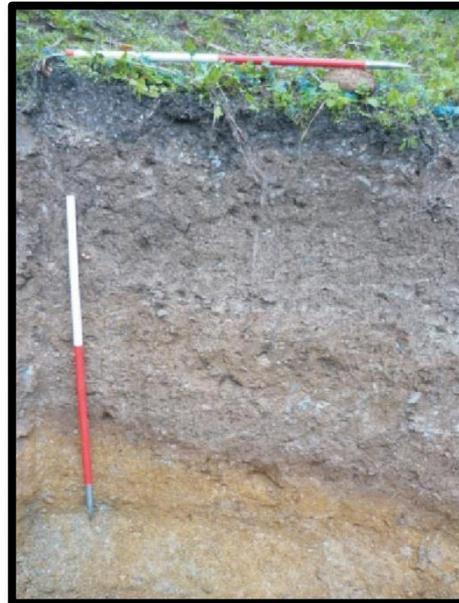
Fig. 17 Section 1, looking east, showing the deposit sequence and depth of colluvium/made ground. 1m scale (Photo by M. Steinmetzer).
