Historic Building Survey

**CHURSTON MILL HOUSE, CHURSTON FERRERS,
NEAR BRIXHAM, DEVON.**

By R. W. Parker

REPORT No. 2012.05

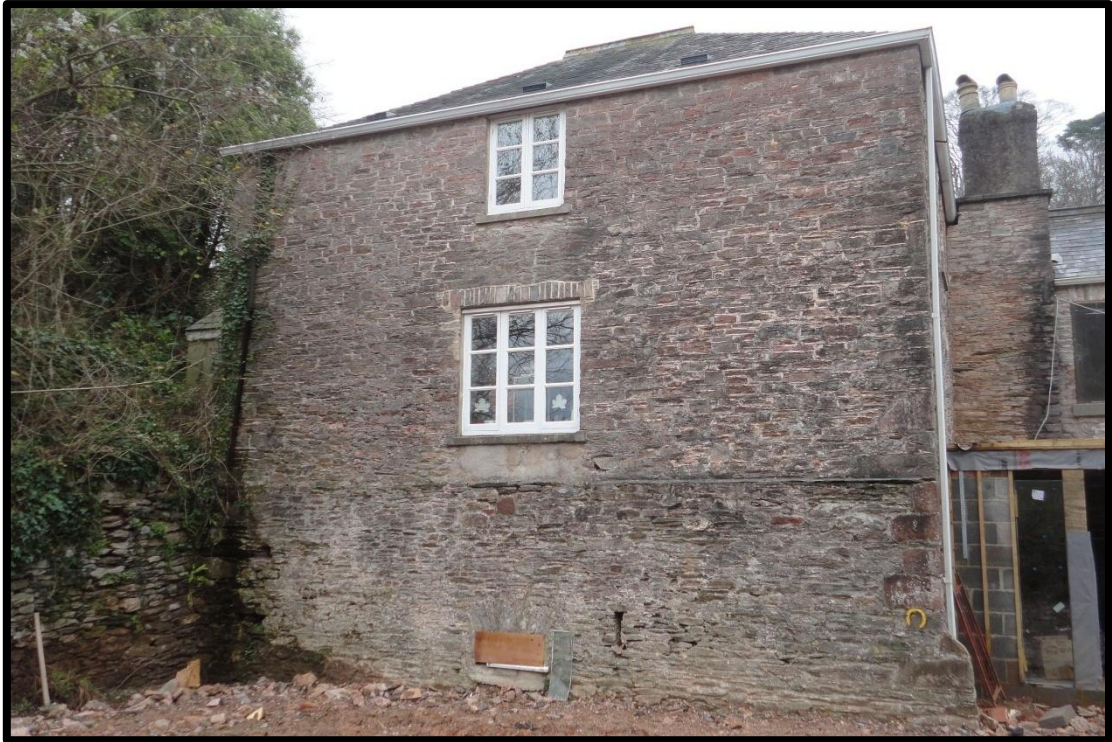
The mill is constructed of a mixture of slaty-mudstone and limestone rubble (Fig. 4). The lower parts of the south-western wall, in the region of the wheel pit, are constructed of undressed and almost uncoursed rubble, rising to an offset at first-floor level. This walling terminates at the southern corner of the mill with a low chamfered buttress-like feature with large, red stone quoins. Similar rough rubble masonry is visible in the north-western wall of the mill. The upper parts of the mill, however, are constructed of larger, squared blocks of randomly-coursed snecked limestone, with large, grey limestone quoins, which appears to be of later date. It is assumed that the present building is a substantial reconstruction of an earlier building from which only the lower parts of the south-west and north-west walls (those areas either terraced into the hillside or facing the wheelpit) were retained.

Fig. 4 Elevation of the mill from the site of the wheelpit, showing possible earlier masonry in the lower part of the wall and the raised level of the mill pond (left).

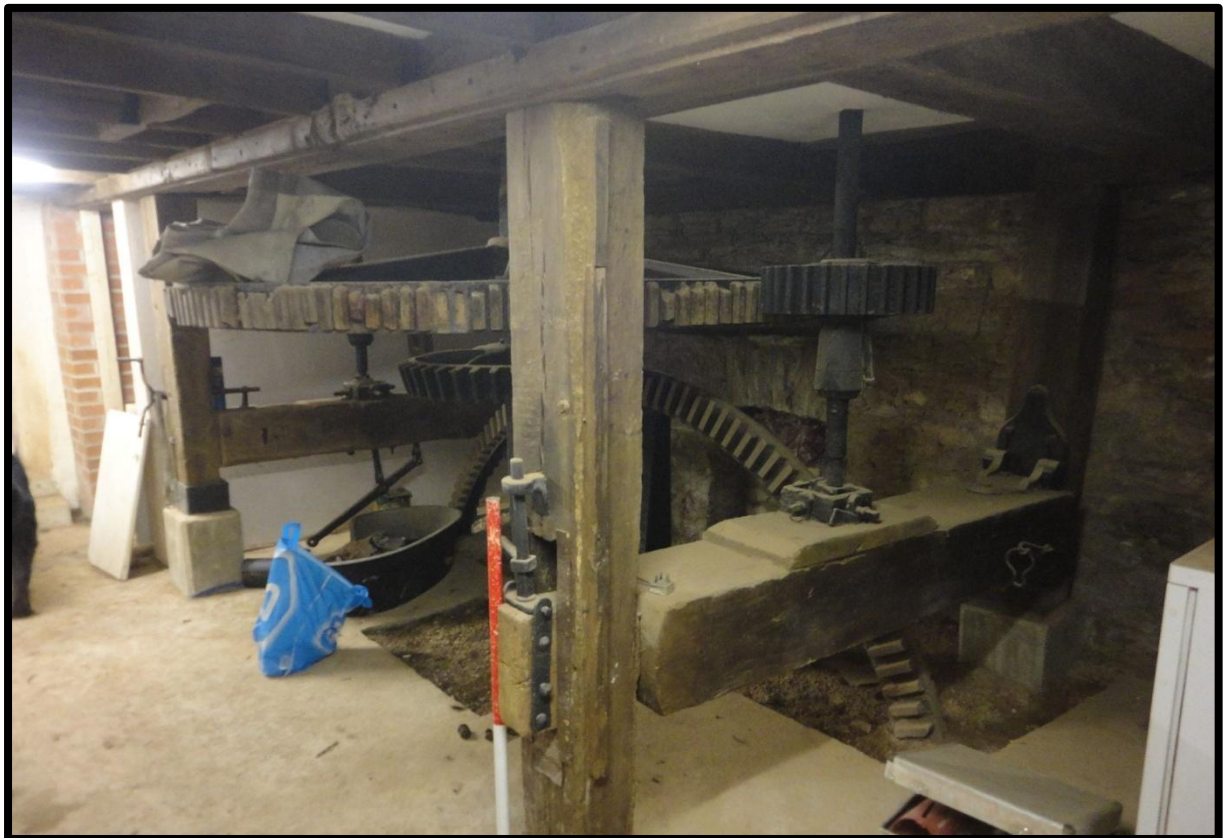
Within the mill house, on the meal floor, the pitwheel survives, now half buried, serving a two-step or spurwheel underdrive in a large Hurst frame rising the full height of the meal floor (Fig. 5). The meal floor of the mill was entered by three doorways: a single doorway in the south-eastern wall and two doorways in the north-eastern wall. One doorway gave onto the land behind the house. The other two doorways open into the area now occupied by the extension to the north of the house. One is blocked in stone, the other has recently been blocked. Both appear to be primary features and presumably served separate areas or structures to the north-east of the mill. These must have been destroyed or built over by the extension to the house. There is a wall scar between the two doorways which may represent the remains of a projecting structure, perhaps a porch or a lean-to shed. The other doorway may have opened directly from the meal floor to the driveway and could have been the main entrance to the mill. There is a further opening in the north-eastern wall of the mill, near the eastern corner. This is now converted into a cupboard within one of the ground floor rooms of the house, but its voussoirs are still visible within the mill, above the level of the stone floor, and it must have pierced the wall. It is assumed to represent an opening for a steep stairway or ladder connecting the ground floor of the house with the stone floor, presumably as a convenience for the miller, allowing access to the stones without having to go outdoors.

Fig. 5 View of the mill machinery on the meal floor showing the pitwheel and spurwheel underdrives providing power to two sets of stones.

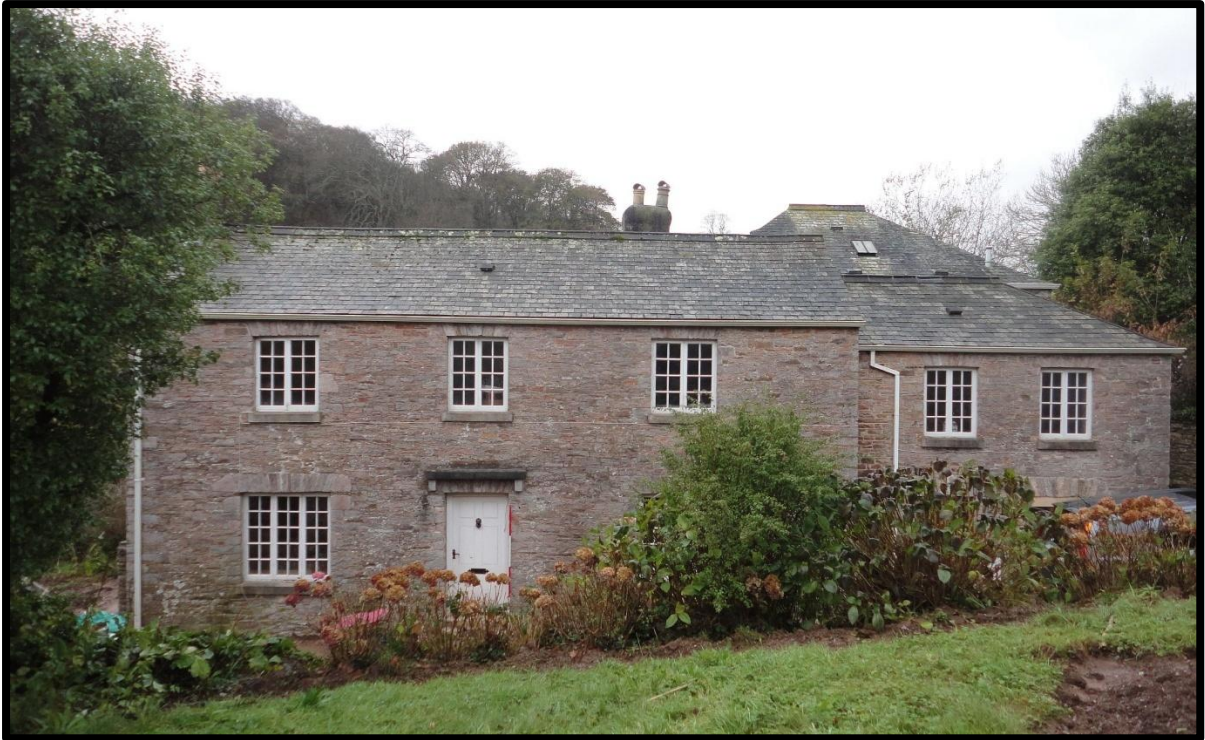
Fig. 6 Elevation of the house, showing the main house, the north-western extension and the higher roof of the mill behind.

The house faces north-east, and has a polite, symmetrical façade of three bays, with a central doorway with a flat hood supported on plain stone blocks (Fig. 6). The ground-floor windows are wider than the first-floor windows, and may have been fitted originally with tripartite sashes. The present casements are modern. All the openings have flat arches of radiating stone voussoirs. The masonry is of sneaked randomly-coursed rubble resembling that of the upper parts of the mill and it is presumed that the two buildings are either contemporary or very close in date. At the south-eastern end of the building is a 19th-century brick chimney stack. One would expect a corresponding stack at the north-western end, but this is absent; the chimney instead rises against the rear wall of the house, in the angle between it and the mill. Unfortunately, this conceals any relationship between the mill and the house.

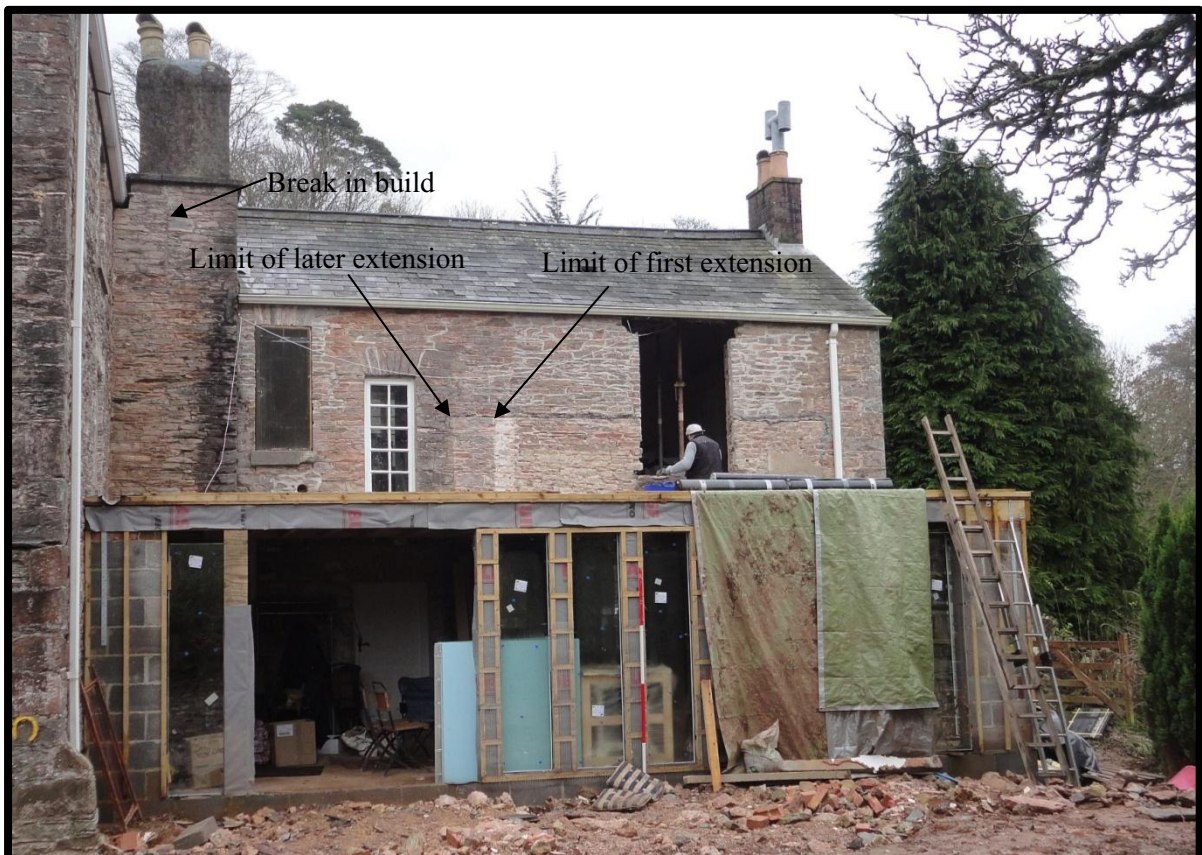
Fig. 7 Elevation of the house from the site of the tail race showing evidence of two phases of rear extension, the rebuilt chimney and the relationship of the lean-to roofs with the first-floor and staircase window openings.

The end gable is rendered and, as it contains a large chimney breast, is unlikely to contain any primary openings. The rear elevation of the house is less regular and has been compromised by modern additions. These included a lean-to extension, visible on the 1936 OS map, but absent on earlier maps and therefore probably of late 19th- or early 20th-century date. The roofline of this lean-to appears to have conflicted with and truncated one of the first-floor windows (Fig. 7). The wall scar of its north-western wall is still visible, together with traces of internal plastering, but all except its south-eastern wall was later demolished and replaced with a slightly larger lean-to structure which has in turn been demolished to make way for the flat-roofed extension now under construction. The roofline of the later lean-to is also still visible, extending a short distance to the north west of the earlier structure. The roof could not extend further because this would have fouled the lower parts of the staircase window. Access between the older house and the rear lean-to was by a large opening made in the rear wall, fitted with sliding glazed door. This is of late 20th-century date and it is not known whether or not it replaced a primary window or doorway.

To the north west of the 20th-century lean-to was a small conservatory approached by a doorway from the original central entrance hall of the building. This had a lower roof than the adjoining extension because of the staircase window lighting the half landing. This retains its original radiating voussoirs. The adjoining window to the former bathroom appears to have original jambs, but its sill has recently been lowered, perhaps because the original window had been partially blocked for the installation of a low-level cistern above a toilet within the bathroom which had been carved out of an original first-floor bedroom. The window does not seem to be an insertion, but it has square, rather than splayed jambs, and might have been inserted when the bathroom was carved out of the original bedroom. In this case the rear wall of the house must have been partially rebuilt at the same time, perhaps in the context of alterations to the adjoining chimney.

The large chimney breast rising alongside this window seems to have been constructed in several phases and clearly butts against the wall of the mill alongside. There is a possibility that the chimney was moved to this position from the north-western gable of the original house, perhaps when the house was extended. The clear vertical breaks near the top of the chimney are difficult to explain,

since they appear to imply the addition of an extra flue. It is possible that the original chimney contained only one flue and that a second was added in a later phase to heat the first-floor room, perhaps after the insertion of the bathroom, which may have necessitated the destruction or repositioning of an earlier fireplace and appropriate reconfiguring of the chimney flues.

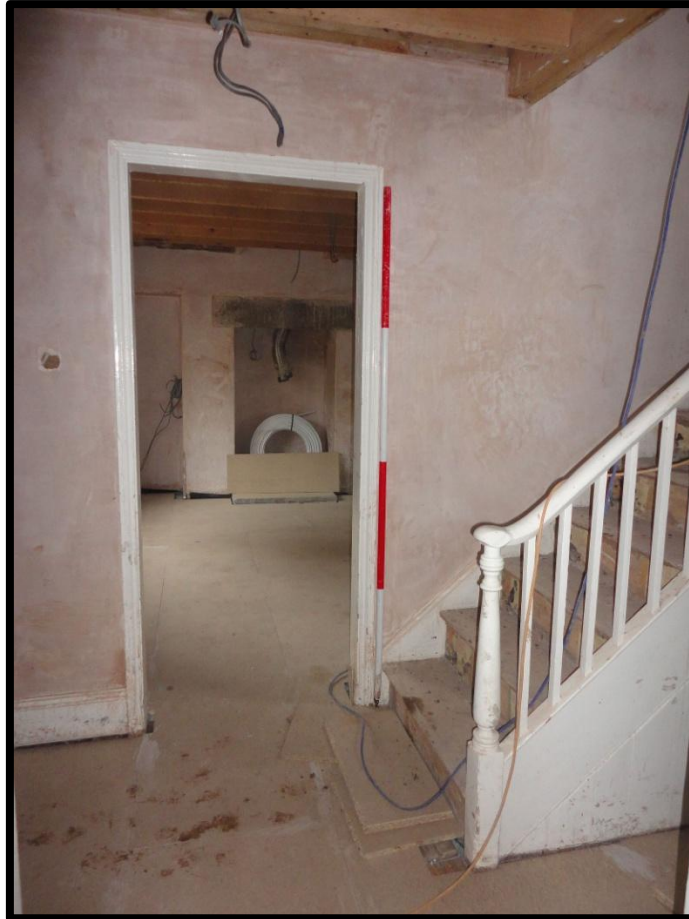
The interior of the house is very modest and without pretension. The main entrance doorway opens upon a narrow hallway with a dog-leg staircase rising against the rear wall over a corresponding doorway in the rear wall. The stair has a turned newel post in the form of an elongated baluster, and a closed string, stick balusters and a plain ramped handrail with 'bun' terminals above each newel (Fig. 8). These details suggest a date in the early-mid 19th century. There is no evidence that the stair is a replacement. It is lit by a window with splayed jambs on the half landing. On either side of the hallway are two large rooms, both entered by doorways with moulded architraves. The doors have been removed but have been retained for reinstatement after completion of the building works. The south-eastern room has no surviving primary features but the north-western room retains a 19th-century panelled cupboard infilling an earlier opening connecting the house and the mill. None of the original fireplaces survived and the present treatments of the embrasures are modern (Mrs Ellis Voisey *pers. comm.*). The ceilings have been stripped of their plaster to expose the joists, however it is clear from the evidence of lath nails that all the ceilings were originally plastered; indeed, unless they were designed to be ornamental, joists and structural timberwork would not have been exposed in a domestic building of this period.

Fig. 8 View of the ground floor and main staircase.

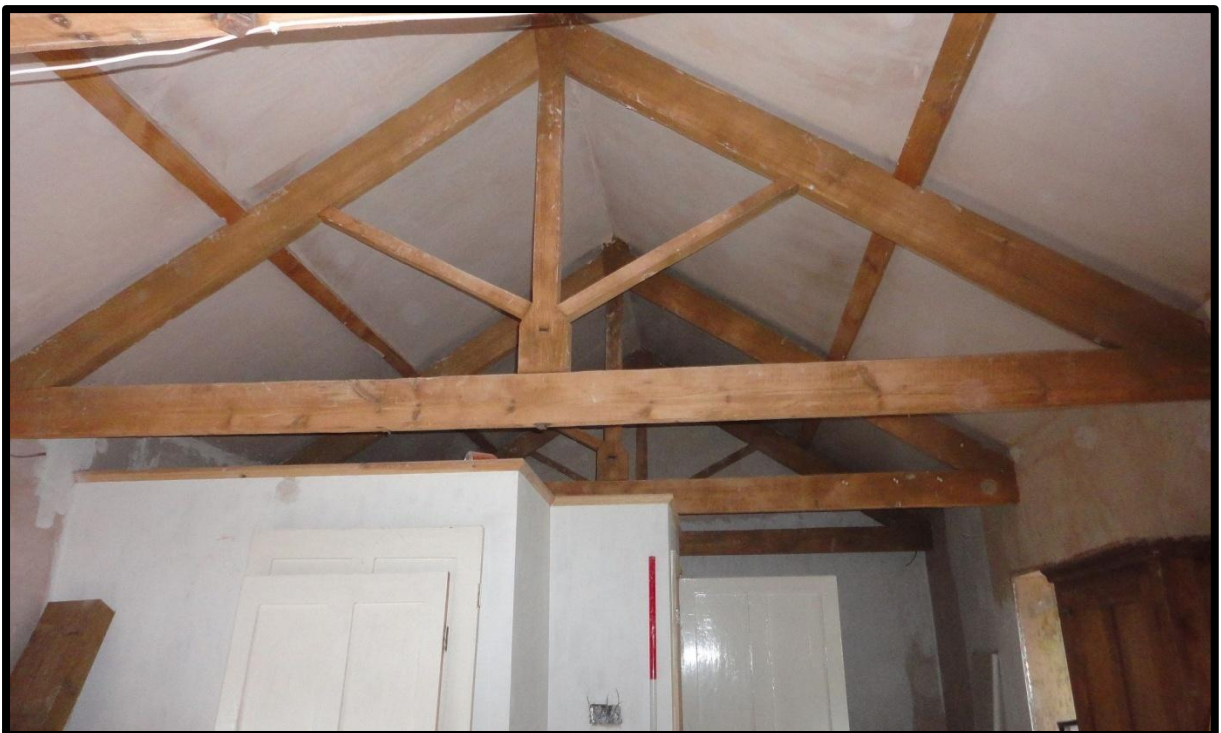
Fig. 9 View of the 19th-century roof structure of the house.

The roof of the house is supported by very handsome and well-made king-post trusses with diagonal braces (Fig. 9). The bases of the king posts are bolted through the tie beams, showing that the post is here understood as a tension rather than a compression member. This type of truss was in use from the late 18th to the 20th centuries and it is considered likely that the roof dates from the early-mid 19th century. Although of good quality, these trusses were not originally designed to be displayed.

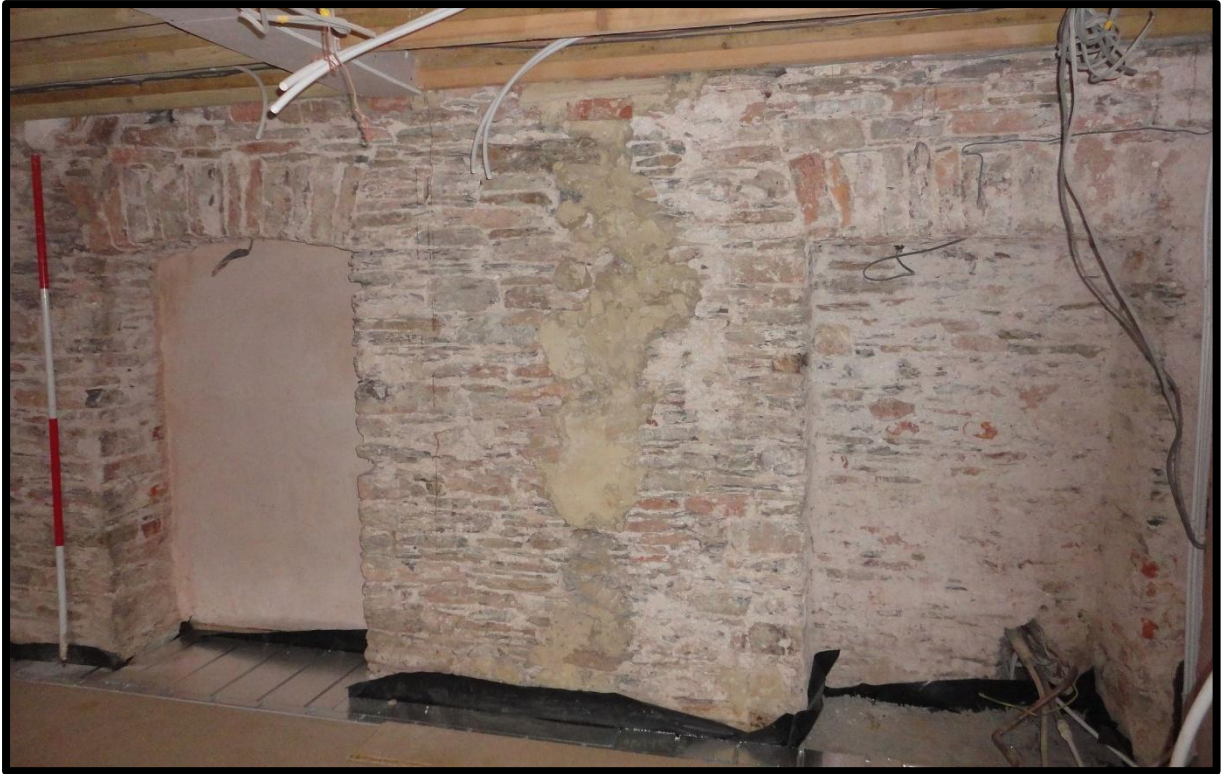
Fig. 10 View of the doorways formerly communicating with the mill, showing the wall scar lying between them, suggestive of a structure abutting the mill and pre-dating the north-western extension.

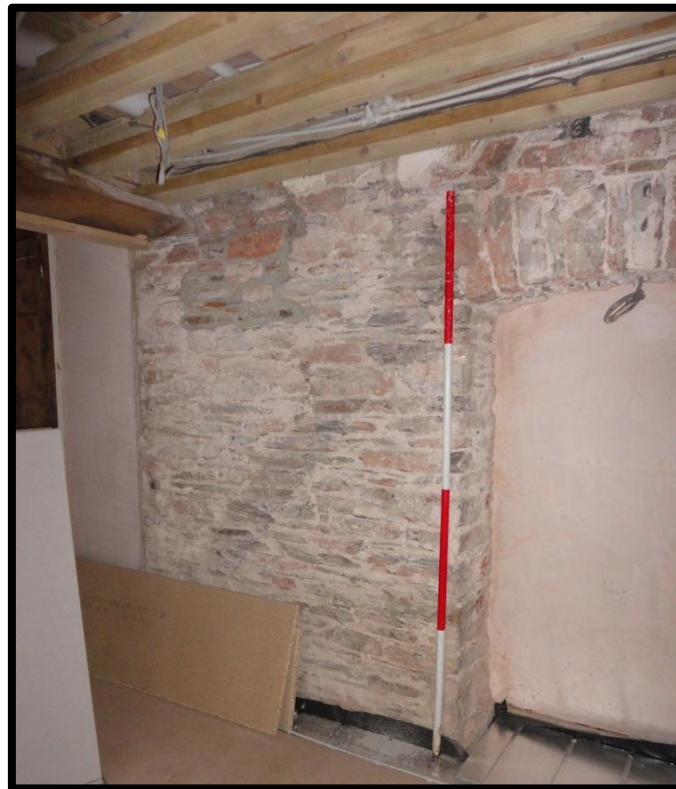
Fig. 11 The shadow of a steep staircase or ladder, rising from the house to the first floor of the extension and with severely restricted head room.

Communication between the extension and the house is difficult to reconstruct. There are two possible openings in the wall. One was, until recently, a doorway communicating with the kitchen in the extension. It is now blocked and plastered over as a recess visible within the ground-floor room of the house. A further opening lies to the south west, and this has been retained as an access point between the two rooms. This opening has a timber lintel which has been crudely cut away on the underside to a sloping profile. Unfortunately it is impossible to be certain whether or not this was an original feature of the lintel or a later modification. The clear shadow of a steeply-sloping stair or

ladder is visible against the mill wall immediately within this opening, on the extension side of the doorway (Fig. 11). This is so steep, and so close to the doorway, that even with the truncation of the lintel it would be necessary to duck as one ascended the steps. It is thus highly unlikely that this was an original arrangement or that it formed any part of the domestic accommodation. The ladder would also have precluded access between the house and the lower storey of the extension. The ladder had been replaced by a later staircase in more or less the same position, but with a shallower ascent. The ceiling structure in this area has been entirely renewed and there is no surviving evidence for the truncation of joists, trimmers or blocked voids in the ceiling.

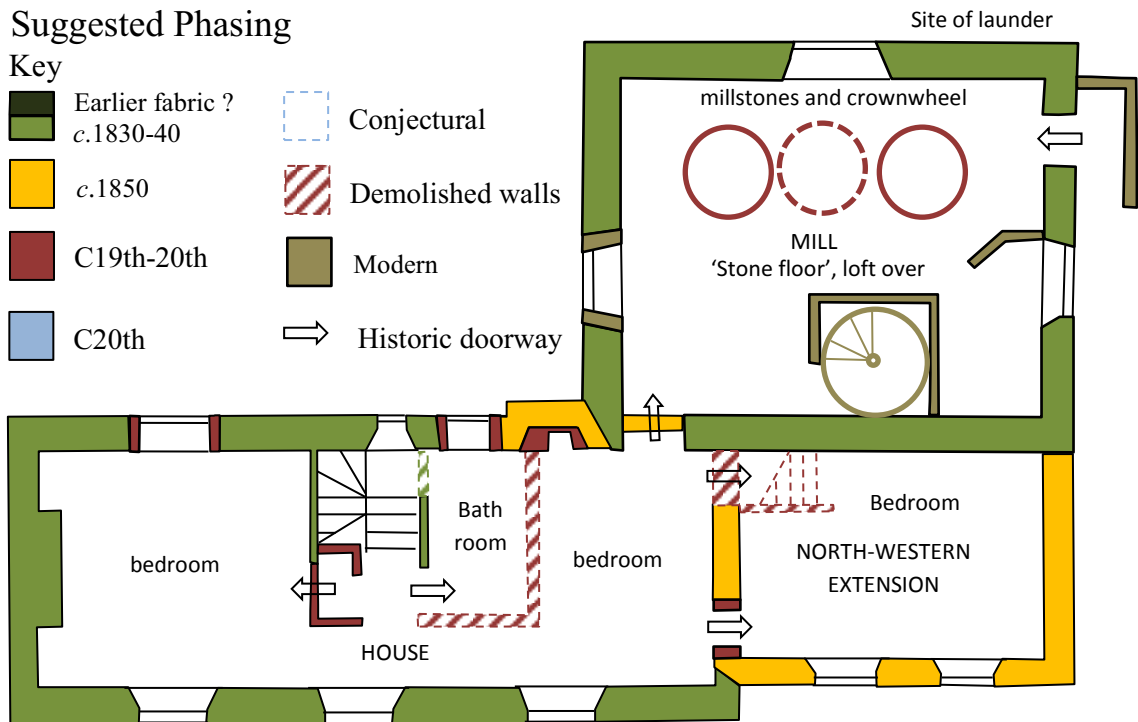
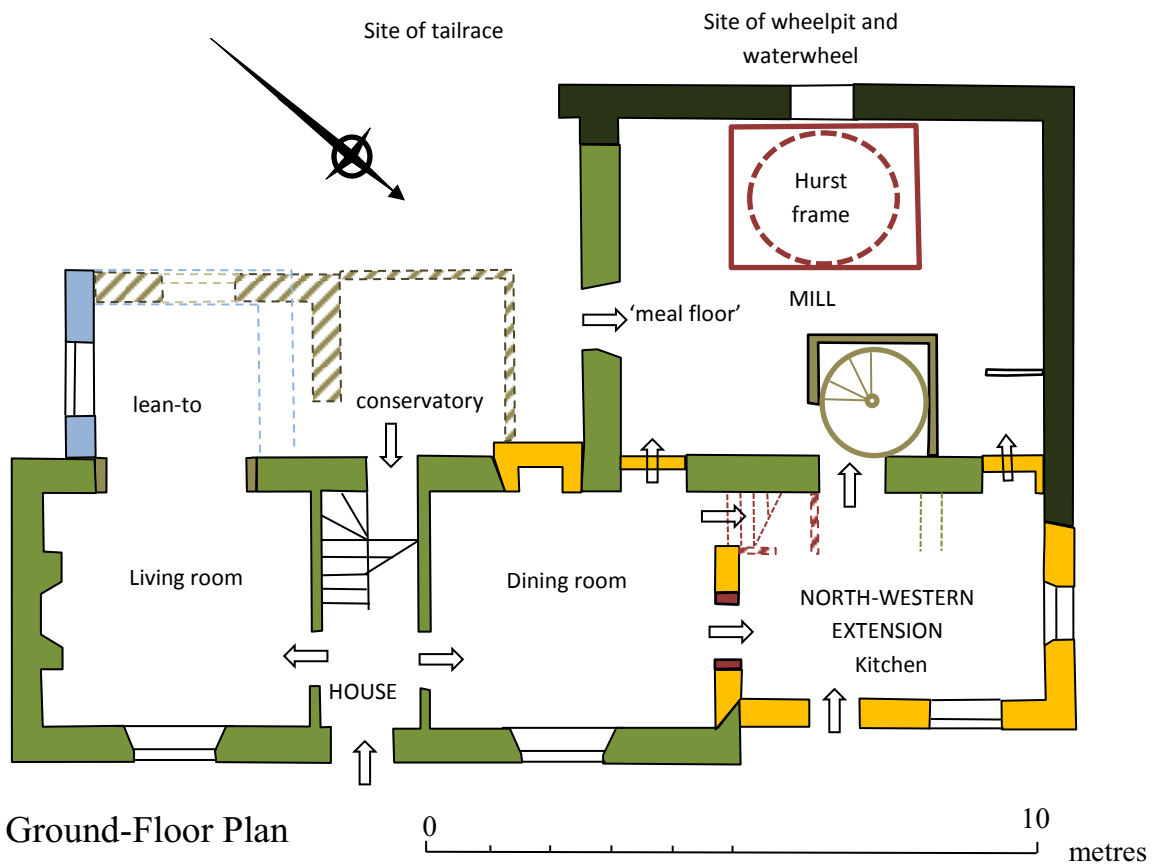
Fig. 12 Phased plans showing conjectural phasing. Based upon drawings by Mark Ledgard of Smithsgore Chartered Surveyors.

Churston Mill and Mill house are clearly estate buildings relating to the nearby Lupton Estate, belonging in the early 19th-century to Sir John Buller Yarde Buller and let by him to tenants. Fig 12 presents a phased interpretation of the historic development of the building.
