Archaeological Building Survey

No. 35, STRAND, TOPSHAM,

By R. W. Parker

REPORT No. 2012.01

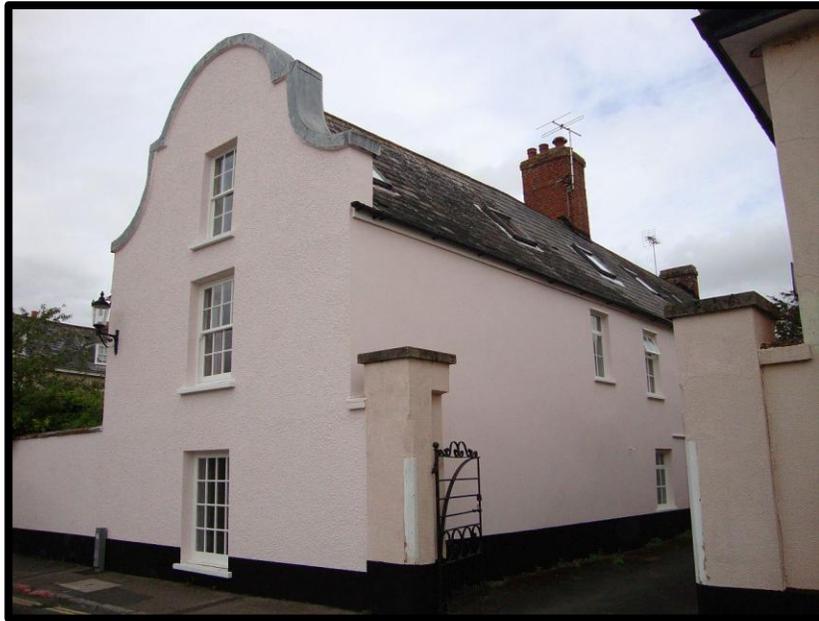
Fig. 4 View of the house and the restored south façade from the south west, showing the gates and gate piers to the yard. The open bathroom window on the first floor is a modern insertion dating from 1992, but occupies an earlier window embrasure.

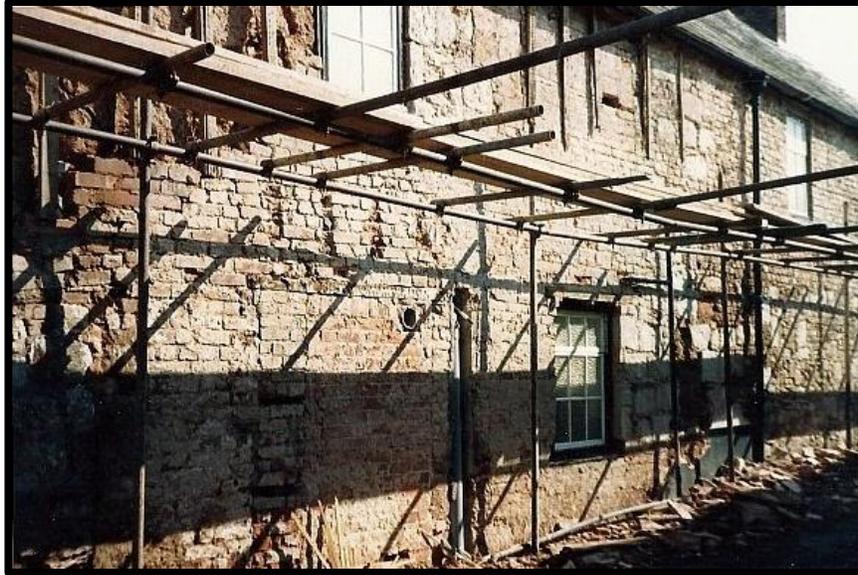
Fig. 5 View of the south façade during building works in *c.* 1987, when the plaster was removed, revealing a mixture of building materials and blocked windows and doorways (Photo held by the Osborn Family).

Numerous disturbances in the walling are visible in the photographs, representing blocked window openings and doorways. Chief among these is a wide doorway with a timber lintel, which would have opened into the staircase hall and which had been blocked in two phases. The door appears to have been narrowed at first, by the addition of a column of brickwork within its western jamb and then finally blocked in orange bricks whose soft texture and large inclusions are apparent even in the photograph.

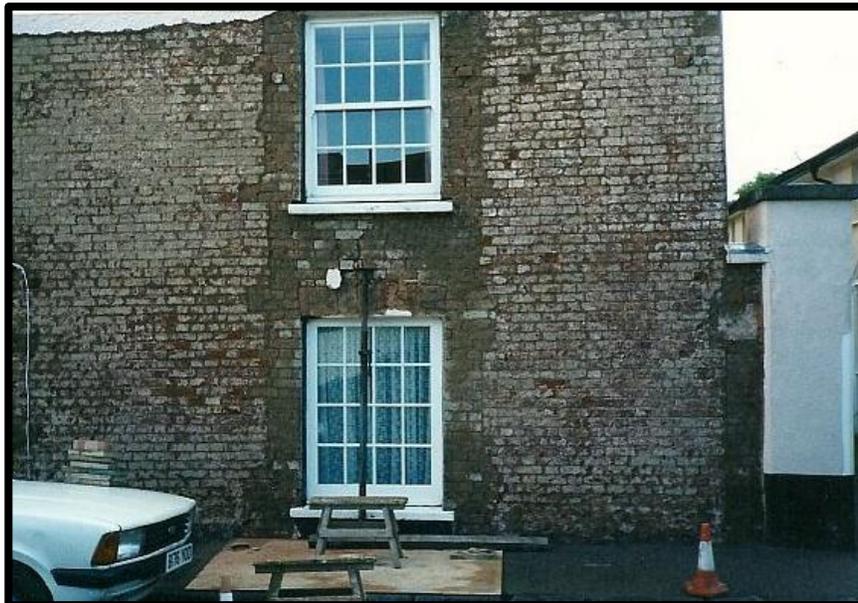
Fig. 6 View of the western façade during alterations, showing 19th-century alterations to the window openings and the blocked opening for a possible bay window (Photo held by the Osborn Family).

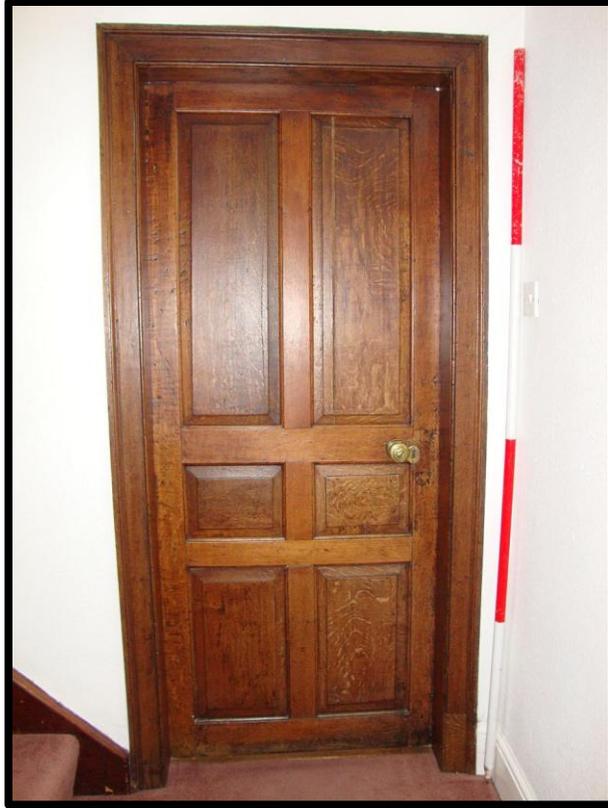
Fig. 7 Detail of the early 18th-century door reset within the doorway to the parlour. Several doors of this period survive in the house.

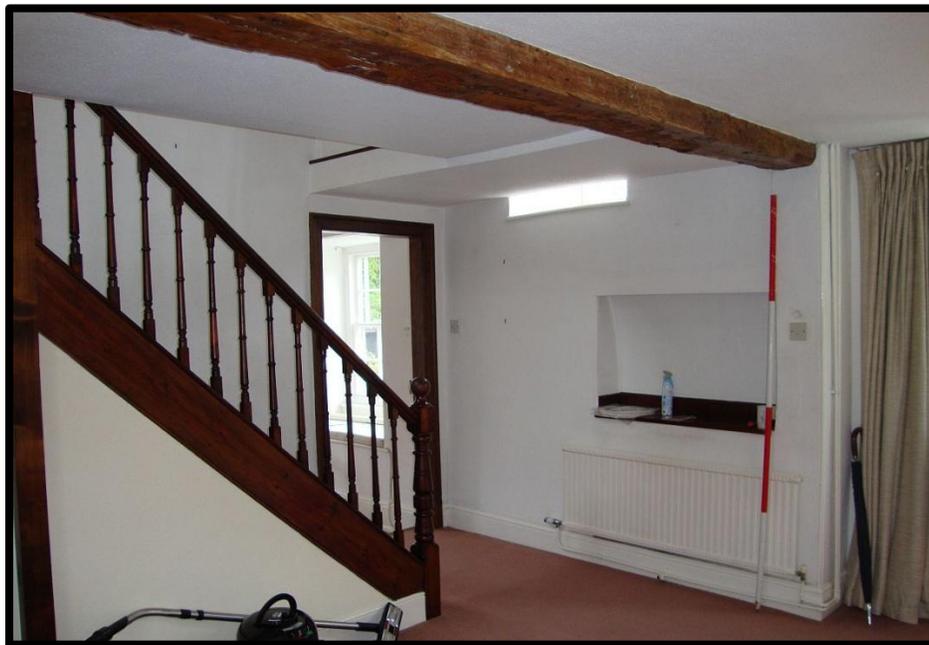
Fig. 8 View of the staircase hall at ground-floor level, showing the awkward relationship of the floor levels with the stair window and the recess in the wall below it. It seems likely that the stair formerly rose to the north alongside a partition under the beam above.

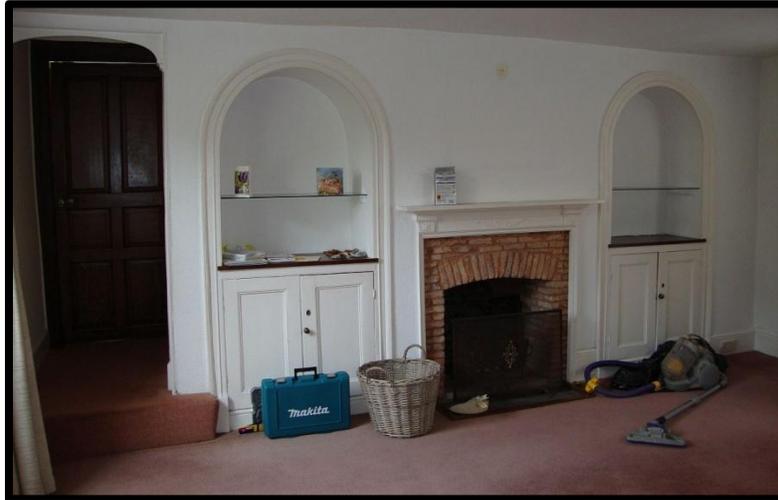
Fig. 9 View of the fireplace and alcoves in the stair hall.

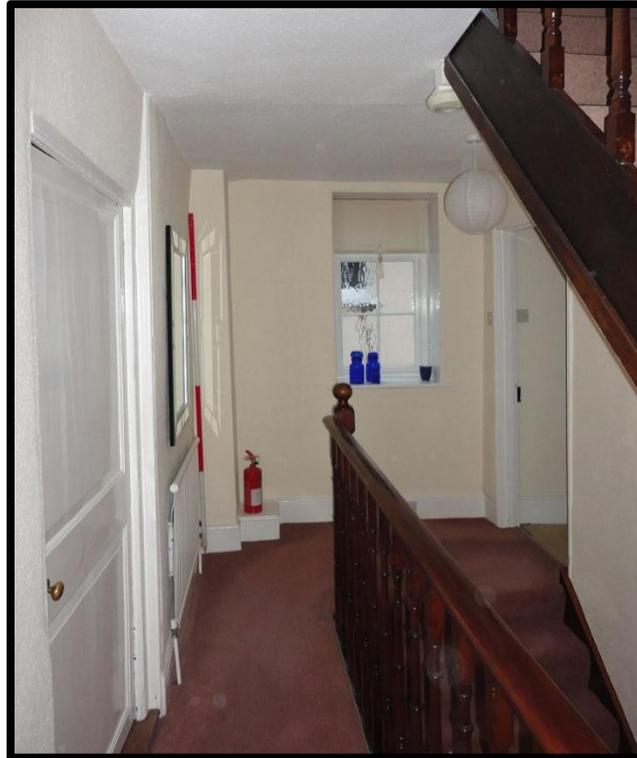
Fig. 10 View of the stair landing at first-floor level, showing the scar across the ceiling and offset betraying a partition. The 18th-century door at left must have opened onto the original stair head.

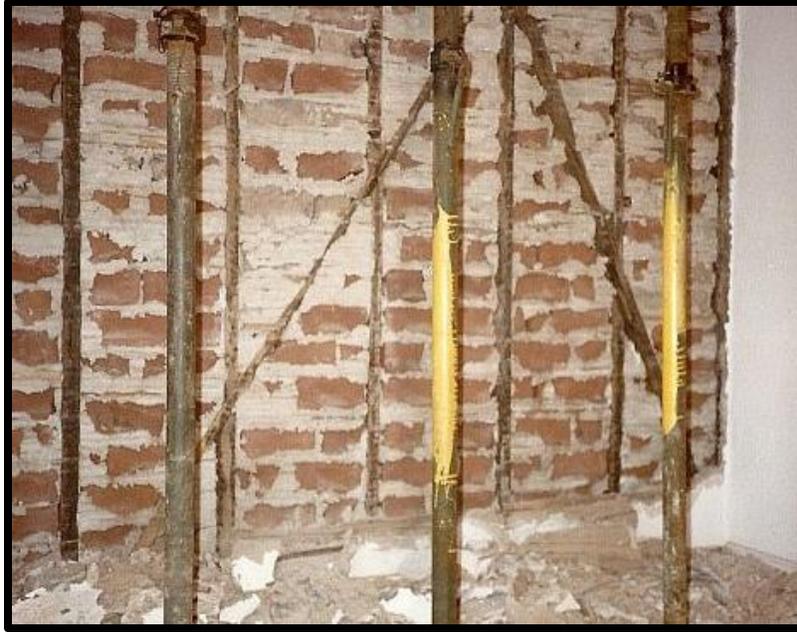
Fig. 11 View of the partition between the eastern rooms at first-floor level before demolition, showing secondary brick nogging within the partition (Photo held by the Osborn Family).

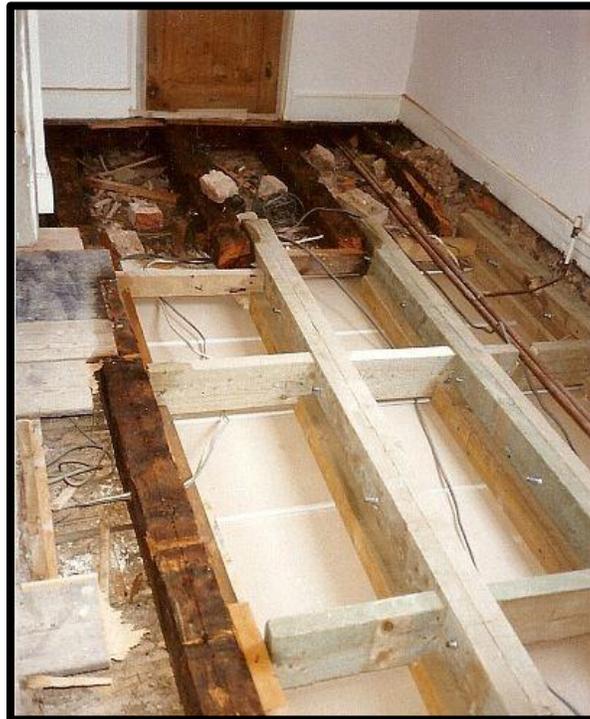
Fig. 12 View of the floor structure at first-floor level, exposed in 1992, showing the character of the early joists, interrupted by a modern intrusion (Photo held by the Osborn Family).

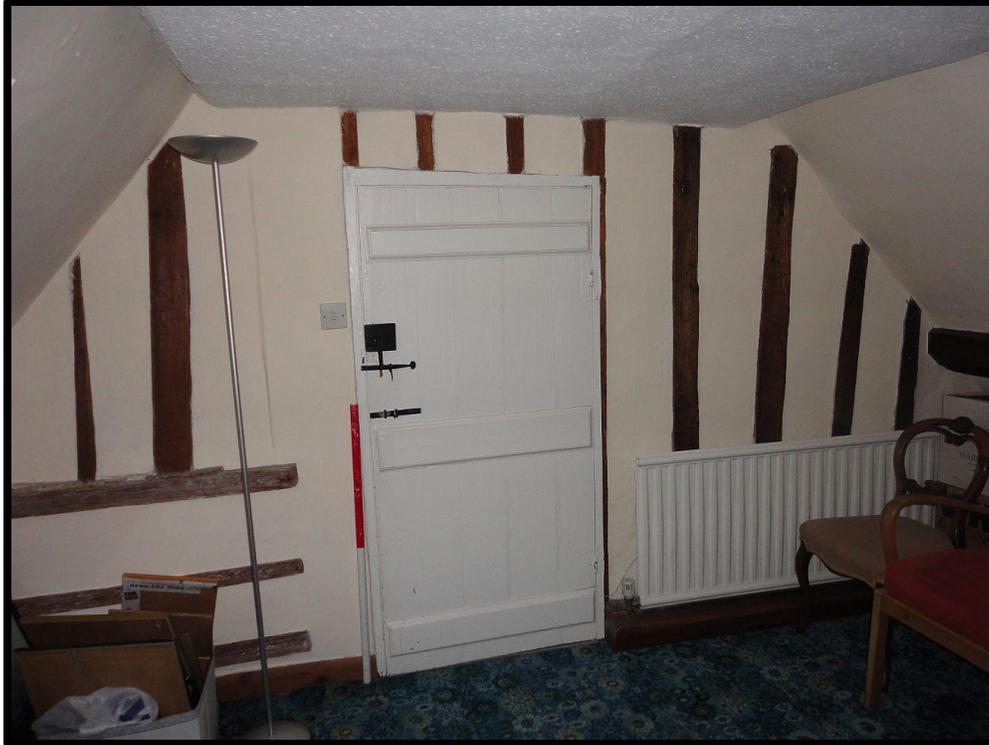
Fig. 13 View of the partition at second-floor level, showing the early plank door and, left the remains of truncated planking protruding into the room, relating to an unknown feature (possibly an hoarding for a service stair).

The western wall of the room is of great interest and is formed of a stud partition formed of vertical studs and plaster panels (Fig. 13). The nature of the infilling is uncertain but it is clear that the studs were originally lathed over and concealed behind plaster, since many bear traces of lath nails. The partition contains a central doorway closed by a plank door decorated, towards the western landing, with applied fillets so as to resemble a two-panelled door. The door is hung on 18th-century 'H' hinges and has very interesting door furniture, including latch, bolt and handle.

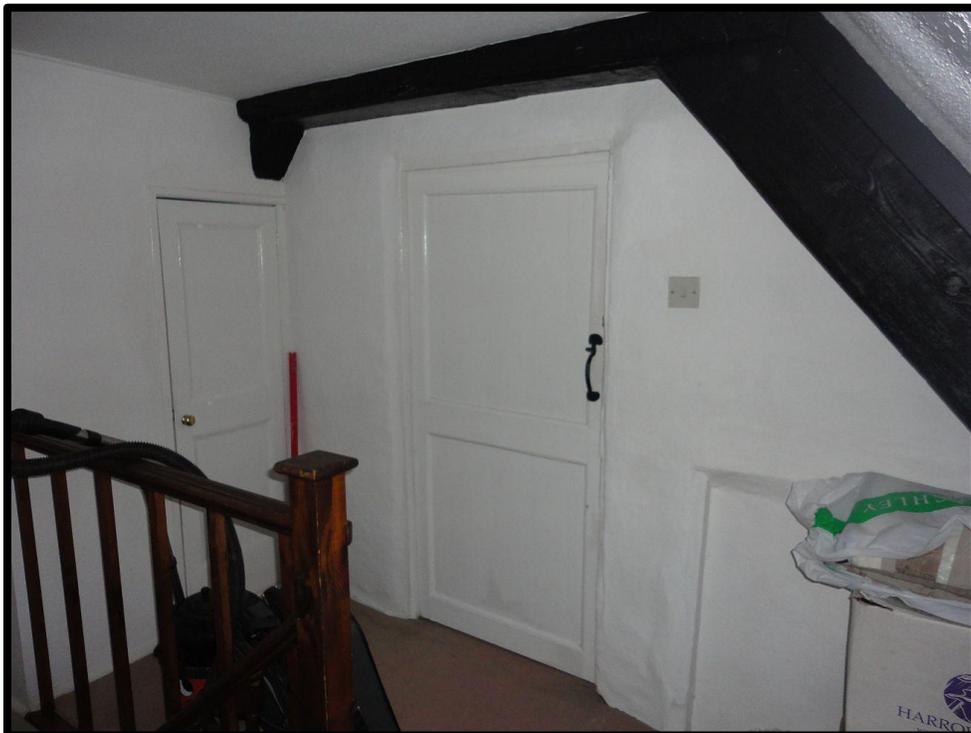
Fig. 14 View of the stair landing at second-floor level, showing the false-panelled door, the character of the roof trusses, and the recess with the sloping soffit (right), possibly for a service stair.

The upper main landing has very poor, modern balusters and handrails relating to the modern reorganisation of the staircase (Fig. 14). A modern bathroom has been contrived at the head of the stairs, divided from the landing by a 19th-century timber partition, with four panelled doors, aligned under the main truss. A four-panelled door with panted mouldings leads onto the western attic room. This appears to have always been unheated, but has a large window in the west wall. It is possible that this room and the present landing were formerly a single room until subdivision in the 19th century, in which case there may be a blocked fireplace in the western side of the large central chimney.
