Historic Building Survey
of
**FARM BUILDINGS AT EAST PEEKE,
WRANGATON, DEVON**

By R.W. Parker

REPORT No. 2010.02

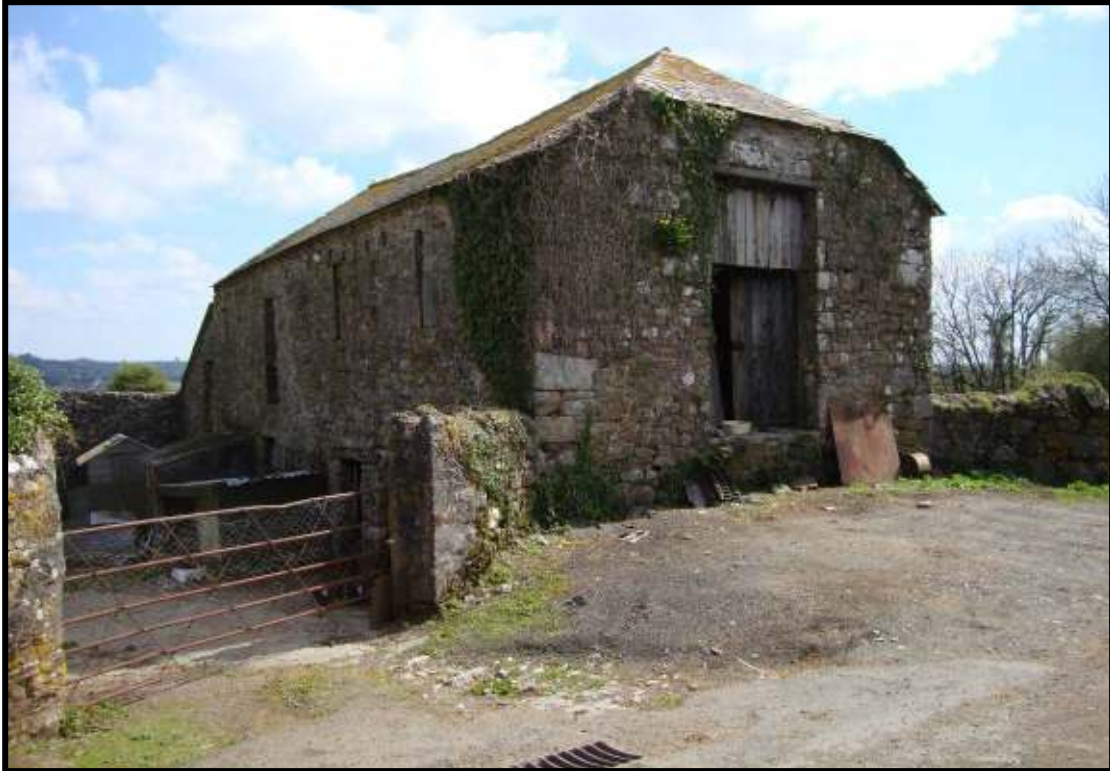
This elevation (Fig. 5) is partially built into the hillside, which rises to within 0.7m of first-floor level. The half-hipped gable end contains a wide opening closed by a pair of tall double doors. This elevation appears to be constructed in a single phase; it is massively constructed of randomly-coursed squared granite rubble, with very large granite quoins to the corners and the edges of the doorway. The doors are relatively modern and retain a varied assortment of strap hinges, some with square terminals and one with spear-head terminals; these may well have been reused. The upper part of the opening, above the doors is infilled with a fixed, boarded tympanum.

Fig. 5. The south-western elevation of the barn, looking east, showing the changes in level between the road to the south west of the barn and the farmyard on the north west.

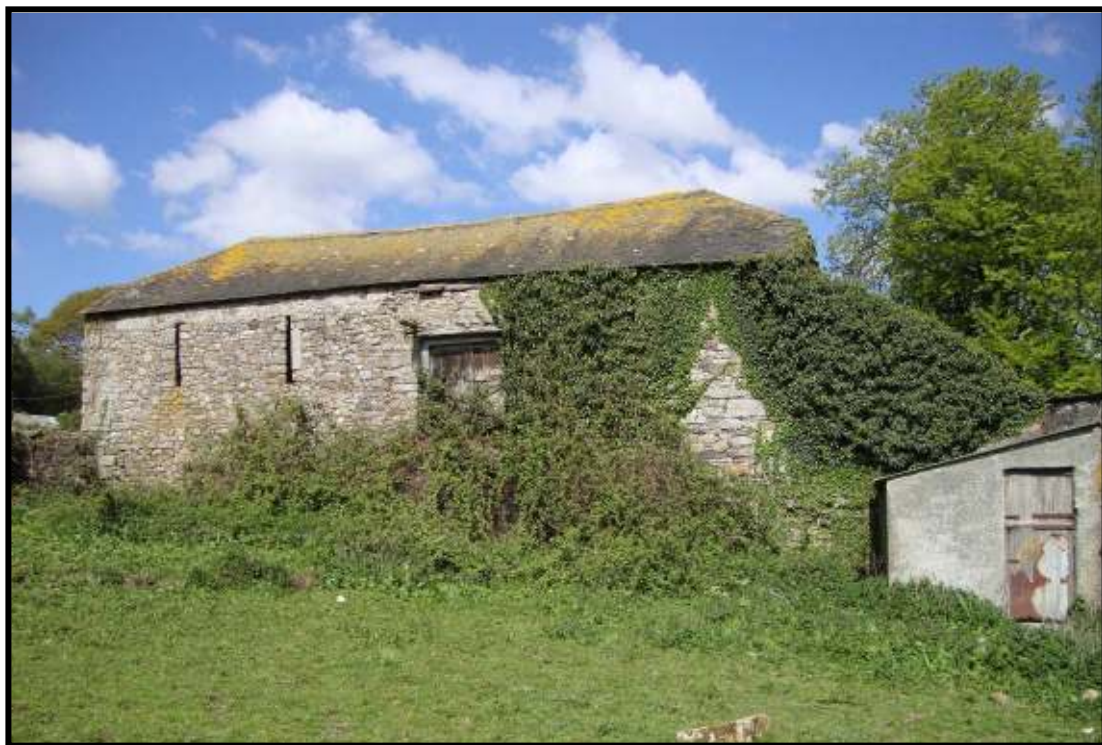
Fig. 6. The south-eastern elevation of the barn, showing the ventilation slits and superimposed doors (partially concealed by ivy) with the remains of a canopy over the first-floor doorway.

This elevation (Fig. 6) has two storeys, the ground falling sharply away towards its north-eastern end, where two lean-tos extend the building to form a 'T' shape.

The south east elevation is also constructed of random rubble in granite, with very large squared quoins, both at the corners and forming the jambs of the primary windows. On the ground floor towards the north-east end is a small rectangular opening which might have been associated with the drive shaft of the putative horse engine. This is cut into the main walling and is certainly a secondary feature.

Above this opening, two primary ventilation slits serve the first floor. To the north east of the centre of the main body of the barn is a pair of superimposed double doors, now much obscured by ivy. The lower door has been blocked in concrete blocks and replaced by a steel-framed 'Crittall' window, but the upper floor has retained a pair of double doors, one of which is divided horizontally. The doors are hung in a plain, unchamfered frame, with a good array of spear-headed strap hinges. The doors are probably of 19th- or 20th-century date. Above the doorway was a canopy supported by short cantilevers, but this has largely perished. To the south west of the door a section of walling below the eaves has been rebuilt; this might suggest that the roof has been raised, though this is unlikely as the primary masonry near the central doorway rises higher. It is possible that this represents the repair or replacement of a cob wall at the wall tops, in which the feet of the principal rafters were formerly seated. To the north east of the double doors is a further slit ventilating the first floor (now completely obscured). There does not appear to have been an opening on the ground floor in this area.

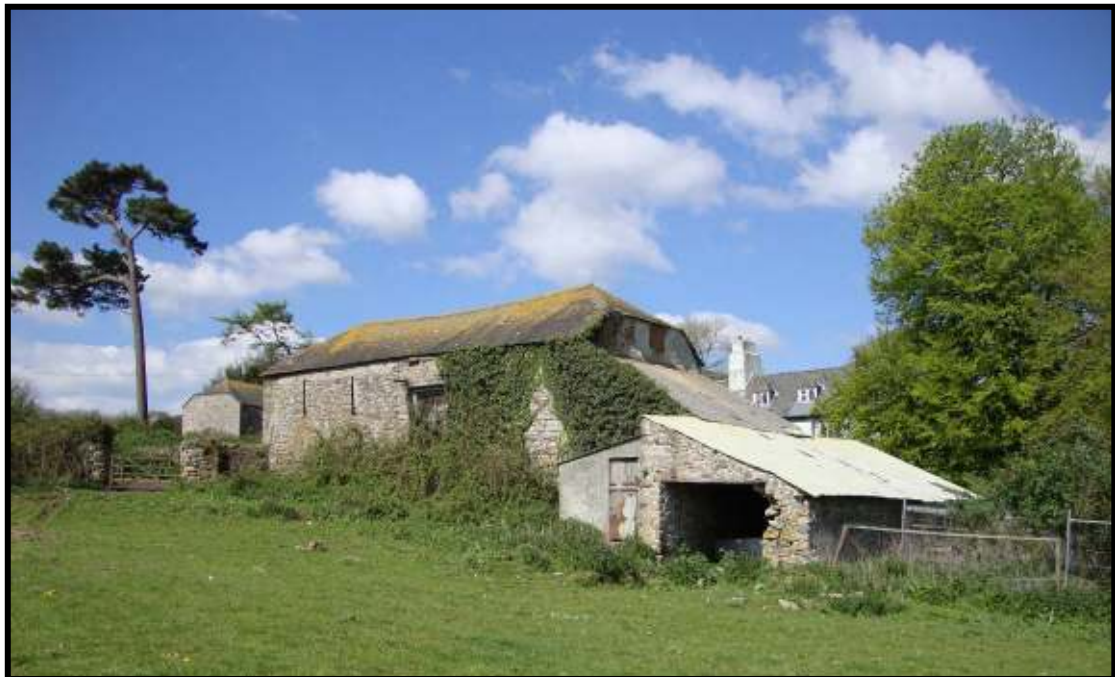
Fig. 7. View of the barn from the east, looking west, showing the lean-to structures against the north-eastern wall and the half-hipped gable of the original structure showing above these.

This elevation (Fig. 7) is now obscured by two lean-tos, one of which is earlier than the other, though both are additions. The upper part of the gable wall of the primary

barn is largely of cob and contains a high-level ventilation slit. There does not appear to have been a corresponding opening below.

Numerous sockets and holes in the north-east wall may be related to earlier lean-to structures; however, they do not really form a very coherent pattern and it is possible that they are cut in, or that they represent putlogs. The two lean-to structures will be discussed below.

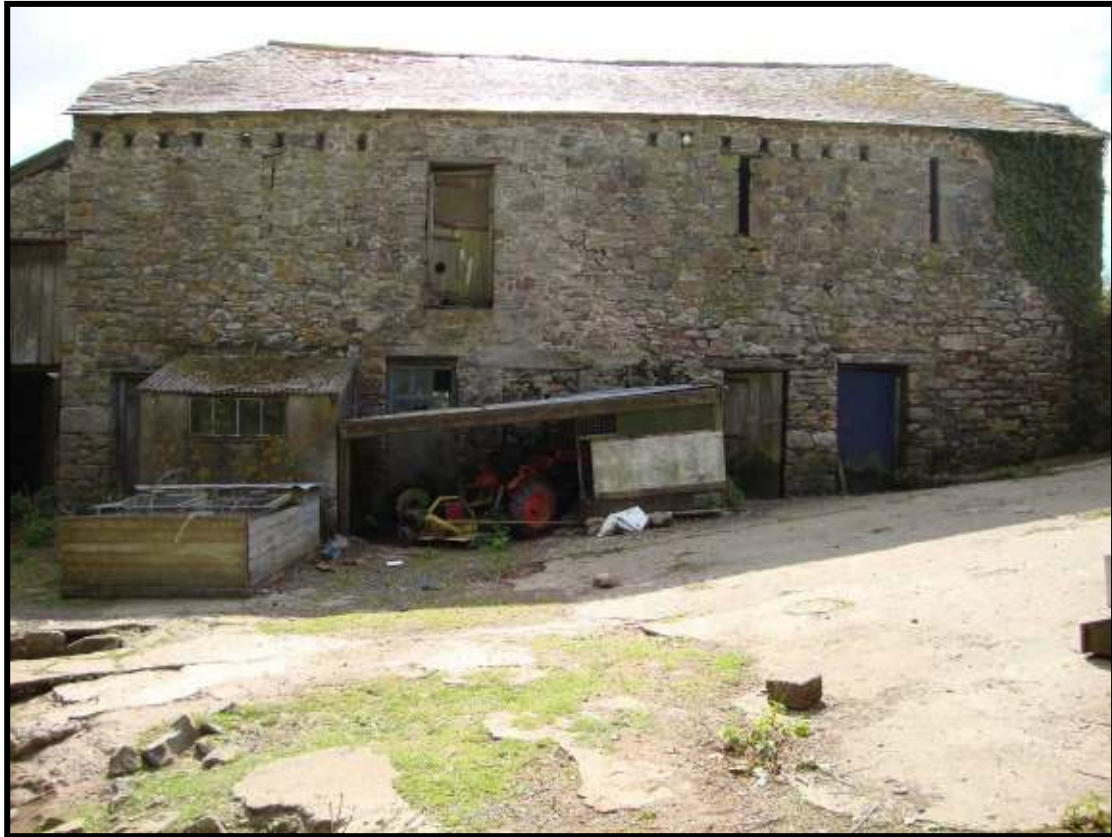
Fig. 8. North-western elevation of the barn, showing the modern accretions hiding the blocked ground-floor doorways and the change in level of the farmyard due to the embanking of the pond.

This elevation is very much more complex and forms the principal façade of the barn (Fig.8). On the ground floor at the south-western end is a pair of doorways, both with timber lintels. These doorways are probably cut in as they have badly-formed jambs. The lintels of both doorways also appear to have been reinforced or repaired, as patches of a hard white mortar cutting into the yellow clay bonding of the earlier masonry would seem to show. It is possible that the south-western jamb of the most south-westerly doorway has been retained from an earlier opening.

On the first floor, above this, is a pair of primary ventilation slits. The row of seven dove holes immediately below eaves level appear to have been introduced in a rebuilt part of the wall. This might again represent rebuilding of an earlier cob wall top securing the feet of the principal rafters.

Towards the centre of the façade is an area of cracked and disturbed masonry which seems to relate both to a repair and an earlier opening. The lower part of the elevation at this point appears originally to have been a single wide doorway, which was subsequently converted into a pair of separate doorways. One of the original

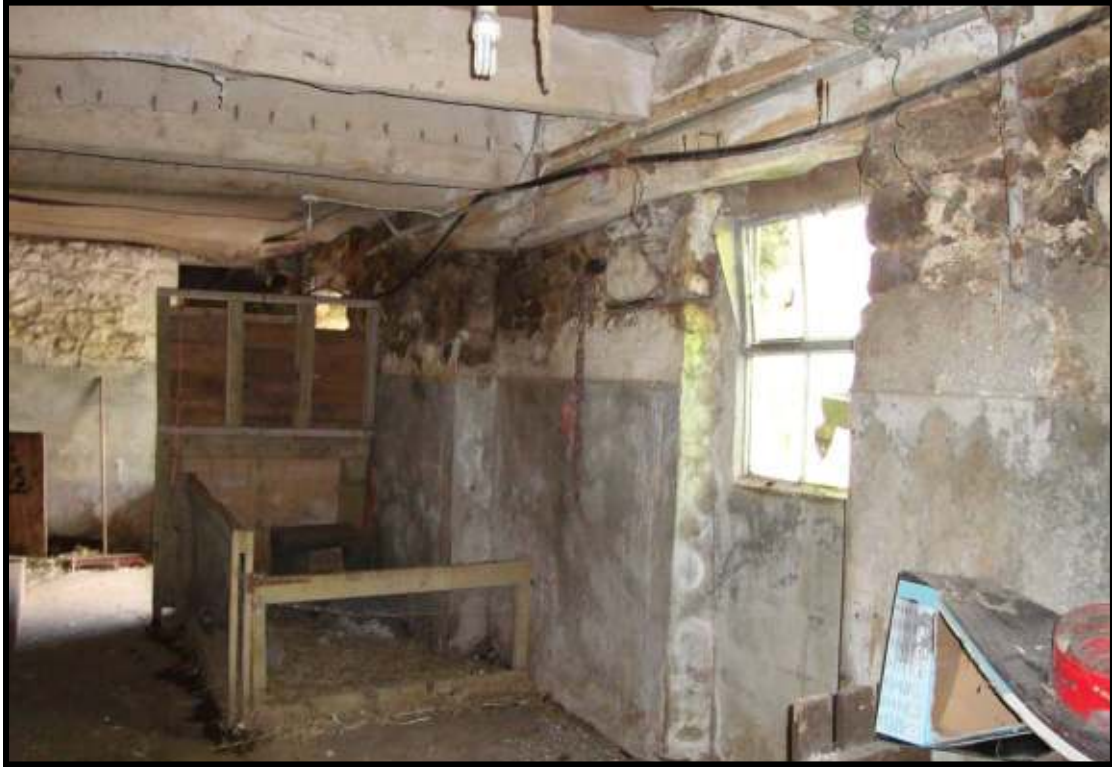
timber lintels is visible within the interior (Fig. 9). The present external lintels are presumably replacements but are obscured by concrete render. Both doors have been blocked: one in stone and the other in concrete blocks incorporating a steel-framed window of mid 20th-century date.

Fig. 9. Interior of the ground floor, looking west, showing the wide blocked doorway in the north-west wall, which is balanced by a similar doorway opposite.

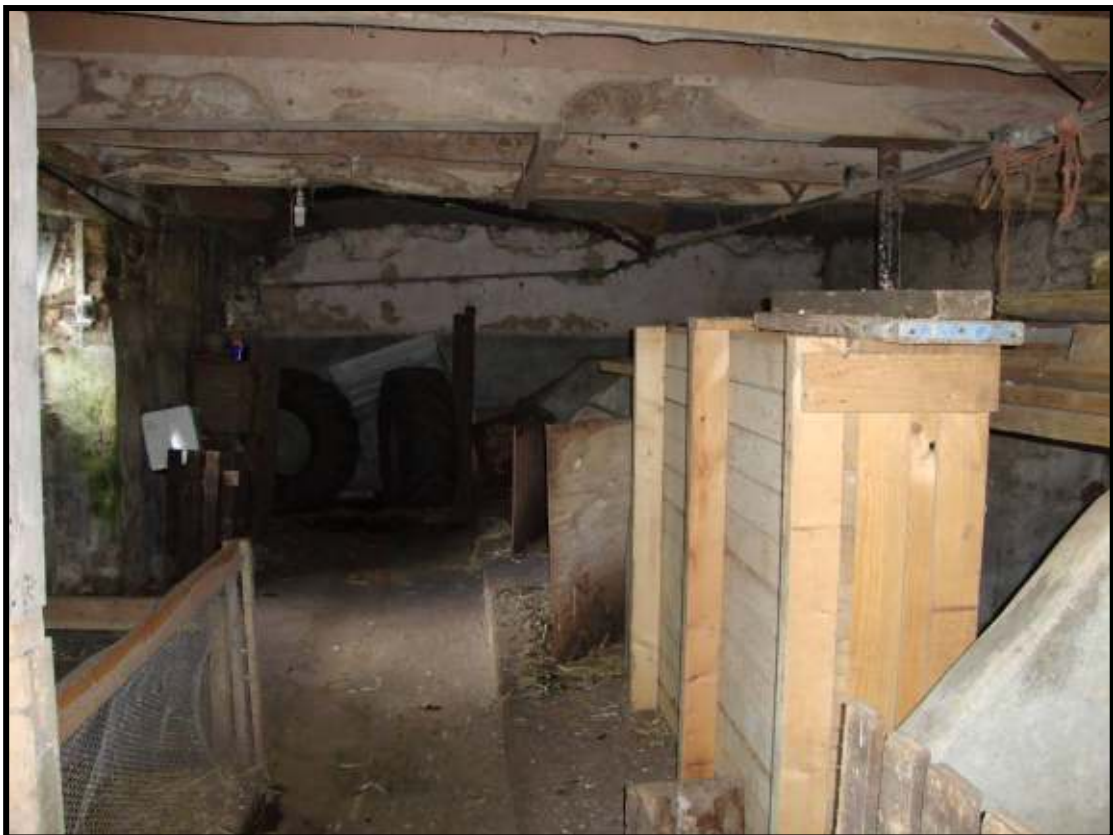
The north-eastern part of the barn is furnished as a cattle shed, with four double cattle stalls, each with two troughs and two tethering staples. To the south east is a broad head walk running to a short passage against the north-eastern wall. The stalls are divided by concrete partitions of 20th-century date and the walls are rendered for the sake of hygiene. The render covers the blocking of both of the doors in the south-east wall. The ceiling joists run parallel with the building except in the area of the former double doors, where the ceiling is crossed by four massive, crudely squared beams of a very blond wood, retaining much bark, probably elm. These appear to represent reinforcement of the threshing floor on the upper storey.

Fig. 10. Interior of the shippon, looking to the north east, showing the concrete stalls and the beams reinforcing the threshing floor above.

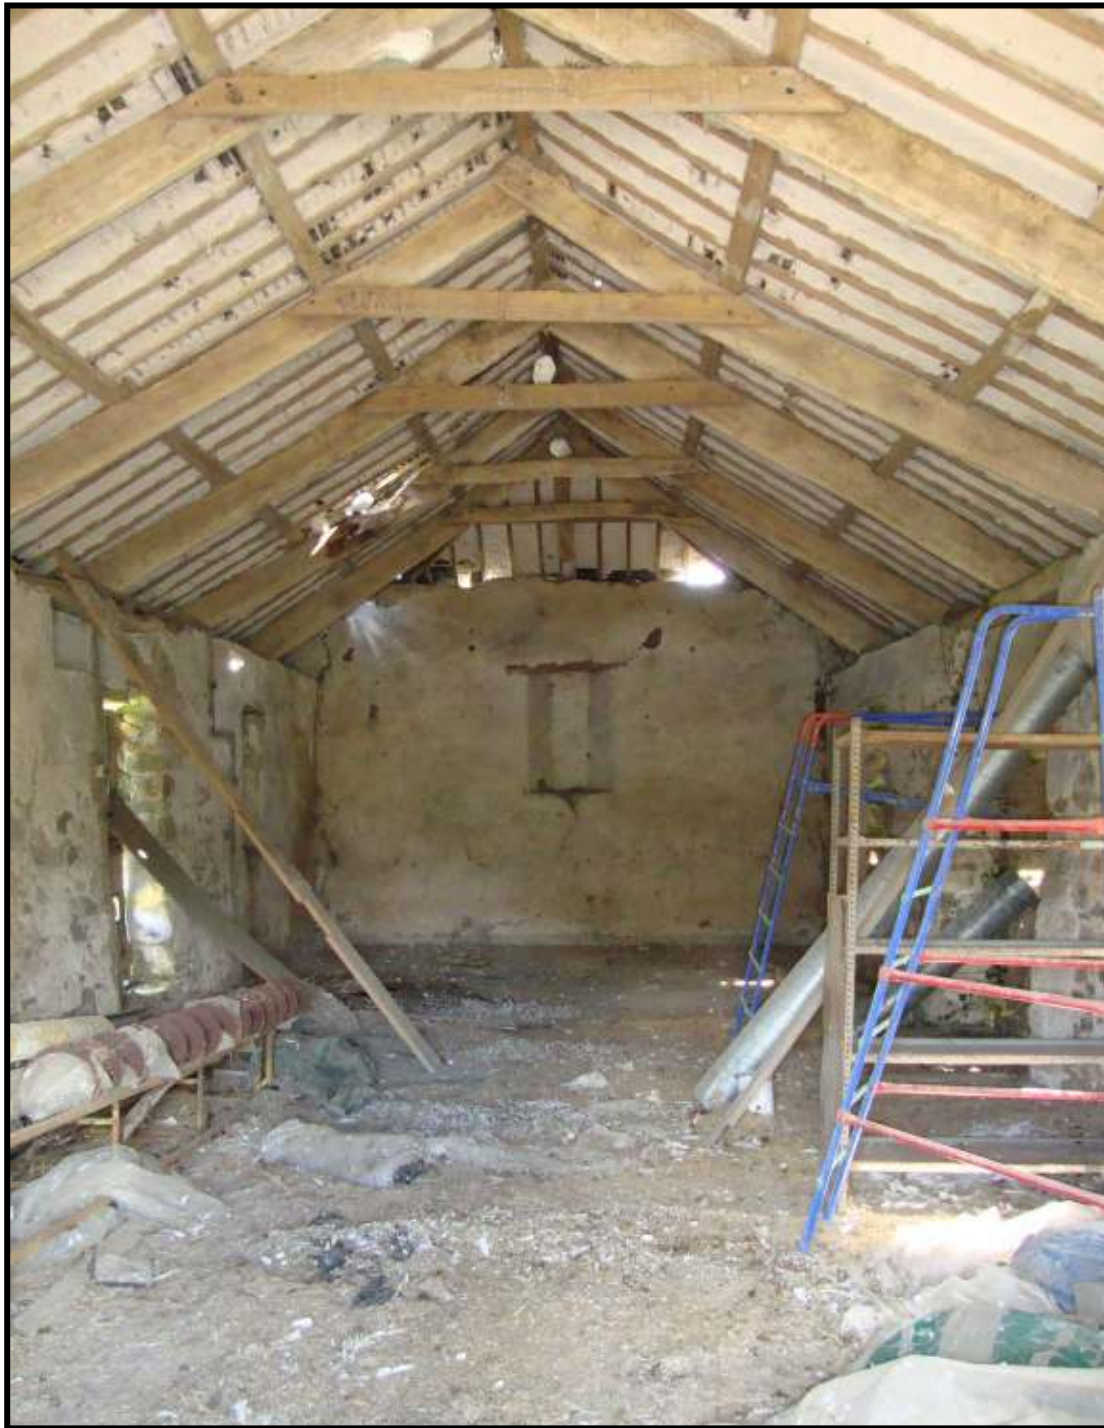
This storey appears to have housed the main threshing area, with good ventilation and lighting and the facility to create a draught through the opposed doors on each side. It may also have been used for the storage of fodder, since it has plastered walls and torching between the rafters (Fig. 11).

Fig.11. Interior of the first-floor threshing barn showing the opposed doorways in each side, the blocked ventilation slit in the north-eastern gable and the structure of the roof.

There is clear evidence that the large door in the north-western wall has been narrowed; the original dimensions of the doorway survive just below eaves level and a timber lintel remains. The alteration must have been made prior to the application of the existing plastering of the walls, which extends over the blocking. The ventilation slits in the north-west and the south-east walls are well splayed to maximise the lighting. The single slit in the north-east wall has been blocked and rendered over and survives only as an embrasure. The plastering at eaves level is clearly secondary and may be contemporary with the common rafters, slating and torching of the roof. The floor is considered to be unsafe and the first floor was therefore not entered.

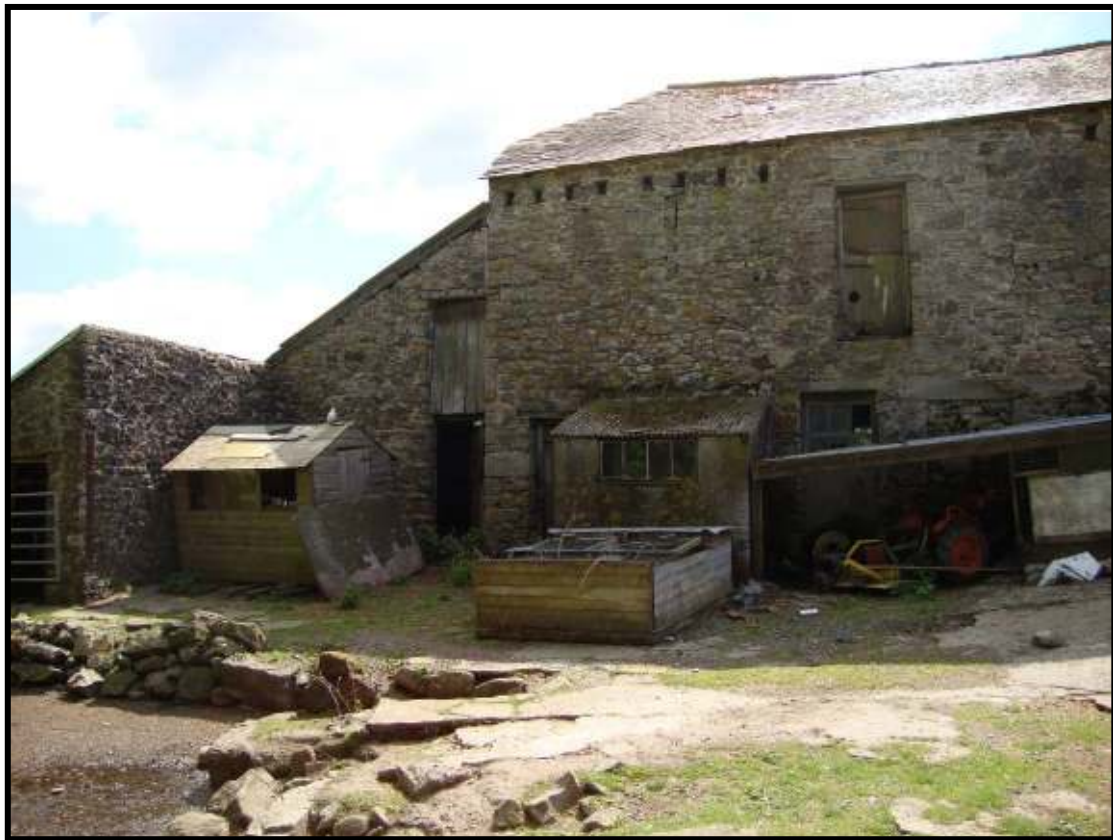
Fig. 12. View of the lower end of the building, showing the clear building break between the end of the barn and the adjacent lean-to structures.

The north-eastern lean-to structures are clearly additions. These structures can be seen to butt against the earlier barn (Fig. 12) and the present rooflines rise higher than the slit window in its gable, entirely blocking it. There is a single, tall opening in the north-west wall of the earlier lean-to, serving both levels of the interior. The upper part of this opening is now completely blocked by boarding. The opening has a timber lintel with a series of drill holes (Fig. 13). This may be a reused vertical stud or muntin from an early partition featuring rod laths to support a plaster panel.

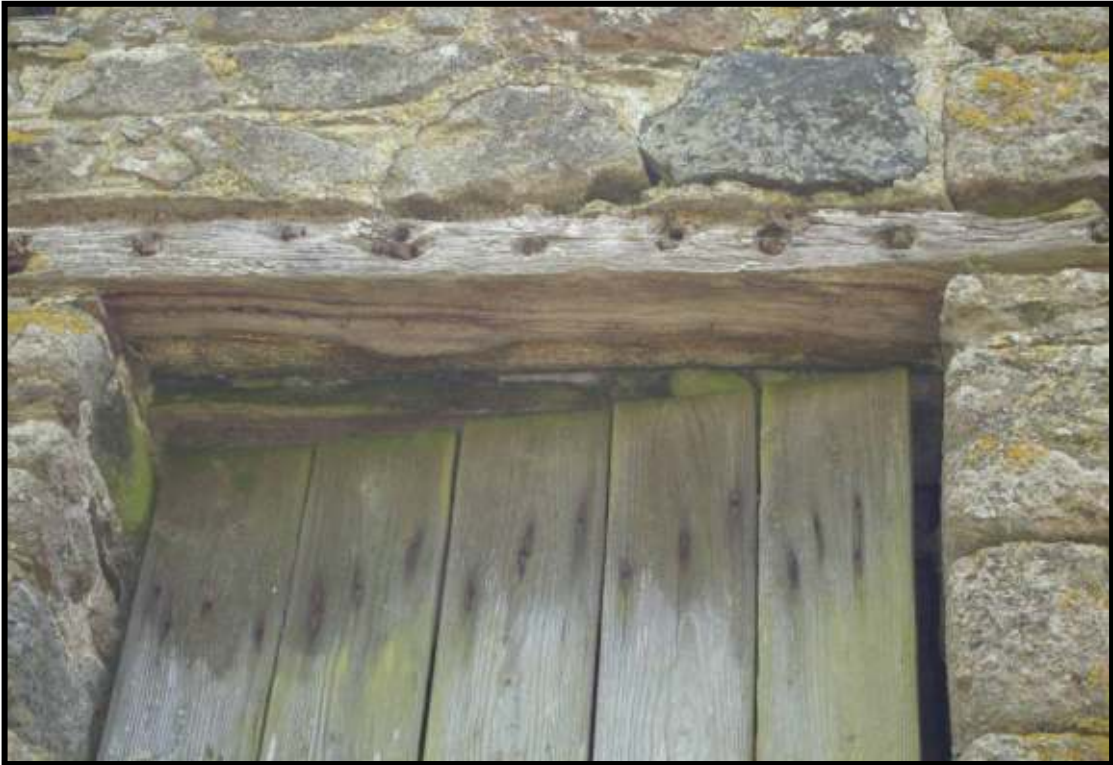
Fig. 13. Detail of the lintel above the lean-to loft doorway showing the series of holes suggesting reuse of the timber from a rod and muntin partition.

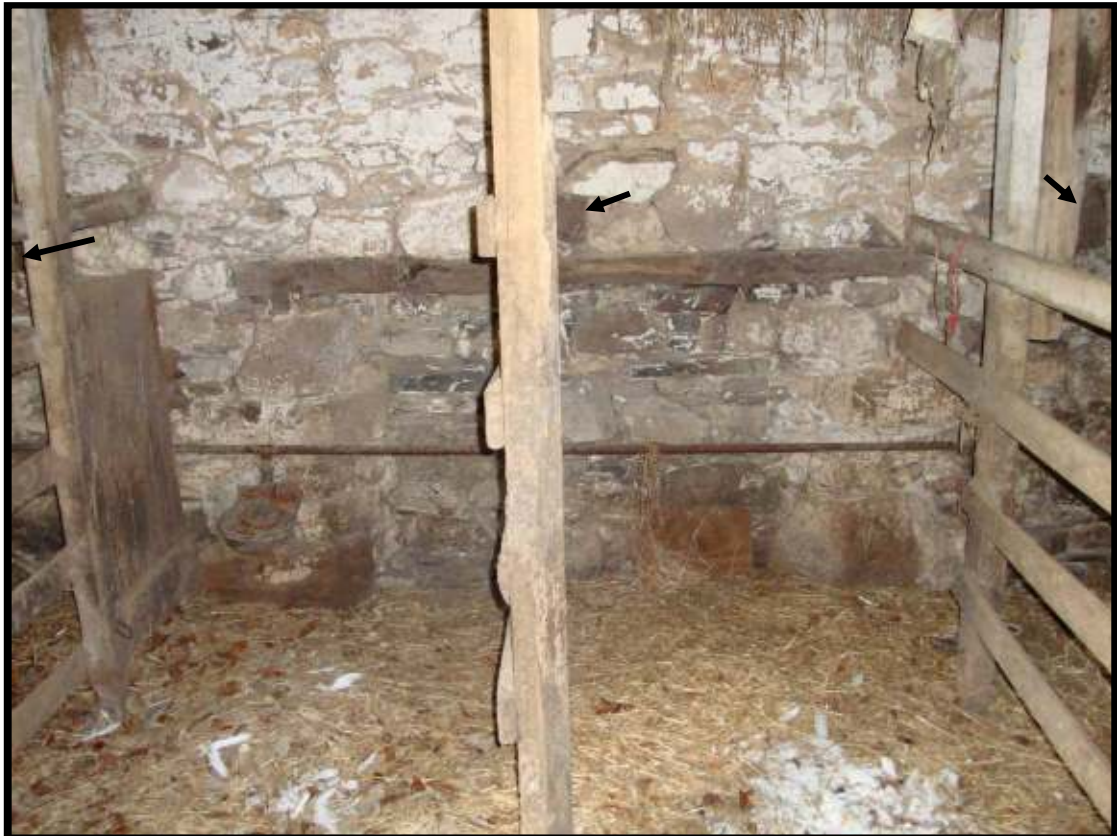
Fig. 14. Detail of the north-east wall of the lean-to showing the blocked, splayed opening at a low level in the end wall of the building and (arrowed) the sawn-off stumps of timbers probably relating to an earlier ceiling, possibly removed when the levels of the farmyard were altered to embank the pond.

The interior of this part of the building is fitted out with very narrow stalls, probably for calves (Figs. 14, 15). The joists of the present loft floor are of undressed poles cut into the gable walls of the earlier barn. The loft floor is entirely gone but does not appear to have been of any great antiquity.

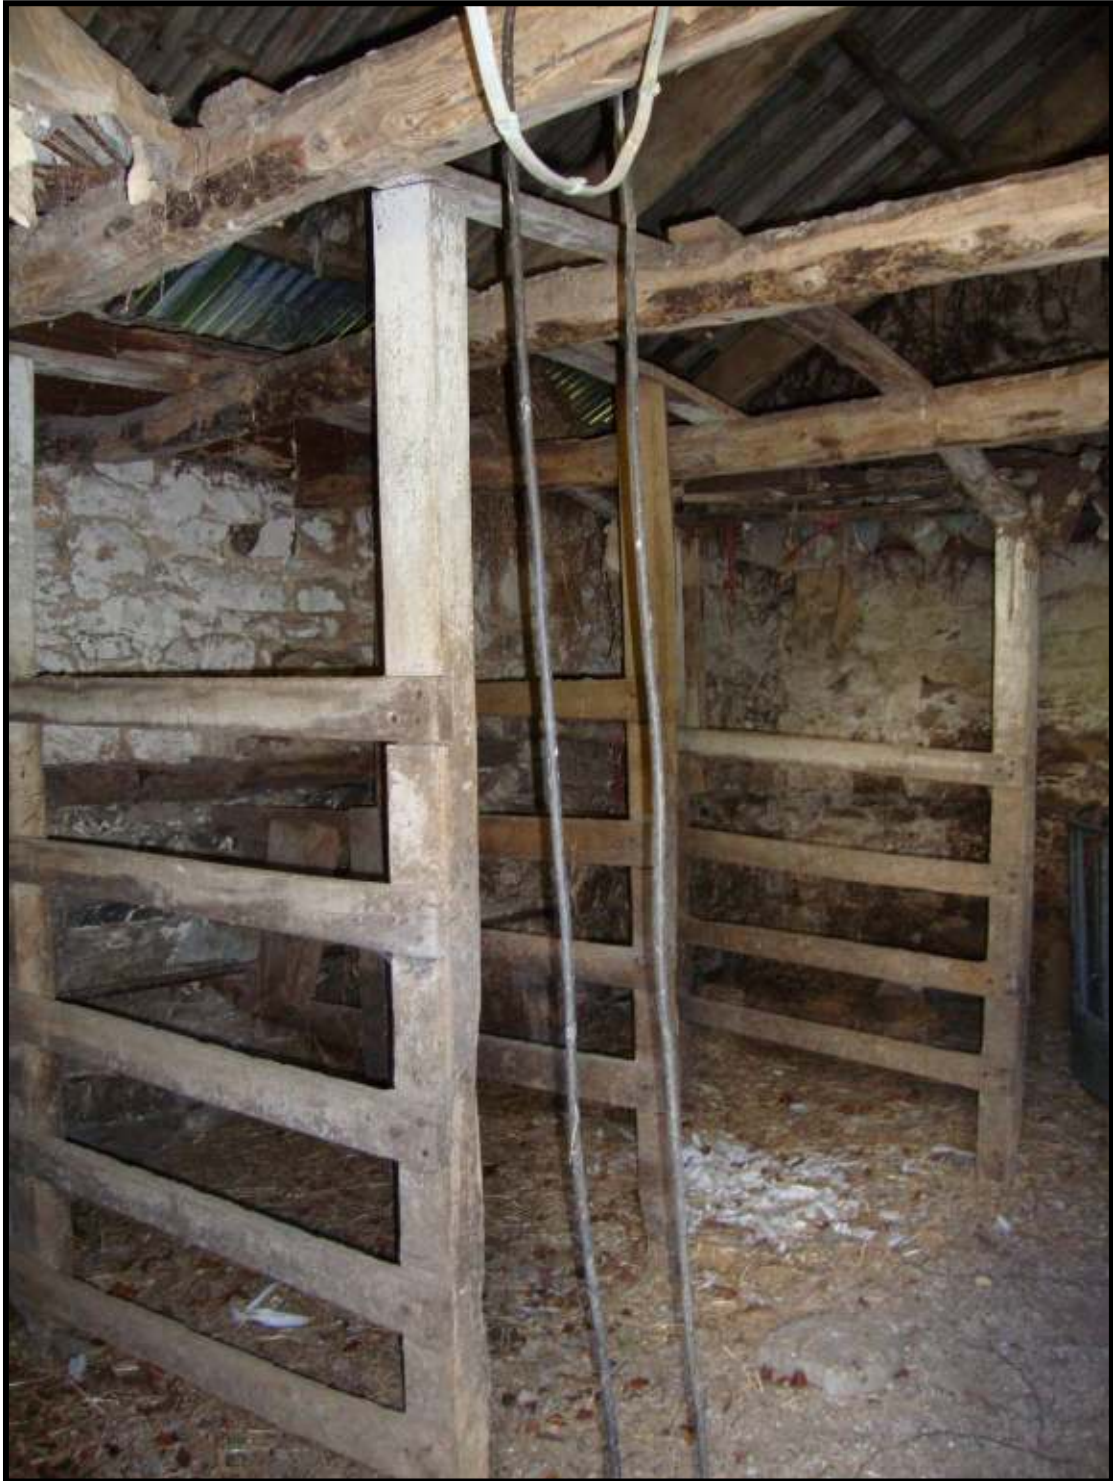
Fig. 15. Interior of the earlier of the two lean-to structures showing the narrow stalls, possibly for calves.

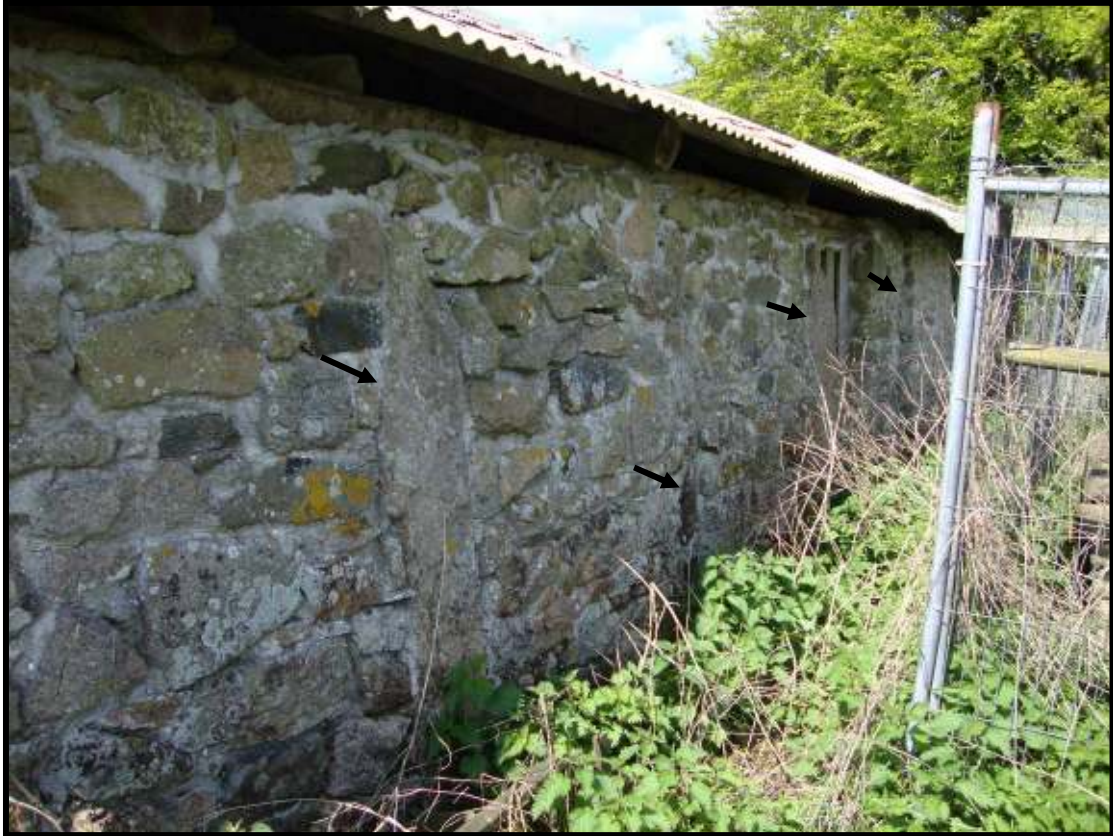
Fig. 16. View of the north-eastern wall of the linhay, showing the positions of some of the granite monoliths (marked by arrows).

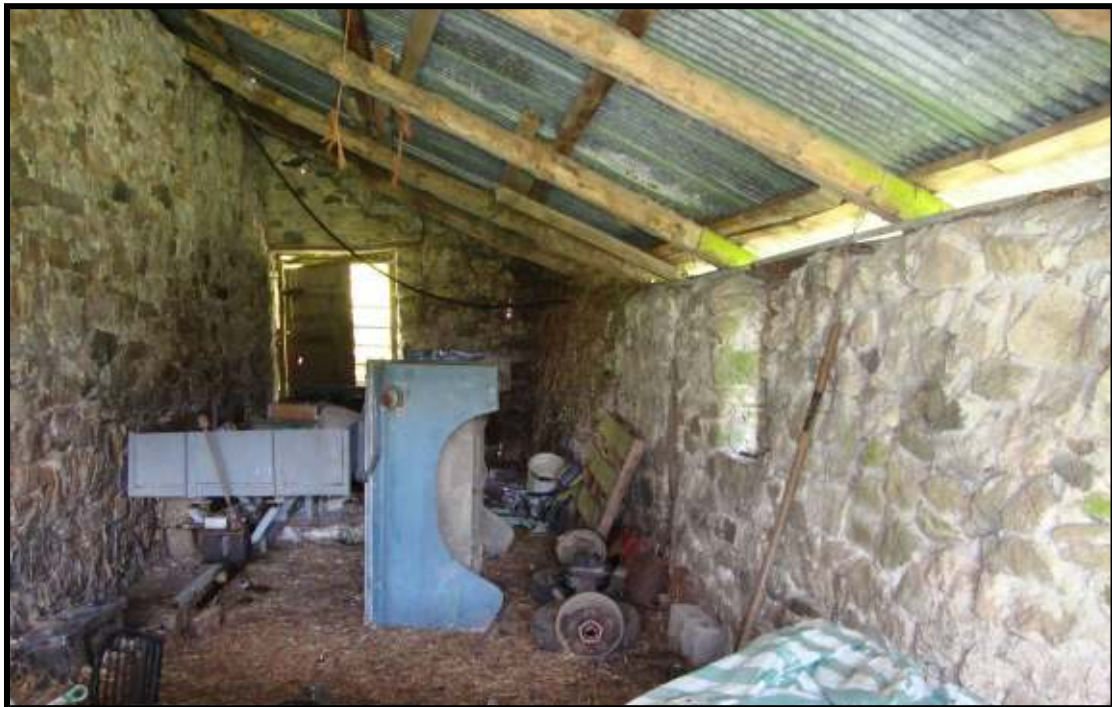
Fig. 17. Interior of the linhay showing the modern roof structure and the wall (right) infilling the gaps between the monoliths.
