10-15 Princes Street

Archaeological Watching Brief : September 2011 – August 2012

Data Structure Report (AA 1944)

Ogilvie Construction Ltd.

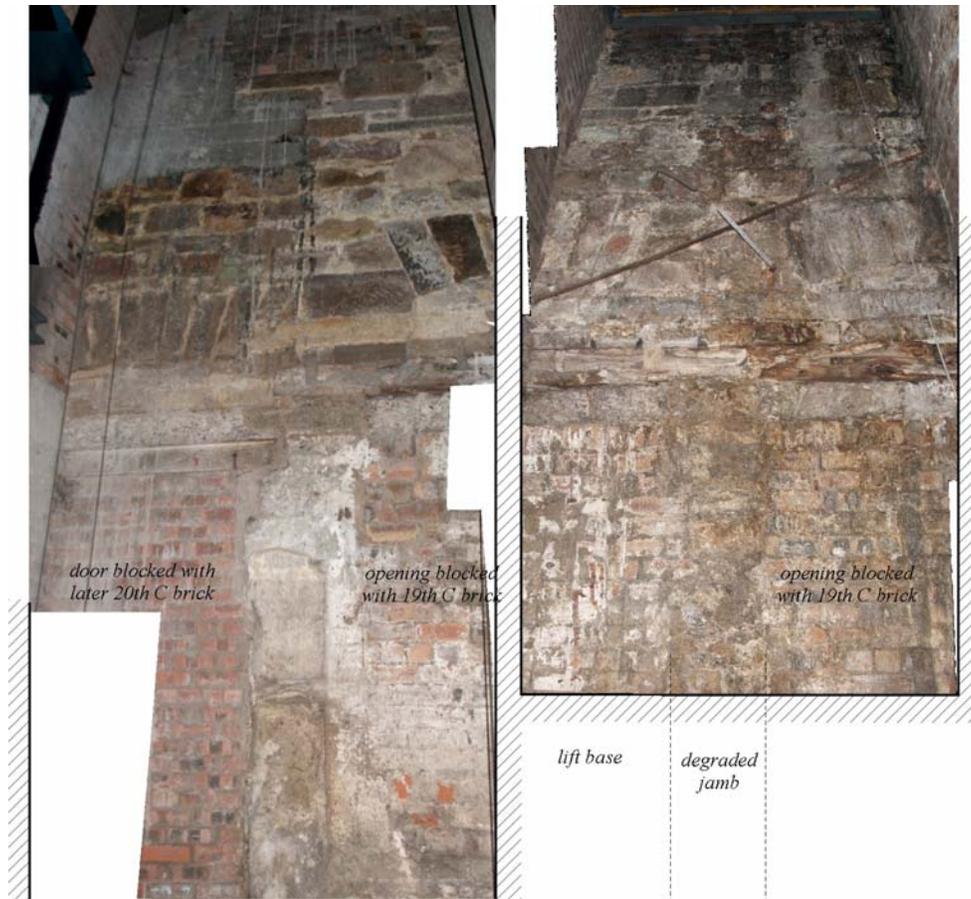
Within the western lift shaft an apparent blocked entrance was seen at basement level; this appeared to have been blocked flush with the wall face with cemented bricks of later 20th century date. The opening was linteled over in stone, with a stone relieving arch over.

To the right (E) of the entrance appeared what may have been a further opening/window again blocked up flush with the wall face; the bricks in this area are of 19th century character and bonded with a lime mortar, some traces of a lime plaster overlay these. Above this blocking was a further stone relieving arch, but at a noticeably higher level than the first; this opening continued behind the central brick wall of the lift shaft and could be seen continuing beyond this on its E side. Further E another stone relieving arch at the higher level indicated the presence of another blocked opening, this continuing behind the eastern wall of the lift shaft. Between and below these last two arches existed a heavily obscured vertical masonry pier, now somewhat degraded at the face – evidently a pier between the former openings.

Above the openings mixed rubblework masonry continued up to approximately ground floor level, with only a couple of patches of brickwork continuing above this the only noted features. These were apparently the blockings of openings/ bases of former windows. The wall face in its upper part was heavily obscured by concrete running down the face, especially to the west.

A horizontal beam of rough timber was set within the masonry at the height of the left-most lintel (above the entrance); this extended for much of the length of the exposed masonry, from the E side of the lintel of the western opening to beyond the east lift shaft. Whether this timber beam was an original safe lintel to the openings/ windows below or a later insertion was not entirely clear as directly beneath this a band of formed concrete ran across and cut into the entire width of the masonry. This cut across the upper part of the entrance, with a new concrete lintel replacing the stone one at a lower level beneath the concrete (poured concrete floor level?). The timber may have provided support for the masonry above while the concrete was being poured though, given its position, a single safe lintel running across both windows is probably more likely.

Plate 1 Composite photograph of the masonry remains surviving within the area of the two lift shafts, showing blocked openings at basement level

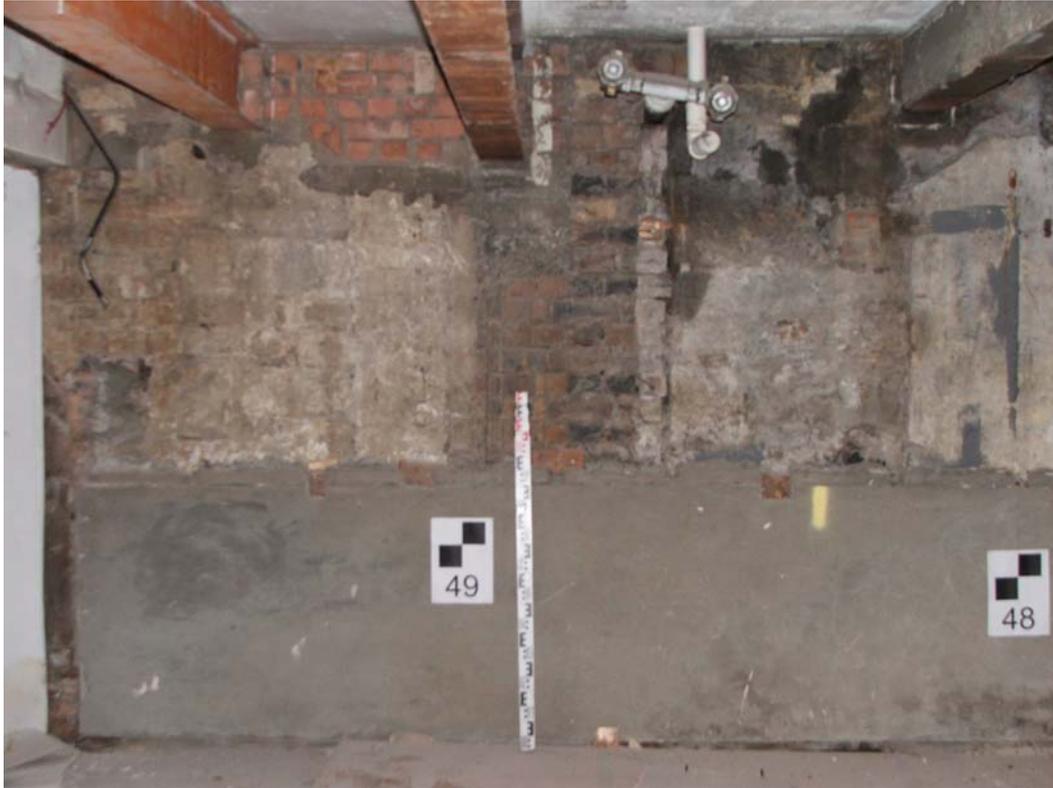
To the west of these lift shafts a further area of stripping part uncovered what is likely to be the remnants of similar features, although these were heavily obscured with later cement, plaster and paint coverings.

Plate 2 Brick patching of blocked openings(?); masonry pier to right of scale (Photo 1944 (079))

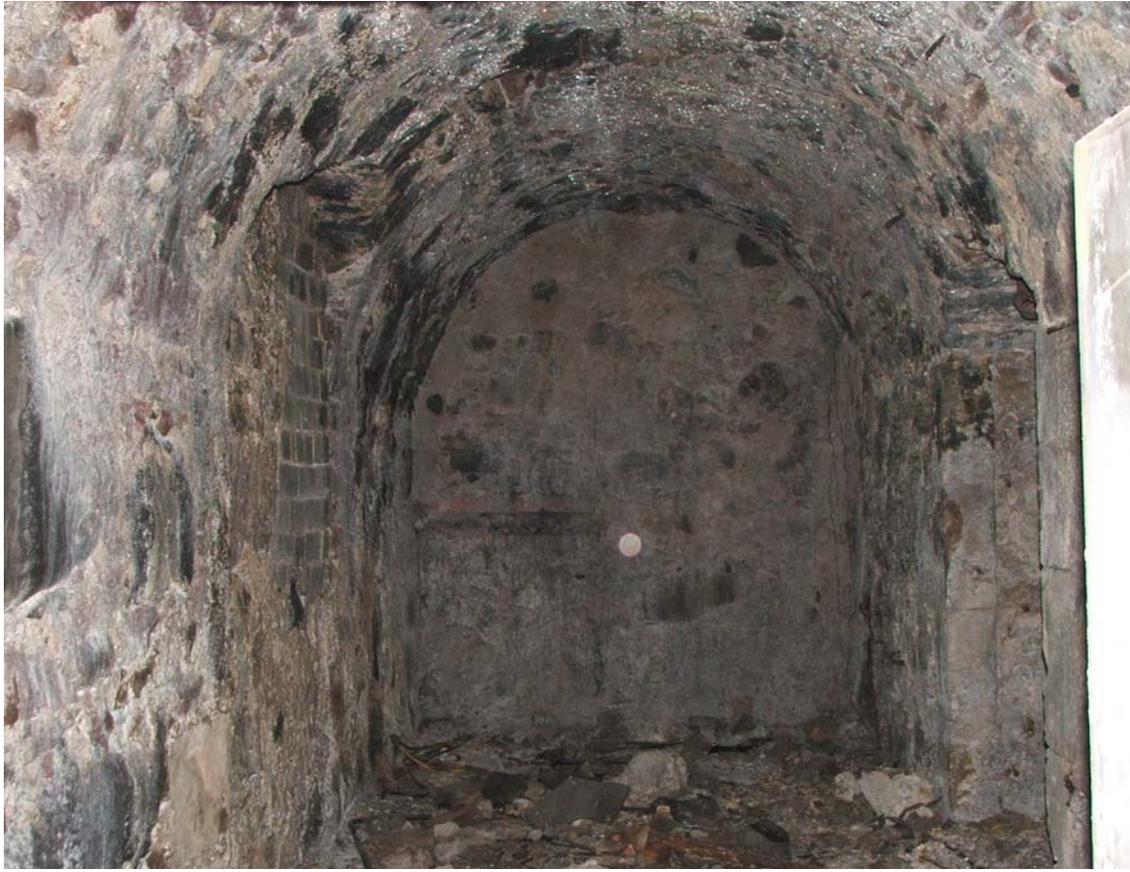
Through this hatch an earlier tiled stairwell was visible, now partly blocked off behind the modern stair linings; the vault leads to the E from this earlier stair. at the time of the initial exposure no access existed to the vault except through this small hatch .latterly the vault was opened up to allow access but no new features were noted. On the south wall there was a brick blocked up door to the vaults to the south this blocked door was visible in the southern vault .to the north is a further apparent rubble and brick blocked opening, this blocked northern door may lead to further vaults as yet undiscovered

Plate 3 Interior of blocked of vault first exposed as seen through the hatch (photo 1944 (031))

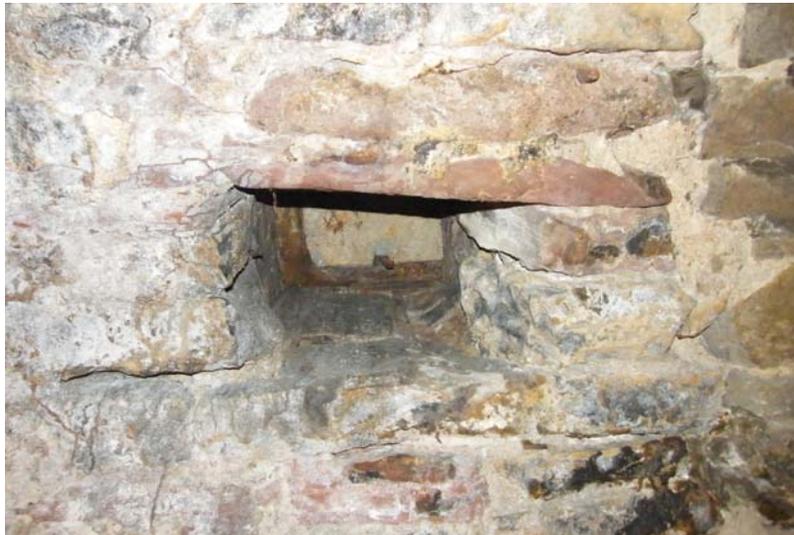
The vaulting was of rubble stone bonded with lime. At the apex of the vault there was a small opening to ground level, a small amount of daylight could be seen coming between a manhole cover covering this and the side. So the vaulting must have been near the exterior ground surface.

Plate 4 Man-hole cover over opening in vault looking up

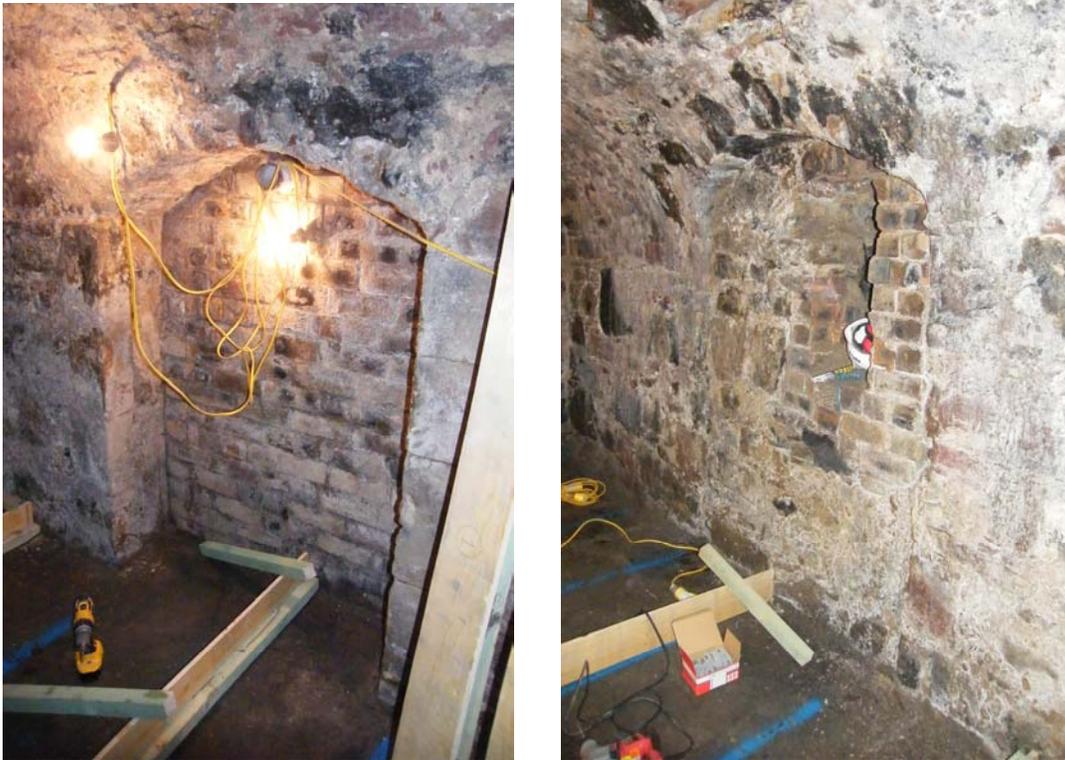
Plates 5 and 6 Brick-blocked southern entrance and, right, blocked northern door (photo 1944 (147-148))

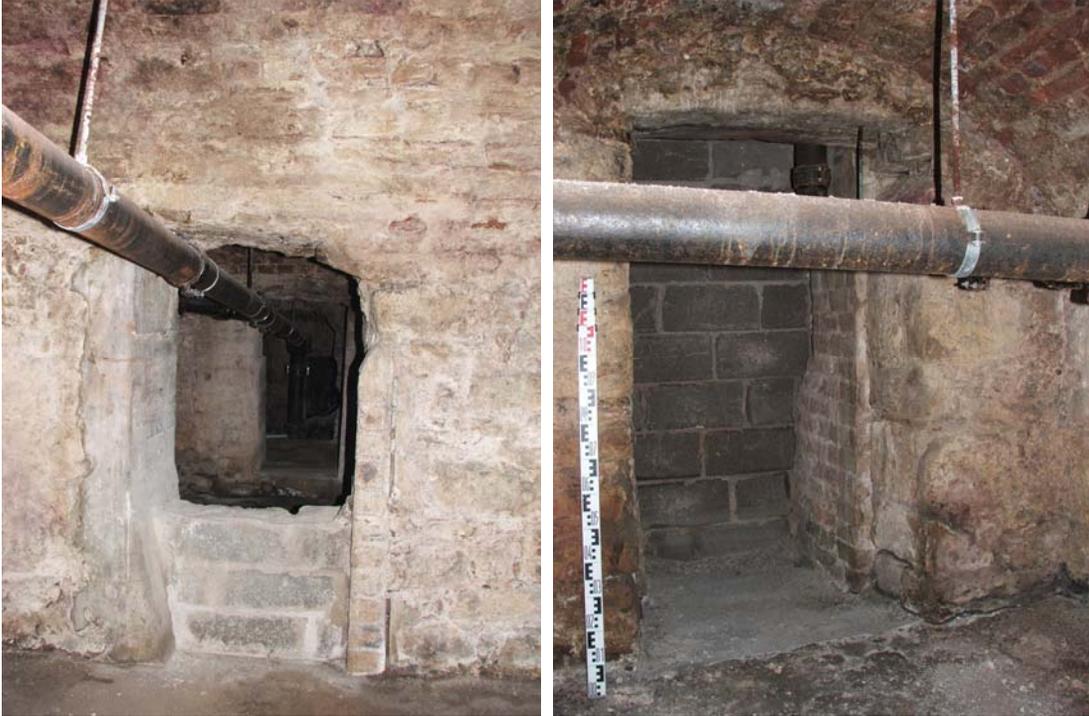
The walls of these were constructed of lime-bonded rubble stone and then vaulted in brick, and at least some of them were plastered onto the hard, though the plaster has mostly fallen. Many of the chambers had had their northern (and only) entrances blocked off and the only access between them now was through rough openings slapped through the rubble partition walls. These slappings were evidently undertaken for the installation of large services pipes, *plates 7 and 8*.

Plates 7 and 8 Interior of vaulting below princess street shows slappings through party walls (photograph 1944 (059)) and blocked door (photograph 1944 (062))

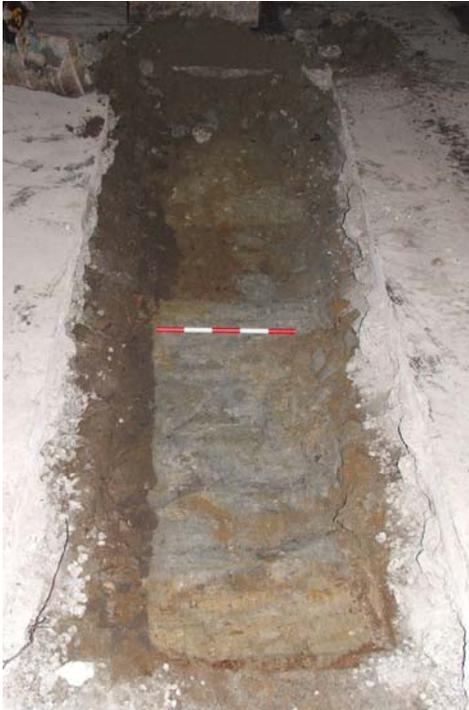
During the foundation work, a series of W-E aligned linear trenches were excavated aligned N-S across the western end of the site, *plates 9-10*. In three of these trenches a dark c.N-S linear was clearly discernable, yet excavation showed this to be a corroded FE service pipe.

Plate 9 Excavation of W-E foundation trench along the western side of the site. Note the long dark cut running N-S along the left of the trench – this is the cut for the existing foundations. Also note the W-E aligned linear feature above the ranging rod (Photograph 1944.02 (159))

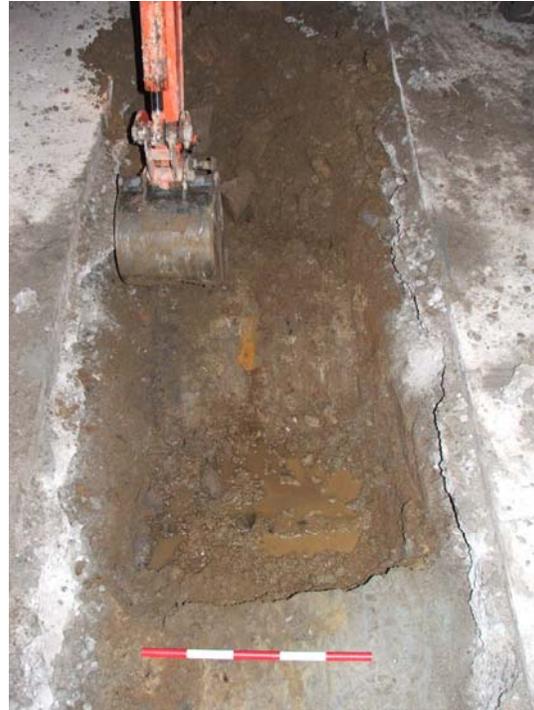
Plate 10 Detail of linear post-excitation showing the Fe pipe (Photograph 1944.02 (172))

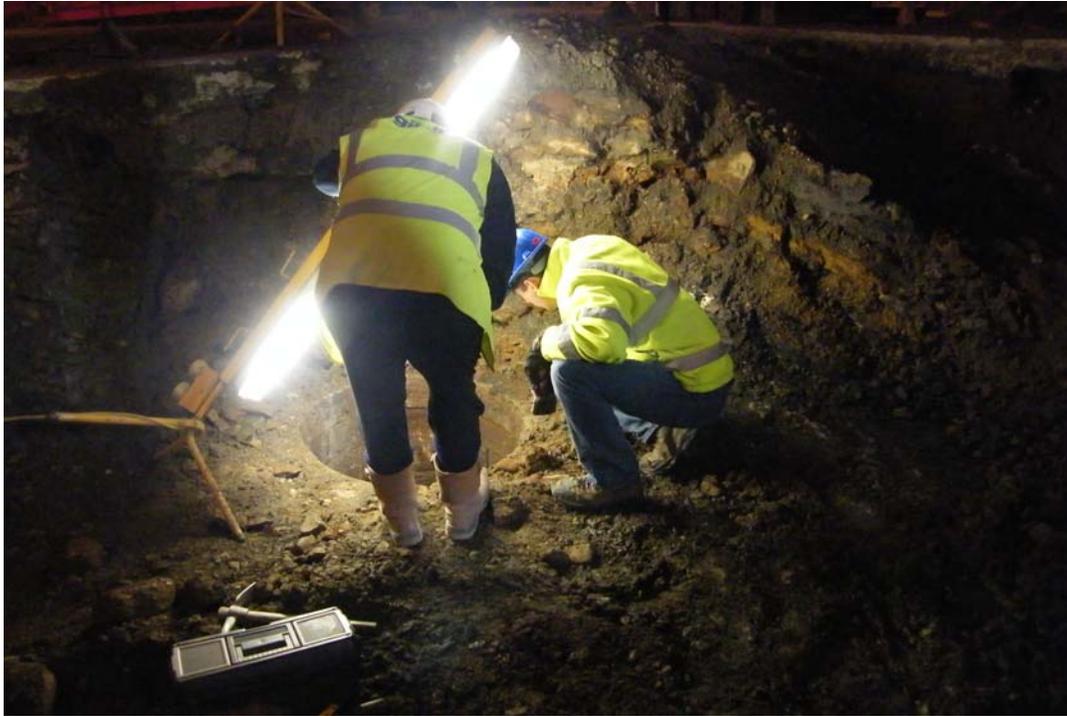
Upon arrival on site it was clear that the remains of the well had been truncated in part by the on-going excavation, with the cut still visible in the section of the access ramp to the E. The well itself was filled with loose debris and rubble, with the base remaining inaccessible and unexcavated.

Plate 11 Assessing the well {003} upon arrival on site (Photograph 1944.02 (109))

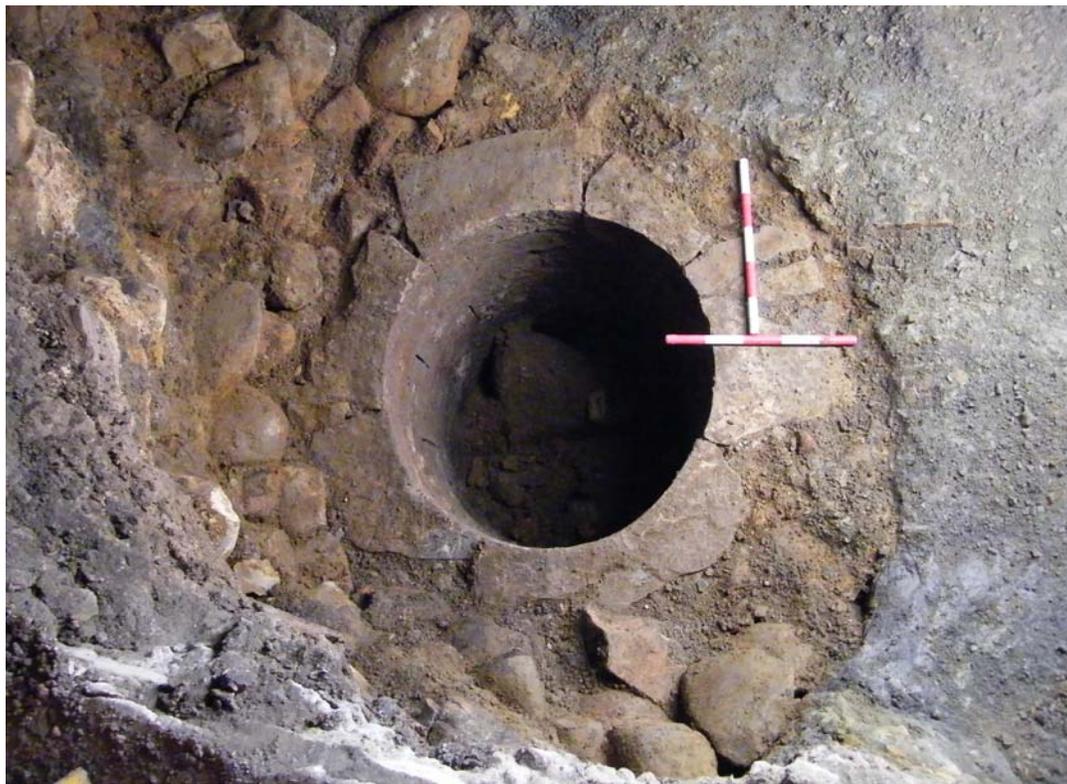
Plate 12 View from above and N into the foundation trench for the crane pad and showing {003} within [004] (Photograph 1944.02 (123))

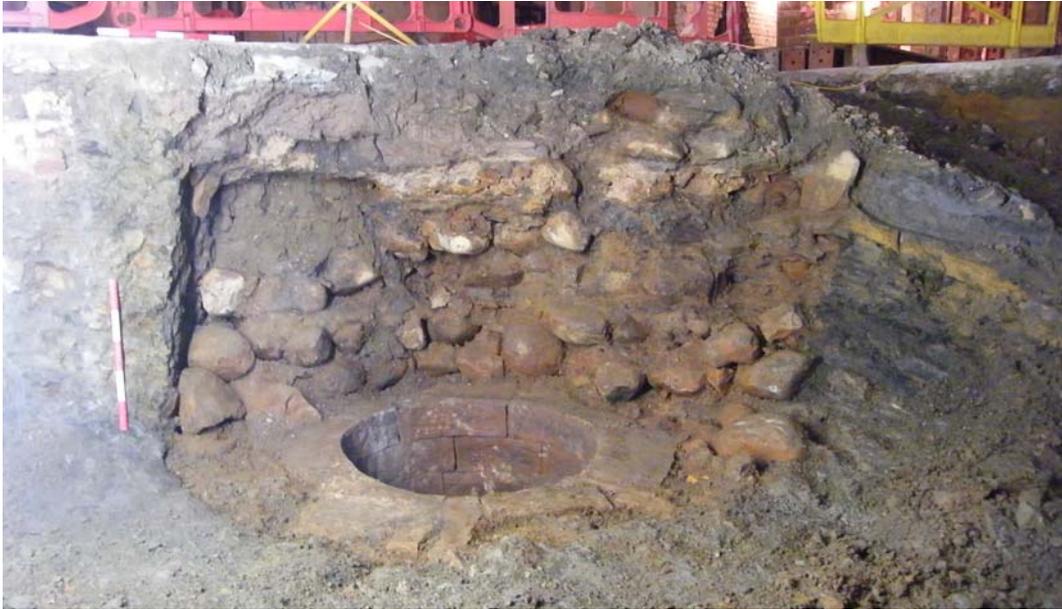
Plate 13 Post-excavation view of {003} looking NNW.
Note the cut running into the access ramp on the right of the image (Photograph 1944.02 (127))

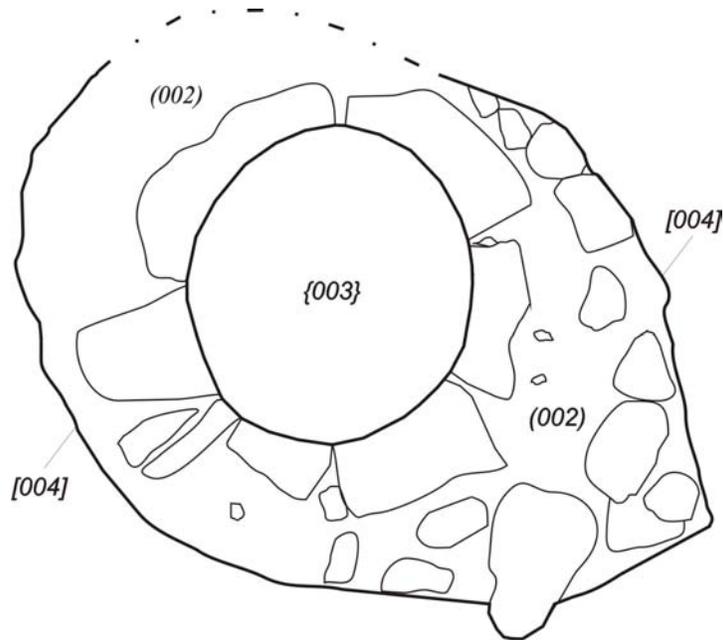
Figure 4 Plan of the well as exposed

Cleaning around the remains of the structure showed it to be a solidly constructed well of roughly tooled ashlar blocks, un-bonded, with open joints – {003}. The high quality of construction is perhaps surprising at this depth within a feature built below ground and never meant to be seen. Deeply truncated through the natural subsoil, the cut [004] had clear, vertical sides against the dark grey boulder clay (001). After the well construction cut was made, the shaft walling {003} had been put in place and the space between the two backfilled with a deposit of abundant medium to large rounded boulders with a surrounding loose matrix of re-deposited natural, this of mid orange brown clay –

(002). The weight and volume of this material would evidently apply pressure onto the structure of {003}, negating the need for bonding material.

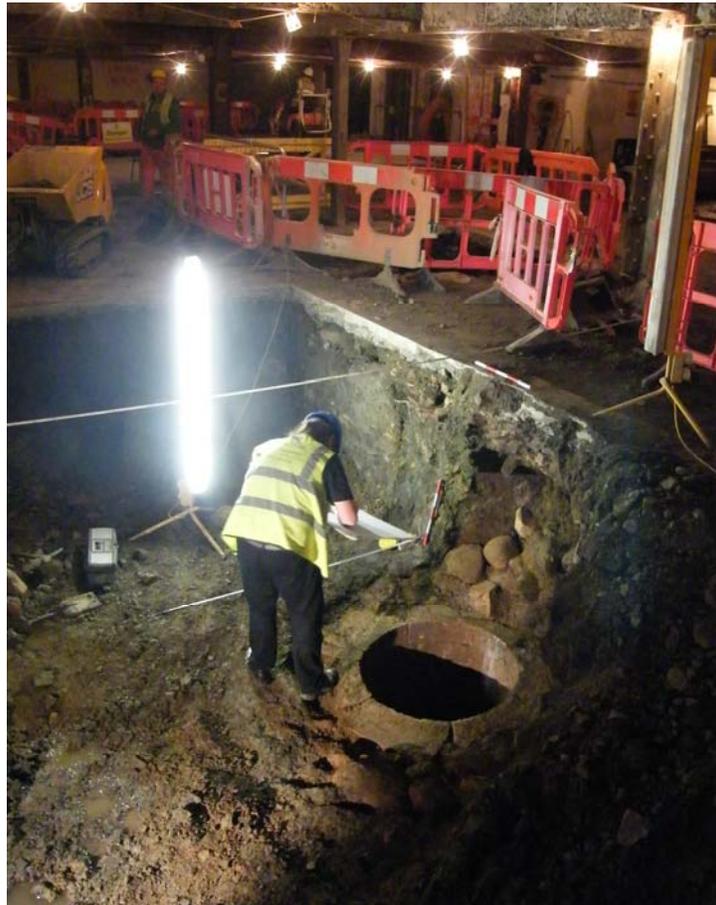
*Plate 14 Working shot – recording {003} from the SE atop the access ramp
(Photograph 1944.02 (129))*

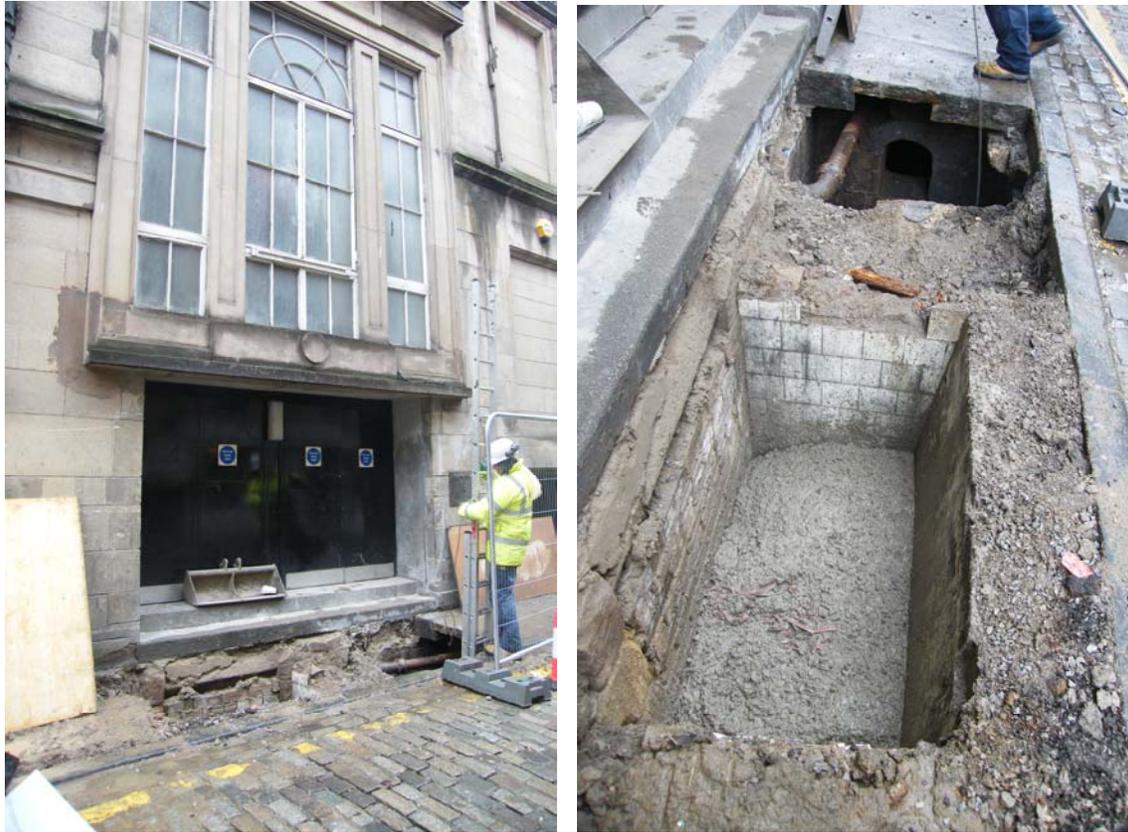
The works followed the breaking away of the existing pavement to allow insertion of foundations for a massive structural propping to support the façade during demolition works. As part of this exercise the slabbing of the pavement was lifted whereby a deep void was uncovered to the extreme west of the area impacted. Immediately east of this was a much shallower and part in-filled tiled light-well to a single brick blocked window (latterly infilled with concrete for the foundations), *plate 16*.

Plate 15 General location of sunken area as first exposed (Photograph 1944 (105))

Plate 16 Tiled light well (Photograph 1944 (107))

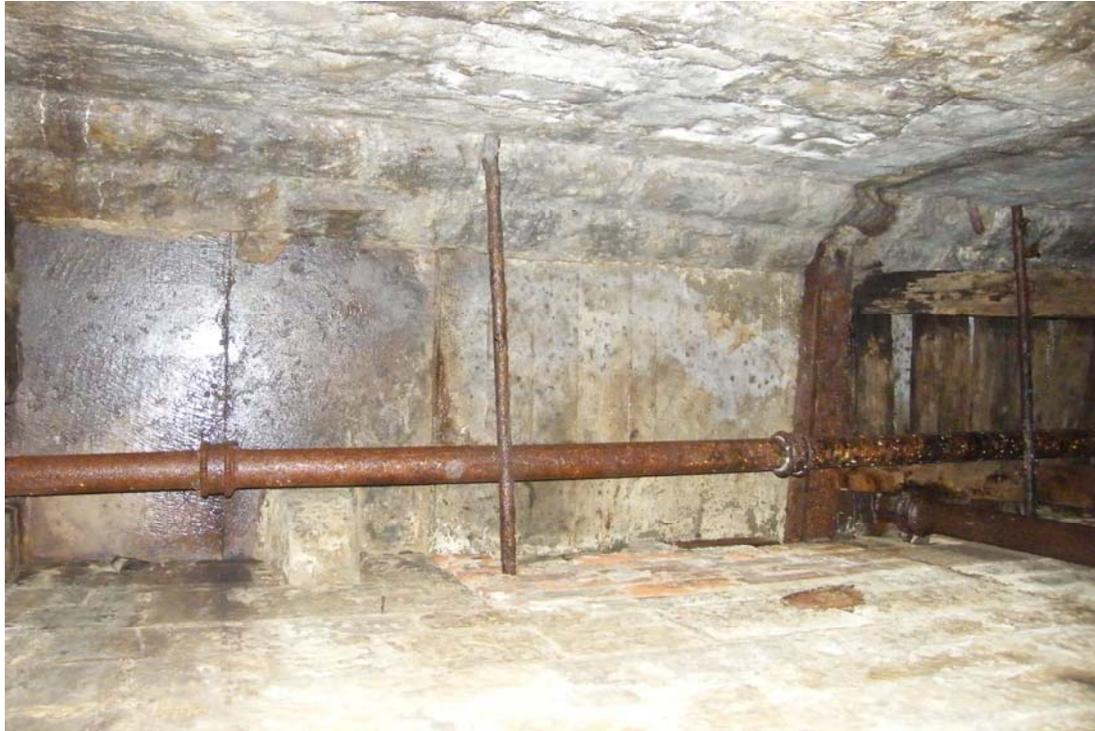
The deeper void consisted of a 4.5m deep narrow alley/light-well running along the rear exterior of the building beneath the pavement. This was capped by the sandstone slabs of the pavement; these were 0.10m - 0.20m thick sitting on a 0.1m off-set to the south and upon a double rounded corbelling-out on the road side, *plate 17*.

Some areas of the slabbing had been replaced with poured concrete, indeed some of the rotten timber forming for this still hung precariously from the roof, the poured concrete slab appears to relate to areas of brick patching with the surviving stone slabs where visible ending in line to the edges of these patches. Access to this sunken area was by a steep ladder down the easternmost narrow “chamber”, this may have had a small manhole in the slabs above (see plate 15 for section) and may possibly have been a coal hole

Plate 17 Looking up to underside of pavement slabs, roadside corbelling to top and timber shuttering for concrete replacement in situ to right (Photograph 1944 (074))

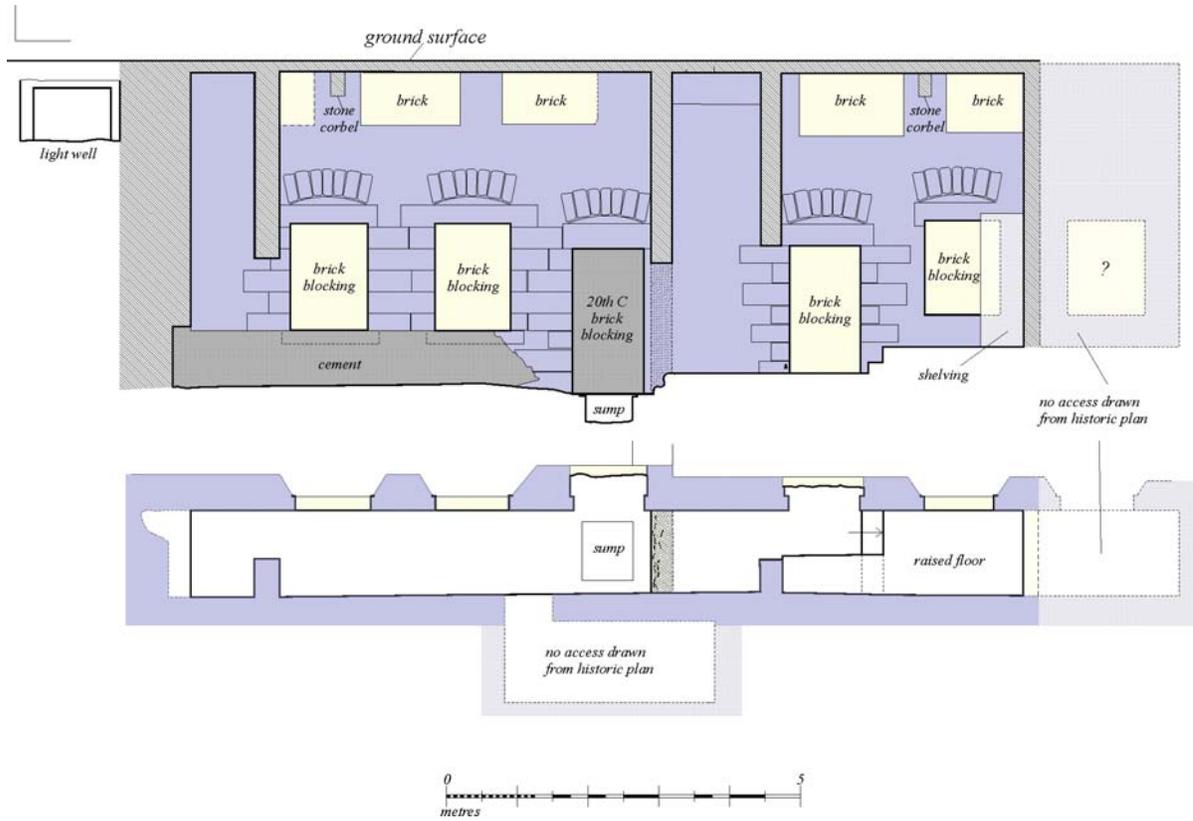
Figure 5 Lower part of the north elevation as exposed, and plan

The walling forming the north side of the sunken area was of plain rubble construction and largely featureless, the main features of note are the double corbelling out at wallhead height for the capping slabs, and an entrance; the latter was not at ground level but half way up the wall. This entrance was blocked by a large stash of rusted metal shelving, though on the historic plan this clearly leads to a small rectangular chamber beneath the road (approximately 2.5m long and 1.2m wide). The door had been hung on two small *pintles* on the east side, and sat within a narrow check around the jamb

The alley originally seems to have been formed into two separate areas, these divided by a central masonry partition wall; the wall had later been slapped through to join the two. According to historic plans and the observed evidence each of the areas seem to have had an entrance and two windows into the lower level of the upstanding building. Each area also featured at their east end a narrow full height compartment with a small man-hole access at the top – evidently coal chutes.

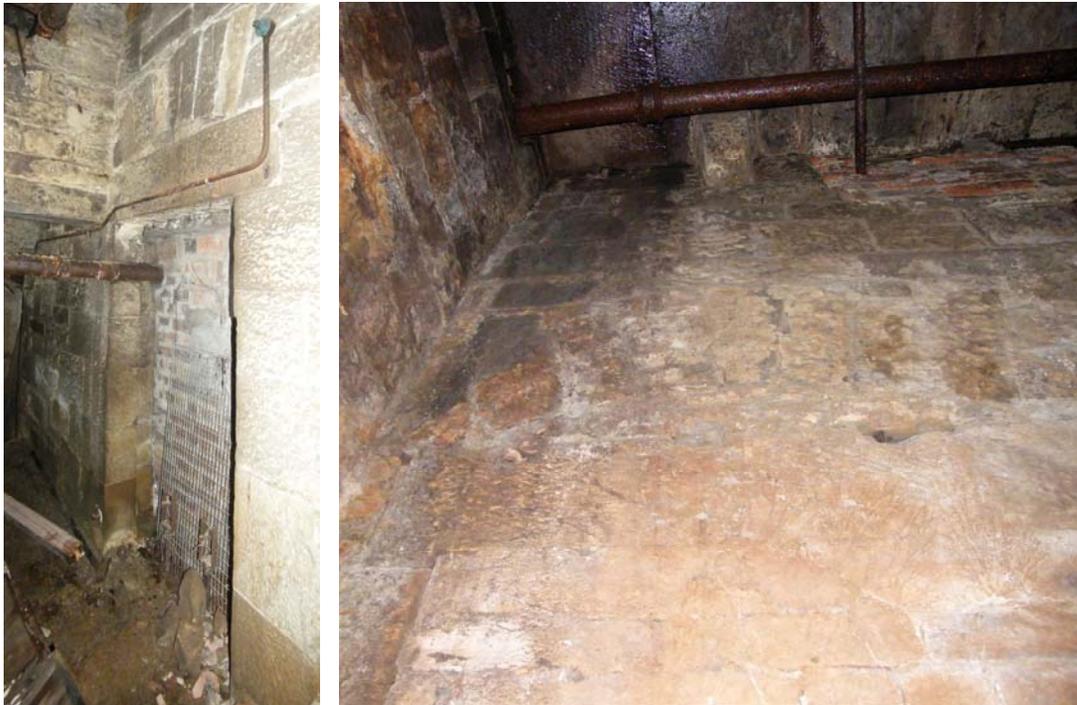
Plates 18 and 19 Western entrance and, right, detail of arch above lintel of eastern window

The masonry of the building façade at this level was of squared blocks of mixed blond sandstones given a pecked finish. Openings were detailed with a narrow margin; the interior faces of the jambs, where exposed, displayed neat horizontal tooling.

The windows and western of the entrances had been blocked with a 19th century type of brick. This left only one open access into the area through the eastern door, which remained open until the late 20th century when it was blocked up with cemented brickwork.

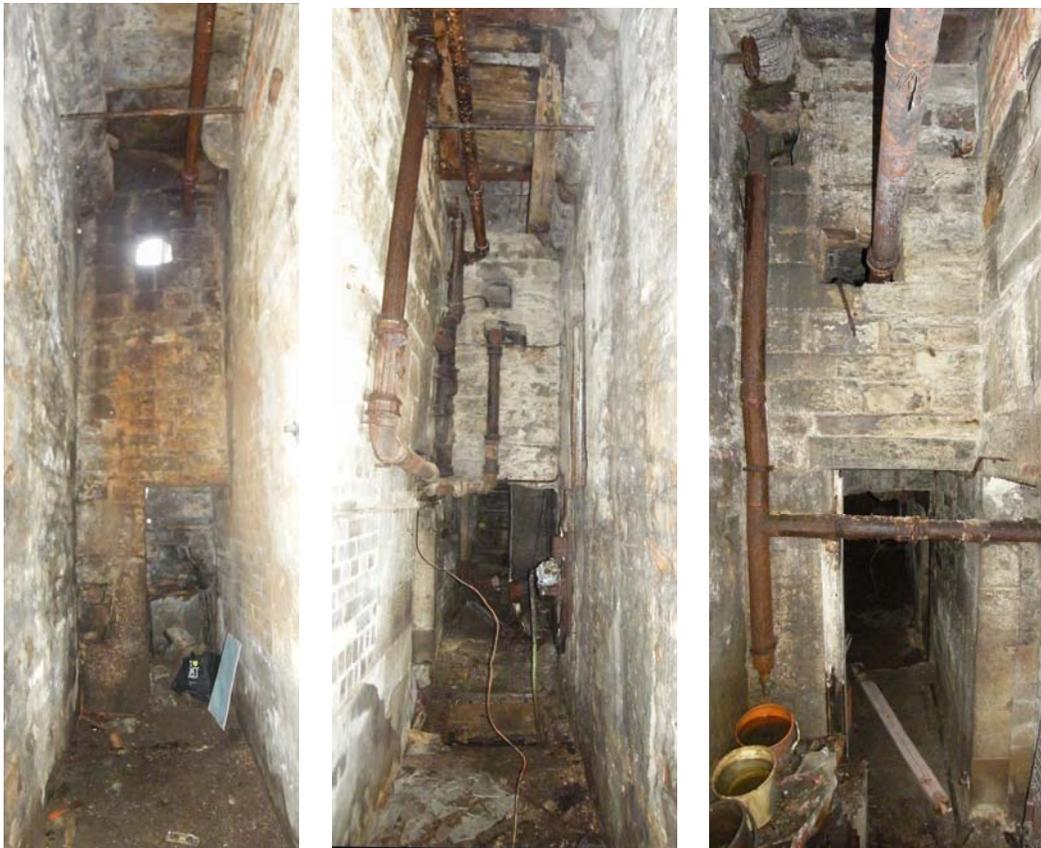
Plates 20-22 1st cross-wall from west (E face); 2nd cross-wall from west (W face); and 3rd cross-wall from west (W side)

The three cross-walls walls that span the alley are all of lime-bonded rubble masonry construction and all rise to the full 4.50m height of the alley. The eastern coal chute measured 0.90m in length; it was accessed from the chamber to the west by means of an entrance within the cross-wall. The chamber itself measured 5.25m in length. Within this, in front of the entrance exists a sump, set beneath floor level, its cover had long gone. From this a pipe ran up to a heavily corroded motor pump attached to the adjacent wall. The western cross-wall has been slapped through to form an entrance to the sunken

area to the west – this presumably occurred after most of the openings were blocked up in the 19th century. Beyond the central cross-wall the second coal chute measured 1.20m in length; a small square hatch exists in the pavement above. Again this chute had had an entrance.

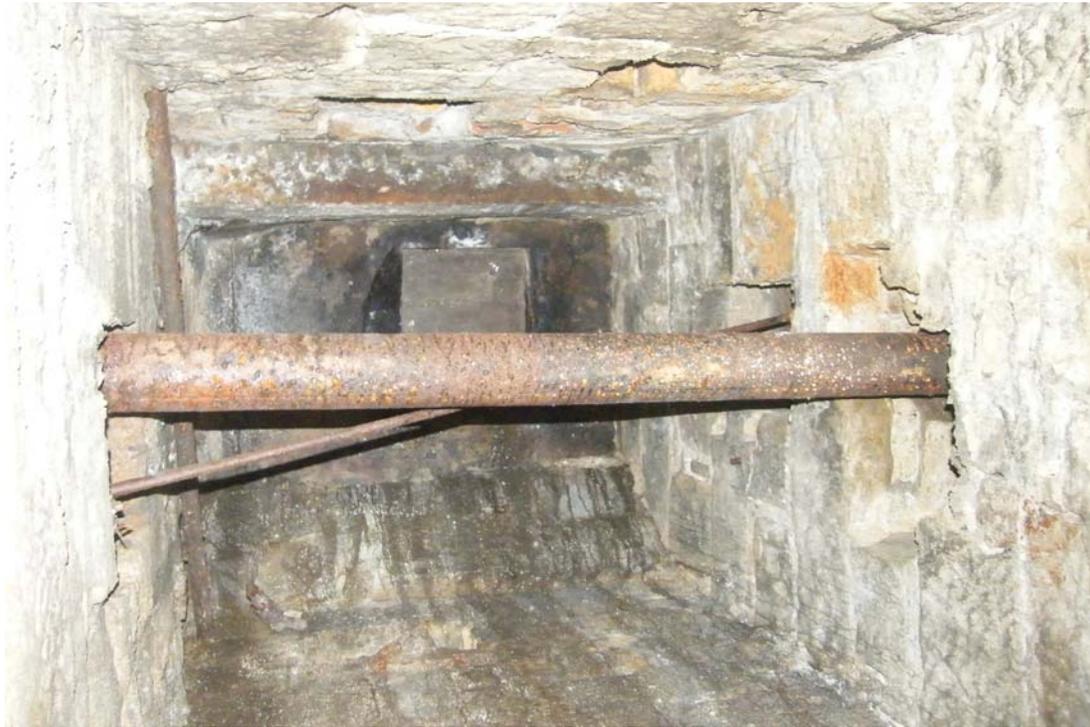
Plate 23 View up in coal chute/store shows access hatch in roof/pavement above,(roadside to bottom of photo)

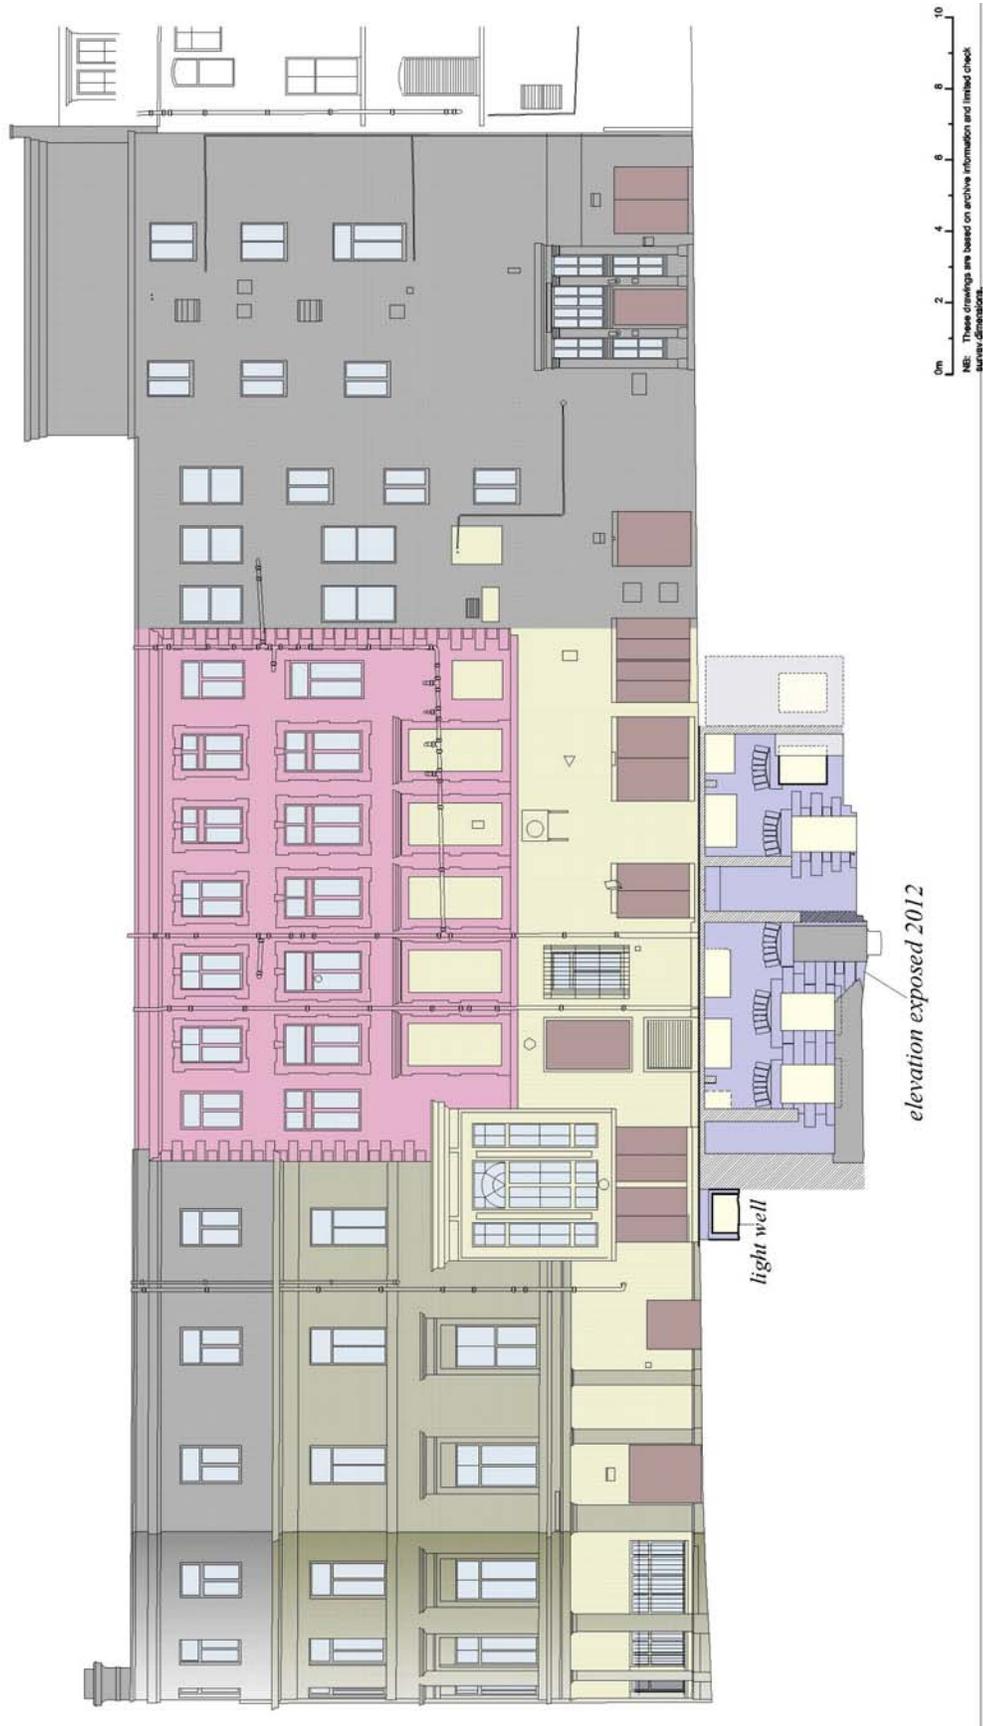
Figure 6 North elevation onto West Register Street showing position of features recorded within the sunken area

The arrangement of the exposed windows and entrances at basement level indicate two separate plots but with identical detailing so built at the same time. As originally intended, and given the presence of windows, it is possible that the sunken area was open at the top originally, with the slabbing over a secondary phase

Above the basement level openings, close to current ground level, are a series of 5 bricked up openings; the jambs of these are well formed from sandstone similar to the lower windows and entrances and can be seen for two courses below the pavement. The slabs of the pavement appear to respect the jambs of the openings and these are likely to represent light wells. Indeed on a historic plan (prepared by Sydney Mitchell 1884, *figure 7*) at ground floor five light wells are shown approximately in this position although the spacing shown is much more even than the spacing noted on the elevation. A further light well is also shown to the east, this is likely the tiled one exposed a few metres to the east at ground level. The outline of the basement level alleyway also appears on these plans in detail, with the entrances and windows represented; it also illustrates the full length of the alley to the west beyond the current brick partitioning of this area.
