# DONSIDE URBAN VILLAGE ABERDEEN

**- Archaeological Evaluation -  
&  
- Standing Structure Survey -  
Carried out 6<sup>th</sup> & 13<sup>th</sup> May 2010  
by  
Murray Archaeological Services Ltd**

**Report No: MAS 2010 - 10**  
by  
H K Murray and J C Murray

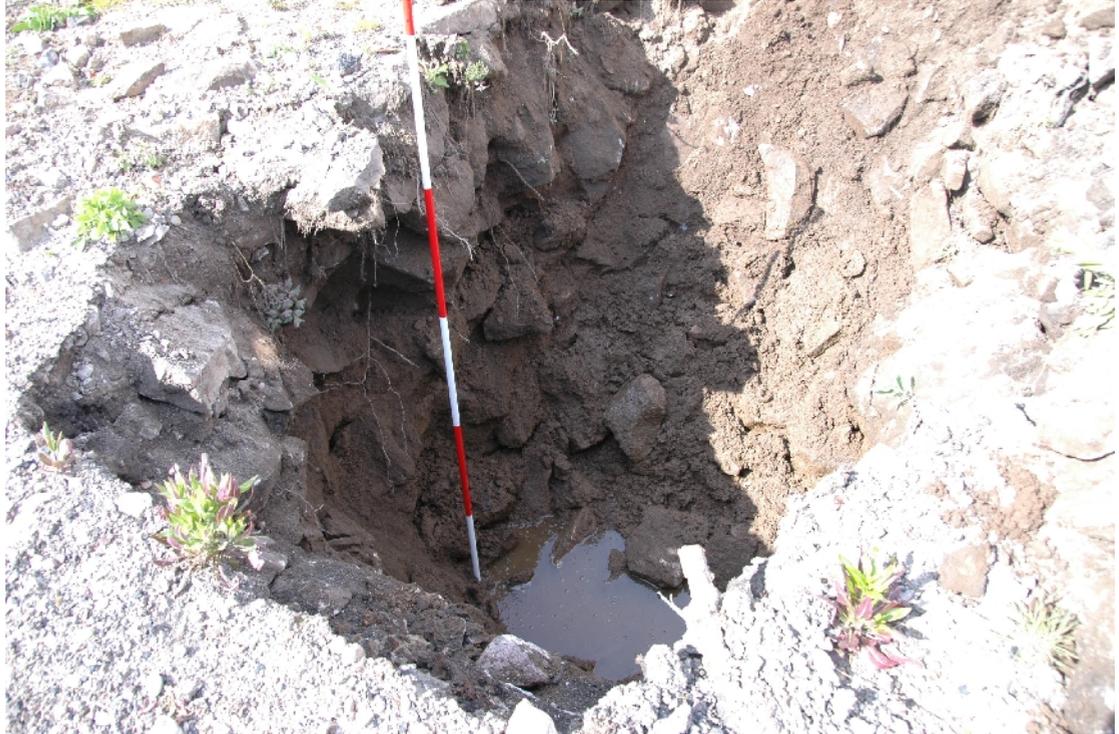
**Illus 4 Trench 1, section**

A band of stoney rubble c 2m wide crossed the site at the trench surface, this unstructured stone rubble continued to c 1.5m depth below surface. Below it there was sandy gravel natural with some large stones mixed in the top. It is considered that this is probably the remains of the weir shown on the 1<sup>st</sup> edition OS map of 1867 (pub 1869).

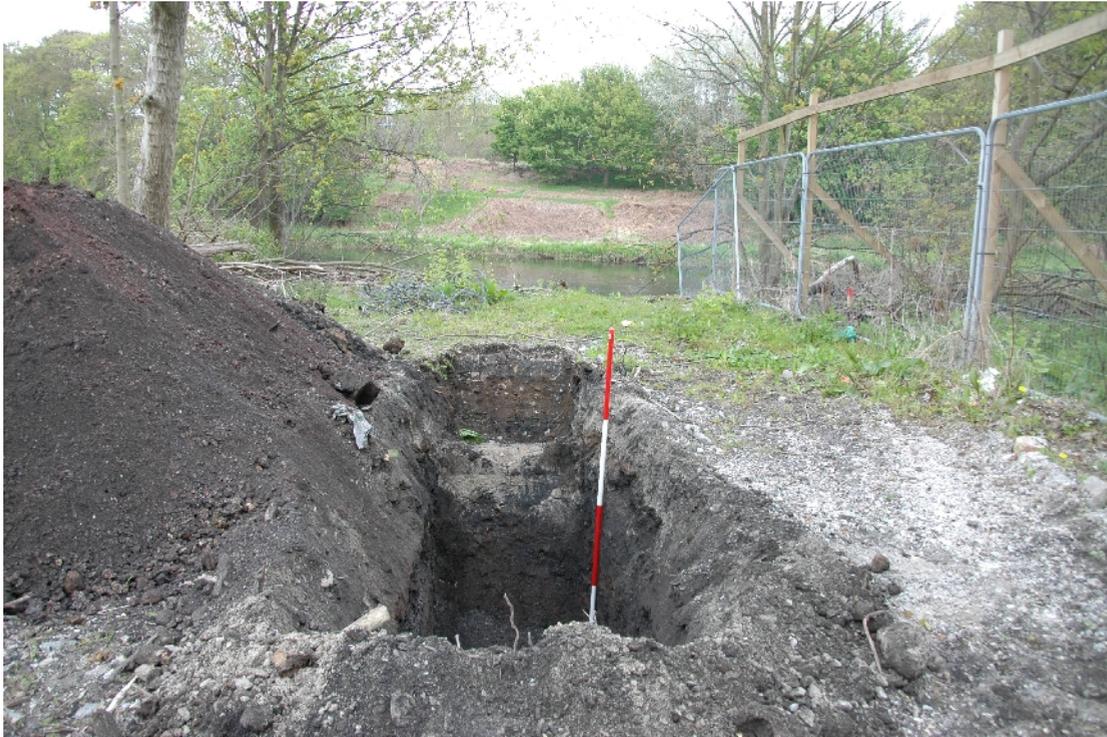
**Illus 7 Trench 4 with river Don behind**

There were layers of dumped cinder, ash and slag from the existing surface to the top of natural gravel at a depth of 2.8m below the surface. There was no evidence of any anthropomorphic activity on the natural.

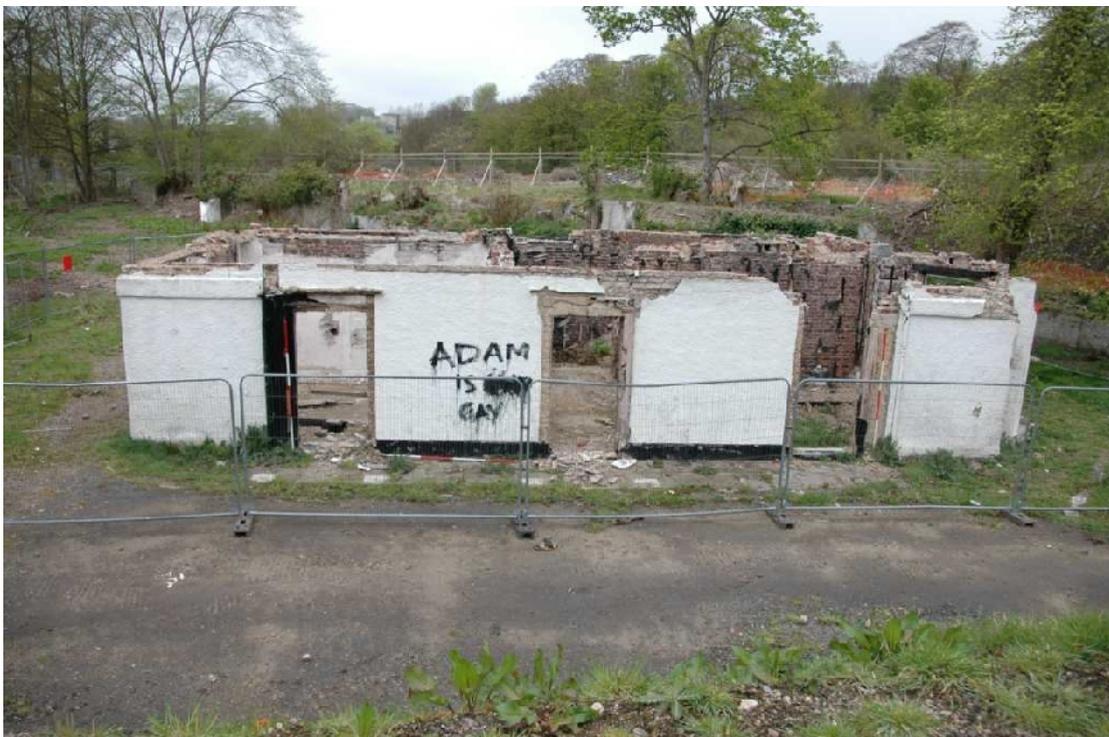
**Illus 10 SE Elevation 2010**

SE front elevation. Central door flanked by french windows. Only the openings survived, with traces of the moulded concrete architrave.

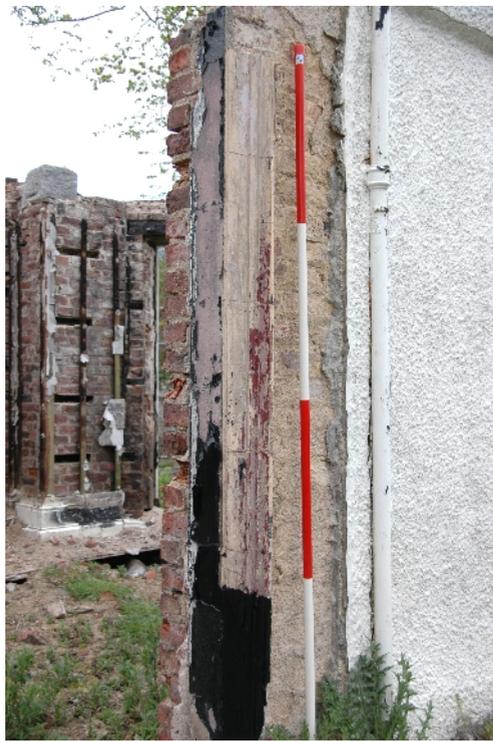
**Illus 11 Detail of pilaster by E french window SE elevation**

There had originally been a balcony at 1<sup>st</sup> floor level supported by rustic style tree trunks. One of these survived at the W side of the W french window. It was half-sectioned and c 320mm in diameter with a square plate on the top to support the balcony. Only the traces of the bases of the other columns remained. The area below the balcony, c 1.2m wide, had been paved with stone slabs.

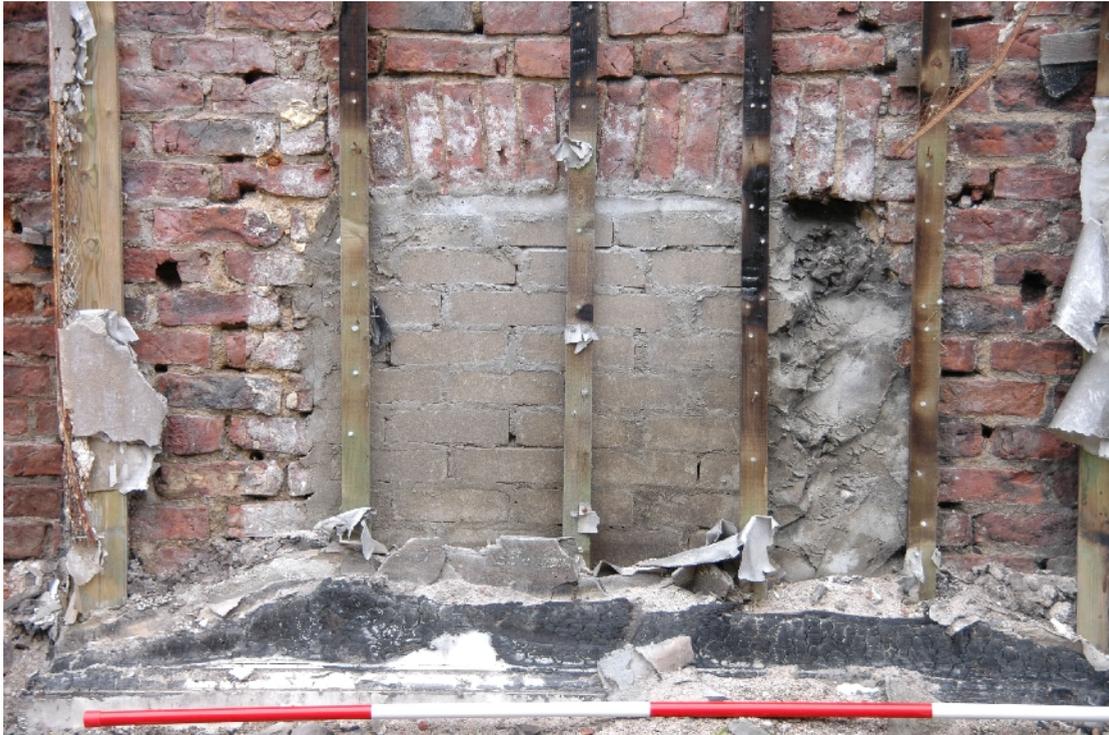
**Illus 12 Blocked fireplace in SE room**

The other blockings were fireplaces in the SE, SW and NW rooms and a blocking of a ? secondary or earlier fireplace beside the large hearth in the NE room. There originally appears to have been a central chimney between the SE and NE rooms and chimneys in the W gable.

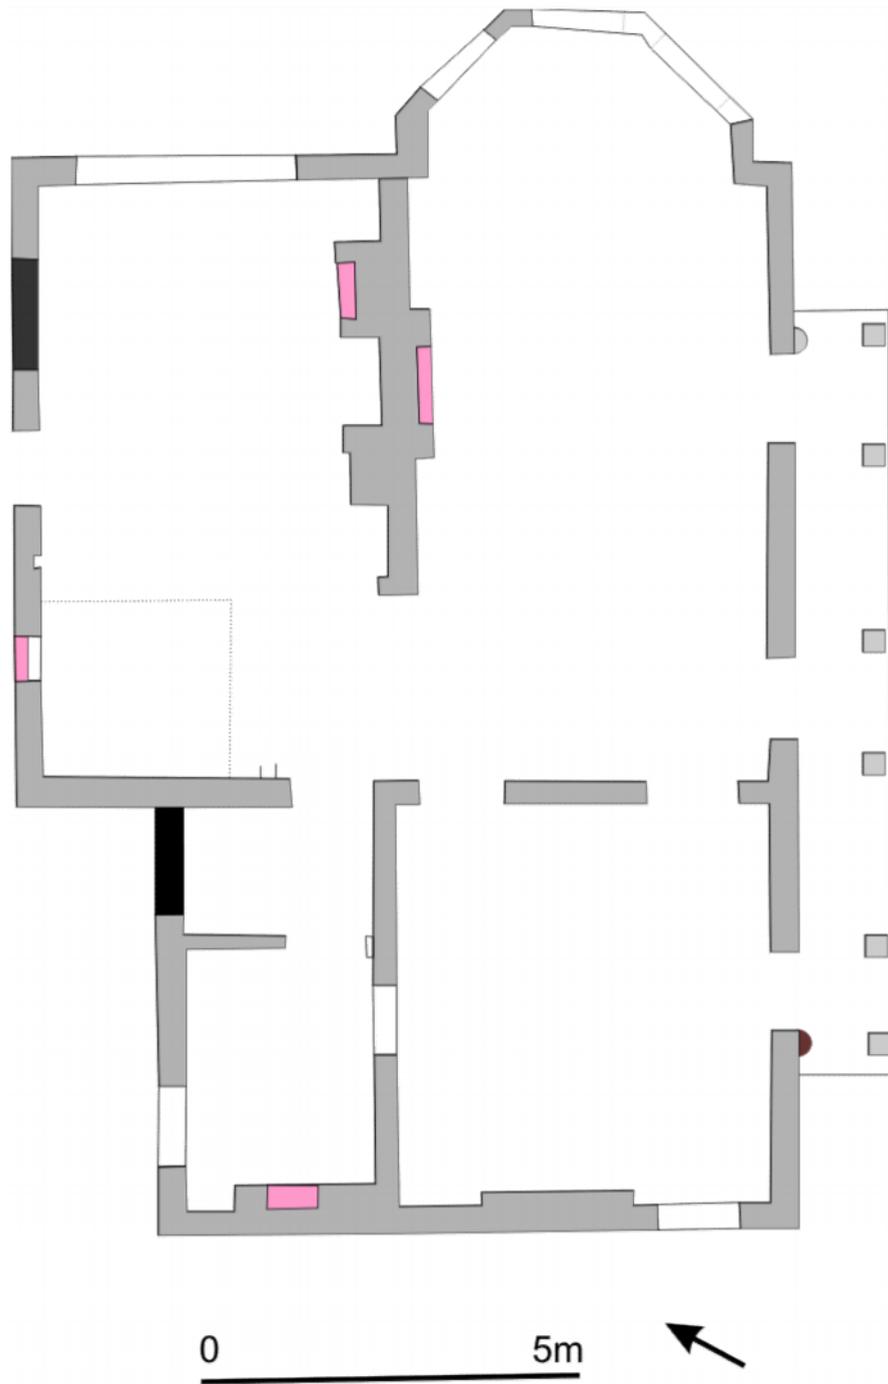
**Illus 14 Plan of Don Cottage**

Internally in most areas the walls had been clad in lathe and plaster, although in the front E room there was some later plaster board. The internal cladding had been partially removed by the fire and a number of blocked features could be seen as a result. These are noted on plan. Some were brick-blocked and possibly fairly old alterations but a large opening in the N wall and a window opening in the N wall had been blocked with breeze blocks and appeared more recent. The large opening was

the blocking of the link section through to the N part of the building demolished post 2003 but prior to the fire in 2009.

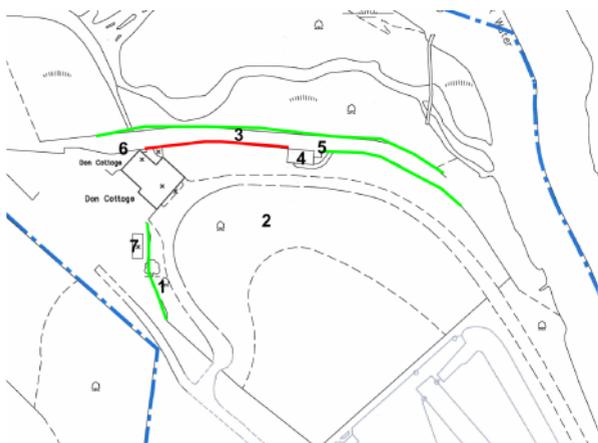
**Illus 17 Don Cottage garden.**

*1 Stone wall with raised bed. 2 open area of grass and mature trees and shrubs. 3 brick wall revetting raised terrace walk. 4 ruins of shed with blocked window in blocked door to terrace. 5 gateway to terrace through stone wall that continued line of brick wall. 6 breeze block 'room' abutting wall. 7 breeze block garage.*

On the W side, the garden was bounded by a stone wall (1) with a raised bed containing generally low ground cover shrubs. On the E side, there was a brick wall (3) built of the same 19<sup>th</sup> century bricks as the house and this appears to be shown on 1867 OS map. The inner face of the wall had semi-circular vertical buttresses. It appeared to be revetting a raised terrace along the E side of the garden. Cut stumps indicate a line of trees had originally stood along this higher level. Steps led from the lower level to this higher terrace and the small shed (4) abutting the wall had originally opened to the terrace. A gateway (5) in the wall to the S of the shed also opened on to it. The terrace also had a rougher wall of stone and pebble along the E side, between it and the river and there appears to have been a walkway between the walls above the river level and above the garden level. To the N of the cottage a breeze block structure (6) had been attached to the wall, apparently with access to the N part of the house (now missing). A breeze block garage (7) stood to the NW of the cottage.

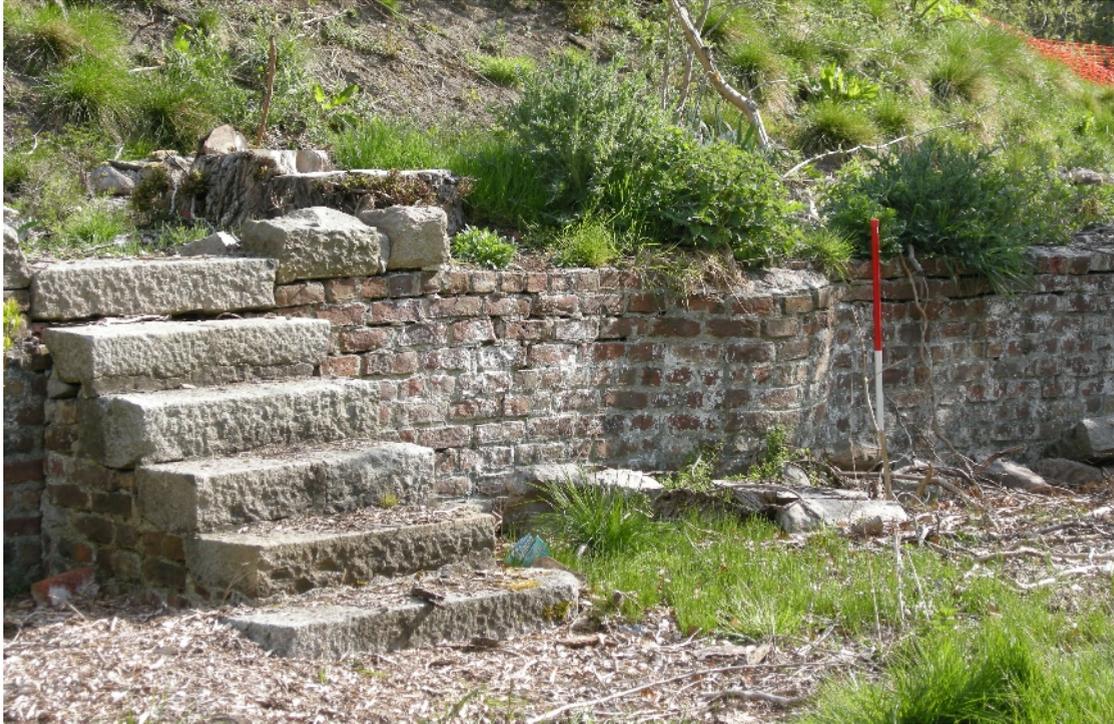
**Illus 18 Wall showing curved 'buttress' and steps to upper terrace path**
