Monks Haven
55-57 Beverley Terrace
Cullercoats
North Tyneside
NZ 3631 7126

Archaeological Building Recording
Report 039-12-HS | December 2012

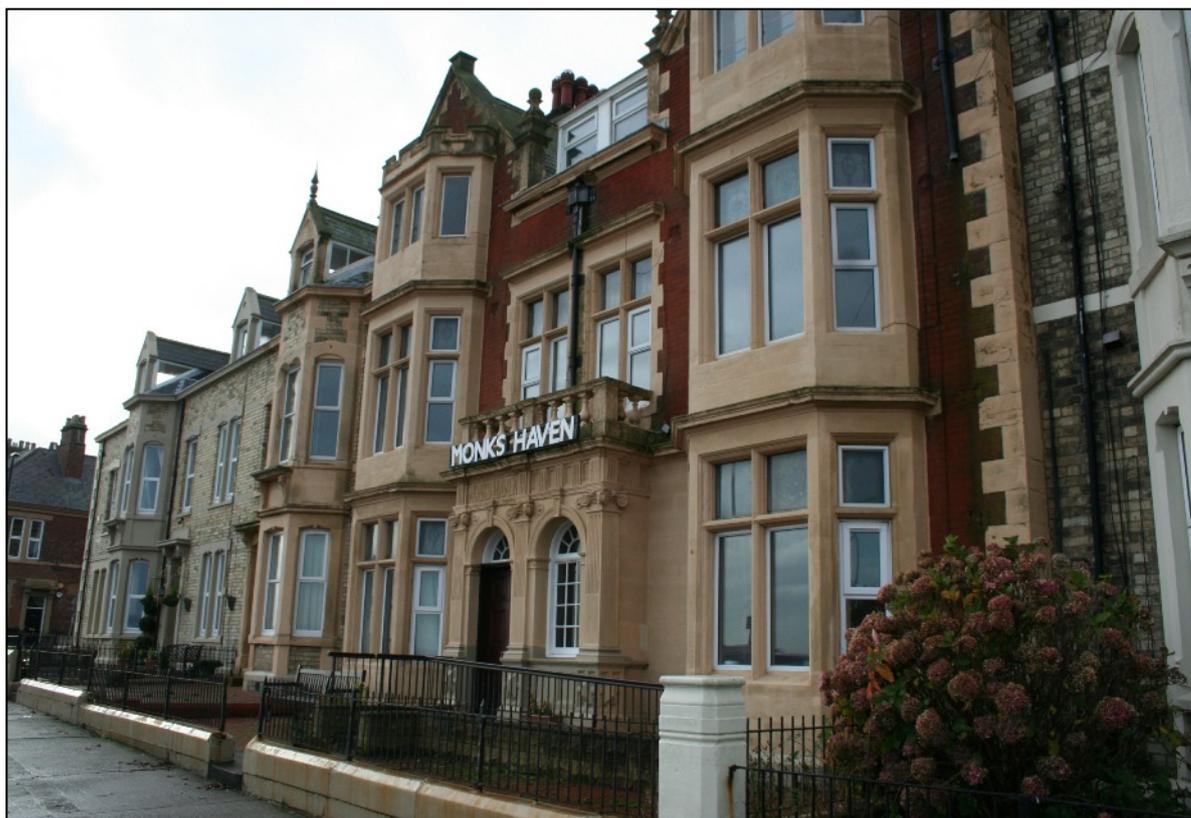
Plate 1. 55-57 Beverley Terrace, looking southwest, MHC12008

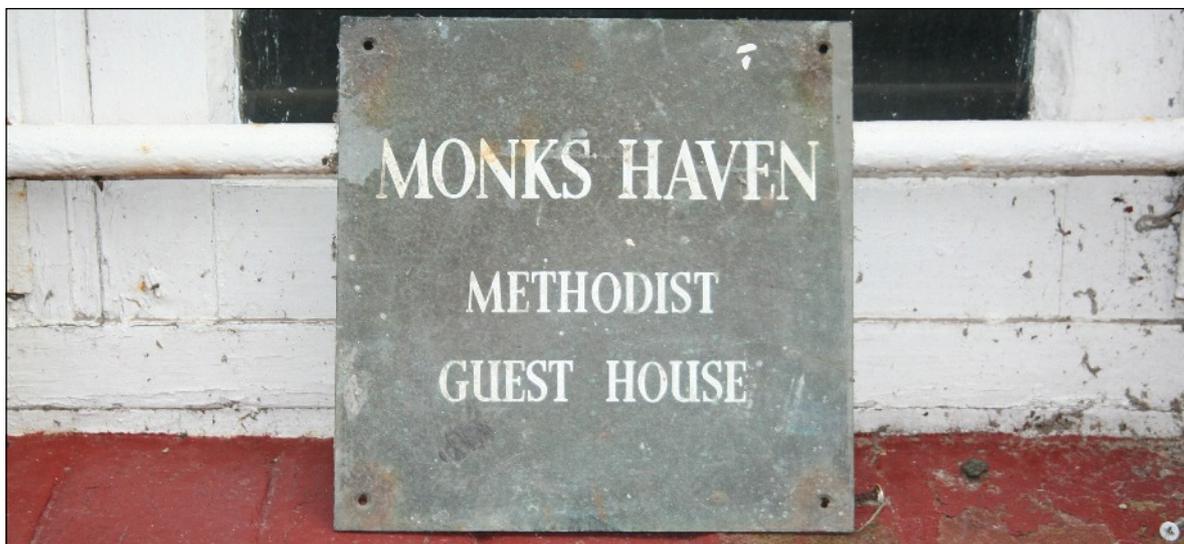
Plate 3. Lead plaque denoting “MONKS HAVEN Methodist Guest House” found in outhouse during survey, MHC12209

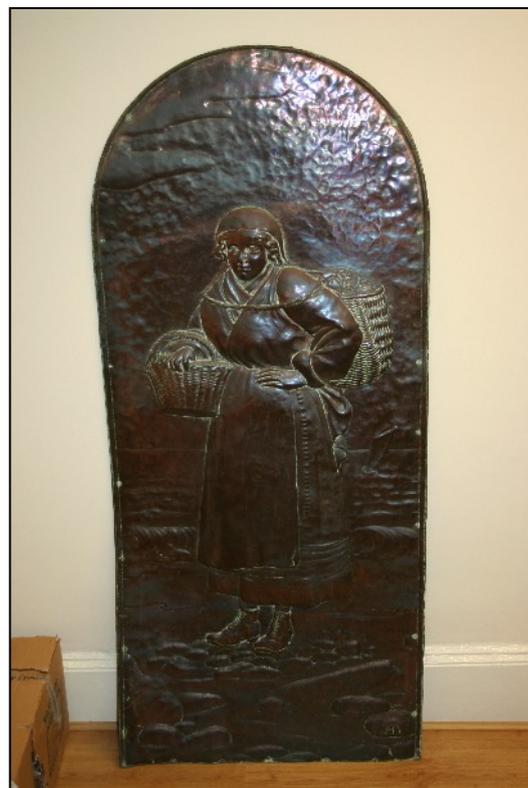
- 3.1.1 It was found that a couple of artefacts/features had been removed from the buildings prior to the photographic survey taking place. The first was the copper plaque of Polly Donkin, which originally stood in the entrance hall of Monks Haven, but which was removed during the de-commissioning of the electricity in the buildings. The decorative newel caps from the main stairwell in nos. 56-67 had also been previously stolen. Additionally, three internal doors had also been removed to prevent theft. The doors were of a varnished hardwood, panelled and potentially early Victorian, or a later replica. The doors and the copper relief are currently stored in the offices of Oaks Properties Limited, Jesmond, Tyne and Wear, and were photographed prior to the survey of the buildings taking place.

Plate 4. Copper relief of Polly Donkin, MHC12001

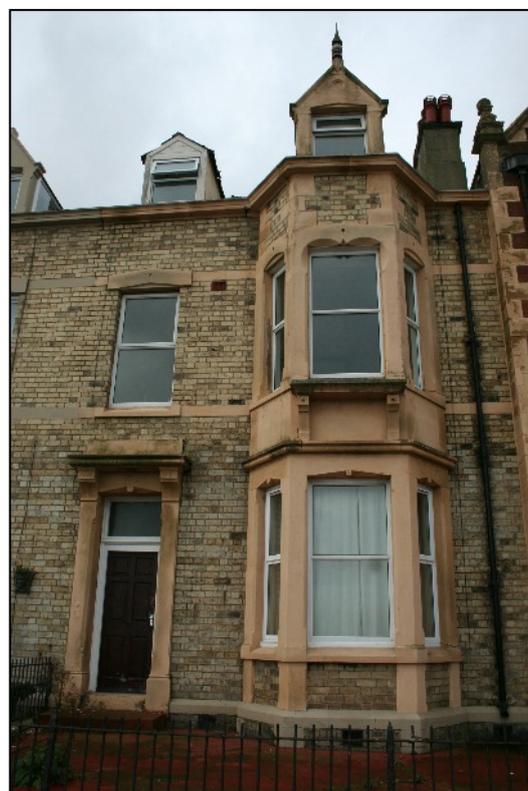
- 3.2.1 55 Beverley Terrace lies to the south of nos 56-57, and at the time of the photographic survey, work had already been undertaken to separate the structure from the rest of Monks Haven. The building is Late Victorian, mid-terraced, with three floors (ground floor, first floor and second/attic floor). The frontage is of classical style, with a two-storey bay, over which is a gable-fronted dormer. The windows of the east-facing elevation are sash-windows, and the facade is primarily yellow/grey machine-made bricks, laid in Flemish Bond. The bay, quoins, lintels, sills, cornice, finials and pilasters are all in yellow sandstone. At the base of the building are three courses of grey brick, this time in English bond, complete with air bricks. The single door into the property is recessed within a classical style surround and hood, with a rectangular transom window directly above. Another hood, again in yellow sandstone, lies above the ground floor bay window, and the lintels of all windows hold classical influences in their design.

Plate 5. External, 55 Beverley Terrace, looking west, MHC12006

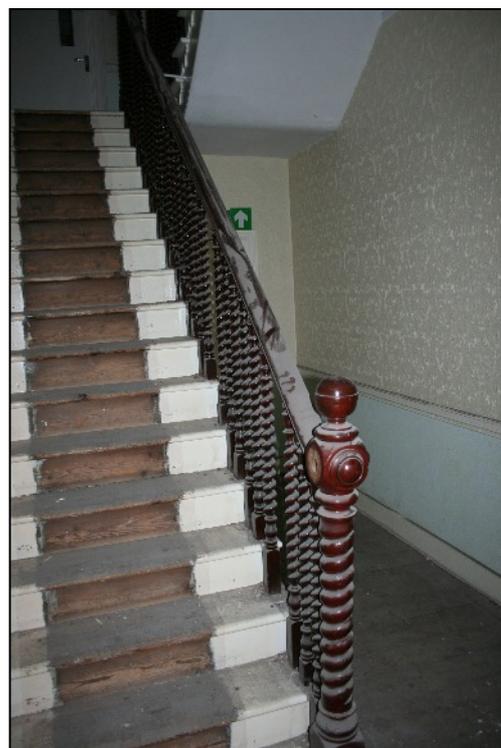
Plate 6. Barley twist balustrade and newel, MHC12020

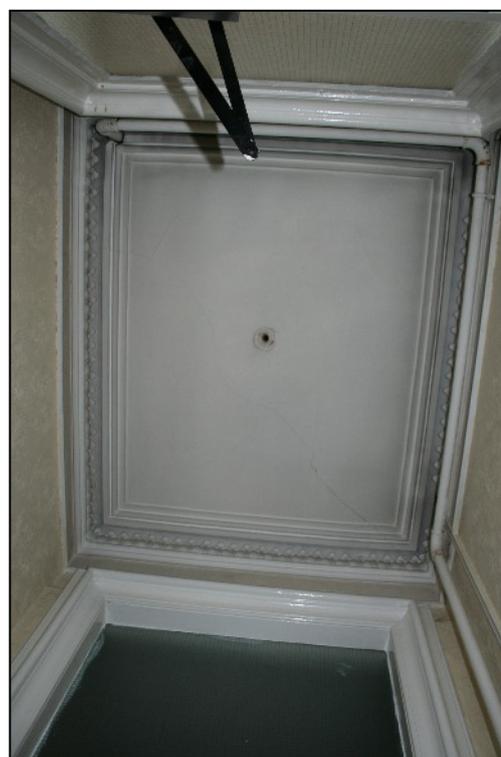
Plate 7. Entrance ceiling with enriched coving, MHC12010

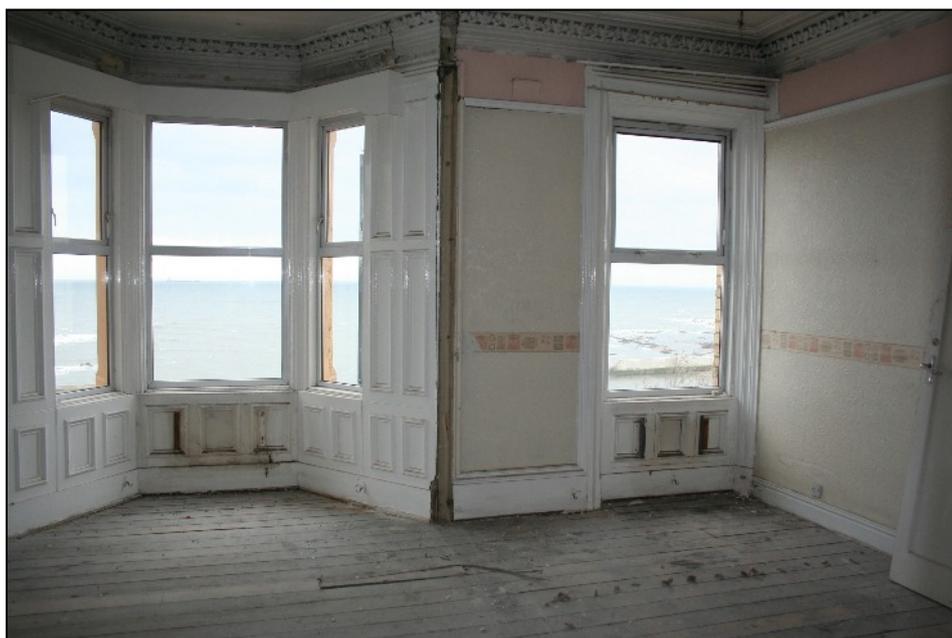
Plate 8. General photograph of 55I, looking east. The remains of the line of the original dividing wall can be seen centrally, MHC12022

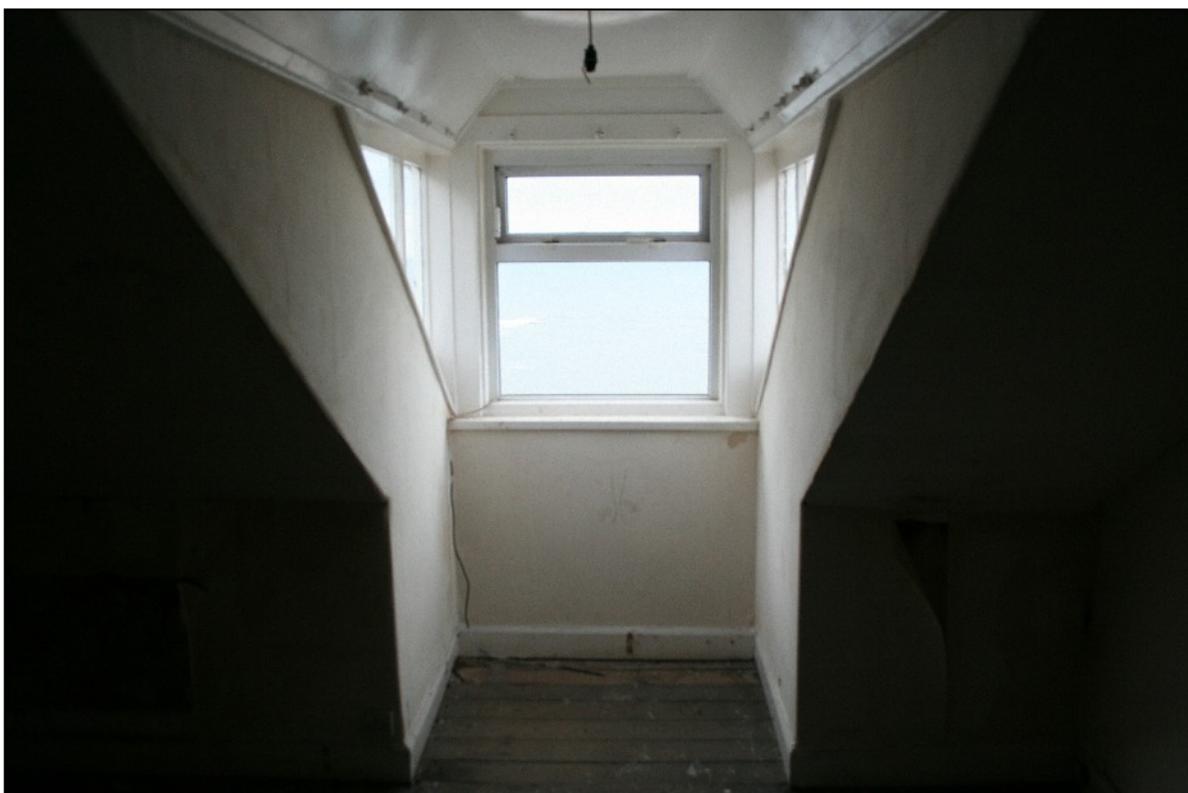
Plate 9. Dormer window in 55N, looking east, MHC12030.

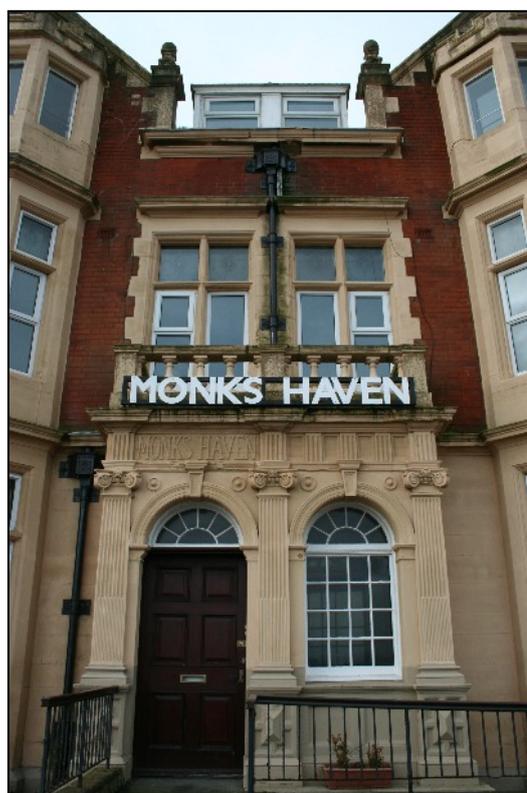
Plate 10. External view of 56-57 Beverley Terrace, eastern elevation, MHC12004

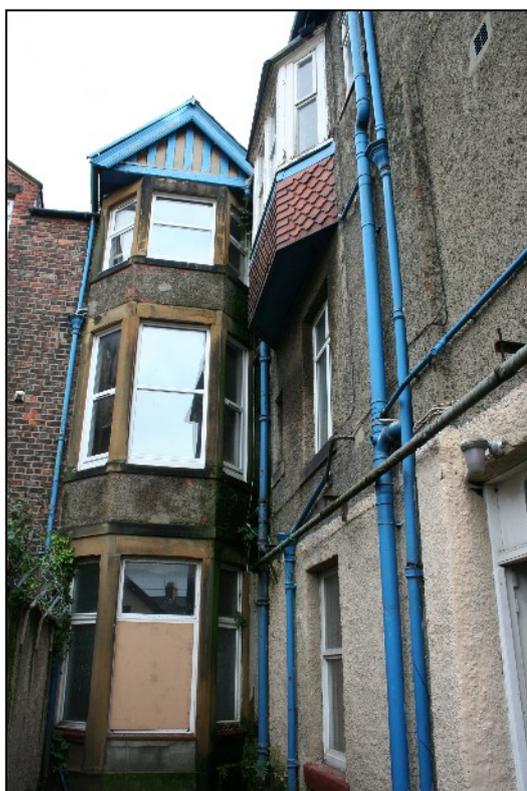
Plate 11. External view of 56-57 Beverley Terrace, section of western elevation, MHC12039

painted the same blue as the drainage piping. This was a popular style in the 1890s, but would usually be placed on the building frontage. On the back of the property, this could be interpreted as a show of wealth and status.

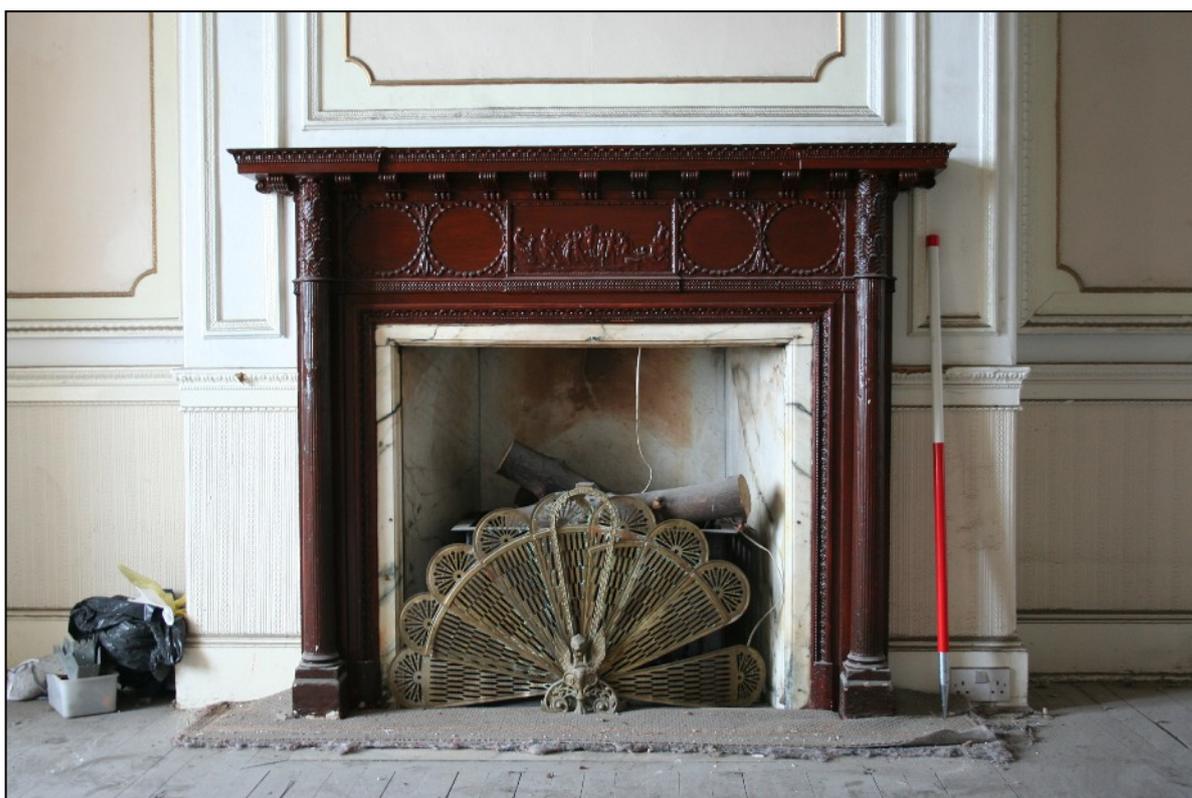
- 3.7.1 56A: at the time of construction, this room was divided into two, the easternmost room described as the dining room, and the western room as a breakfast room. Both rooms had their own fireplace on the southern wall, and with the suspended ceiling now removed from this room, the remains of the dividing wall can still be seen in the ceiling. The ceiling mouldings are plaster on a hessian backing, and are damaged from the remains of the aforementioned suspended ceiling. During the restructuring of 56 and 57 Beverley Terrace into essentially one building, the original entrance hall from no.56 was removed and the space added to the northern aspect of room 56A. Due to the uniform nature of the decoration, it can be assumed that the majority of the room was redecorated following the remodelling: the walls of the room are panelled and also sport moulded dado rails, elaborate cornices and skirting. The main eastern windows also contain stained glass frames with a trophy motif, and the rectangular transom window that now sits above the modern doors to the conservatory also holds a stained glass motif: according to the original plans, this was originally a window or set of french doors, presumably designed to let in light to the breakfast room. The western fireplace has been removed, but the main eastern fireplace is still in-situ with a marble surround and heavily decorated mantle. Two Victorian hardwood doors remain in-situ (4 panels in each, two large upper panels and two smaller panels below) in the northern wall, each within a moulded door surround with painted moulding in classical bay leaf style.

Plate 12. View of the fireplace in 56A, MHC12047

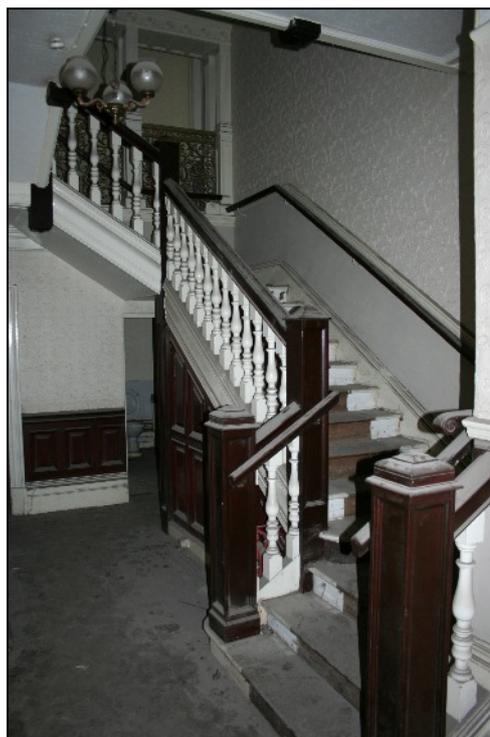
Plate 13. View of well stair, MHC12061

- 4.2.3 Any destructive work within 56-57 Beverley Terrace should be agreed upon by the Tyne and Wear Archaeology Officer prior to any work commencing. If the restructuring of the buildings impacts on the well stair, Venetian grate or surviving fireplaces, it is recommended that further detailed recording work should be undertaken.

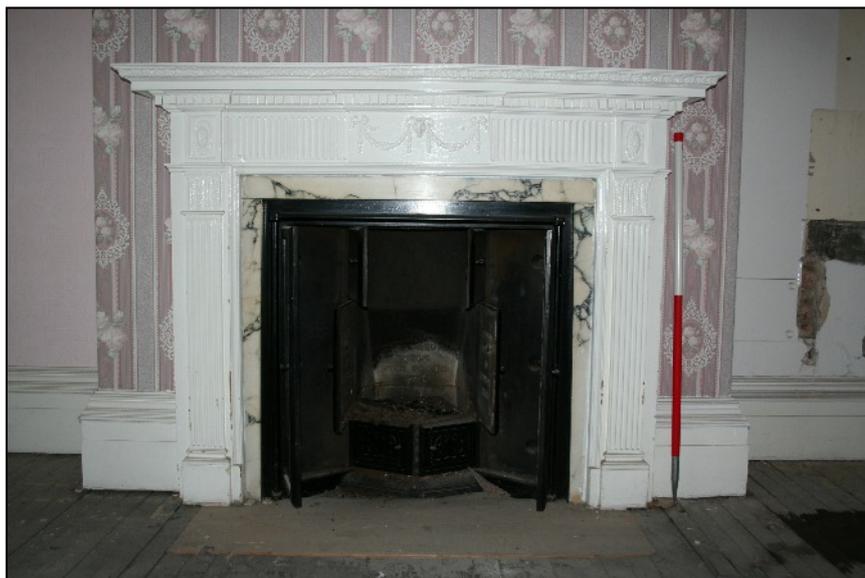
Plate 14. Fireplace *in-situ* in 56G, MHC12079

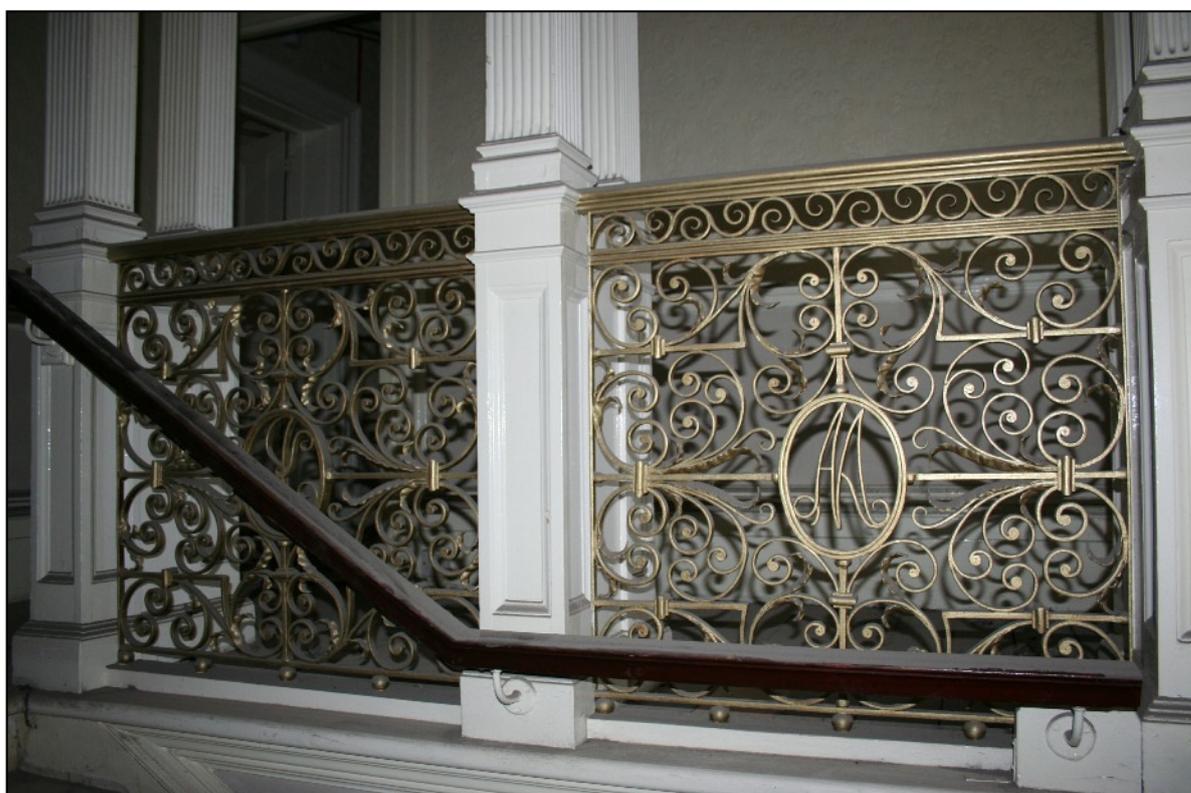
- 3.8.12 57K: this is the continuation of the well stair. At the head of the first landing is a small balcony with a metal Venetian form grille. The grille has two initials set into the centrepieces of the panels, the first being 'J' and the second 'M'. These initials likely belong to James Knott and his wife Margaret, giving an installation date for this piece between 1893 and 1911, and is also presumably an original feature associated with the construction of the new central stairwell. The grille is set in a white painted classical surround, with a curved arch leading through to the rooms to the west. Turning to the east, the doors through to the front rooms are headed by a fanlight, and the walls have moulded skirting boards and a dado rail.

Plate 15. Venetian form grille set with the initials 'J' and 'M' - likely to be James and Margaret Knott, MHC12095

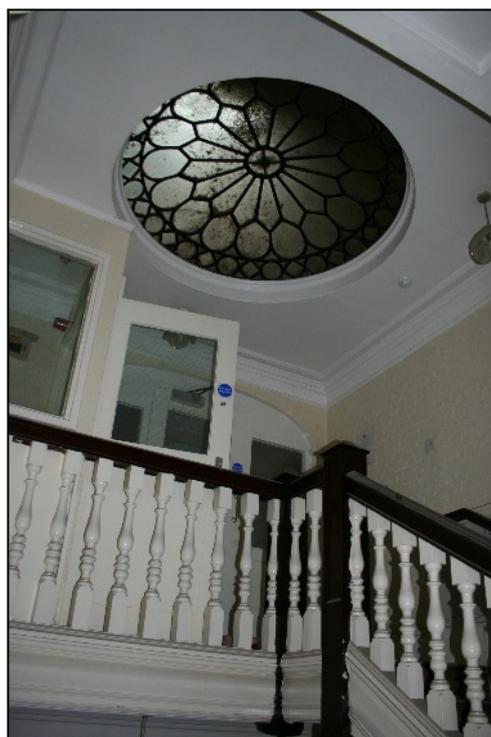
Plate 16. View of the roof dome, MHC12114

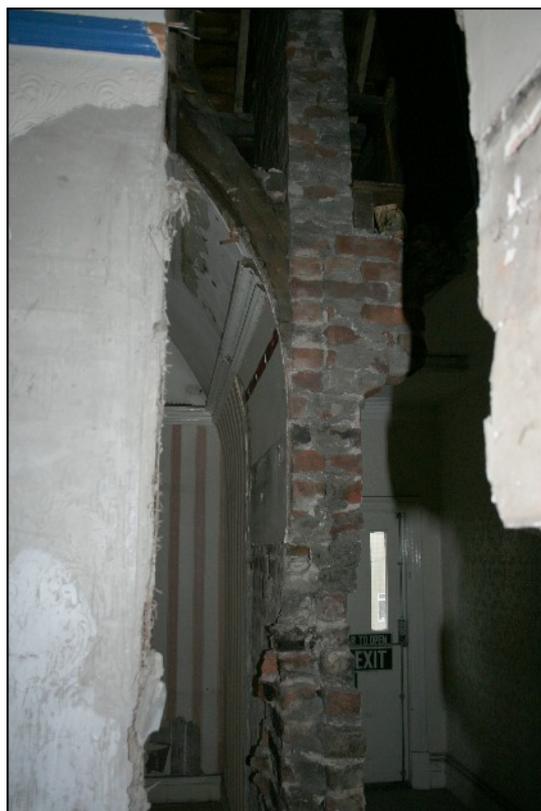
Plate 17. Cross section of the vaulted ceiling, MHC12120

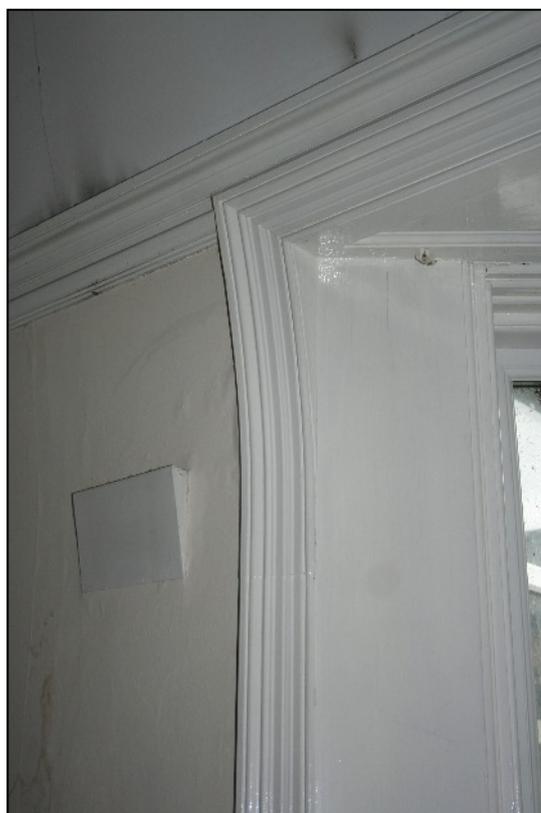
Plate 18. The curved moulding in 56S, MHC12110

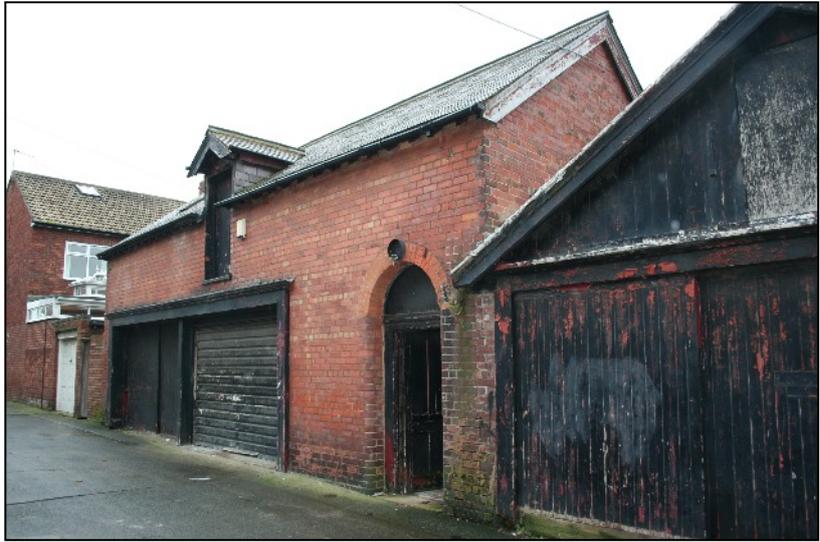
Plate 19. Main frontage of coach house, looking southwest, MHC12122

- 4.2.1 The surviving material within the Coach House is fairly generic with no special need for recording beyond what has been undertaken in this survey, with the interesting features on the eastern frontage remaining intact. It is recommended that no further work need be done before work commences in the Coach House.

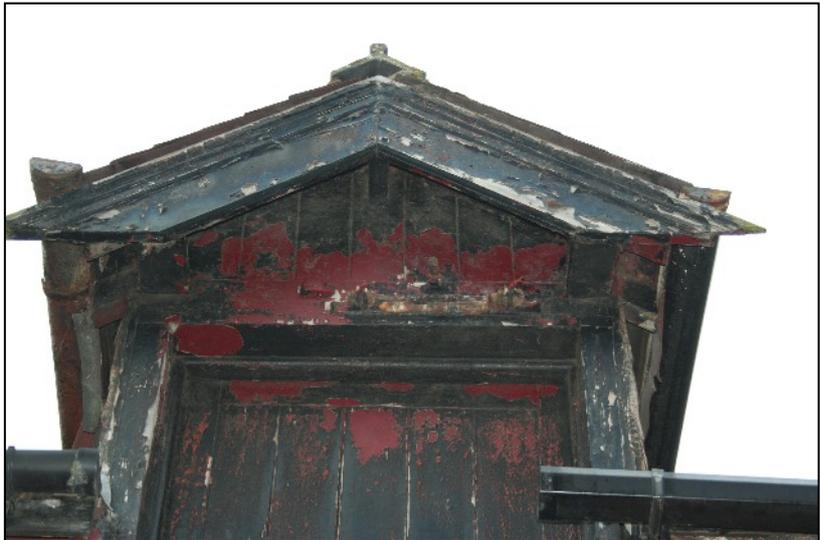
Plate 20. Remains of a pulley or hoist above the hayloft door, MHC12126

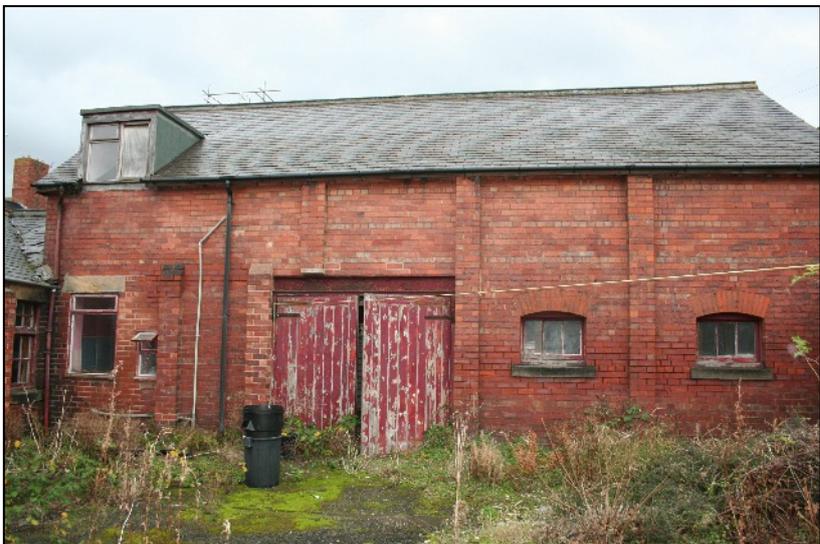
Plate 21. Western elevation of pony trap house, MHC12129

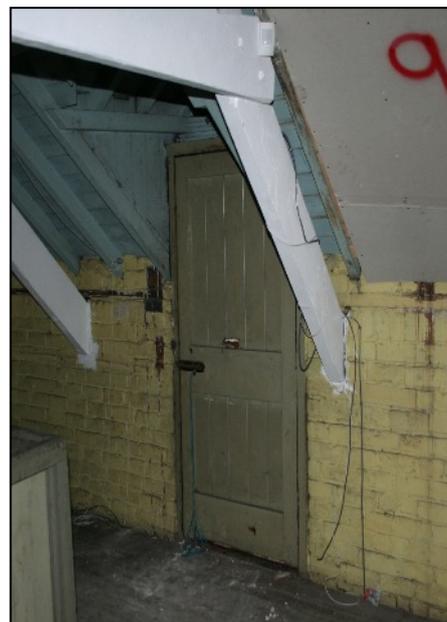
Plate 22. View of the inside of the hayloft door, MHC12147
