Hamsterley Hall
Hamsterley
County Durham
NZ 14257 55637

Archaeological Building Recording
for Mr. Steven Spry

*Report no. 069-13-HS
Final Version January 2014*

VINDOMORA SOLUTIONS
Heritage Support

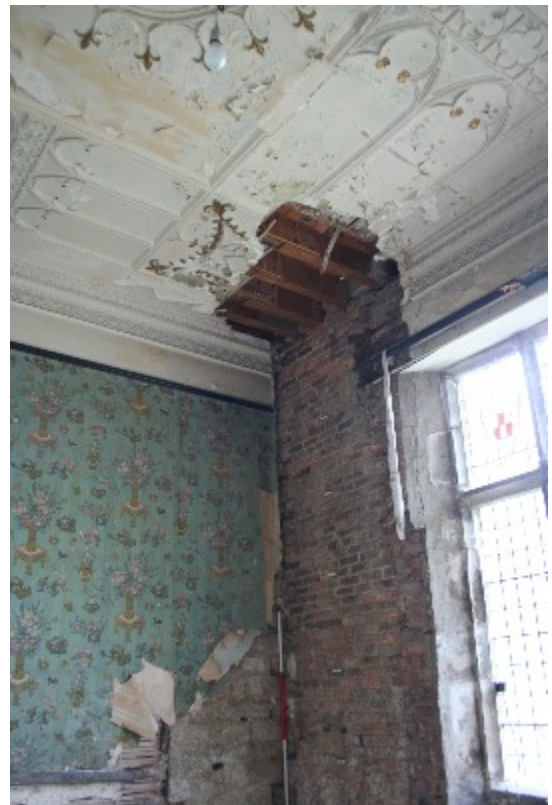
Plate 27. The damaged ceiling and wall (frame HHR13118)

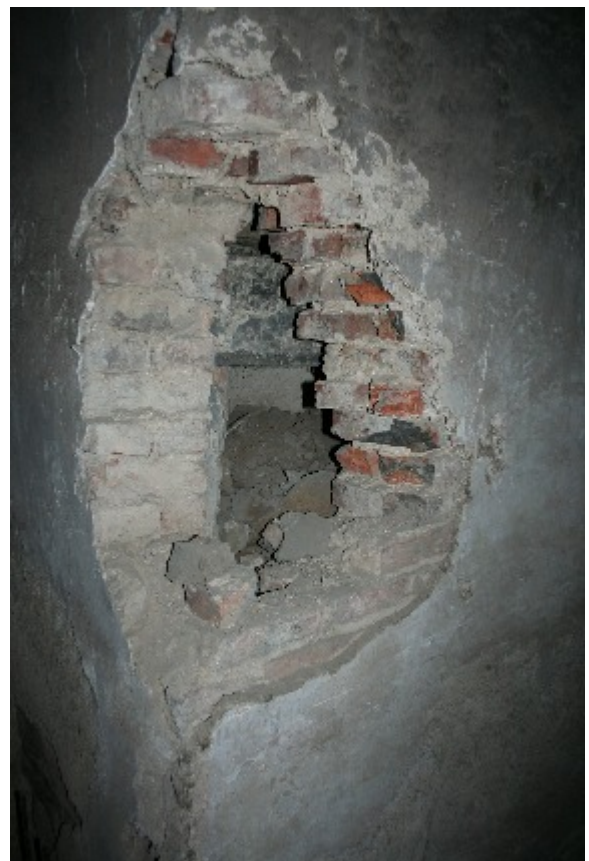
Plate 38. The blocked up fireplace (frame HHR13177)

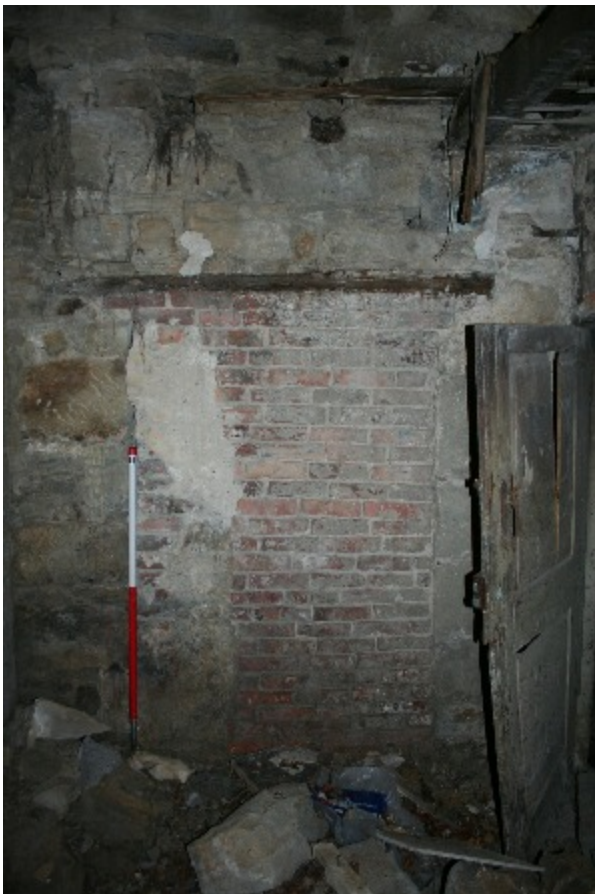
Plate 39. The blocked up doorway (frame HHR13179)

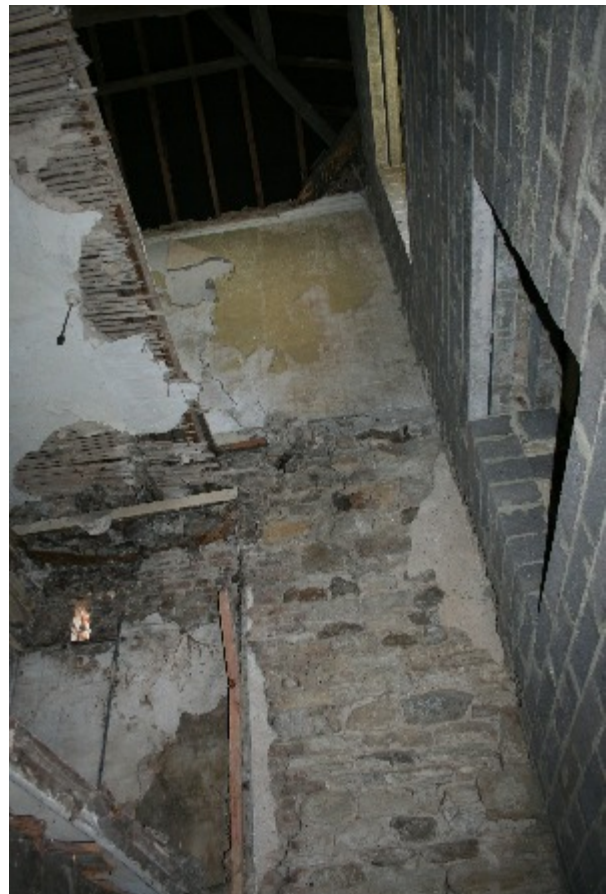
Plate 40. The damaged floors (frame HHR13187)

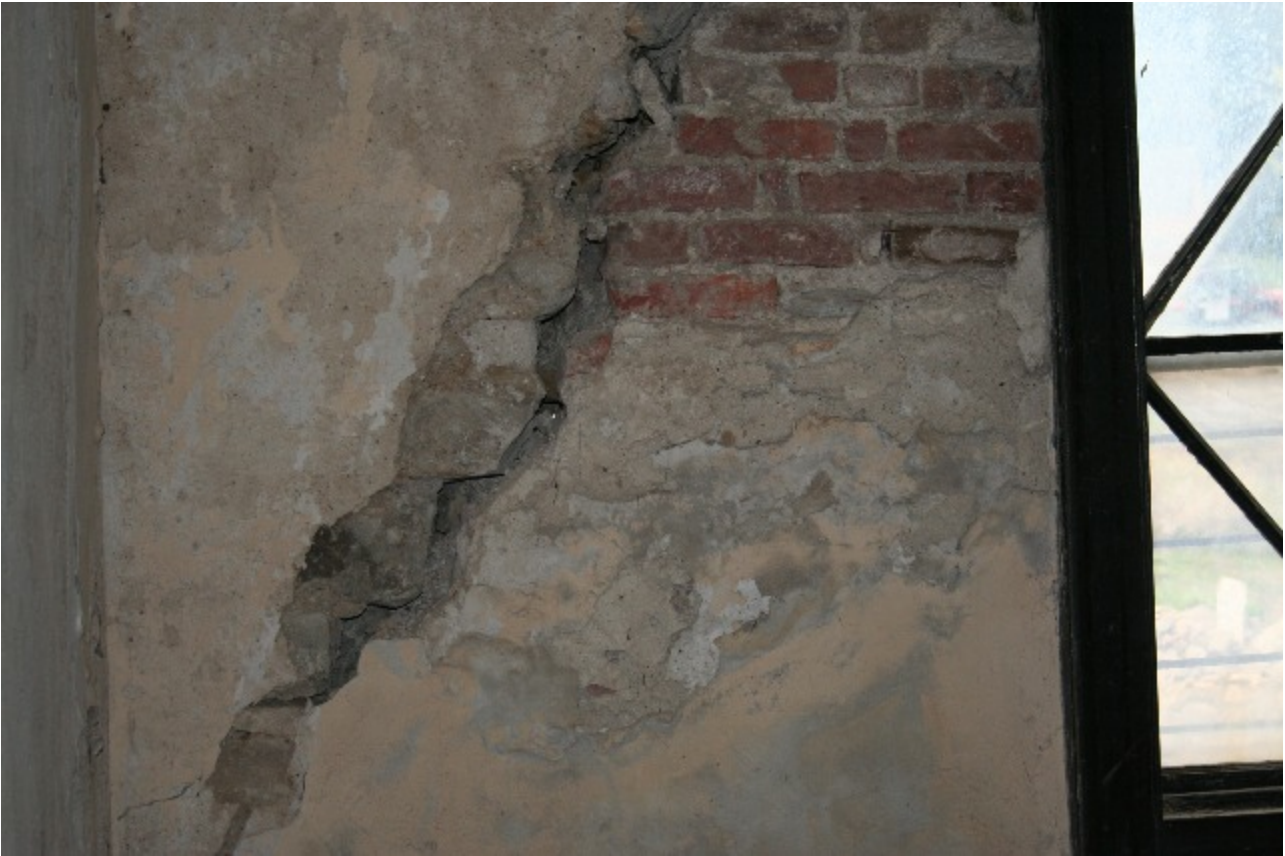
Plate 55. Area 38, crack in south external wall (frame HHR13254)

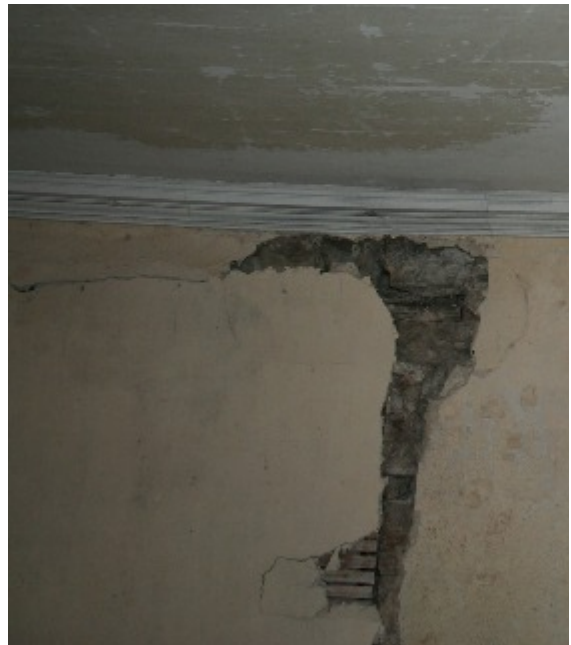
Plate 56. West wall of Area 38, showing blocked up external window (frame HHR13259)

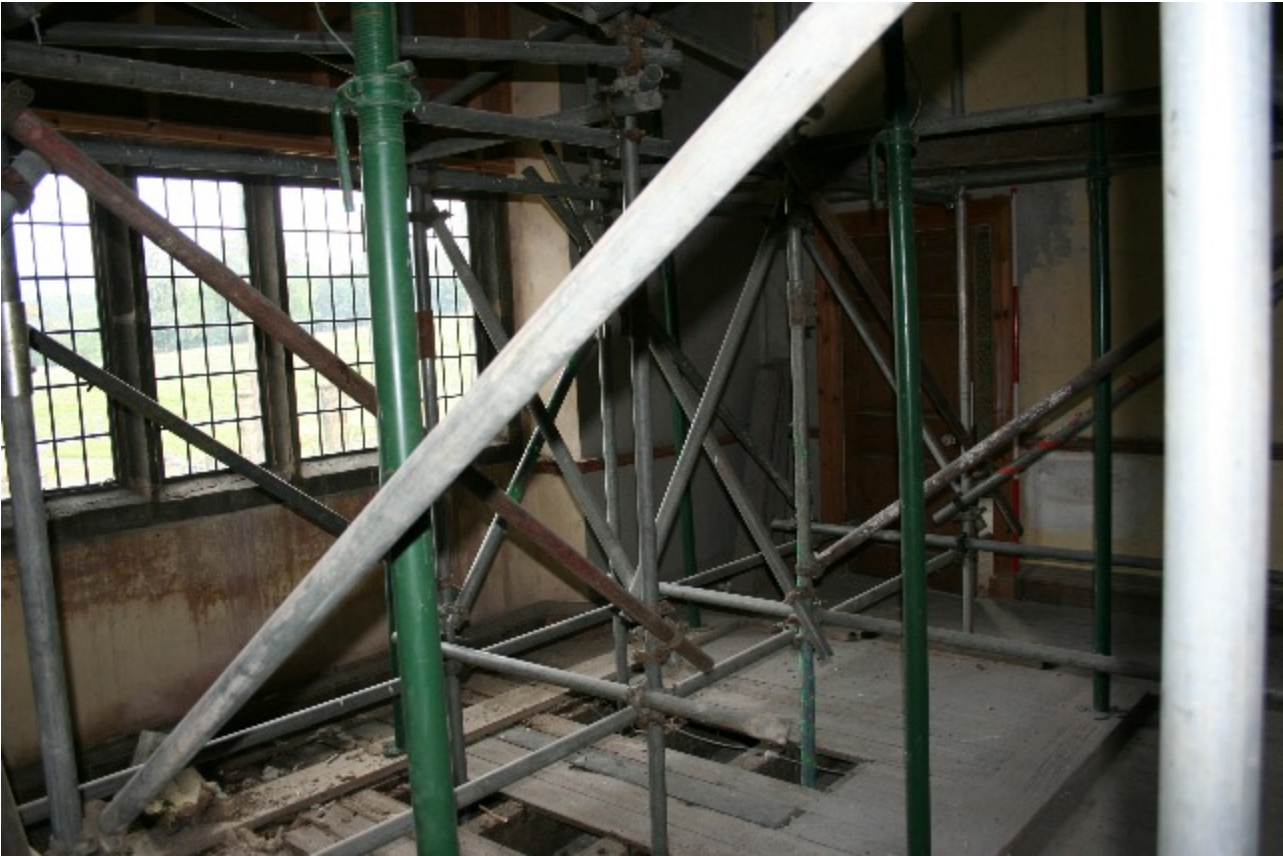
Plate 69. The ceiling in Area 10 is held up by emergency scaffolding (frame HHR13320)

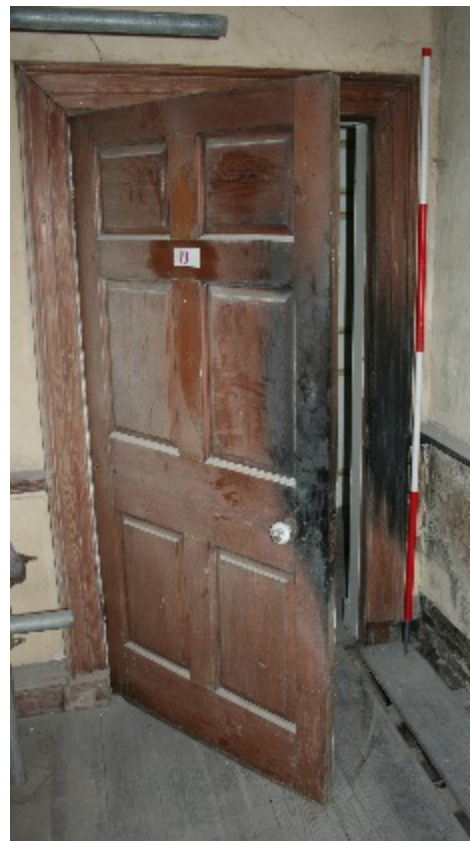
Plate 70. Fire damaged door, Area 10 (frame HHR13322)

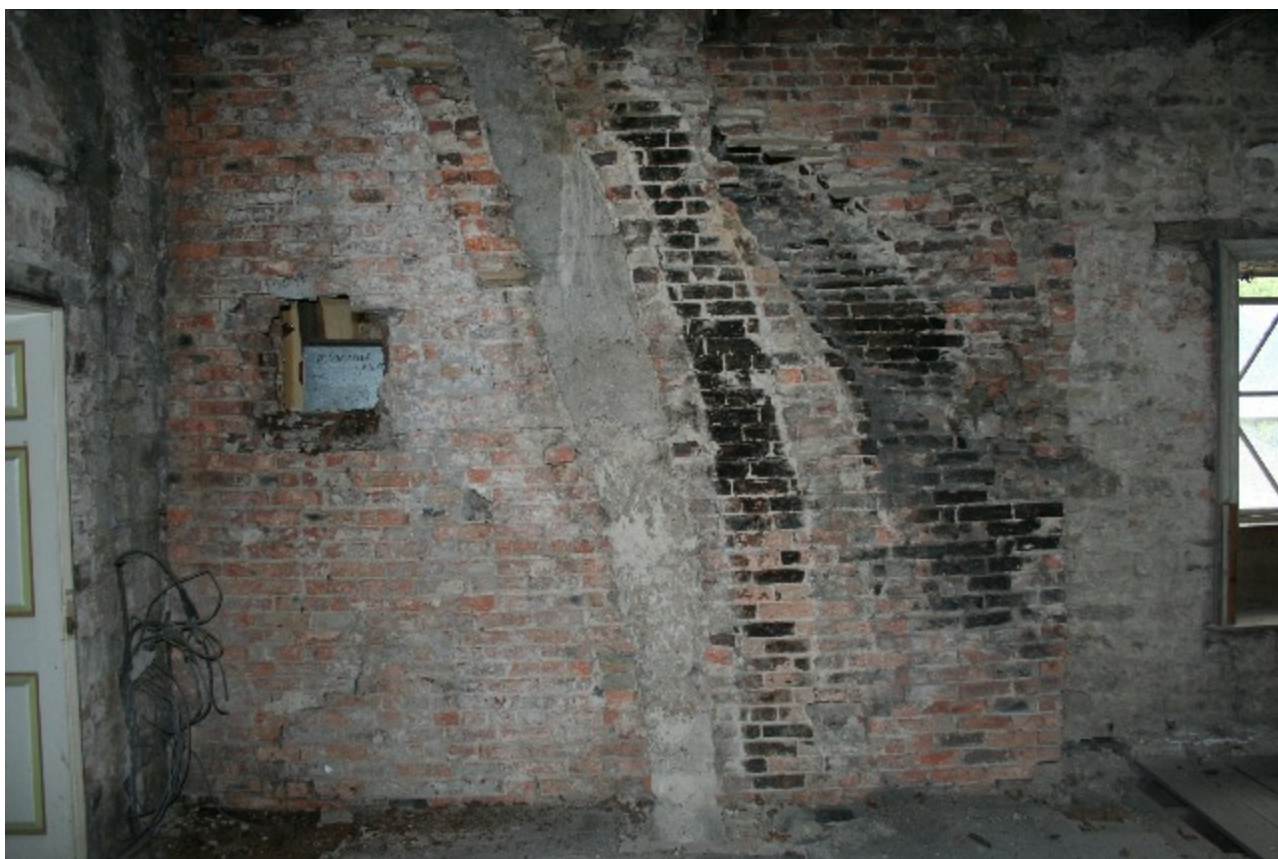
Plate 81. Brick structure in southeast corner of Area 12, view void to duct and flue staining (frame HHR13365)

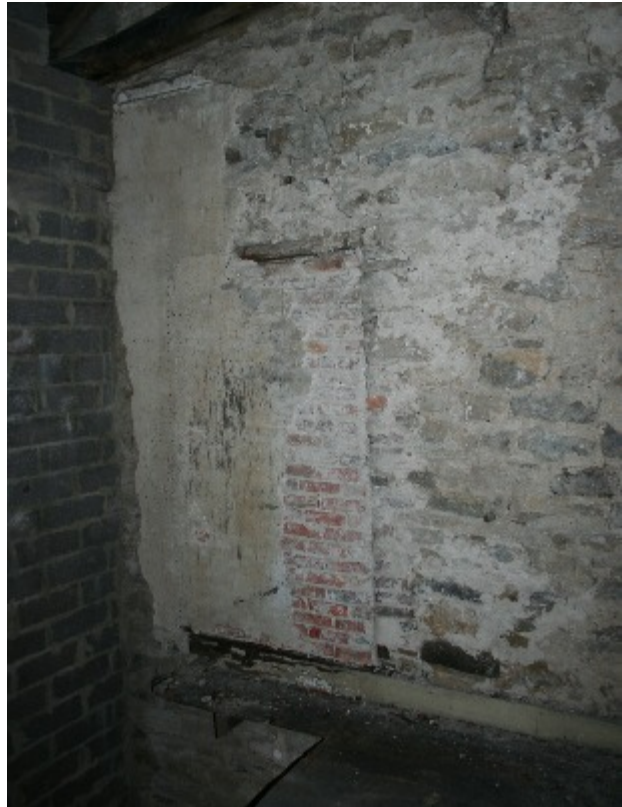
Plate 88. Blocked doorway in Area 32 leading through to Area 33 (frame HHR13393)

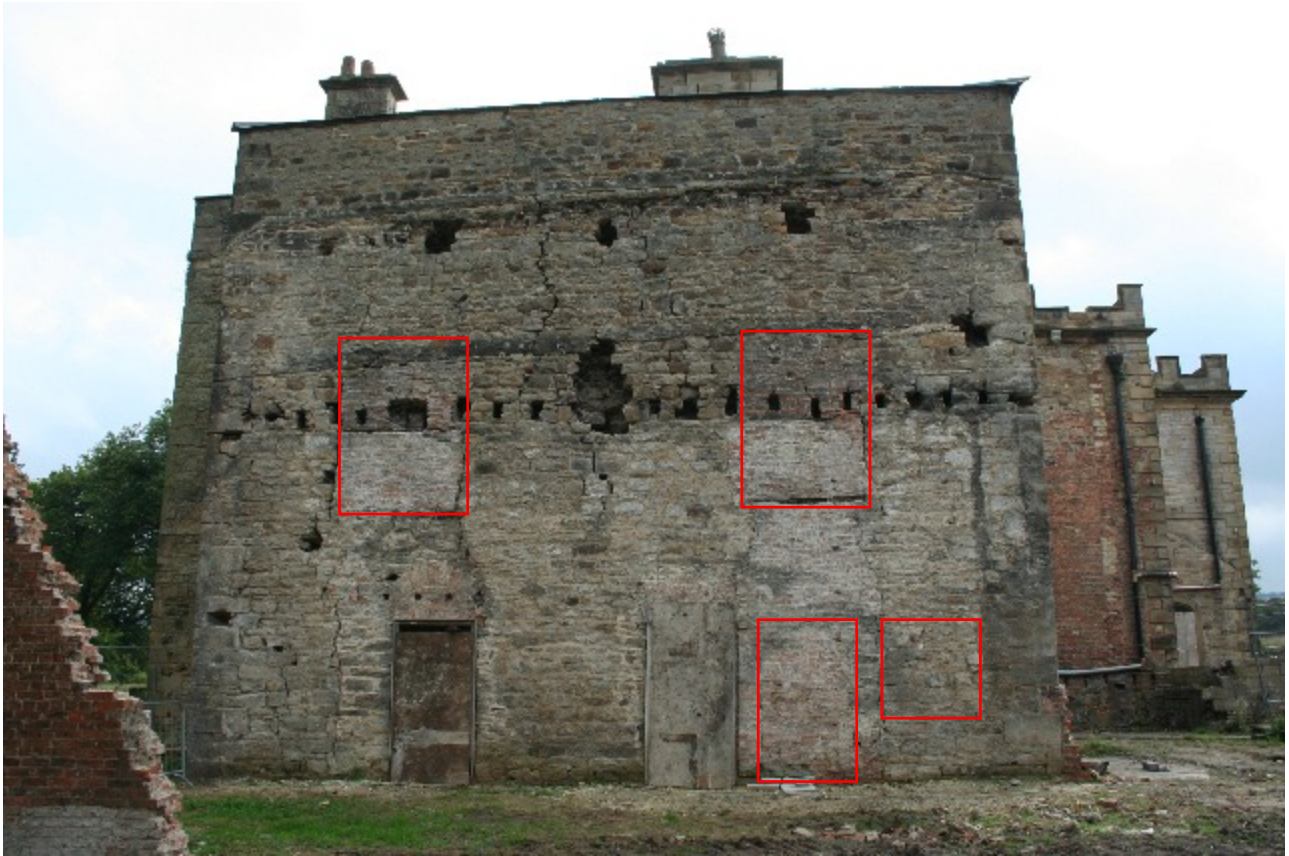
Plate 103. The western elevation, showing blocked openings in red (frame HHR13425).

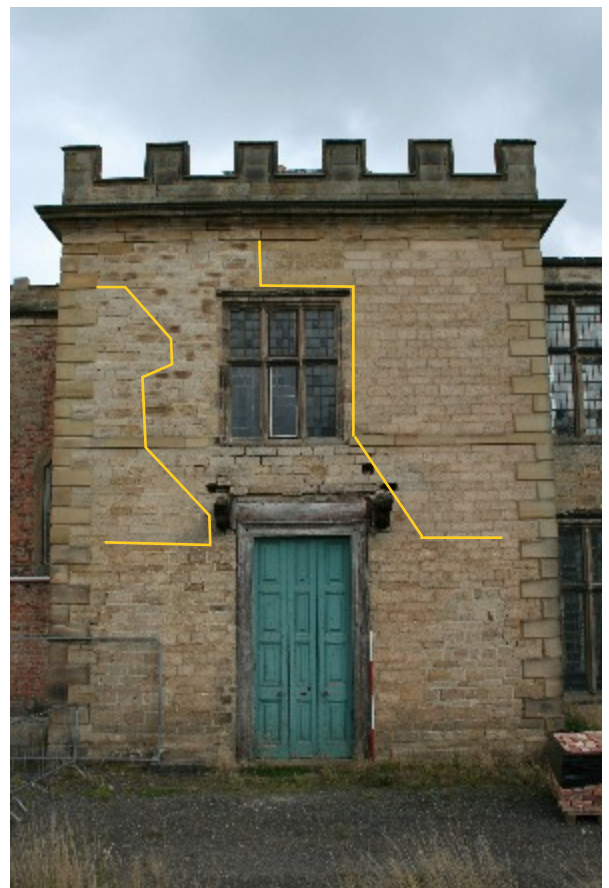
Plate 115. The southern elevation of the east wing and current main entrance, with stonework repair-line in yellow (frame HHR13443)
