Bedlington Old School  
Front Street West, Bedlington  
Northumberland  
NZ 426015 581860

## Archaeological Building Recording

Dysart Developments Ltd

109-14-HS | December 2014

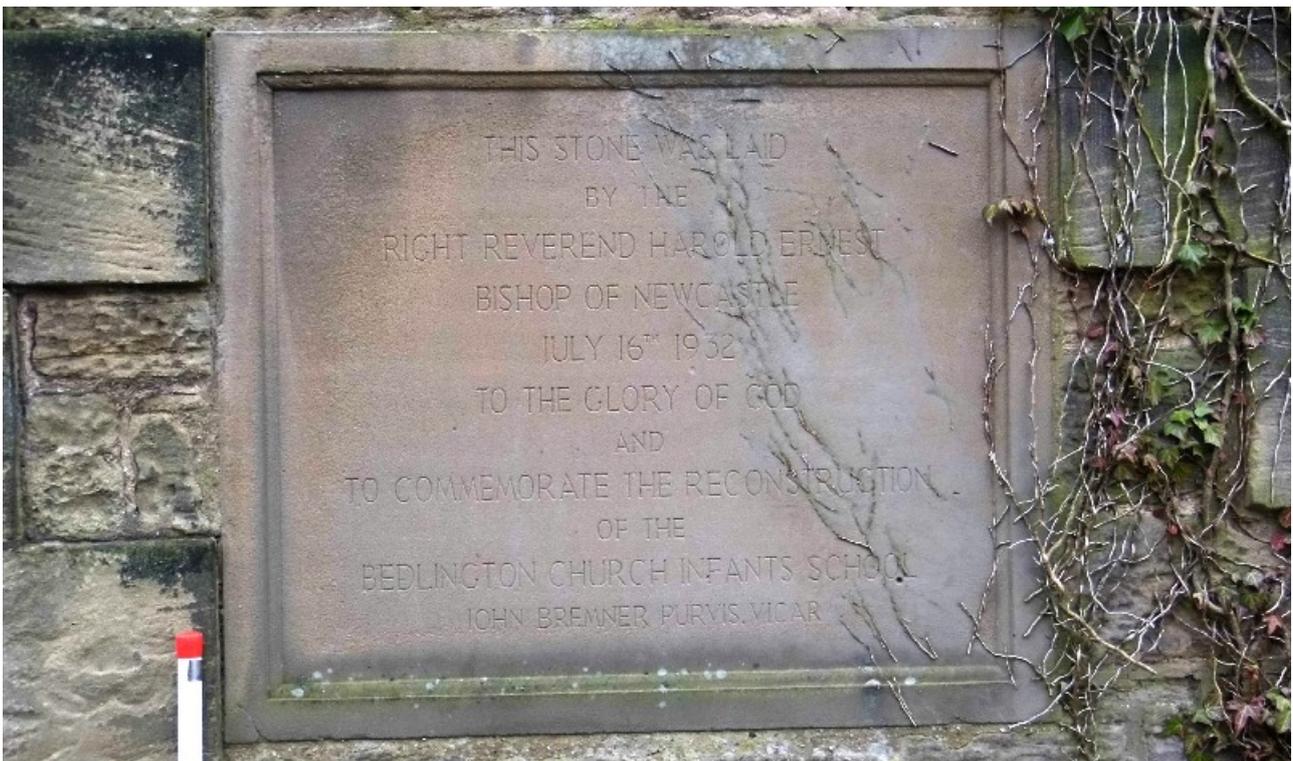
Plate 1. Commemorative stone set in the eastern elevation of the building (frame BOS14002)

3.2.17 Of interest on the eastern elevation is an inset inscribed stone (Plate 1, page 8), set just over a metre height off the ground at the southern extent of the elevation. The inscription reads:

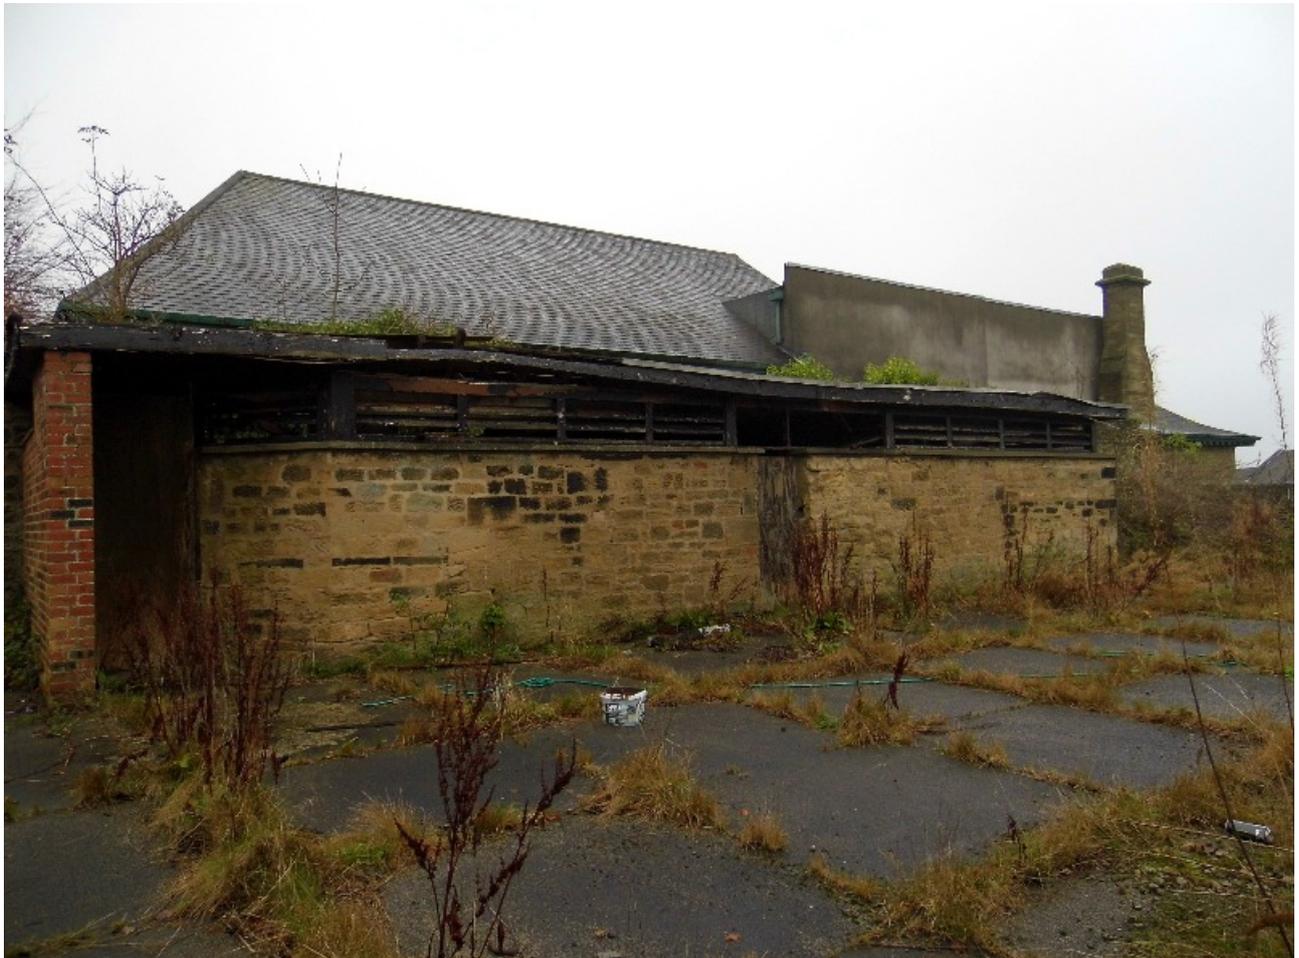
*Plate 2. The outbuilding looking northwest (frame BOS14003)*

- 3.2.1 Outbuilding store: The outbuilding was not accessible at the time of the survey but is simply included here for completeness. The building lies on the western boundary of the development site and is constructed in roughly coursed sandstone rubble with brick piers and a flat felt roof. The outbuilding was constructed between 1937-1959 and replaced earlier buildings. See *Plate 2* below for more detail on the outbuilding.
- 3.2.2 The school: A feature plan of the structure can be found on *Figure 7* overleaf. Externally, the original school elevations are built of roughly coursed squared sandstone blocks with the 20<sup>th</sup> century additions being in red brick. The roof is slate and the building corners quoined. The structure has

sustained a great deal of external damage due to fire and ivy ingress. The original structure also sports a shallow stone plinth at the base of the walls.

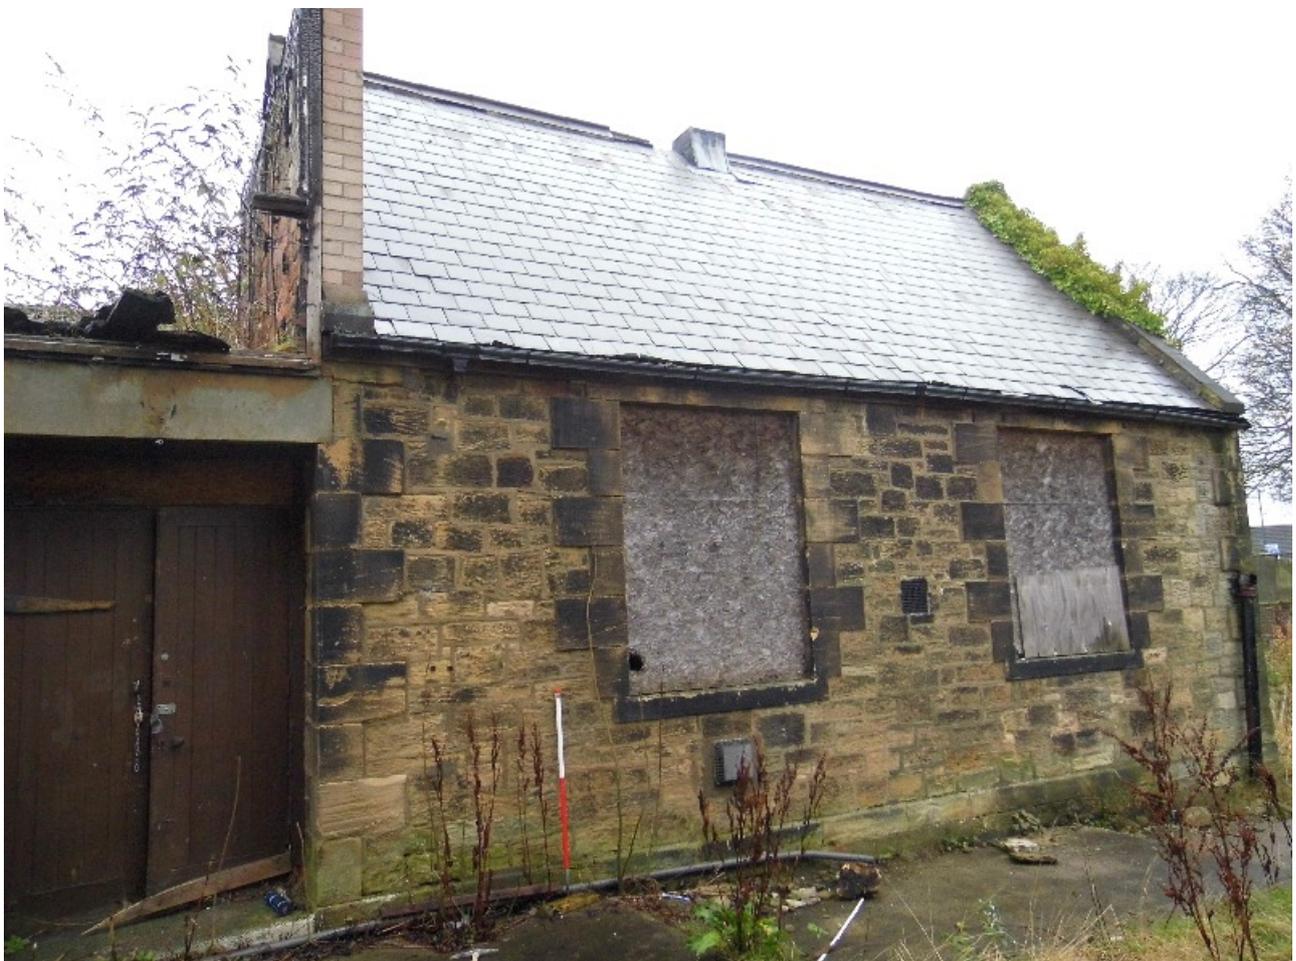
*Plate 3. The southern elevation of the school, showing the original phase on the right (frame BOS14004)*

- 3.2.5 The eastern side of the southern elevation (*Plate 3*) contains two windows, now boarded up. Both windows, W1 and W2, have stone sills and lintels with quoined jambs. A shallow stone plinth is also present.

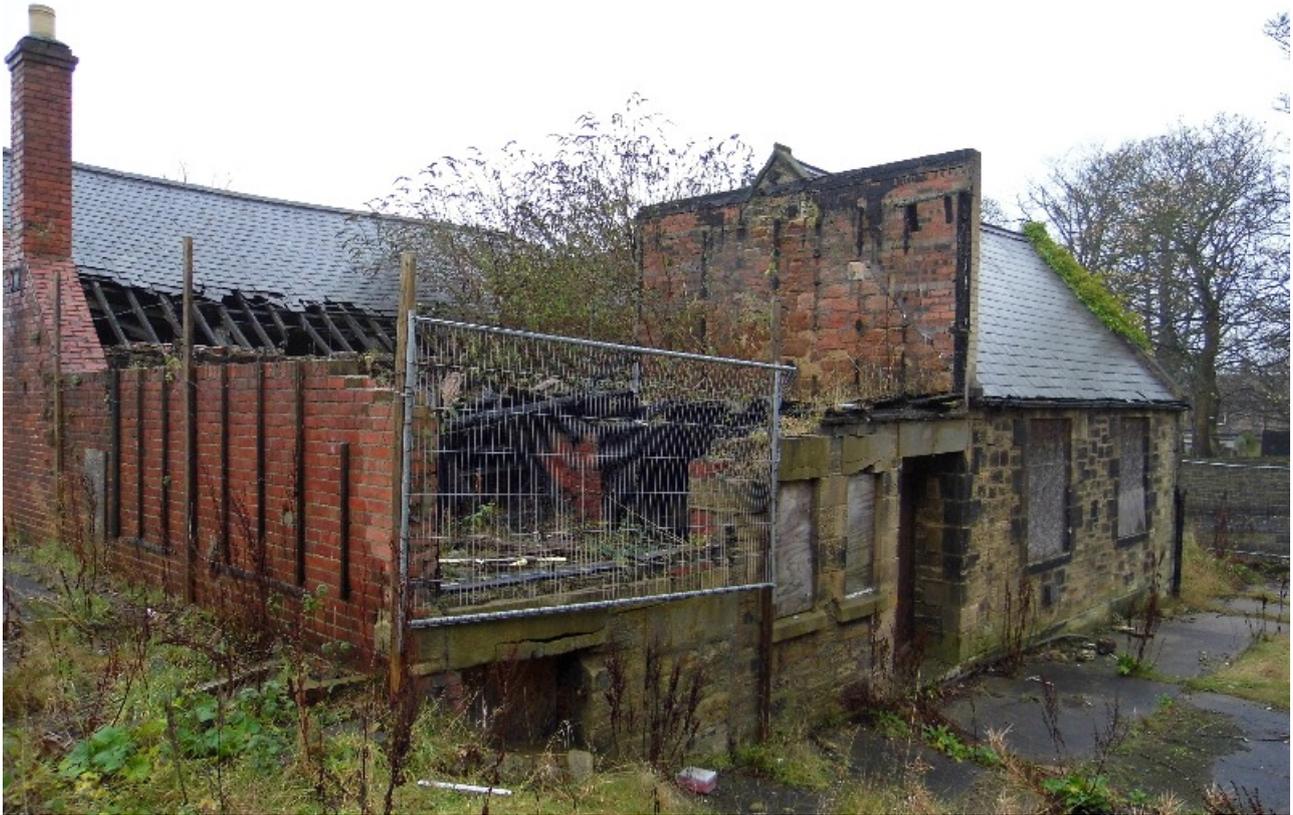
Plate 4. The southern elevation of the school from the southwest, showing the damage to the 1932 building phase (frame BOS14005)

- 3.2.6 The western side of the elevation (*Plate 4*) is badly damaged by fire, though whether through one incident or multiple incidents is uncertain. This block was built in 1932 with a sandstone frontage mimicking the earlier stone phase of construction. The two windows (W20 and W21) are narrow and boarded up, with stone lintels and protruding sills. The doorway (D2) to the storage area is blocked, and it was observed that the area behind this wall was too unstable to enter safely.

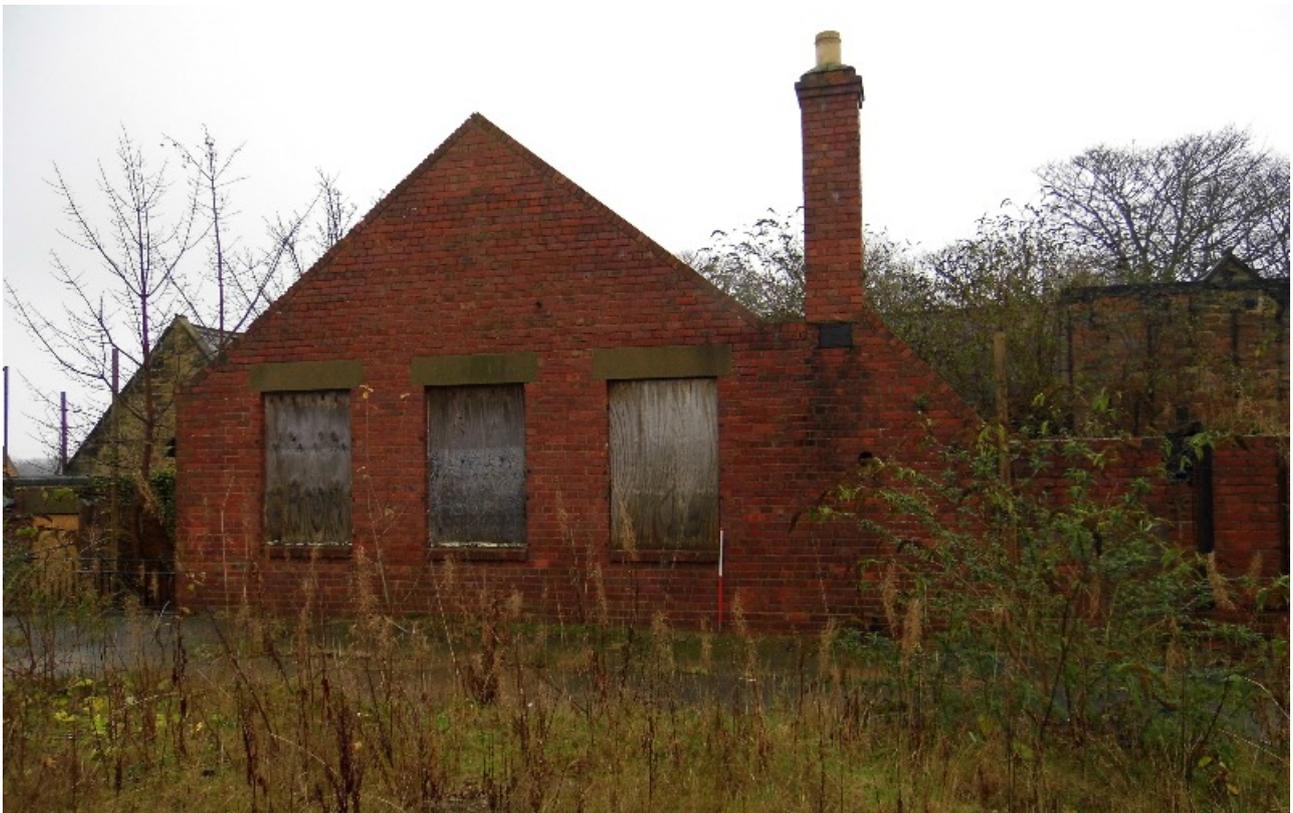
Plate 5. The western elevation, central section (frame BOS14007)

- 3.2.8 **Western elevation:** The western elevation is primarily made up of the 1932 additional build (*Plate 5*), constructed of coursed red brick in English Bond style. The main frontage holds three large windows (W17-19), boarded up, each with a stone lintel and a protruding brick sill.

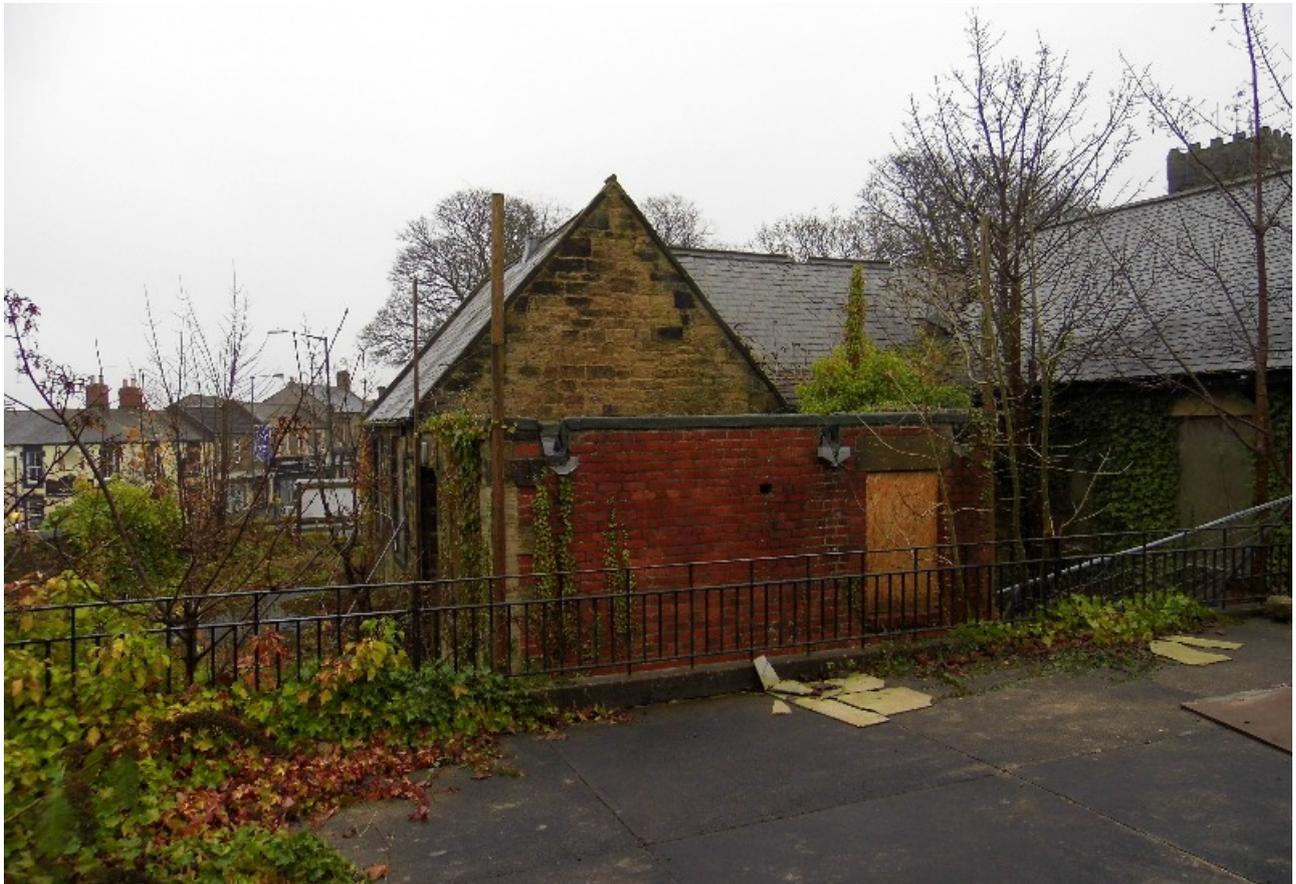
Plate 6. The northern extent of the western elevation showing the original gable in-situ (frame BOS14009)

- 3.2.10 In turn, the elevation returns north for a short section of multiple phased wall, with the base of the wall being the original sandstone built and the upper courses being the 1932 brick build. Where the wall breaks west again onto a further 1932 addition, the original stone gable end of the school can be seen *in situ* (Plate 6).

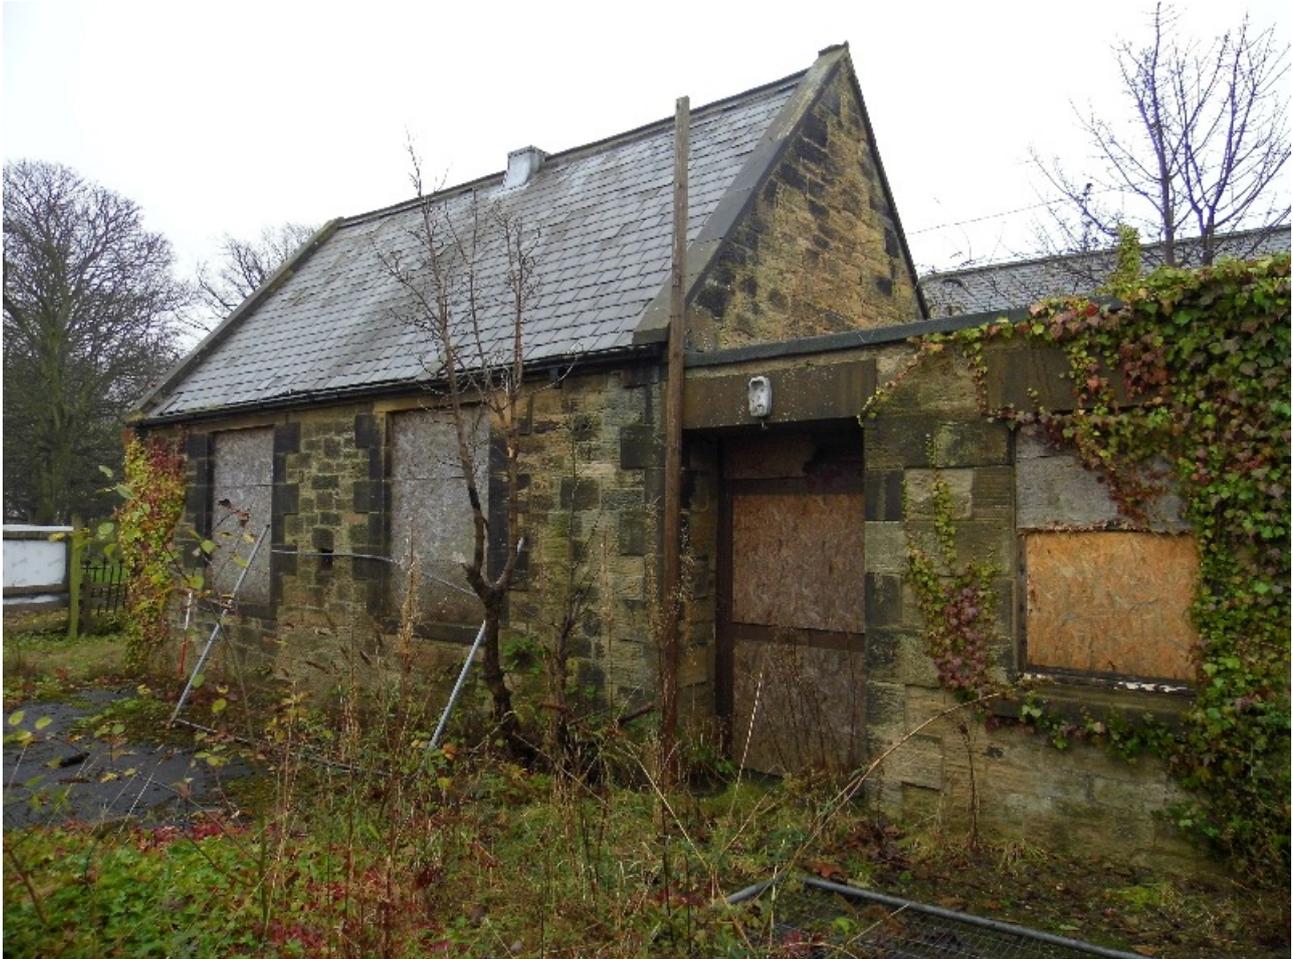
Plate 7. The northern elevation (frame BOS14011)

- 3.2.12 **Northern elevation:** The western section of this elevation belongs to the building's second phase and is built of sandstone rubble, mimicking the original build. The block is squat with a flat felt roof, and holds a single quoined double doorway (boarded up, D3) and one boarded window, W11. This window has a stone lintel and protruding stone sill, while the door has stone sill.

- 3.2.13 The eastern section of the elevation is the original stone build of the school and has two boarded windows, W9 and W10, both of which have stone lintels, sills and quoined jambs.

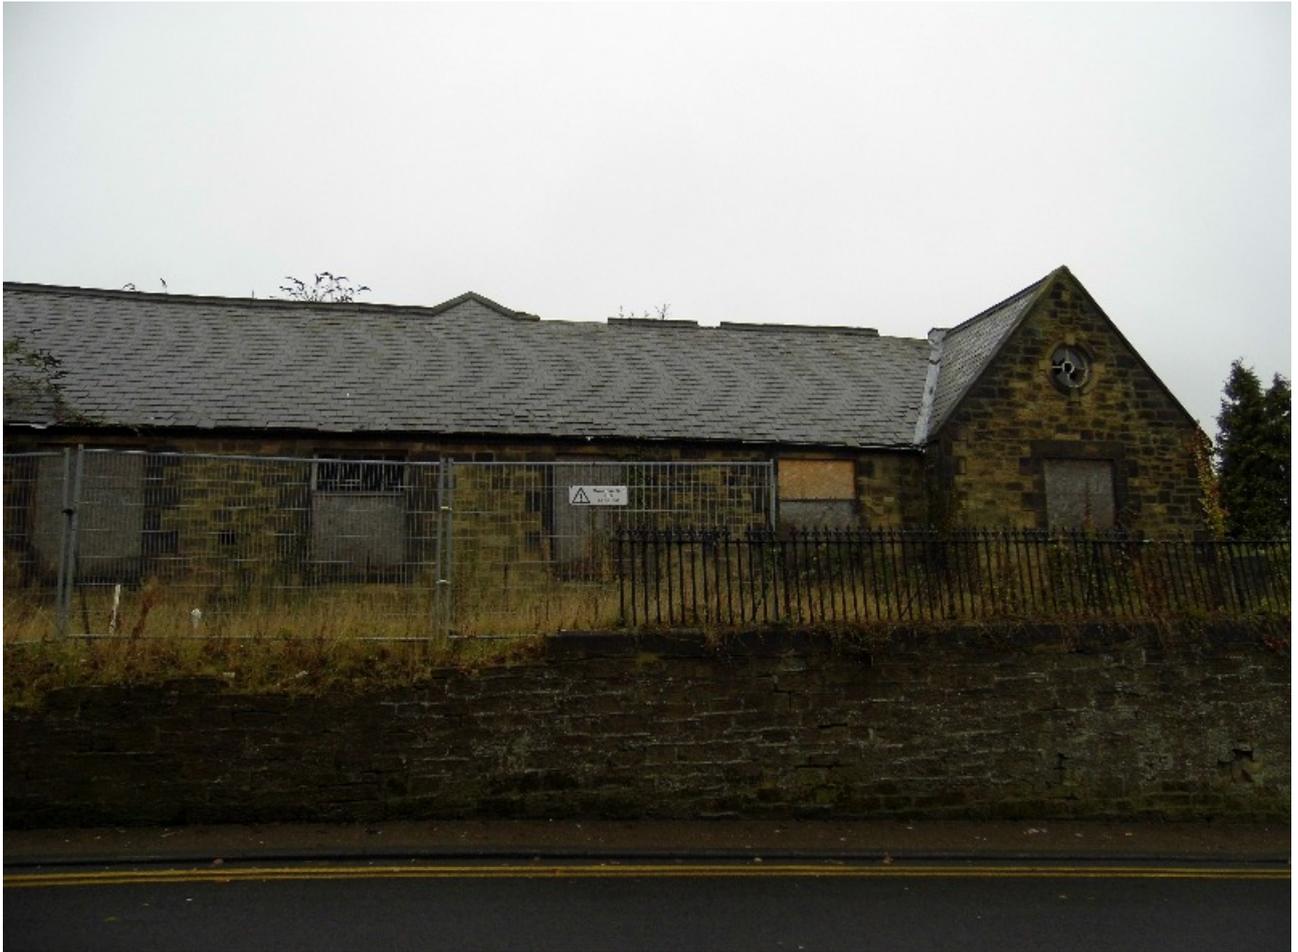
Plate 8. The eastern elevation from Church Lane (frame BOS14014)

- 3.2.16 Each gable end holds a Victorian round leaded window centrally at loftspace height, set in a stone surround with keystones set at each 90° angle. The glass in the northern window is broken, and the southern window (and most of the associated gable) is obscured by a heavy ivy growth.

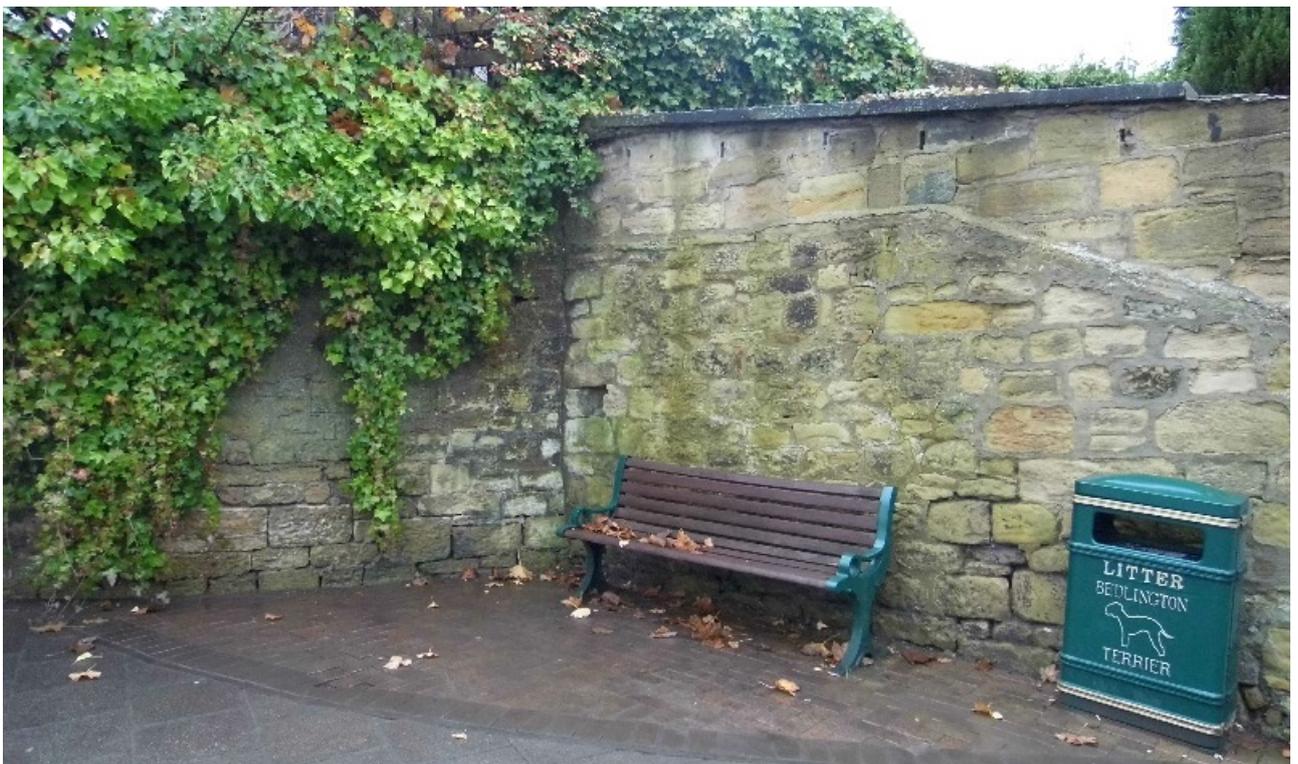
Plate 9. The northeast corner of the boundary wall, taken looking southwest (frame BOS14018)

3.2.18 **The boundary wall:** Like the majority of walls in this section of Bedlington, the property's boundary wall is built of sandstone rubble. For the most part, the current wall follows the original line of the property boundary shown in the 1865 Ordnance Survey map. However, it has been repaired over the years and added to. Plate 9 (opposite) shows a view of the northeastern corner of the boundary wall, used as a shelter: the layers of repairs and additions are clearly visible.

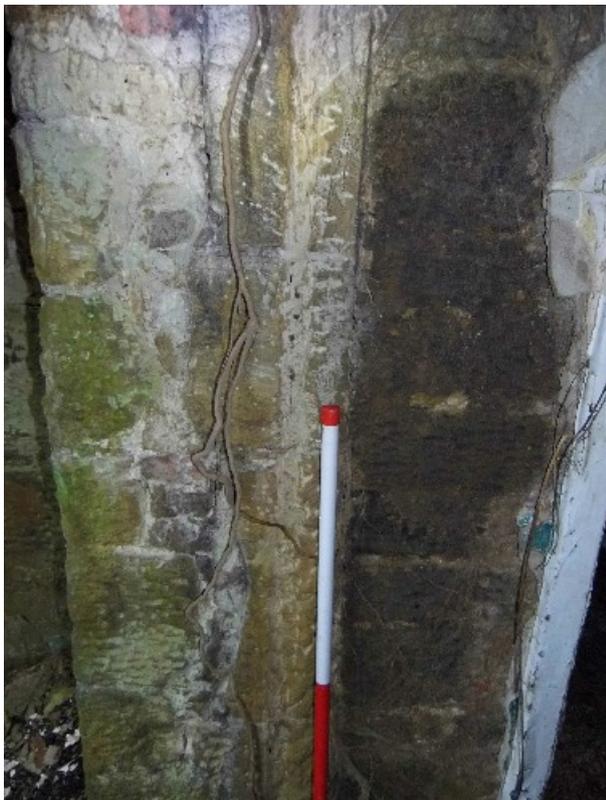
Plate 12. Storage area 2 looking southwest (frame BOS14023)

3.3.4 **Area 2 (storage room):** 2.1m x 1.8m. This small storage area was extremely unstable, with a loose damaged overhanging ceiling and floor debris. For health and safety reasons, this room was not entered but simply photographed from doorway D14.

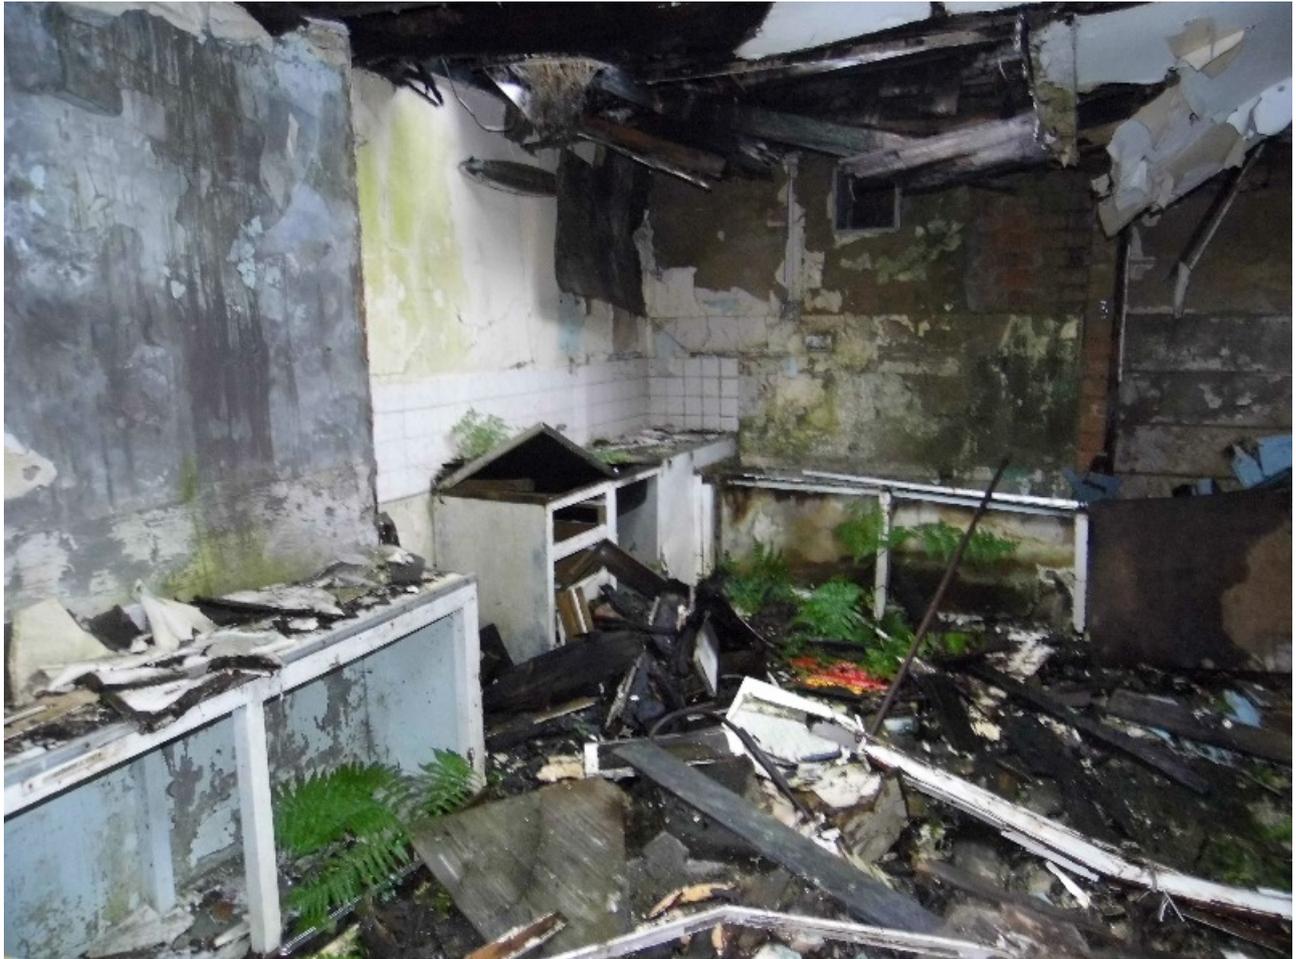
Plate 13. The kitchen (Area 4) looking southwest (frame BOS14026)

- 3.3.8 **Area 4 (kitchen):** 5.1m x 4m. The kitchen was severely damaged by fire (see *Plate 13* above), rendering it too dangerous to enter. The room was photographed from the doorway. The ceiling had mostly collapsed and the floor was strewn with debris, making it impossible to gauge safe footing.

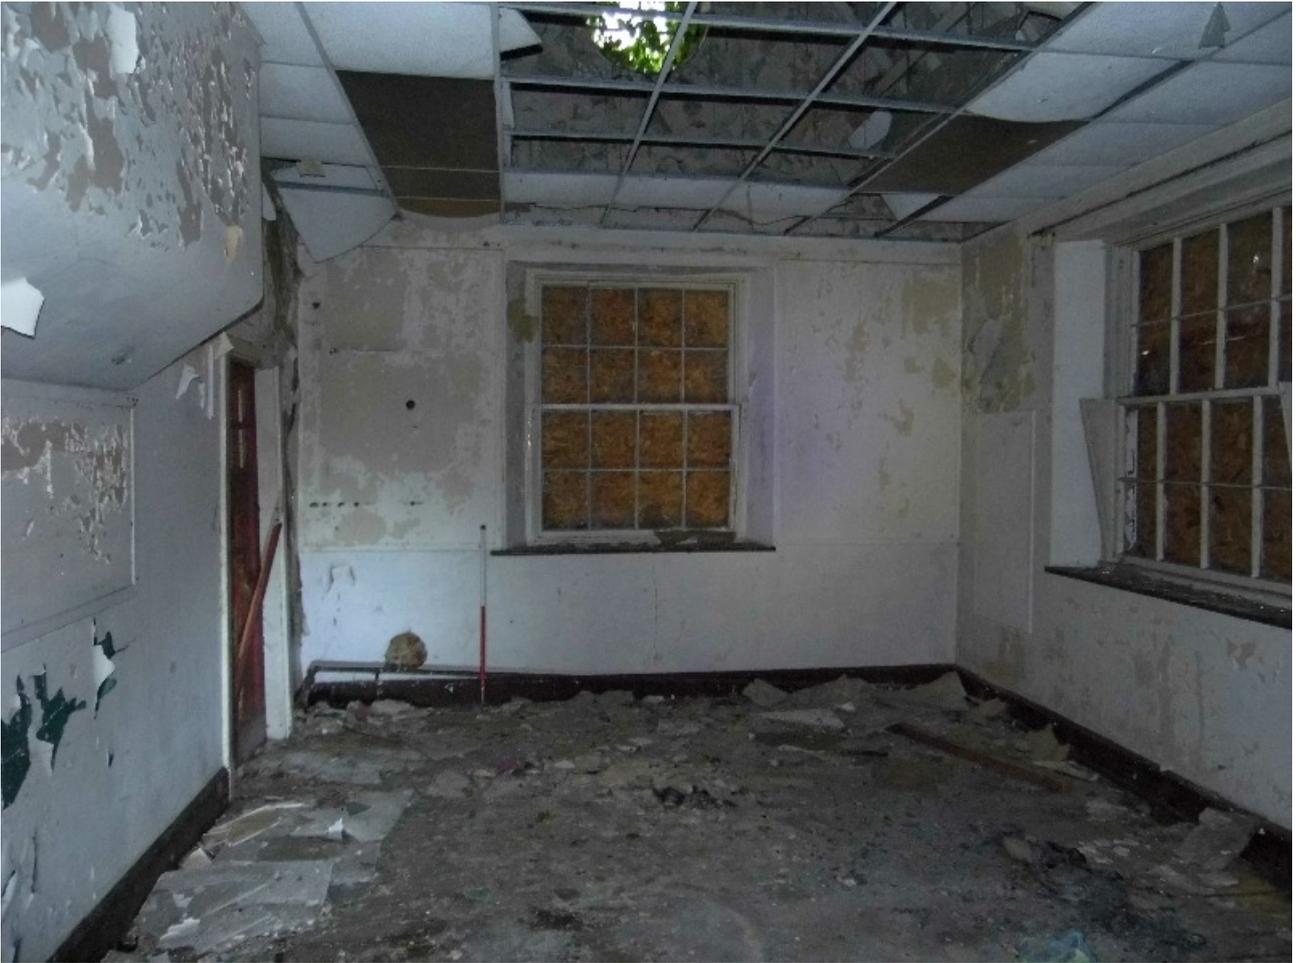
Plate 14. Room 1 (Area 5) looking east (frame BOS14027)

- 3.3.10 **Area 5 (Room 1):** 7.5m x 4m. Room 1 had been a relatively spacious classroom, with a suspended ceiling and three large hopper windows for light. Windows W1-3 all had 16 lights divided between the upper and lower frames. The room also had a basic skirting board and in the north wall were the remains of a chimney likely to have been removed in the 1930s rebuild or later. In the north wall was a rotten timber door (D6) with 6 upper lights and wooden panelling, set in a plain architrave.

- 3.3.11 The wooden floorboards were rotten and the suspended ceiling was collapsing, making access to the room an issue.

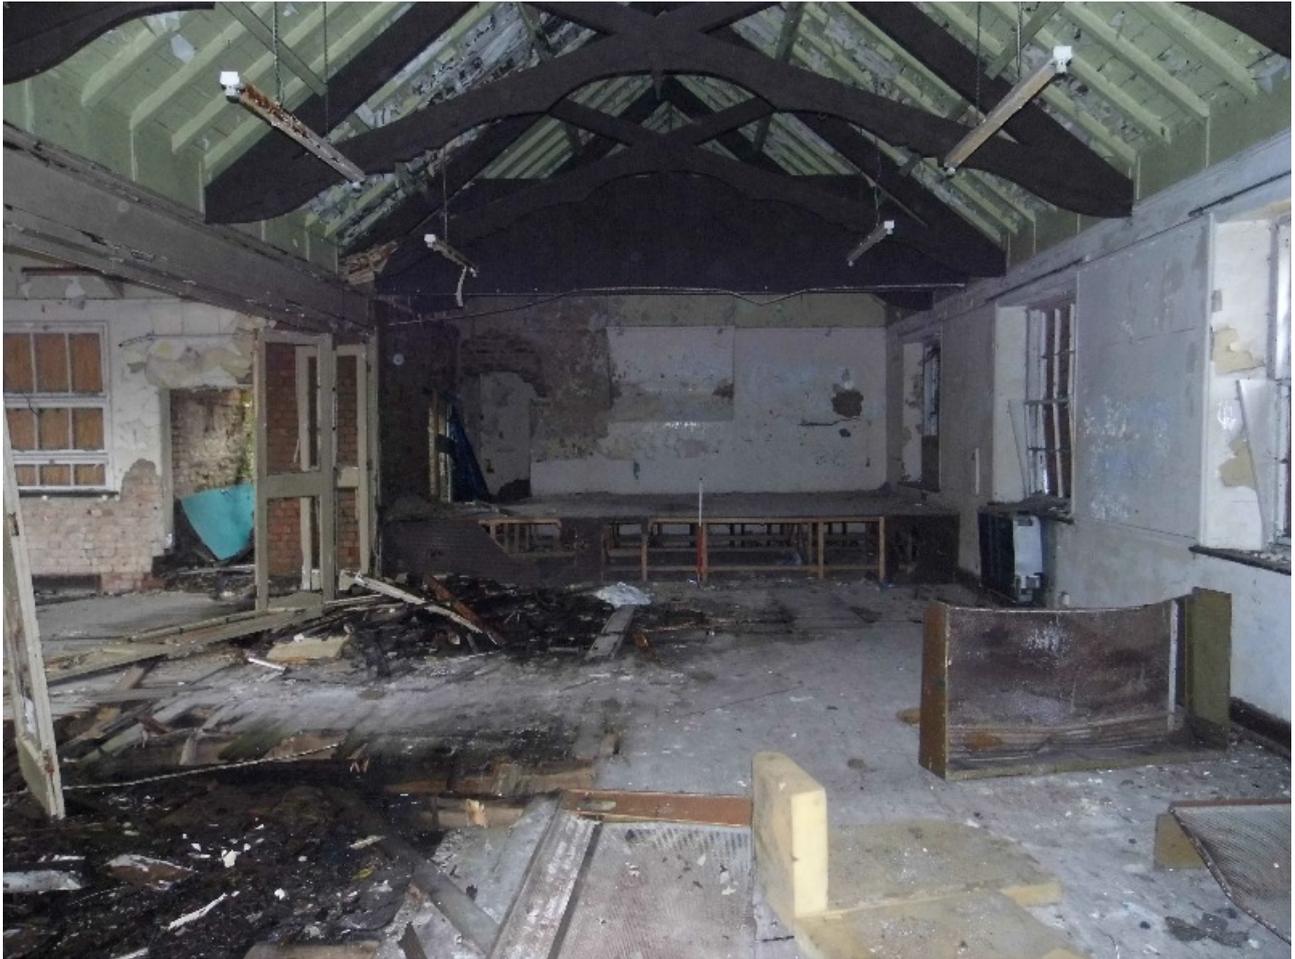
Plate 17. The Assembly Room (Area 6) looking north (frame BOS14031)

- 3.3.12 **Area 6 (Assembly Room):** 15m x 6m. The Assembly room had a number of access issues, with the floor timbers being primarily rotten and in some cases burnt as well as the accessible floor area being strewn with syringe tips and other potential narcotic paraphernalia. The western stud wall that would once have divided the hall from Room 2 (Area 7) was gone, and had been in part used to cover large areas of damaged floor in Area 7.

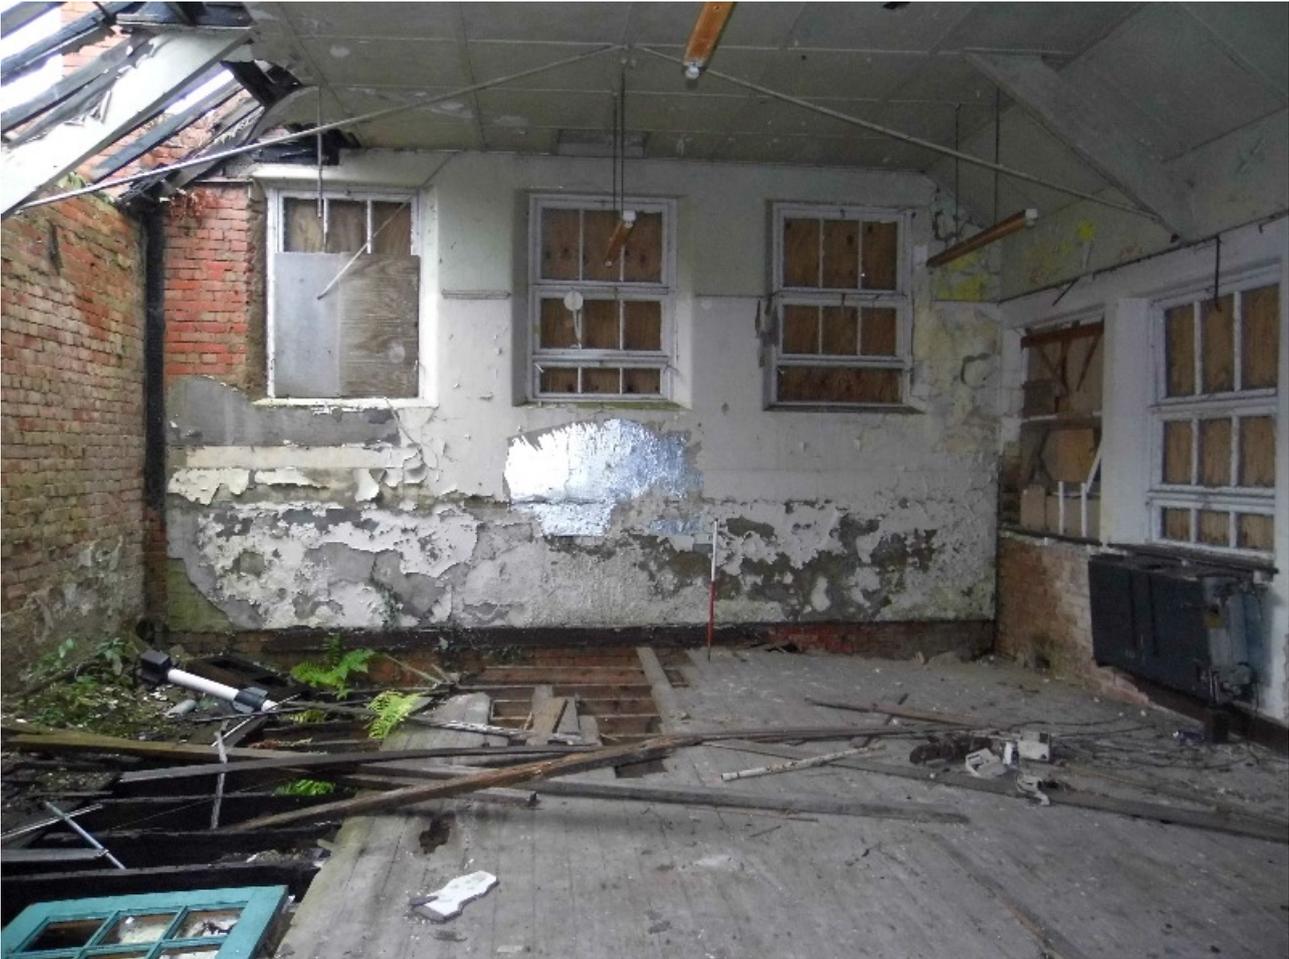
Plate 18. Room 2 (Area 7) looking west (frame BOS14035)

- 3.3.15 This room would have been the primary hall for the original 19<sup>th</sup> century school build.
- 3.3.16 **Area 7 (Room 2):** 7.8m x 7.7m. Room 2 was added in 1932 and divided by a stud wall from the Assembly Room. Like Area 6, Room 2 had access issues due to the rotten and broken floorboards, coupled in this case by the southern extent of the room having been subject to a fire causing severe roof and ceiling damage.

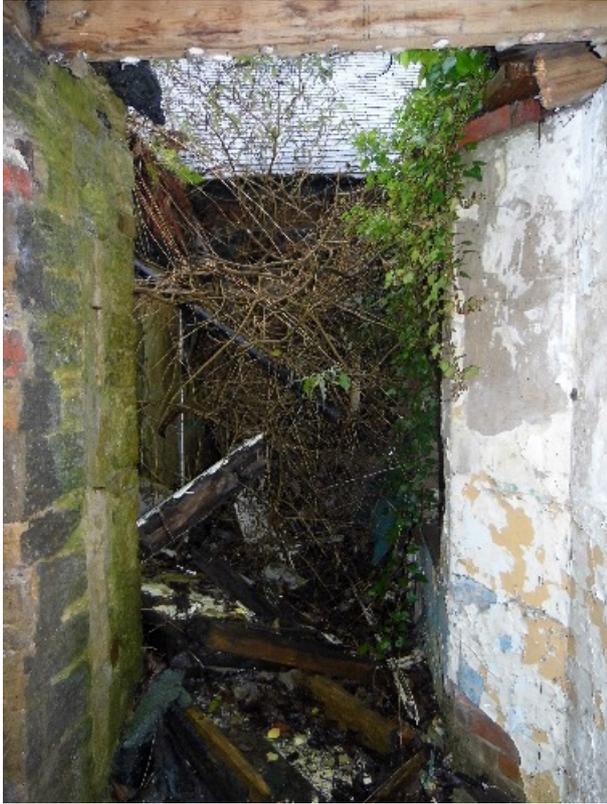
Plate 19. Access through the northern doorway in Area 7 to lobby Area 8 (frame BOS14037)

- 3.3.17 Nothing of architectural or historical interest was observed in this area.
- 3.3.18 **Area 8 (northern lobby):** 8.7m x 2.1m (max). The northern lobby could only be accessed across the stage in Area 6 and through the northern door (D11), through Area 9 and back into the lobby. The ceiling and roof in this area had almost fully collapsed, leaving precarious overhangs: a tree

had also grown up through the debris causing further problems (see *Plate 19*). In the northern extent of the lobby is a timber double door, likely to be original to the 1930s build. (See *Plate 20*).

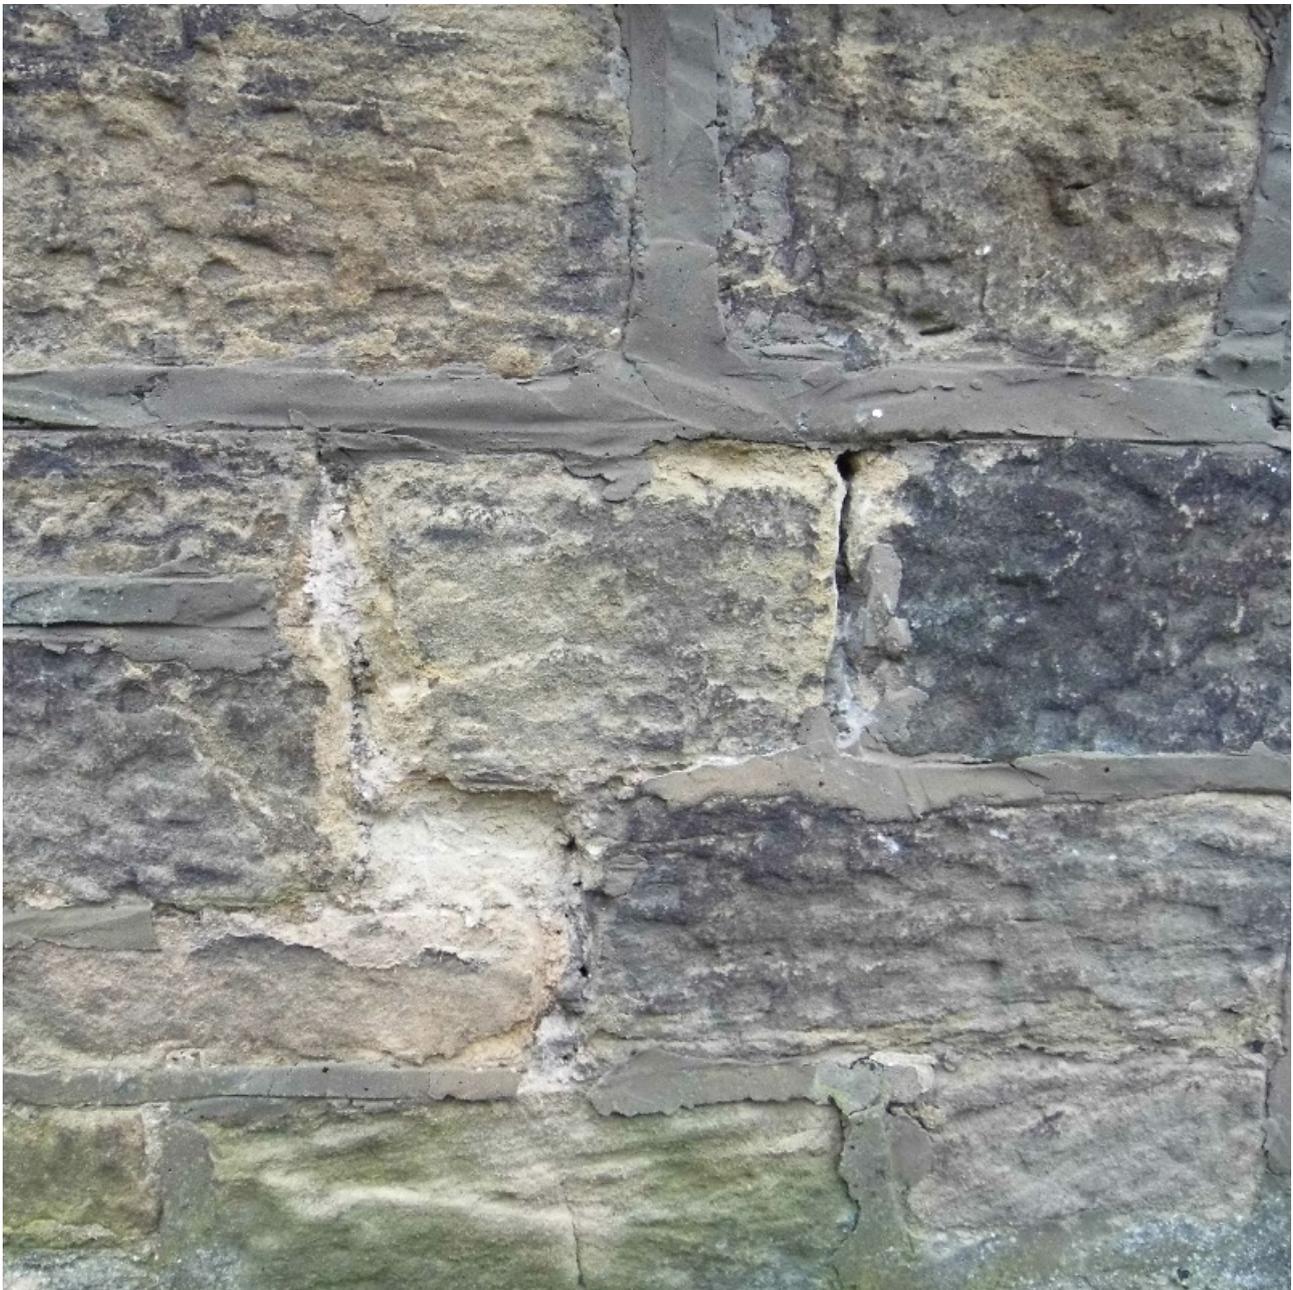
Plate 22. An example of the degraded stone on the southern elevation with inappropriate pointing materials (frame BOS14017)

3.4.1 The stone was very soft sandstone of poor quality with high porosity levels similar in appearance to Blaxter or Millnock stone.

- 3.4.2 Unfortunately this type of stone is commonly used in and around the Bedlington area and almost without exception, buildings made with this stone have issues with both porosity and structural stability.
- 3.4.3 Stone of this type has a problem with moisture and is prone to surface decay or dusting. This problem is increased when it has been pointed in cement as the joints become waterproof and any moisture that is formed is forced to expel from the stone and not the joint (lime pointing would allow the joints to breathe).
- 3.4.4 In conclusion we would not recommend the re-use of this stone in any new build. The only exception to this is the plaque which is built into the south side of the east elevation as this is sandstone of a much higher quality.

- 4.2.2 **03/00508/CON Condition 3 (Heritage Consolidation Ltd)**: Examination of the stone comprising the current school building has suggested that the material is subject to porosity and structural stability issues. It is recommended that the stone is not re-used in the new build, except the stone inscription block on the eastern elevation which is of higher quality than the rest of the material used in the building and thus usable in the new build.
