Cow Tag <u>111</u>		Function Code <u>526.3A</u>
Brief Description: [timber element, p/s, condition, fragments] <u>NEAR COMPLETE PLANK, BROKEN AT STERN END CENTRE UPPER EDGE ALSO BROKEN</u>		
Notable Features: [tool marks, scribed lines, decoration, repairs] POINTS TO LOOK OUT FOR WHEN RECORDING ufos <u>SCRIBED LINES AT 3rd TREEMAIL FROM BOW. - SNIT 3mm PIN</u> <u>Rounded depression adjacent to treemail - failed engraving?</u> <u>- see attached diagram. Many indentations on inboard face. Why?</u> <u>See also 456 - two frags probably from aft area adjacent to pile.</u> <u>Cut into 3 pieces due to flimsiness 2803 + 2804</u> <u>see sketch on reverse</u>		
Wood Science: [rings, ARW, knots, sapwood, conversion] <u>Occasional small knots. Pith <del>at</del> at upper edge (based on age trend). Marked age trend with aw for 1st decade of 5.5mm</u> <u>At forward end c 90H aw = 202/90.</u> <u>True radial.</u>

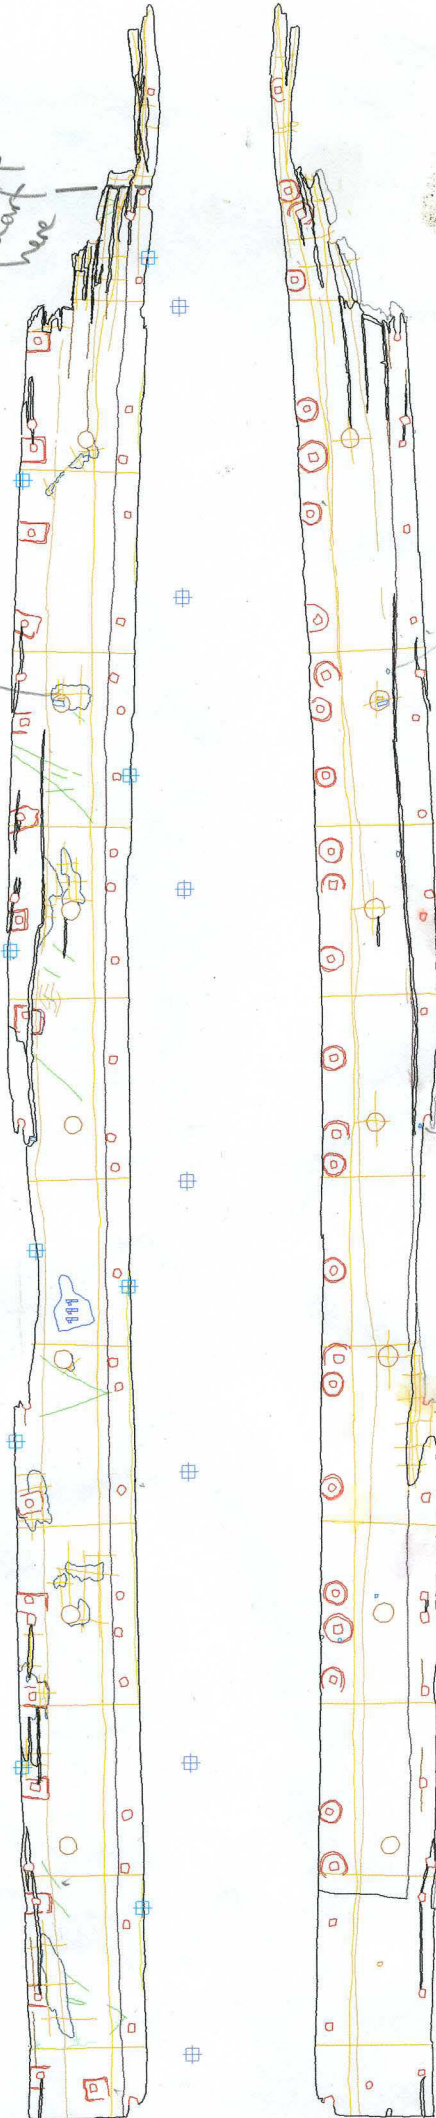
COWTAG  
III

rounded depression  
- faded auger?

Needs  
line of  
scarf  
here
