DB 11/2/8 [REDACTED]

Cow Tag 11/4 Function Code 524.24

Brief Description: [timber element, p/s, condition, fragments]
Foreman HALF of S24.2, lower edge eroded,
cut prior to clearing (from 115)

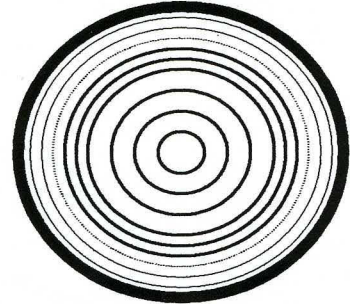
- 1. B. line c. 20cm from top edge
 - " c. 20cm from top edge, lower edge
 - " ? c. 40cm from top edge, next to area of damage
 - " c. 70cm from top edge centre stain
- TYPE (7+3)

O.S :- Surface v. smooth, continuous, hard, softwood
Soft.
- POSSIBLE BORER DAMAGE

PART OF AFT END IS SAWN OFF, REST IS BROKEN OFF

c 60H Radial Pith beyond
upper edge on opposite side
ARW = 215/60.

CALIBRATION WAS NOT PERFECT ON OUTBD. FACE (X-Y-DEVIATION OF 0.5-07); DIMENSIONS OF DRAWING SEEM TO BE OK
