Cow Tag 124	Function Code 516.2B	
Brief Description: [timber element, p/s, condition, fragments] Damaged on both ends. Sapwood clearly defined on upper edge.		
Notable Features: [tool marks, scribed lines, decoration, repairs] POINTS TO LOOK OUT FOR WHEN RECORDING ufos Inboard: Additional nails on aft scarf. Inscribed lines to centre of plank. Outboard: A number of inscribed lines. Large abundance of borers. Inboard: sample 25kg = from rim of land → plant material outboard: - type 2 lines (?) grouped around 5th tree nail - type 2 lines - additional nail next to 4th tree nail - deep axe mark further comment: P.T.O		
Wood Science: [rings, ARW, knots, sapwood, conversion] Radial. c 75H + 10S P.A. beyond lower edge. ARW = 222/85

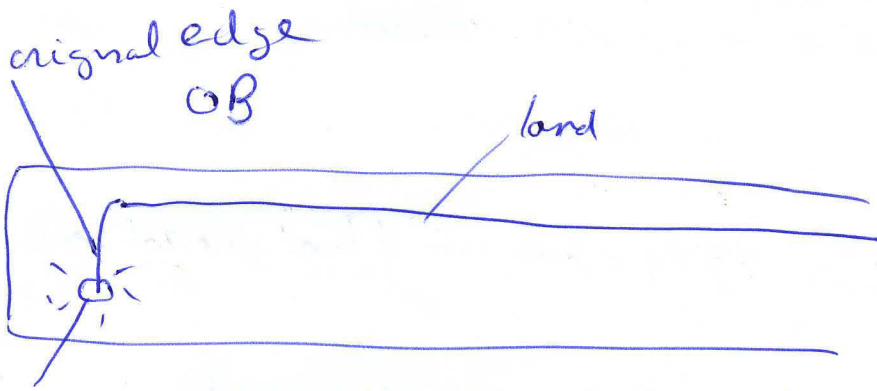
line ends here, doesn't connect up to lower edge of planks
